Photograph 1

David Welch House, Litchfield, Ct.

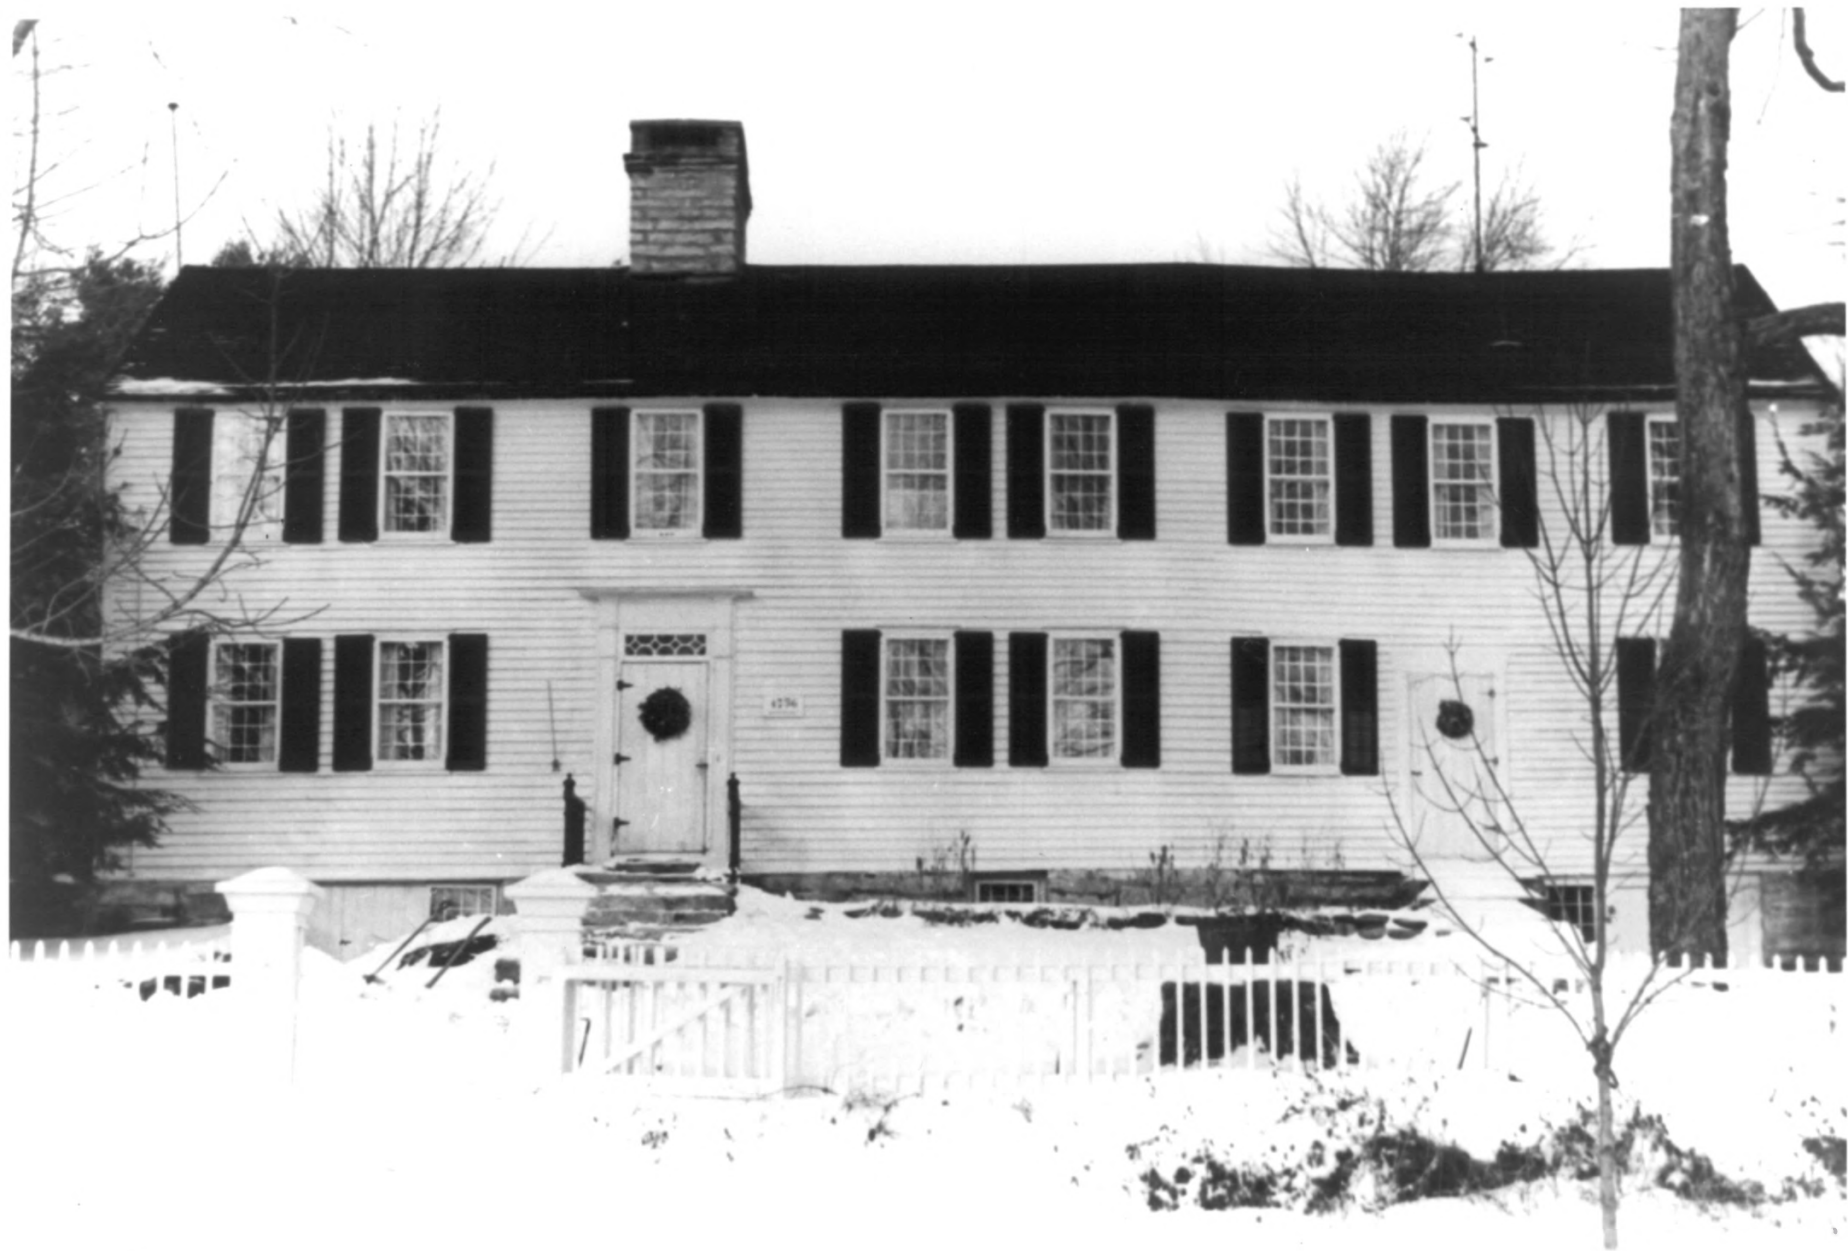
Photograph 2

Front elevation, looking north. Shows unbalanced facade with lights over main door and Dutch door to right leading to former store addition.

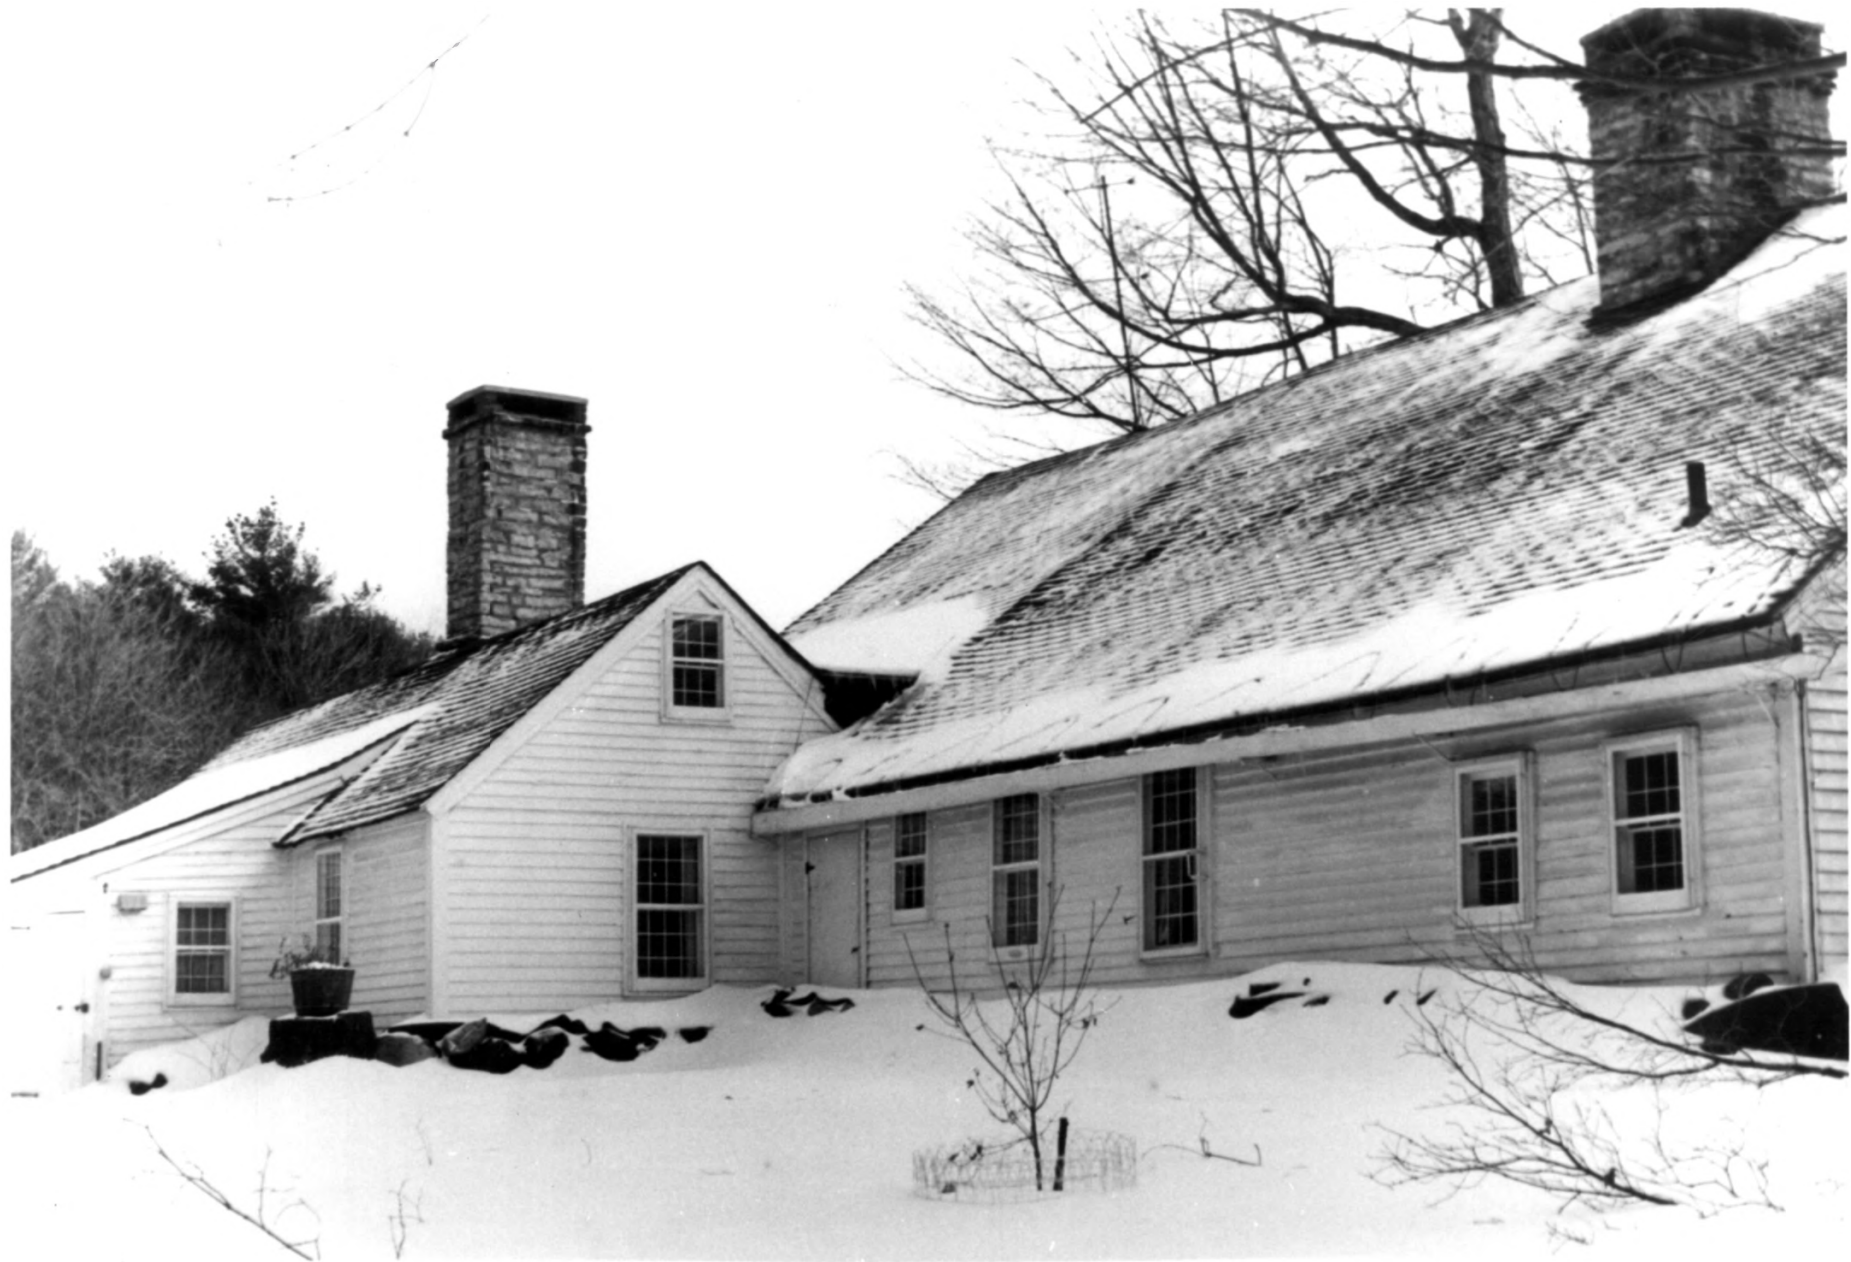
Photograph 3

Rear elevation, looking woutheast, showing 1792 kitchen
and pantry, extended by modern kitchen and sheds.

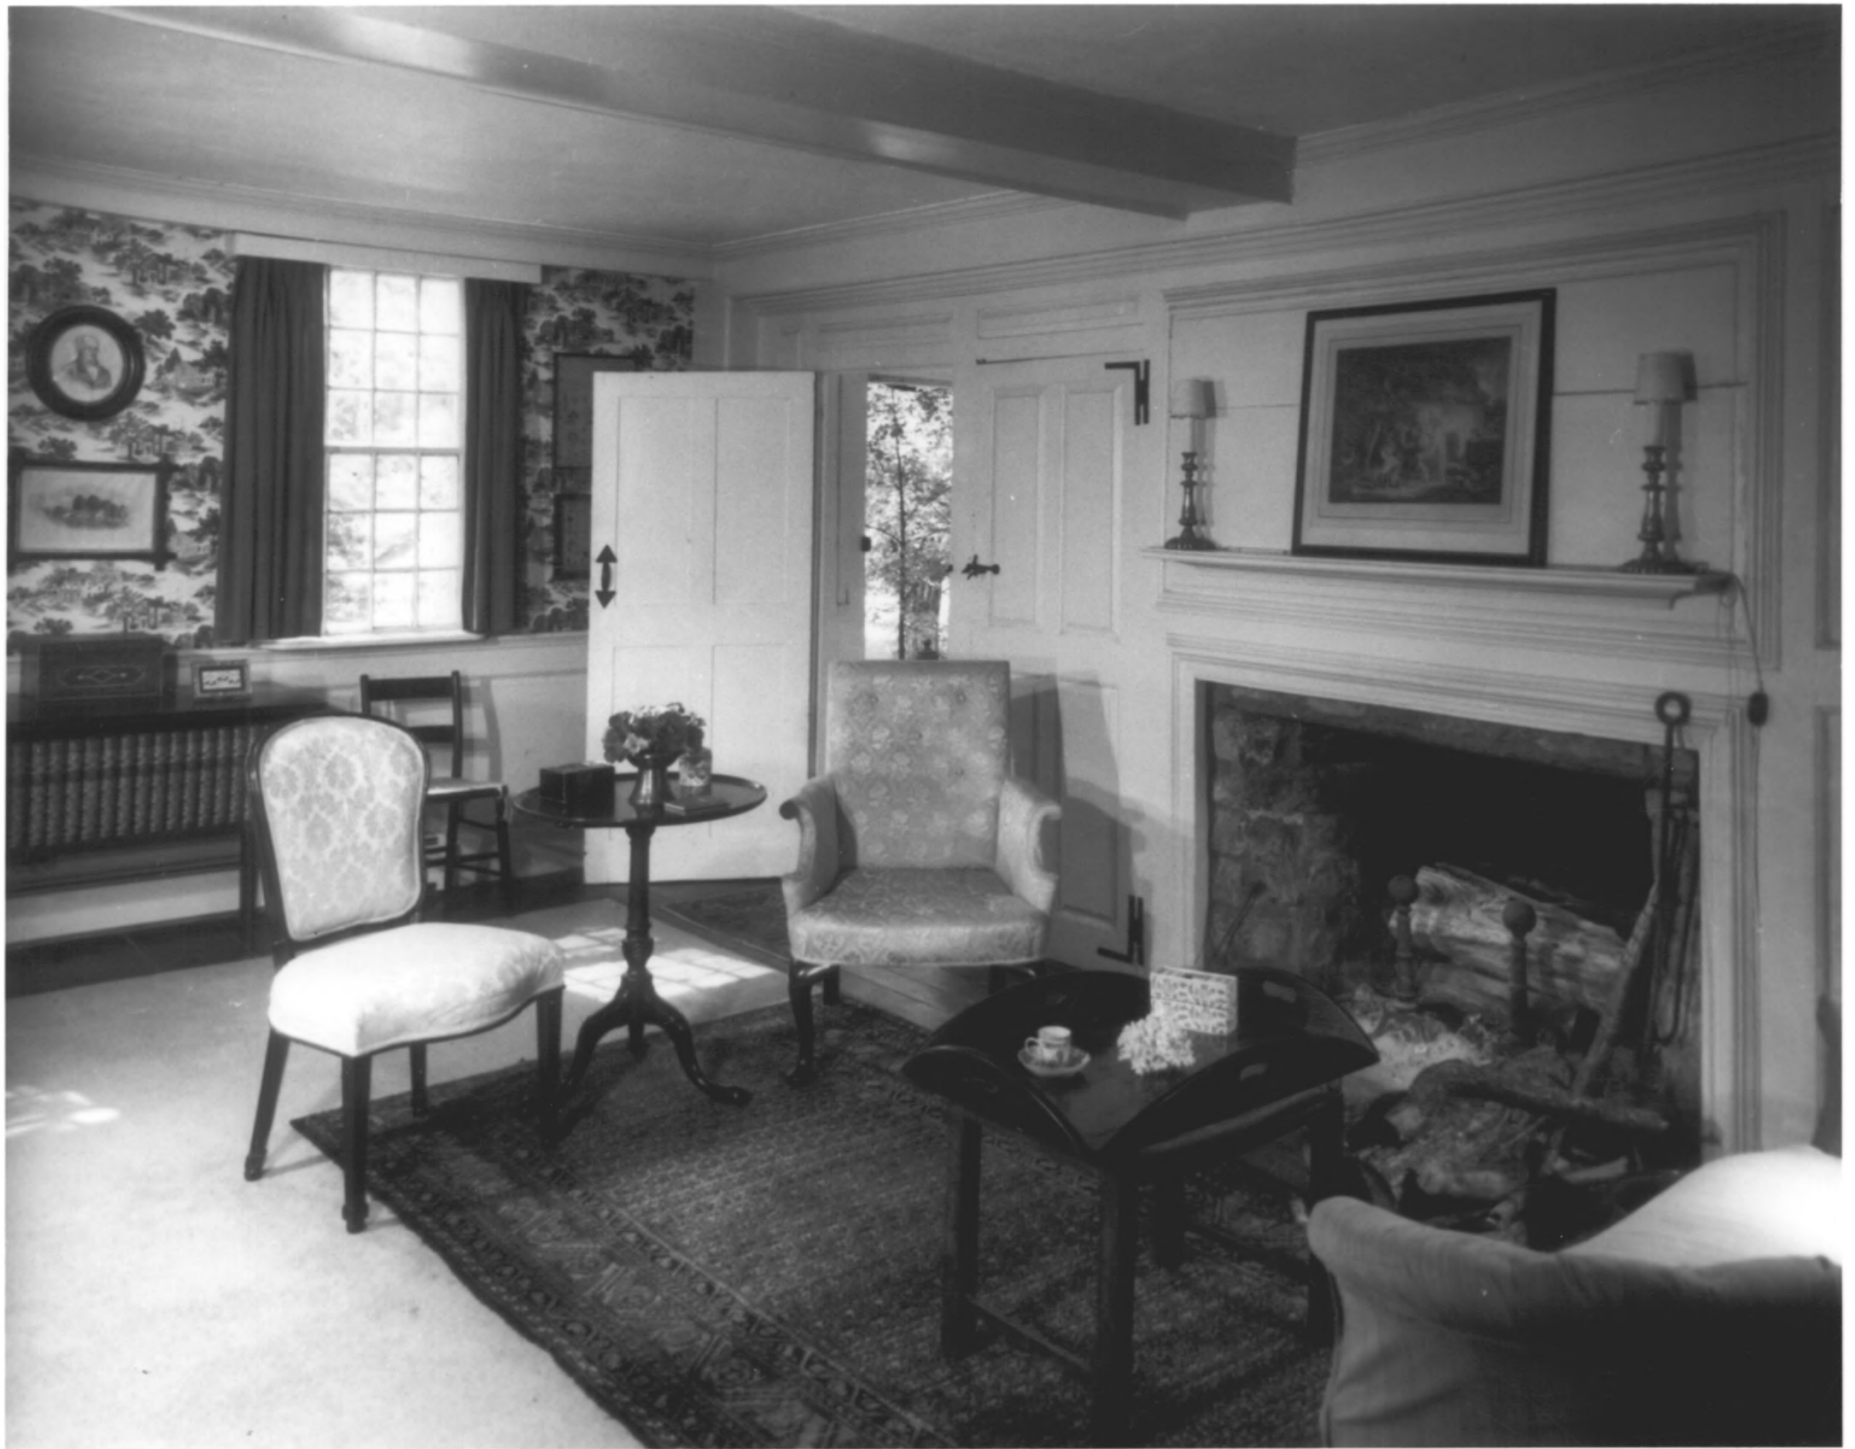
Photograph 7

Living room, facing west, showing vertical panelling and finished trim. Wide, white oak, random-width flooring is original.

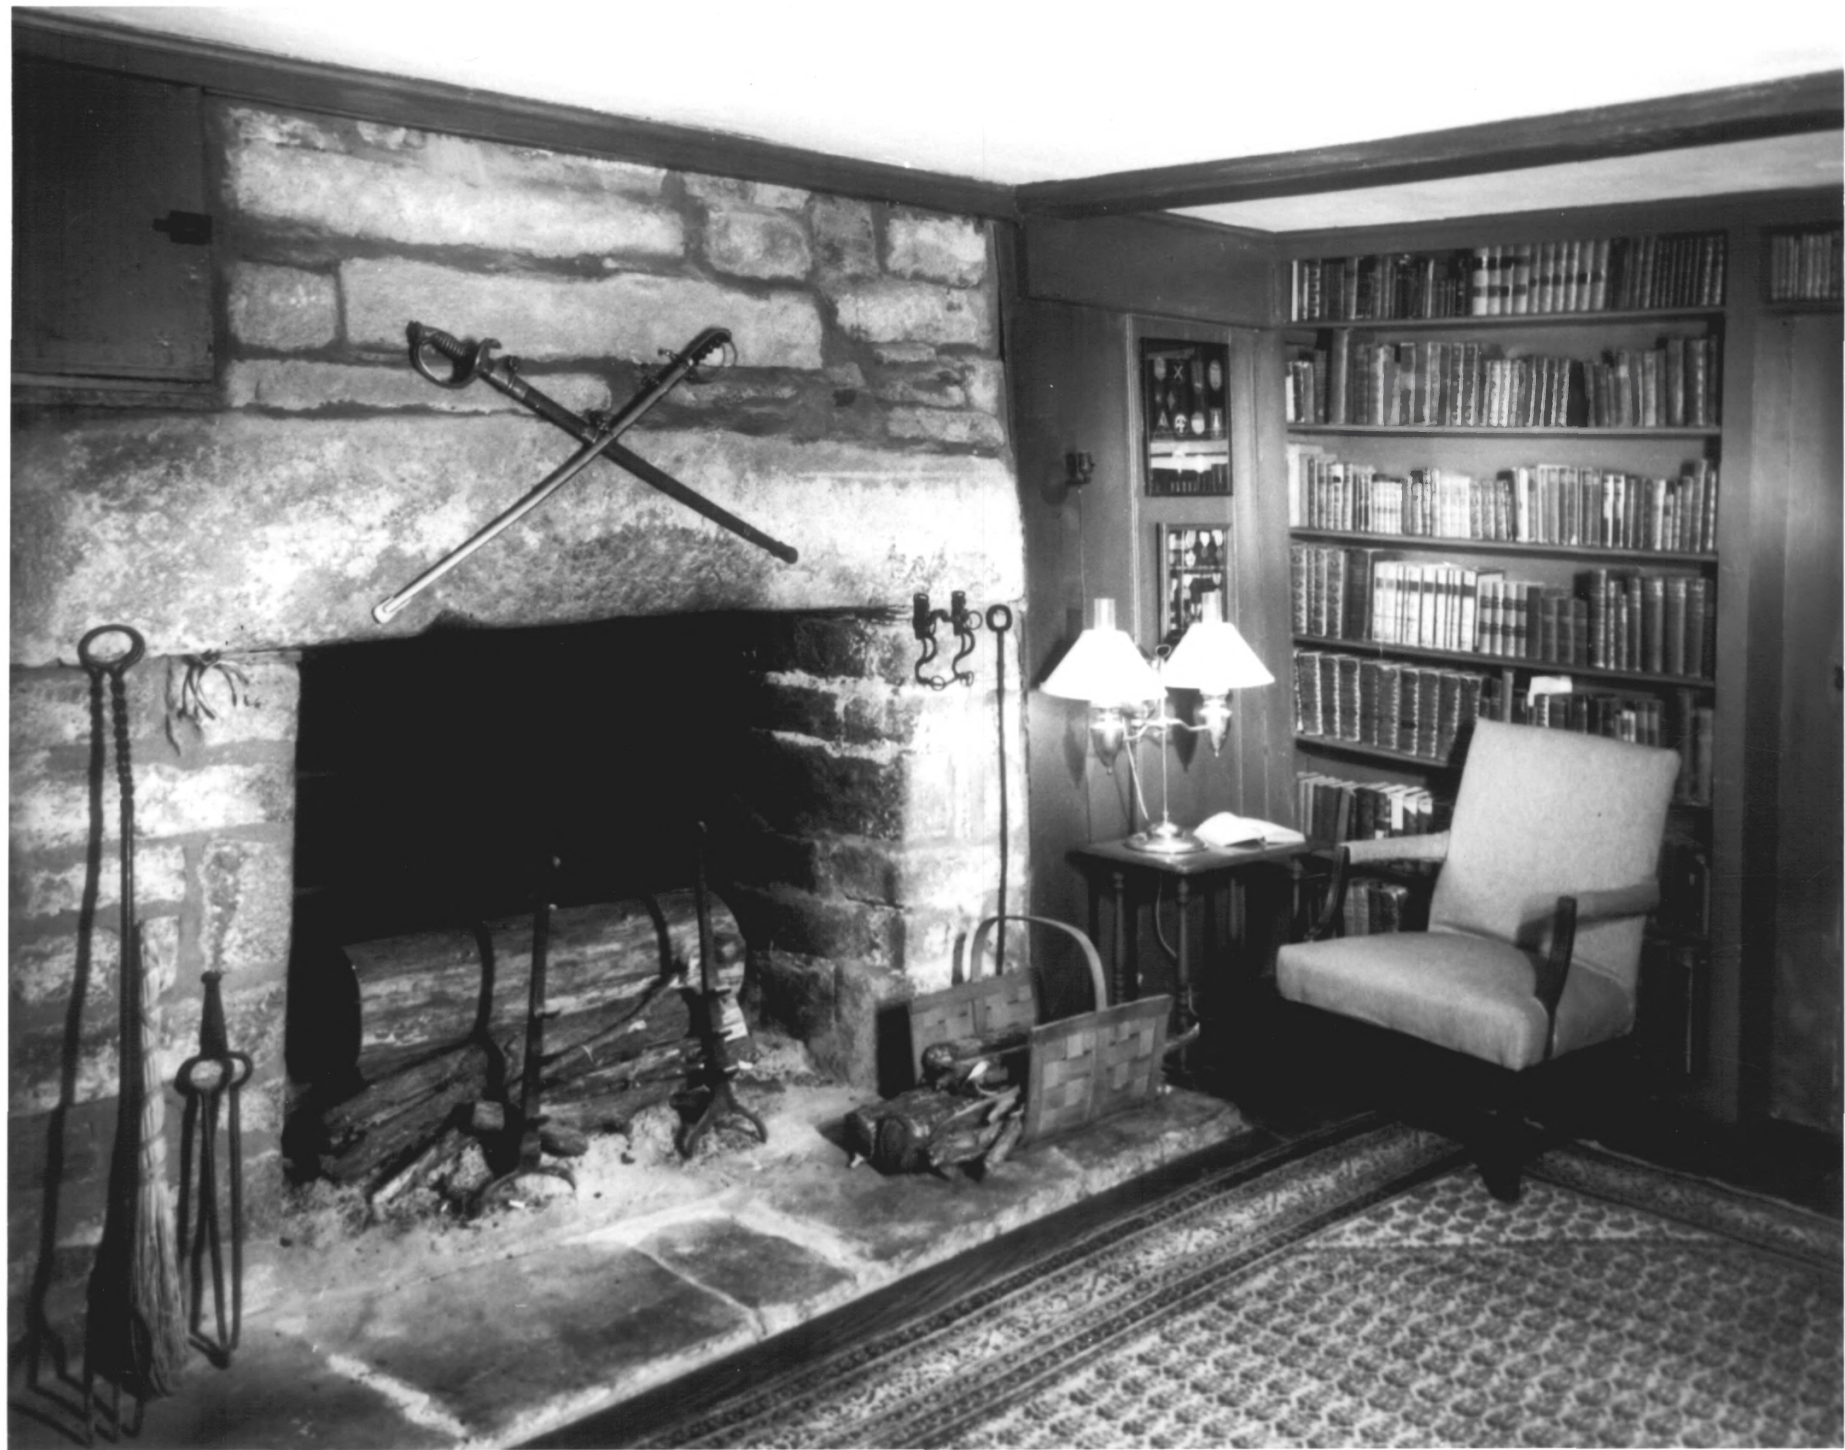
Photograph 8

Study, looking southwest. Modern bookcases shorten the original houseroom, which ran the length of the original house. Some of the books belonged to early owners. Fireplace was built outside the original chimney of massive masonry.

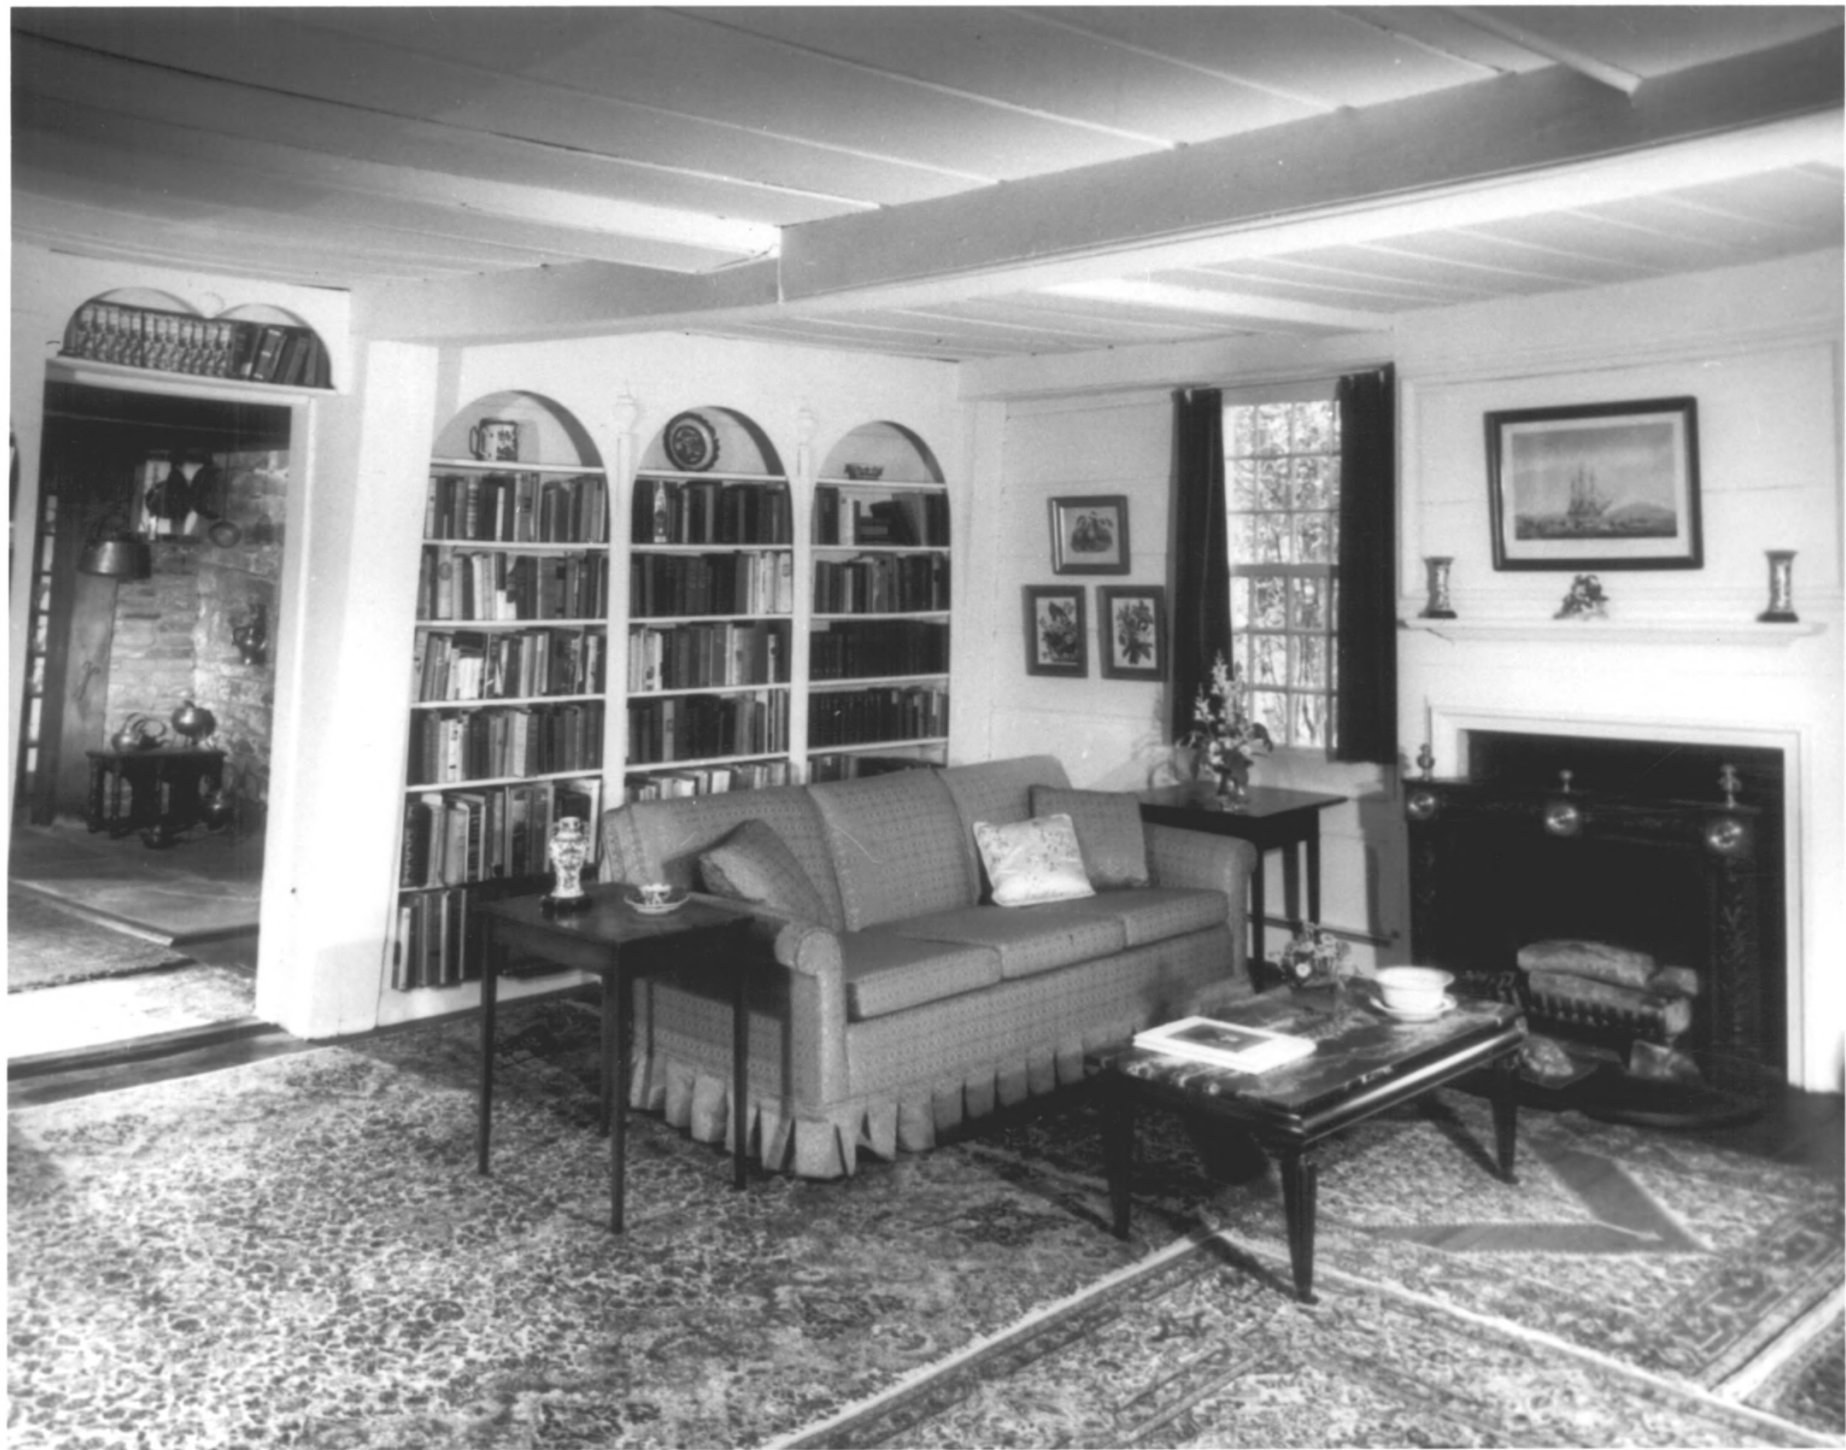
Photograph 9

Living room, looking northeast. Counter of early store stood where sofa sits. Franklin stove was placed in the house at an early date, and is one of the first models.

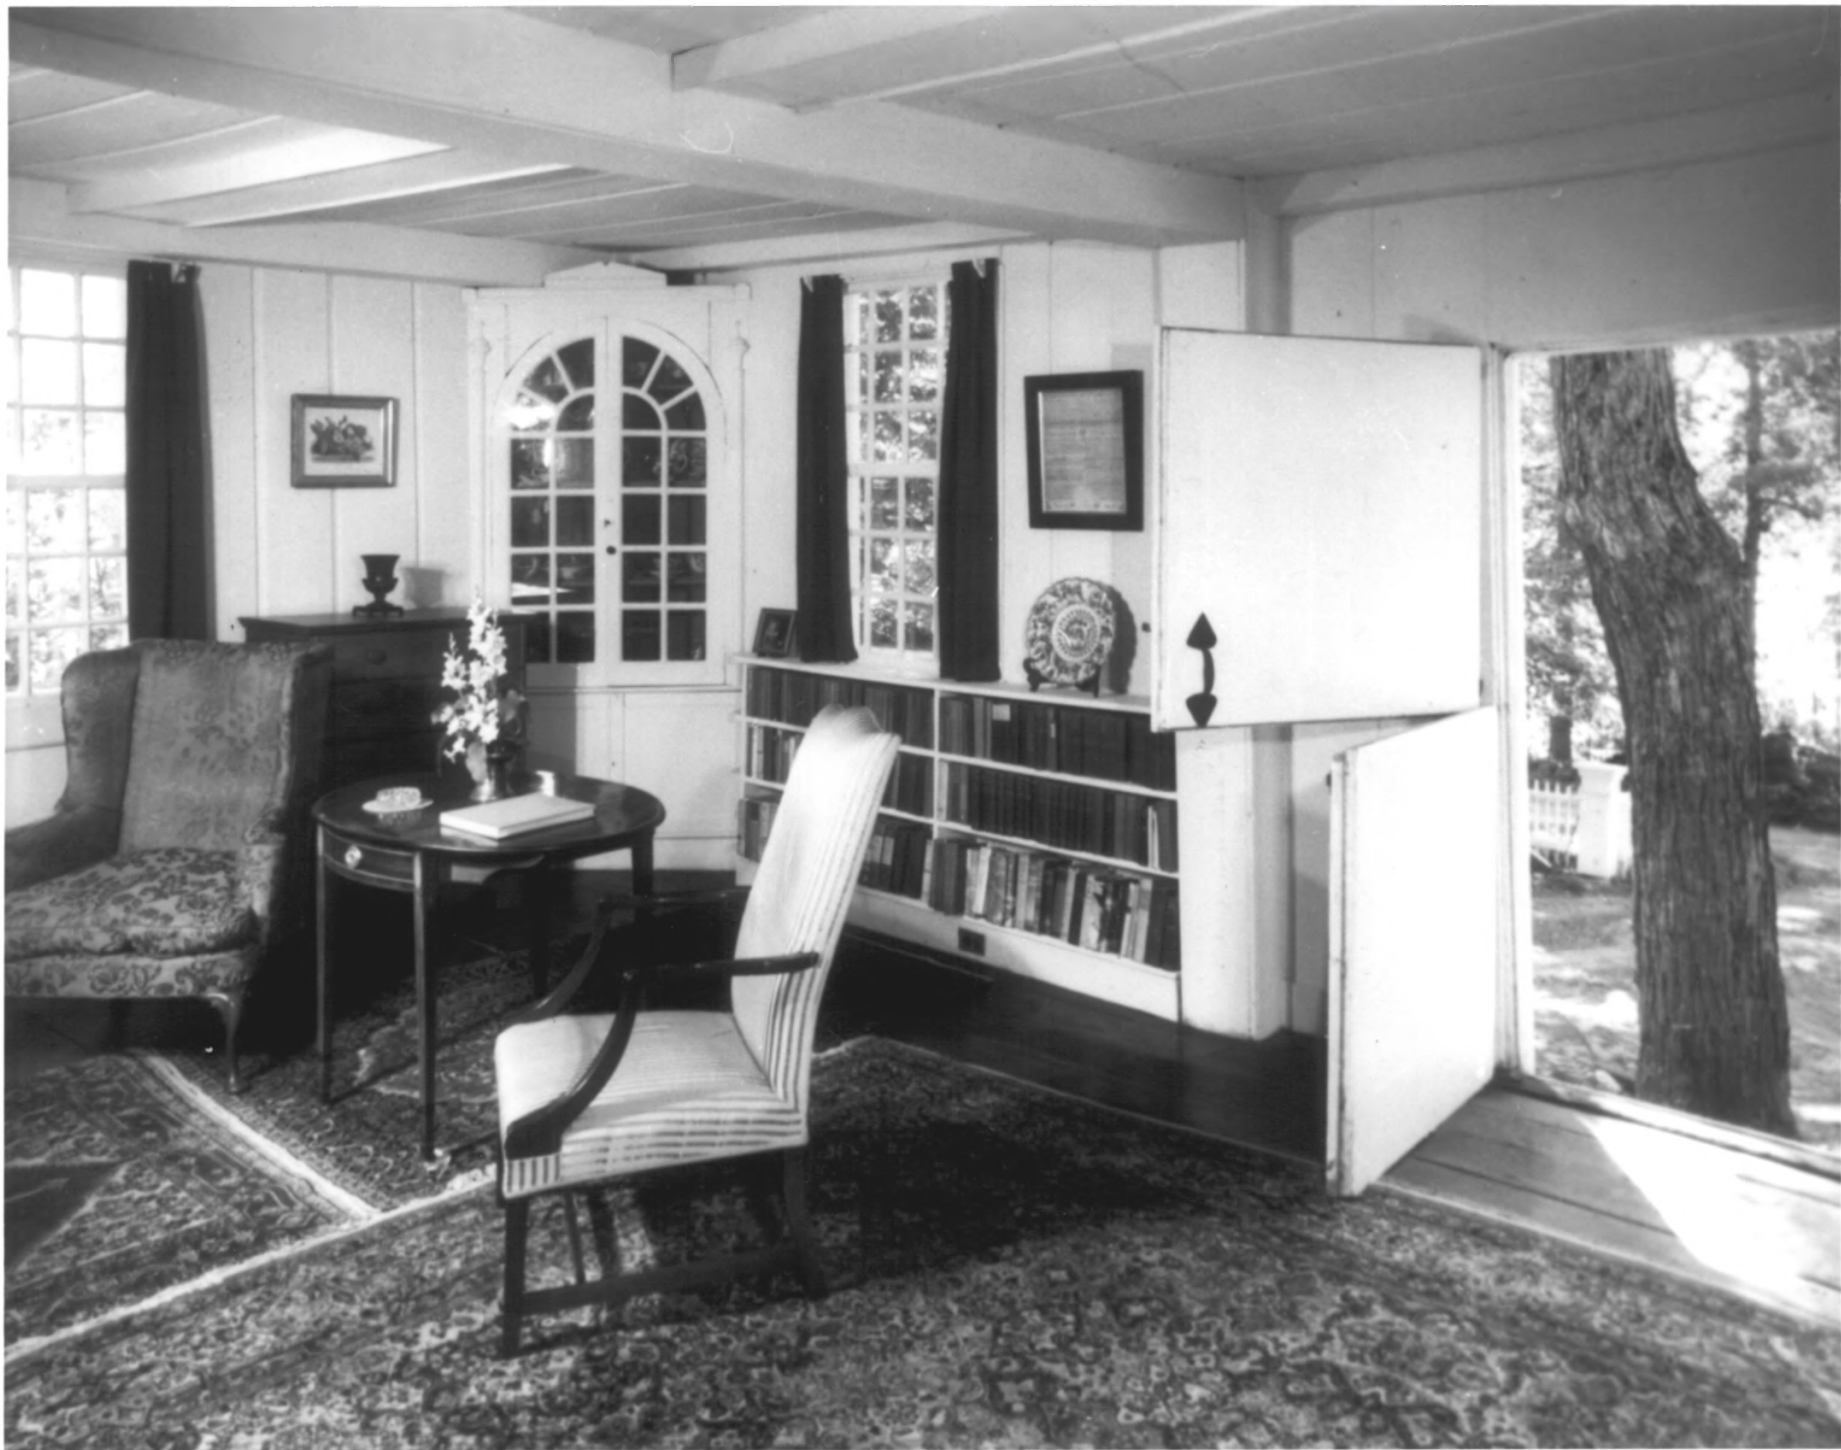
Photograph 10

Living room, looking southeast. Dutch doors make a second front entrance. China closet and adjacent blanket chest are original.

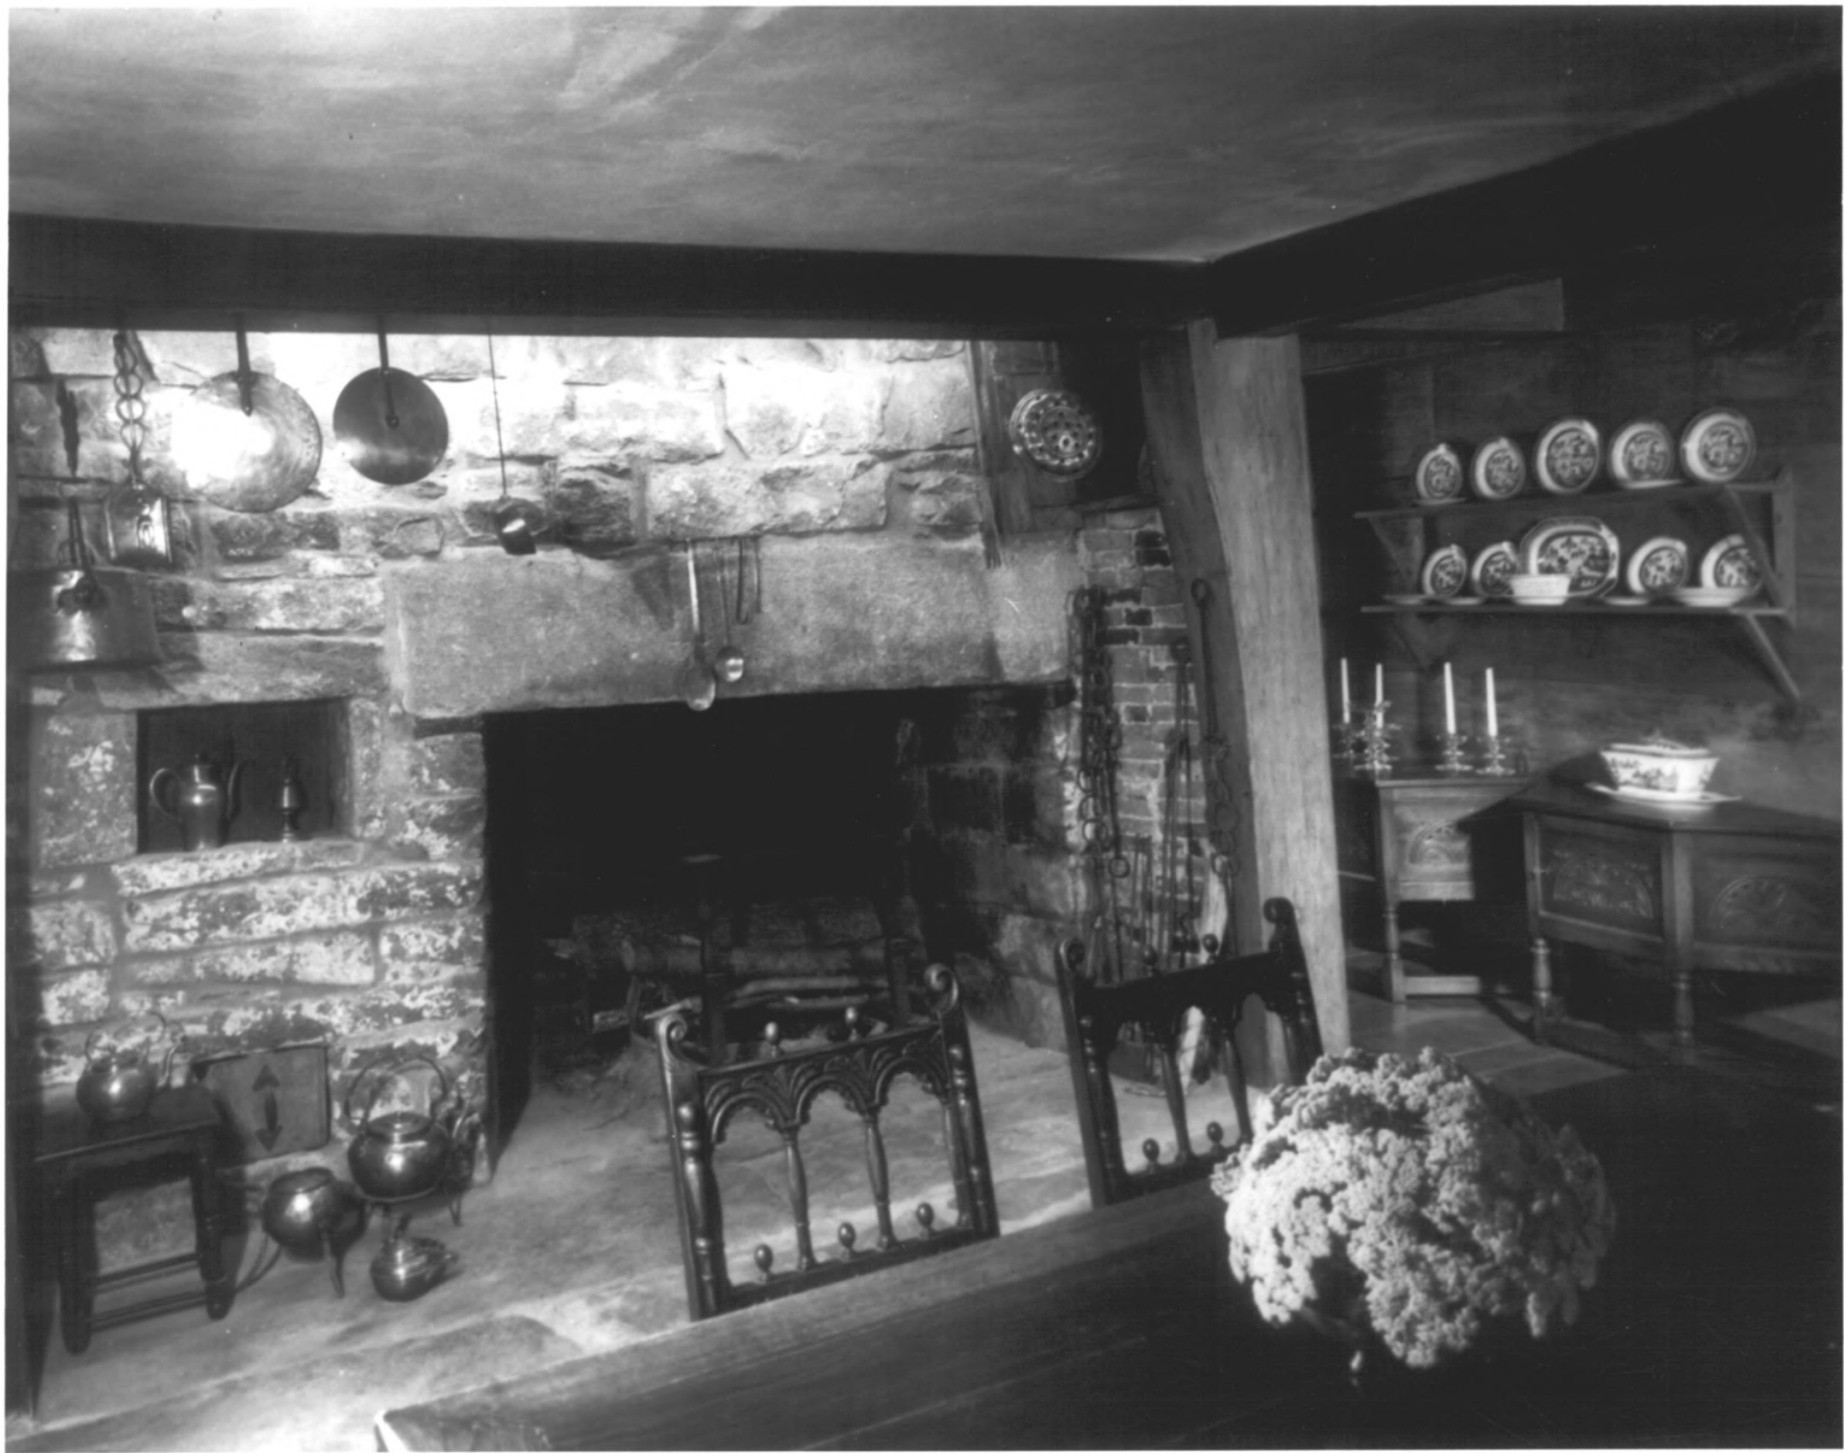
Photograph 11

Dining room, looking east. Shows size of lintel over fireplace and ship-stepped beams, narrower at base. Panelling on walls to right is horizontal. Oven is outside fireplace with an ashpit below. Tinder box is behind bed warmer above lintel.

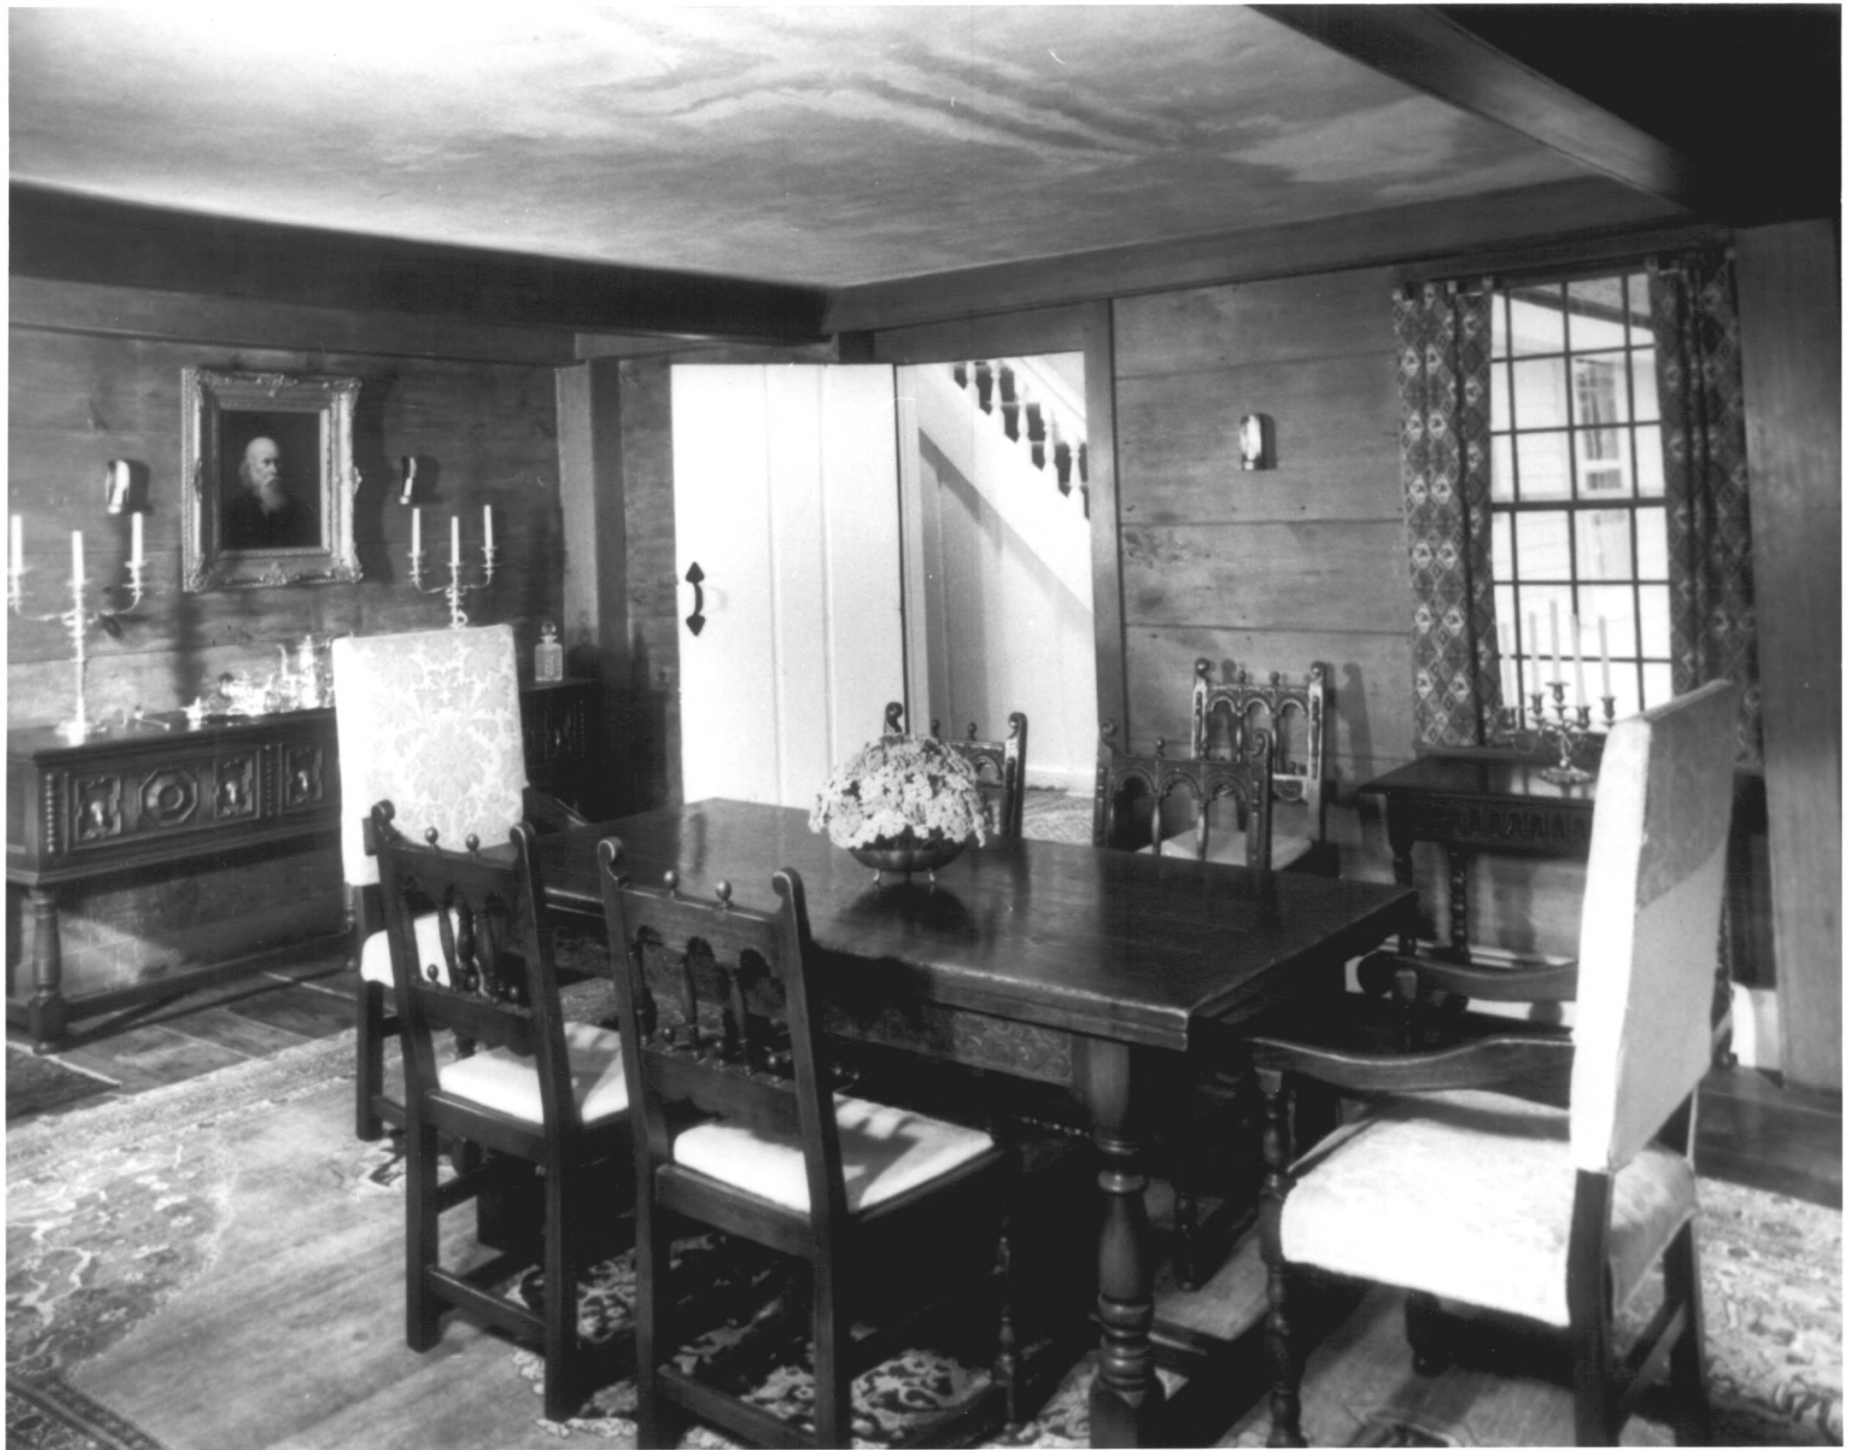
Photograph 12

Dining room, looking southwest. Shows manner in which addition joins the older section of the house (to the right) and the east wing (in the left half of the picture.)
