KENTUCKY HISTORIC RESOURCES  
Individual Inventory Form

Resource # Me-146  
Mercer County

1. Name of Resource: Adams House

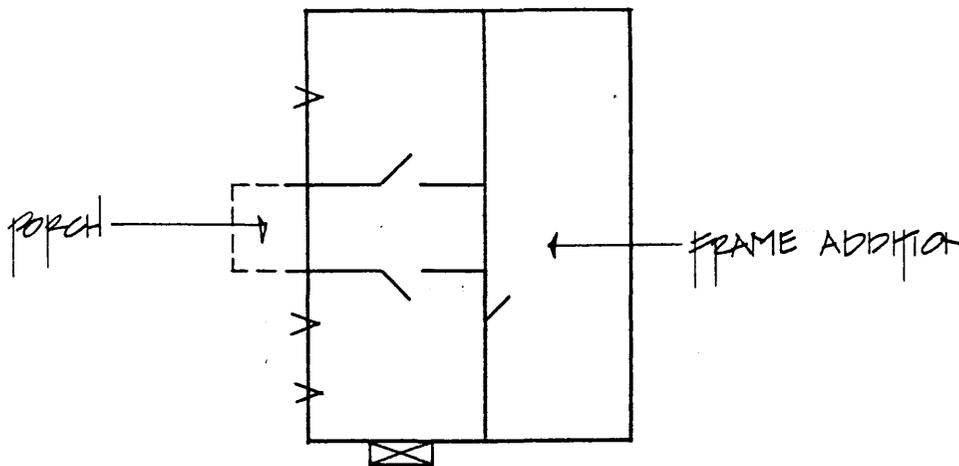
45. Description and House Plan:

According to an analysis of the Adams House done by Clay Lancaster in 1982, the original portion of the dwelling consists of the eastern two bays which have the exterior stone chimney. It was a two-story hall with six over six windows. The interior of this section has beaded beams in the ceiling and an enclosed straight flight of stairs to the second story. The wooden vertical sheathing on the interior of the room has watermelon pattern painted on walls. One wall has building painted on it which resembles the early state capitol. There is a loft above. A similar room was added to the west across an eight foot hall. Hallway or dog-trot is open to the loft where the hewn logs can readily be seen.

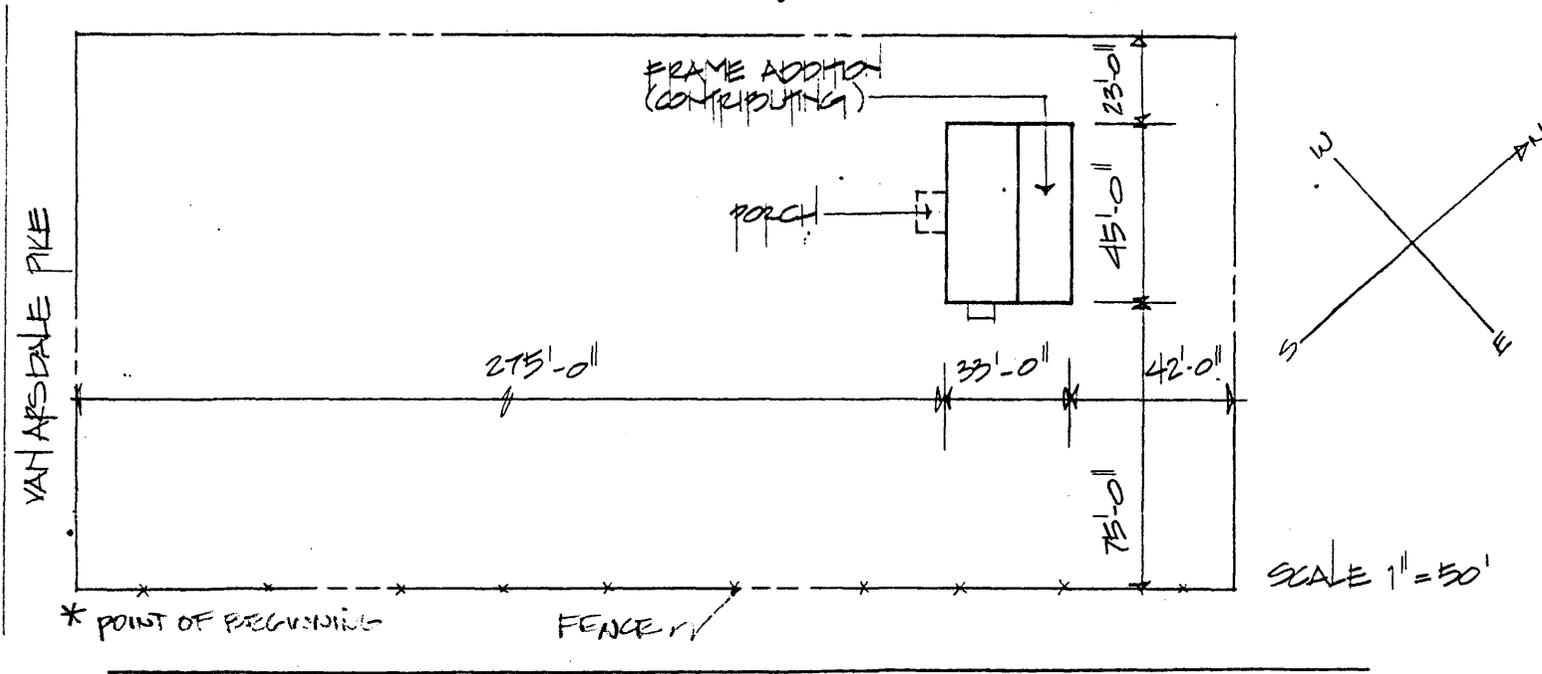
Sketch of Site Plan (Showing outbuildings, structures, landscape features  
and the site boundary as described above.)

From a point in the north right of way of Van Arsdale Pike;  
then west 143 feet to a point; then north 350 feet to a point;  
then east 143 feet to a point; then south 350 feet to the  
point of beginning.

The point of beginning is 275 feet south and 75 feet east  
of the southeast corner of the building.

The boundary was chosen arbitrarily using Van Arsdale Pike as the southwestern boundary to preserve the setback from the road. The other boundary lines were chosen to provide a setting for the house.
