KENTUCKY HISTORIC RESOURCES Individual Inventory Form

Resource # 124 Shelby County

| 1. | Name of Resource: |
|---|---|
| | Brackett Owen House |

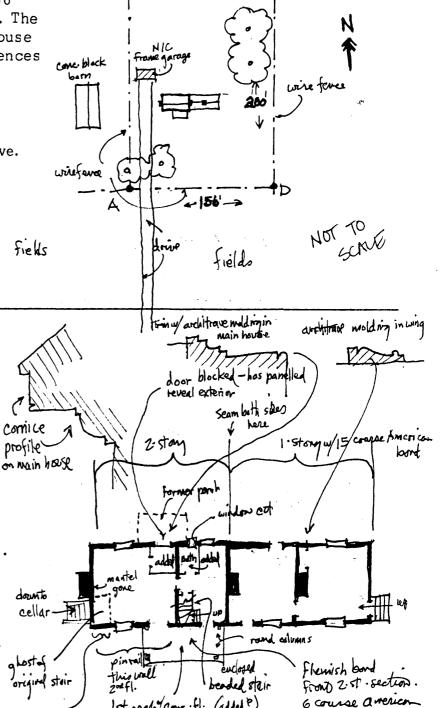
1st. prcht come.fl.

(added?)

3-bay 2-story brick hall-parlor (two-room) plan with early added 1-story two-room lateral wing. South (principal) facade has central door flanked by a door on the east and a window on the west. Whether door on east was a window cannot be determined. Random glazed header Flemish bond front, 6-course common bond elsewhere, 15-course bond on wing. Doors and windows altered, sashes replaced. Jack arches remain, as does panelled reveal at blocked north center door, where former 1-story porch stood. Cellar entry beside chimney at west end.

blocked opening for de

First floor mantels removed; bathroom partitions inserted in both rooms. Ghost of stair in larger room in southwest corner. Beaded-board-enclosed stair in southwest corner of smaller room may have been added. Door bricked up in southwest corner of main section may have been added (?). Second floor incorporates pin rail on south wall of west room, original shelf and architrave mantels. Molded and beaded chairrails and baseboards. First floor moldings include beaded trim with reversed quarter round architrave (see detail) in main section and ovolo in 1-story section. Two-panel doors in interior of main section.
