KENTUCKY HISTORIC RESOURCES
Individual Inventory Form

Resource # SH 246
SHELBY County

1. Name of Resource:
G.W. STEWART HOUSE

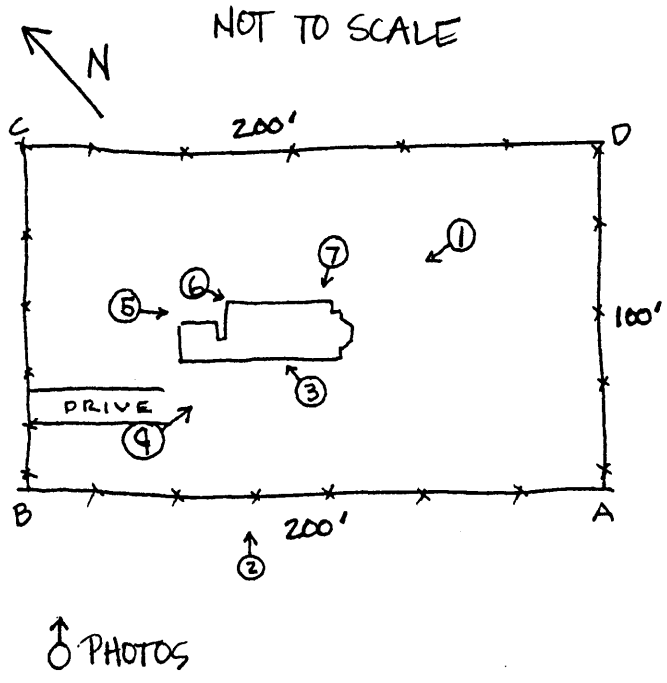
THE PROPERTY IS THE RESIDENCE OF A DAIRY FARM IN NORTH CENTRAL SHELBY CO. LOCATED ABOUT 2/5 OF A MILE WEST OF KY. 55 (EMINENCE ROAD) AT THE END OF A PRIVATE DRIVE. THE DRIVE PASSES SOUTH WEST IN FRONT OF THE DOMESTIC YARD AREA, THEN CURVES WEST-NORTHWEST BETWEEN THE HOUSE AND BARN YARD AREA. A WOOD POST AND BOARD FENCE SURROUNDS THE IMMEDIATE DOMESTIC YARD AREA, CONTAINS LARGE MAPLE TREES AND FORMS THE MAJORITY OF THE SITE BOUNDARY. THE REMAINING LINE IS MARKED BY A WOVEN WIRE FENCE THAT CONNECTS TO THE WOOD FENCE. THE PROPERTY COVERS ABOUT ONE ACRE, CENTERED ON THE HOUSE. (CONT.)

44. Site Plan, continued

The boundary is justified as the immediate yard area surrounding the single nominated building. The property does not include the several farm buildings and acreage beyond the domestic yard due to poor condition, alteration and lack of historic context for evaluating the significance of extensive historic landscapes.

Beginning at point A, the south corner of the yard fence, proceed 200' NE along the fenceline to point B, the west corner of the yard fence; then NE 100' along the fenceline to point C, the north corner of the yard fence; then SE 200' along the fenceline to point D, the east corner of the yard fence; then SW 100' along the fenceline to the point of origin.

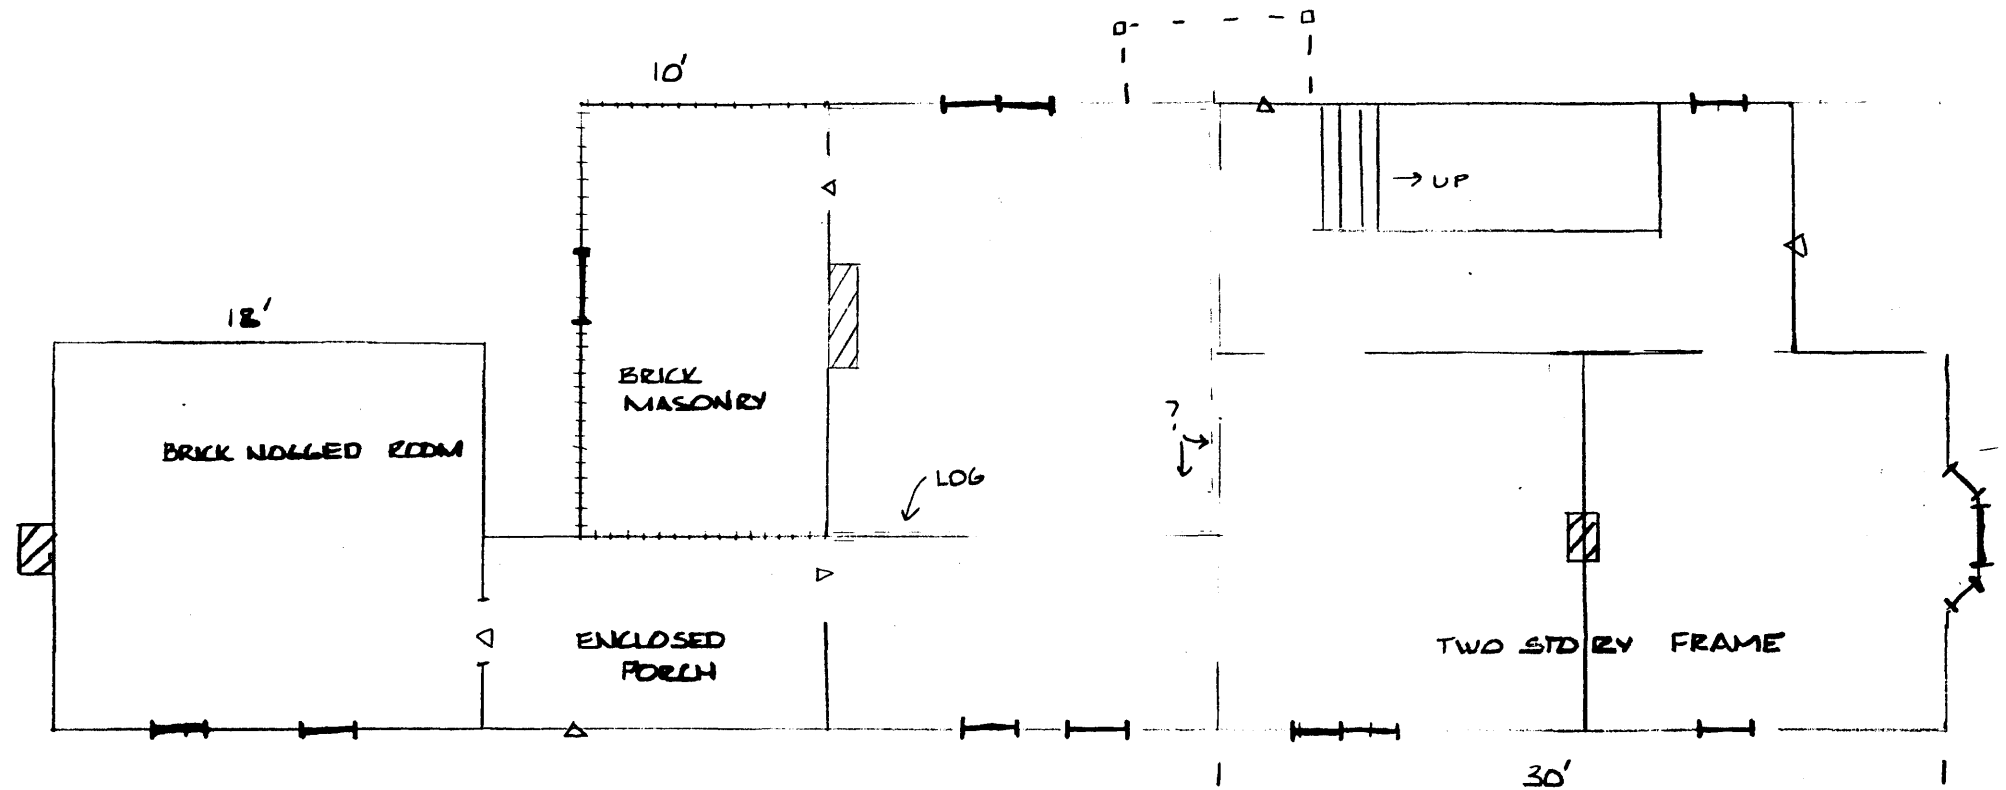
FIRST
FLOOR PLAN
SH 246
G.W. STEWART HOUSE

NOT TO SCALE

room with undetermined original function, and a one and one-half story room of frame construction with brick nogging. (Either the brick or brick nogged room may be the original kitchen, separate from the hall-parlor). Photos 7/36-37 and 8/1,5 view these other sections. The chronology of the house is not known, but the two ends, the hall-parlor and nogged room (possibly the original kitchen) may be contemporary, indicated by some remnants of brick nogging in the two-story portion and identical beaded and tapered rake board on both. During the late 19th century, an L-shaped addition to the southeast end of the hall-parlor radically changed the appearance of the house, creating a new front facade with polygonal bay and side passage entry behind the original single pile form (photos 8/2,3). The original hall-parlor entry is indicated by the beaded weatherboard patterns on the southwest wall and also, the bay addition break is visible in the eave line on that wall. Original second story features include Federal woodwork: carved and beaded door and window trim, rounded front and fillet chair rail, six panel raised doors, and the ghost of a frame partition in the west room (see plan). Apparently the stair, once located in the larger, downstairs west room was moved and extended to its present location when the southeast front was added. The upstairs, because of the ghost wall, may have had a center passage plan. No outline of old fireplaces is indicated in the upstairs rooms, later ones have been added. The roof structure is of log common rafters, hewn with half lap and peg. The new front, upper southeast window is an addition.

The center, one story area has some log walls, but its date in relation to the other components and manner of joining, is unknown. It is sided with wide lap boarding, has newer sash windows, a central brick chimney, new, exterior, concrete flue, and enclosed porch with shed roof attached to the southwest side.

Between the log and brick nogged rear room, is a narrow (10' by 16') brick masonry room with gable roof that aligns with the log. The shed porch of the log also fronts the masonry portion.

The final element is the brick nogged, one and one-half story room with brick foundation, sash windows, (photo 7/37) a brick exterior flue and attic door in the north gable end, and boarded entry in the east wall.
