National Register of Historic Places Registration Form

Historic name: Harms, J. Casten and Magaretha, Farmhouse

"Chaska Brick Resources in the Vicinity of Carver County, 1857-1961"

Street & number: 11110 County Road 152

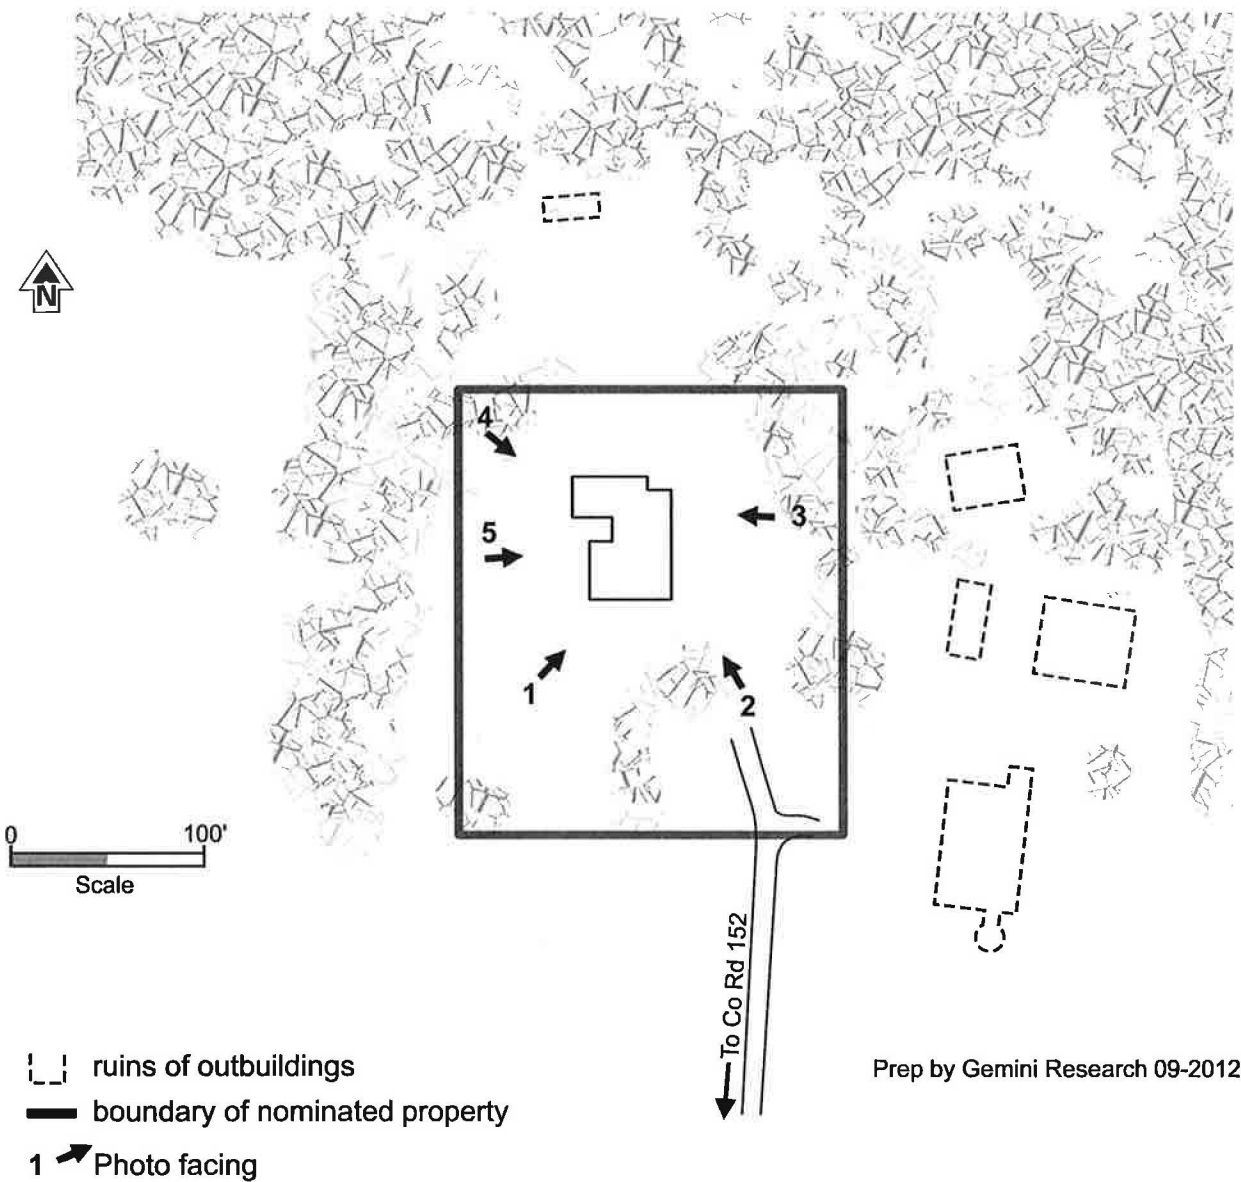
The boundary of the nominated property is shown by the solid gray line on the Sketch Map on Page 1 of Additional Documentation. The nominated property measures 200' (east-west) by 230' (north-south). The eastern boundary line is 87' east of the southeastern corner of the house. The southern boundary line is 120' south of the southeastern corner of the house. The property is located in Section 23 of Benton Township (T115N R25W) in Carver County, Minnesota.

The nominated property is a rectangle measuring 200' (east-west) by 230' (north-south) that contains the farmhouse and its grassy lawn (see Sketch Map). The nominated property is surrounded by an approximately 4-acre farmstead that no longer retains historic integrity and is excluded from the nominated property. The excluded area contains the ruins of about five outbuildings including a chicken house, concrete-block automobile garage, silo, milk house, and the foundation of a 1916 barn that housed about 16 dairy cows. A small Chaska brick smokehouse (also razed) once stood about 25' northwest of the house. North and west of the farmstead is an approximately 17-acre woodlot, also excluded from the nominated property. The Harms farmland historically extended north, west, and east of the farmstead and woodlot.

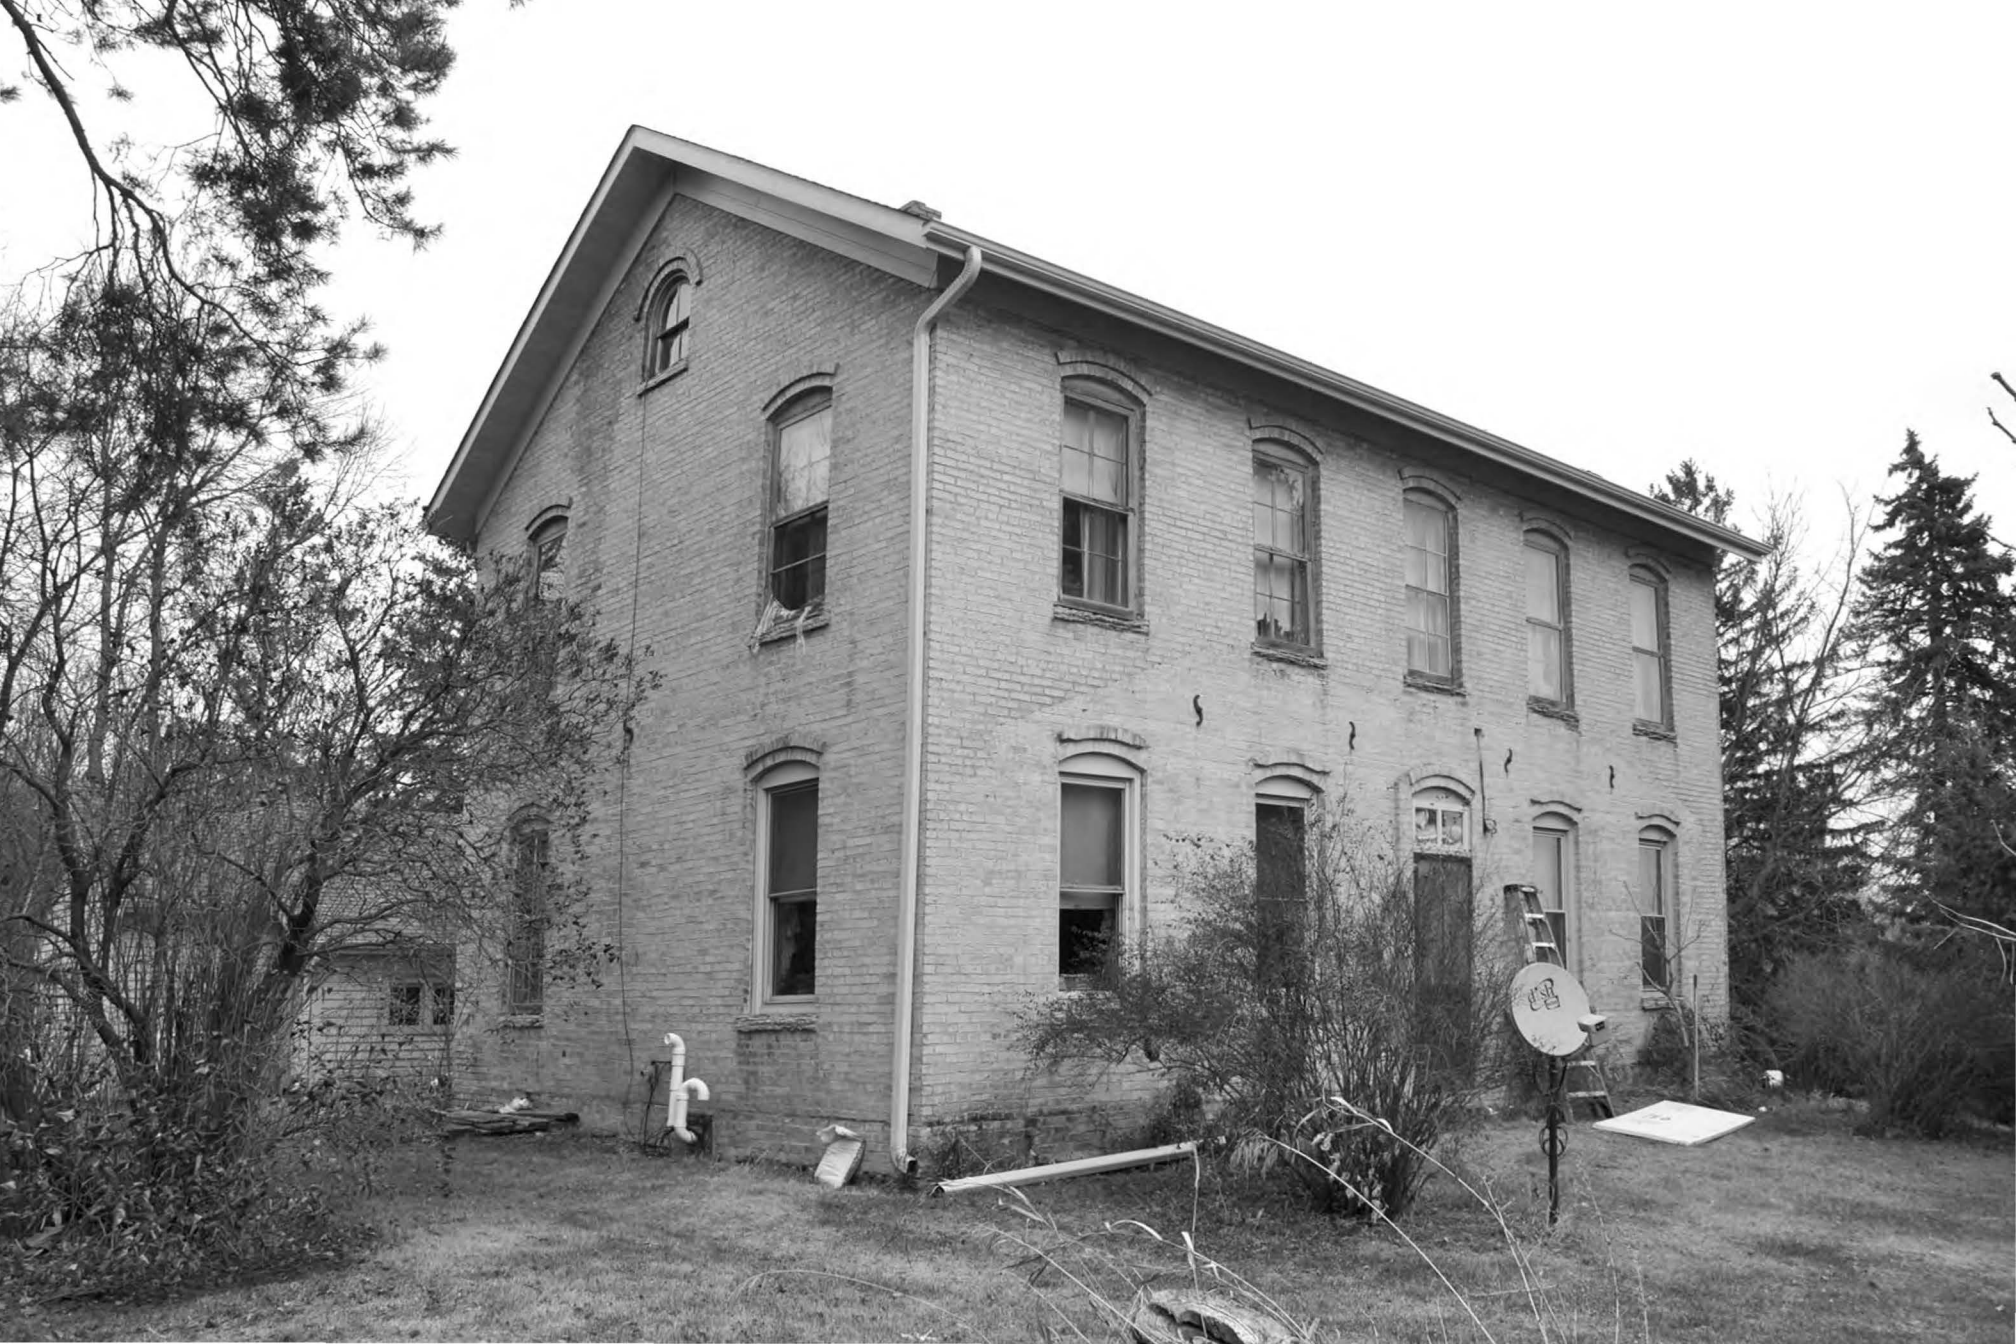
Photo 1 of 5

Western facade and southern (main) facade of the southern wing; camera facing northeast.

The Harms Farmhouse was built of cream-colored brick manufactured in Chaska (Photo 1). The house is a well-built, moderately large building with an L-shaped plan. It has an intersecting gabled roof covered with asphalt shingles that replace original wood shingles. Each of the building's two wings has an interior brick chimney. The interior chimney on the southern (main) wing replaces a symmetrical pair of original interior endwall chimneys, and the house possibly had one more chimney originally (Henning *Phase III* 2005).

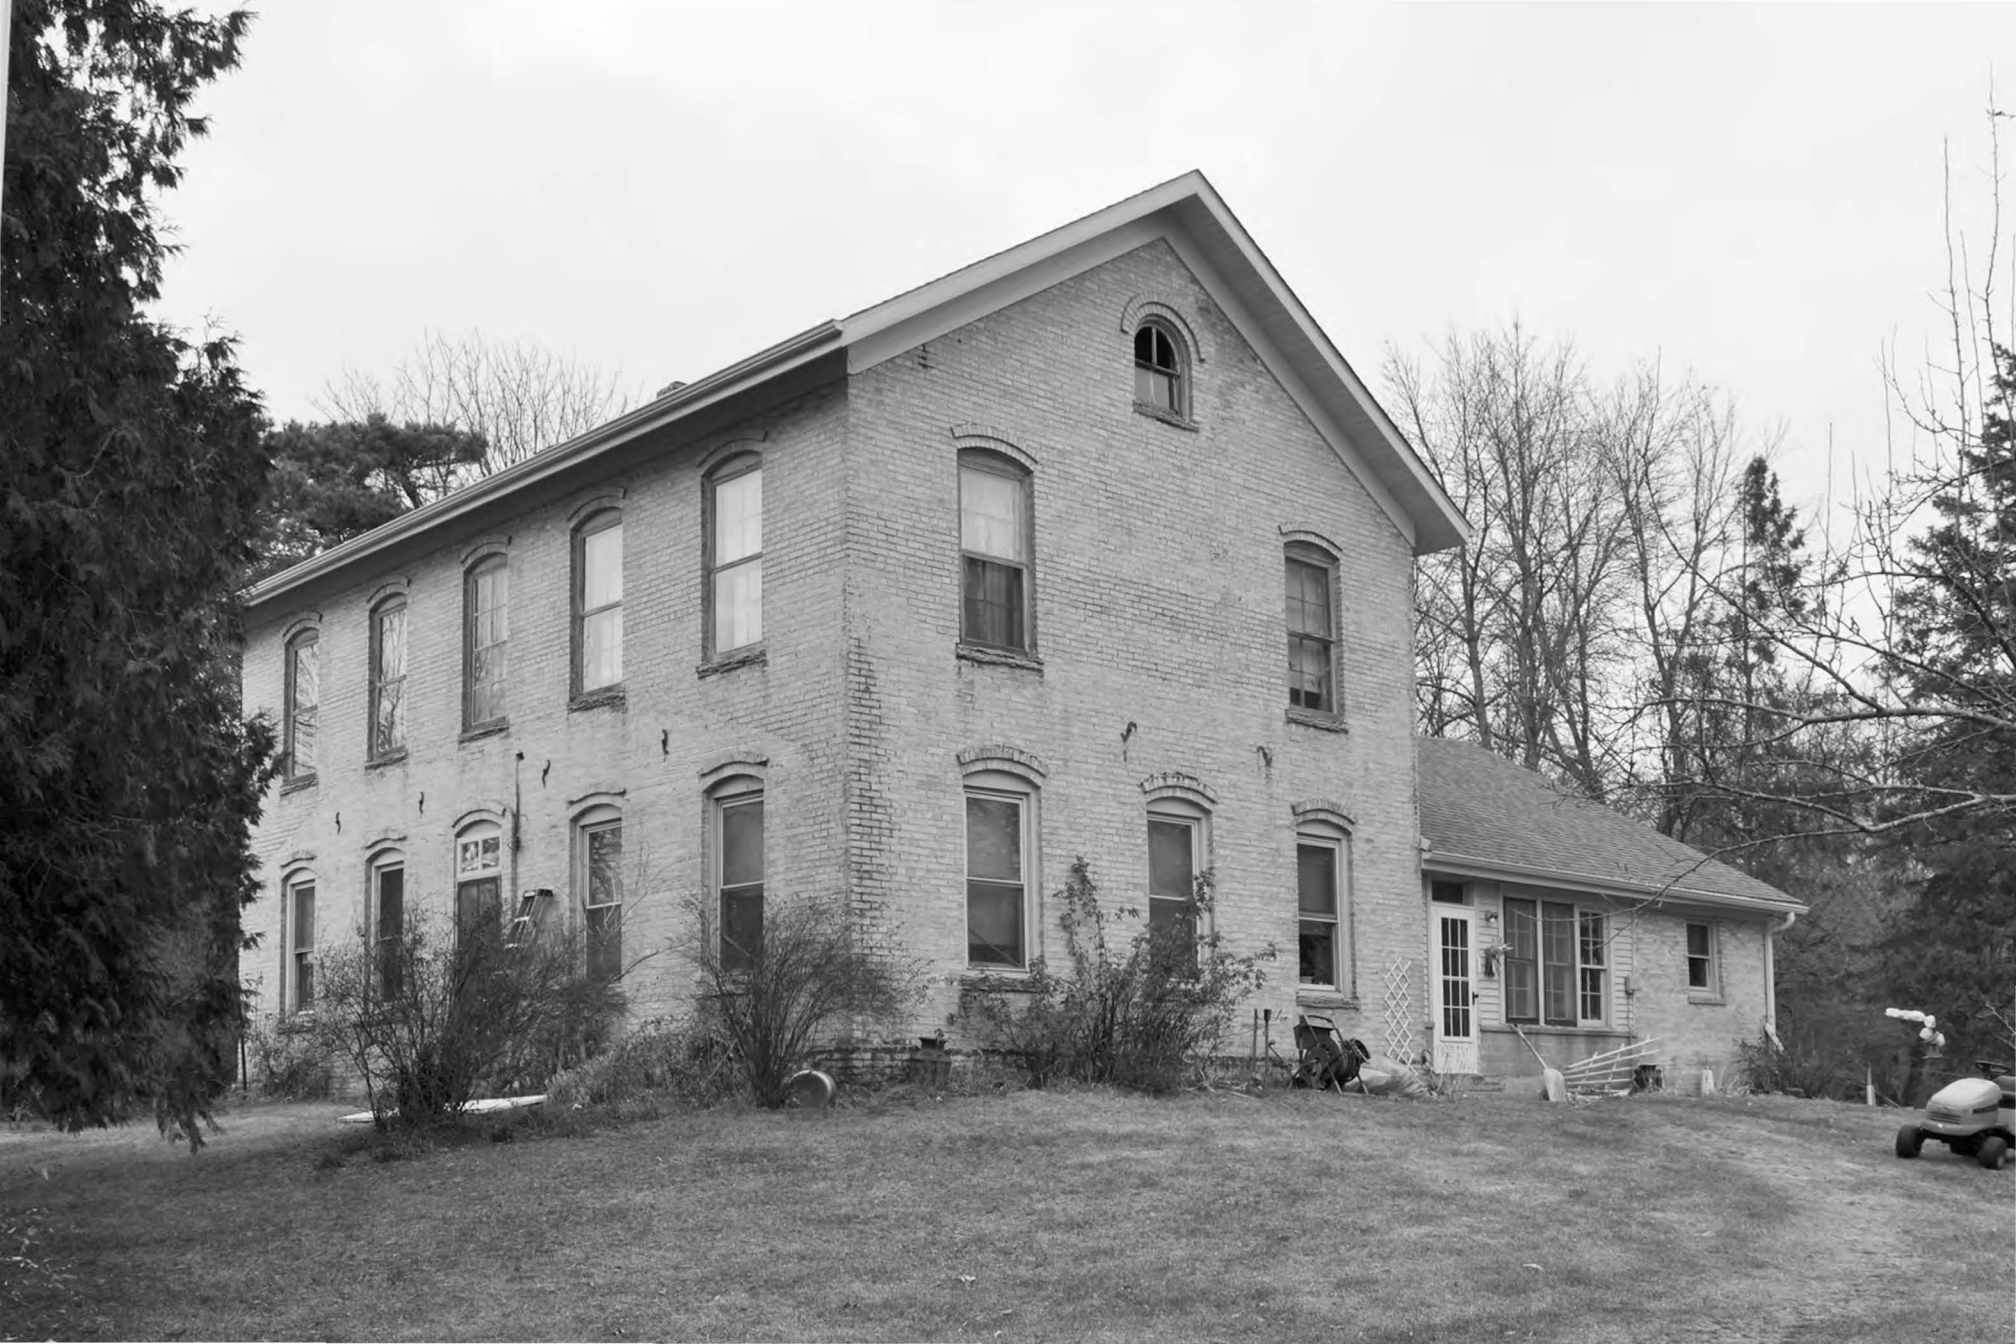
Photo 2 of 5

Southern (main) facade and eastern facade; camera facing northwest.

The larger of the two wings, the southern, measures about 26' x 40' (north-south by east-west). It has a somewhat imposing Georgian-inspired design with a formal main facade that faces south toward the county road (Photo 2). This facade has a symmetrical, five-bay arrangement of windows and central

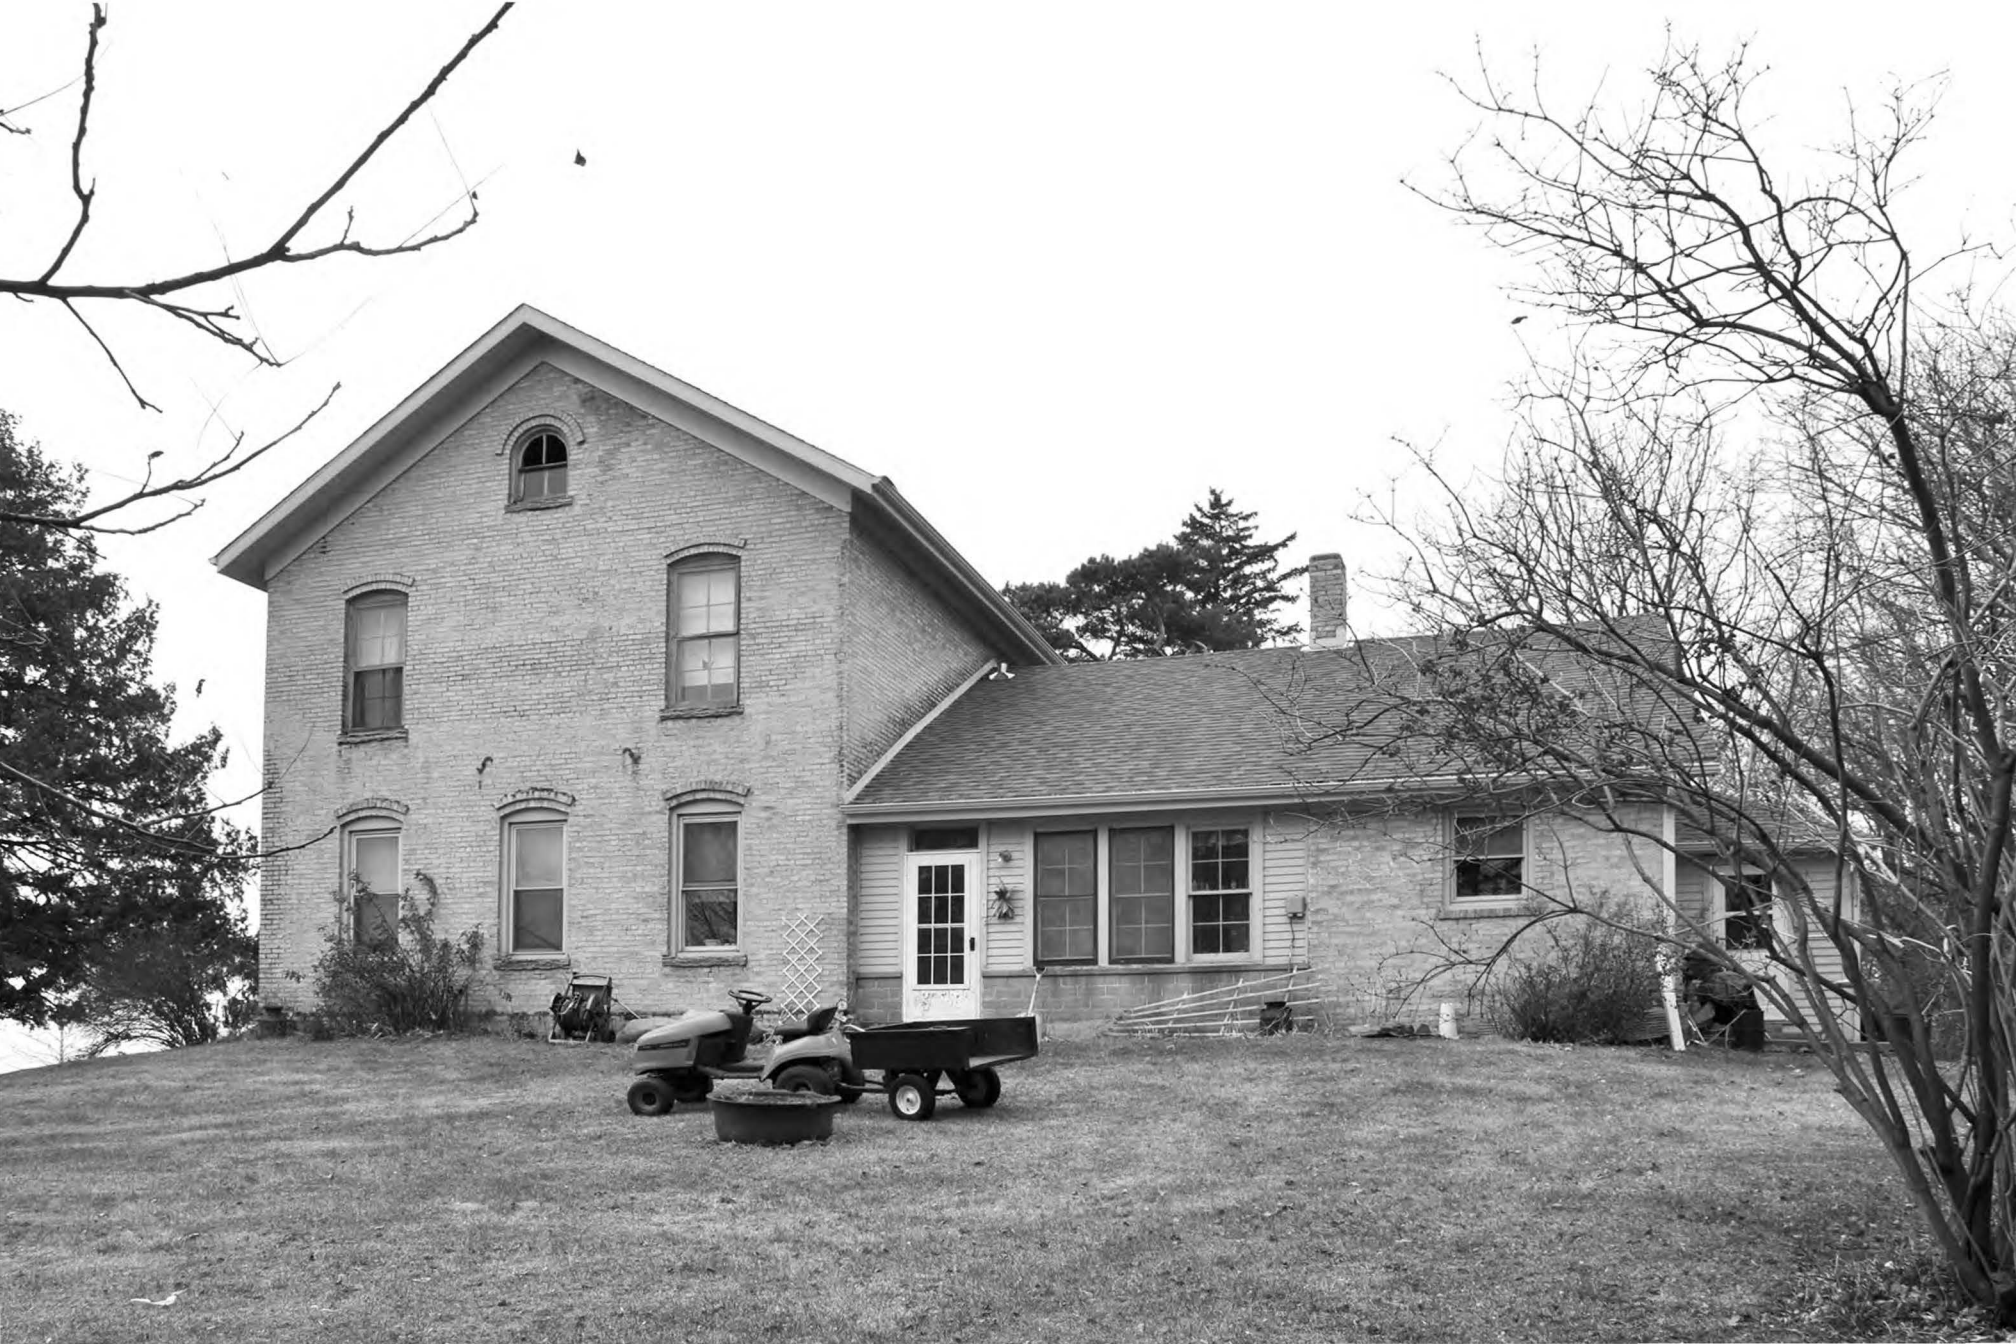
Photo 3 of 5

Eastern facade, which faces the former farmyard; camera facing west.

The northern or kitchen wing measures about 26’ x 28’ (north-south by east-west) (Photo 3). It has a segmental-arched exterior entrance on each of the long walls (Photo 5) and on the northern end. The eastern entrance was especially important because it faced the farmyard, driveway, barn, and other outbuildings. The northern wing has segmental-arched window openings, including one at the attic level on the northern end. One window opening – the northern one on the eastern facade – is now rectangular. On the eastern facade is a shed-roofed porch that shelters the house’s eastern entrance. The porch is also entered from the southern wing. The porch is tucked into the brick massing so that it has brick walls on three sides. It was originally open on the eastern side, and there was probably one turned wooden column supporting the eastern edge of the roof. (This unusual configuration of shed-roofed, brick-walled, open porch with a single wooden column can be found on at least two other extant Chaska brick farmhouses in Carver County.) In the 1930s or 1940s the eastern wall of the porch was enclosed with screens. The porch’s current poured-concrete floor may also date from circa 1940. More recently, the eastern side of the porch was enclosed with three 4/4 windows and clapboard siding above four courses of concrete block. The porch interior retains segmental-arched window and door openings and exposed brick walls. A porch, perhaps small, may have been removed from the western side of the kitchen wing.

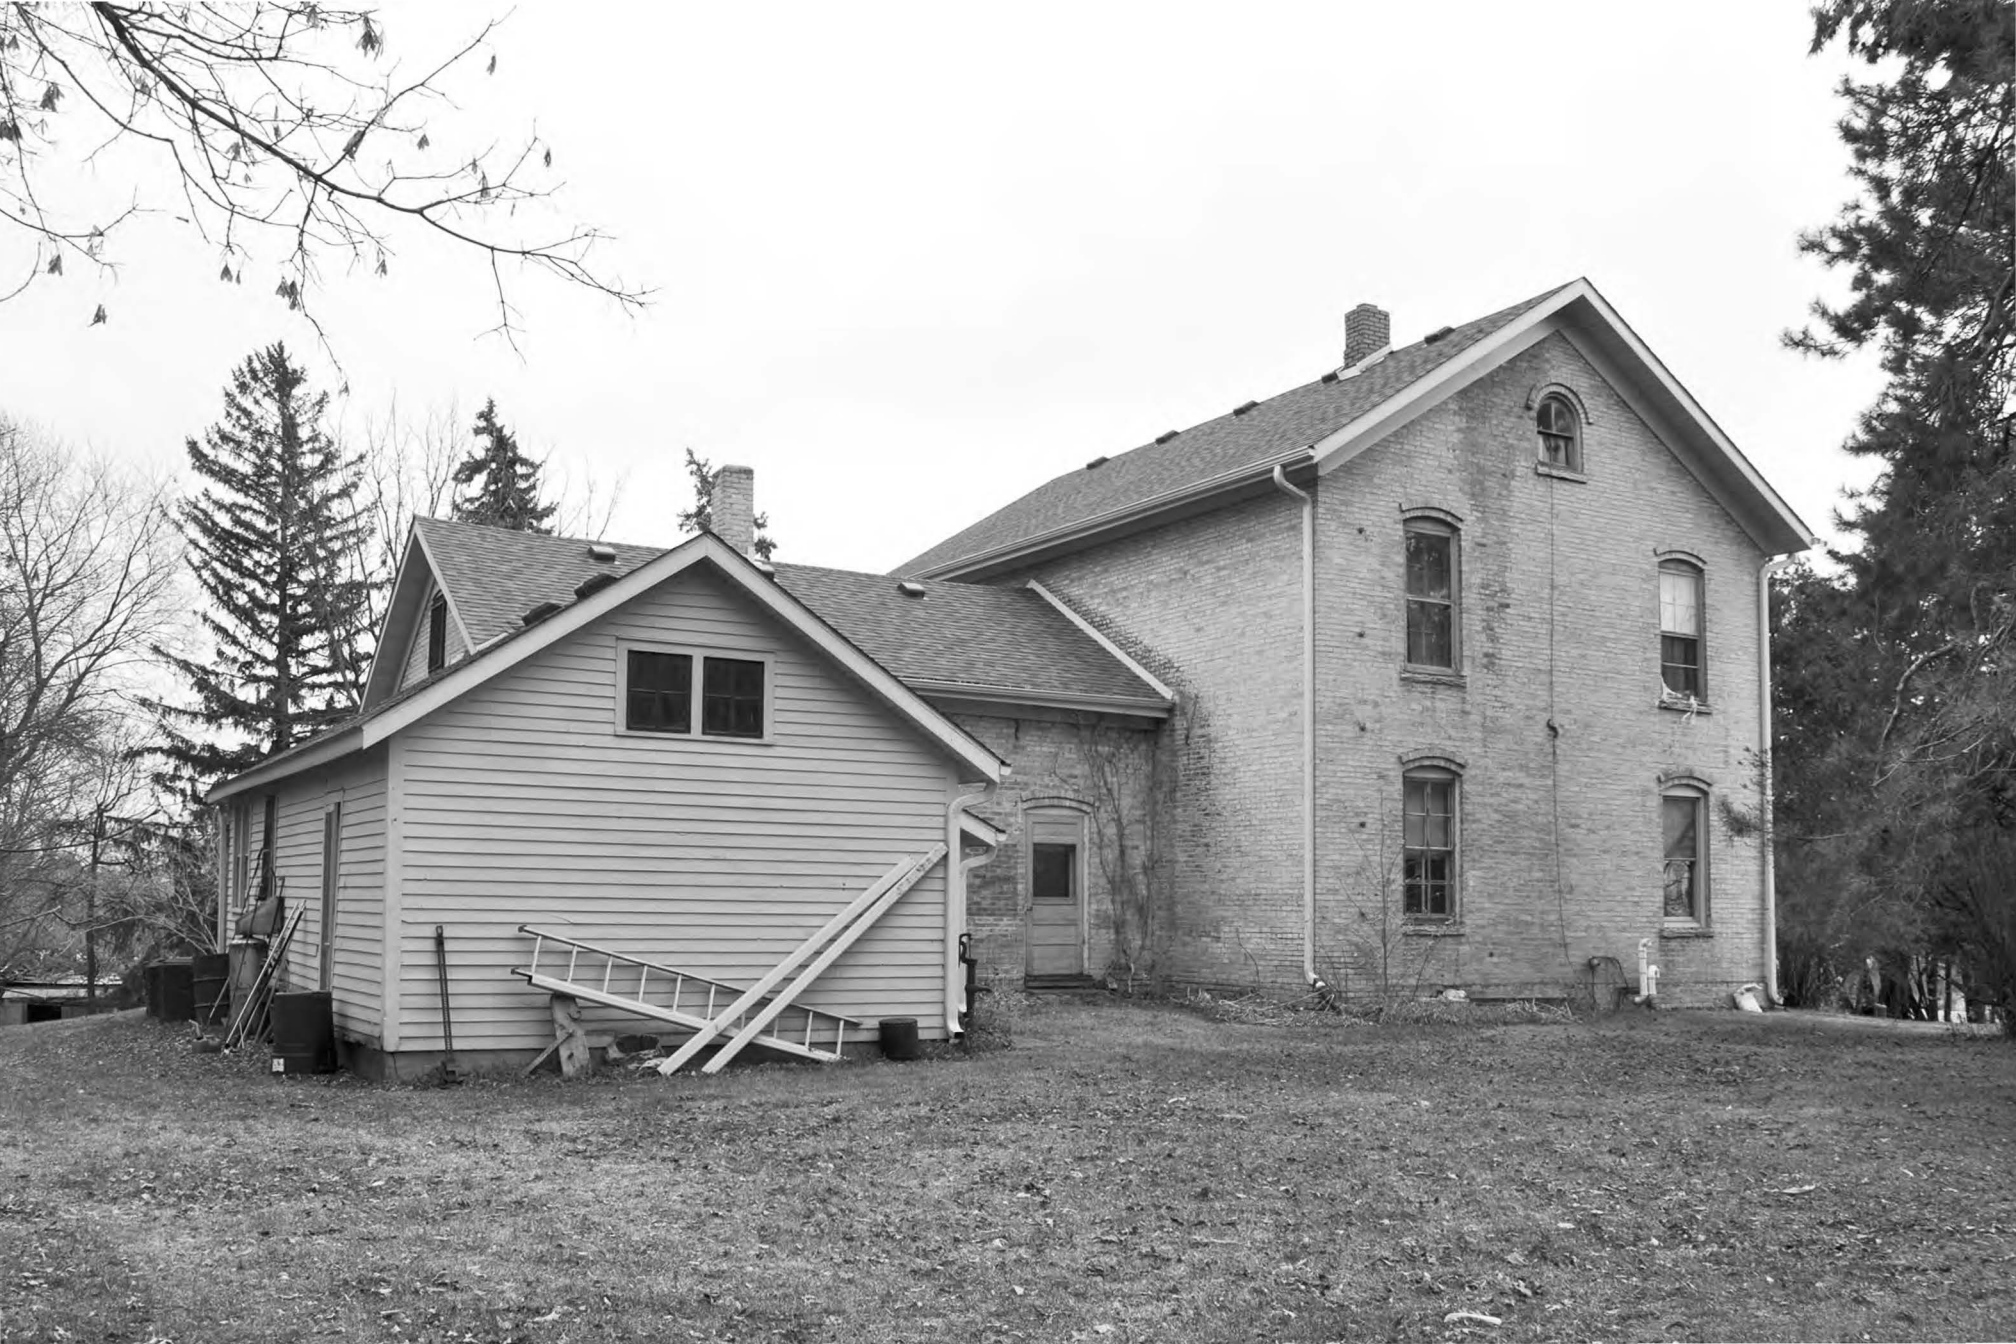
Photo 4 of 5

Western facade and northern woodframe addition; camera facing southeast.

The first floor of the kitchen wing has a dining room (the southern room) and a kitchen (the northern room). There was a cistern under the kitchen from which water was pumped for washing. The kitchen wing’s small attic room usually served as a bedroom for the boys of the family and hired men. Direct first-floor access to this upper room was provided when an interior stairway was added circa 1910; it became the house’s second stairway. The kitchen once had a woodframe summer kitchen on the northern end that was replaced in the 1940s by the current woodframe kitchen workroom addition (Krueger 2011). The one-story, clapboard-covered addition measures about 18’ x 35’ (north-south by east-west) and has a gabled roof with a hipped eastern end (Photo 4). The southeastern part of the addition shelters steps to the basement.

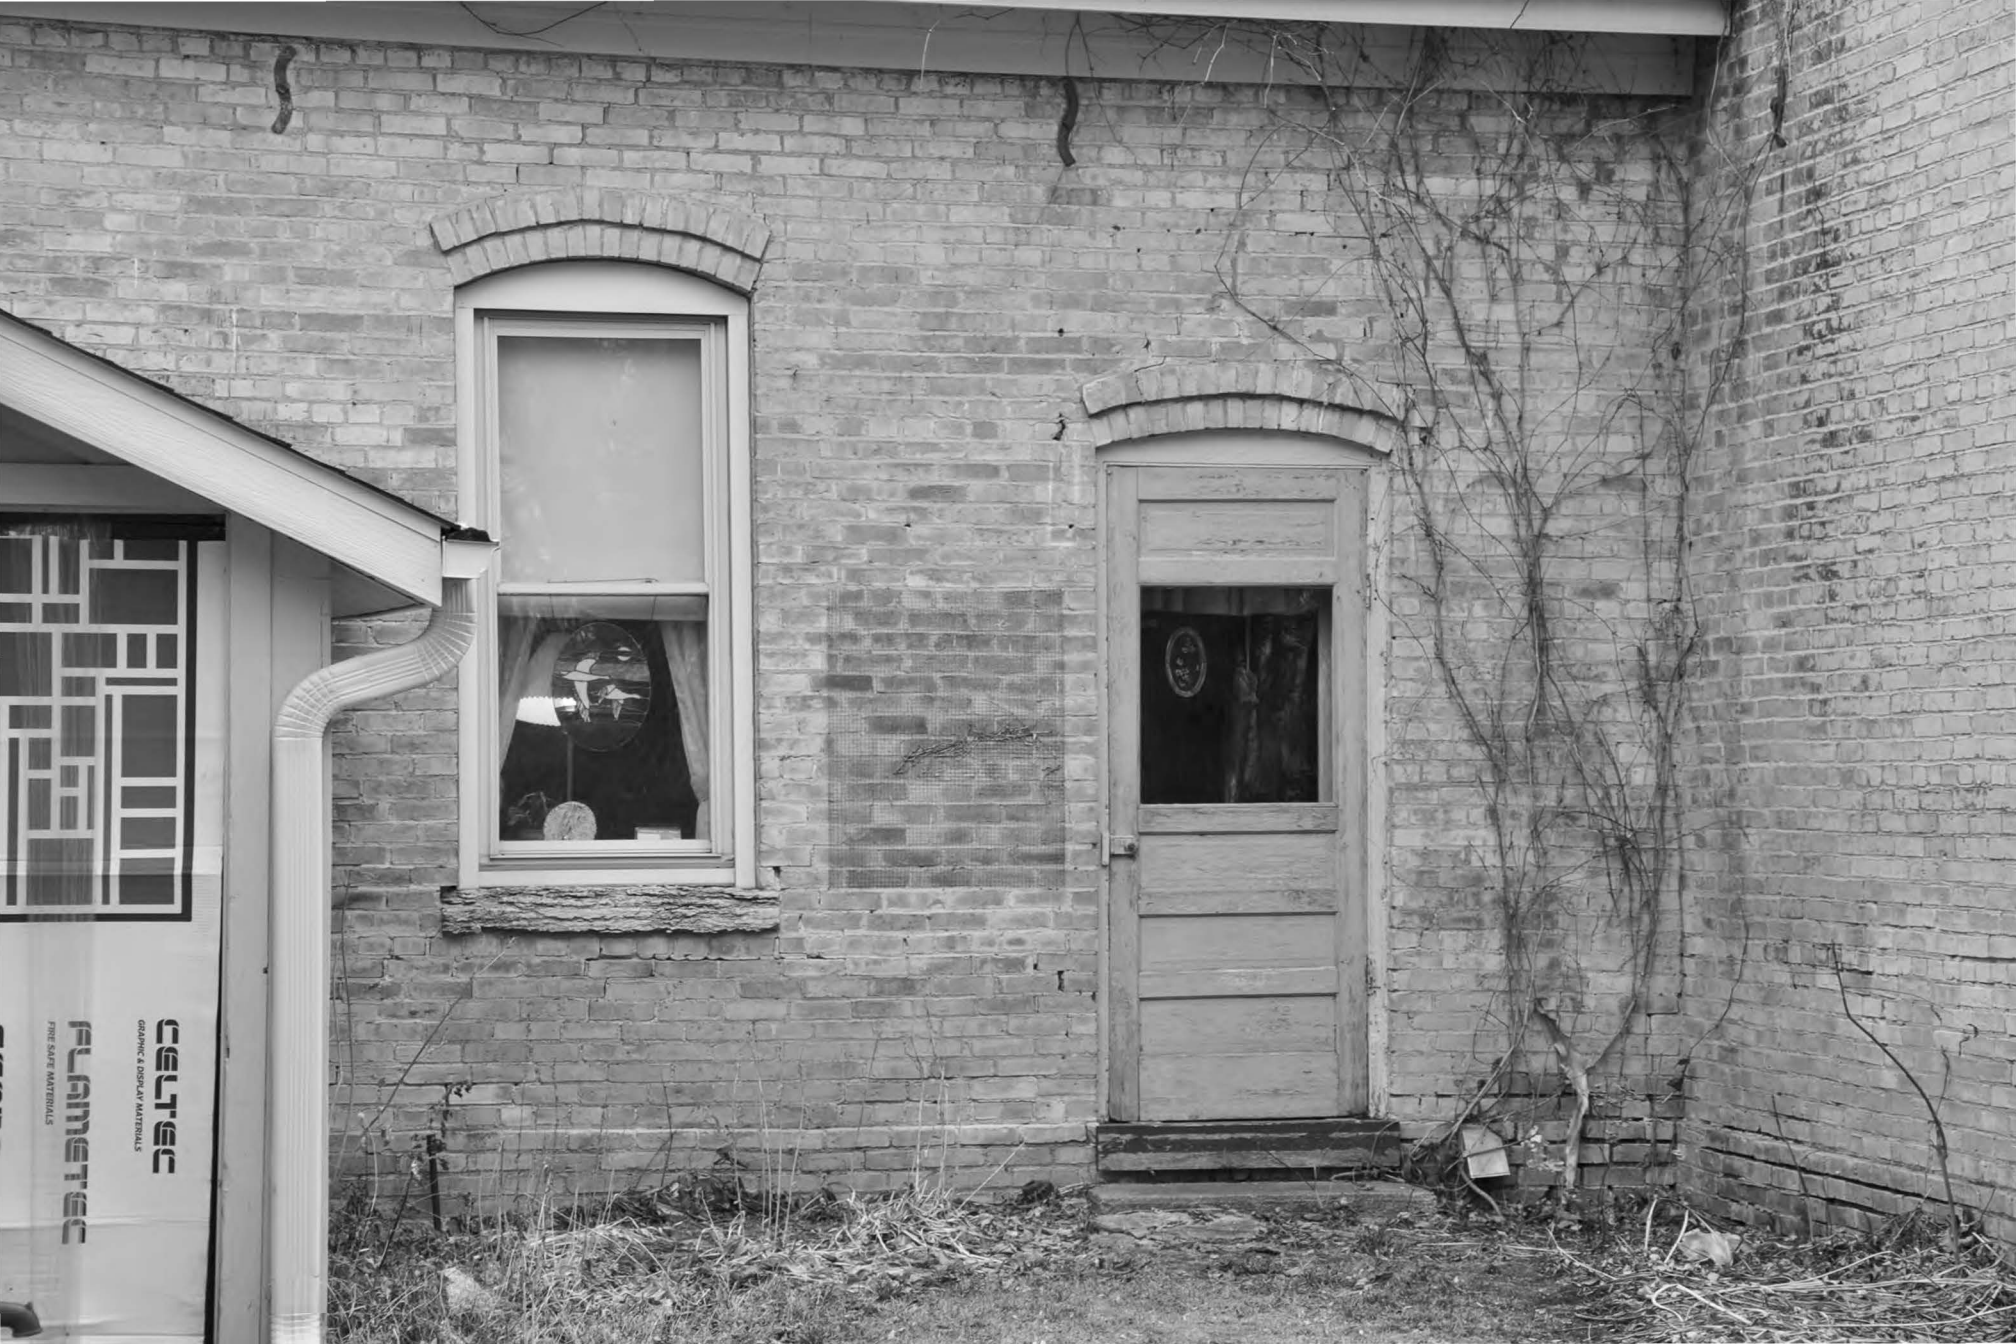
Photo 5 of 5

Western door and window on the northern kitchen wing; camera facing east.
