National Register of Historic Places Registration Form

Historic Name: Lincoln, George, House
Other Names/Site Number: N/A
Name of related multiple property listing: N/A

Street & Number: 30783 Parish Highway 11
City or town: Nairn State: Louisiana County: Plaquemines
Not for Publication: Vicinity:

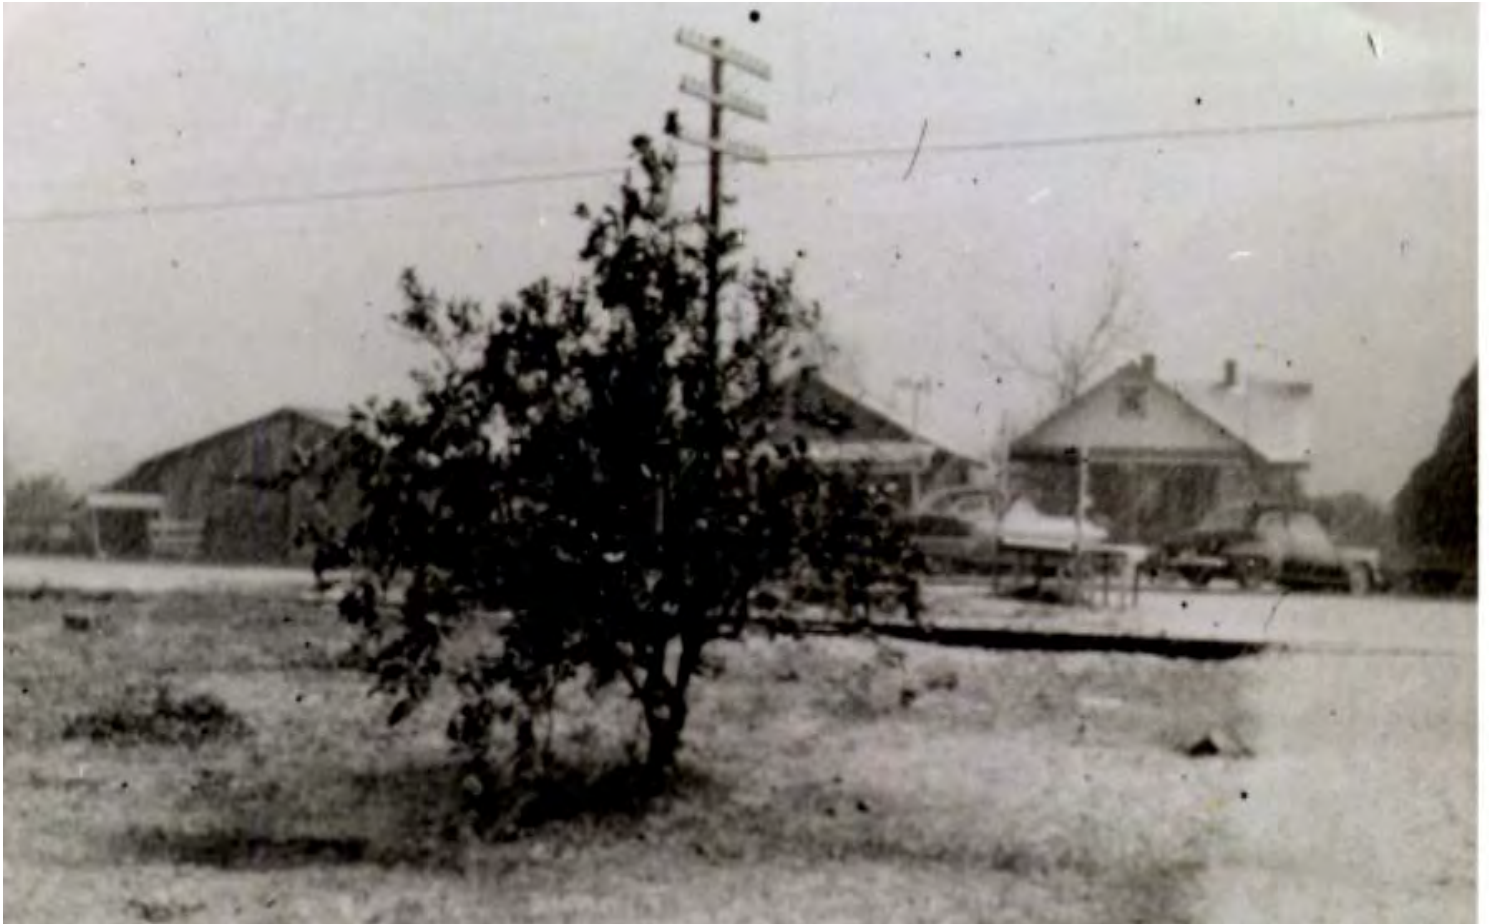
Figure 1. Lincoln House in December 1959 (right). In the middle is the George Lincoln General Store and the building to the far left is the barn for Louisa Farm (located next door). Highway 23, an orange tree, and railroad track in the fore ground. The highway and the George Lincoln House are all that remains. Image courtesy of Rod Lincoln.

The façade features a set of three grouped three over two double hung wood windows and a front entry multi-lite door with matching multi-lite side lites and transom. The side lites and transoms retain their original screens. The entire building is clad in wood siding painted white and the roof is now a metal roof, replaced following Hurricane Katrina and installed directly on top of the original diamond shaped asbestos roof. The inset full width front porch is supported by three full height concrete columns. One of the three matching columns was broken and had to be replaced after Katrina when the house was floated off its pier foundation by 20 feet of water. Between the three columns is an eight inch wide by four inch thick "handrail" used by guests as benches as well as handrails. At the top of the columns is a small, compressed column of sorts. Above these features is a beam spanning the length of the porch. A band of 13 repeating wooden blocks is above the beam and is topped with the fascia of the front gabled roof. A two lite window with decorative framing is centrally located in the gable end. The overhanging front roof is supported by five triangular knee braces. (See Photo 1, Figures 1, 2, 3, 4, and 11)

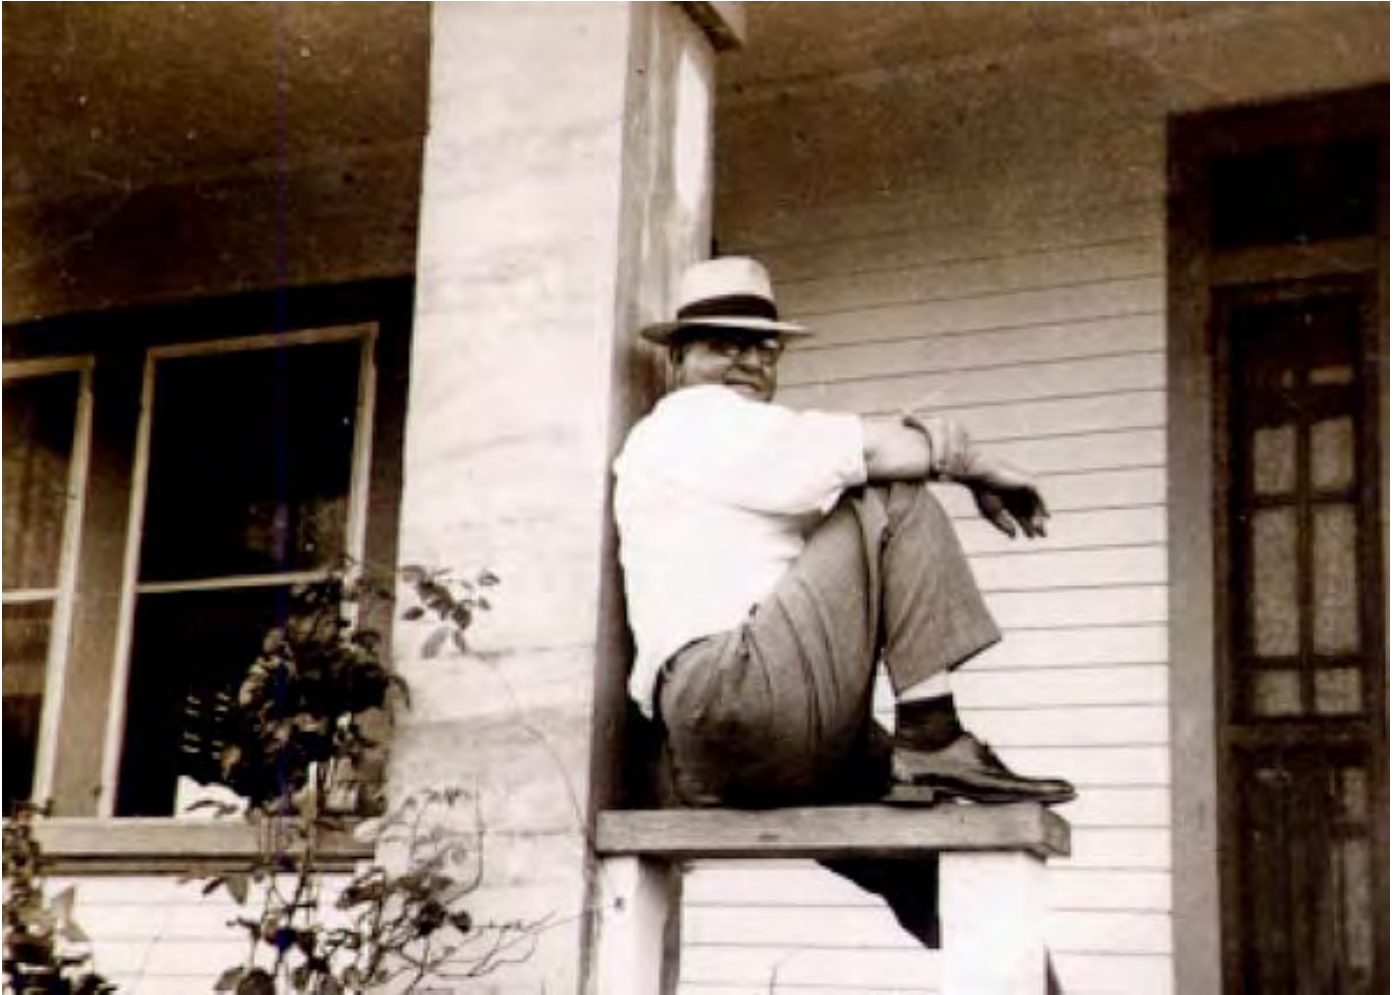
Figure 2. George J. Lincoln sitting on his front porch in 1949. The large porch handrails were popular benches for family and visitors. Image courtesy of Hays Lincoln.

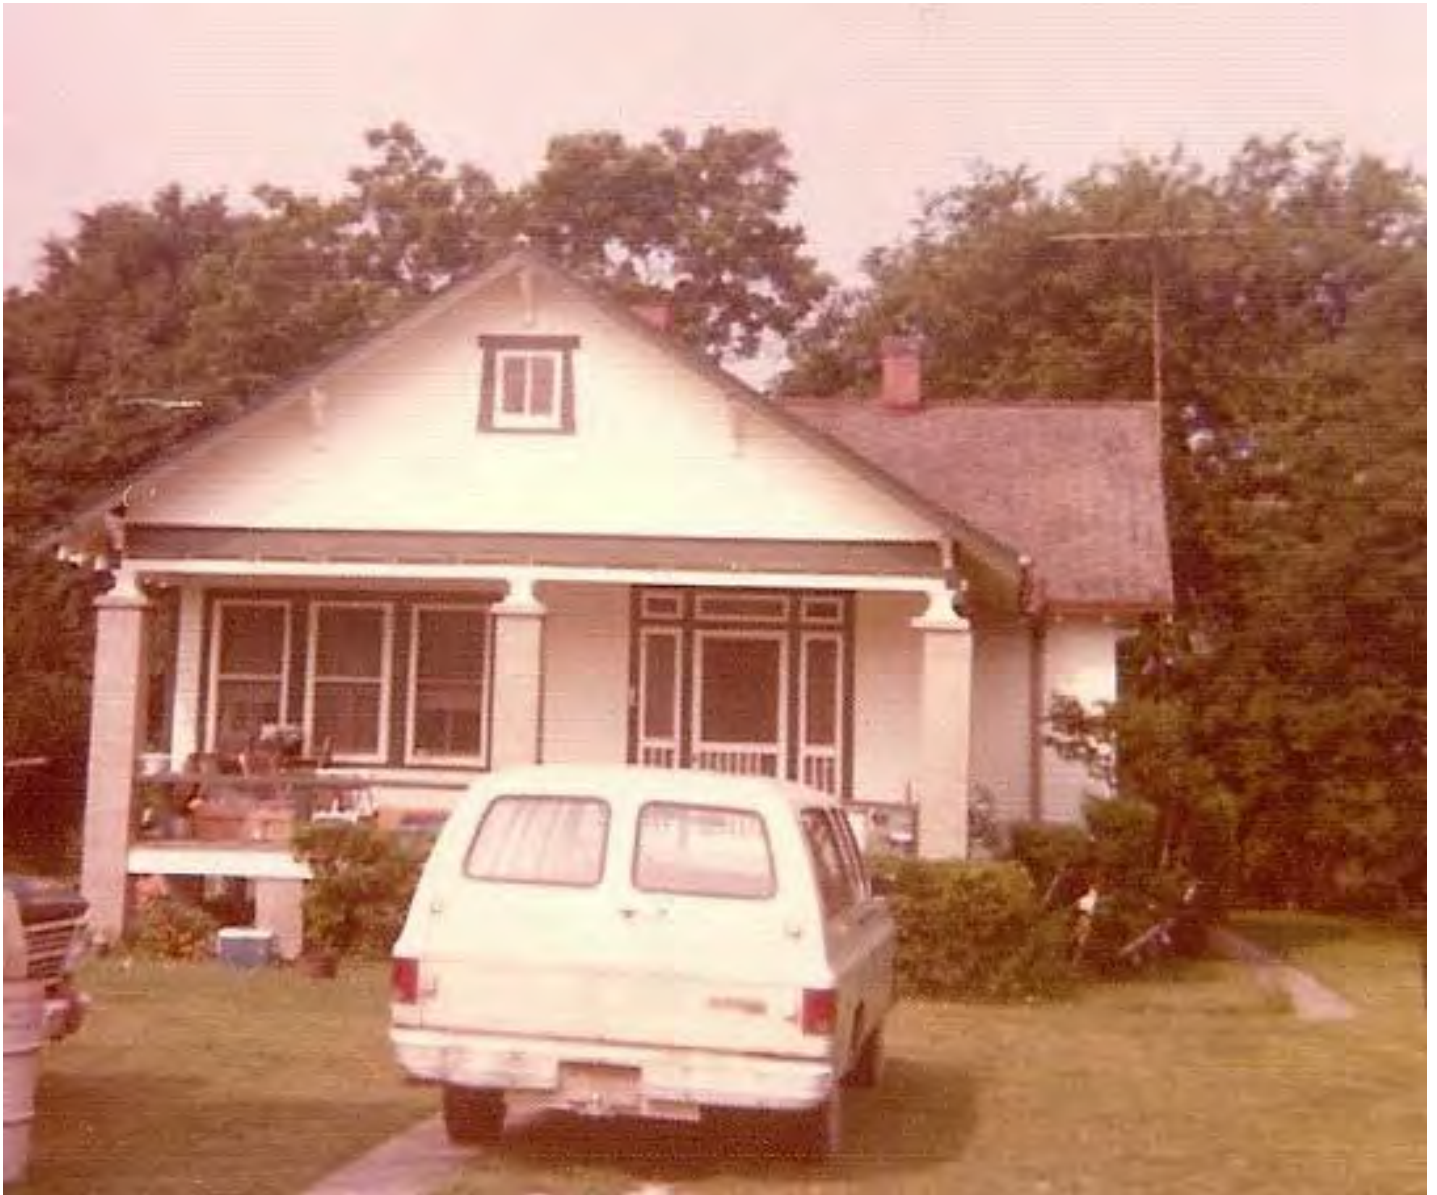
Figure 3. The Lincoln House in 1993. Image courtesy of Rod Lincoln.

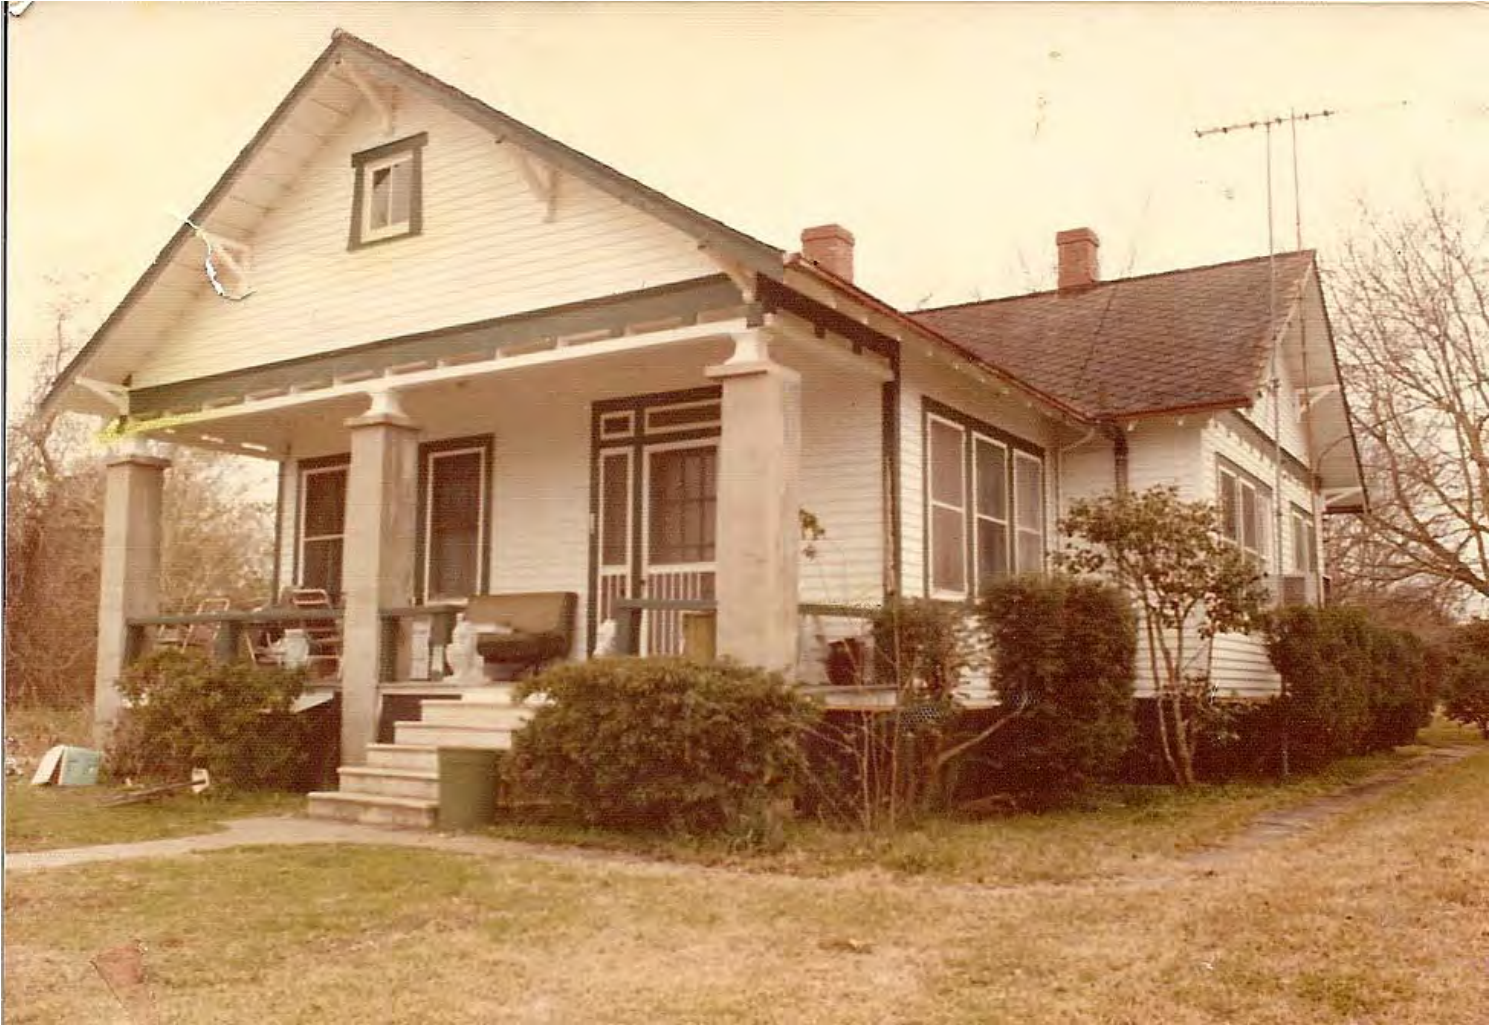
Figure 4. The Lincoln House in 1985. Image courtesy of Rod Lincoln.

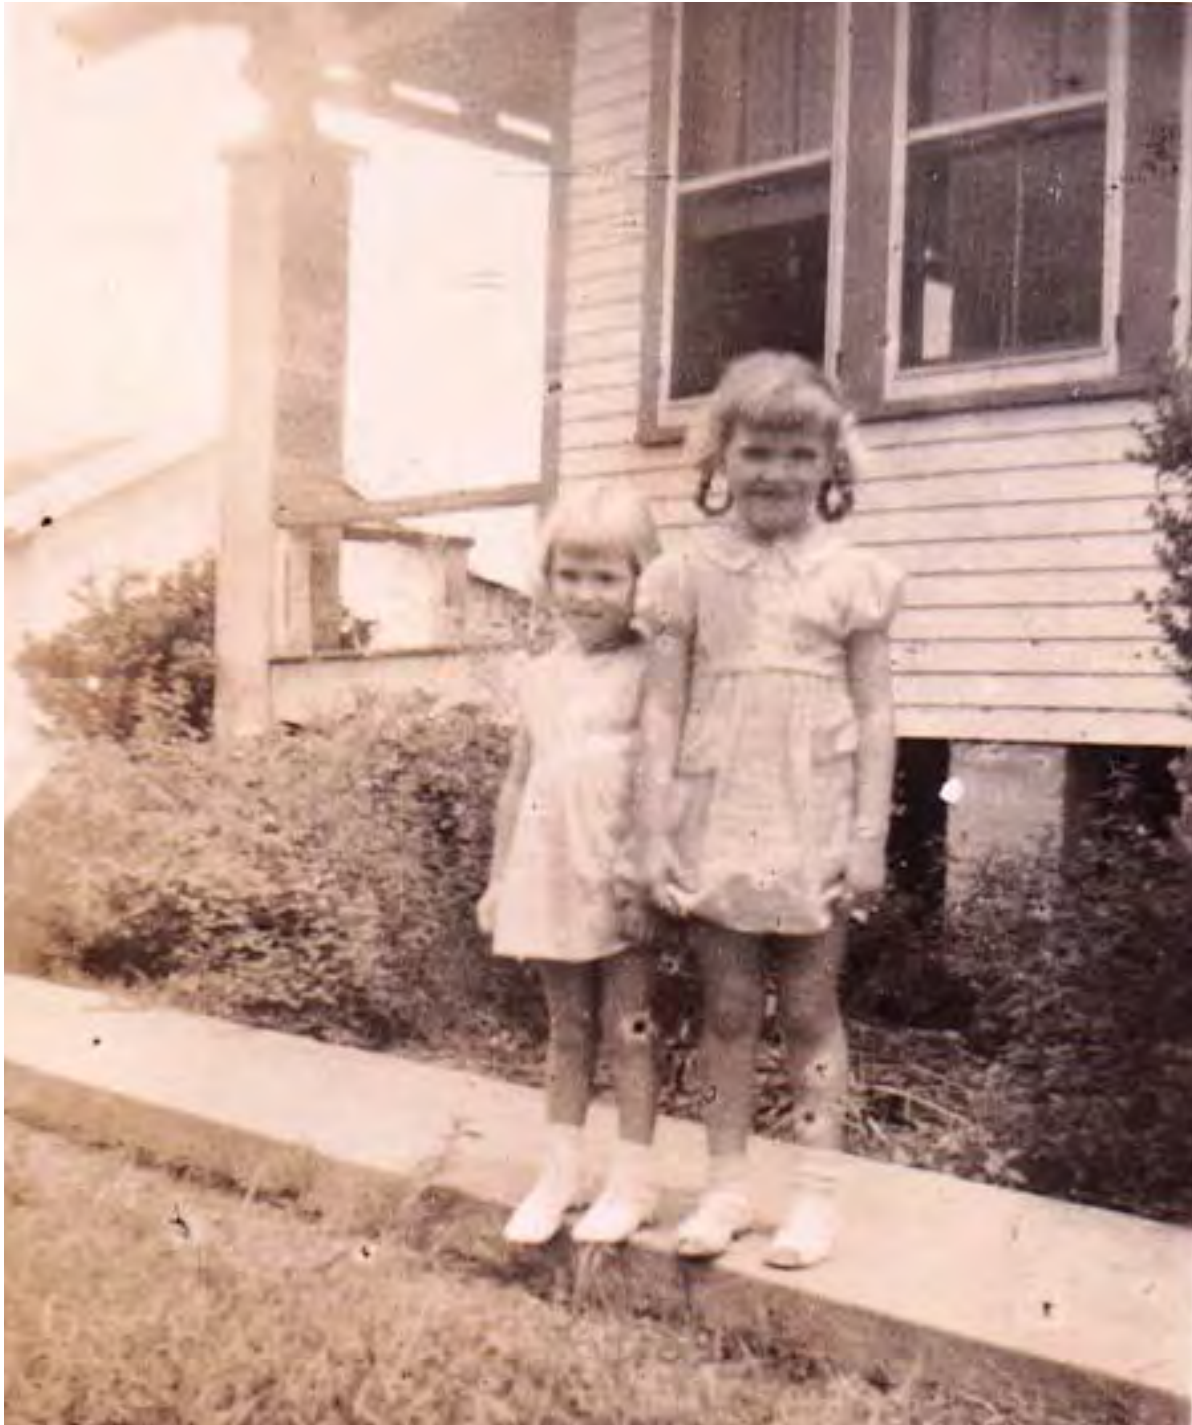
Figure 5. Photo from 1942 facing the northeast corner. Notice the large windows with screens. The screens are no longer extant and a simple wooden handicapped ramp has been added in this location. The Lincoln General Store can be seen in front of the house. Image courtesy of Rod Lincoln.

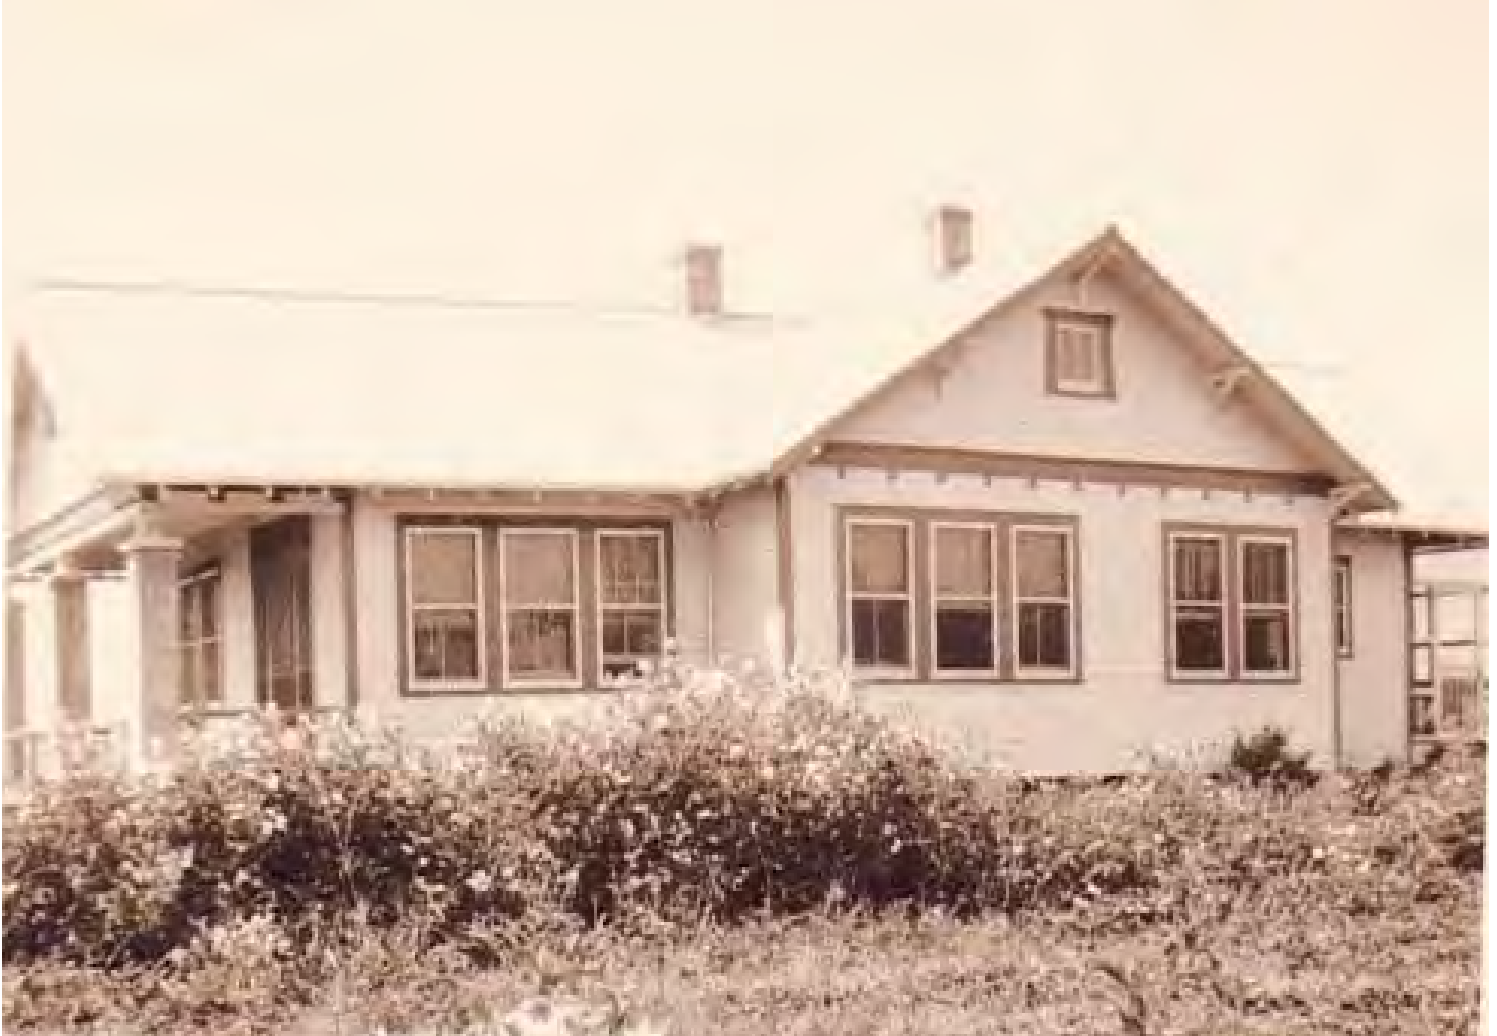
Figure 6. 1931 photograph, the earliest known photo of the house. This shows the original configuration before the back porch was screened in (the screening has since been removed but the framing for the screens remains). Image courtesy of Rod Lincoln.

This elevation features the previously mentioned inset full width back porch with a centrally located entrance, which leads to the rear hallway. A narrow three-lite transom sits atop this door. To its right is a single double-hung three over two wood window. To its left is another window, paired with a second entrance, leading directly into the kitchen. This door has been replaced with a more modern door while the other entrance is an original multi-lite door. Original screen doors are intact on both entries. The gable end has a two-lite window matching the one on the façade. The gable also has 5 matching triangular knee braces. The ceiling of the porch is bead board. (See photos 3 and 4 and Figures 6 and 7)

This elevation has a centrally placed projection with a cross gable roof. The projection has two sets of grouped double hung wood windows – a set of three and a set of two. Above the windows is a band of repeating square wooden blocks just below the fascia. The gable end has another matching two-lite window like on the front and rear and five triangular knee braces in the eaves. To the rear of the projection, there is a smaller three over two double-hung wood window, which is the kitchen window. To the front of the projection is a set of three grouped double-hung wood windows. A wooden handicapped ramp was added to the front of the projection in 2008, providing access to the front porch. It runs parallel to the north elevation. (See Photos 5 and 6 and Figures 6 and 7).

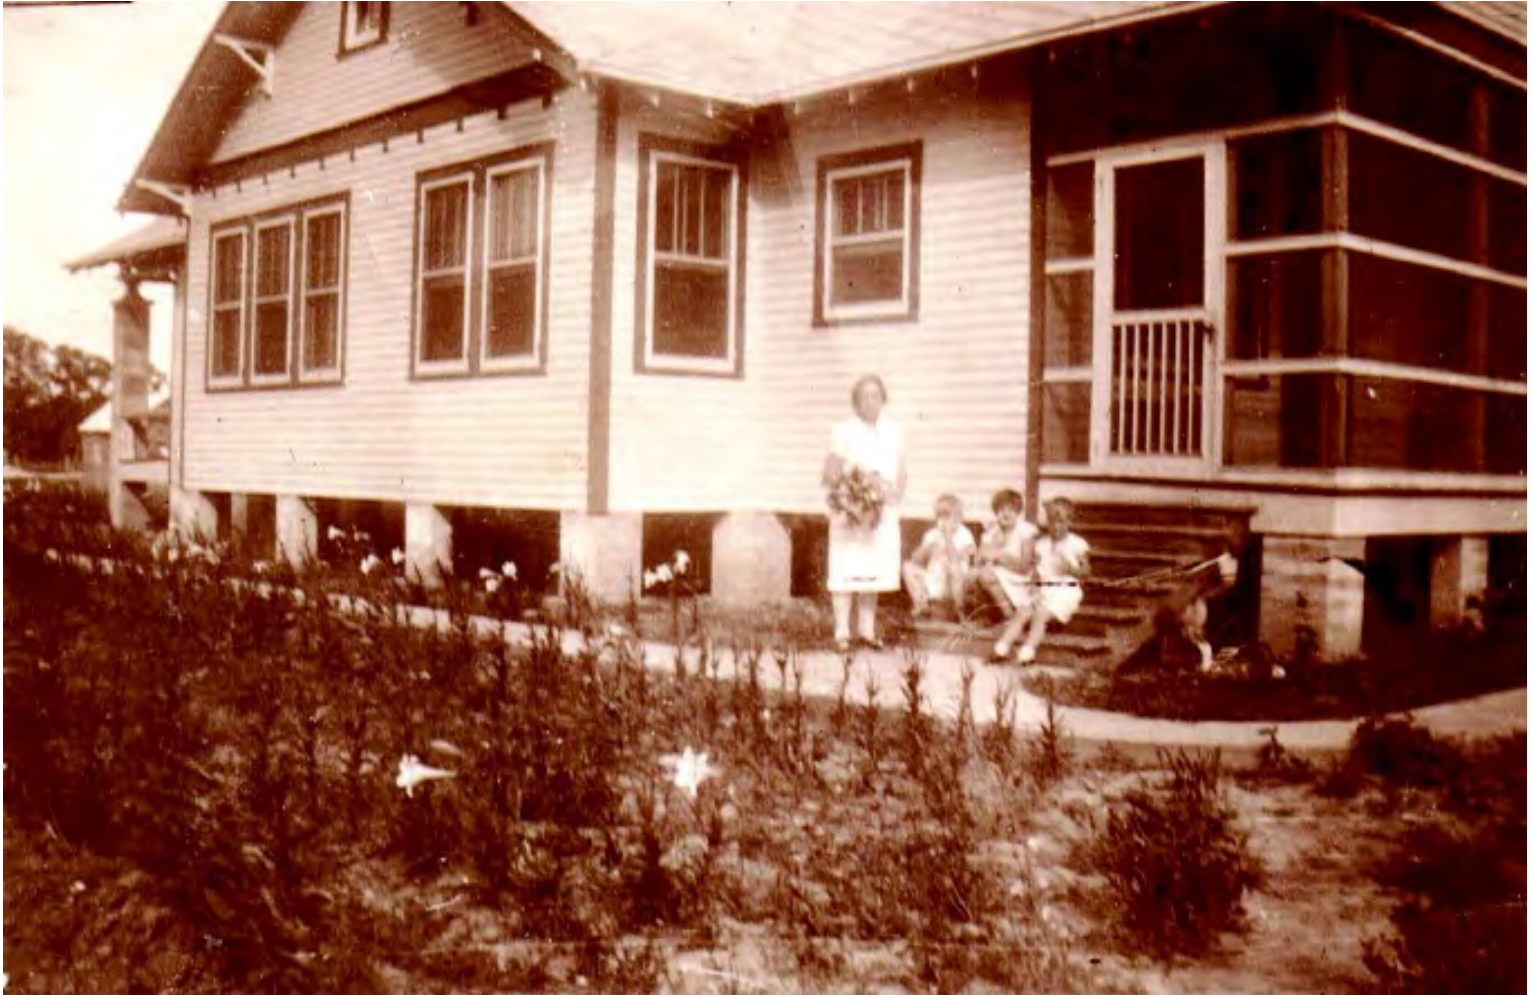
Figure 7. 1932 photograph of the rear and side elevation showing the rear porch once the screening had been installed. The screening has since been removed, but the original framing and door remain in place. Image courtesy of Rod Lincoln.

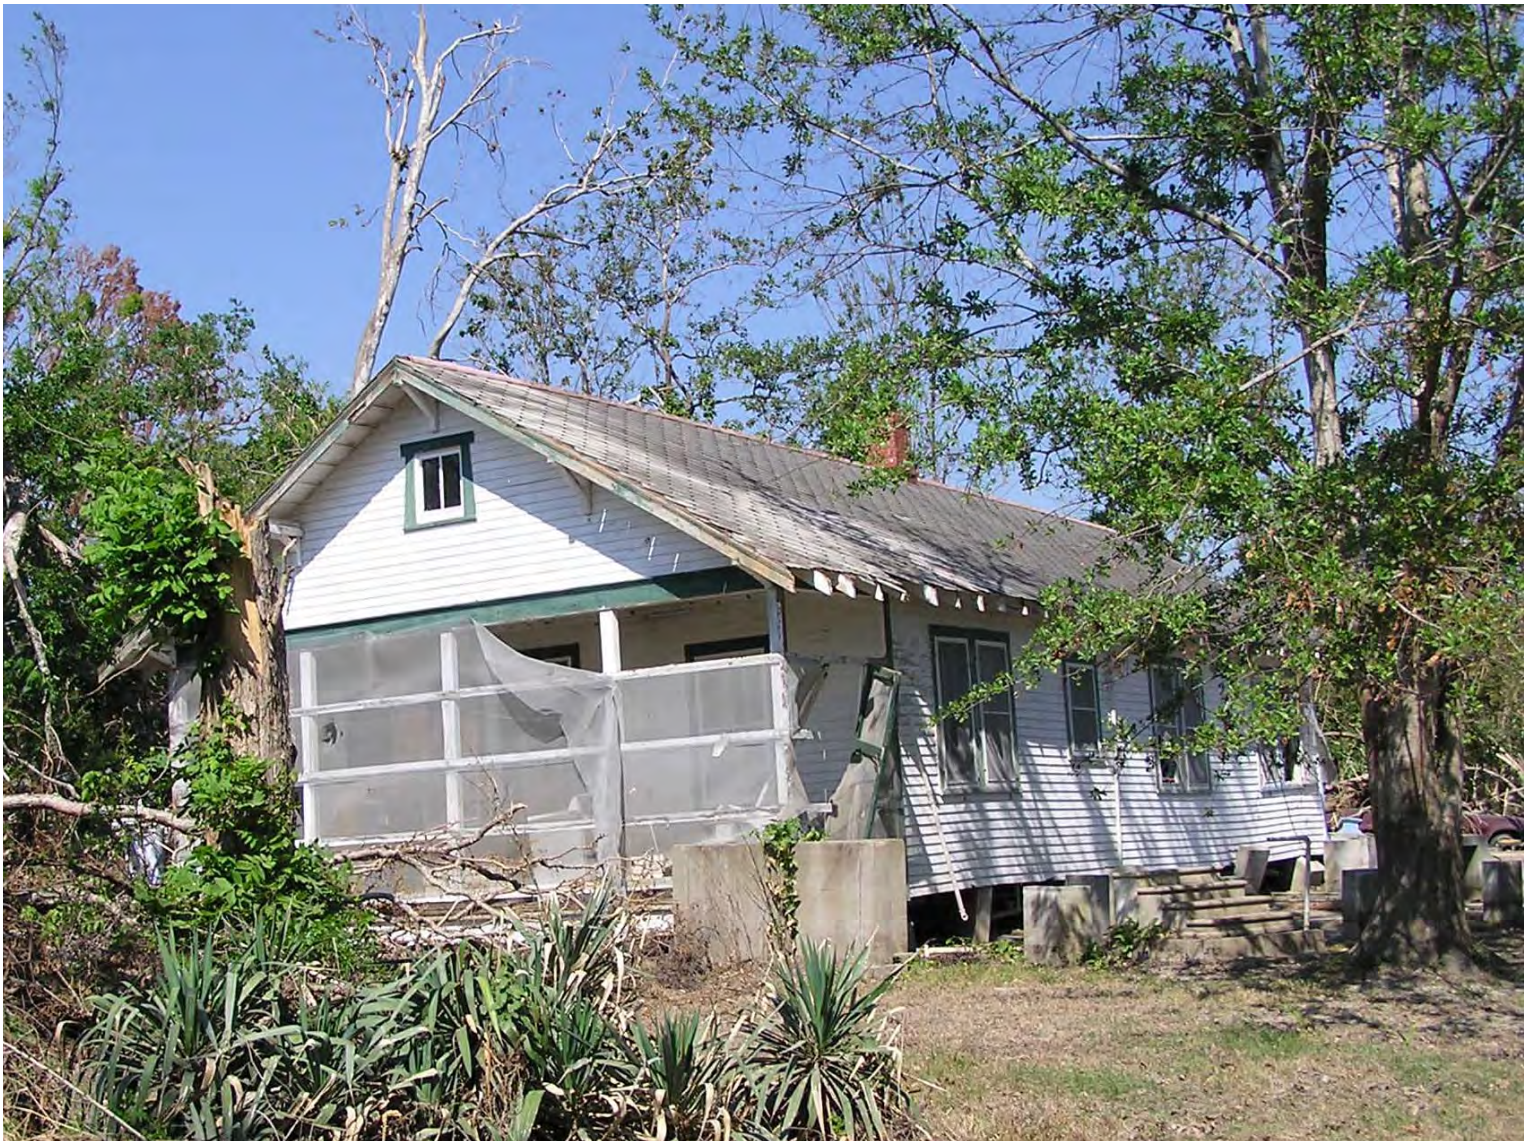
Figure 8. The Lincoln House in 2006. Notice the concrete structure on the right corner of the house. This was the cistern support. To the right of that are the steps that went onto the back porch. The house was still off its piers when this photo was taken. Image courtesy of Rod Lincoln.

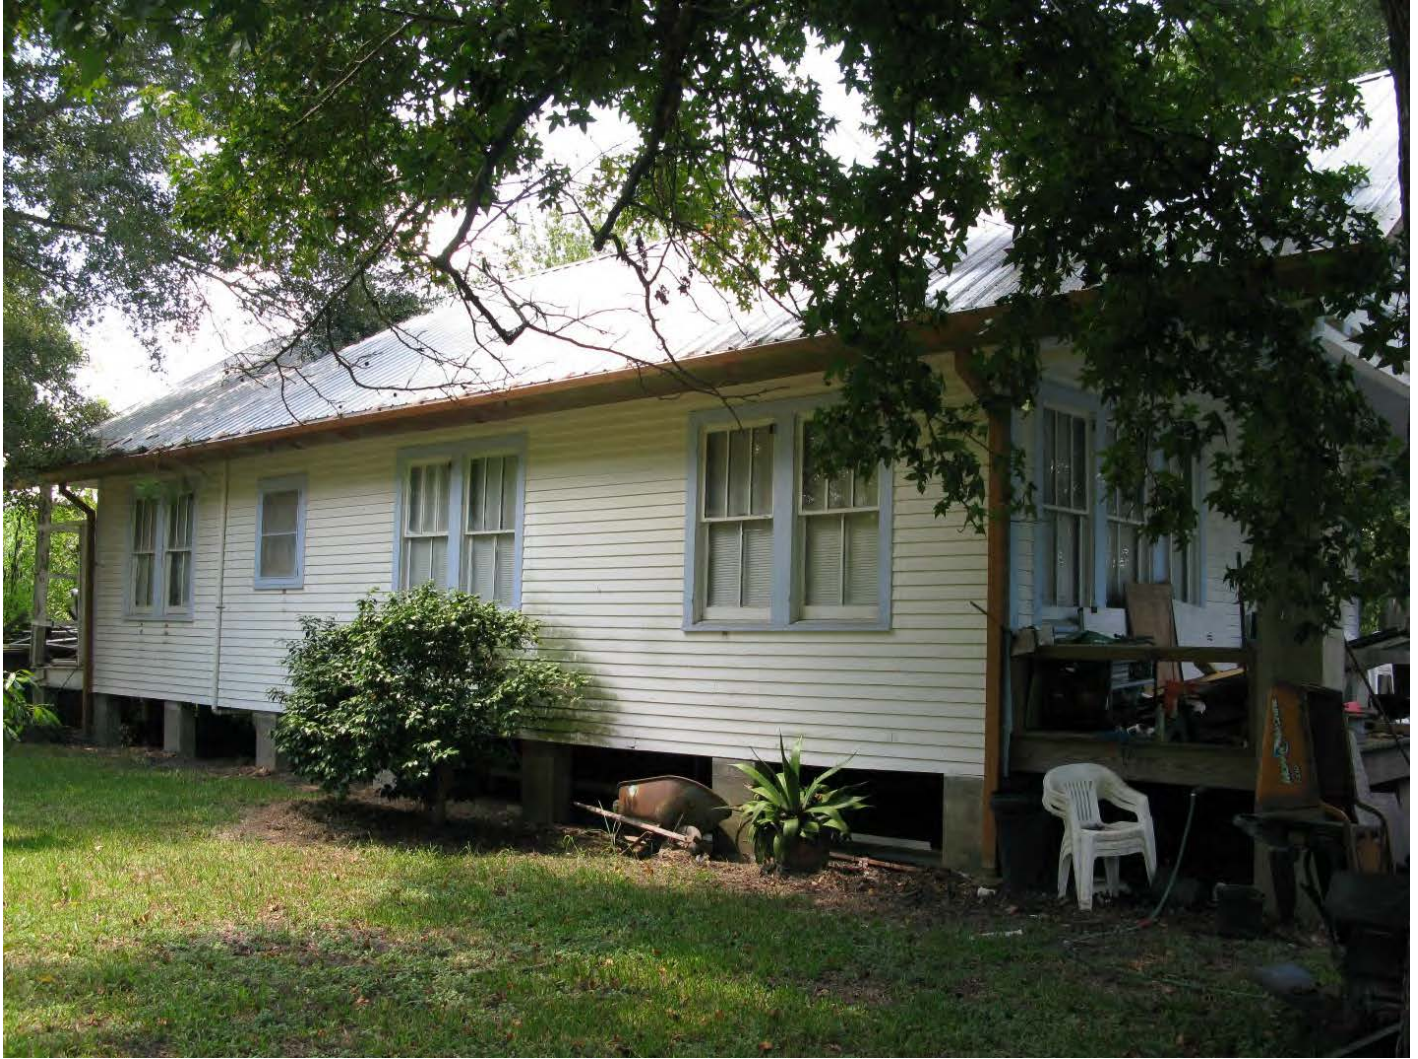
Figure 9. 2015 image of the Lincoln House. The original forest green accent paint color was changed to light blue. Image courtesy of Rod Lincoln.

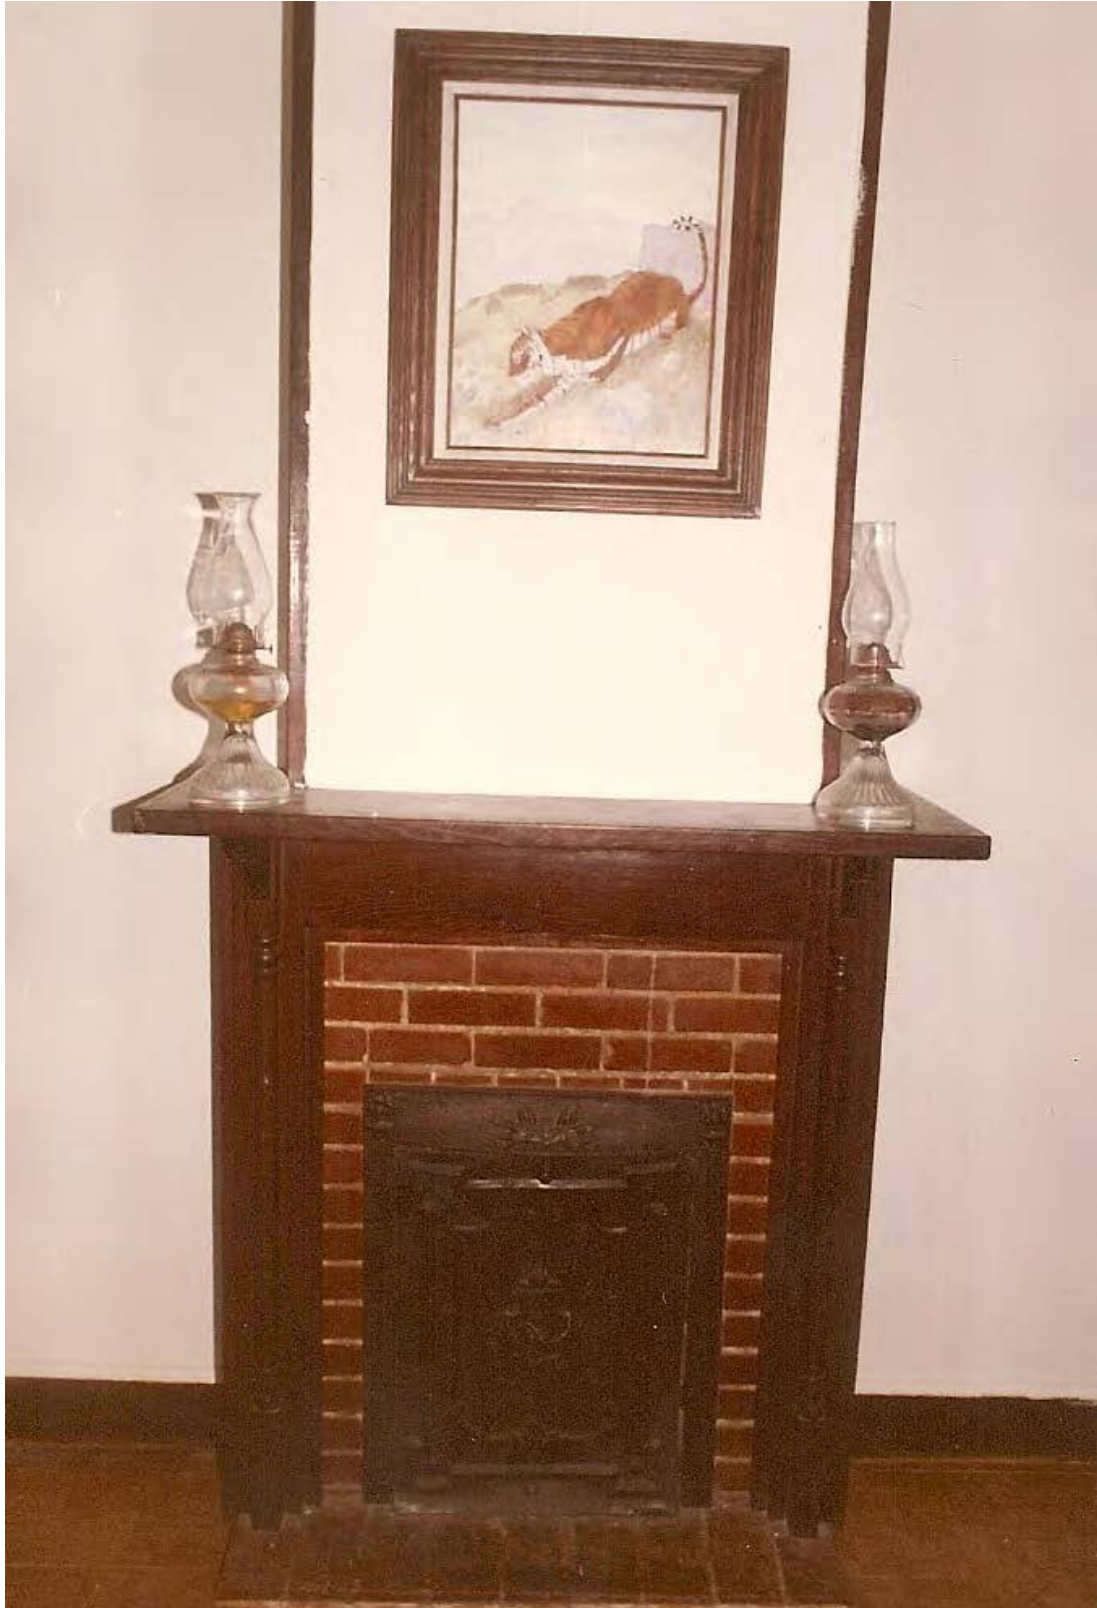
Figure 10. 1990 photograph of the original fireplace located between the living room and the middle bedroom. It was destroyed when the house was lifted off its piers during Hurricane Katrina. Image courtesy of Rod Lincoln.

The George Lincoln house was not built with electricity. Electricity was added in the early 1940's and completely updated in 2008 when the house was restored to its foundations and renovated after Katrina. It originally had two fireplaces. The one in the kitchen was removed in the 1940's when they bought a modern stove. The double fireplace between the Family Room and middle bedroom had to be removed because the chimney bricks had gotten damaged when the house floated during Hurricane Katrina.

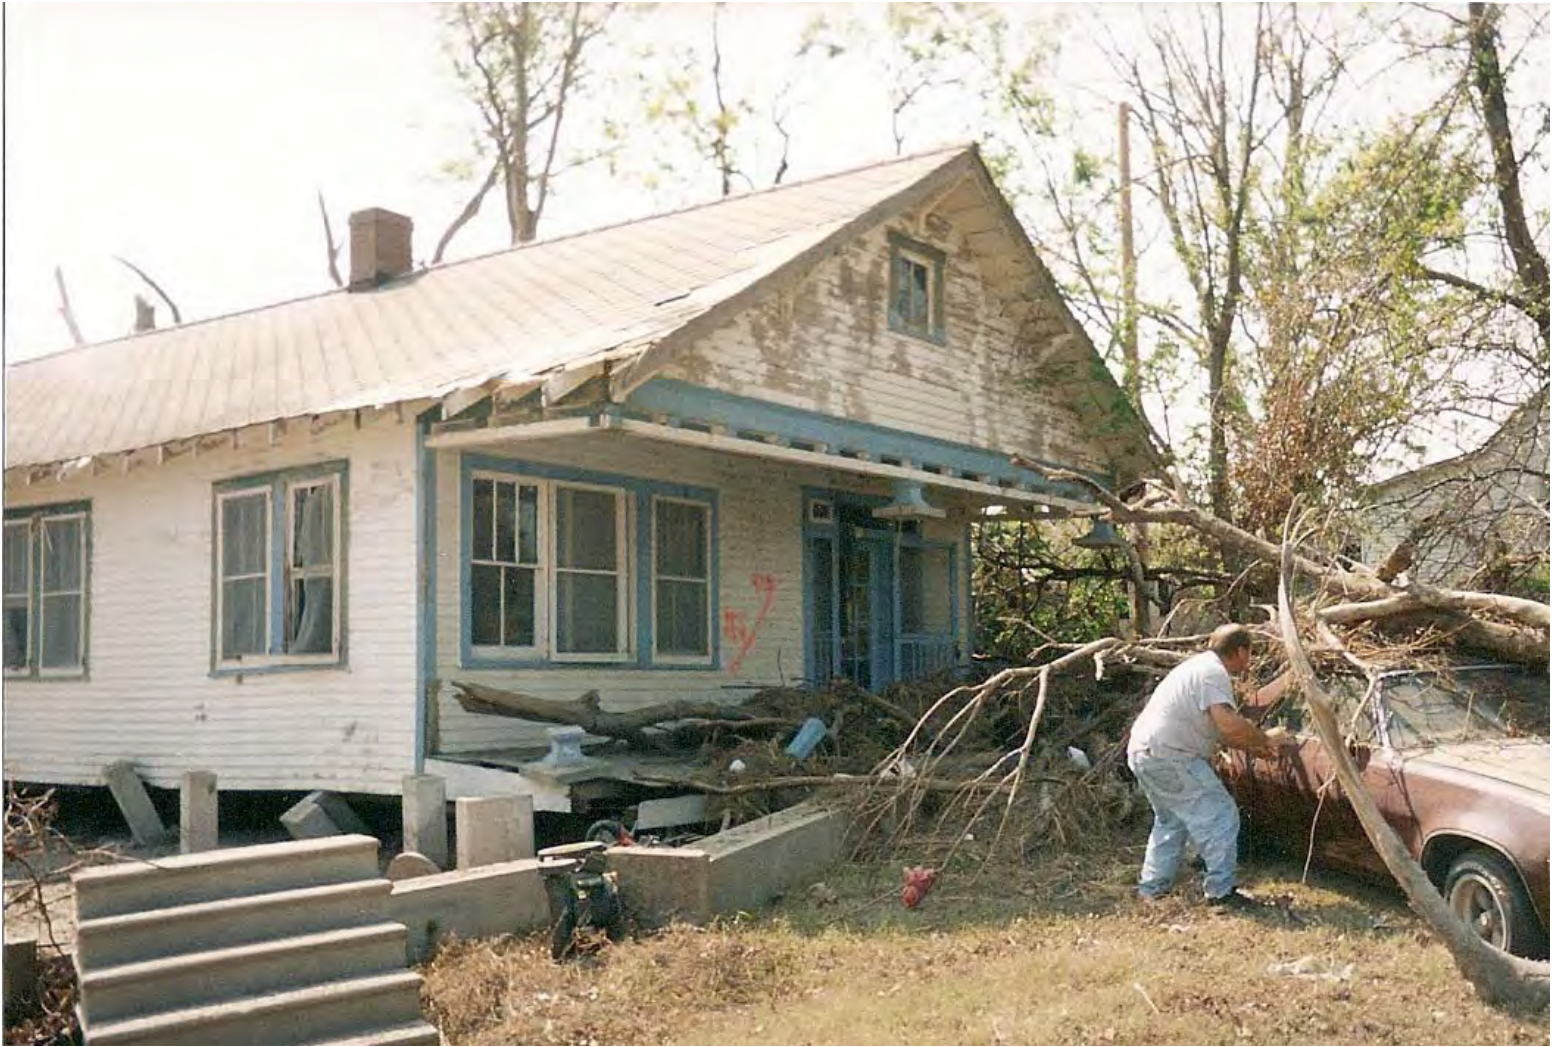
Figure 11. More than a year after Hurricane Katrina the George Lincoln house was still off its piers waiting for workers to help set it back. Two of its three columns on the front were intact. Surprisingly the porch overhang maintained its integrity. Image courtesy of Rod Lincoln.

When Hurricane Katrina hit, the house was not attached to its pilings, so it broke the piping and fireplace and floated in place until the water went down. It returned just a few feet from its original foundation. Because of difficulty getting workers at the time and complete destruction of virtually all housing in the area, the house remained off its foundation, lying at an angle for over two years. Despite being water soaked, structurally it was in excellent condition. In 2007, George Lincoln's grandson, Kerry Lincoln, began renovating the house. In 2008, it was put back onto its original piers in its original place. The sheetrock was replaced and some modifications made to make it livable, but care was given to maintain its structural integrity. After Katrina, the pine floor was heavily damaged by the water and it was covered with heavy oak.

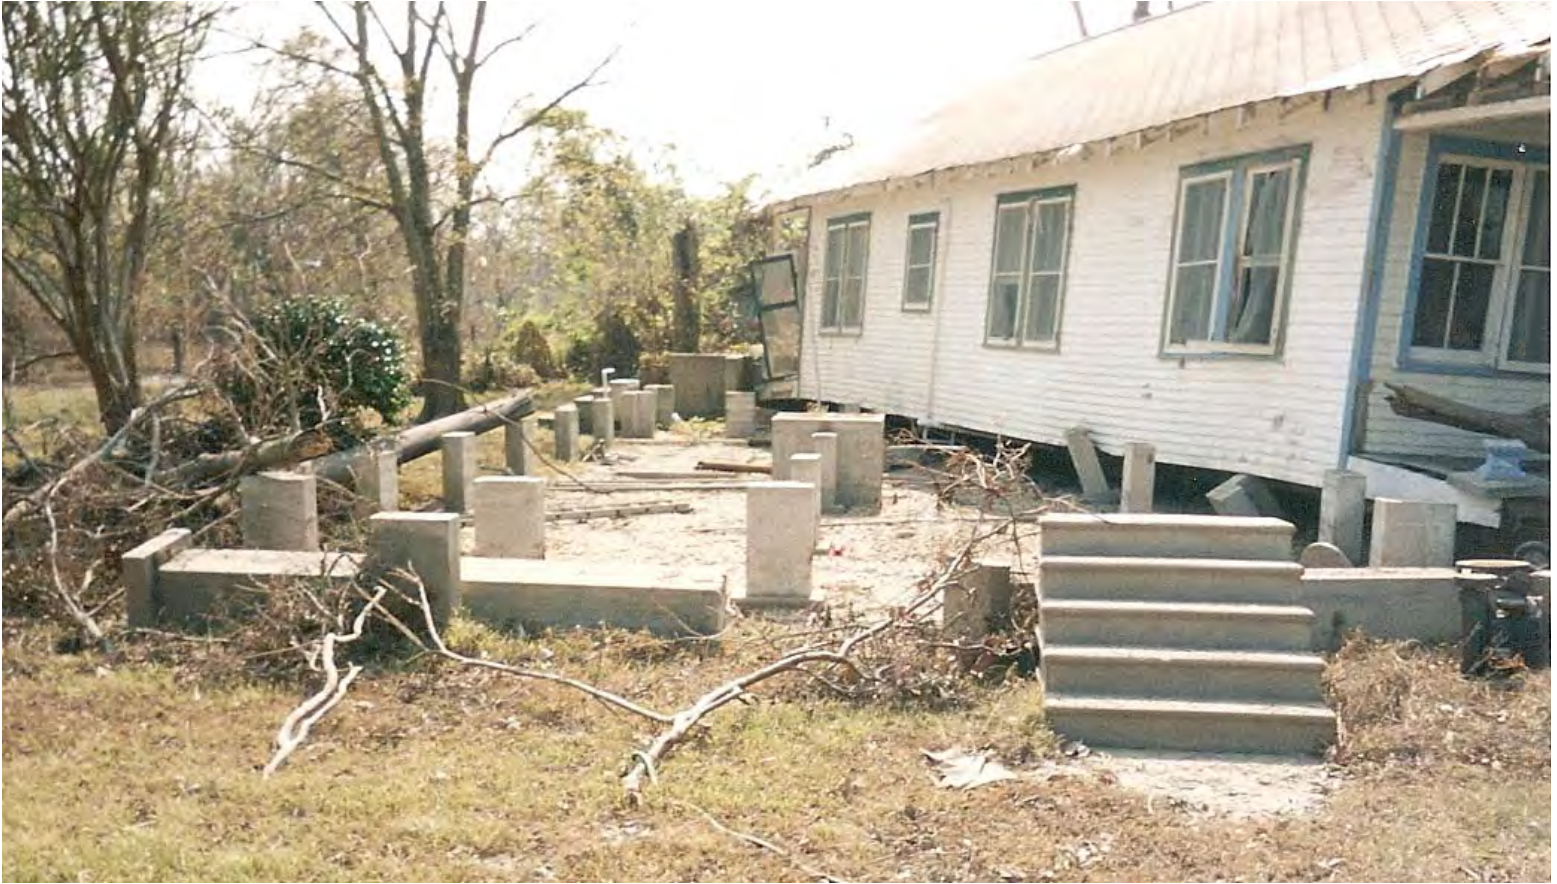
Figure 12. 2006 photo from the front (east) of the house showing the original piers and how much the house floated from its original location. Image courtesy of Rod Lincoln.

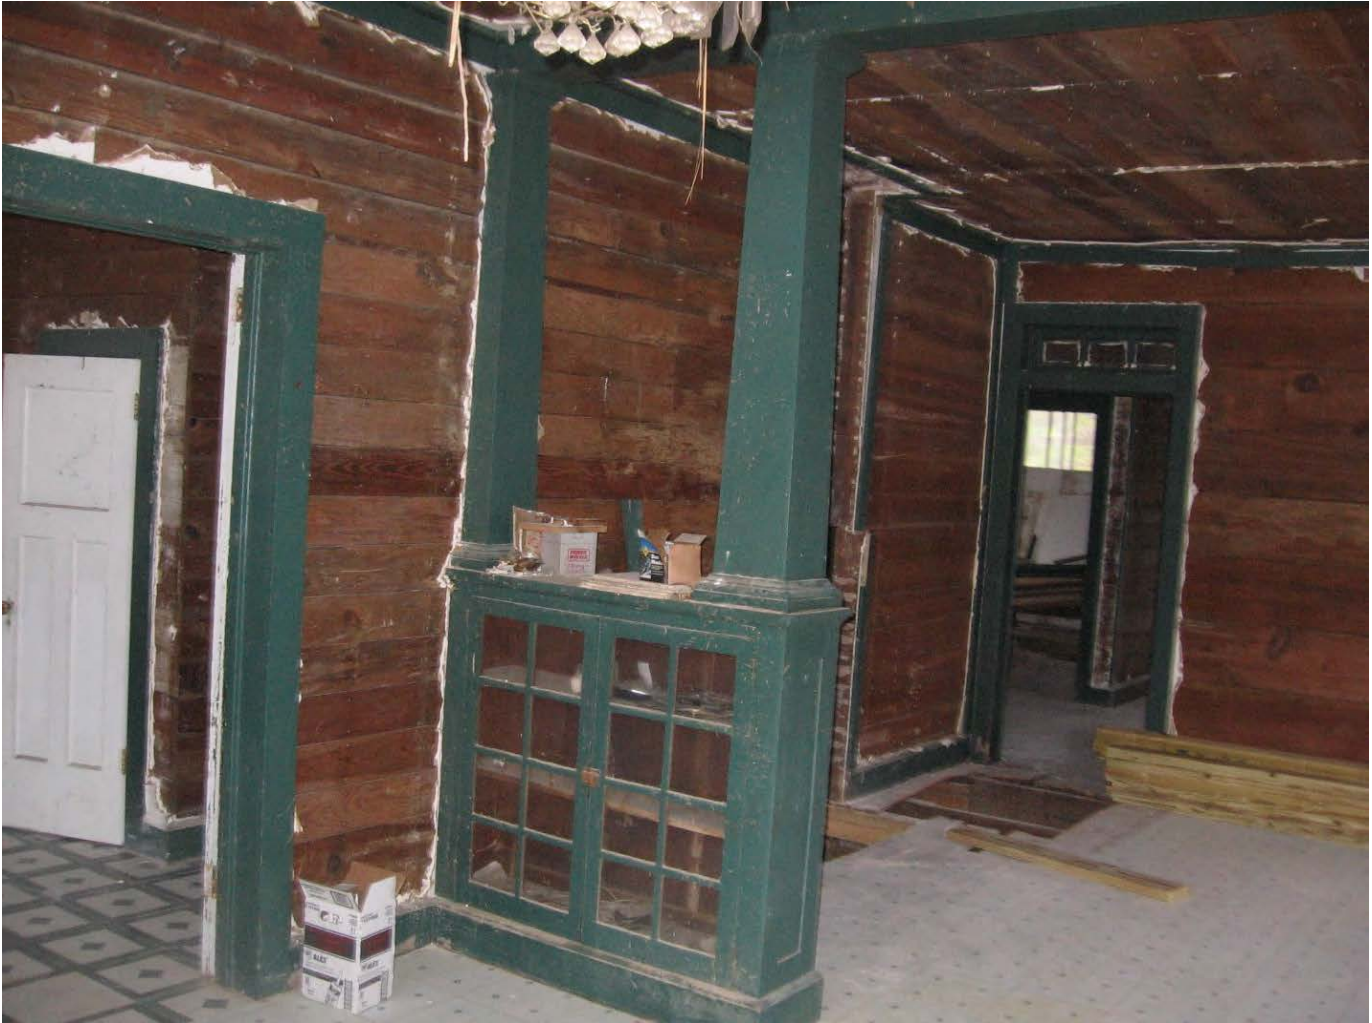
Figure 13. 2009 photograph taken from inside the front door facing slightly south towards bedroom door (far left). A built in book shelf is noticeable in the center. The door in back right of photo goes into the hall where two bedrooms and a bath connect to a small hall to back door. The sheet rock had been peeled off exposing solid cypress walls. Image courtesy of Kerry Lincoln.

The house was built primarily of cypress and probably 90% of the original wood remains intact. Several areas where the cypress had to be removed were: (1) the front porch had to be rebuilt as a result of hurricane damage; (2) some of the interior trim work was replaced as it got damaged; and (3) a non-cypress plywood patch was installed on the roof, but all joists, etc. are original cypress. The original floor was pine, which was later covered with linoleum (see Figures 13-24).
