National Register of Historic Places Registration Form

Historic Name: Lincoln, George, House
Other Names/Site Number: N/A
Name of related multiple property listing: N/A

Street & Number: 30783 Parish Highway 11
City or town: Nairn State: Louisiana County: Plaquemines
Not for Publication: Vicinity:

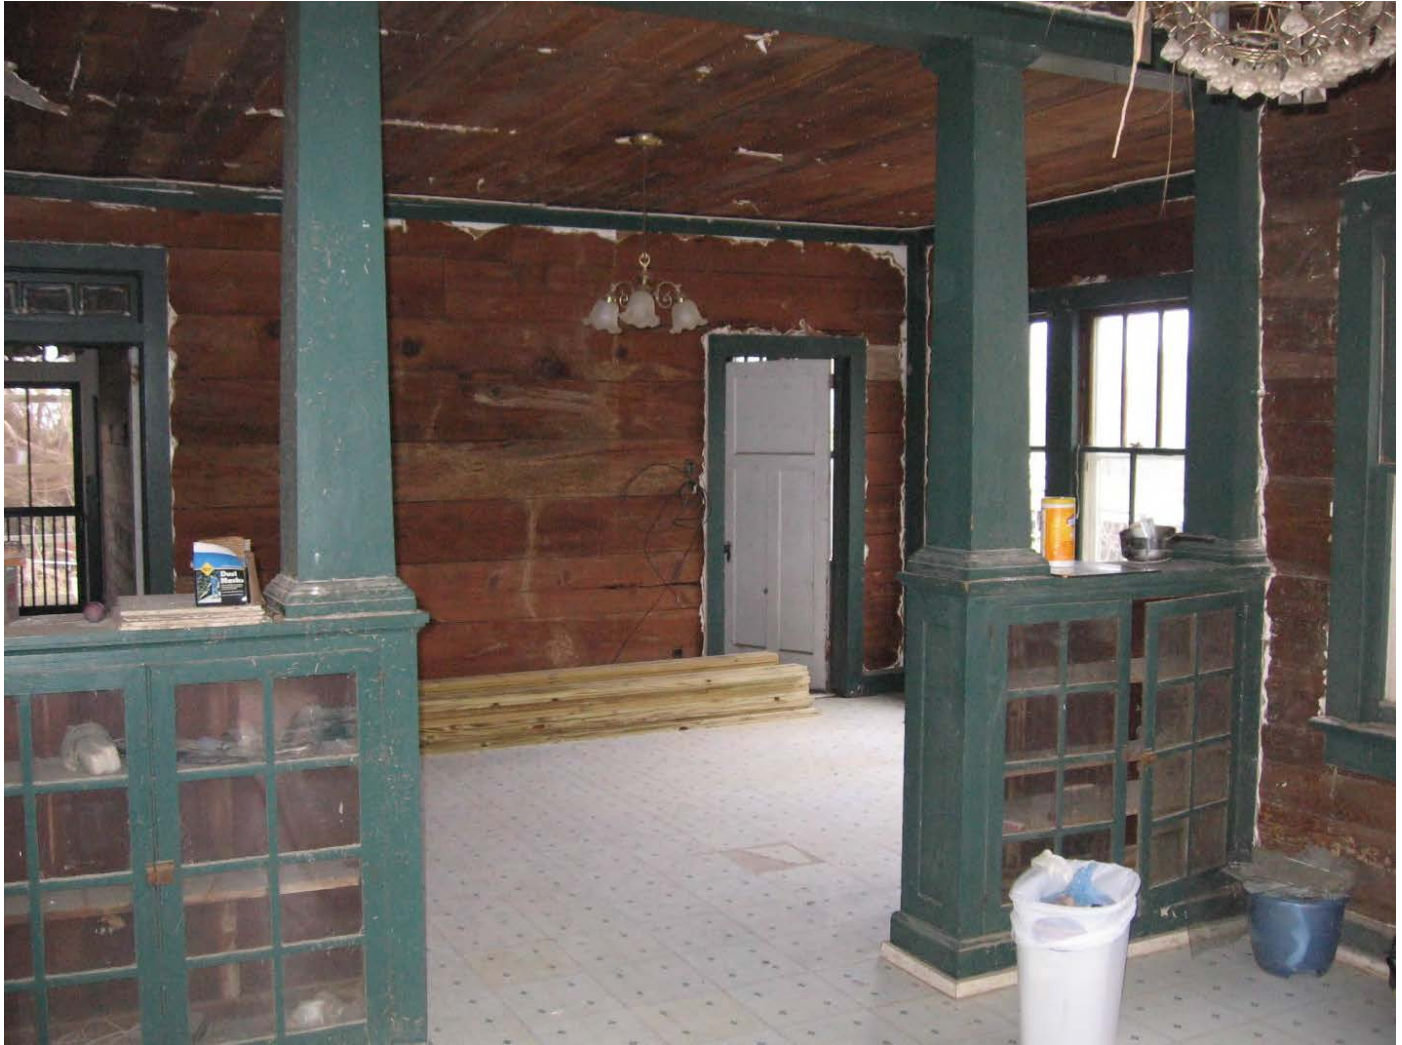
Figure 14. 2009 photograph Shot from front door looking northwest. The two built-in book shelves are in the foreground. In the back left corner the rear entrance is visible down the hall. The door in the back right is the door to the kitchen/dining room. Image courtesy of Kerry Lincoln.

The house was built primarily of cypress and probably 90% of the original wood remains intact. Several areas where the cypress had to be removed were: (1) the front porch had to be rebuilt as a result of hurricane damage; (2) some of the interior trim work was replaced as it got damaged; and (3) a non-cypress plywood patch was installed on the roof, but all joists, etc. are original cypress. The original floor was pine, which was later covered with linoleum (see Figures 13-24).

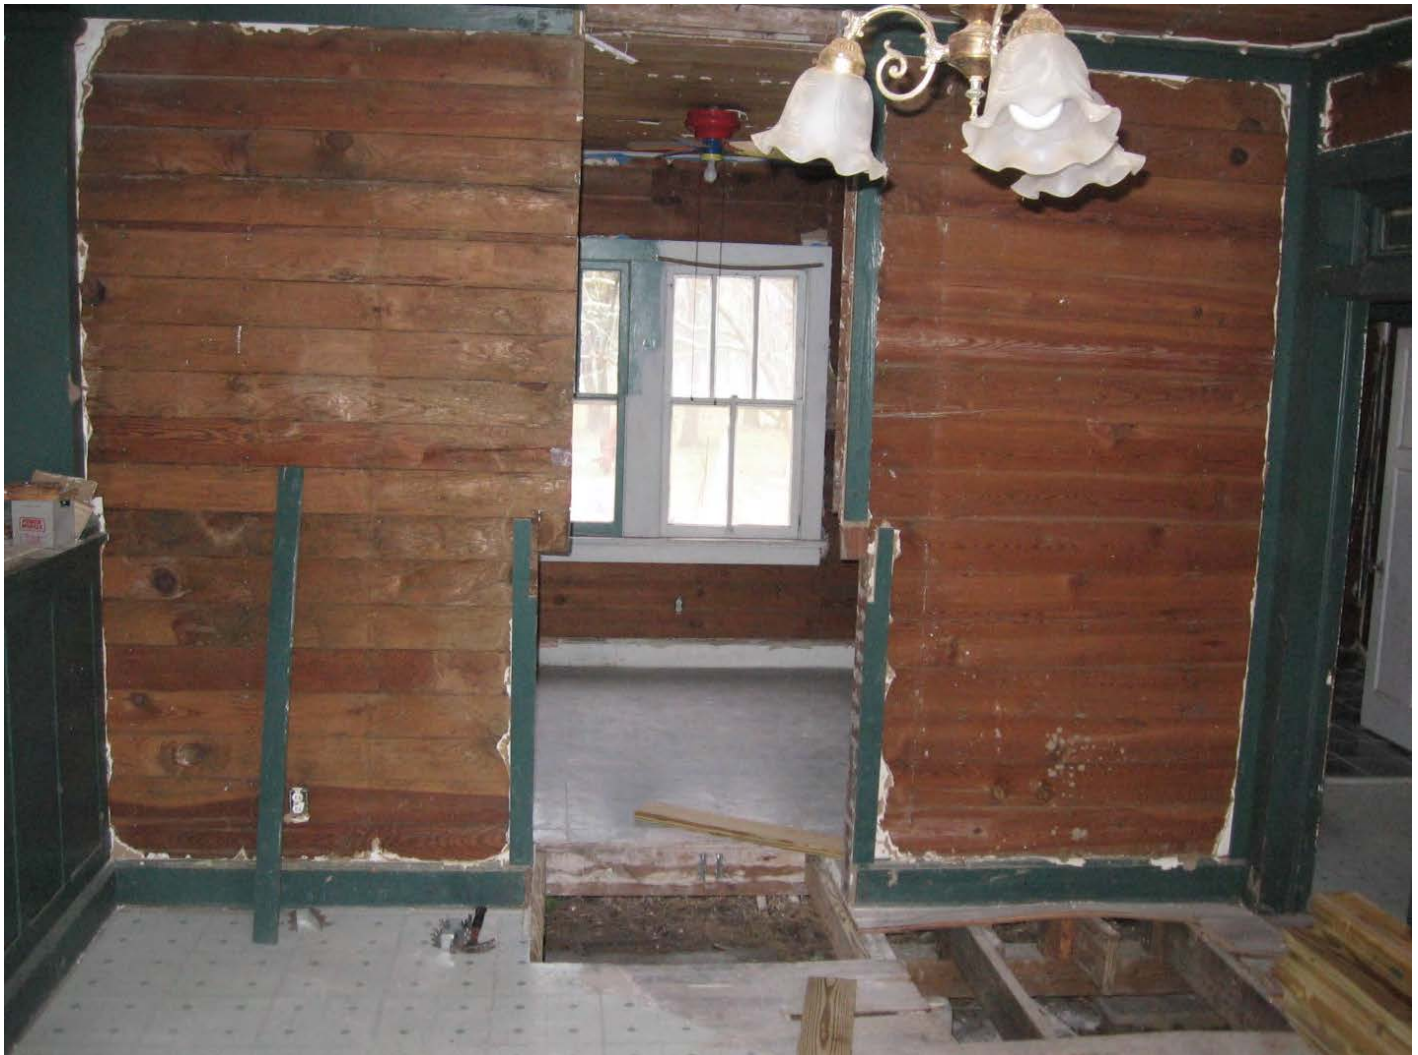
Figure 15. 2009 photograph of the Lincoln House. To the left is the back of a built in book shelf and to the right is the door into the hall from the Living Room. This hole was previously where a fireplace was located between the Living Room and the middle bedroom. The chimney was damaged when the house floated during hurricane Katrina and had to be removed. Image courtesy of Kerry Lincoln.

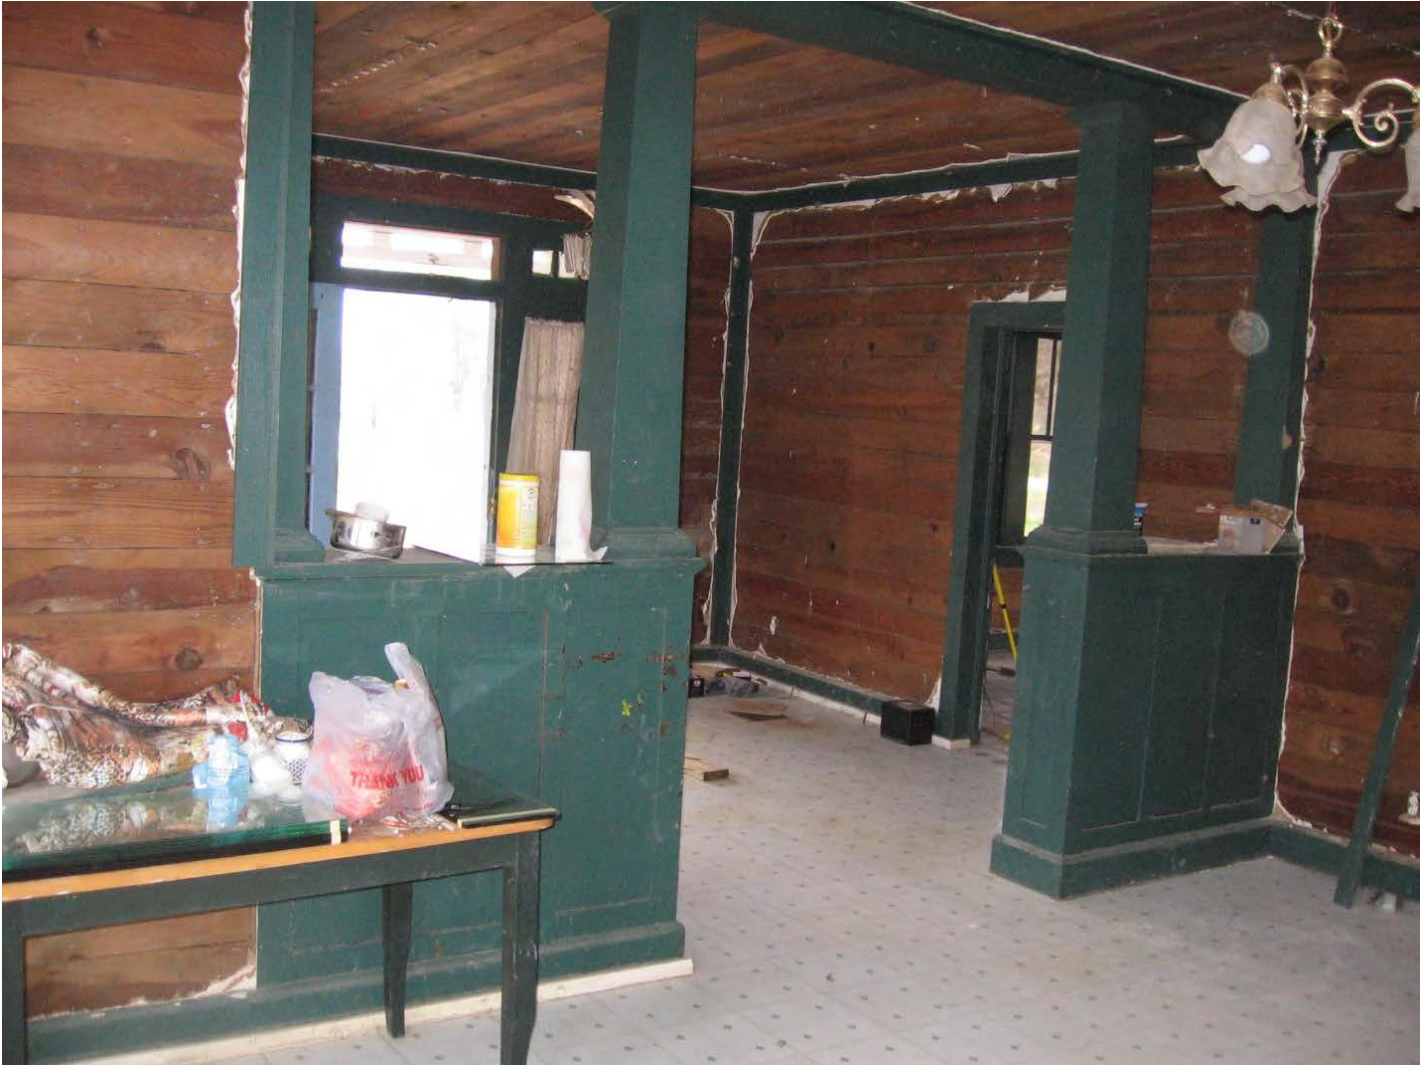
Figure 16. 2009 photograph taken from the kitchen door into the Living Room towards the front door (just left of center in background). The green “boxes” are the backs of the two built-in book shelves. Notice that even the ceiling is made of cypress planks. Image courtesy of Kerry Lincoln.

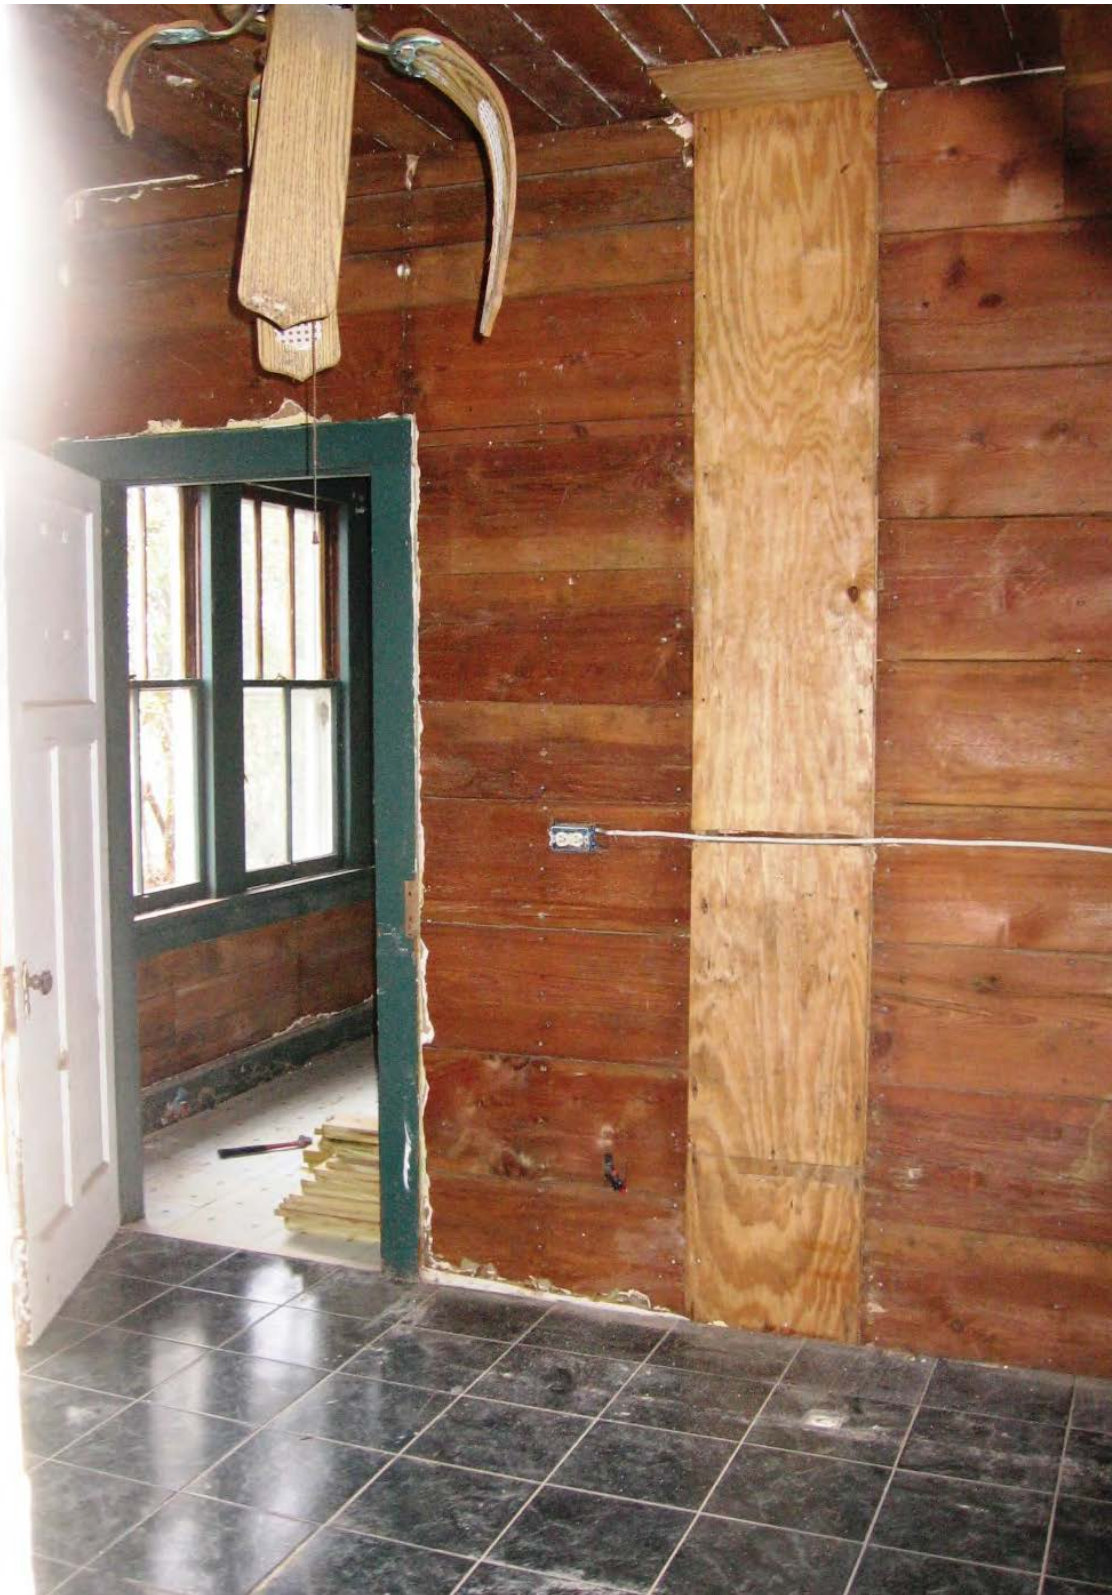
Figure 17. 2009 photograph in the kitchen facing east where the second fireplace was located. The light colored wood was used to fix the walls in the 1940's when this fireplace was removed and a modern stove was installed in the space. Image courtesy of Kerry Lincoln.

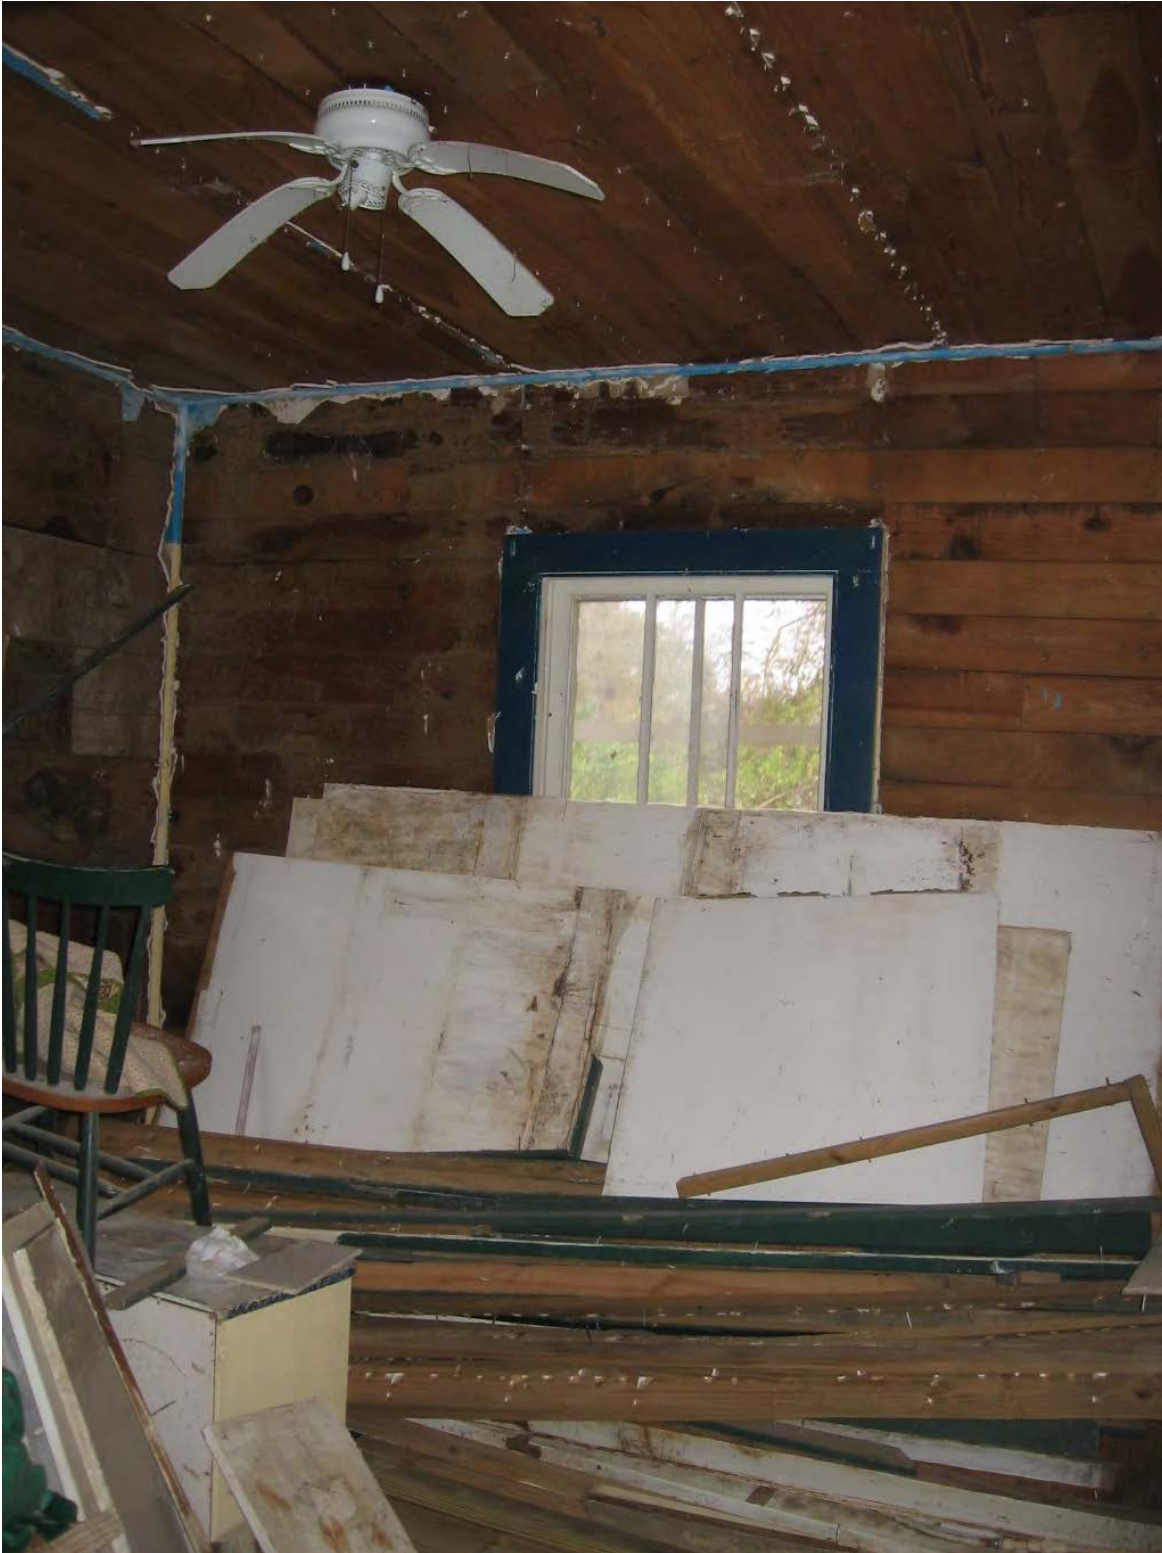
Figure 18. 2009 photo showing the back bedroom. This room was used for staging much of the cypress and hardware during renovation. To the left are two doors. The closest to the window was a closet. The more distant from the window was the entry door from the back hall. The west facing wall has a window looking onto the back porch. The wall behind the photographer is just a long blank wall running parallel with the hall. Image courtesy of Kerry Lincoln.

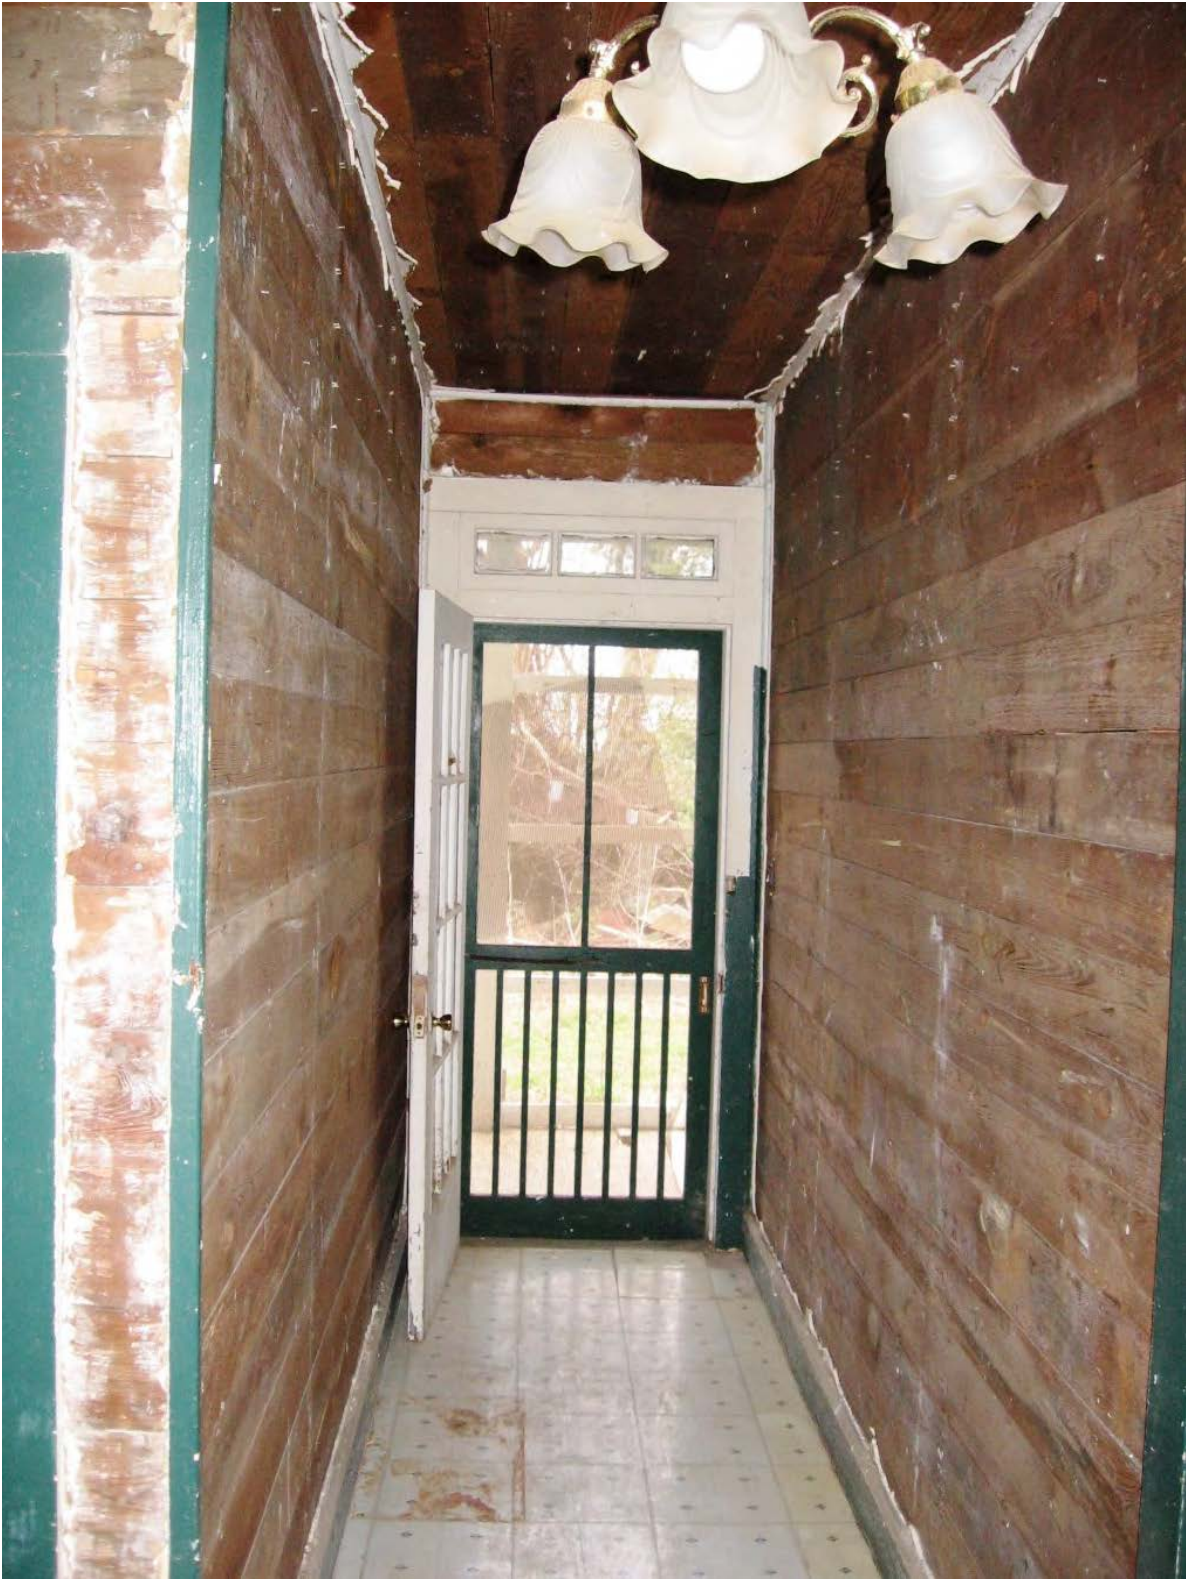
Figure 19. 2009 photo showing the back hall to the outside porch. The kitchen is to the right and bedroom 3 is to the left. Image courtesy of Kerry Lincoln.

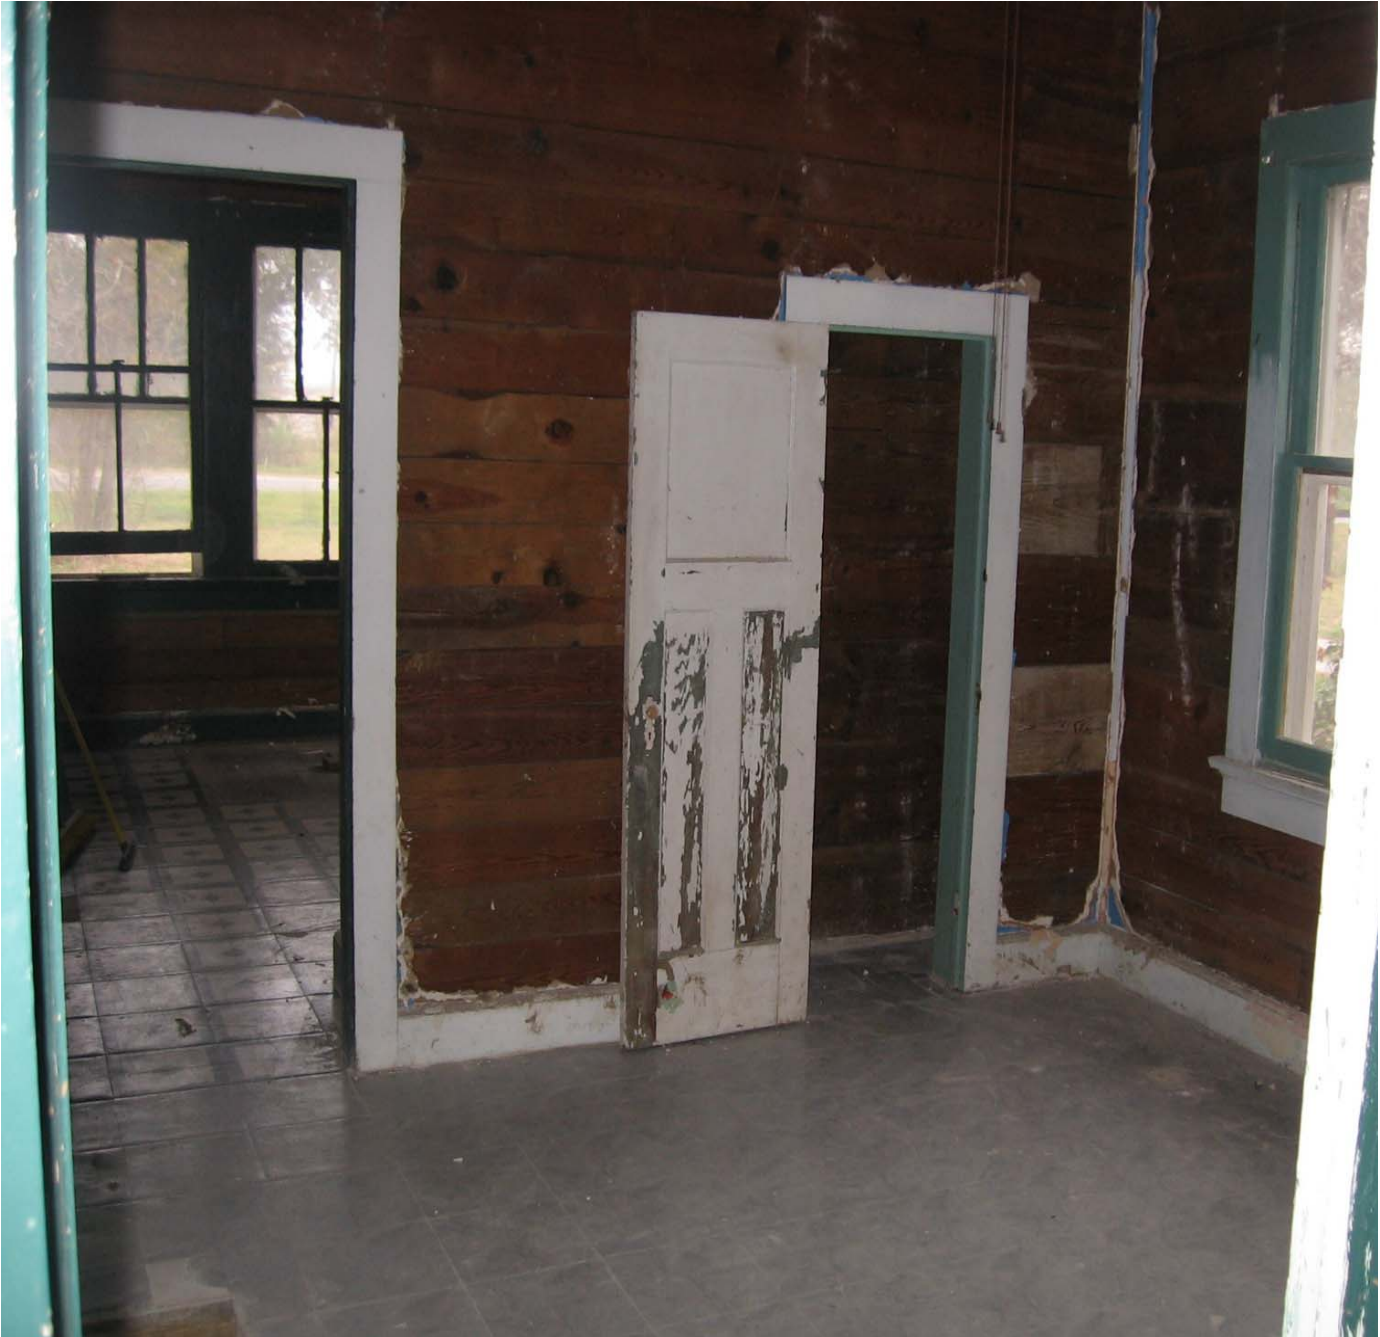
Figure 20, 2009 photo facing east from back hall looking through the middle and front bedrooms. The white open door is a closet. Each bedroom has one closet. Image courtesy of Kerry Lincoln.

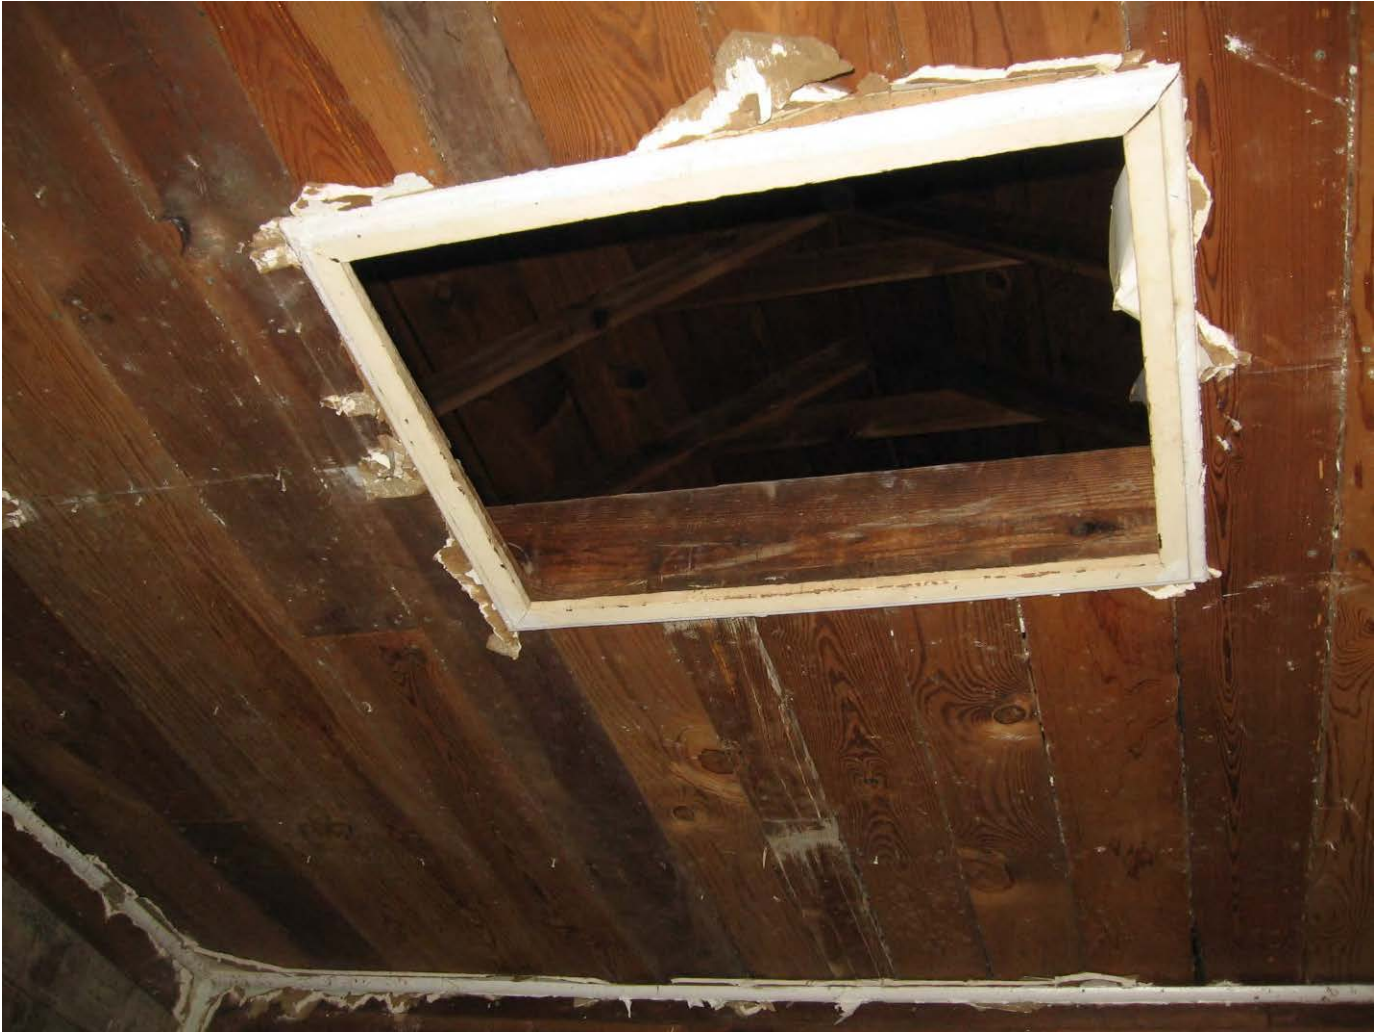
Figure 23. 2009 photo showing the attic opening in the back hall. Image courtesy of Kerry Lincoln.

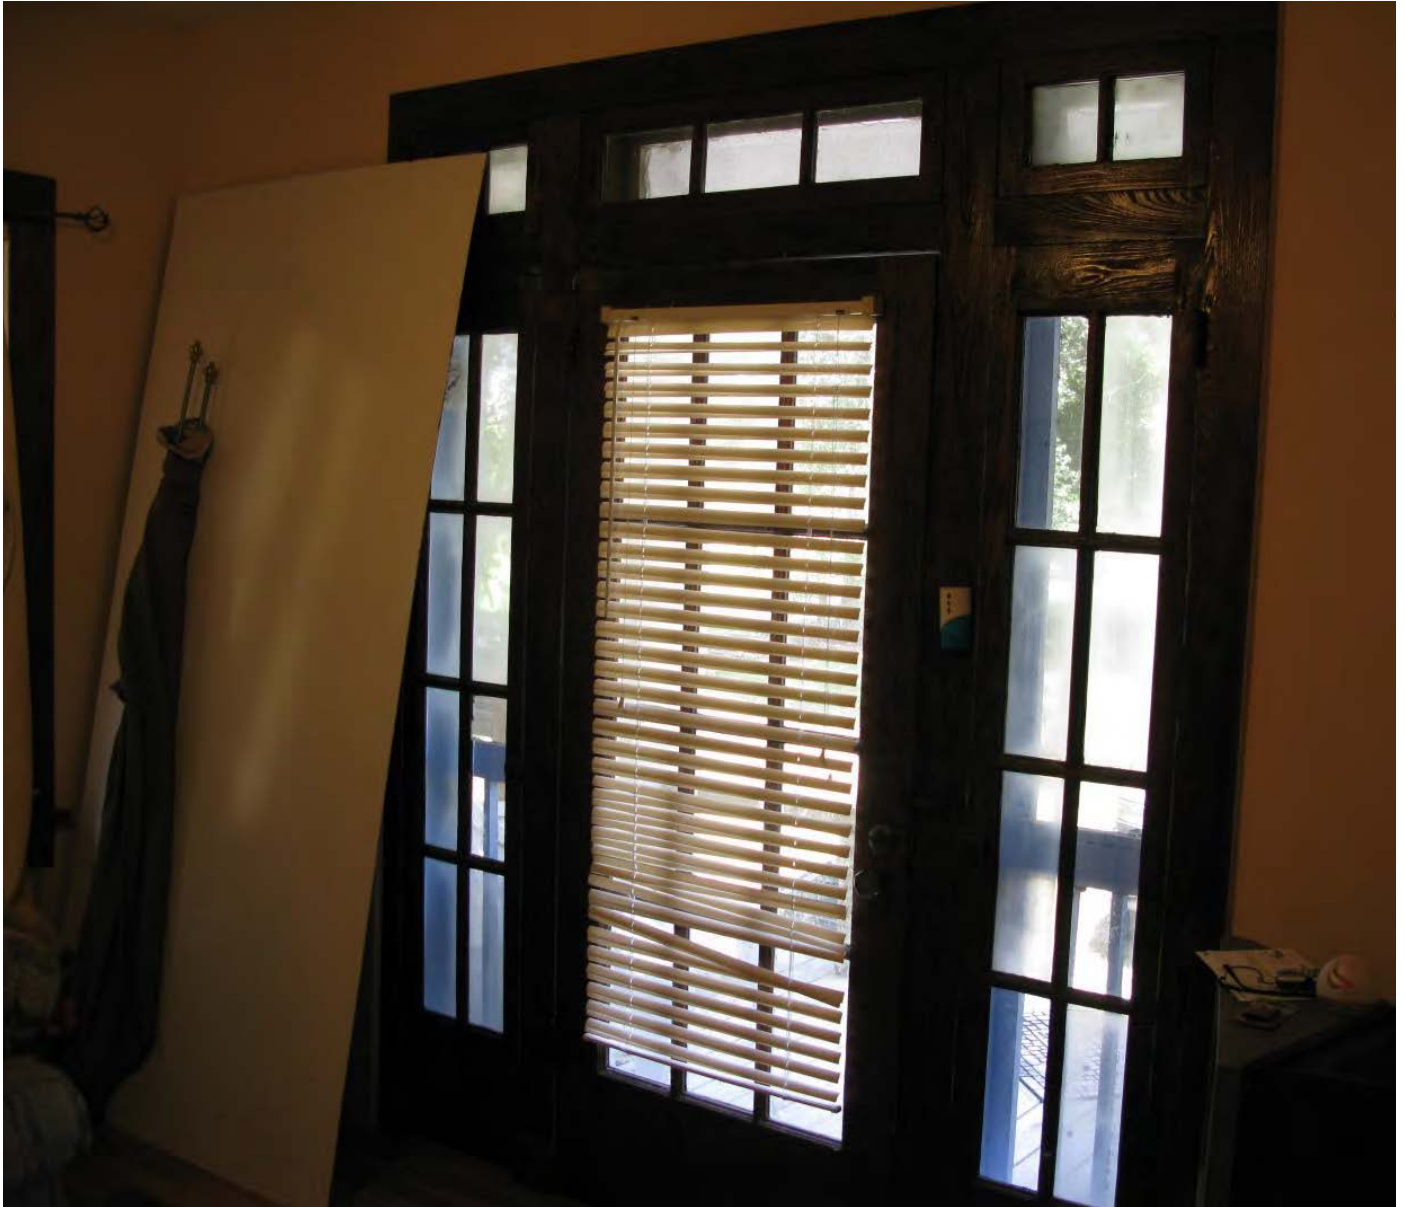
Figure 24. 2009 photo showing the inside of the front door. Image courtesy of Rod Lincoln.
