National Register of Historic Places Registration Form

Historic name: Salmon Mt. Lookout
Other names/site number: 10-IH-1524
Name of related multiple property listing:
L-4 Fire Lookouts in the USFS Northern Region (Region 1), 1932-1967
(Enter "N/A" if property is not part of a multiple property listing)

Salmon Mountain Lookout
Name of Property

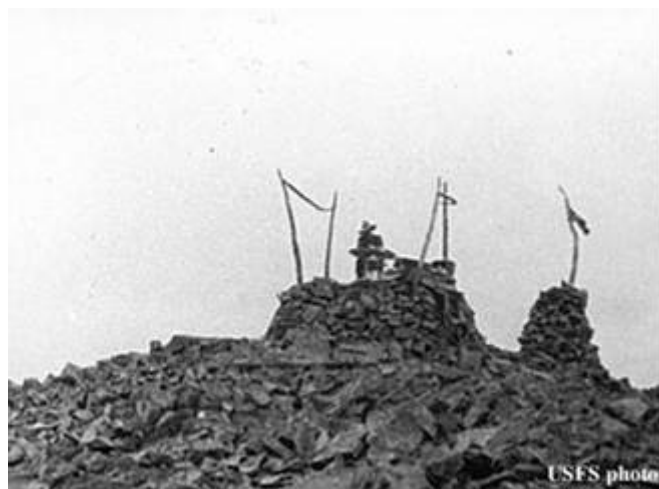
Figure 1. 1922 photo of the Salmon Mountain lookout improvements.

The Bitterroot National Forest established Salmon Mountain Lookout as a lookout point sometime prior to 1920. In September of that year, Forest Examiner Elers Koch conducted a review of the Salmon Mountain and Moose Creek ranger districts. Koch described Salmon Mountain as “an excellent lookout and an ideal place for location of an observatory.”² At the time of his visit, improvements consisted of a map board and map mounted on a “substantial stone terrace,” which had required “the expenditure of ... a lot of work” (Figure 1). He noted that the lookout camp, occupied by a smoke chaser and a lookout man, was located adjacent to the nearest water—a spring about a quarter of a mile south of the lookout point.

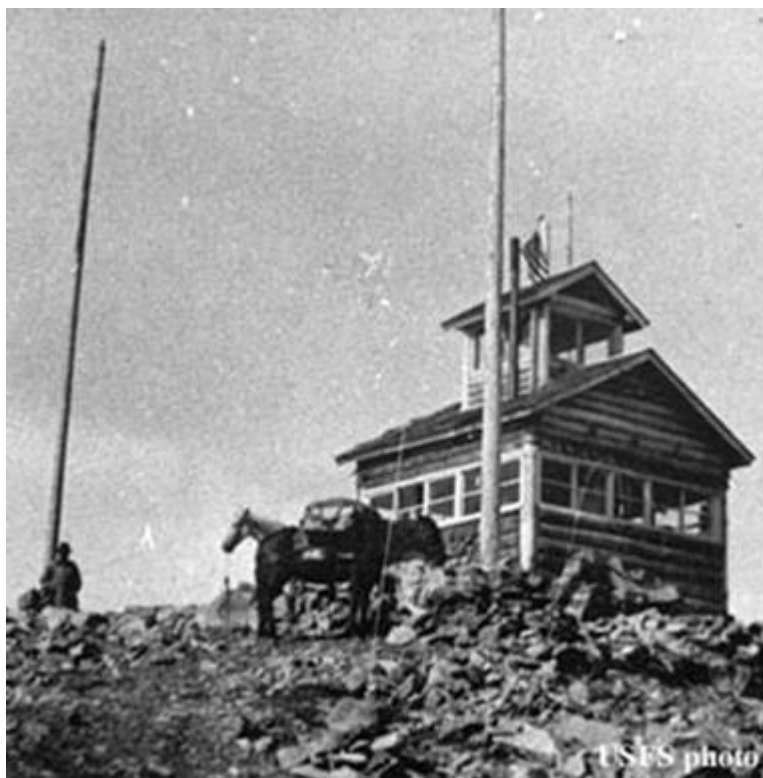
Figure 2. 1928 log cupola lookout on Salmon Mountain.

The forest finally erected a log cupola atop Salmon Mountain in 1928 (Figure 2). Judging from the photographs of the building, it was well built with the ground floor used for storage and the

cupola for observation purposes. The construction of the original Salmon Mountain Lookout occurred just before Clyde Fickes designed the original gable-roofed style of L-4, and three years before the region approved the pyramidal roof version. While the L-4 lookout was designed specifically to replace cupola style lookout buildings, limited funding for Forest Service buildings likely precluded the replacement of a relatively new, serviceable lookout for the sake of increased efficiency—especially when so many of the forest’s lookout points had only rudimentary improvements.

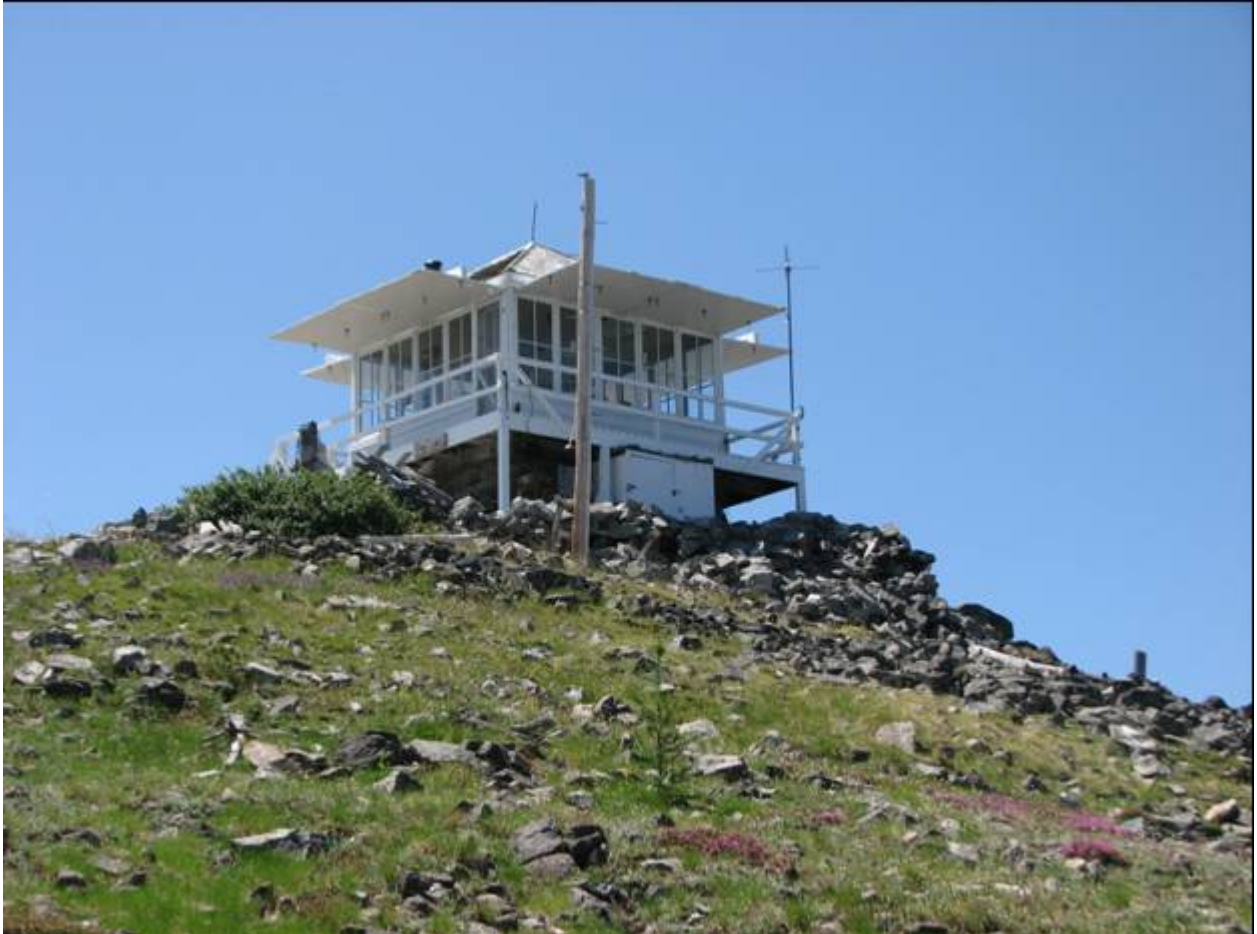
ID_IdahoCounty_Salmon Mountain Lookout_0001. Lookout and storage shed, looking southwest to the east (front) and north walls of the lookout.

The lookout is a 1936-pattern L-4 lookout. The 14 ft. by 14 ft. wood frame house or cab has a pyramidal roof and sits atop a mortared stone foundation. A short set of wood stairs at the east end of the north wall leads to the catwalk. The catwalk safety railing consists of two horizontal rails with diagonal bracing along the south, west, and north sides. Unique to Salmon Mountain Lookout are a series of small, home-made wind gauges that are affixed to the top of the catwalk railing at its southwest, northwest, and northeast corners. They consist of a triangular piece of wood shingle affixed with a homemade spring to a nail driven into the top rail of the catwalk.

A small wood-frame shed is located beneath the catwalk at the north edge of the lookout's foundation. The front wall of this structure extends slightly beyond the edge of the catwalk. The walls and roof are covered with plywood and the front edge of the roof is held down with rocks. A plywood door is located in the east half of the north wall.

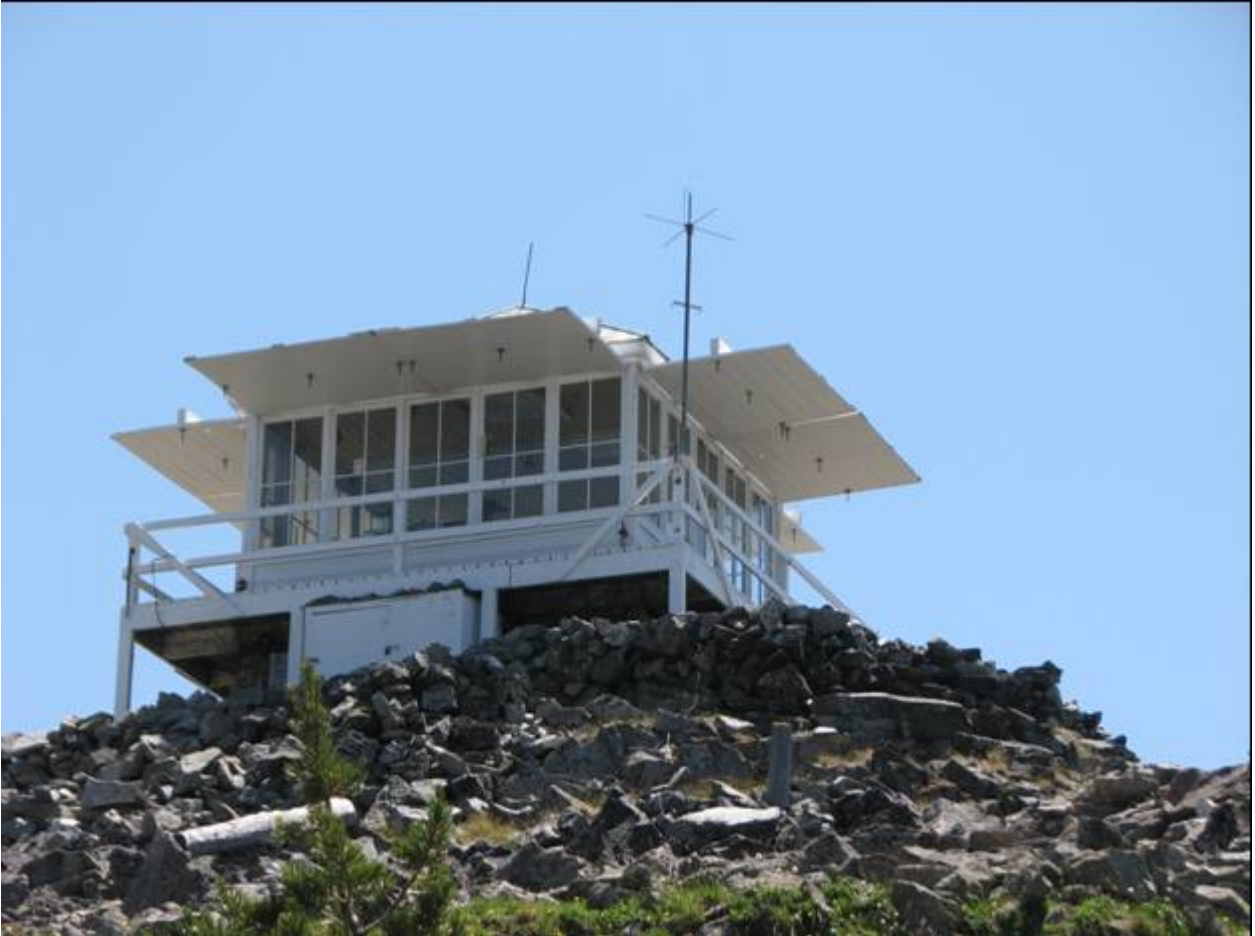
ID_IdahoCounty_Salmon Mountain Lookout_0002. Lookout and storage shed, looking south to the north and west walls of the lookout.

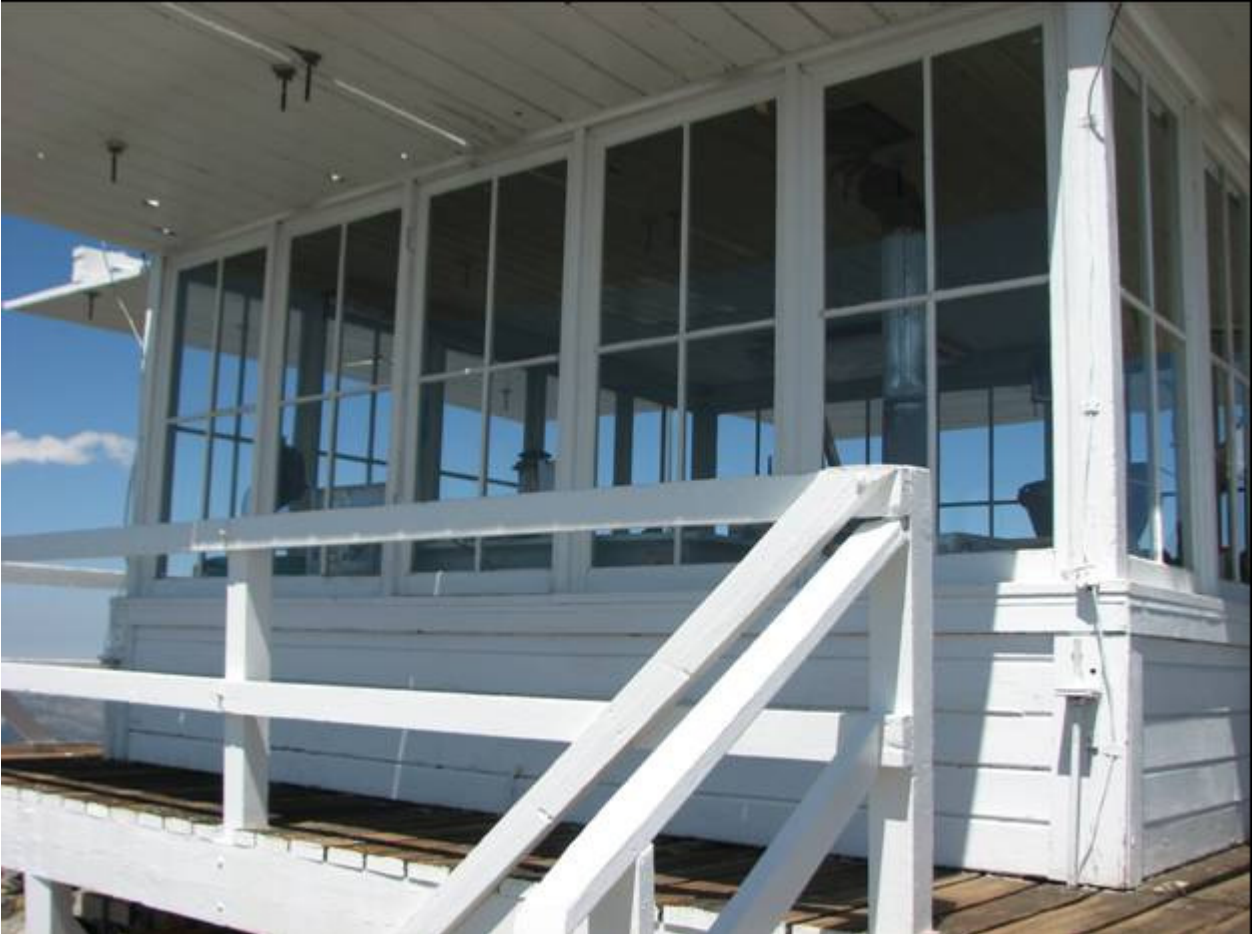
ID_IdahoCounty_Salmon Mountain Lookout_0003. Lookout, looking east-northeast to the south wall of the lookout.

Simple drop wood siding covers the lower portion of the cab's exterior walls, and the roof is covered with sawn cedar shingles with metal ridge finishes; lightening protection remains in place. A stainless steel stove pipe extends above the south slope of the roof. The entry into the lookout cab is located at the north end of the east wall. The entry contains its original wood door with four lights over one panel, as well as a wood-frame screen door. Four, four-light windows are located in the wall south of the entry. The remaining three walls each contain five, four-light, wood windows. The central sash in each wall opens casement style for ventilation, while the remaining windows are fixed. A radio antenna is affixed to the catwalk railing at its northwest corner.

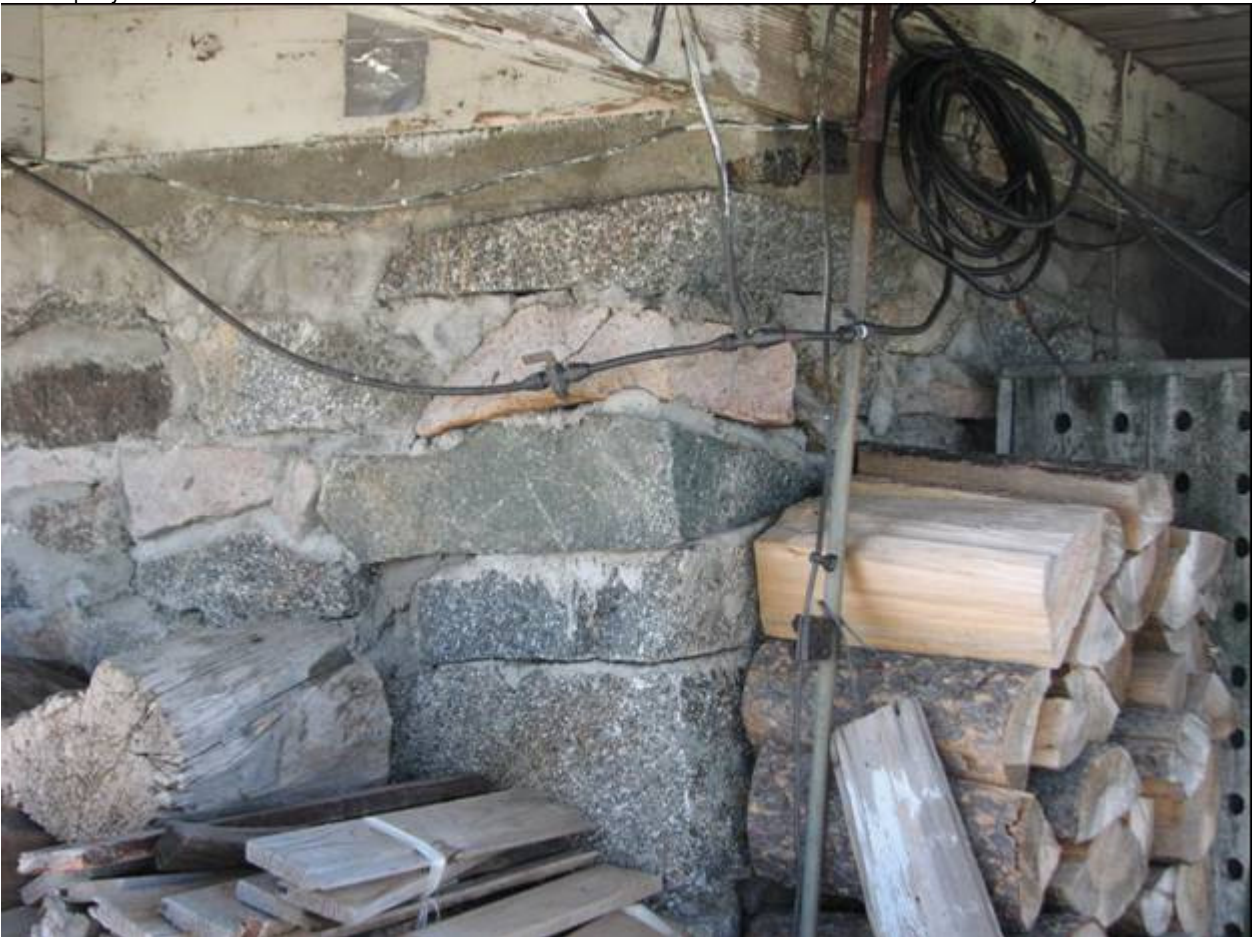
ID_IdahoCounty_Salmon Mountain Lookout_0004. Detail of the mortared stone foundation of lookout.

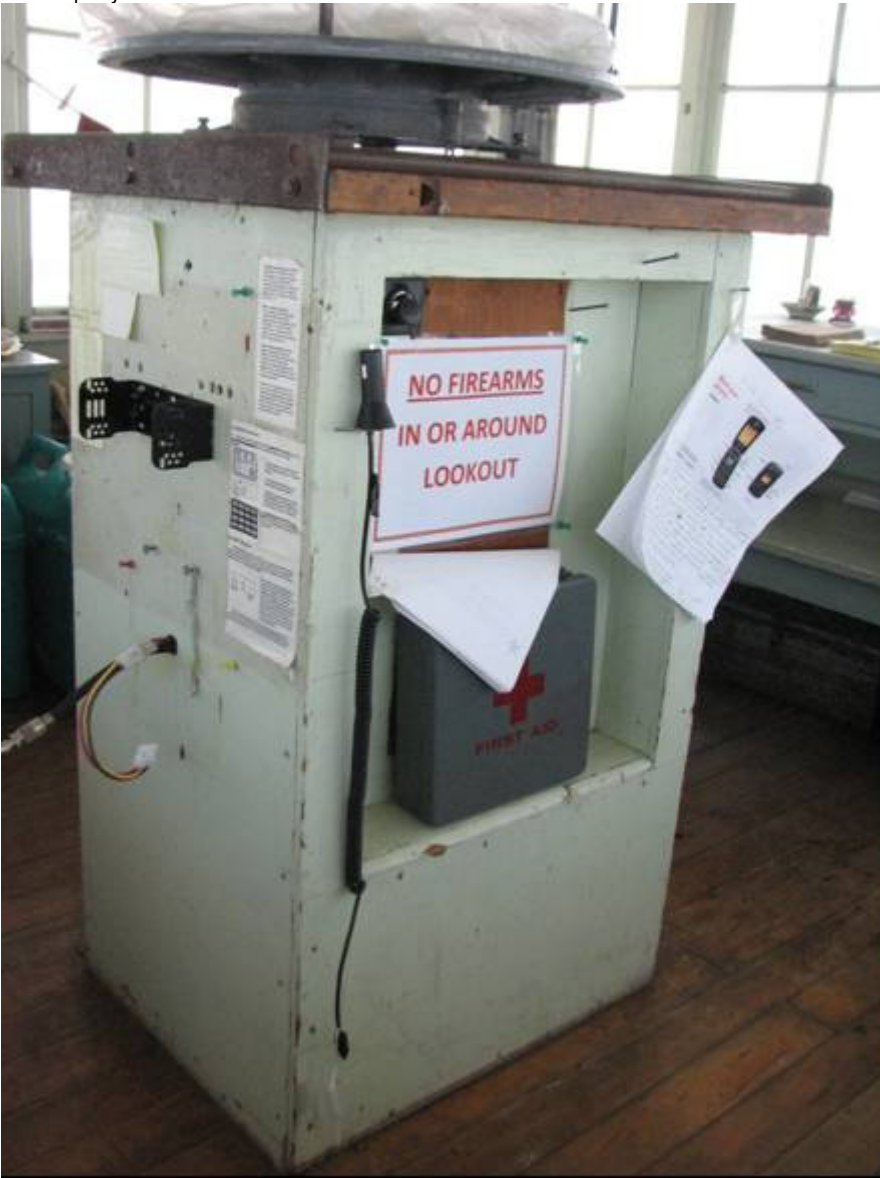
ID_IdahoCounty_Salmon Mountain Lookout_0005. Interior detail of lookout: Stand for Osborne fire-finder.

In the one-room interior, the fir floor is intact and in fair condition. The space is fitted with a stand for an Osborne fire-finder, a small wood-burning stove, a propane stove, a platform bed with drawers beneath for storage, and several tables, storage benches, and a wood box.

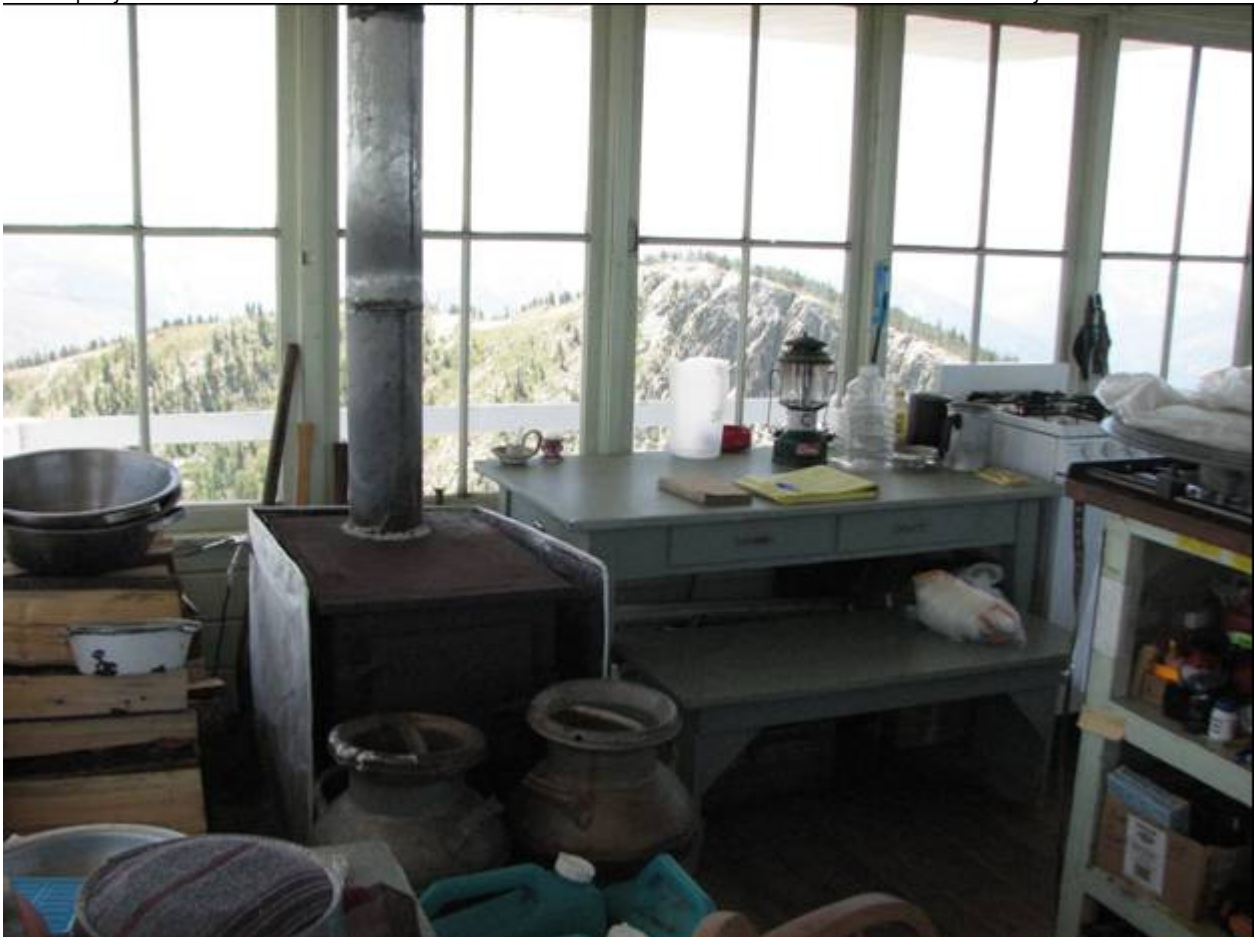
ID_IdahoCounty_Salmon Mountain Lookout_0006. Interior detail of lookout: wood heating stove, table, and propane cook stove.

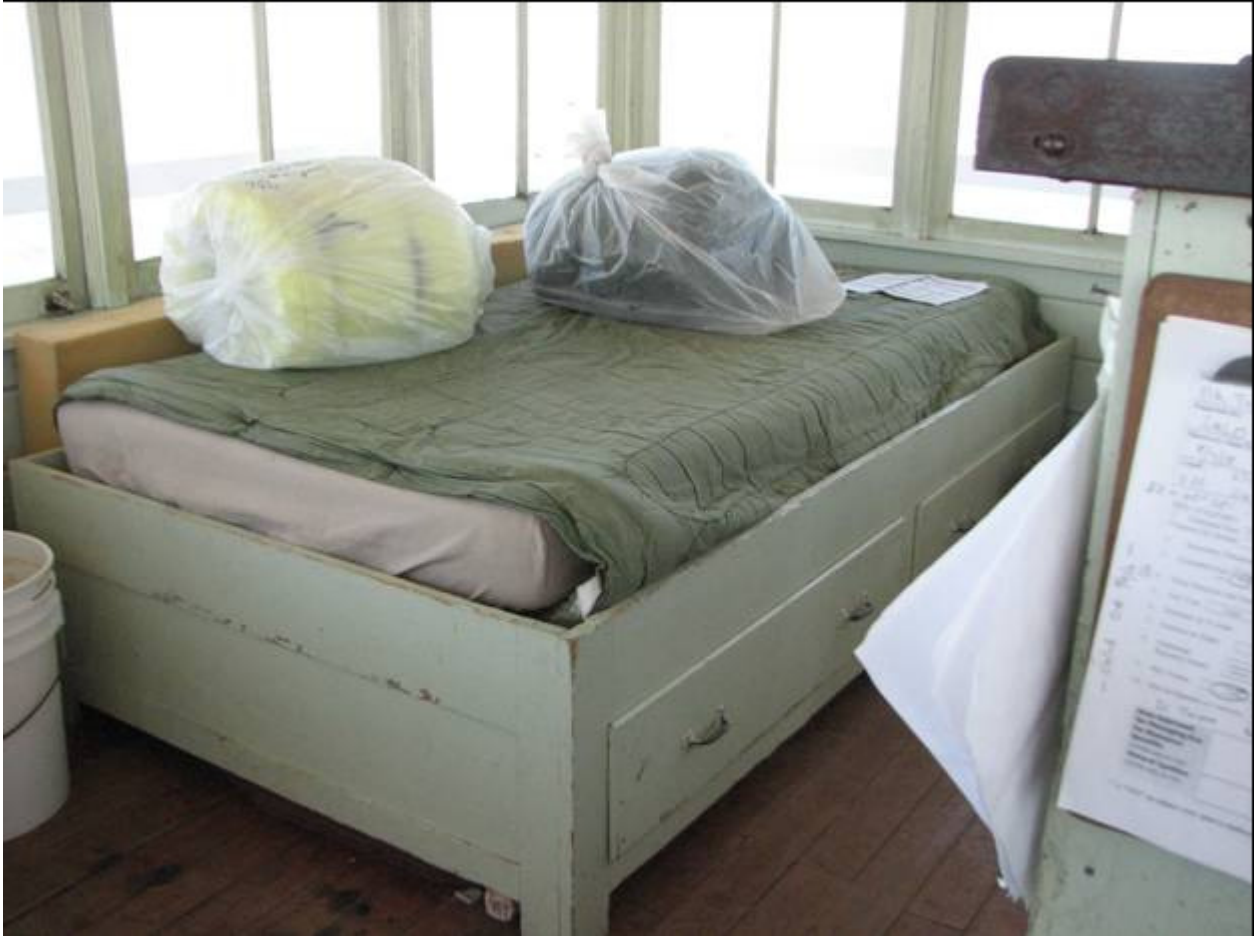
ID_IdahoCounty_Salmon Mountain Lookout_0007. Interior detail of lookout: platform bed with storage drawers.

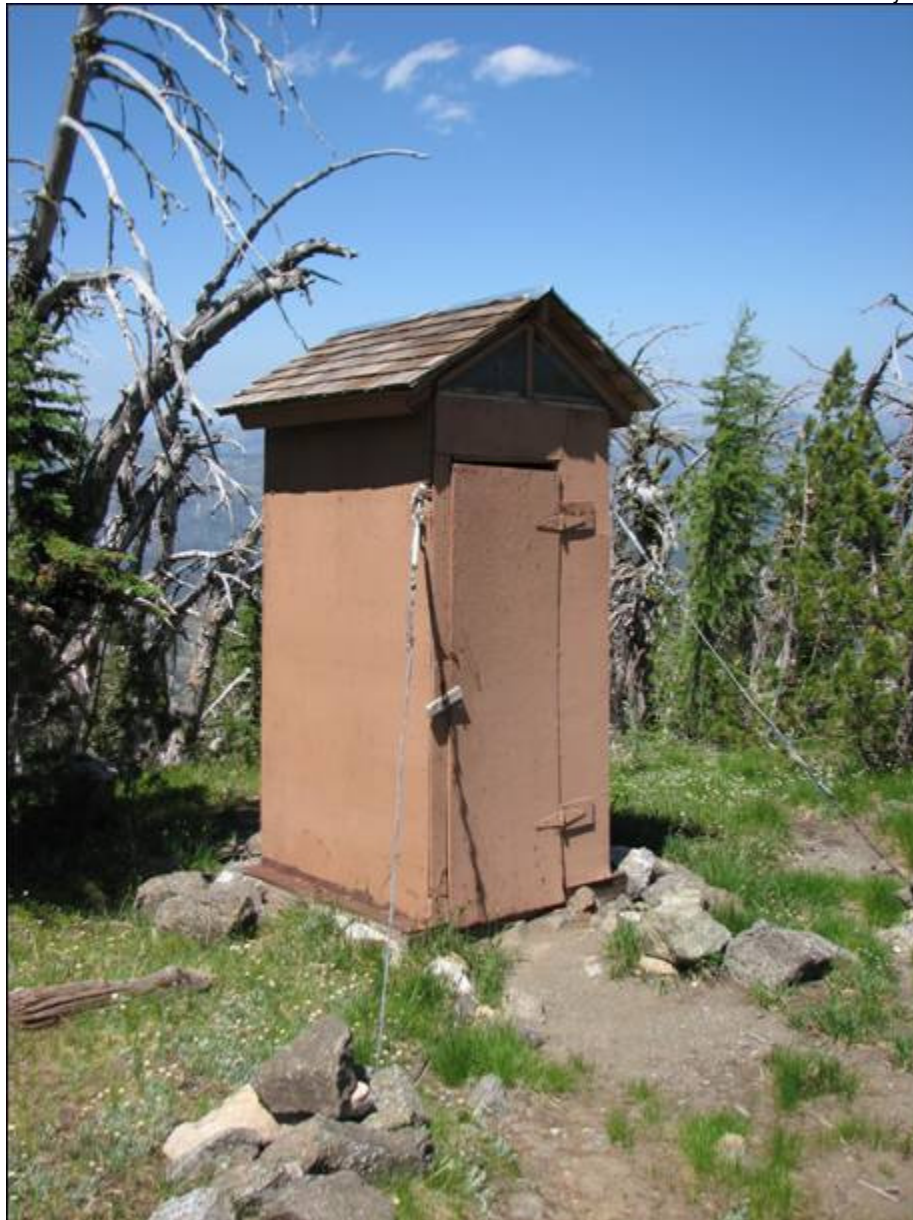
ID_IdahoCounty_Salmon Mountain Lookout_0008. Looking northwest to the south and east (front) walls of the outhouse.

The non-historic outhouse is located about 260 feet north-northeast from the lookout. It is a wood frame building with a front-gable roof that measures about 3.75 ft. by 4 ft. It sets atop a timber framework that is placed over the privy hole. The building is also guyed to the ground on two sides. The exterior walls are covered with plywood and the roof is covered with sawn cedar shingles with a metal ridge finish. The east wall contains an entry with a plywood door.

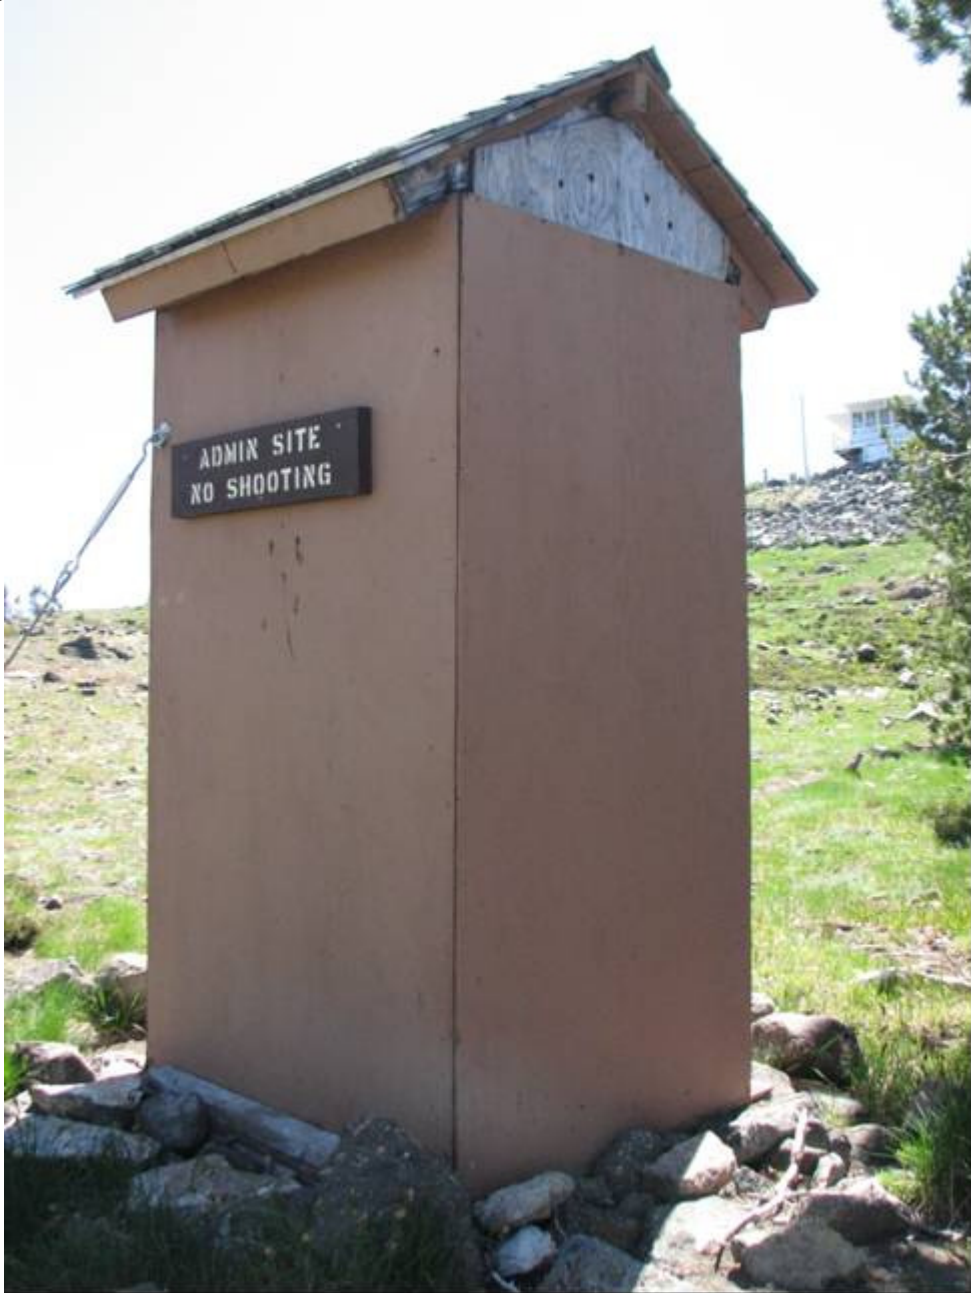
ID_IdahoCounty_Salmon Mountain Lookout_0009. Looking southeast to the north and west (rear) walls of the outhouse.

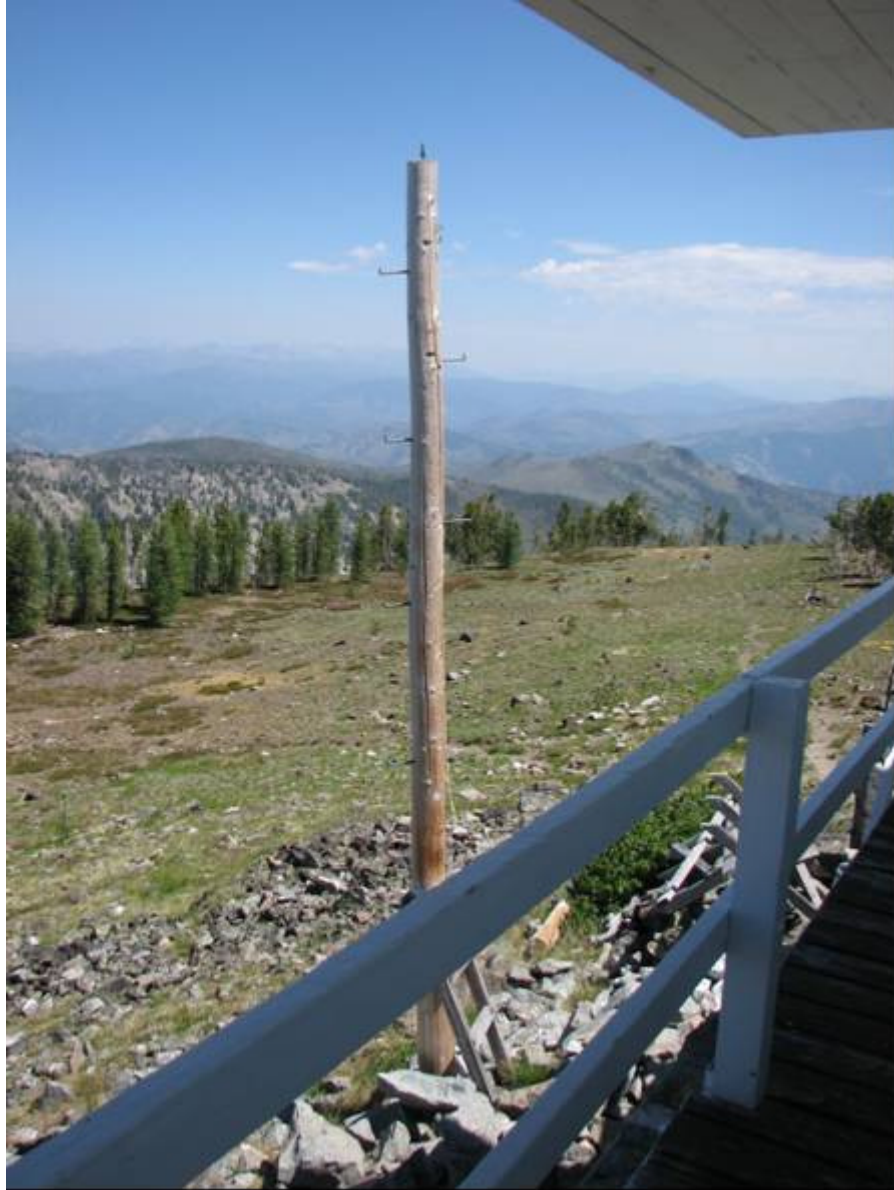
ID_IdahoCounty_Salmon Mountain Lookout_0010. Looking east-northeast to the flagpole adjacent to the northwest corner of the lookout.

A peeled log flagpole is located adjacent to the northeast corner of the lookout. It is fitted with metal climbing spikes. Another home-made wind gauge is fixed to the top of the flagpole.

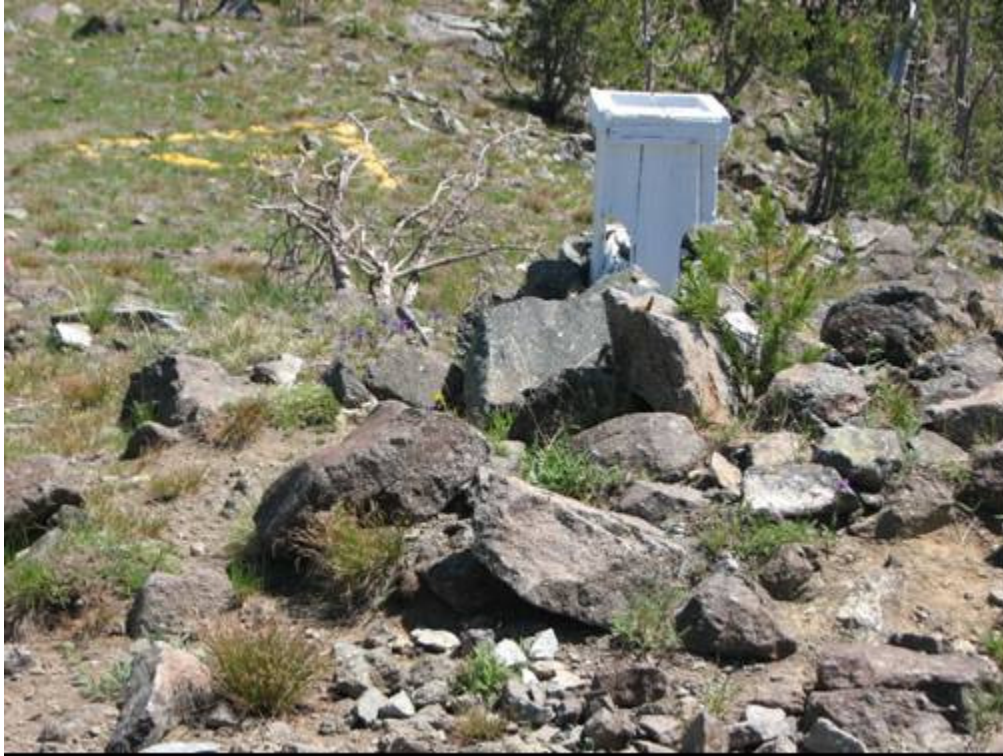
ID_IdahoCounty_Salmon Mountain Lookout_0011. Looking east to the small wooden box containing a rain gauge.

A small wood-frame container-apparently to accommodate a rain gauge, is located about 75 feet east of the lookout. It is about 20 in. square and firmly emplaced within the talus.
