National Register of Historic Places
Registration Form

historic name THE MOUNTAIN HOUSE

street & number 1148 Old Highway 99 South not for publication

city or town Ashland vicinity

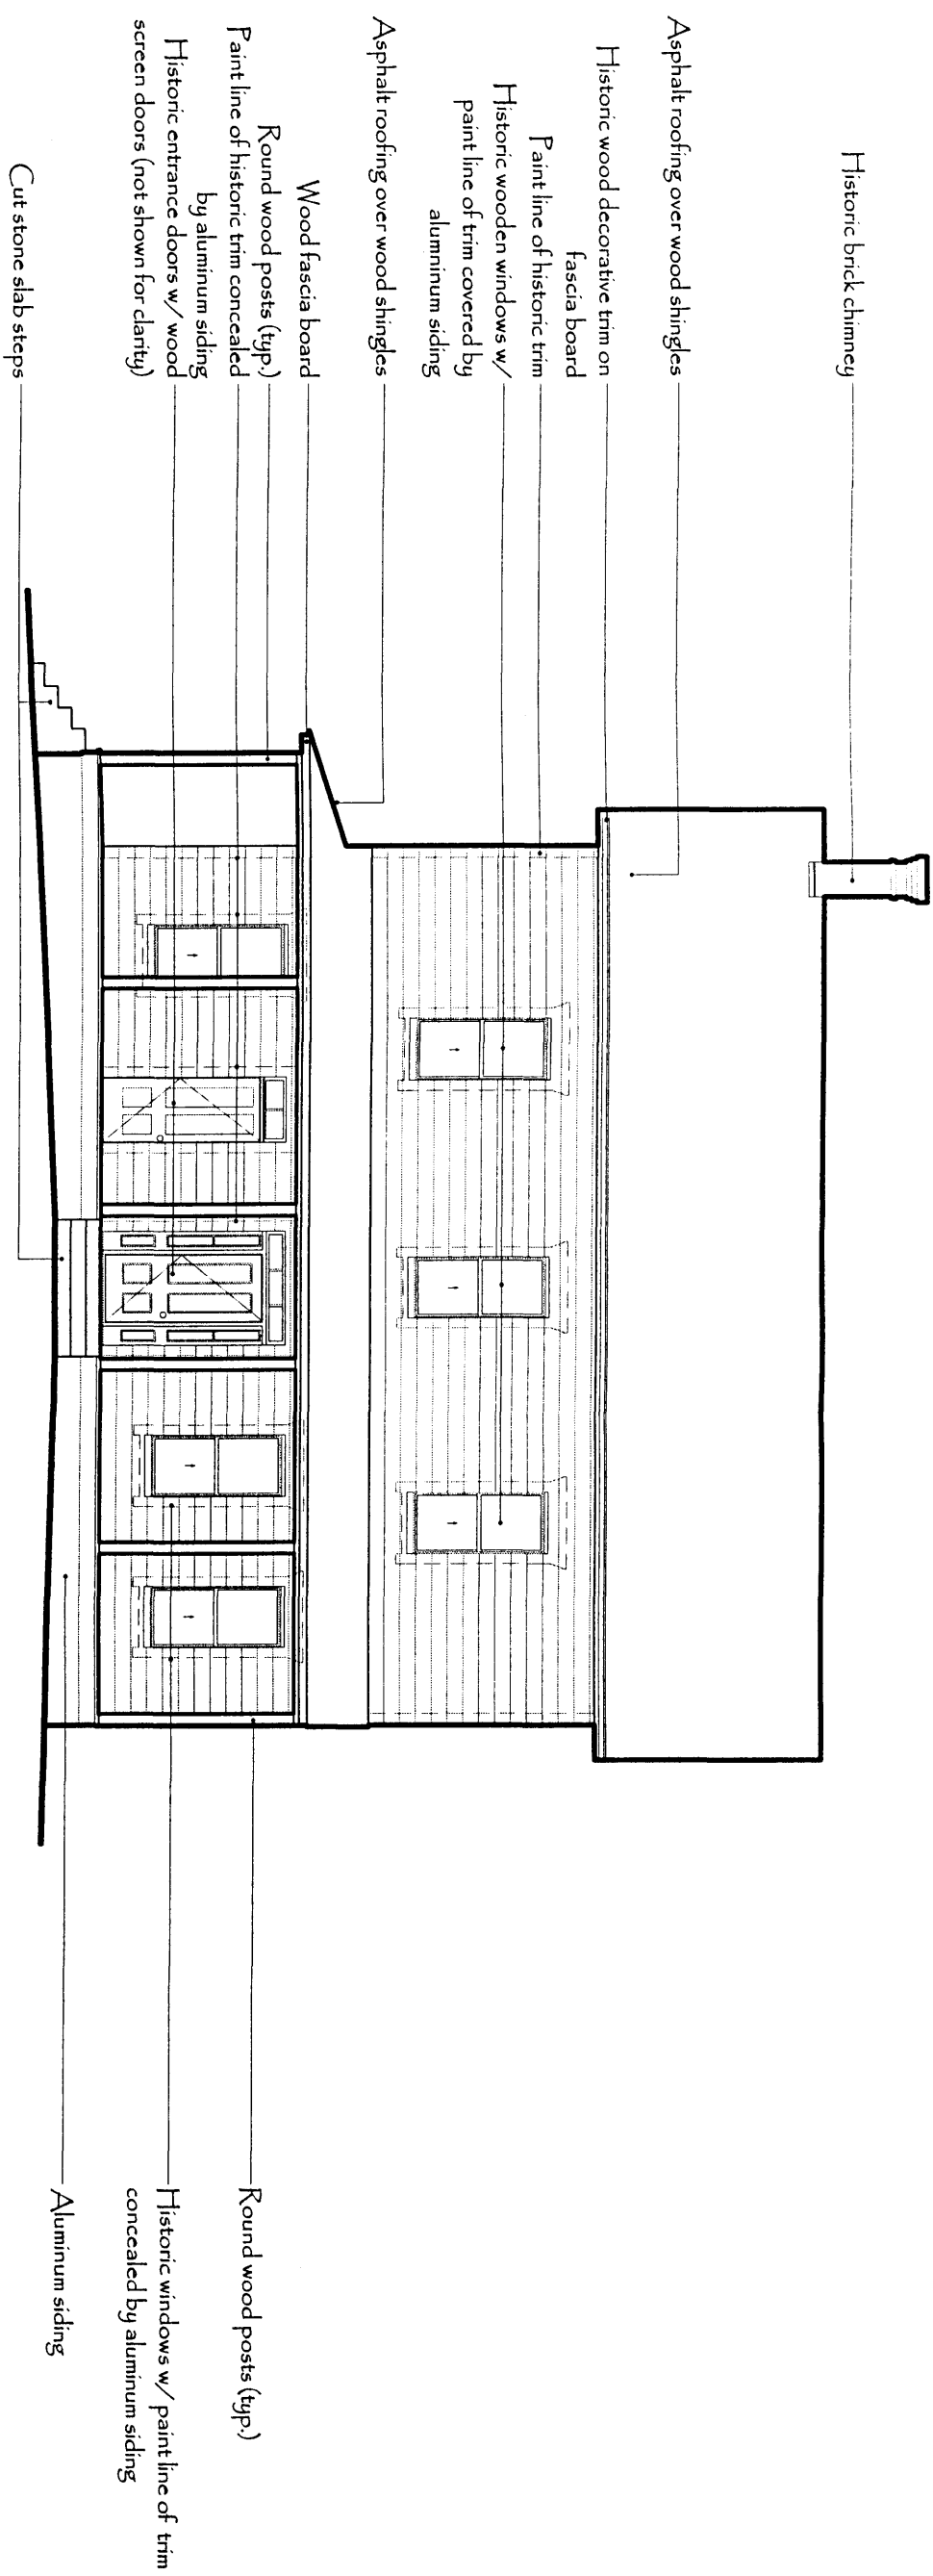
North East Elevation
 (facing highway)

Historic brick chimney

Aluminum siding

North West Elevation

⁷ The Mountain House had a fireplace located along what is now the north elevation (originally the east elevation). The chimney of this fireplace is shown in Photograph #1 and presumably did not survive the 1887 relocation of the original Mountain House to its present site and orientation.
