Property Name: Green, John, House

## National Register of Historic Places Registration Form

RE: Technical Assistance Grant  
Conditions Report  
John Green House  
23 Main Street, Nyack NY

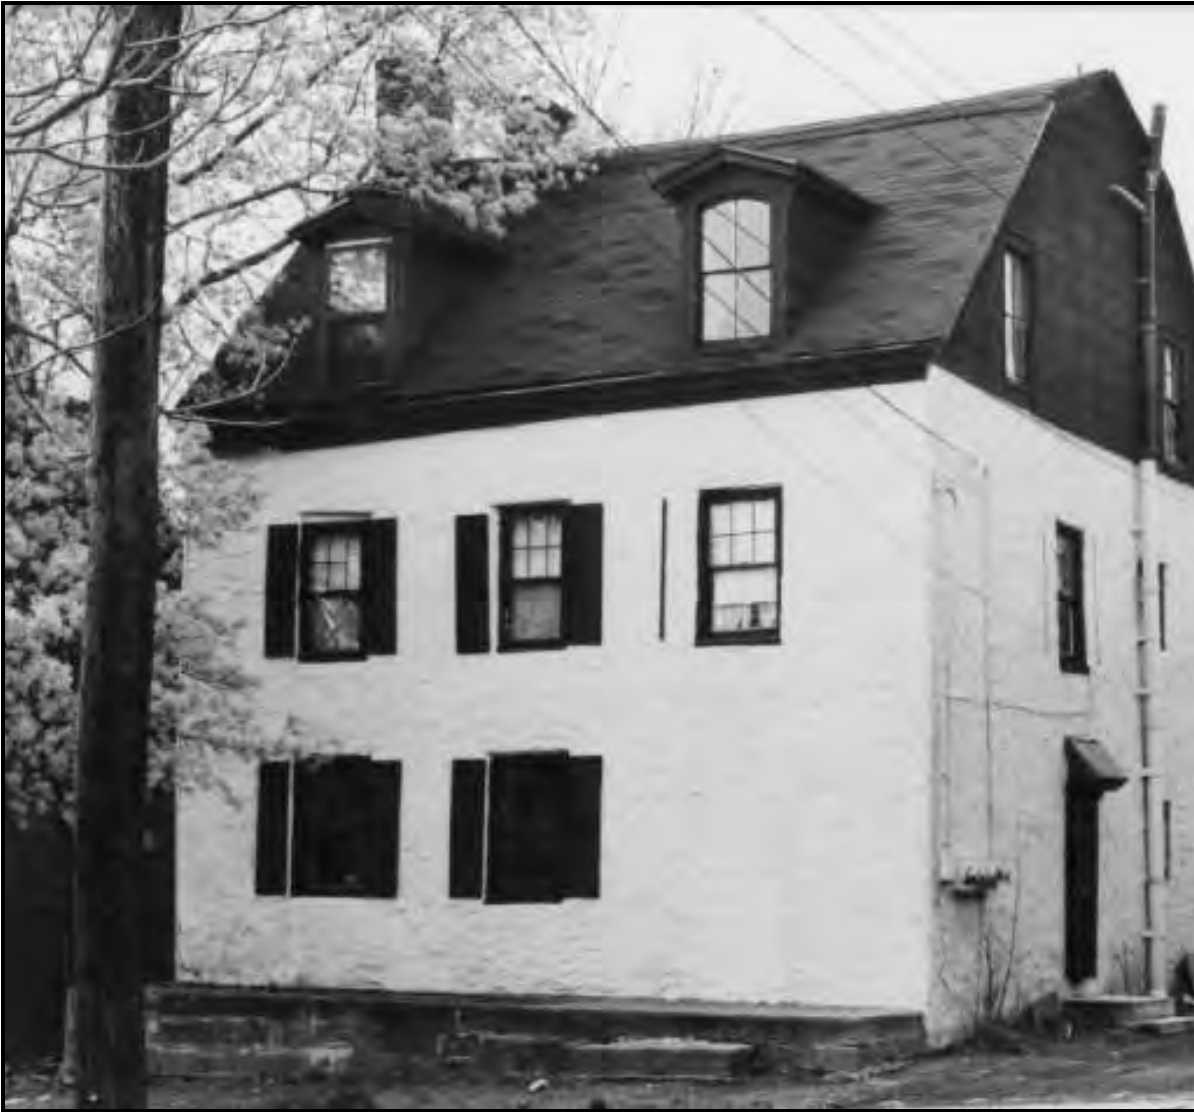
ABOVE, view of house as it appeared in 1984; note stucco-clad exterior, some remaining window sash, and parged-over entrance door.

ABOVE, view of house as it appeared in 1984; note stucco-clad exterior, some remaining window sash, and parged-over entrance door.

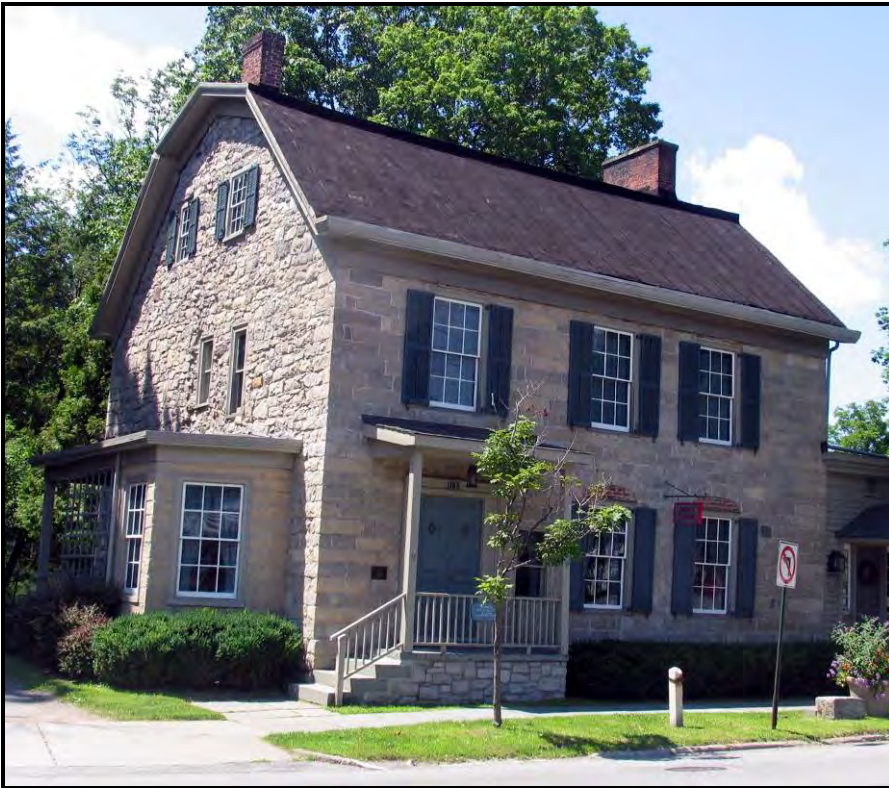
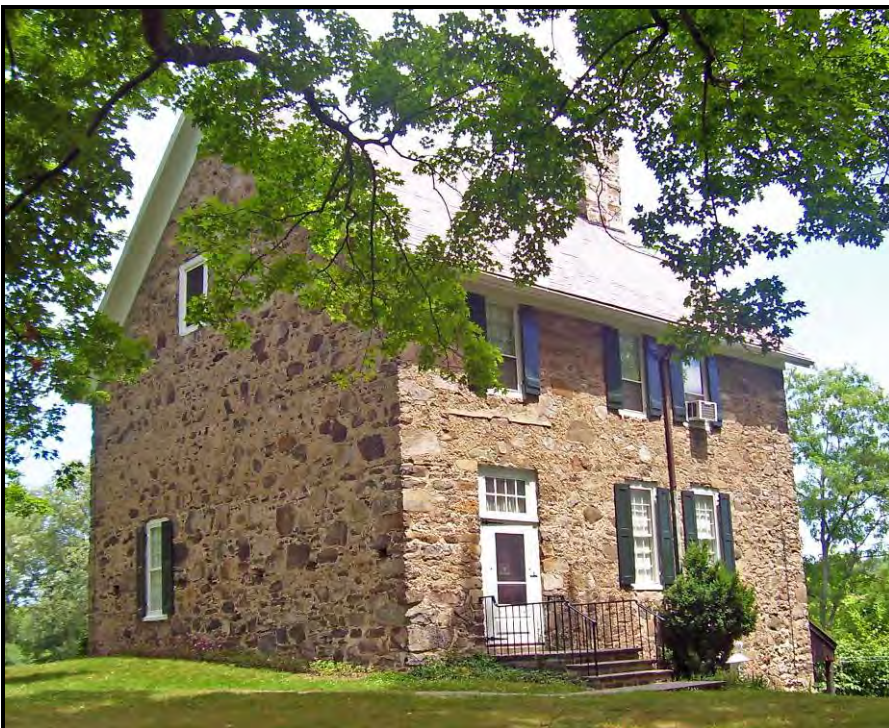
Two examples of two-story, three-bay side hall plan houses in Orange County constructed with stone masonry. ABOVE, Baird's Tavern, Warwick, Orange County, ca. 1766; BELOW, Bull House, Hamptonburgh, ca. 1722.

Two examples of two-story, three-bay side hall plan houses in Orange County constructed with stone masonry. ABOVE, Baird's Tavern, Warwick, Orange County, ca. 1766; BELOW, Bull House, Hamptonburgh, ca. 1722.

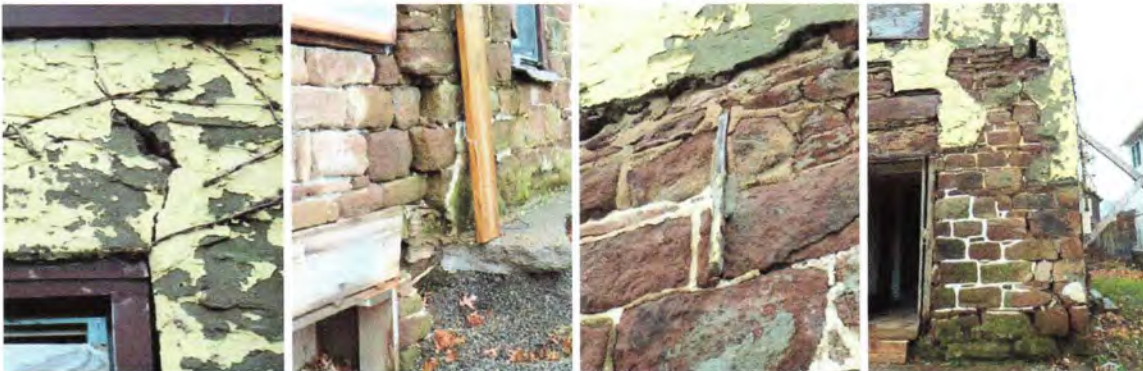
- 2. Cracks above center window at second floor*
- 3. Uneven wall face where newly rebuilt wall at Northeast corner meets remainder of North wall*
- 4. Tie at Second Floor joist level between center window and door*
- 5. Masonry separation and mortar voids at Northwest corner*

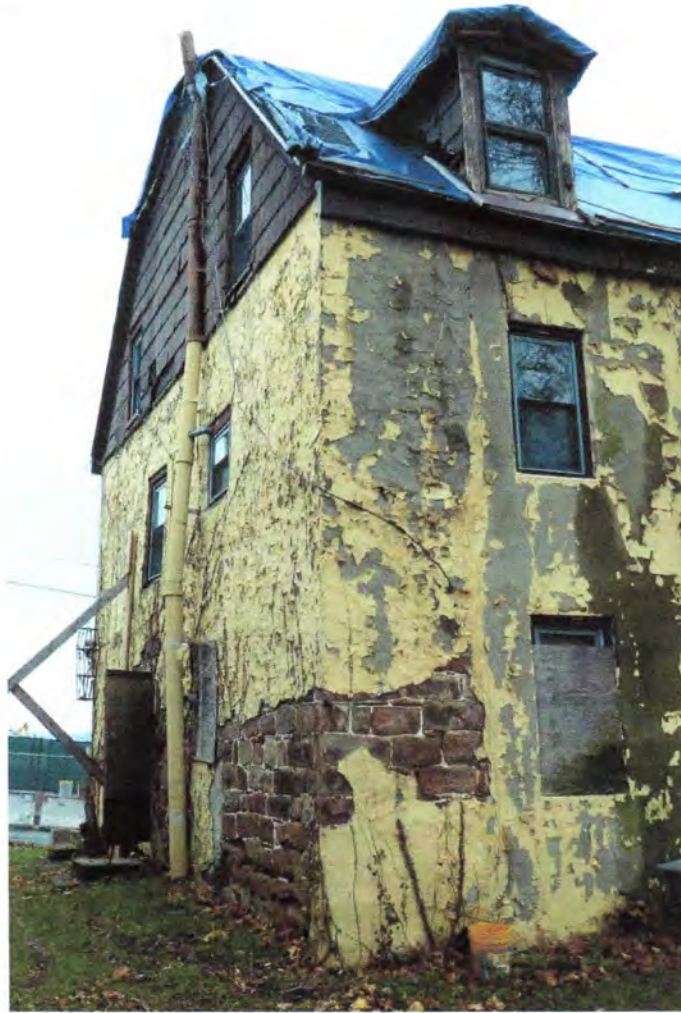
*6. West Elevation and Southwest Corner*

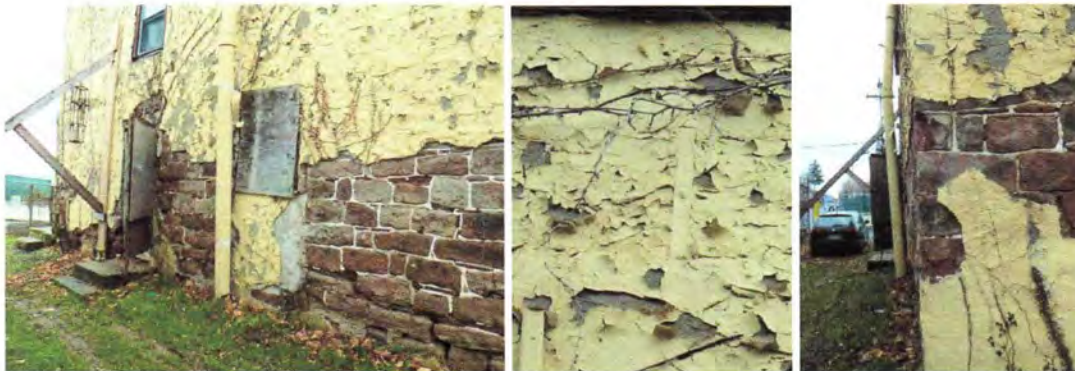
- 7. Bracing, loss of stucco and bulge at lower portion of West wall*
- 8. Tie evident beneath stucco at level of Attic floor joists, near the center of the wall*
- 9. Southwest corner*

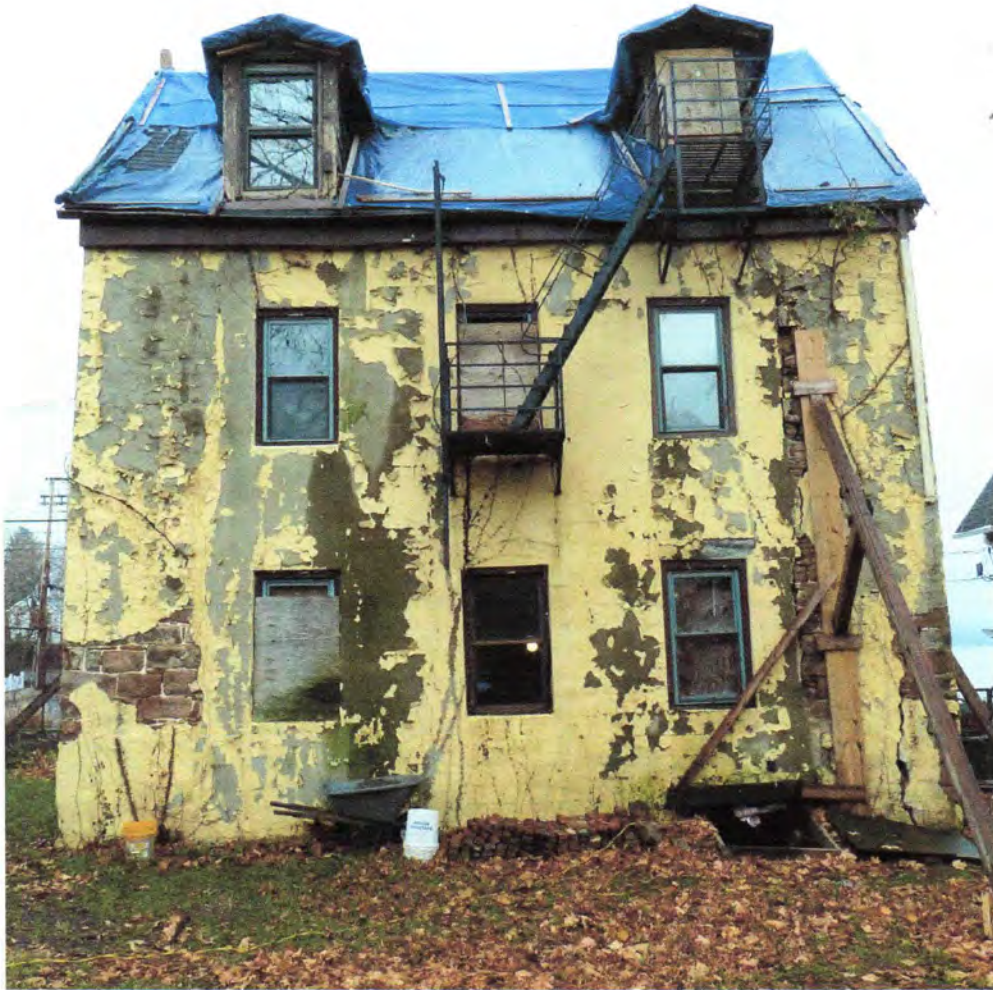
*10. South Elevation*

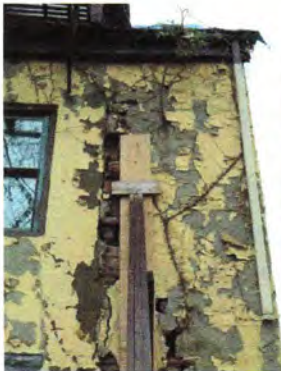
*11. Upper portion of bracing*

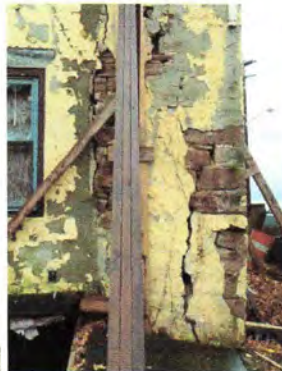
*12. Lower portion of bracing and masonry separation at Southeast corner*

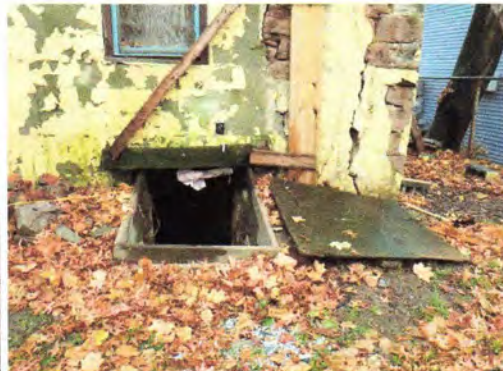
*13. Entry to Cellar*

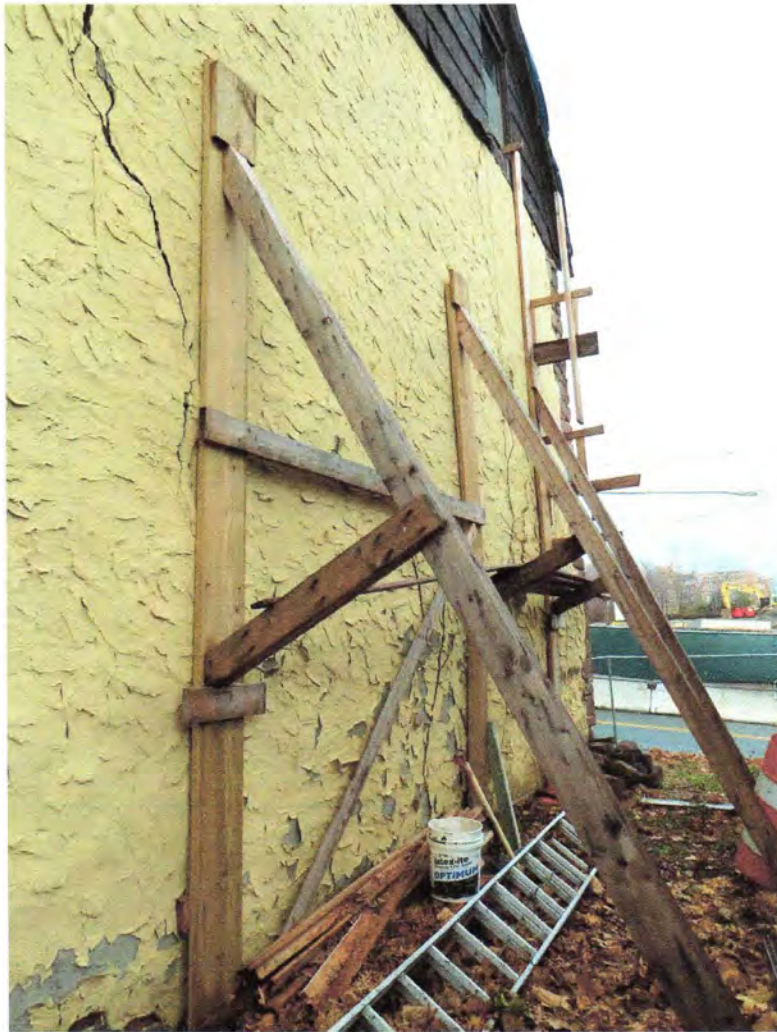
*14. East Elevation*

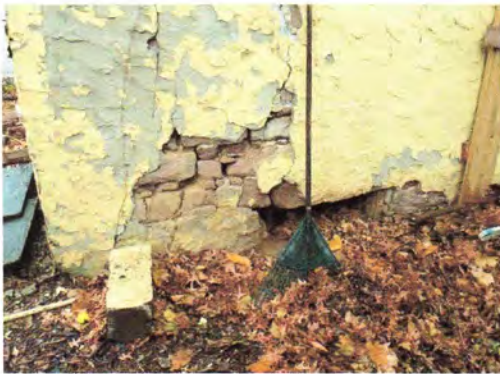
*15. Failing plaster and masonry at Southeast corner*

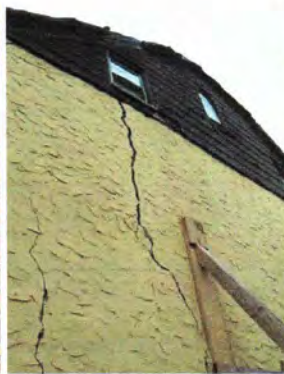
*16. Large cracks at Southern portion of East wall*

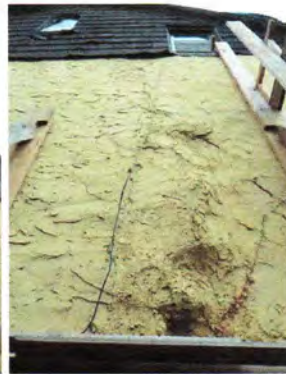
*17. Bulge at Western portion of East Wall, adjacent to chimney*

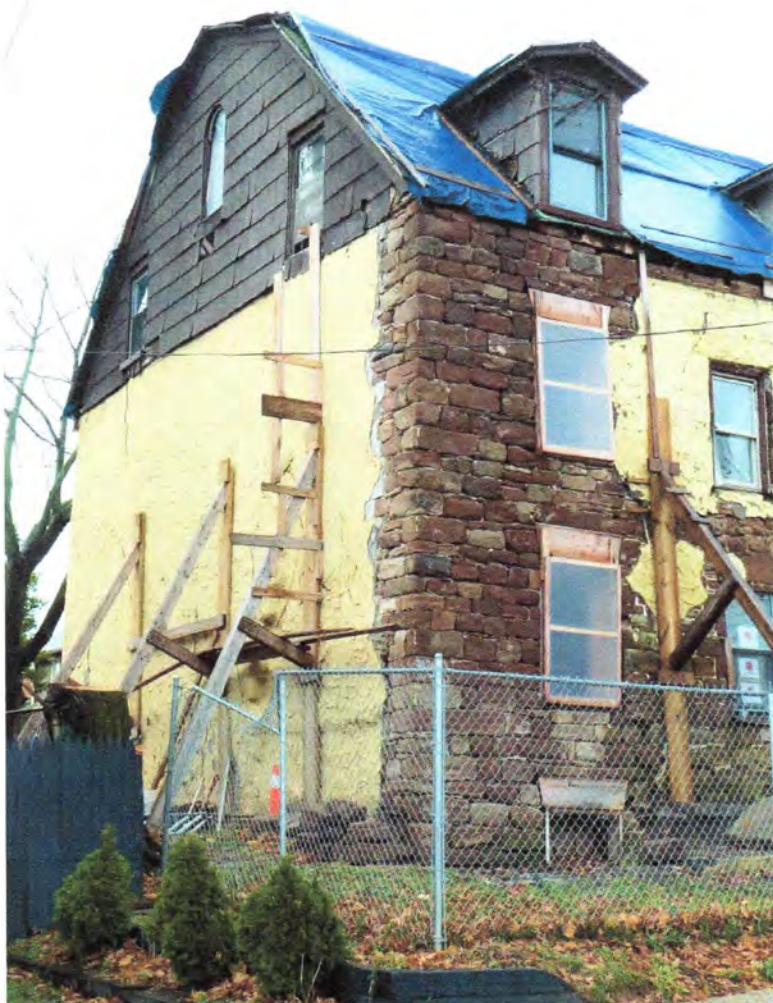
*18. Northeast Corner (rebuilt 2016)*

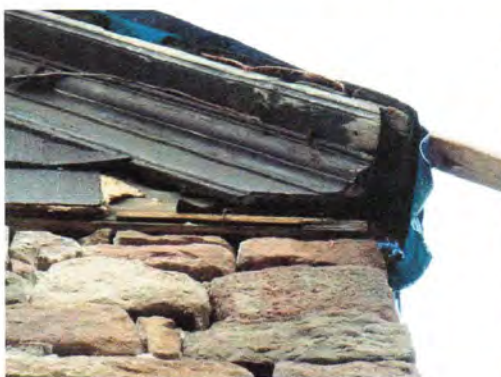
*19. Eave trim at East roof*

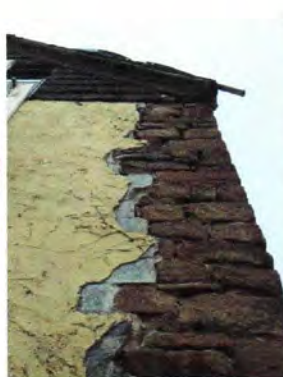
*20. Upper portion of rebuilt East wall*

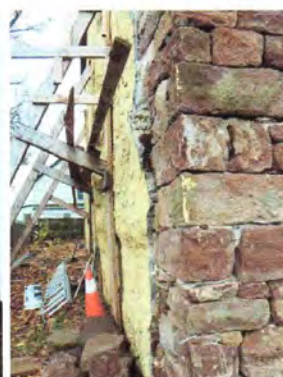
*21. Bulging (stuccoed) lower East wall and rebuilt corner*

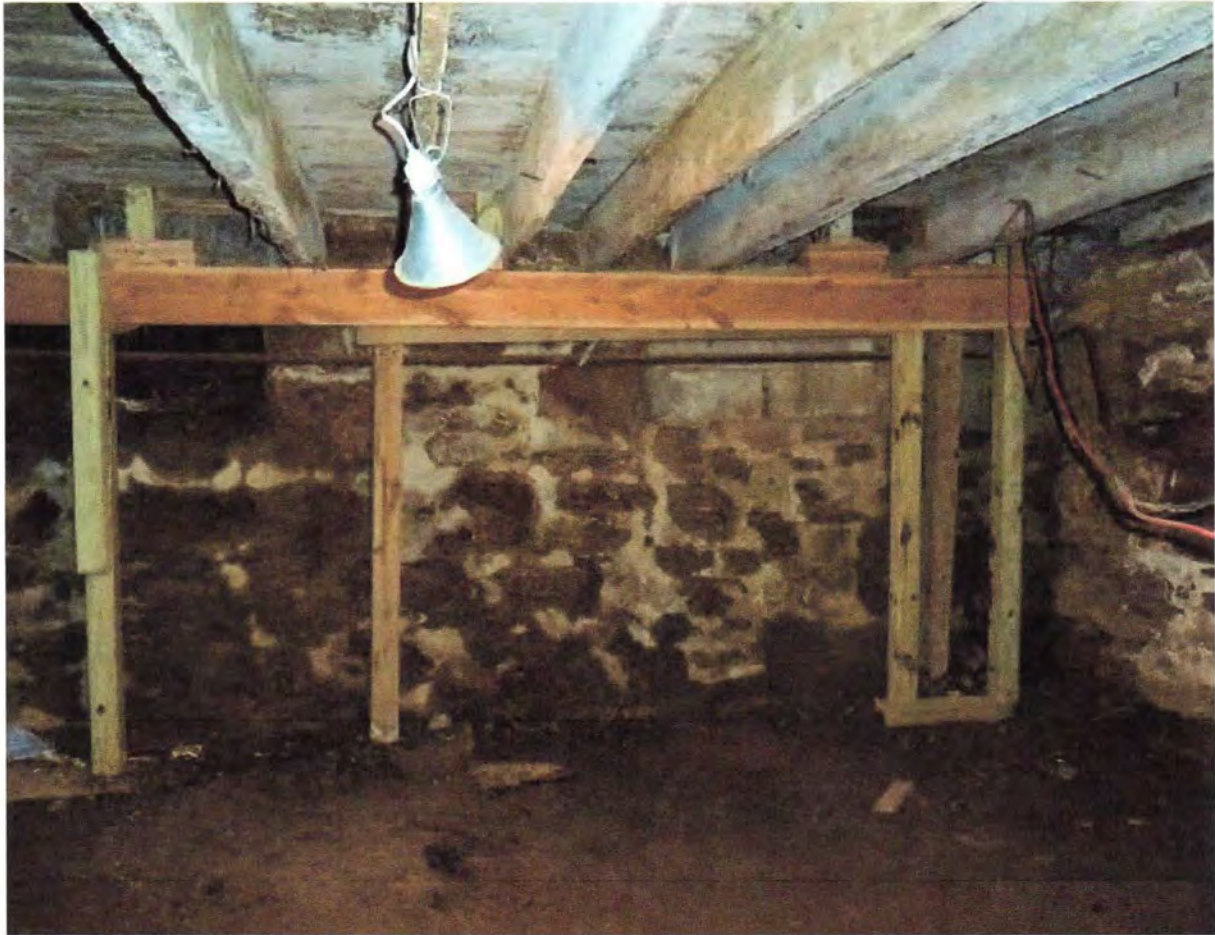
*22. Cellar, North Wall at East Corner*

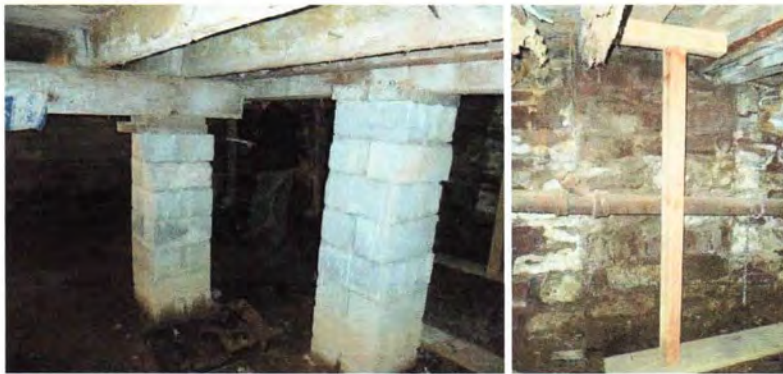
*23. Concrete masonry piers, looking Northwest from Cellar entry  
24. Outline of masonry infill of previous opening at West wall*

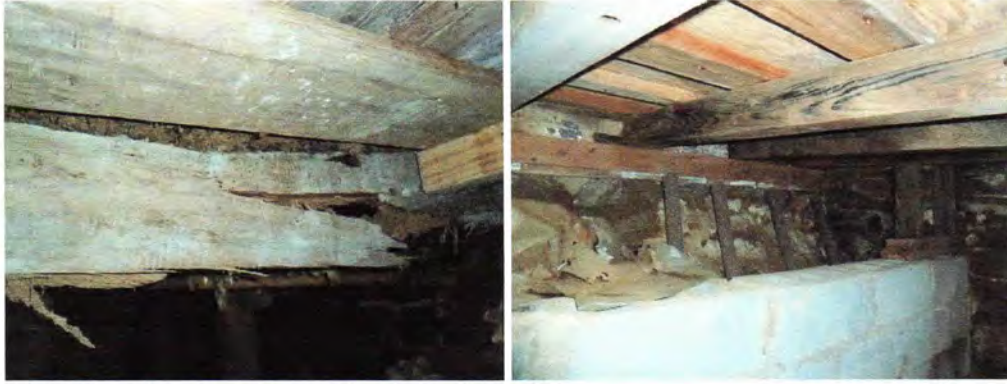
25. Failing First Floor joist at West wall of Cellar

26. Concrete block inner wall at South Wall, looking toward Southeast corner

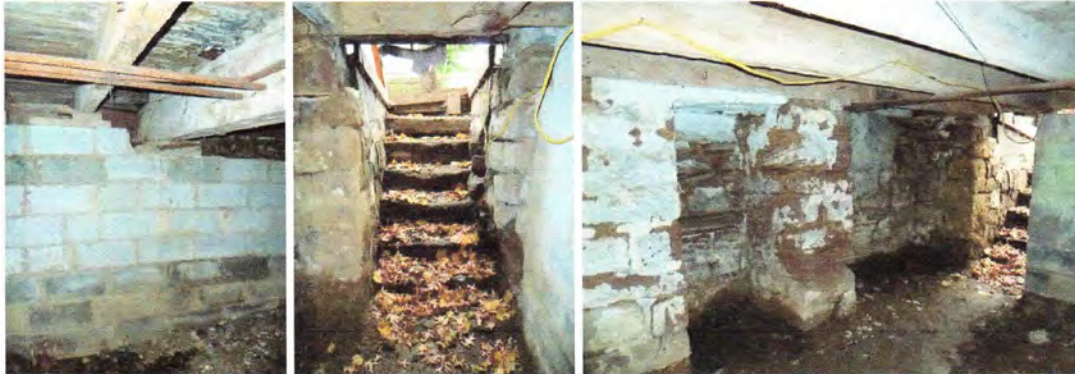
27. Concrete block inner wall at South Wall

28. Cellar entry

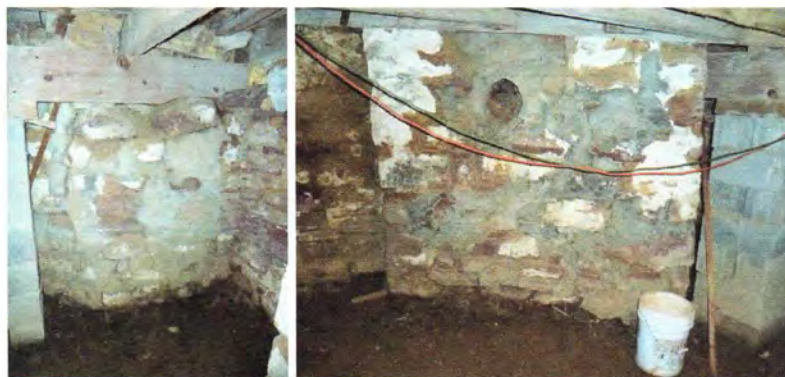
30. Back of triangular chimney mass, with joist cut to accommodate masonry

31. Front of chimney mass

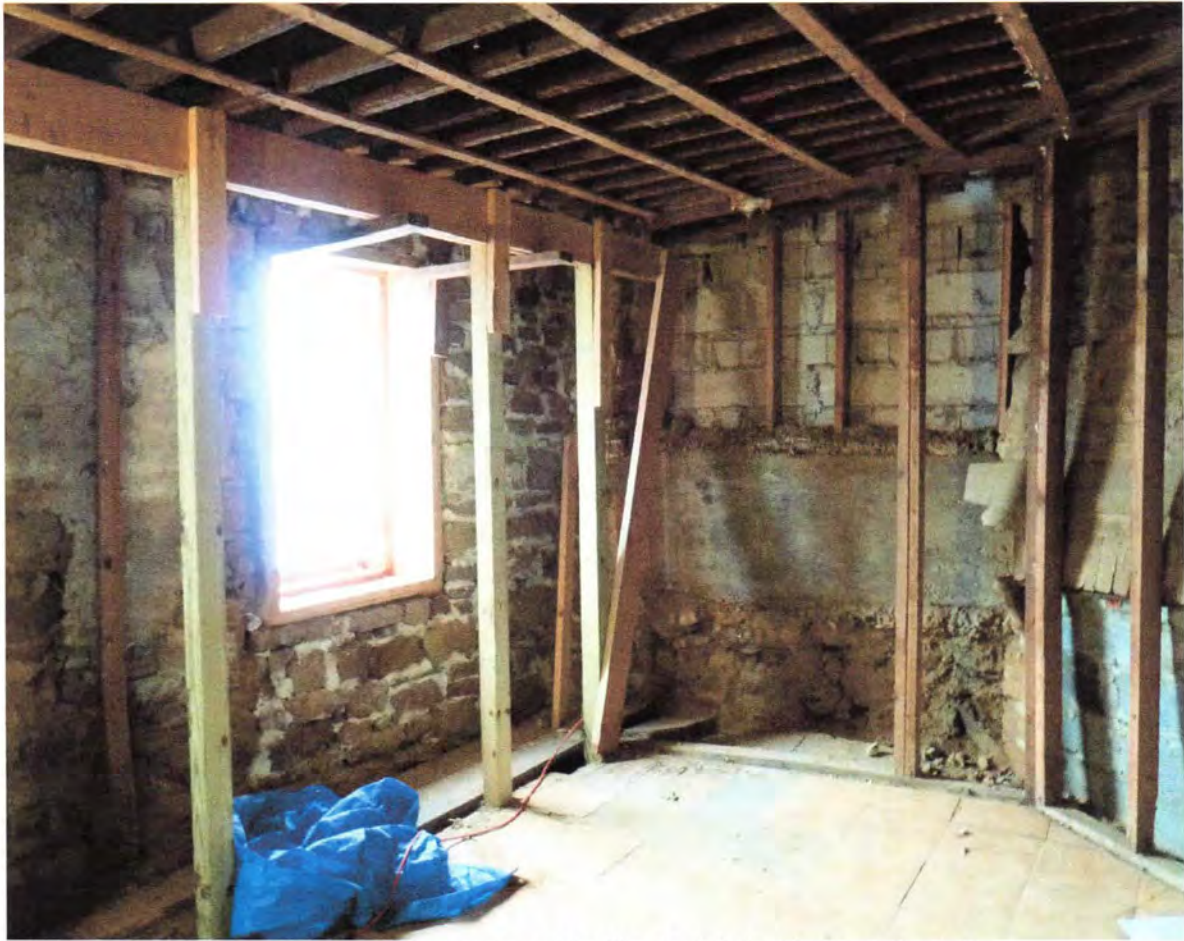
32. First Floor, Northeast corner with reconstructed wall to the left & chimney to the right

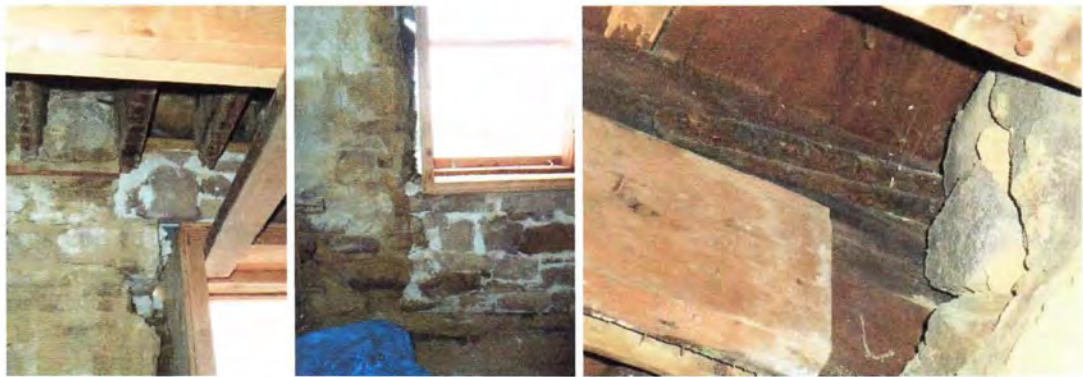
33. Joint between existing and reconstructed North wall at East window head  
 34. Joint between existing and reconstructed North wall below East window  
 35. Tie at Second floor joist level

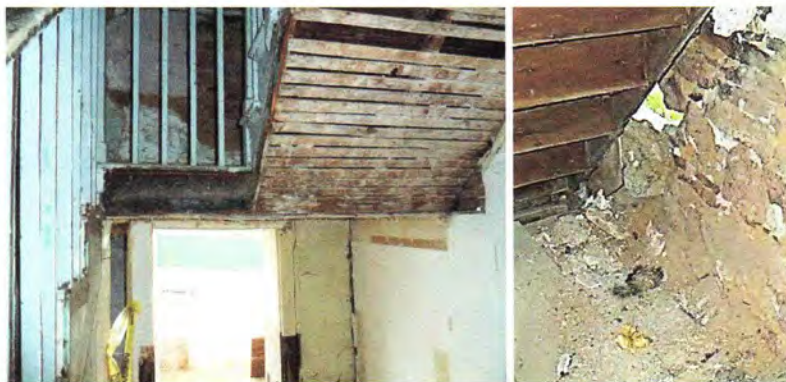
36. Stair landing just above head of North door & upper run to Second Floor  
 37. Missing masonry at West wall beneath stair, just North of West entry door

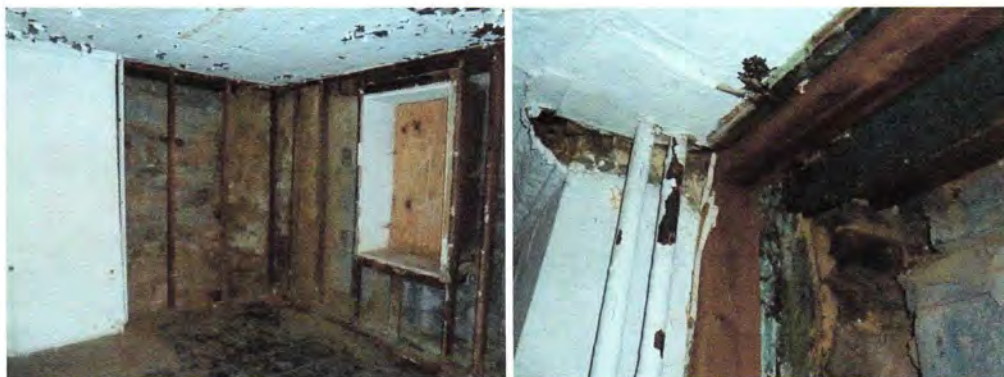
38. Southeast corner (brownstone) with concrete block infill at East & South walls  
 39. Interior finishes & trim, inner wood-framed wall, finishes & trim on interior of masonry wall, brownstone & concrete block infill at East wall, South (right) of chimney in Figure 38

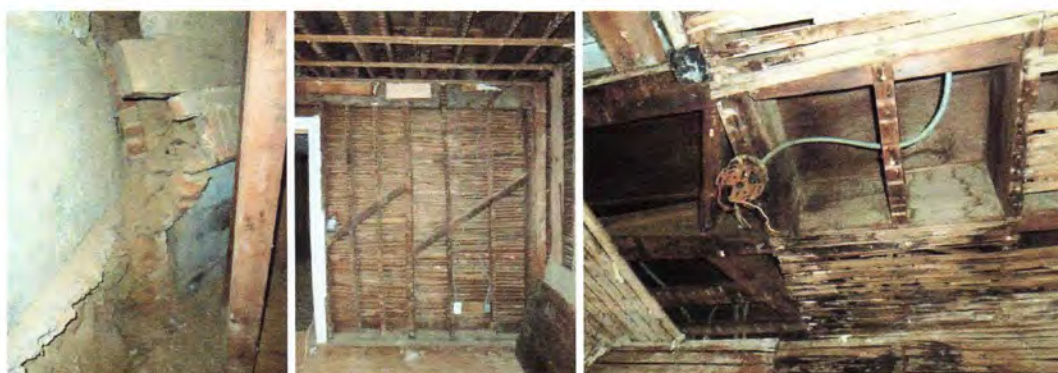
40. Failing brick structure at interior chimney, North room  
 41. Interior partition wall studs and bracing, between North & South rooms  
 42. Charred lath at walls and ceiling at Stair Hall

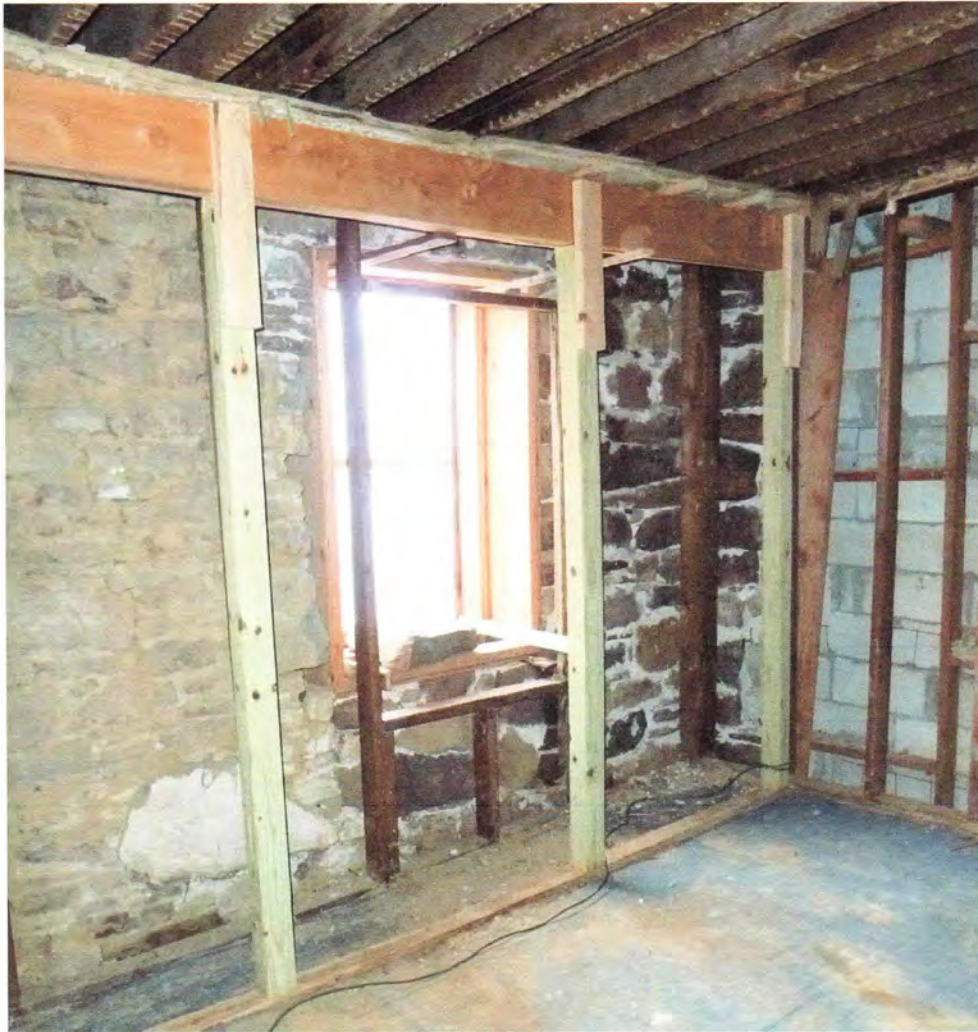
**43. Second Floor, Northeast corner with original construction West (left) of the window, reconstructed brownstone masonry wall to the East (right) of the window, and concrete block construction on the East Wall (far right)**

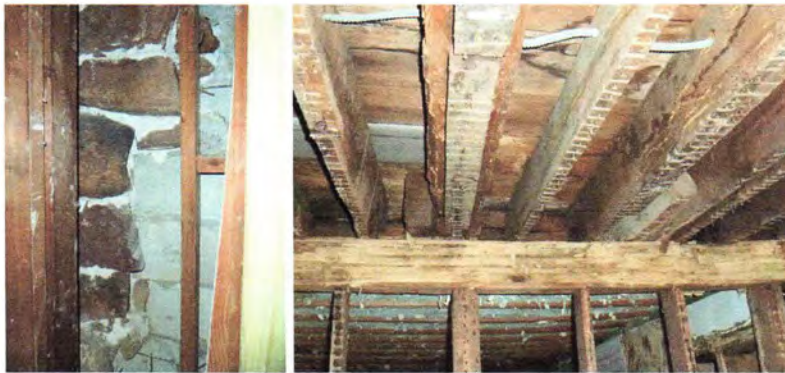
**44. Joint between brownstone & concrete block construction at East wall**

**45. Discontinuous Attic floor joists above partition between North & South rooms**

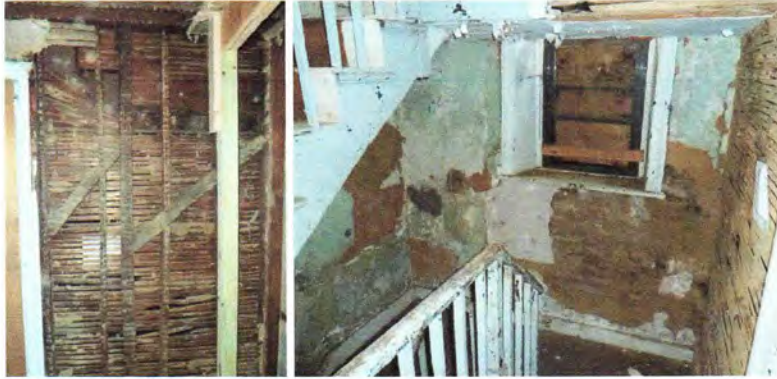
46. Wood lath (including ray configuration below wall string of upper run to Attic) & bracing  
 47. Stair landing between First and Second Floors

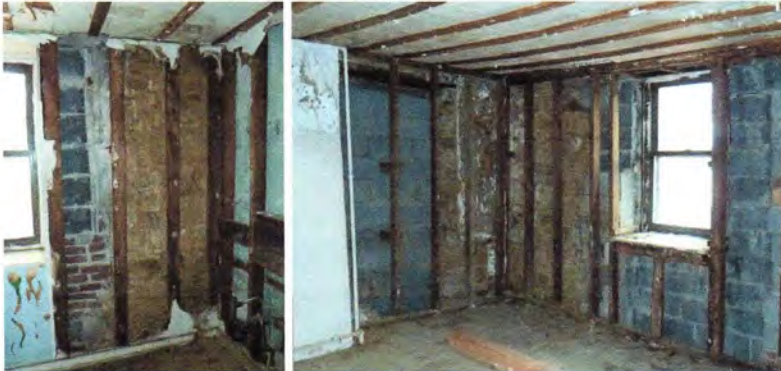
48. Concrete block, brick, and original brownstone masonry construction at Southwest corner (Bath previously)  
 49. Concrete block construction on both sides of brownstone masonry at Southeast corner

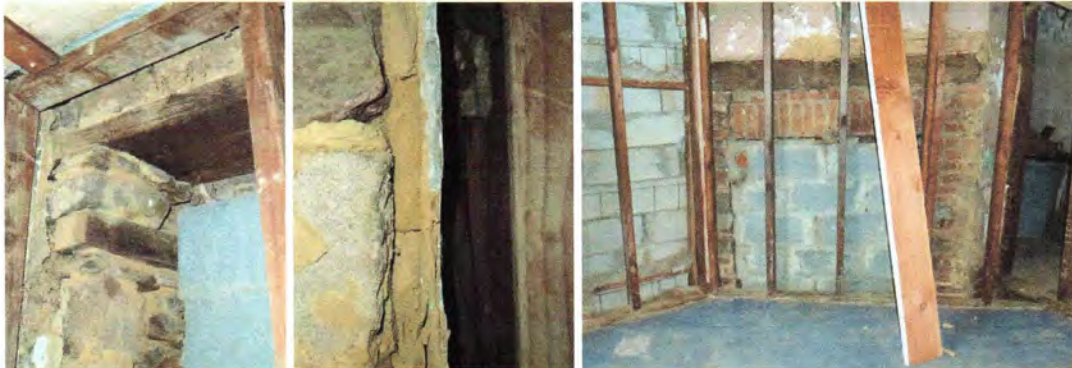
50. Inner wood-framed wall, original wood header & nailer at brownstone opening with concrete block infill at East wall, South (right) of chimney in Figure 49  
 51. Original plaster, mortar and brownstone section at opening south of chimney in Figure 49  
 52. Concrete block construction at East wall and fireplace opening

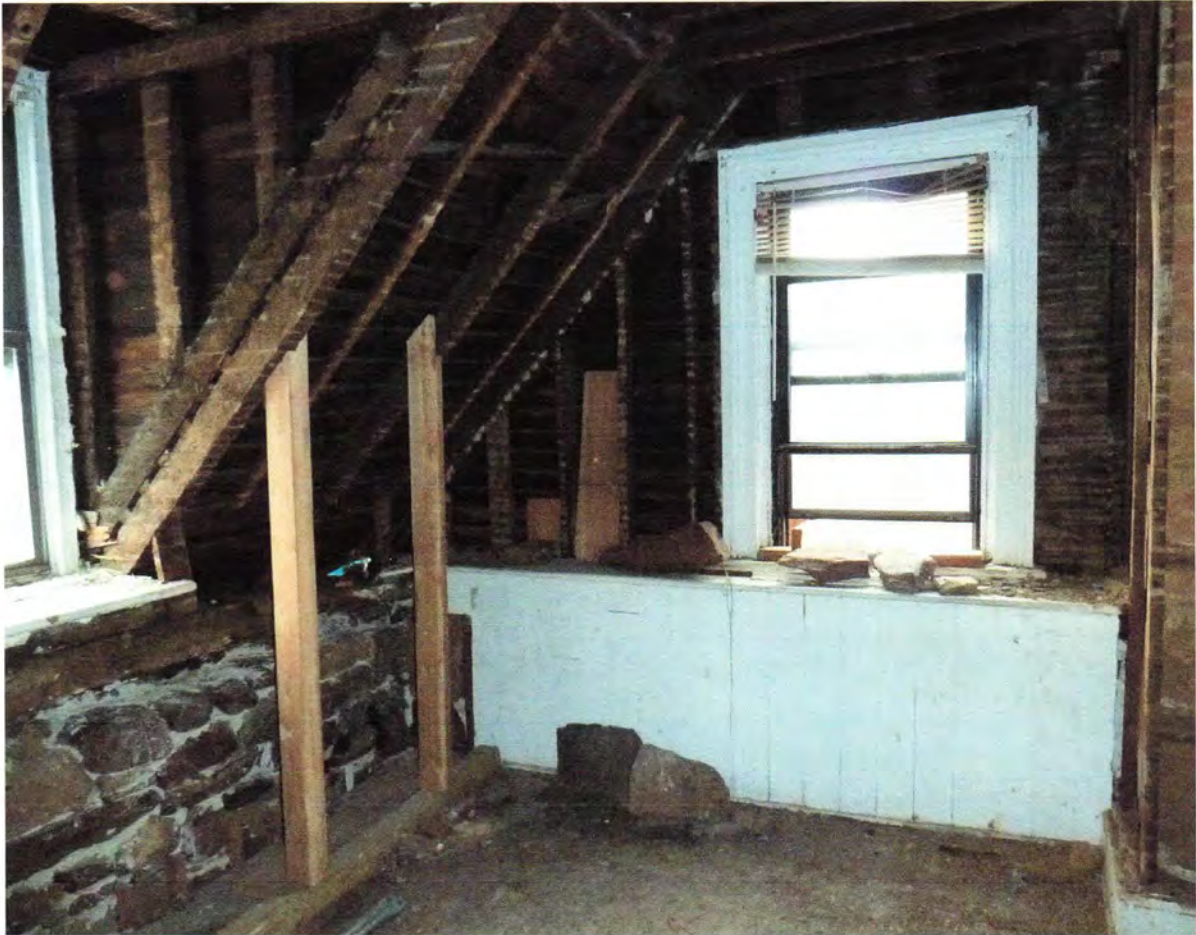
53. Attic, Northeast corner with reconstructed brownstone masonry wall below the dormer window (North wall)

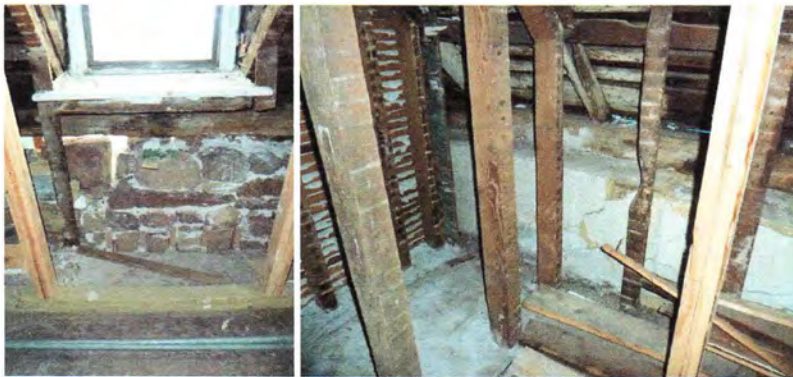
54. Reconstructed brownstone wall beneath Eastern dormer window (North wall)  
 55. Original plaster-finished masonry knee wall (North wall)

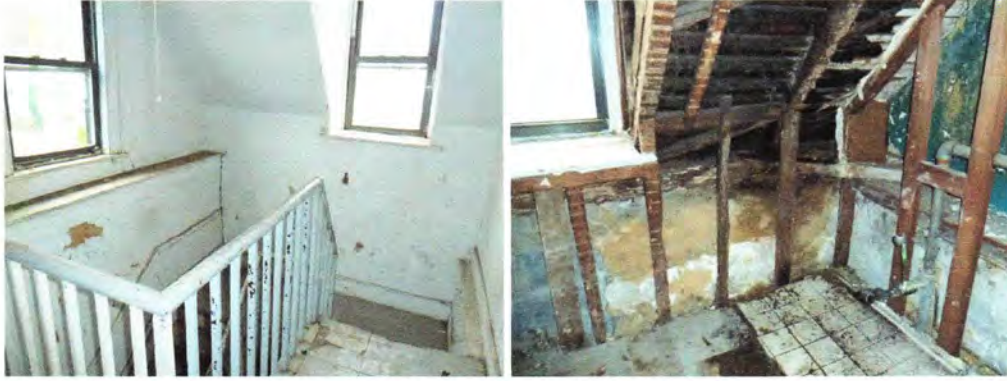
56. Northwest corner at stair landing between Second Floor and Attic

57. Deteriorated plaster of knee wall & roof framing at Southwest corner (Bath, previously)

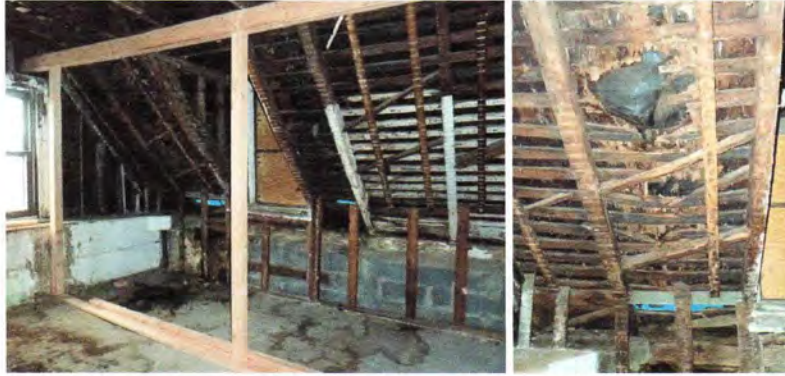
58. Deteriorated roof and dormer framing & concrete block knee wall at Southeast corner

59. Failing skip sheathing of roof at Southeast corner

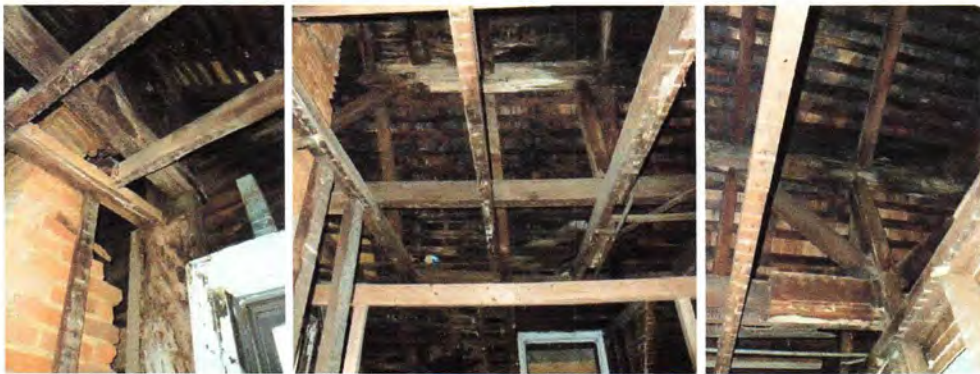
60. Missing section of South chimney at East Wall

61. Deteriorated purlin at South roof

62. Deteriorated purlin and bracing at South roof

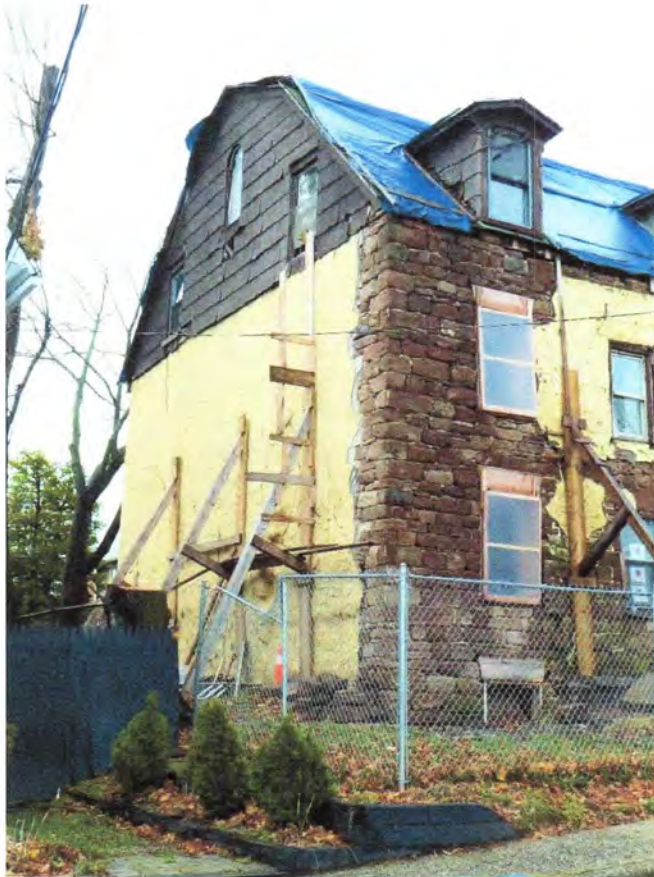
**Photo 01** – General view of northeast corner of house showing shoring at east and north walls. Northeast corner of masonry wall has recently been rebuilt.

Both the east and west walls of the building are displaced and/or deformed. The east wall is leaning to the east and has been braced with 2x wood struts. The west wall appears to be either partially leaning to the east (in to the building) and/or bulging. The displacement / deformation in the west wall appears to correlate to the bulge in the foundation below. Substantial cracks were observed along the south wall and the corner where the east and south walls meet. A smaller crack / open joint was observed at the north wall, just west of the entry. The northeast corner of the bearing wall was recently rebuilt using salvaged materials.

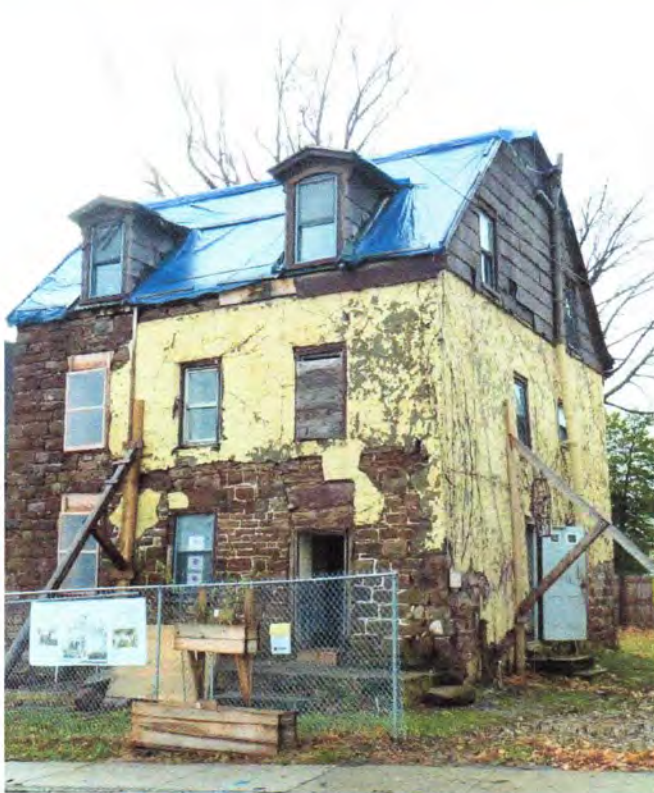
**Photo 02** – General view of northwest corner of house showing shoring at west and north walls. There is an open joint / crack in the north wall, just west of the entry door. The masonry wall is leaning / bulged at the brace on the west wall.

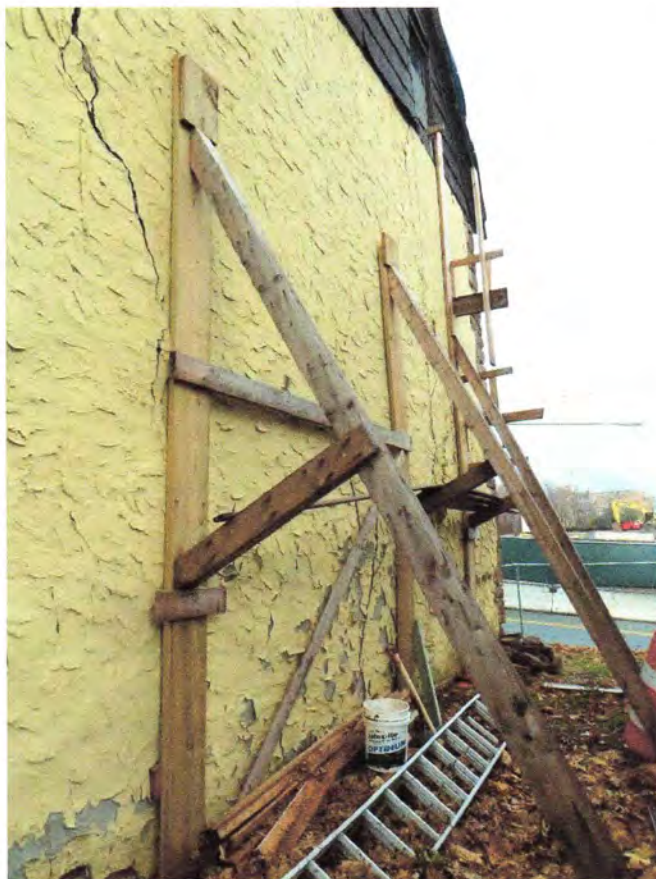
**Photo 03** – General view of east side of house showing bracing and cracks in masonry. The concrete masonry unit (CMU) infill and concrete bond beam installed at the north end of this wall has been covered with stucco.

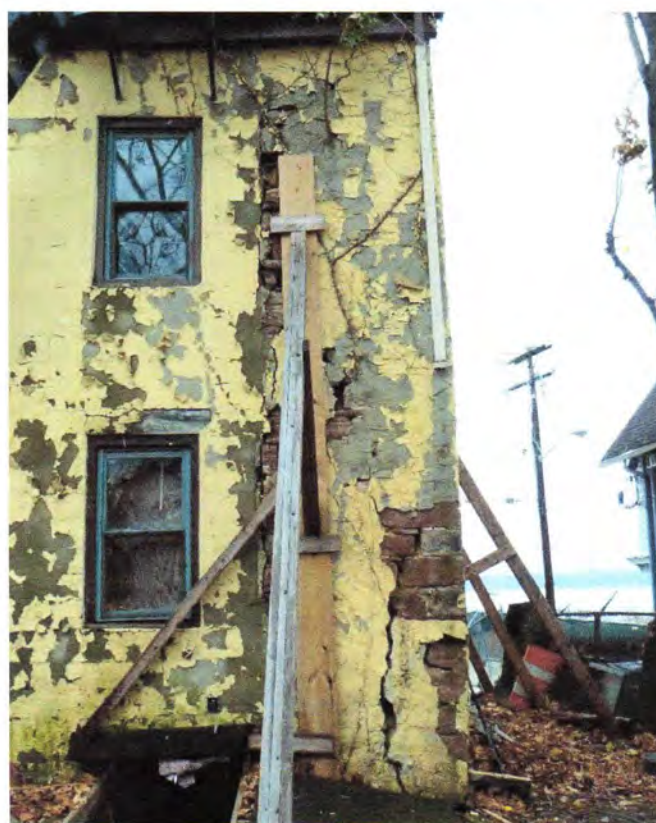
**Photo 04** – General view of southeast corner of house showing shoring at east and south walls, as well as the large crack that has developed. The joint between the original masonry and the CMU at the south wall is along the right or east jamb of the windows.

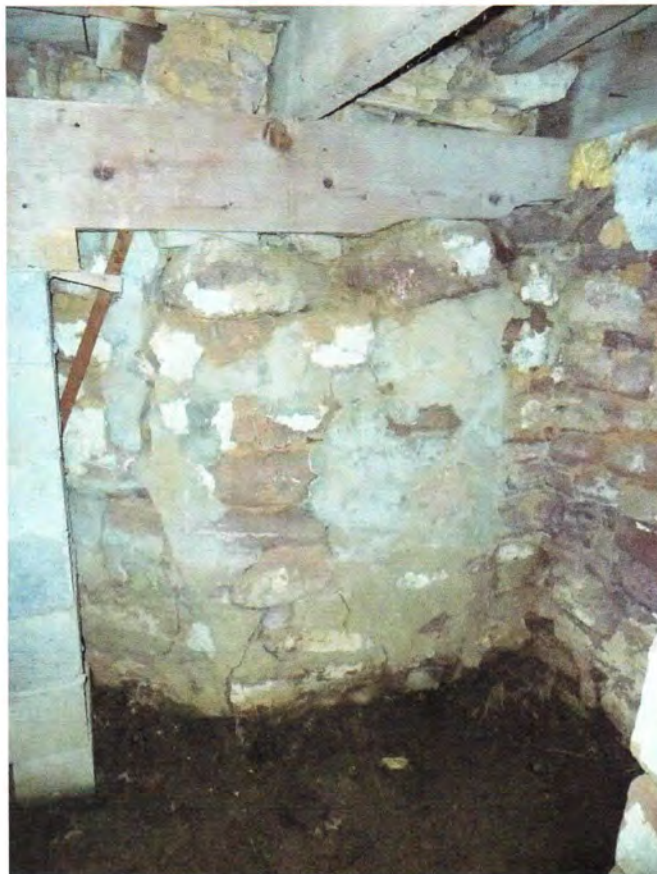
**Photo 05** – Bulge at the northwest corner (west wall) of the foundation. There is a door opening to the left of the bulged section of wall that has been filled with masonry.

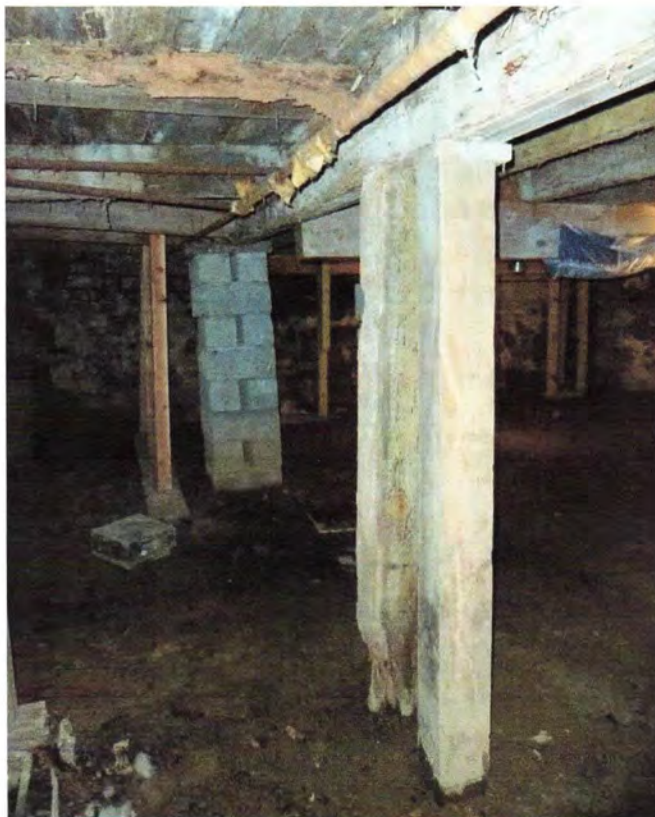
**Photo 06** – General view of first floor framing and the girders, posts, and piers that support the first floor framing. Most, if not all of the first floor framing is severely deteriorated.
