Property Name: Green, John, House

## National Register of Historic Places Registration Form

RE: Technical Assistance Grant  
Conditions Report  
John Green House  
23 Main Street, Nyack NY

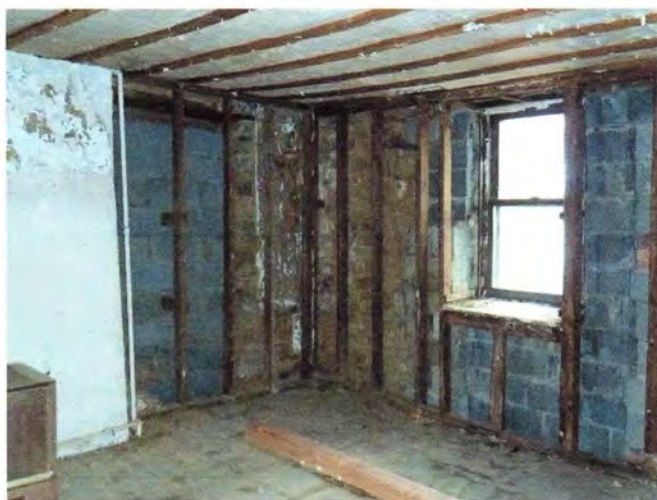
**Photo 07** – General view of southeast corner of house at interior showing existing “liner wall” along south and east elevations and the remains of the original masonry butted to the CMU built following local collapses of the original masonry.

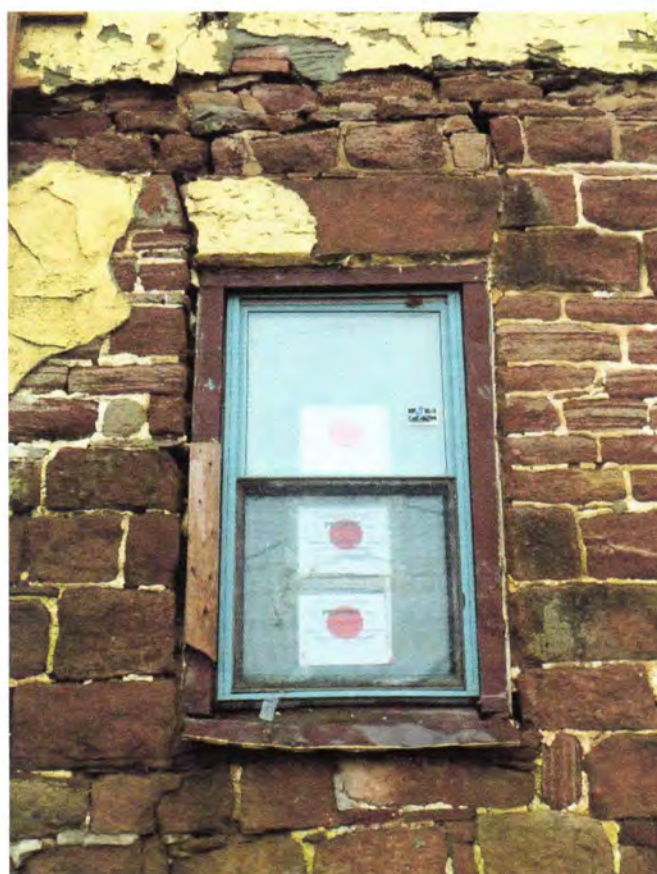
**Photo 08** – Typical single-piece “jack arch” lintel in the exterior leaf of stone. Where the wall has been rebuilt, the arches have not been replaced. Temporary 2x lintels were placed in the wall until the stones can be replaced.

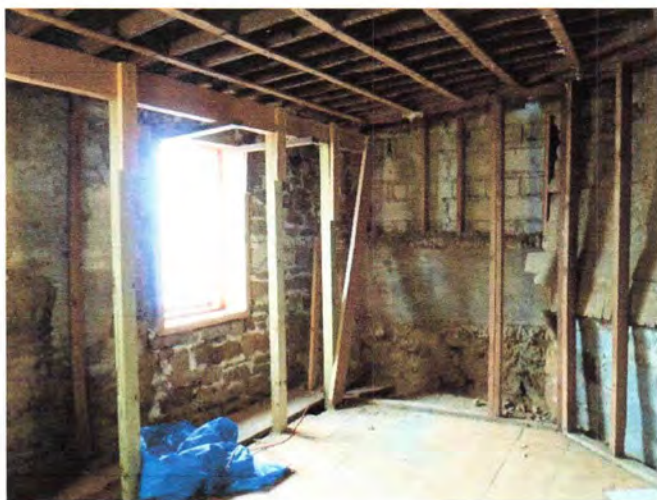
**Photo 09** – General view of northeast corner from the interior showing rebuilt corner and the CMU and concrete bond beam at the south wall. The masonry at the firebox has partially collapsed.

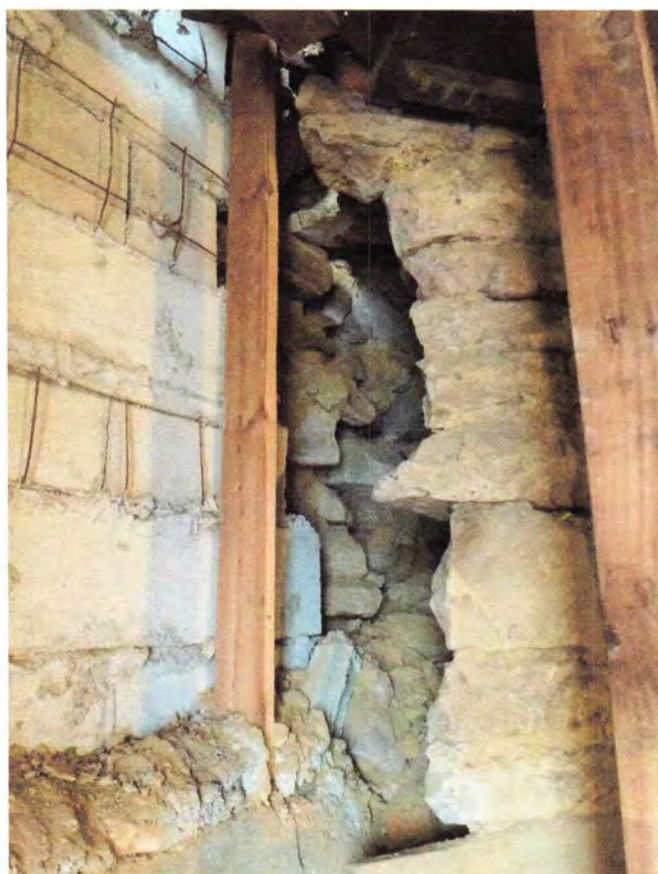
**Photo 10** – Separation between the exterior wall (left in image) and the chimney mass is evident at the first floor, north room.

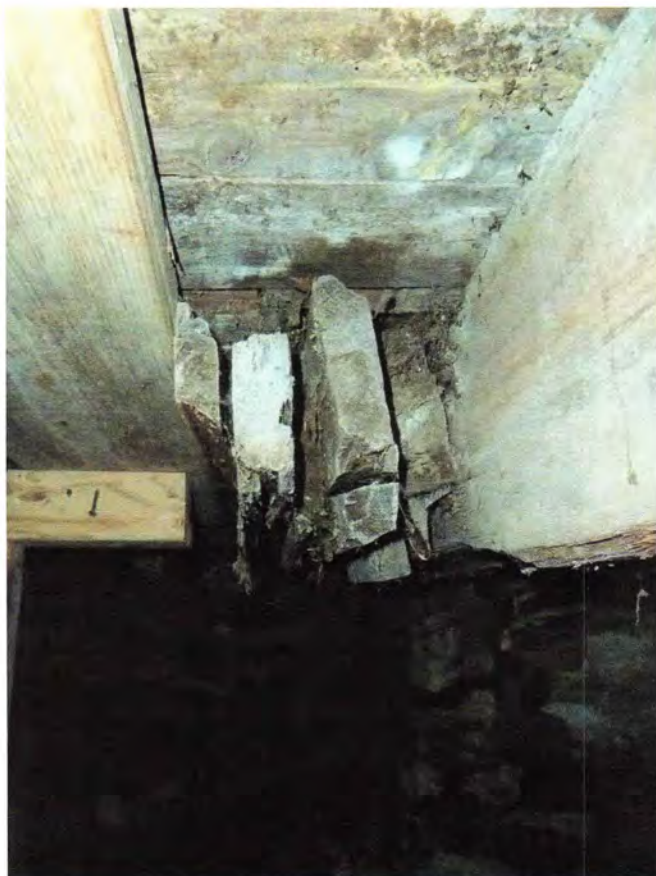
**Photo 11** – Typical condition of first floor framing. Pressure-treated material (left in image) has been installed to shore both the joist and the flooring. The flooring is shown supported in this image. See Photo 06 for shoring at joists, in background.

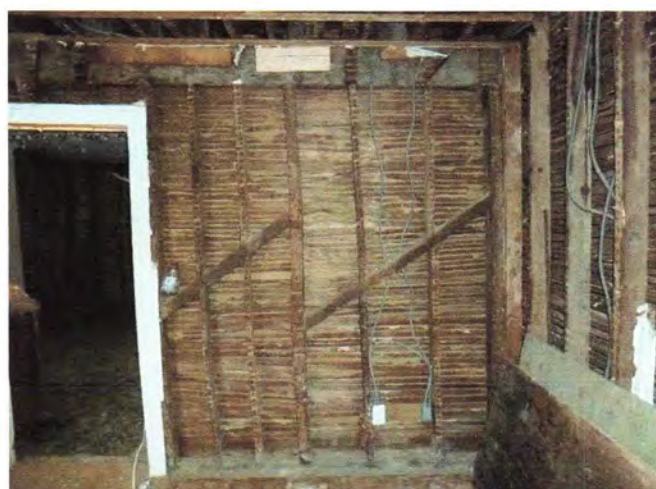
**Photo 12** – Bearing partition between north and south rooms at the first floor. Once vertical studs and square door opening are now skewed to the east.

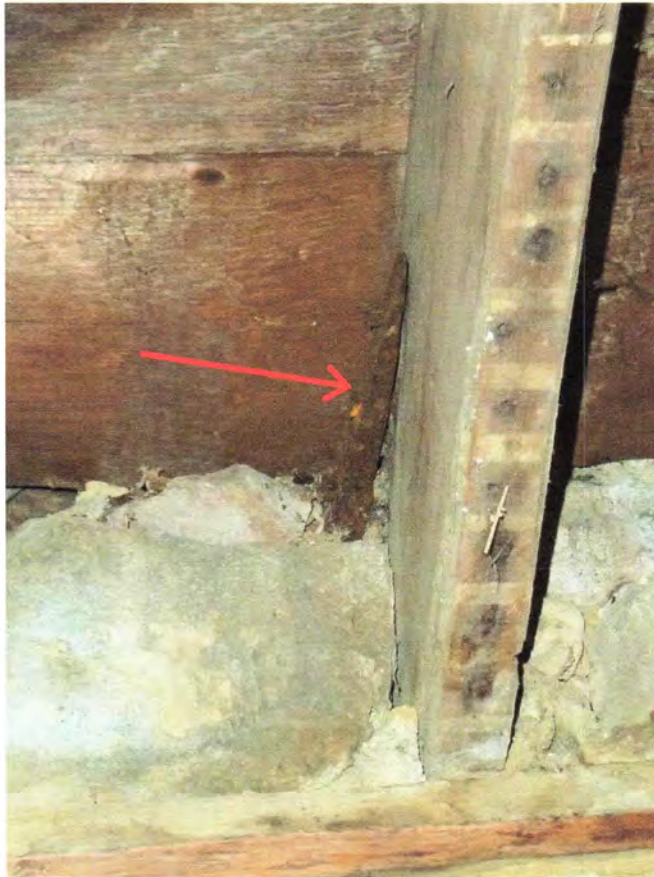
**Photo 13** – Close-up view of interior leg of anchors at facades (arrow).

*Exterior Bearing Walls* – The original masonry walls are, like the foundation, built of sandstone. Iron ties were used at the north, south, and west walls to secure the masonry to the floor framing at the second floor. (Ties may not have been present at the east side because the chimney stacks braced the wall; evidence of ties at the east wall may have been lost when the wall collapsed.) While robust on the exterior the connection of the ties to the floor framing is not nearly as substantial. Portions of the south and east wall collapsed in the past and were rebuilt with 8-inch, concrete masonry units (CMU). A reinforced concrete bond beam was also installed at the east wall, at the portion rebuilt with CMU. All of the masonry has been coated with a cementitious stucco, except where the masonry has been rebuilt (see below).

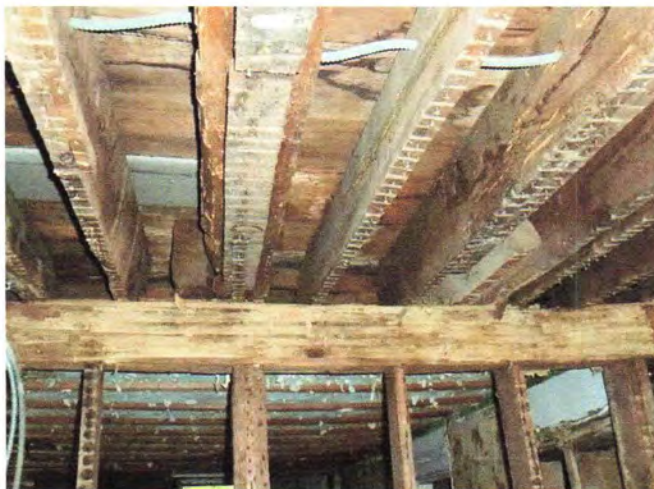
**Photo 14** – General view of idiosyncratic framing at second floor.

*Second Floor Framing* – Details on the existing framing are shown on the plans in the appendix. Framing is a mix of “standard” lumber commonly found in floor framing, as well as salvaged and/or “non-standard” material, such as 5/4-inch boards that been put into service as framing.

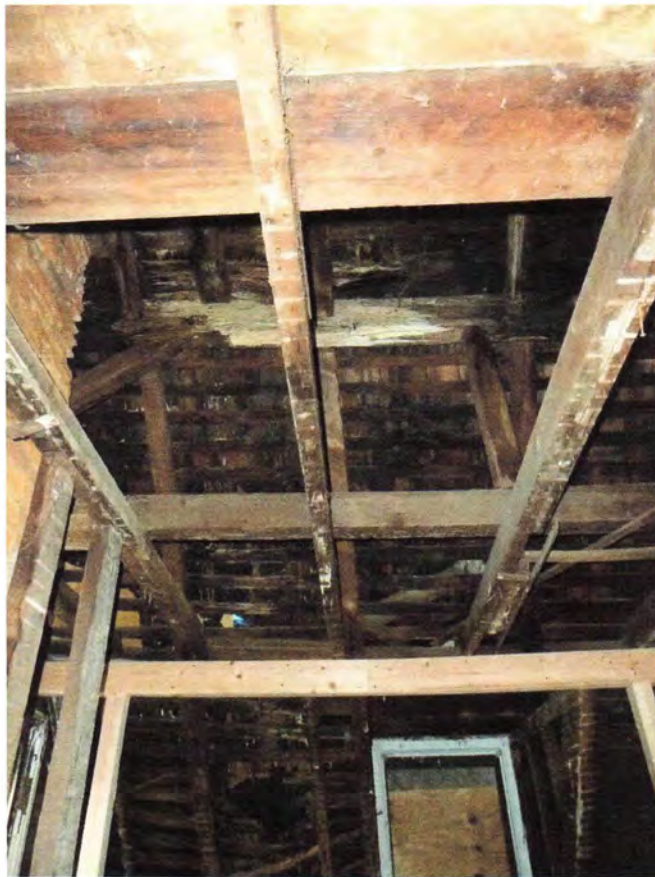
**Photo 15** – General view of roof framing, looking south at east end of south slope of roof. Water damaged “upper chord” of “truss” is visible at the center of the image.

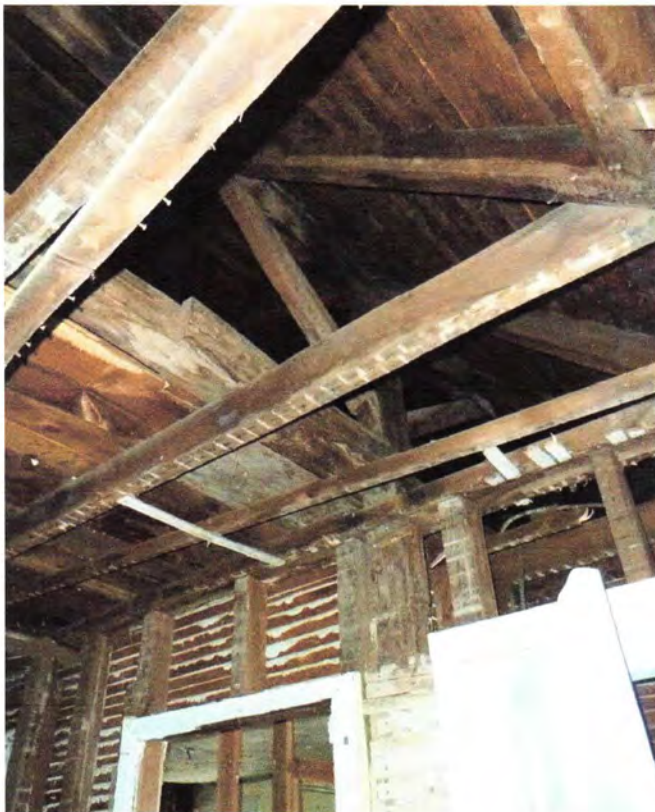
**Photo 16** – General view of “truss” framing over post at mid-span (east to west). Post appears to bear on floor, not on beam in floor.
