# National Register of Historic Places Registration Form

Historic name: Carrier Congregational Church

Street & number: 204 North Fifth Street

City or town: Carrier State: OK County: Garfield

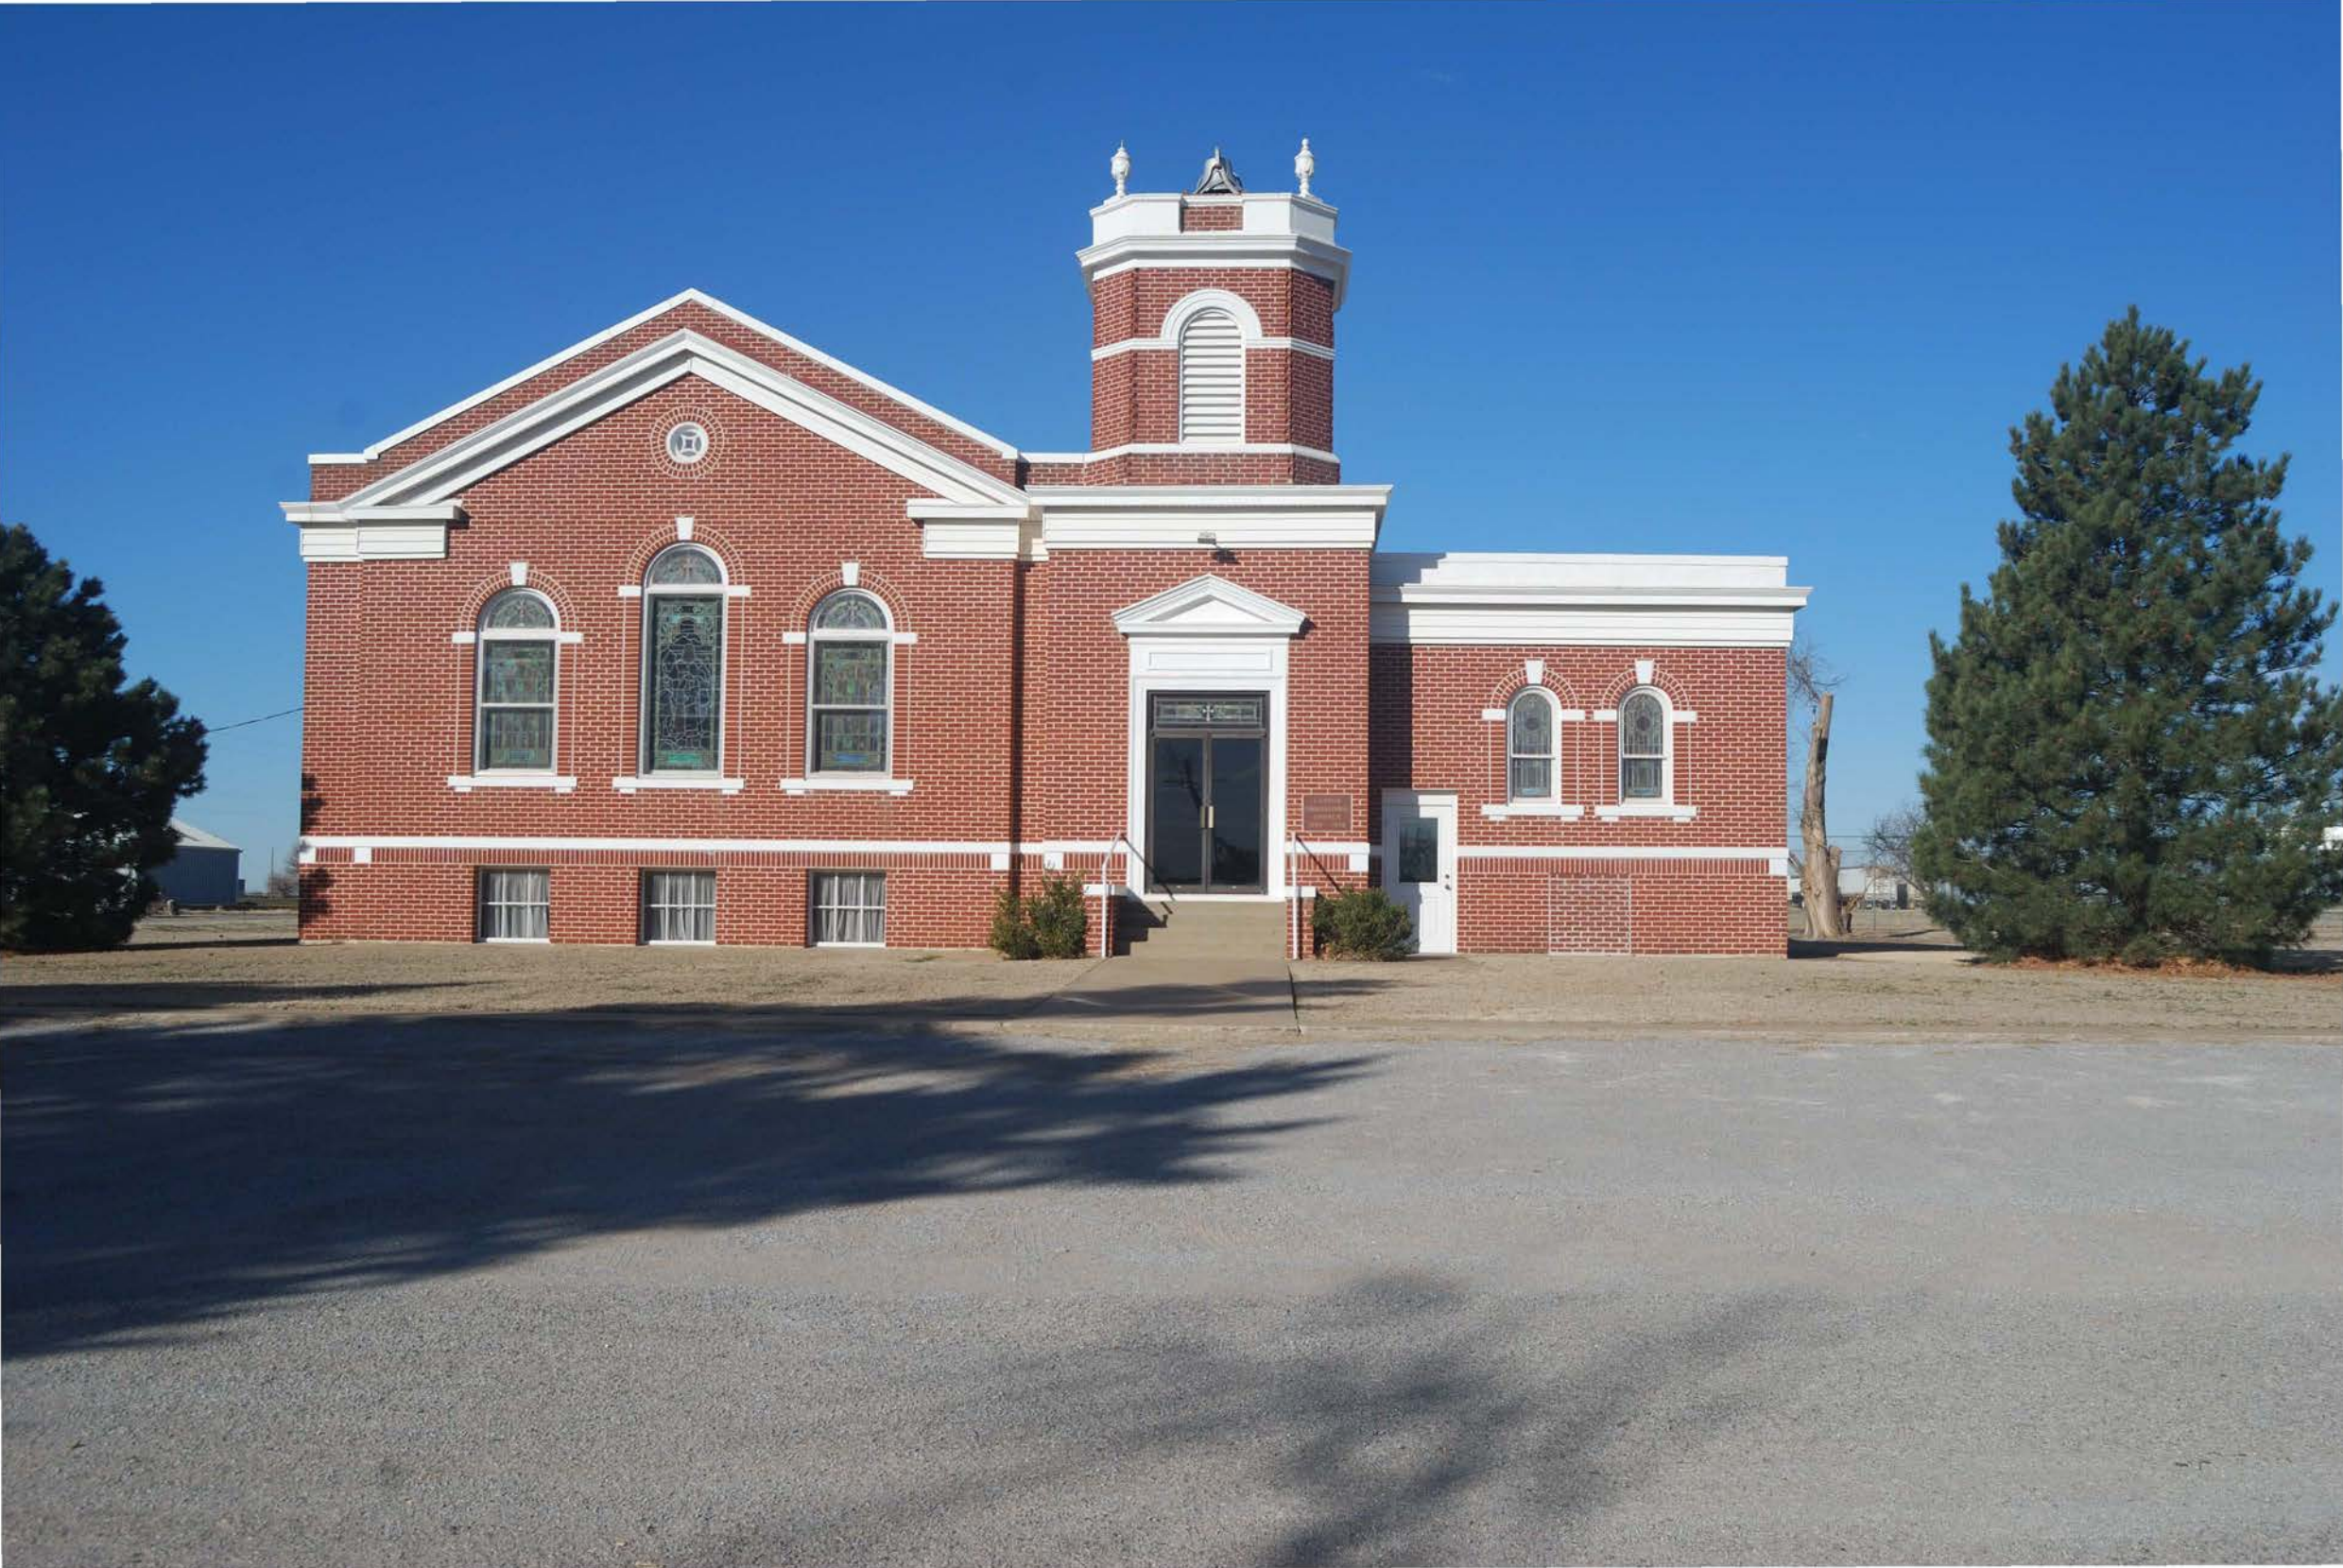
Photograph Number	Subject	Camera Direction
0001	Facade	West
0002	North Elevation	South
0003	West Elevation	Northeast
0004	South Elevation	Northeast
0005	Steeple Detail	Northwest
0006	Stained Glass Detail	West
0007	Signage	Southwest
0008	Basketball/Tennis Court	West

The sanctuary side of the façade (south end of east elevation) has three evenly spaced six-pane windows with concrete sills at the basement level. Between the basement level and the main floor of the sanctuary, extending along the east, south and north elevations at the same level, is a masonry beltcourse. The main floor has a tall, Roman-arched, display stained-glass window flanked by two arched, stained-glass sash windows of lesser height; the keystone and imposts of each are artificial stone, painted white to match the sills, verge boards, fascia and other roof trim. Each window is trimmed with a single row of soldier course bricks on the lower two-thirds of the window with a double row of header course bricks that surround the arched portion of the window opening. A bull's-eye window is positioned above the central stained glass window on the gable pediment and is surrounded by a double row of header bricks. The gable pediment features gable returns. A gable parapet wall extends above the primary gable pediment and has masonry coping. Located between the sanctuary and the assembly hall is the main entry. A triangular pediment tops the surround of the main double-door entry. Above the entry is a belfry in the shape of an isogonal octagon. At the top of the belfry are four masonry ornamental urns, one on each short side, and a silver church bell rung by a rope from the vestibule. In the drum of the belfry are four arched side openings that are filled with louvers. The façade of the flat-topped portion of the building (assembly room) has two arched, stained-glass sash windows on the main floor, neither as tall as the smallest ones on the sanctuary side. Each window is trimmed with a single row of soldier course bricks on the lower two-thirds of the window with a double row of header course bricks that surround the arched portion of the window opening. Originally, a

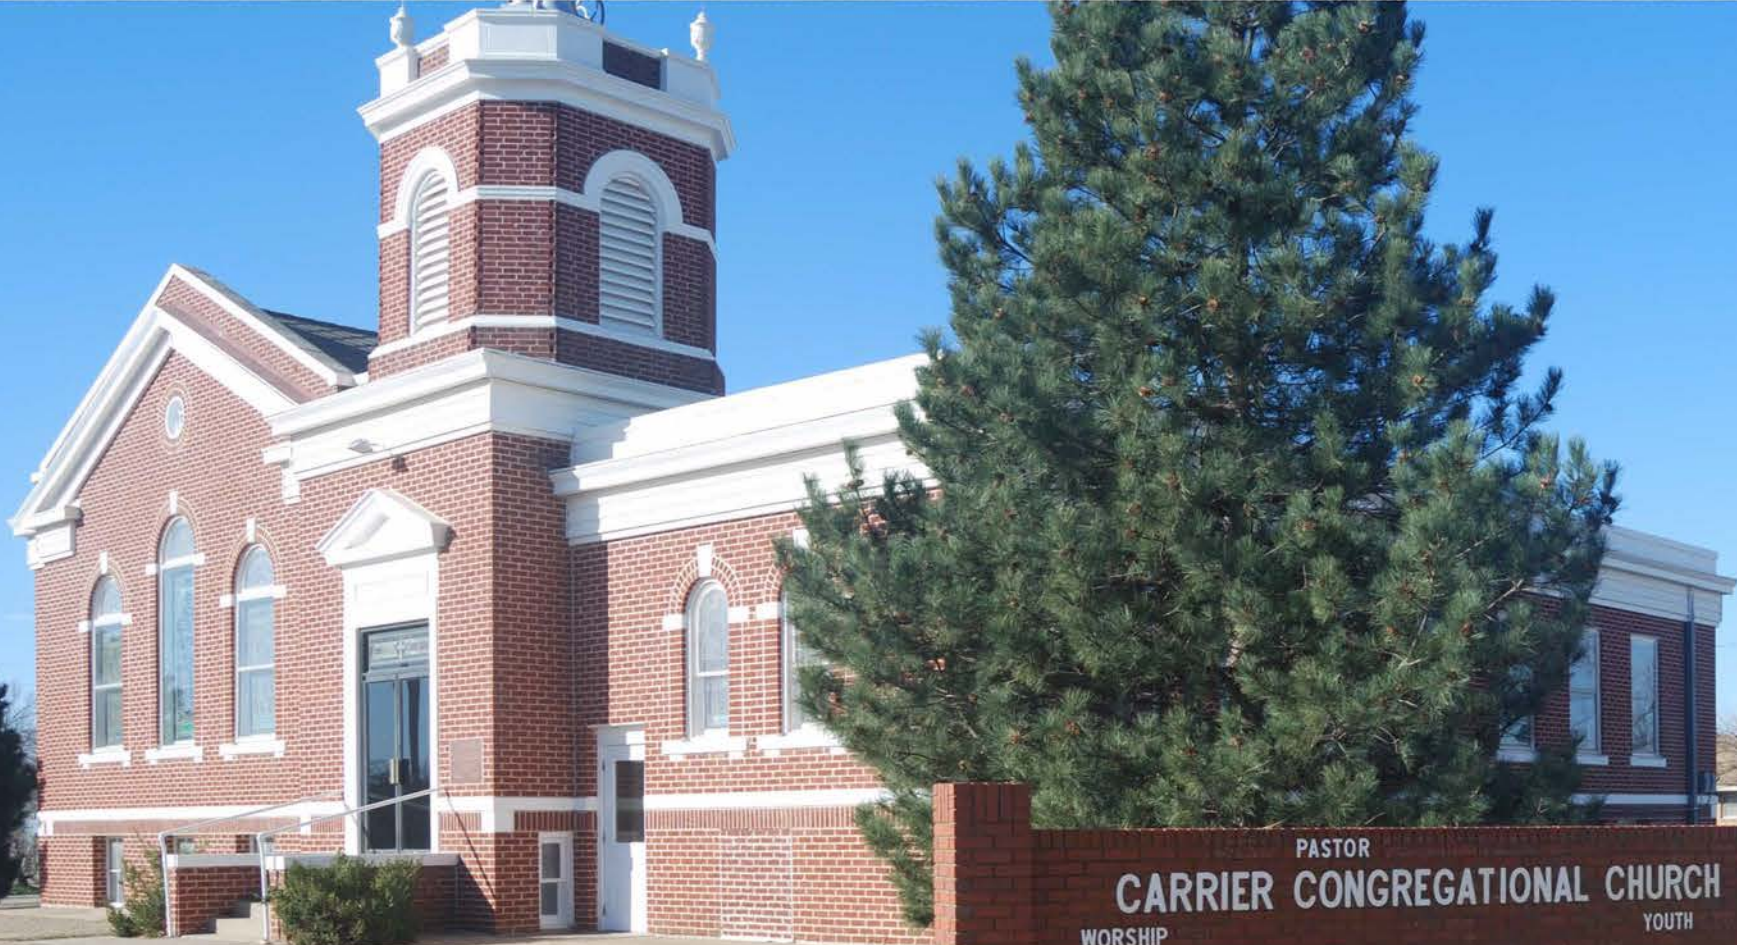
PASTOR  
**CARRIER CONGREGATIONAL CHURCH**  
WORSHIP YOUTH  
SUNDAY SCHOOL

Located northeast of the church building is a brick wall which functions as the sign for the church. Each corner has a square brick column with the "wall" running between the columns. The foundation is poured concrete. The north side of the sign features the lettering for the church.
