NATIONAL REGISTER OF HISTORIC PLACES
REGISTRATION FORM

historic name Tipton/Black Willow Ranch Historic District

other names/site number Enoch Tipton Ranch

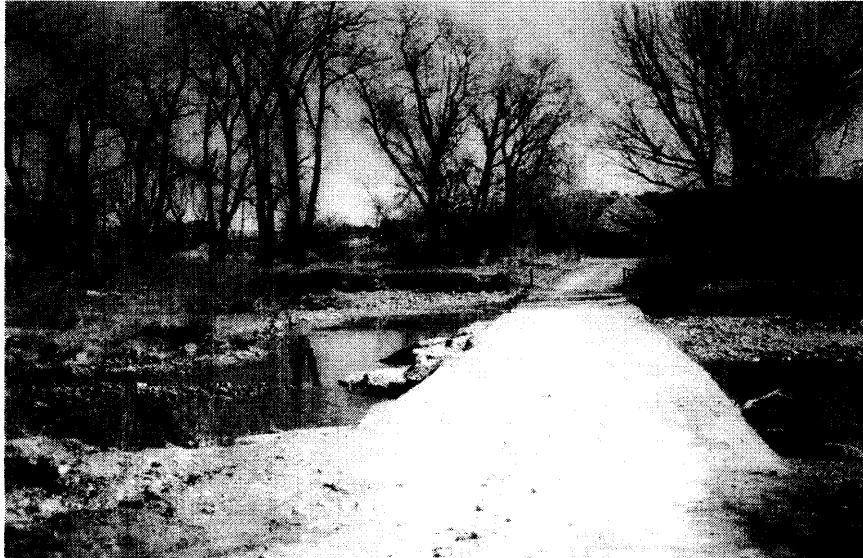
Figure 2: Road crossing Mora River to enter Tipton/Black Willow Ranch Historic District (Nancy Hanks, 2000).

The only road leading to the Tipton/Black Willow Ranch Historic District lies to the northwest of the main buildings (from the upper left in Figure 1) and crosses the Mora River without benefit of a bridge (Photograph 1; Figure 2). The Martha Jane Tipton house lies to the east, past a line of Black Willow trees (Photograph 2; Figure 3). To the west lies the historic west fence line (Photograph 3; Figure 4) that joins the still-working Tipton irrigation ditch (Photograph 4; Figure 5) to form part of the southern boundary of the district. As the road turns to the east, the Martha Jane Tipton house sits to the north of the Tipton adobe barn (Photograph 5; Figure 6), with the Enoch Tipton house further east (Photograph 6; Figure 7). As the road turns to the north past the Enoch Tipton house, it meets the low line of Dakota sandstone cliffs (Photograph 7; Figure 8), and ends at the Marshall family cemetery (Photograph 8).

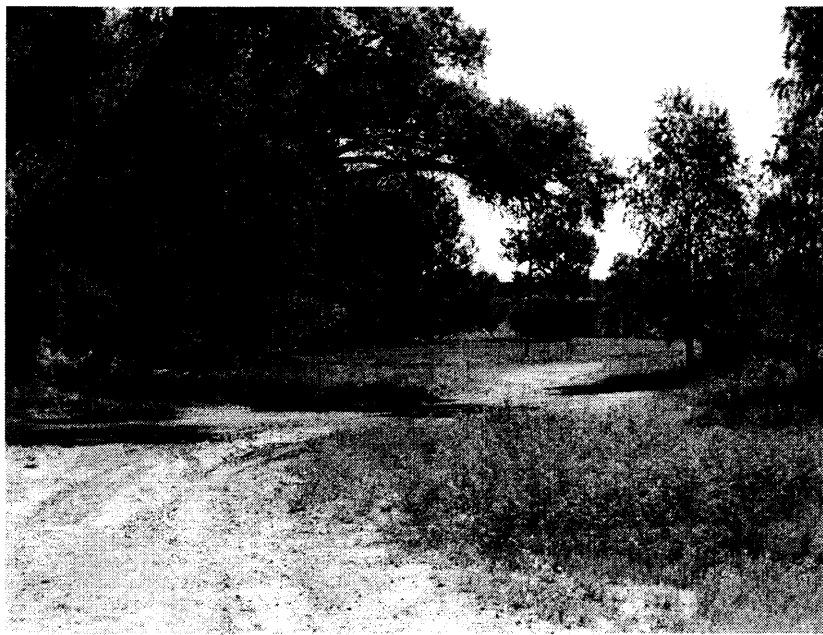
Figure 3: Road leading to the Martha Jane Tipton house (in distance; Nancy Hanks, 2000).

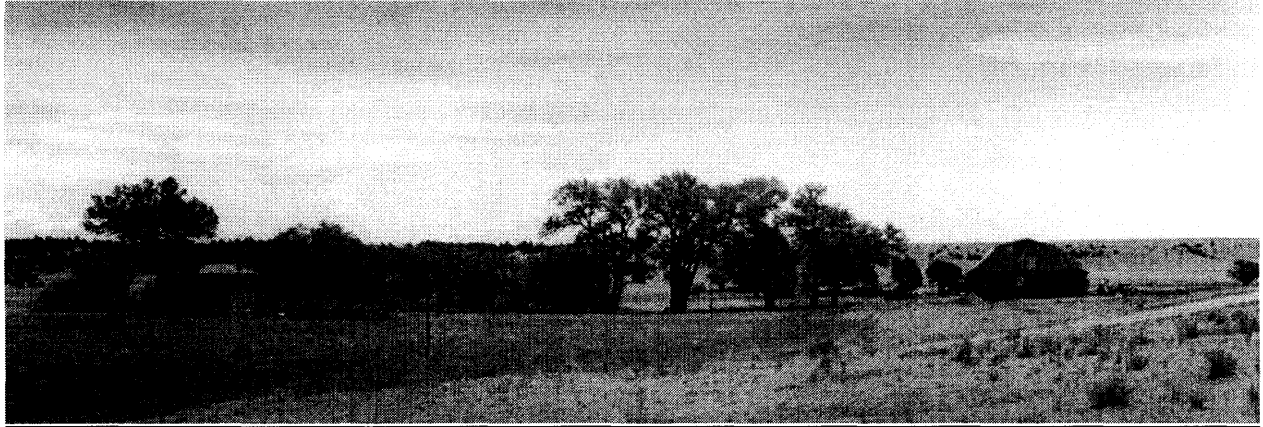
6: Martha Jane Tipton house on left, Tipton adobe barn on right (Nancy Hanks, 2000).

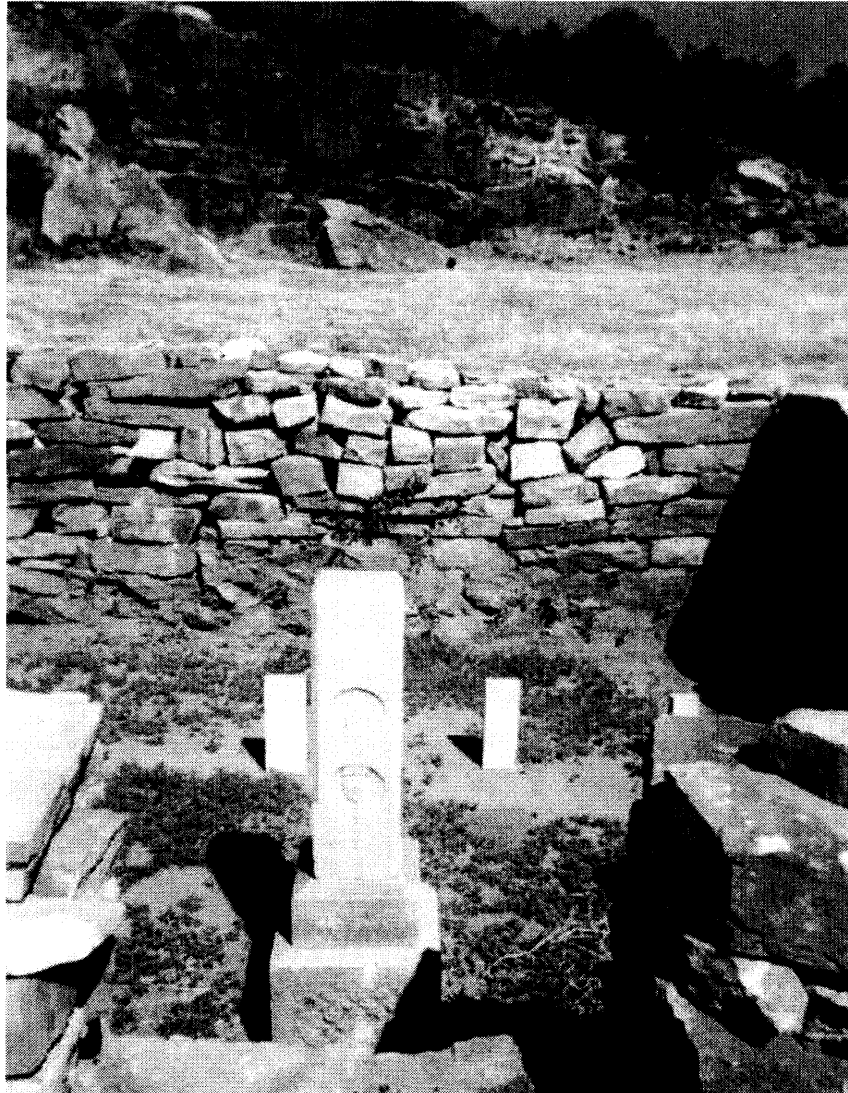
Figure 8: Marshall family cemetery with Dakota sandstone cliffs in background
(Nancy Hanks, 2000).

The Marshall family cemetery belonged to Robert J. and Mary E. Tipton Marshall, a daughter of Enoch and Martha Jane Tipton. The section of Enoch Tipton's land they inherited from an 1892 probate decision was at the northern end of the Tipton/Black Willow Ranch Historic District (Figure 19). The Marshall family cemetery lies three-quarters of a mile north of the houses and barn, and sits at the base of the Dakota sandstone cliffs that provide the northern boundary of the Tipton/Black Willow Ranch Historic District. The cemetery contains five monuments and is dug into the ground with two steps leading down about 12" (Photograph 8). It is 12' x 12' with chunks of sandstone used as a wall and an opening that steps down in front.

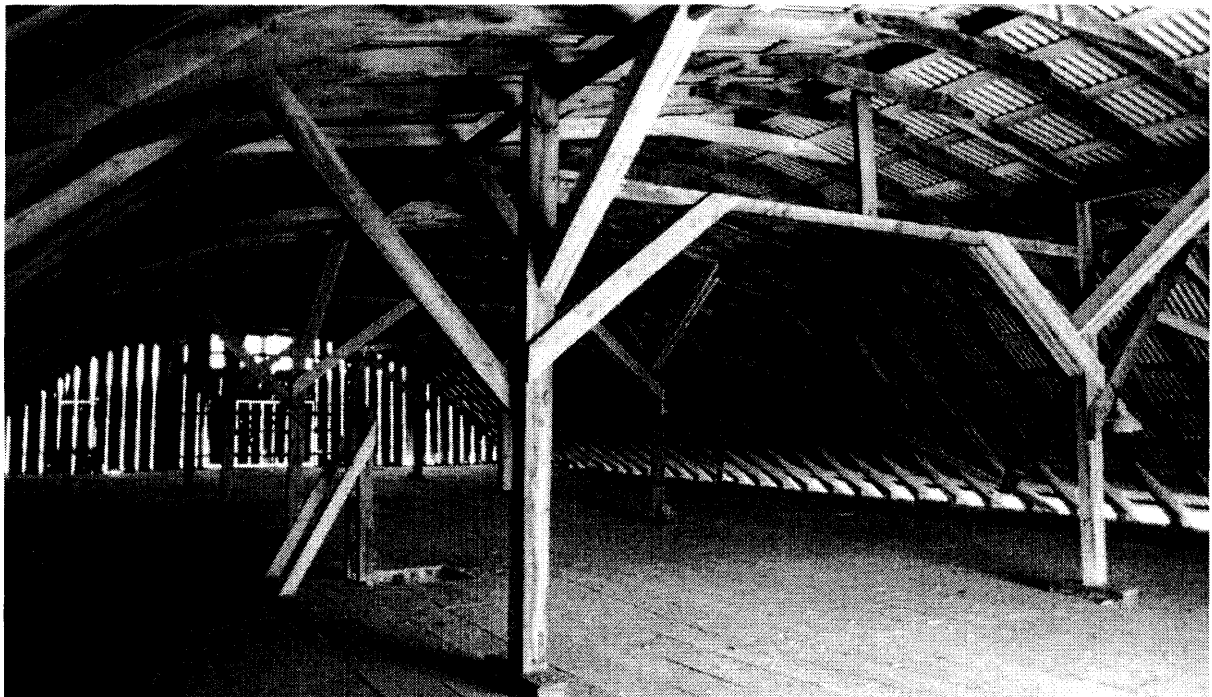
Figure 18: Roof framing in Tipton adobe barn (Dale Zinn, 2000).

Early in the twentieth century, a fire destroyed the roof structure of the Tipton adobe barn, which is presumed to have been a simple pitched roof with traditional gable ends. The fire burned all available wood in the building, including the embedded "gringo blocks," heavy timber blocks built into the adobe walls for the purpose of anchoring doors and windows. A layer of ash almost six inches thick can be found at a level 18" below the level of the tack room concrete floors.

After the fire, rebuilding the barn consisted primarily of putting on a new roof, and in the shape of its roof the Tipton adobe barn bears some similarity to barns built by Tipton's neighbor, German-born William Krönig. Of the four large hay barns Krönig built in the Watrous area, three remain, and they share roof styles and materials with the Tipton adobe barn. They all have gambrel roofs with the same size of wood louver vents in the upper gable ends (Photograph 10), identical types of framing members and diagonal V-shaped 1" x 10" wood braces (Figure 18), and the roofing materials for all four barns is light gauge, corrugated metal, although the flashing details at the break between roof planes are less crisply executed in the Tipton barn. It remains possible, due to design and materials similarities and construction era, that Krönig or at least his "barnsmith" was responsible for directing the replacement of the roof of the Tipton adobe barn.

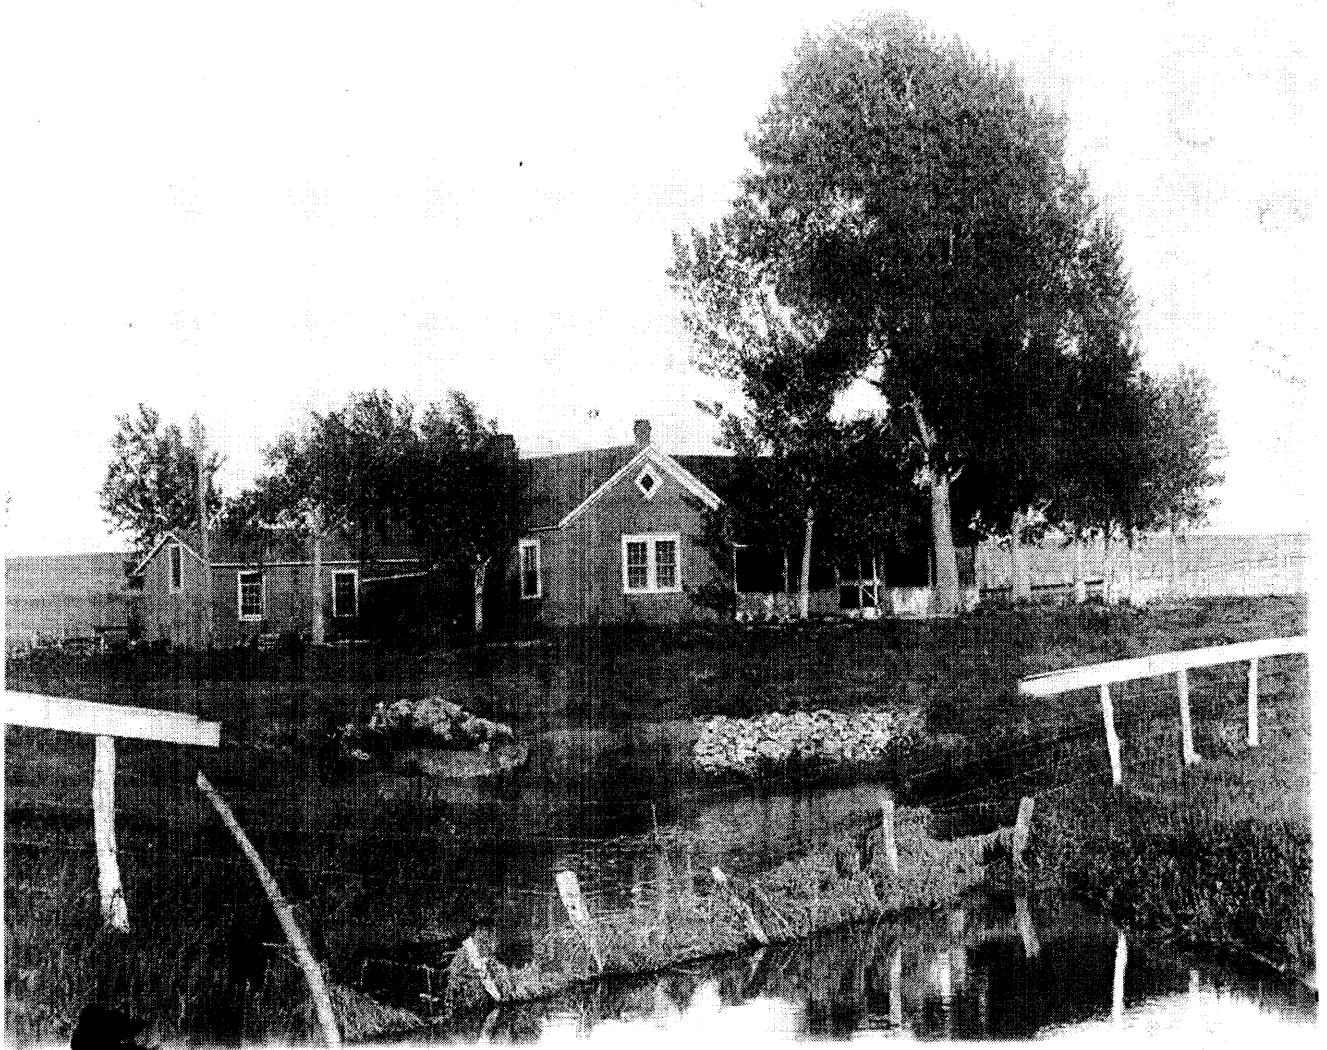
Figure 21: "El Cedrito, Mora, Co., N. M., July 1913," exterior of Enoch Tipton house, looking east (Newman, 1913).

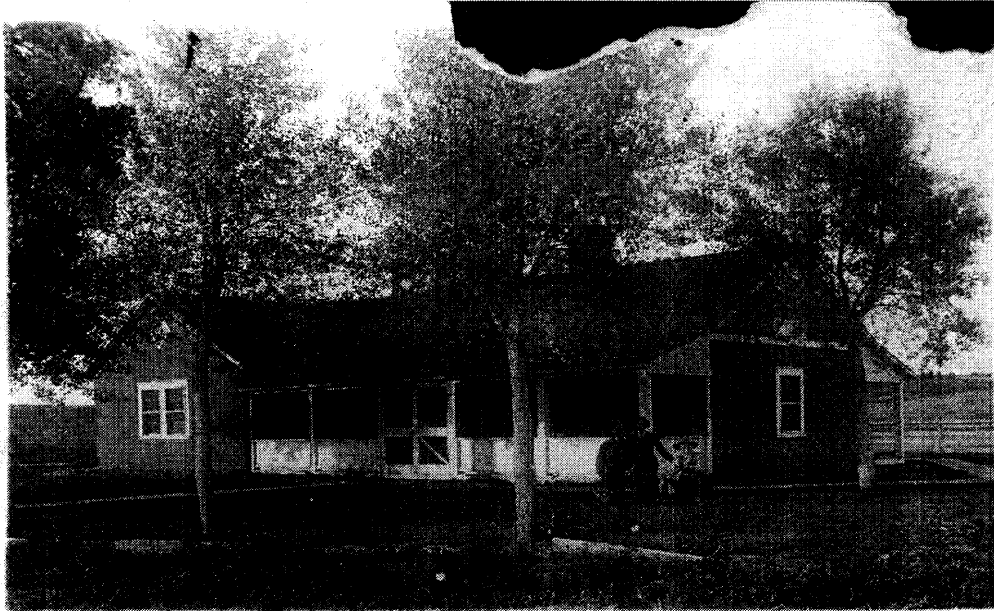
Figure 22: "Mr. and Mrs. Murray Carlton, Jr. & Hopi Carlton, El Cedrito, Mora Co., N. M., July 1913," exterior of Enoch Tipton House, looking northeast (Newman, 1913).

The 1862 Enoch Tipton house (Photograph 6) is located south of the Mora River and west of Tipton Creek, facing east, into the center of the Tipton/Black Willow Historic District. It is a one-story, gable-front-and-wing farmhouse of adobe and log construction. Obtrusive 1960s and 1970s additions have been recently removed, leaving a building that looks much the same as it is shown in a series of 1913 photographs (see Figures 22-26 in Section 8).

The Tiptons retained control of the property on which the Enoch Tipton house is located from 1862 until 1945. Descriptions of property improvements were not documented in the deeds and abstracts. Figures 22 through 26 (in Section 8) provide the best knowledge of what the house may have looked like during its period of significance, as does the physical evidence found during the restoration.

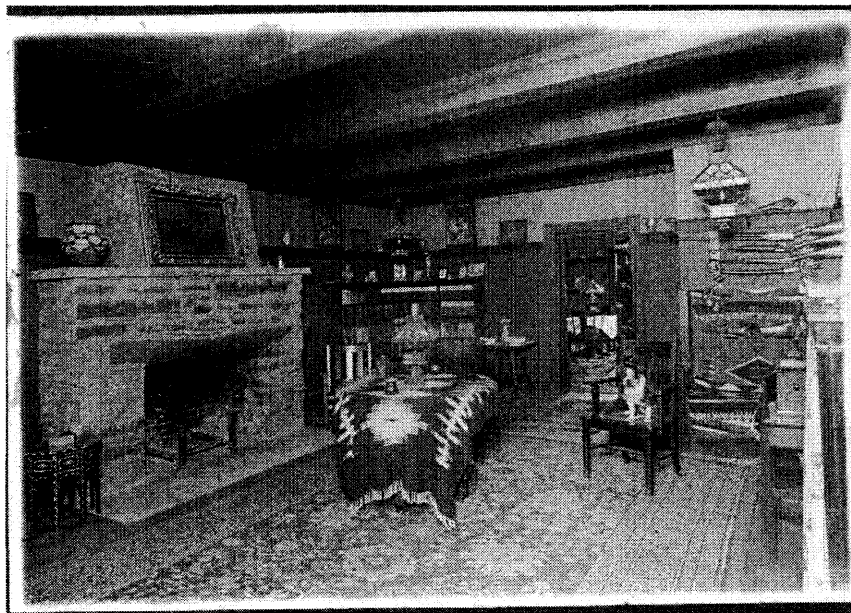
Figure 25: "Interior of house, Rancho del Cedrito, N. M., July 1913," Enoch Tipton House, fireplace on north wall of center section of house (Newman, 1913).
