National Register of Historic Places Registration Form

Historic name: Bradford Center Meetinghouse
Other names/site number: N/A
Name of related multiple property listing:
N/A
(Enter "N/A" if property is not part of a multiple property listing)

Street & number: 18 Rowe Mountain Road
City or town: Bradford State: NH County: Merrimack
Not For Publication: Vicinity:

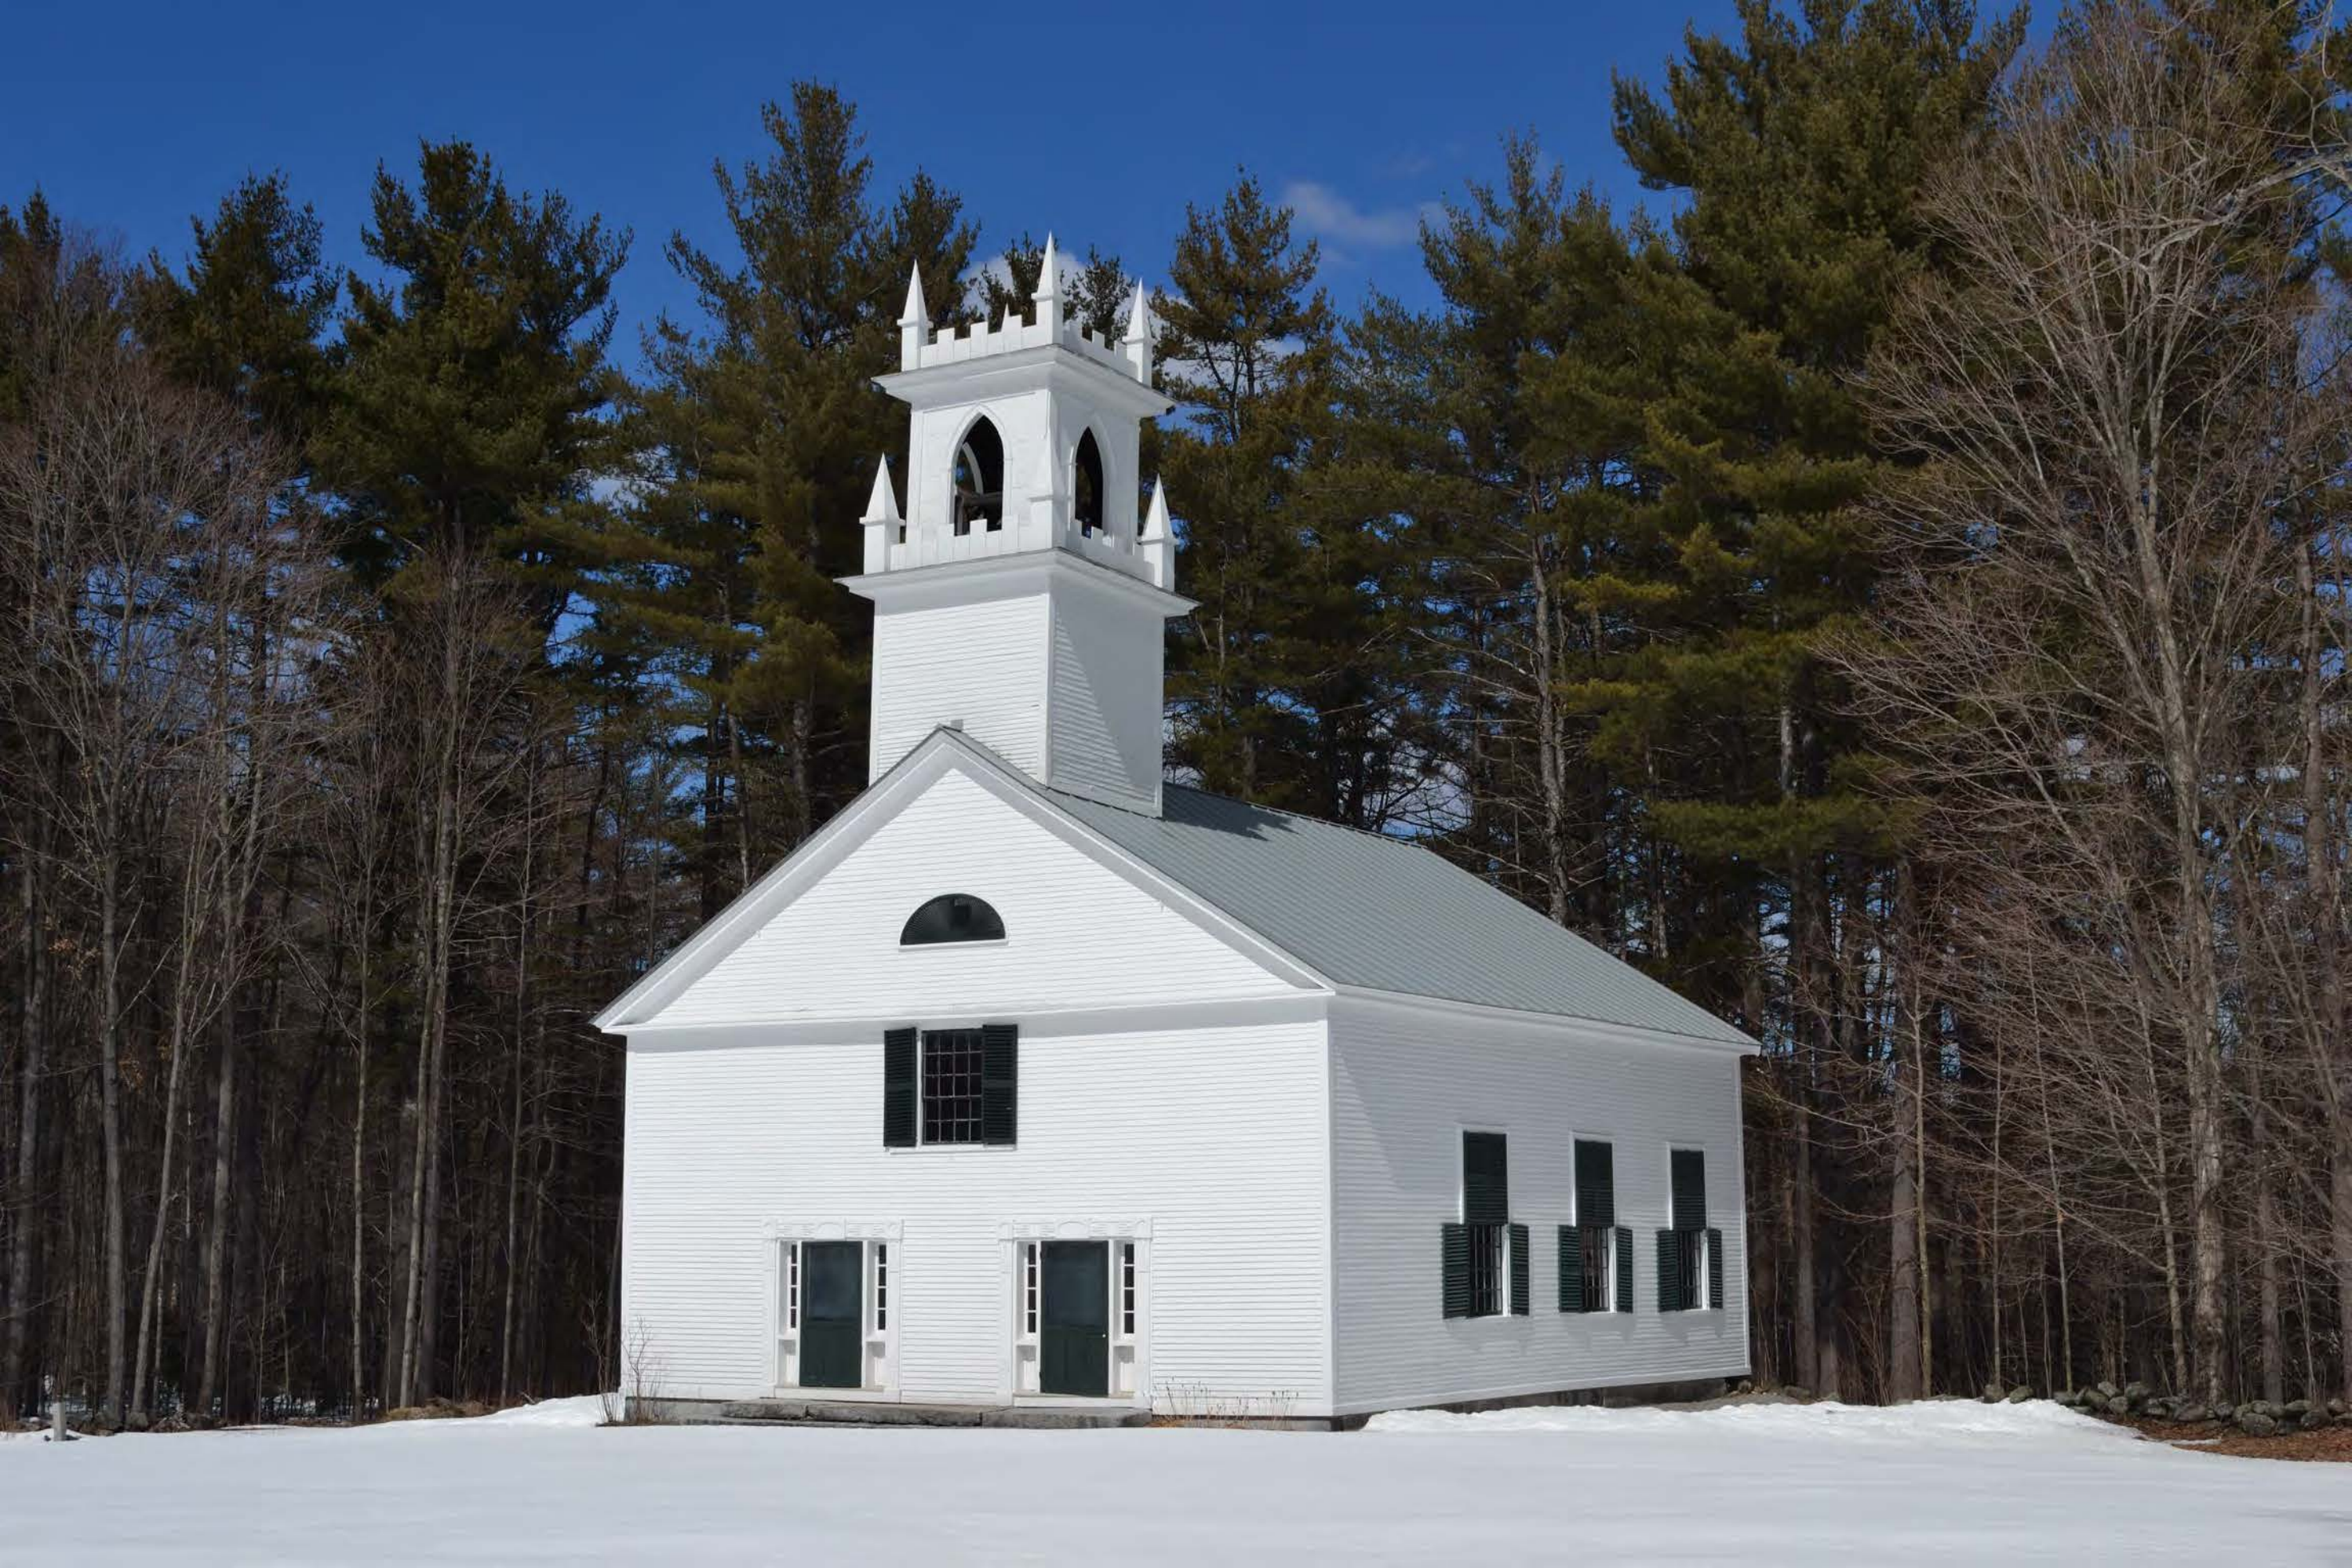
Photo 0001 Southwest and southeast facades of the Bradford Center Meeting House with camera facing northwest.

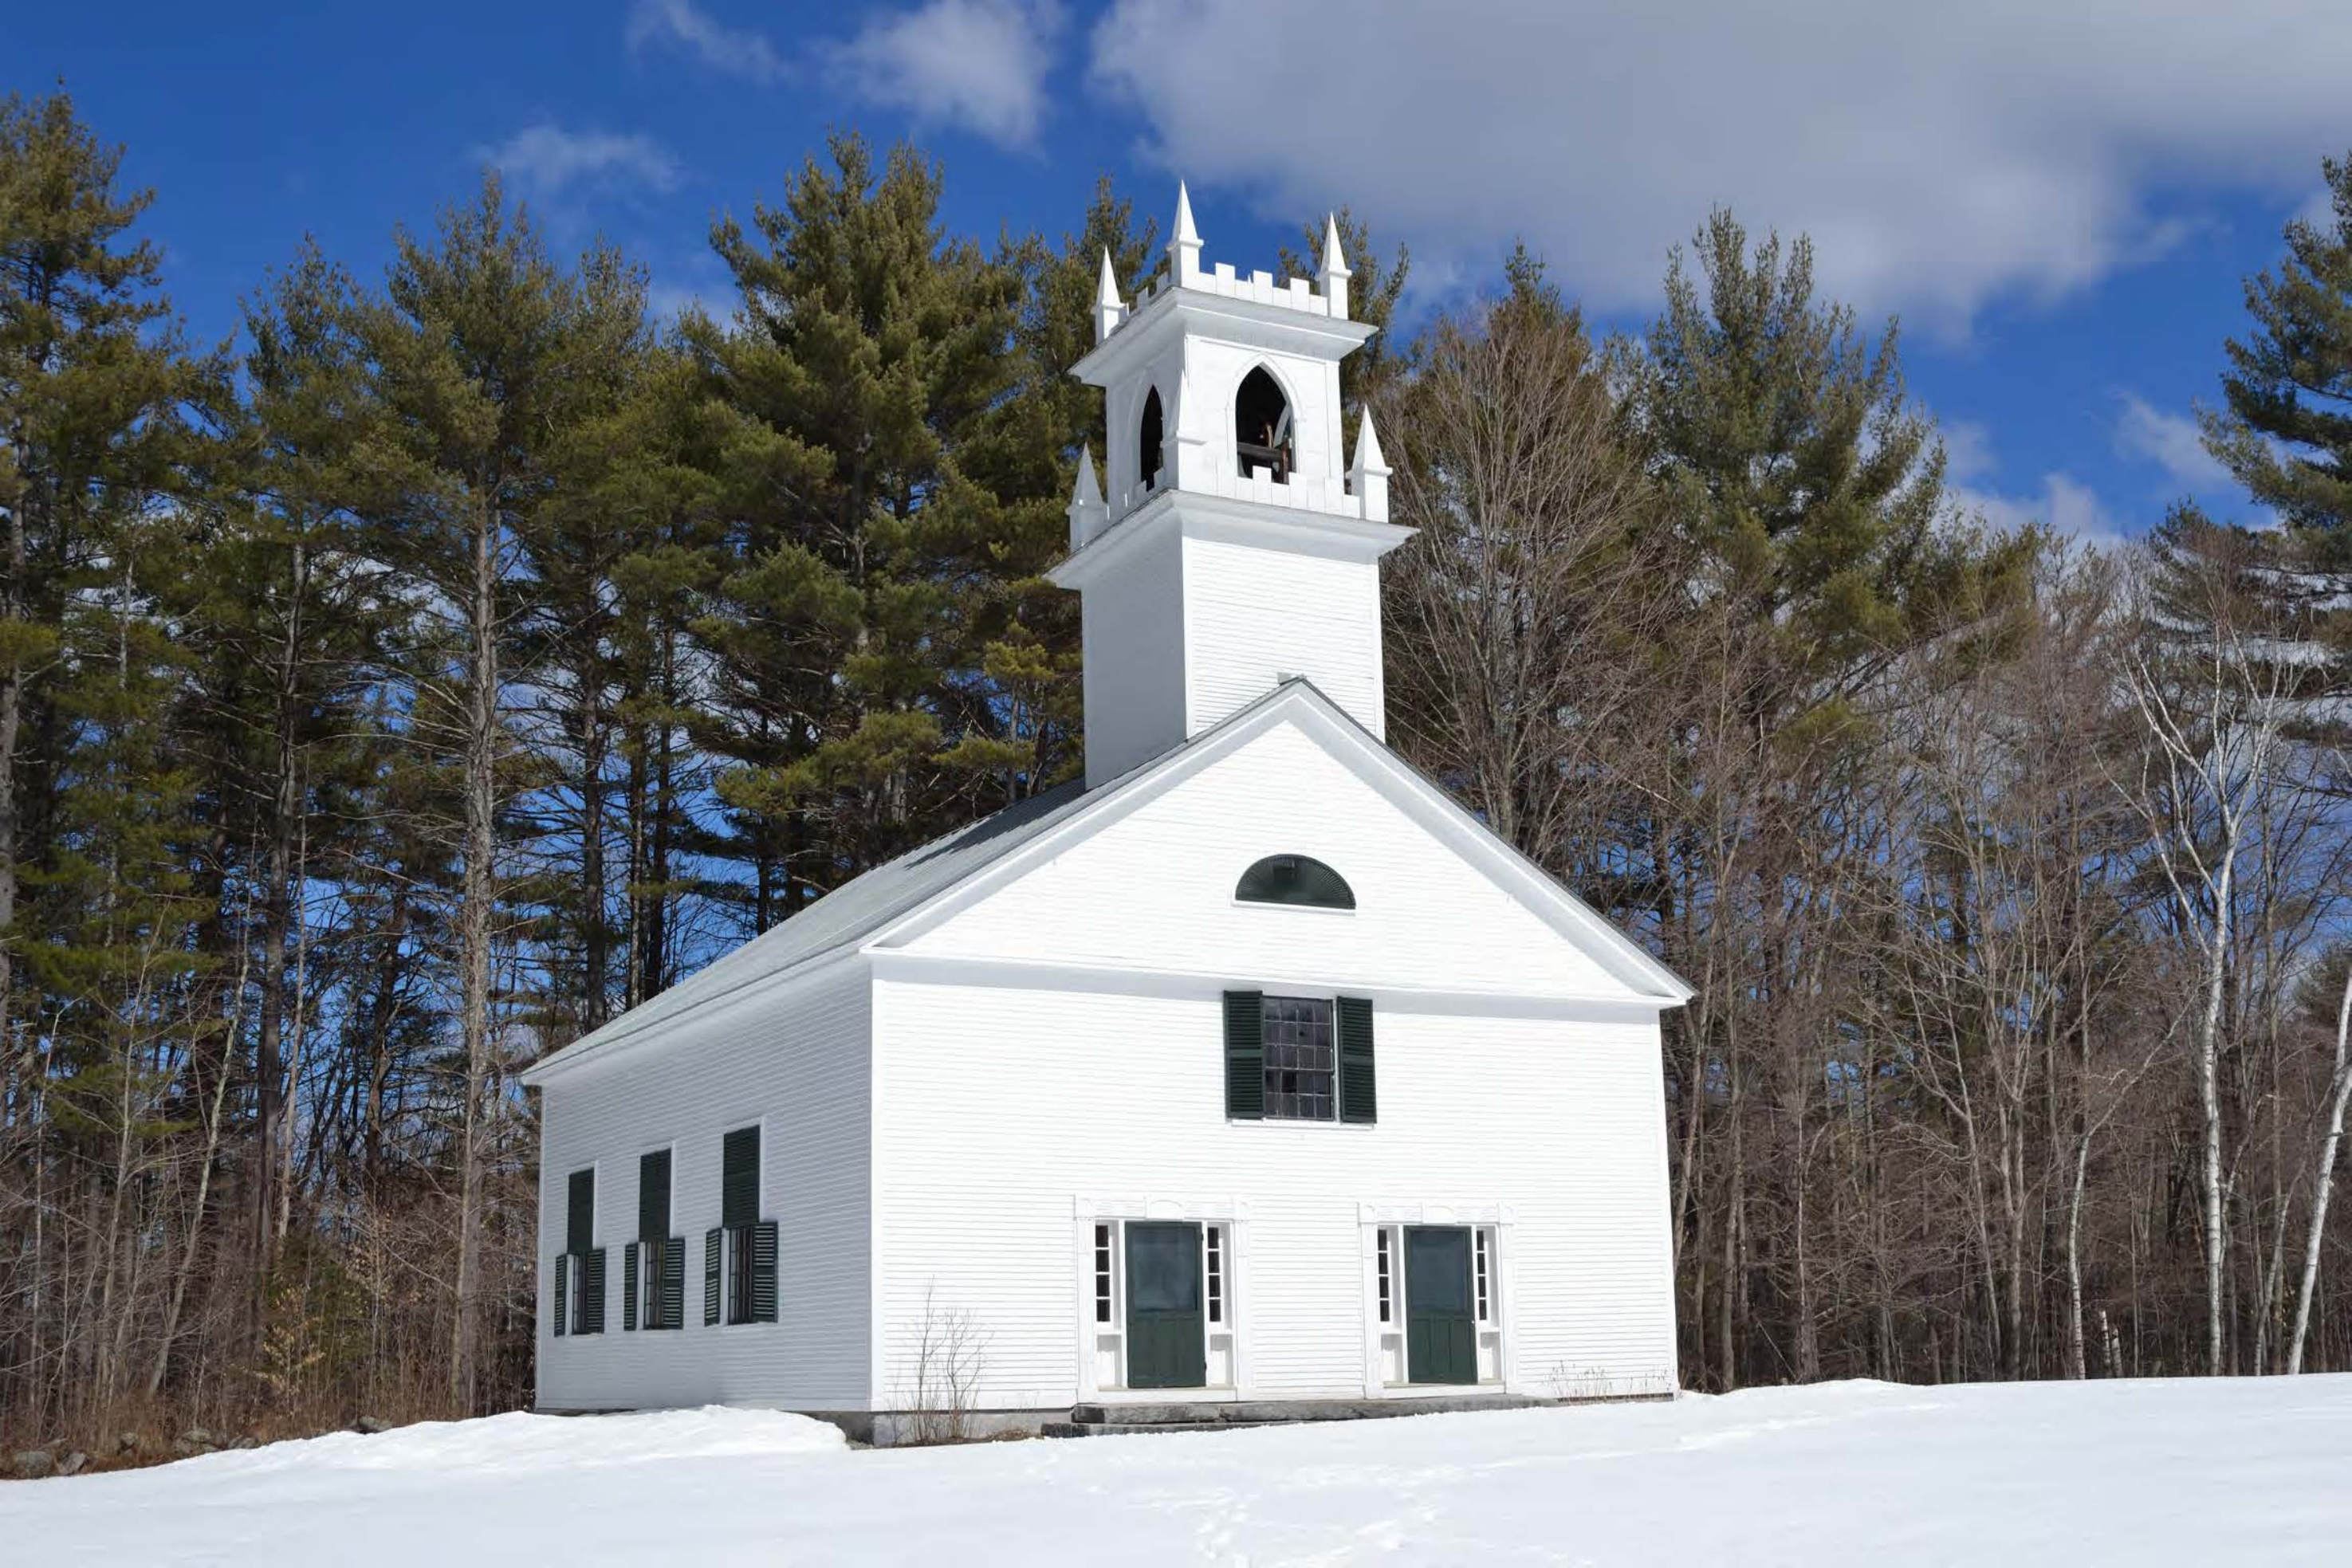
Photo 0002 Southeast and northwest facades of the Bradford Center Meeting House with camera facing northeast.

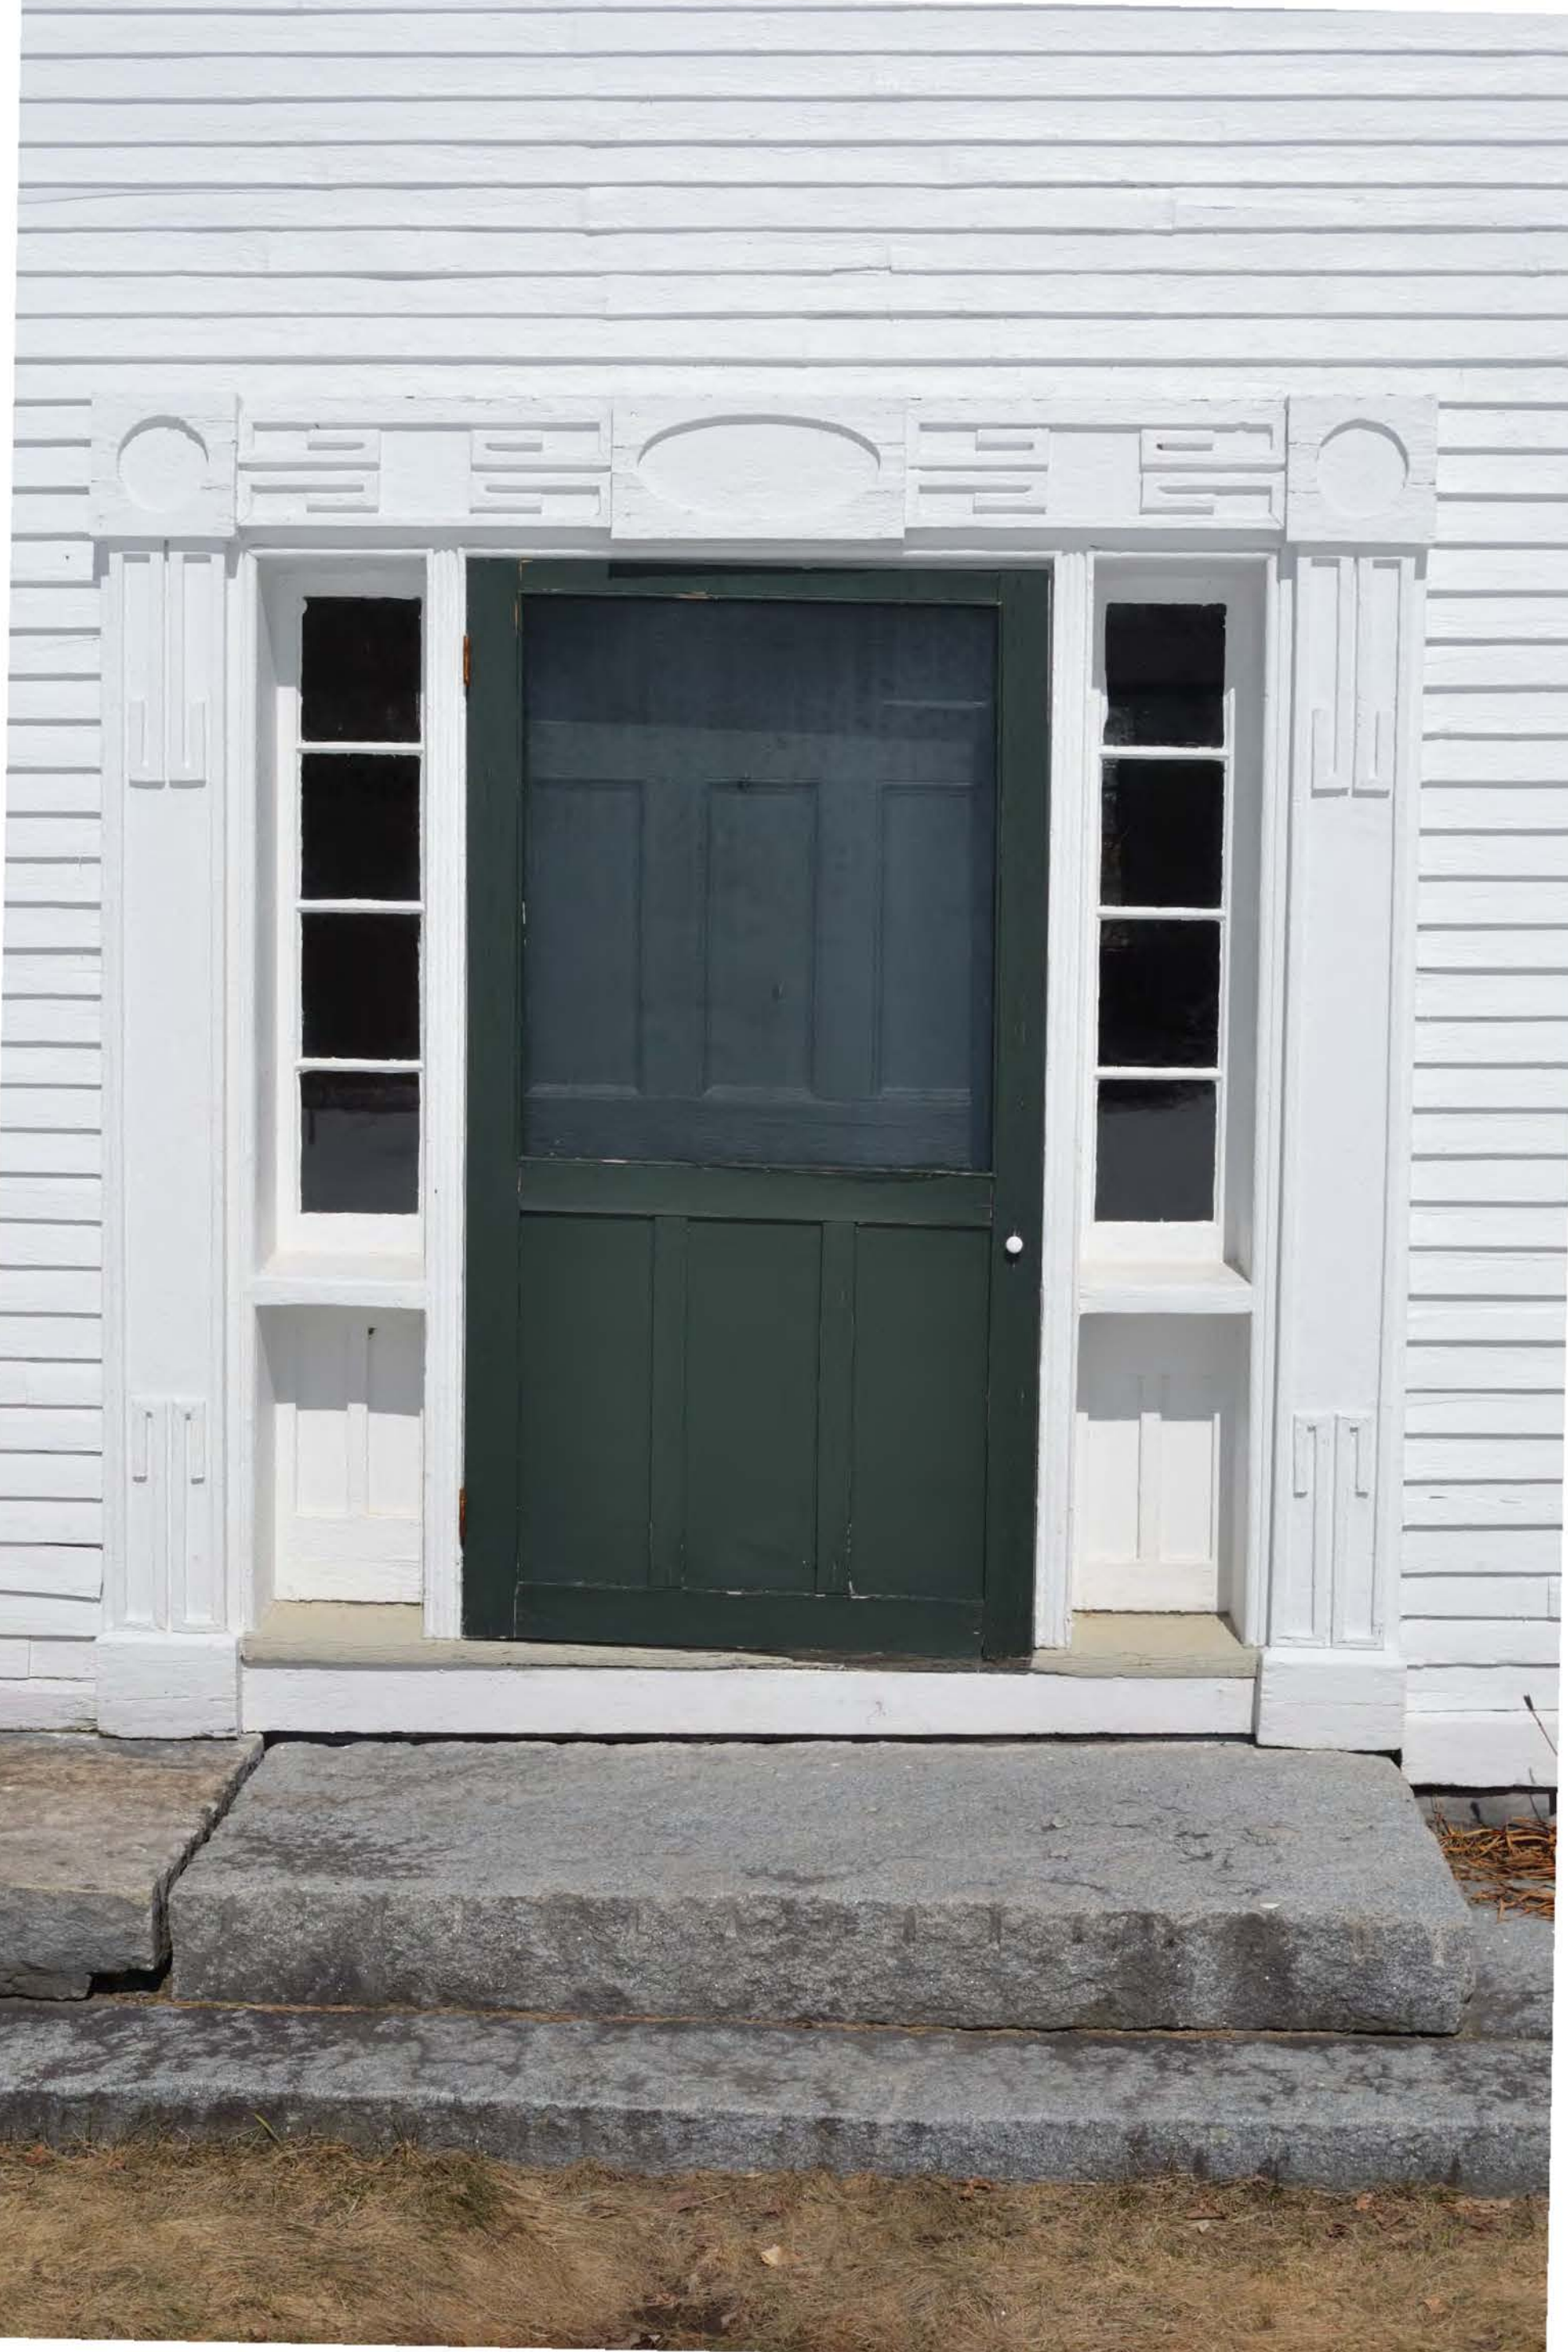
Photo 0003 Detail of easterly door on southeast façade of the Bradford Center Meetinghouse with camera facing northeast.

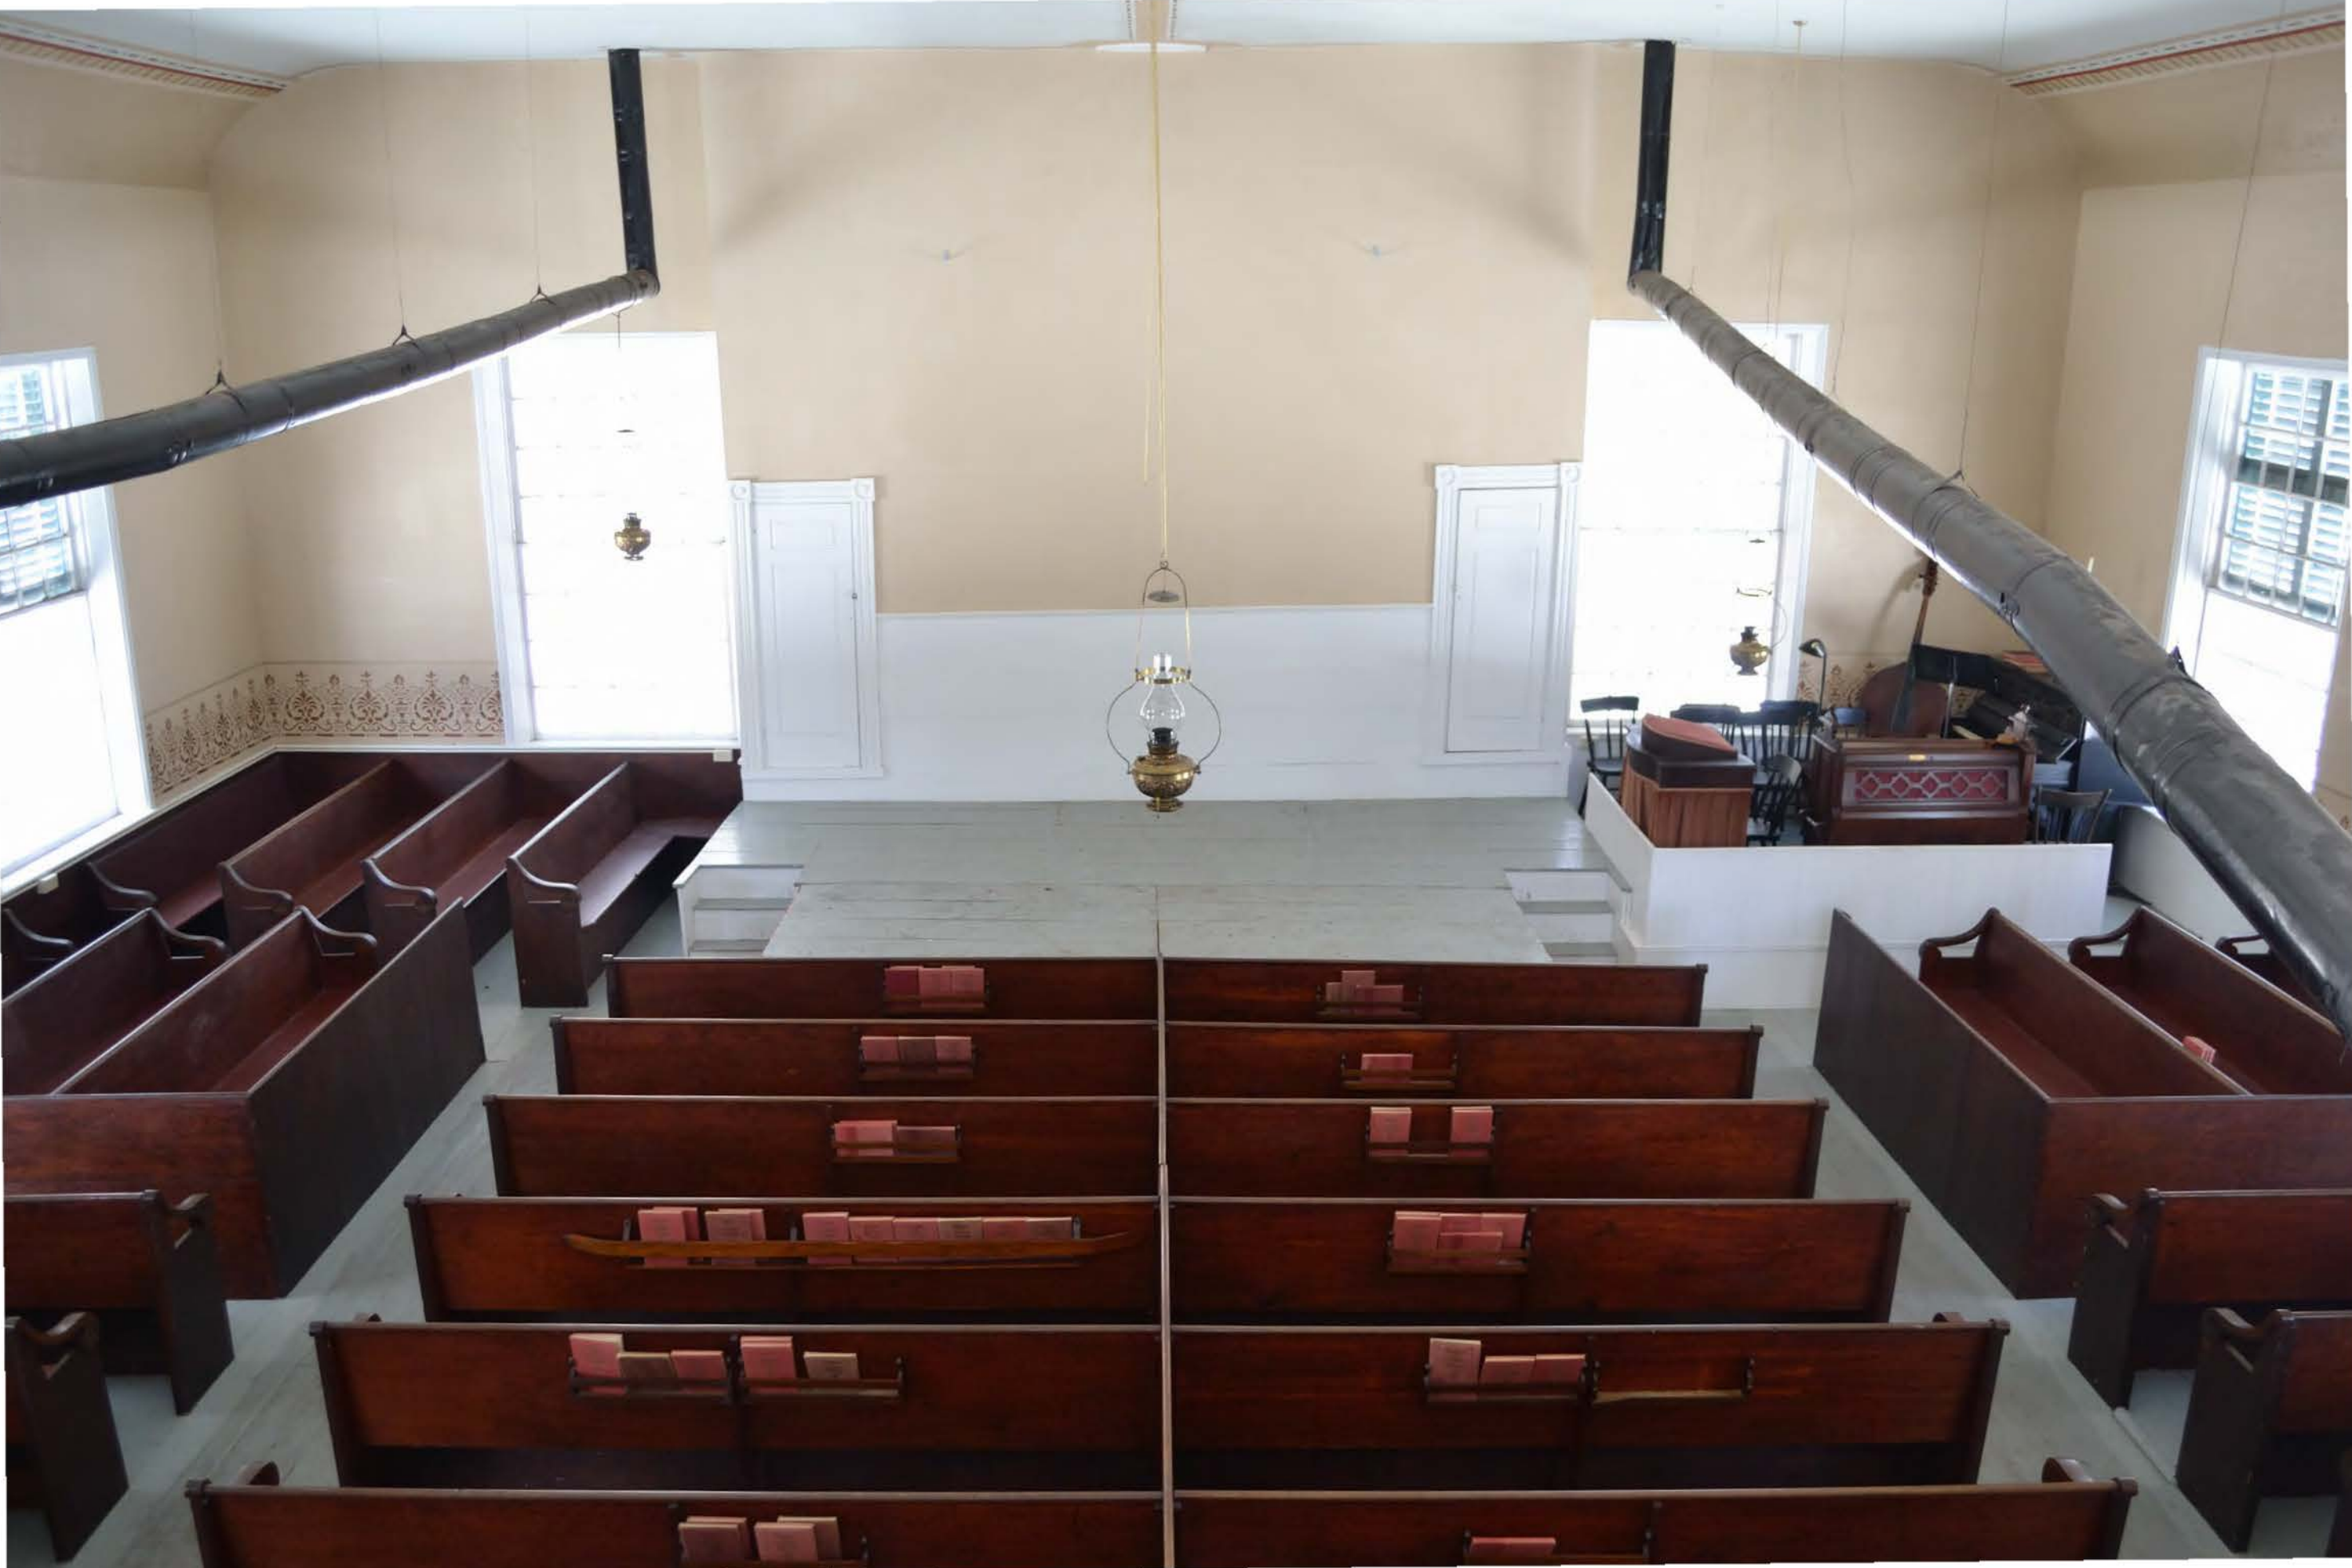
Photo 0004 Interior of the Bradford Center Meeting House with camera facing northeast

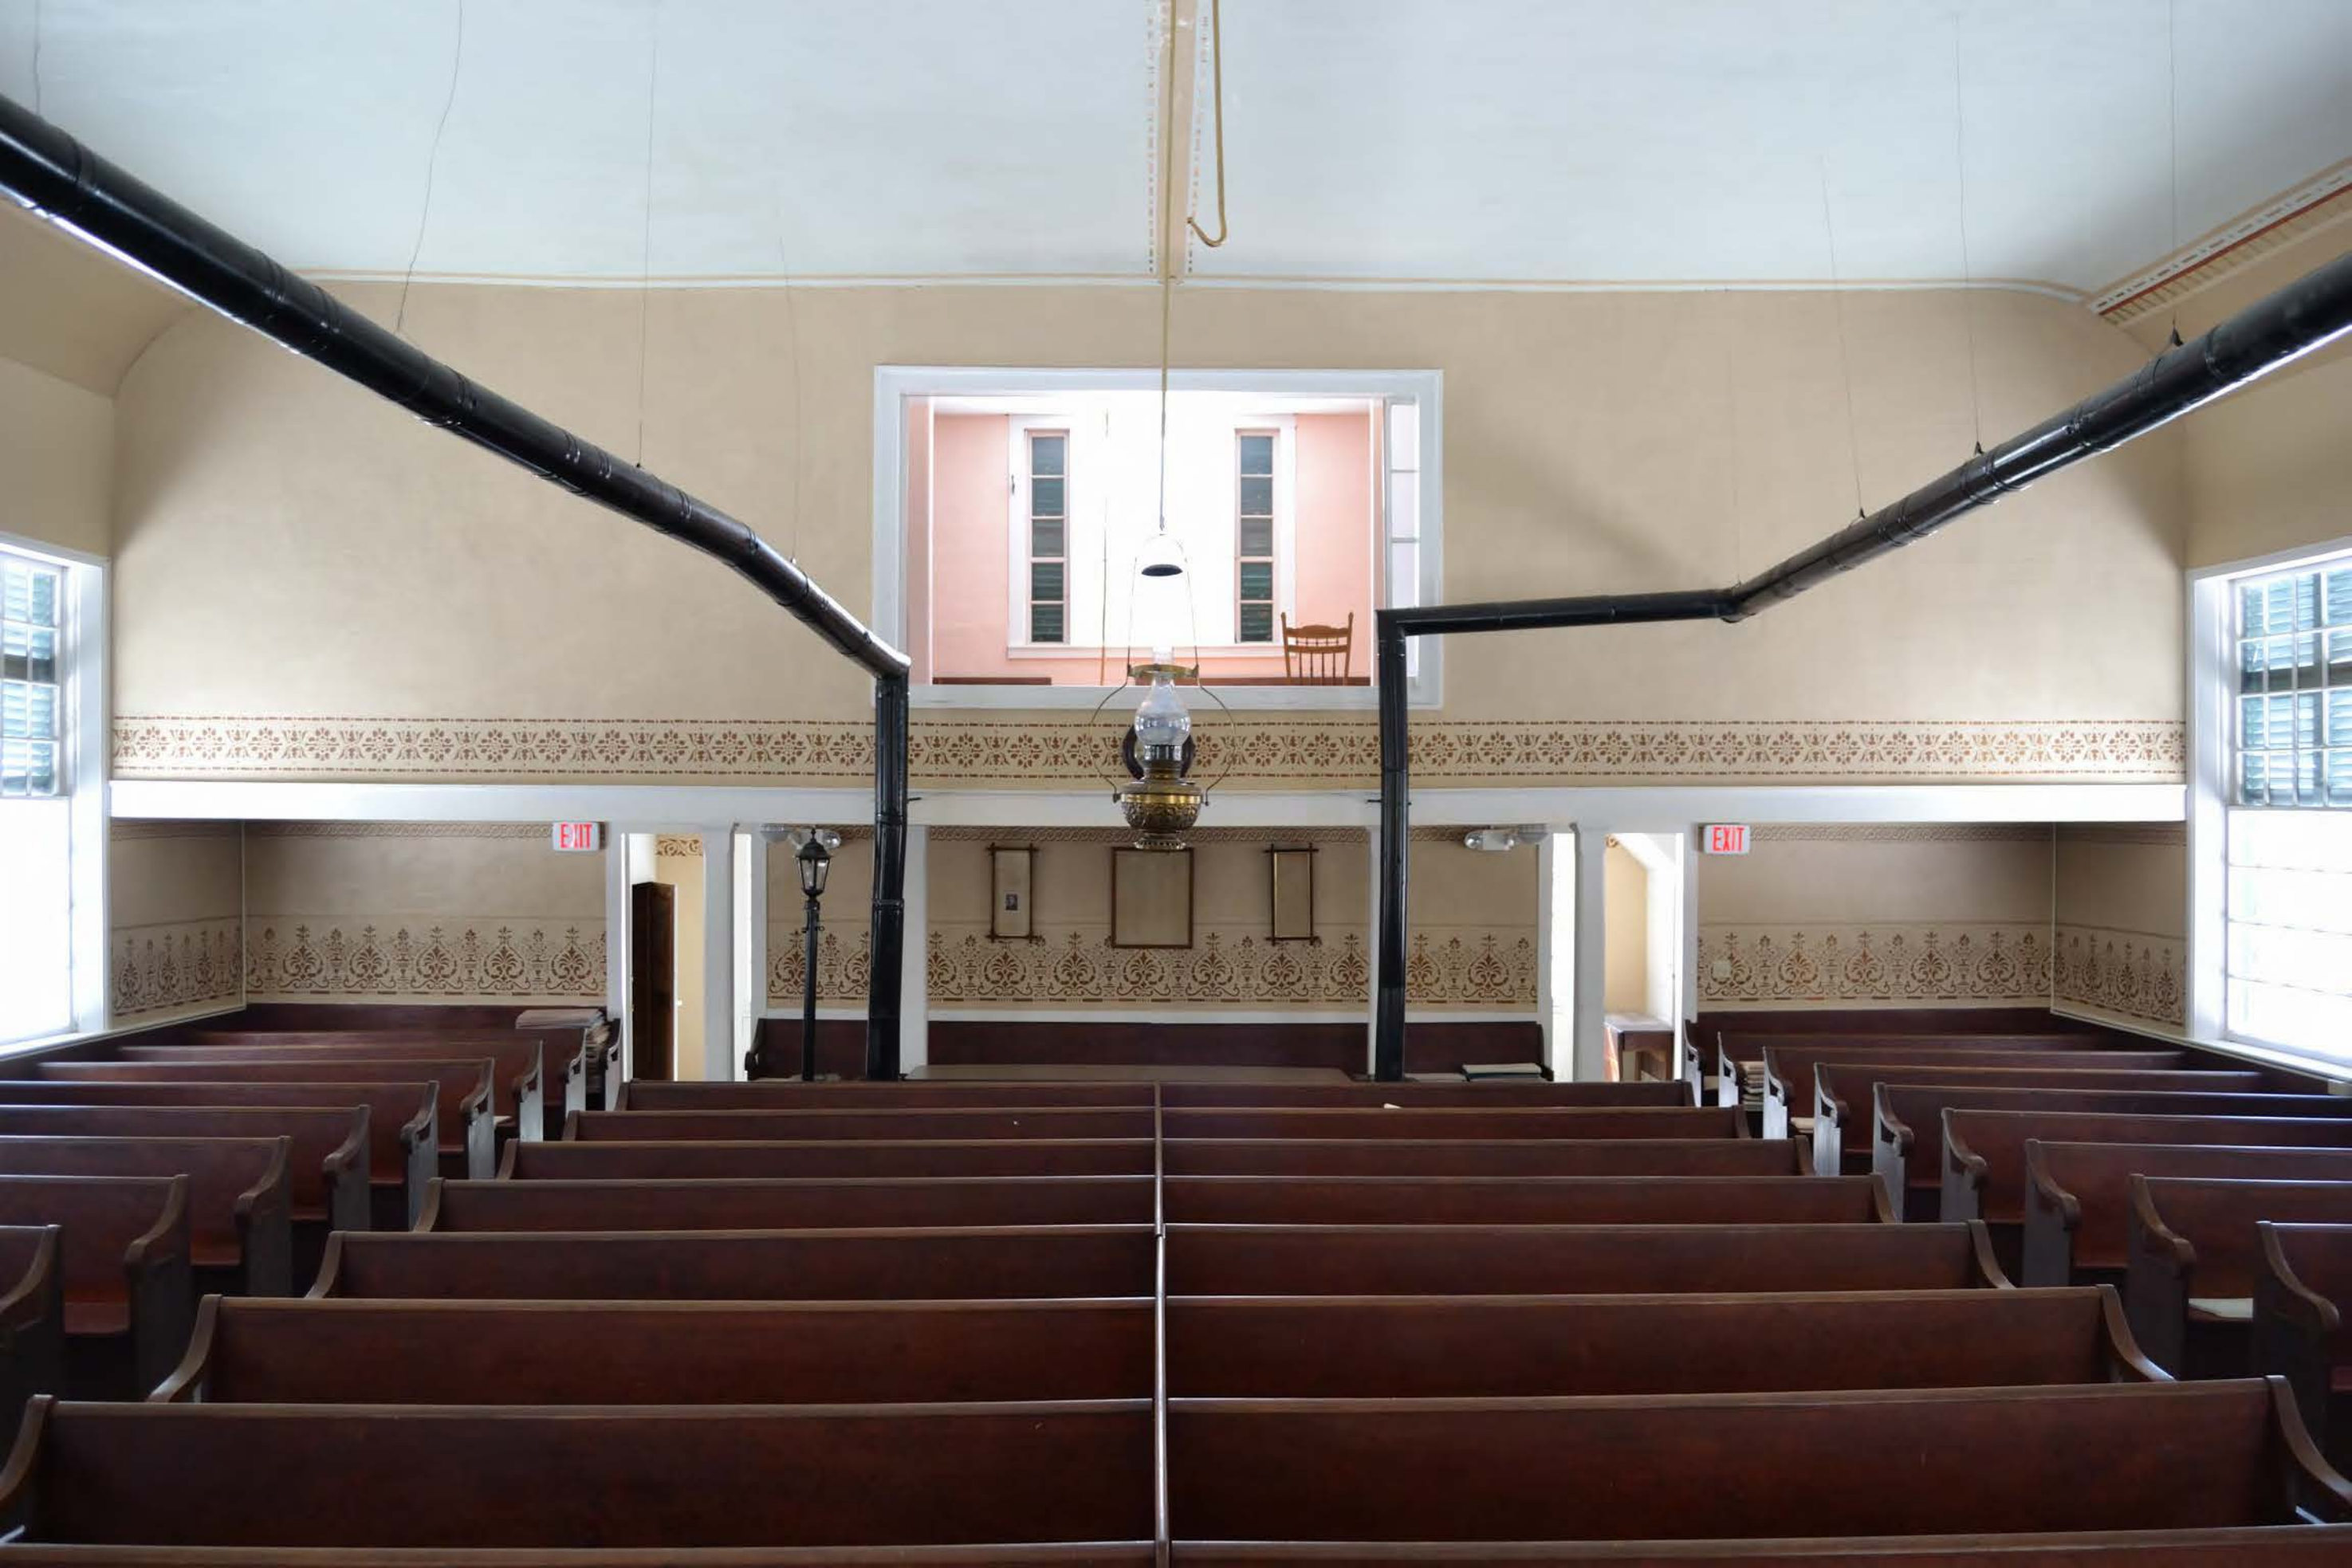
Photo 0005 Interior of the Bradford Center Meeting House with camera facing southwest.

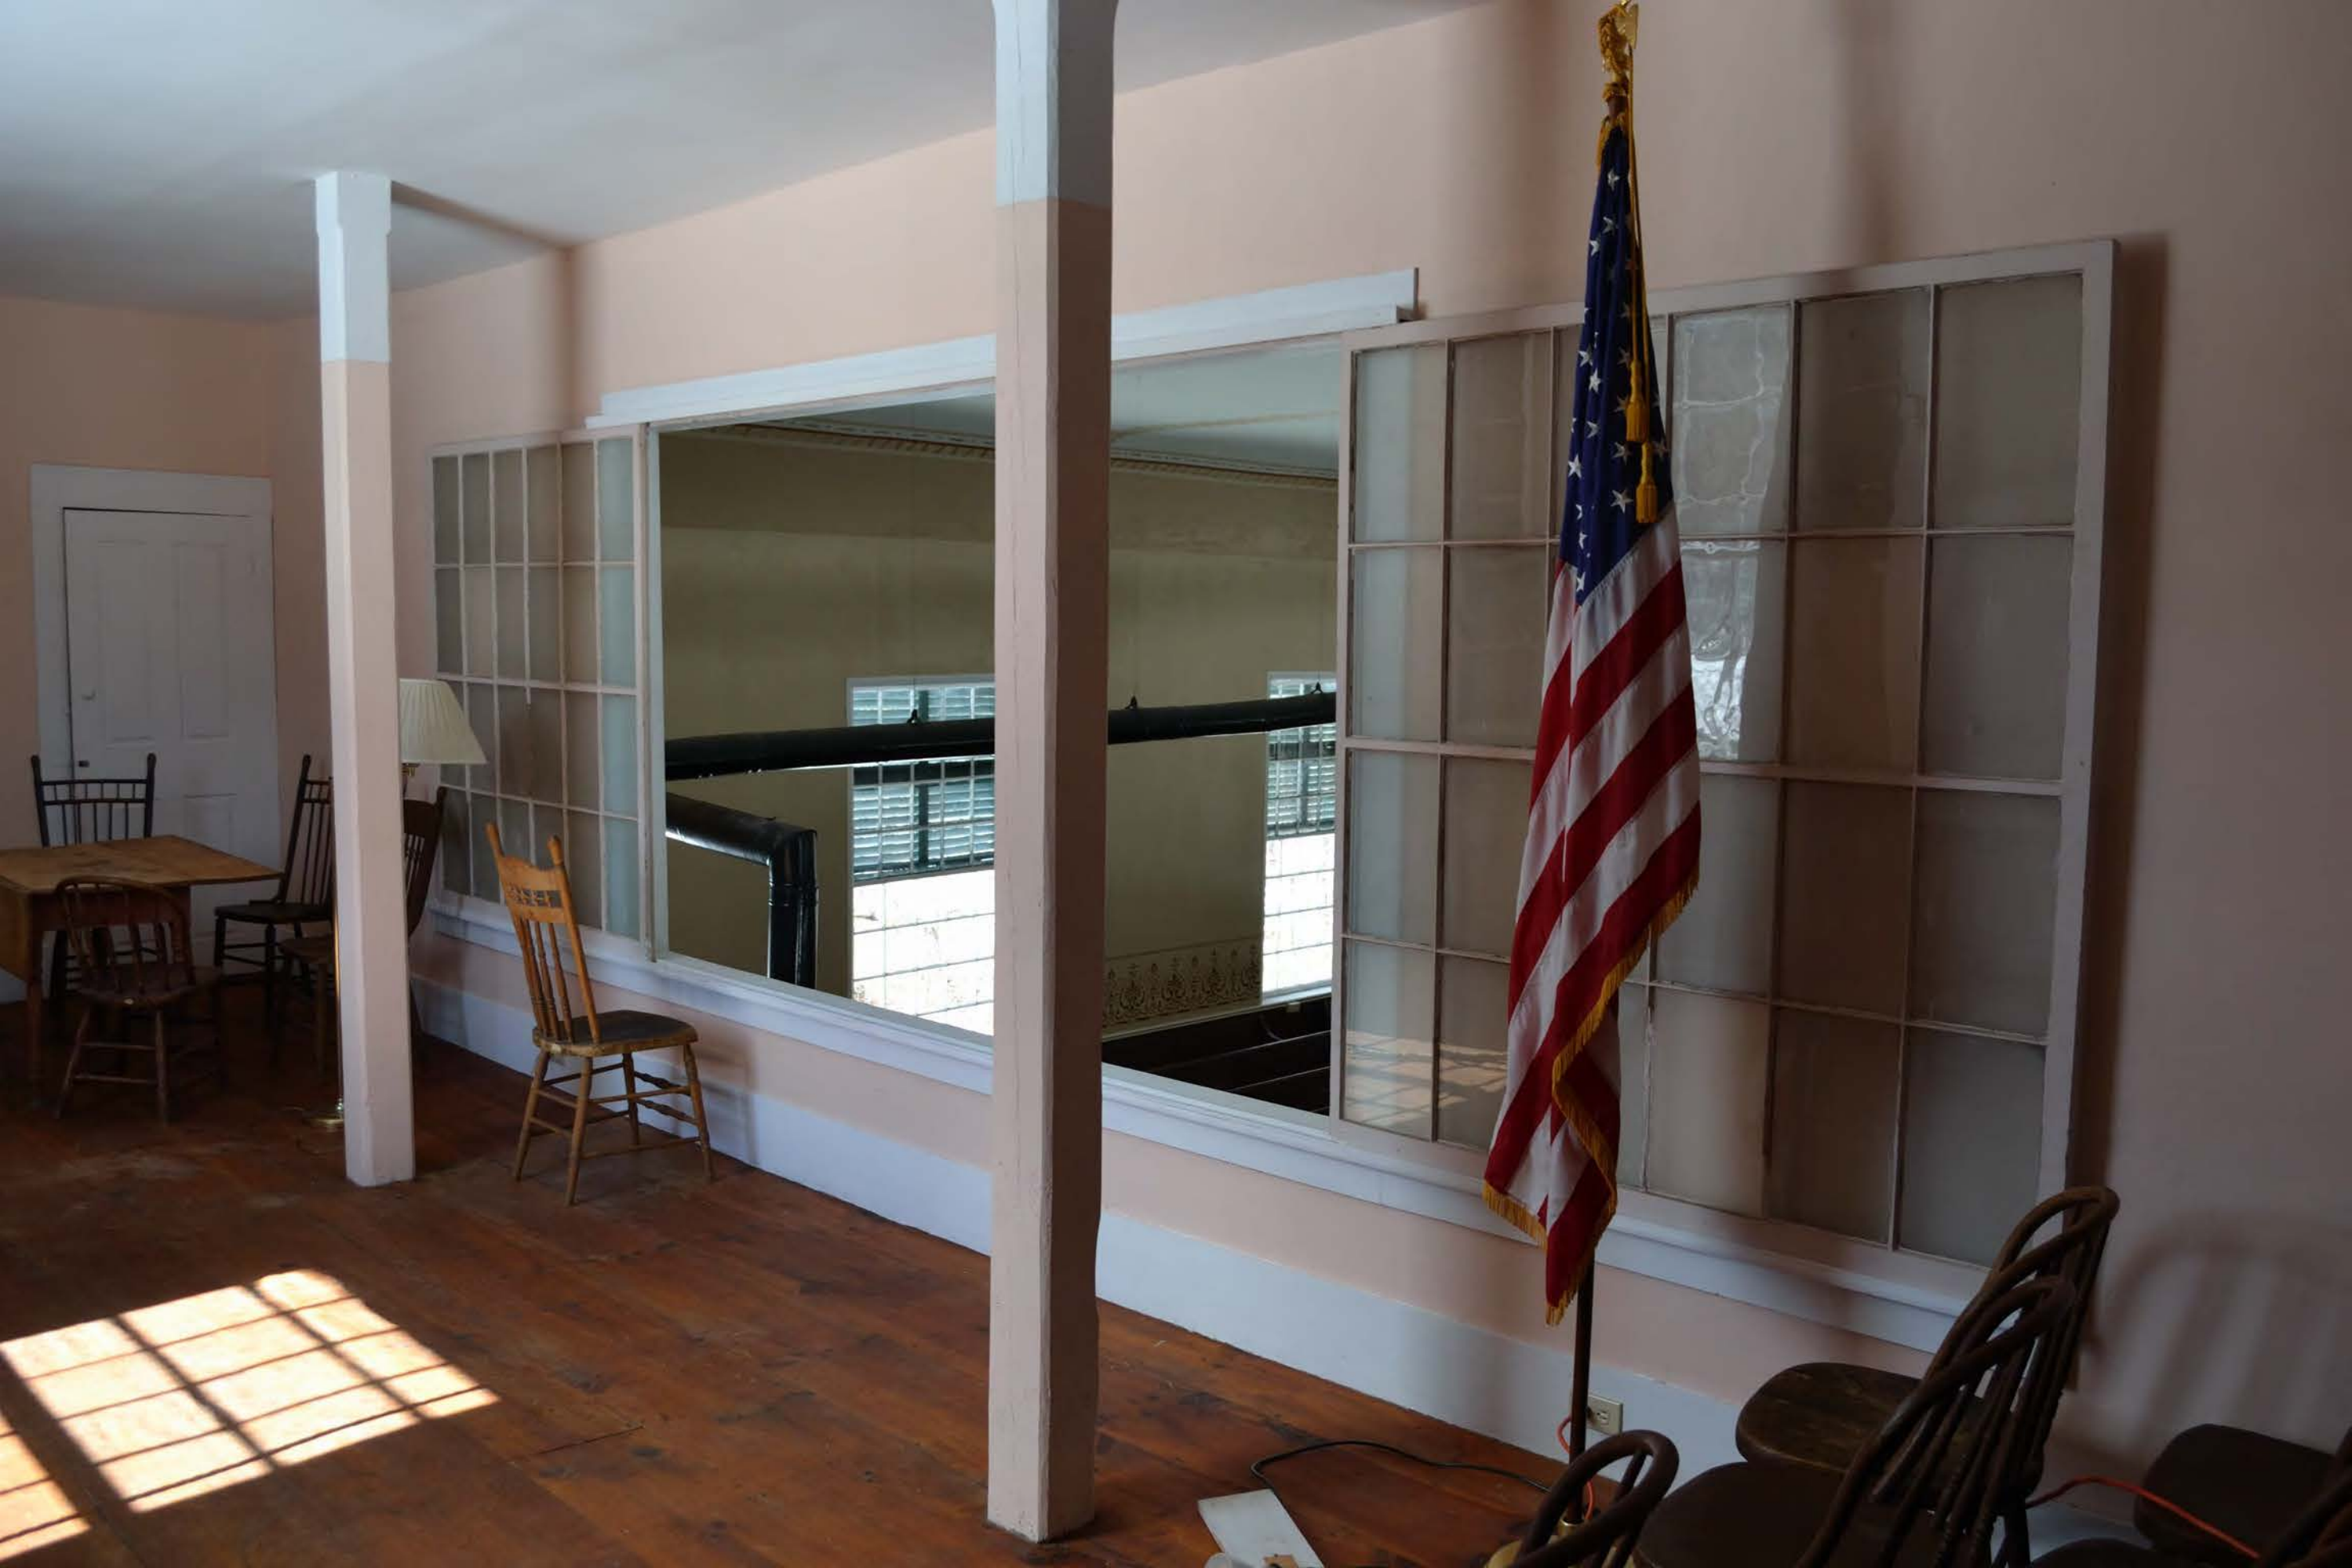
Photo 0006 Interior of the second floor vestry of the Bradford Center Meeting House with camera facing northwest.
