National Register of Historic Places Registration Form

Historic name Kenner Manor Historic District
Other names/site number N/A
Name of related multiple property listing N/A
(Enter "N/A" if property is not part of a multiple property listing)

Street & Number: Clearview Drive (672-910); Crescent Road (700-722); Kenner Avenue (111-201); Woodmont Circle (200-313)
City or town: Nashville State: Tennessee County: Davidson
Not For Publication: N/A Vicinity: N/A Zip: 37205

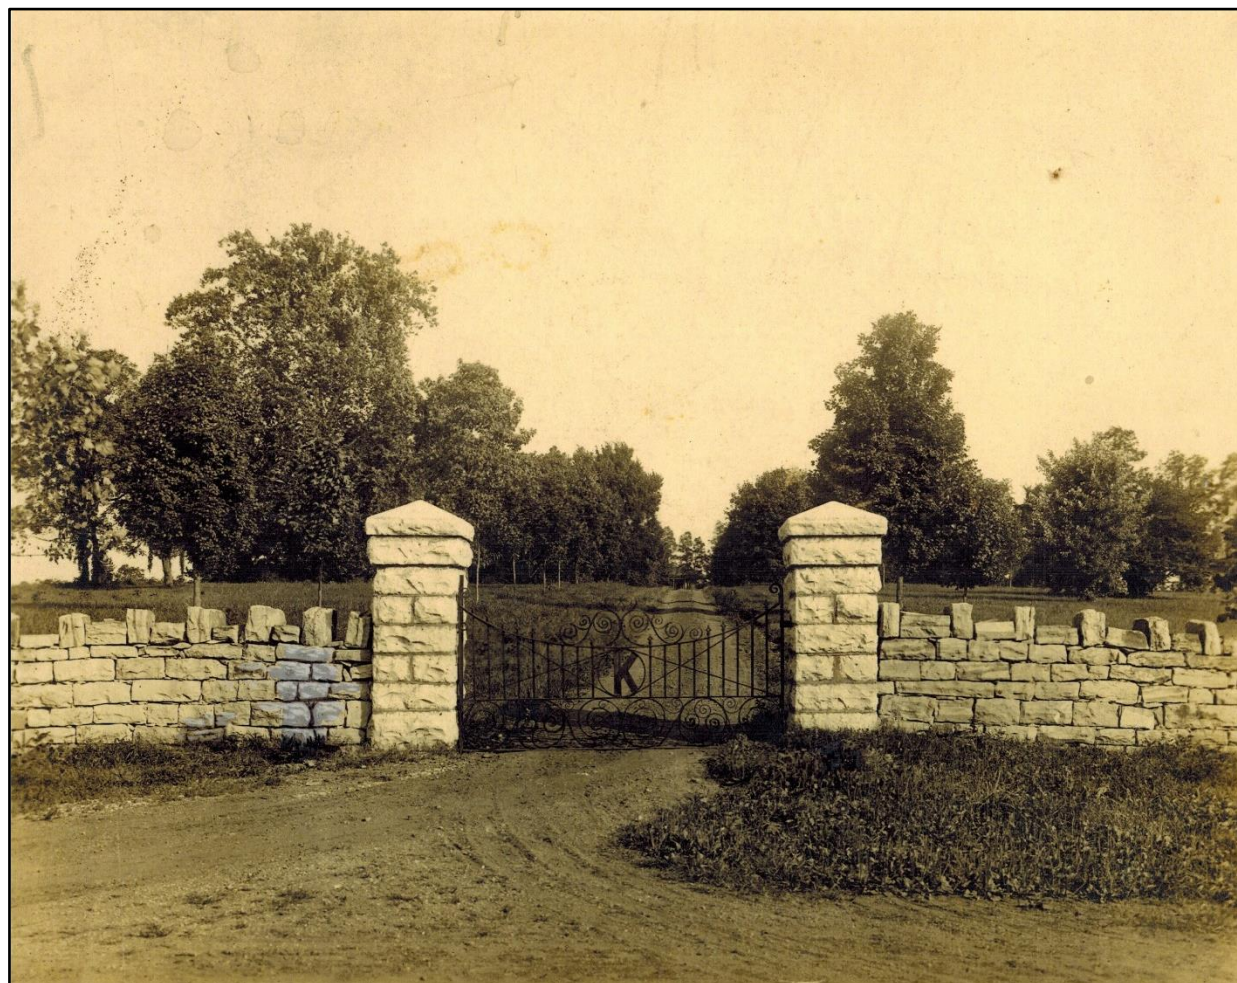
Figure 7: Entrance to Woodlawn from Harding Road, featuring the original stone fence and gate, c.1905. Source: Margaret Davitt, granddaughter of Duncan F. Kenner.
