NATIONAL REGISTER OF HISTORIC PLACES
REGISTRATION FORM

historical name Oxon Cove Park

other names/site number Mount Welby, Godding Croft, Oxon Hill Farm, Oxon Hill Children's Farm/P.G. 76A-13/ Fed. Reservation NACE 404M

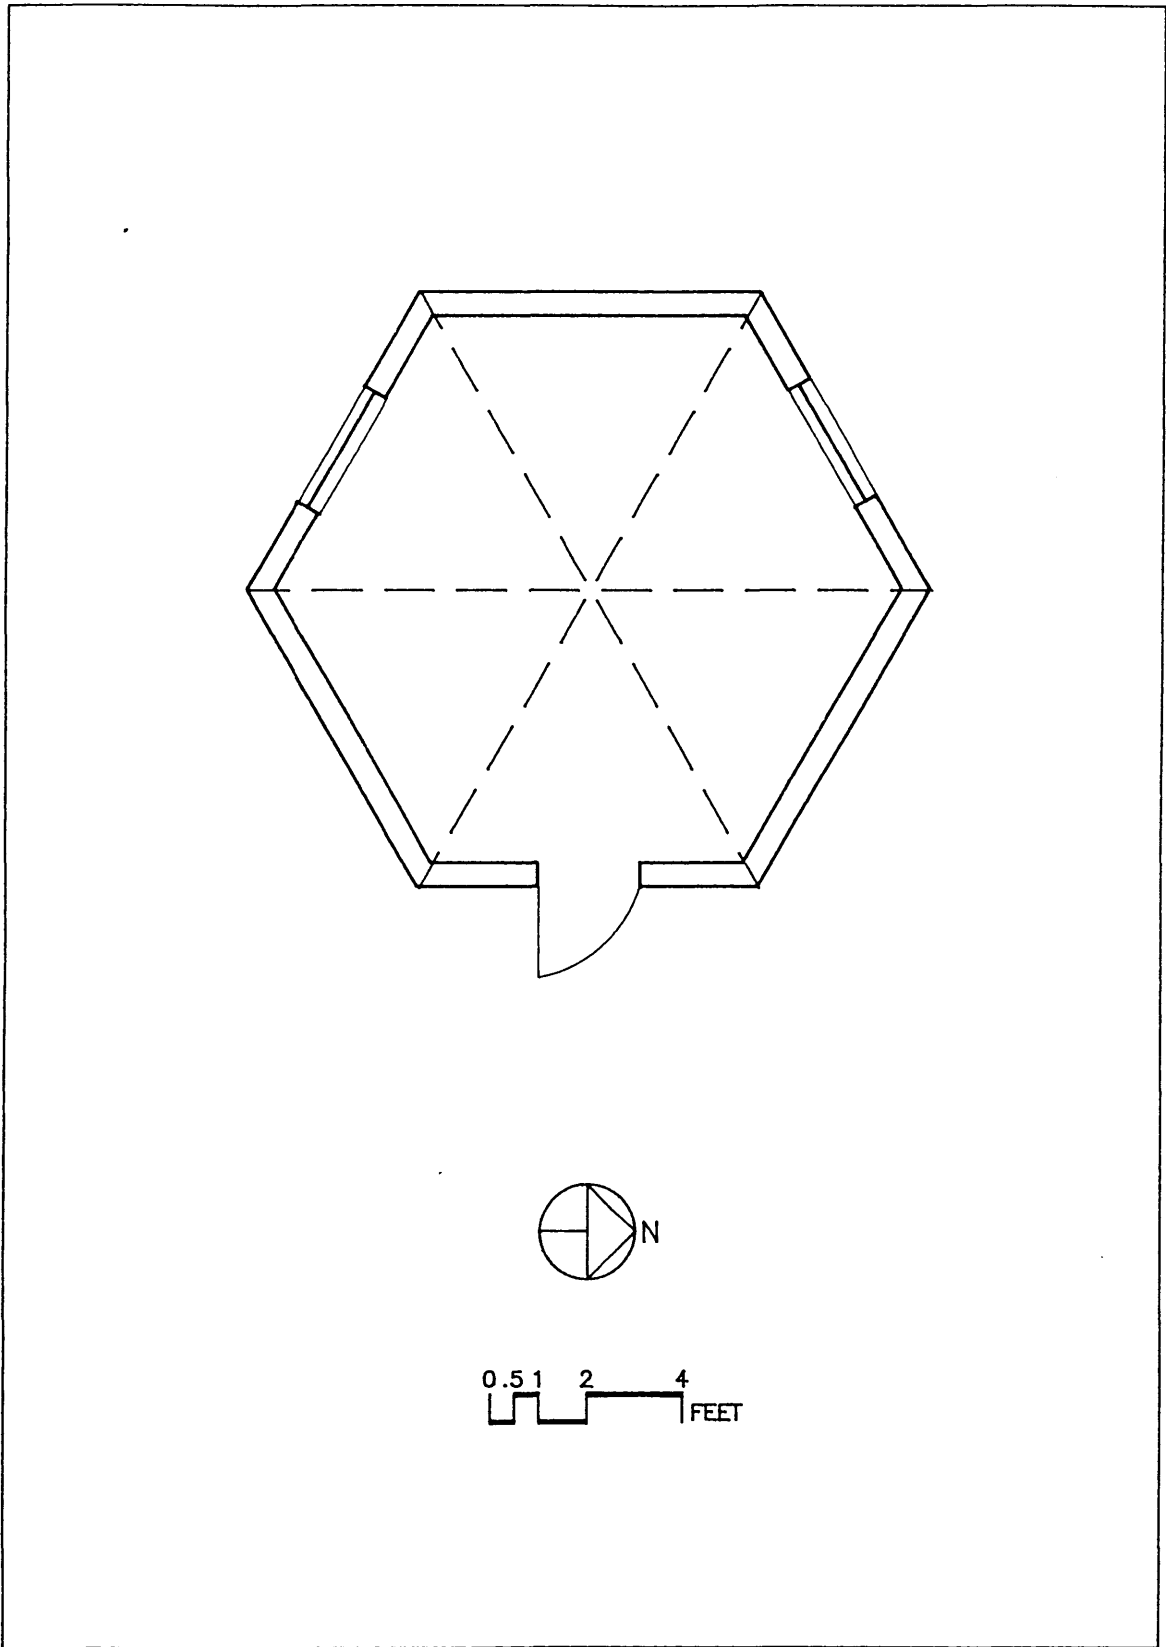
Fig. 14

Hexagonal Outbuilding (c. 1900; Contributing Building; B) Approximately 200 feet southeast of Mount Welby is a hexagonal outbuilding (figures 14 & 15). Archival investigations have not identified its original use. The one-story, one-bay, wood-frame outbuilding has a six-sided pyramidal roof. The structure stands on a brick foundation parged

OXON COVE FARM - HEXAGONAL OUTBUILDING PLAN

None of the seven buildings incorporate discernable structural alterations or replacements. The interior walls of the hexagonal outbuilding are plastered, obscuring the building's structural system. The horse and pony barn, feed building, and hay barn are constructed primarily of circular-sawn wooden structural members. Circular saw machinery was developed during the mid-19th century. The use of circular-sawn wood in the construction of rural buildings became common about 1870, when improved transportation methods and reductions in the cost of production made the purchase of machine circular-sawn wood more economical than manually-sawn lumber. The silo is constructed of glazed tiles, a material used to build utilitarian structures between about 1925 and 1975. All seven buildings associated with the agricultural operations conducted at Godding Croft retain integrity of materials and workmanship.
