National Register of Historic Places
Registration Form

historic name Hall, Rev. Plummer T., House

other names/site number Hall-Jackson House

street & number 814 Oberlin Road N/A not for publication

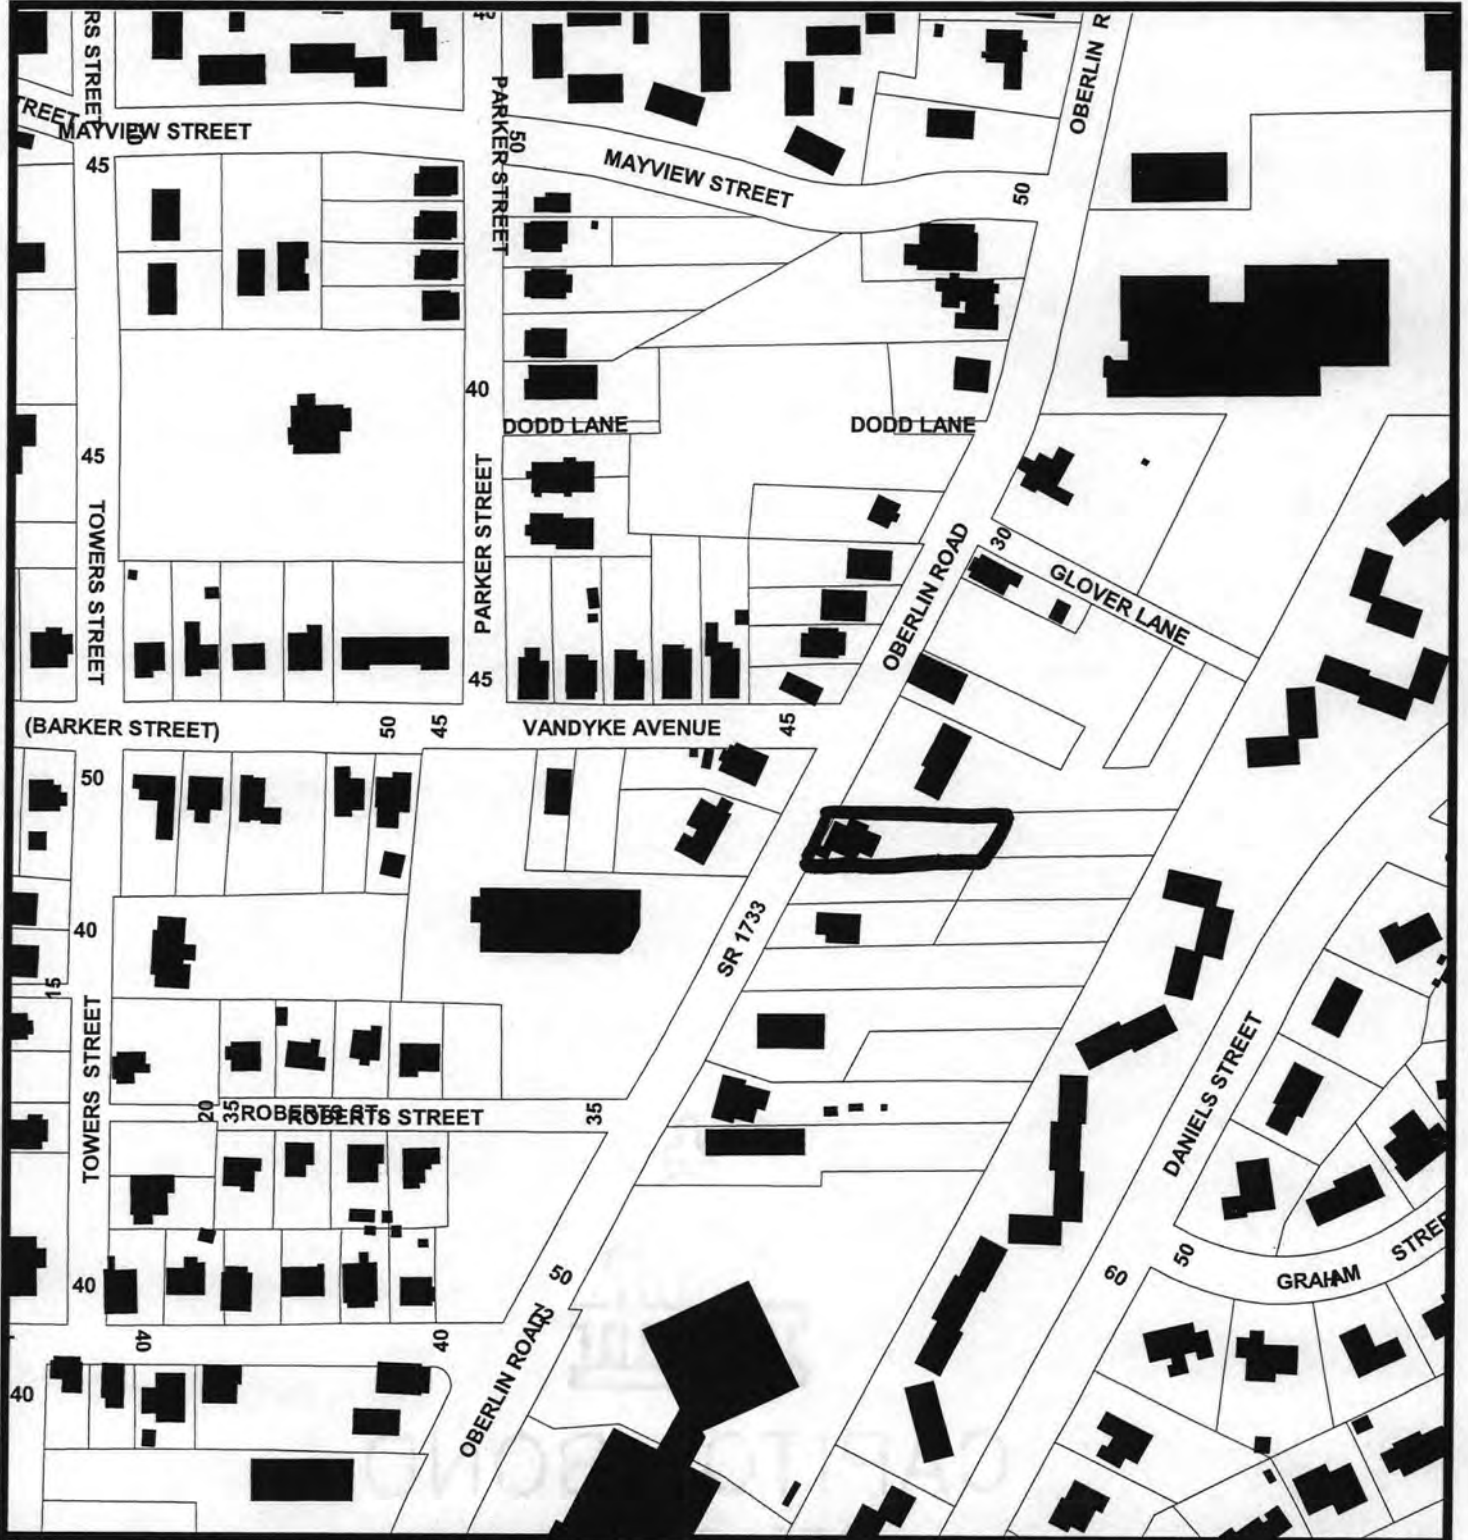
Exhibit A
Wake Co. Tax Map

— = property boundary

The nominated property includes the entire parcel historically associated with the Reverend Plummer T. Hall House.

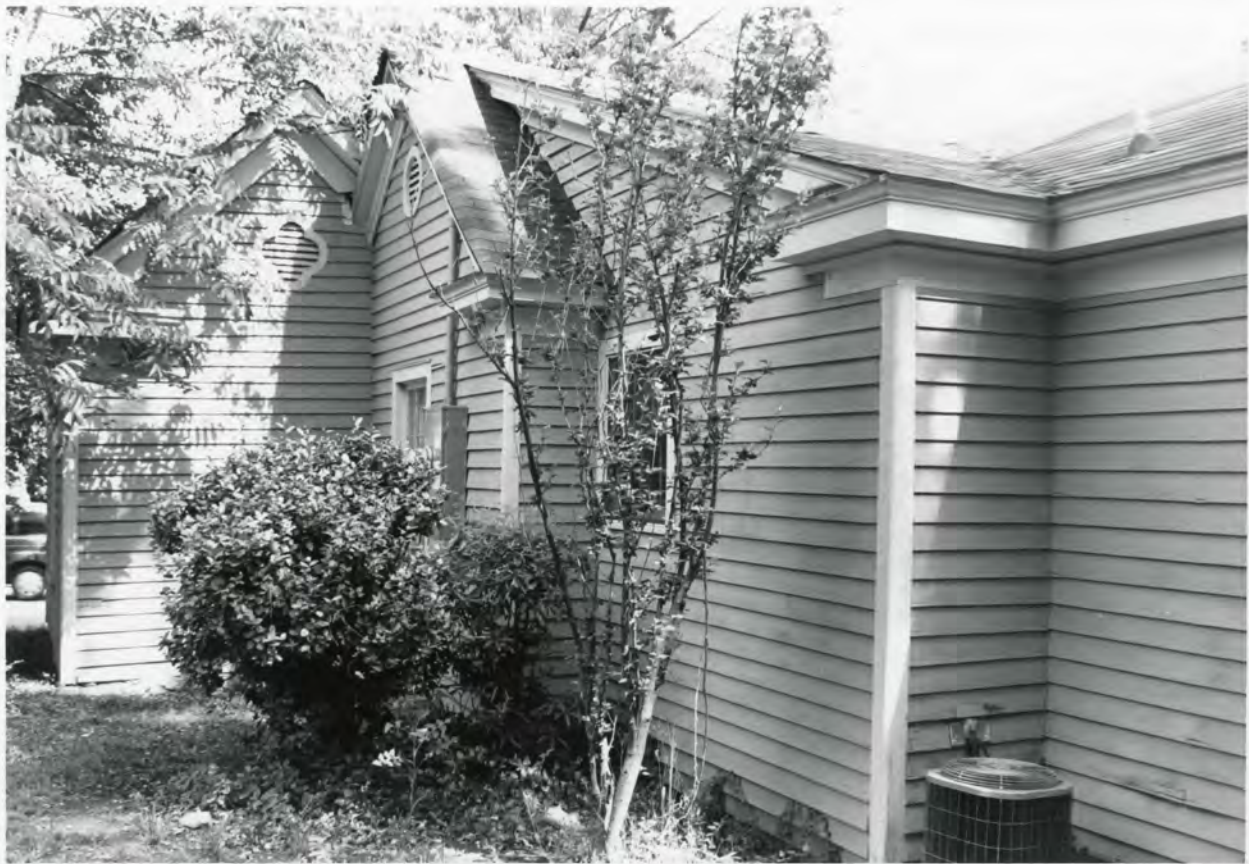
Rev. Plummer T. Hall House
South elevation
814 Oberlin Road
Raleigh, Wake Co.
SJWjtt
2001

The original, or front, section of the house has a side gable roof with deep cornice returns. Over the entry is a central, front-facing gable. There are round attic vents in the gable ends. The gable front addition on the southwest corner has a quartrefoil attic vent on both the front and rear. The front porch extends north from this addition to the end of the front facade, terminating in an original gazebo with a polygonal roof. The porch has turned posts and sawnwork brackets. The historic addition also has a three-sided bay window on the front facade.

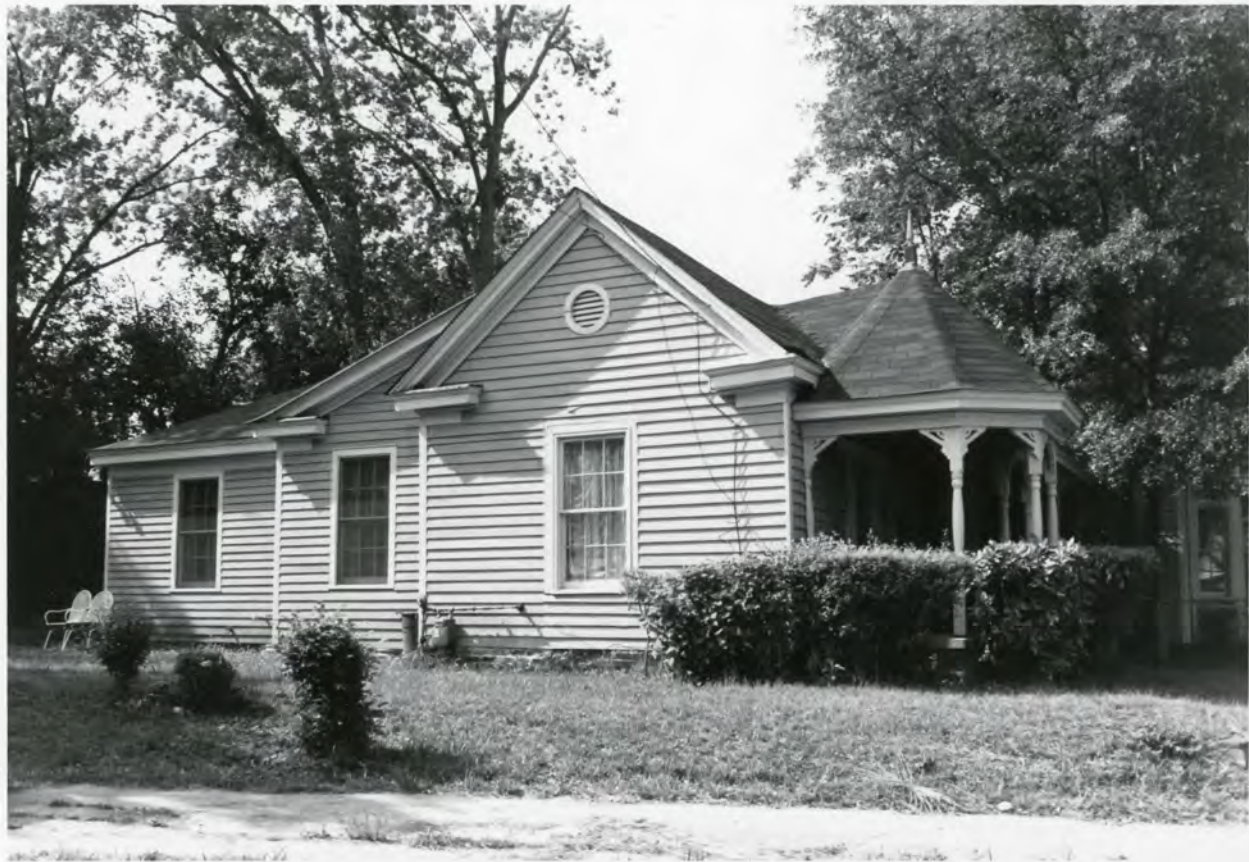
Rev. Plummer T. Hall House
814 Oberlin Rd
Raleigh, Wake Co.
S. W. Platt
2001

north elevation

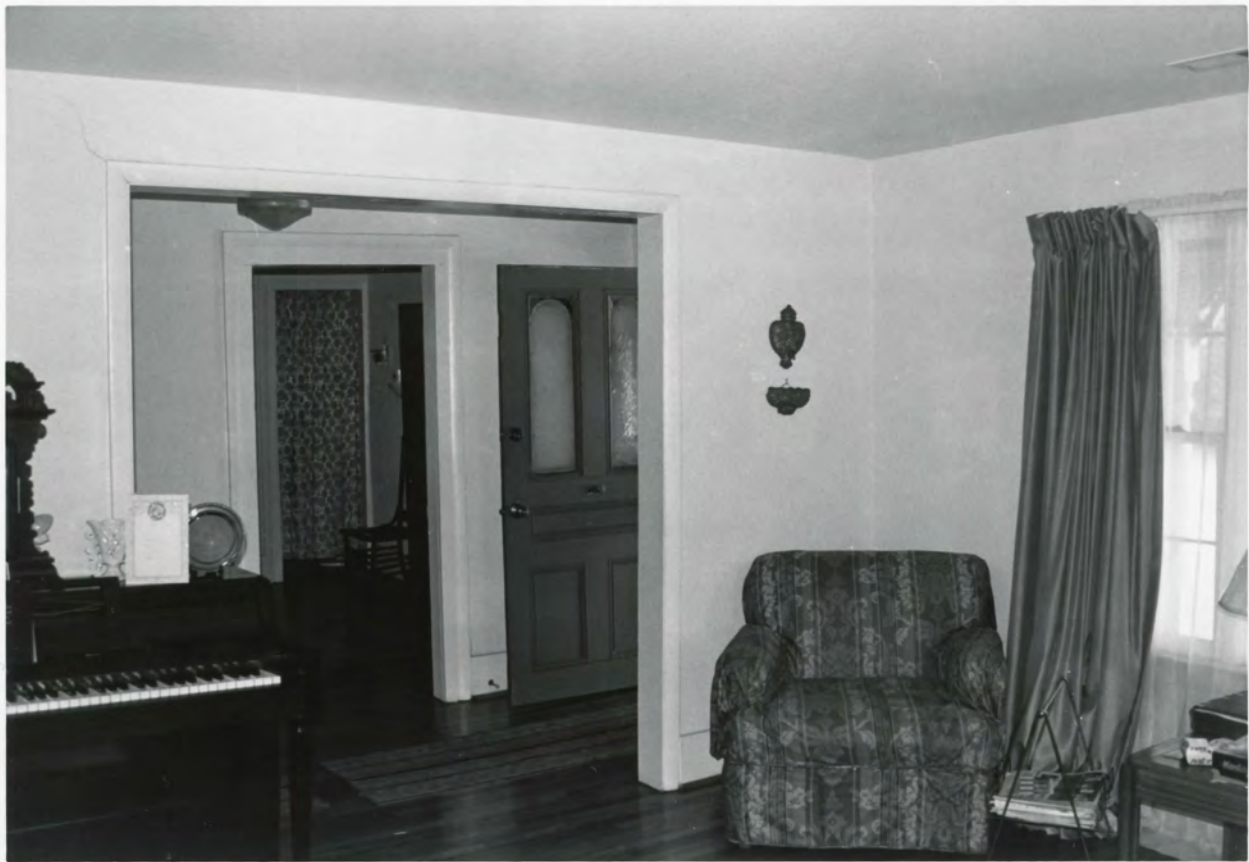
Rev. Plummer T. Hall House

living room

Interior walls were once plaster, but have been replaced with gypsum wallboard. New wood floors were installed in the 1960s and refinished in 1996. Rooms in the 1996 addition are carpeted. In the front living room, there was a fireplace on the east wall which has been enclosed. Door and window trim is simple, without ornate moldings. Materials in the rear addition date from 1996.

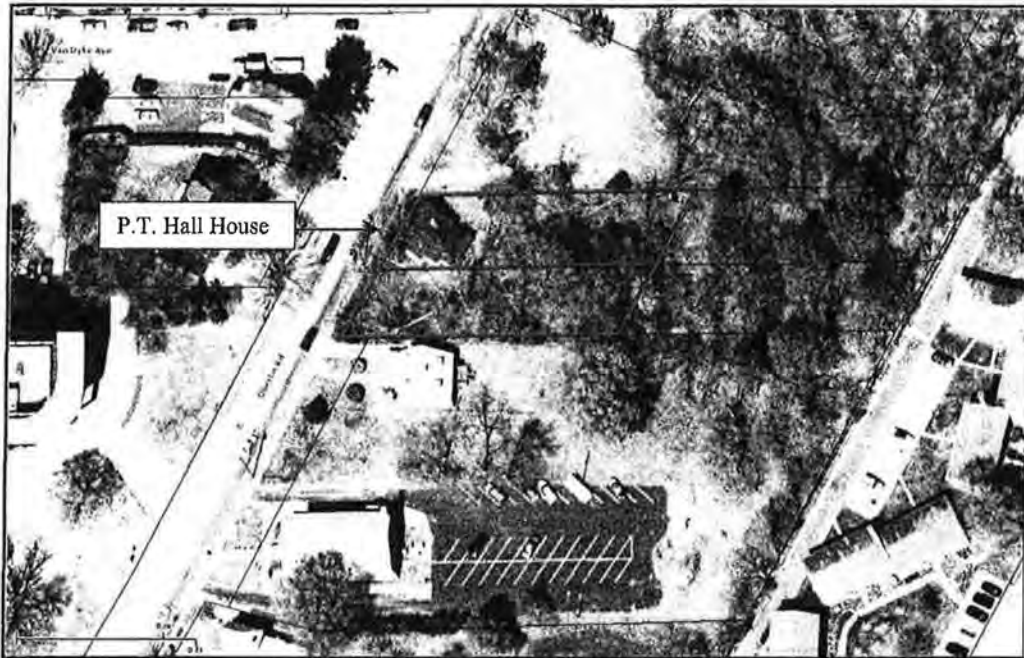
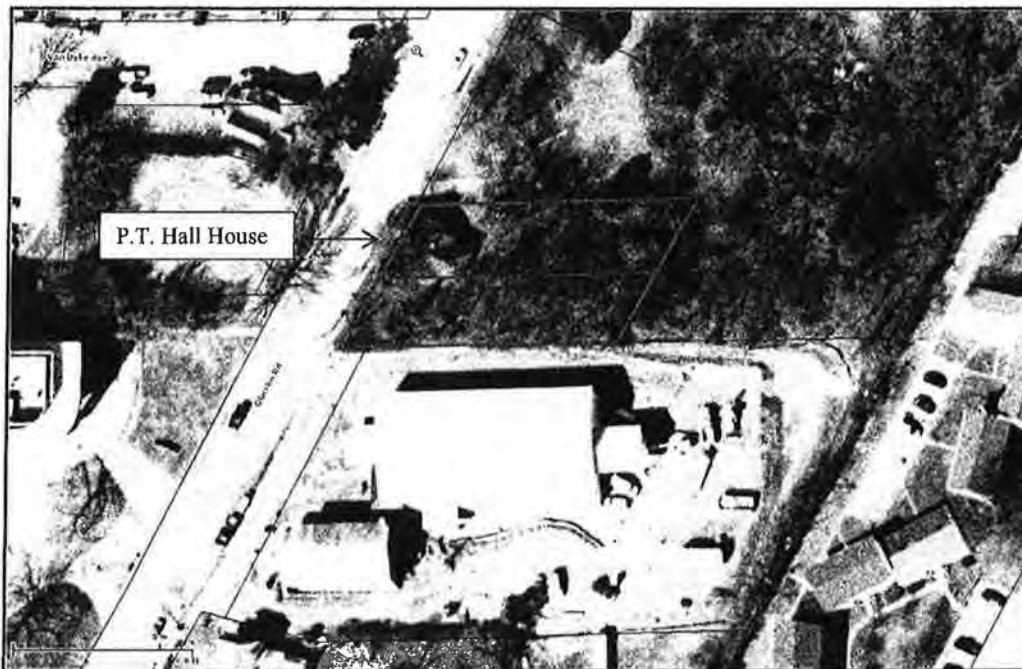
Figure 10: 2002 Aerial Photograph of Project Area.

Figures 10–12 show aerial views of the property from 2002 to 2007. Although no significant changes to the Plummer T. Hall house were noted during this time, the dwellings on either side of the house were demolished and a new church was constructed adjacent to the c. 1955 Oberlin Baptist Church. According to the National Register nomination form, former occupant Ms. Jackson recalled only one outbuilding on the property (a privy); however, the nomination form cited a 1989 local designation report that mentioned two standing metal shed roof outbuildings were located on the property at that time.

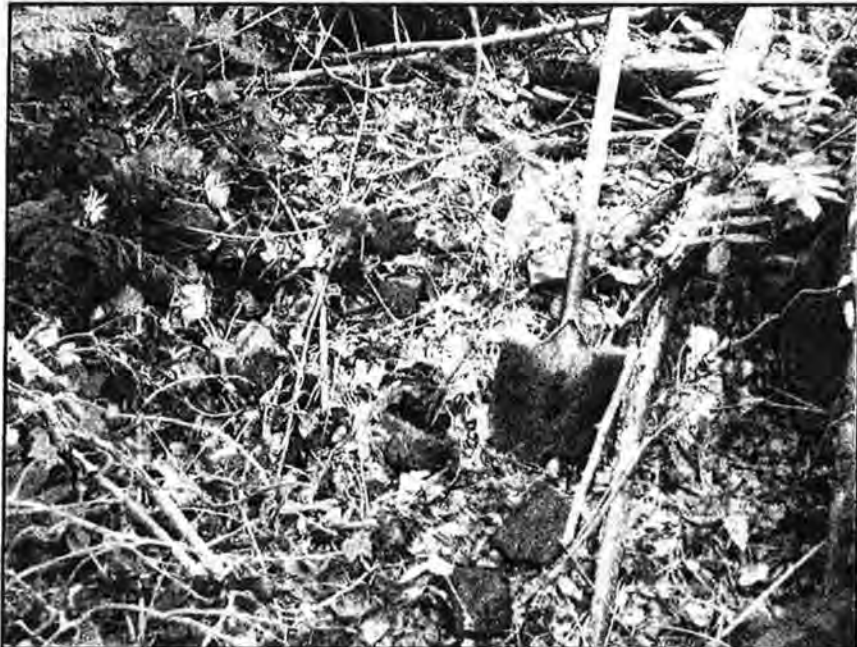
Figure 18: Brick and Concrete Rubble near ST 22.

A long outbuilding consisting of three rooms was noted on the 1914 Sanborn map. Visual inspection and shovel testing noted a small pile of cinderblocks (around ST 22), as well as some brick rubble (near ST 14). Slight elevation changes in this portion of the property appear to denote the approximate footprint of the former structure location. Based on the current plat

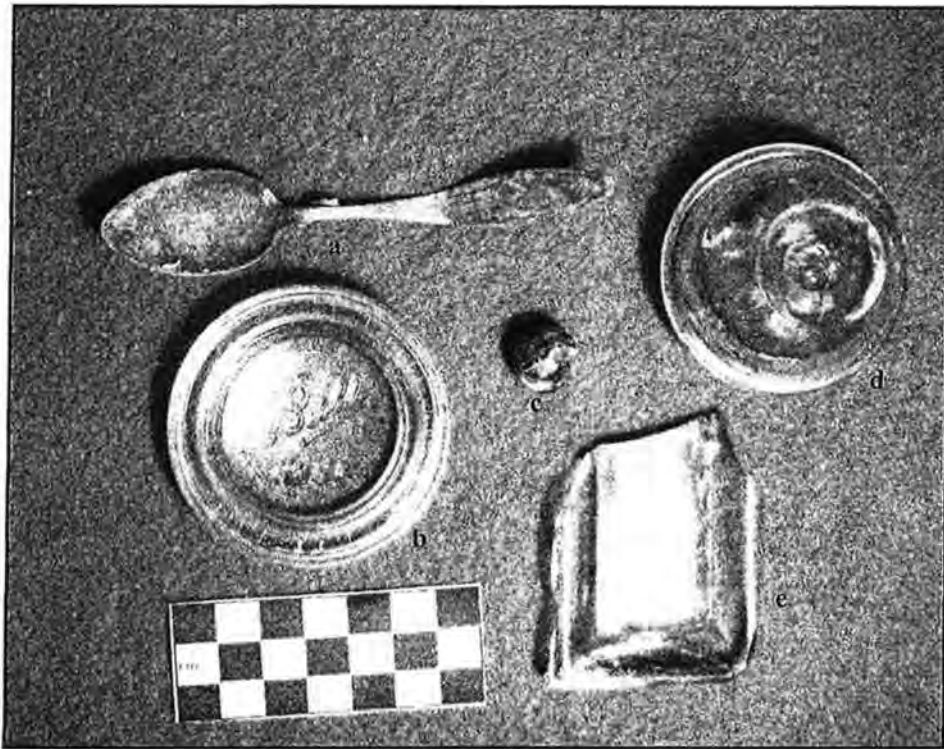
Figure 26: Miscellaneous Artifacts from ST 7

- a) Silver-plated Spoon*
- b) Ball No. 10 Canning Lid*
- c) Glass Marble*
- d) Decorative Glass Lid*
- e) Glass Panel Bottle Fragment*

Shovel test (ST) 7 yielded the largest number and diversity of artifacts. A total of 75 artifacts were recovered, including 27 intact large brass paper fasteners (**Figure 22**; similar to those for sale in the 1897 Sears, Roebuck, & Co. Catalog), a silver plated teaspoon (**Figure 23**), unbroken glass sugar or small candy dish lid (**Figure 26**), iron door hasps and hinges (**Figure 24**), an adjustable wrench, iron chisel, and a stack of nine intact rubber canning jar lid seals. The shovel test corresponds to the general location of an outbuilding shown on the 1914 and 1949 Sanborn maps. The 1949 Sanborn map indicates that this structure was a garage. The materials recovered from the shovel test appeared to have been undisturbed following their deposition (the canning lid seals were stacked together, as were the brass paper fasteners). This shovel test may represent the contents of an abandoned and collapsed structure, or general refuse midden from the demolition of that structure. Soils in this area were deeper than the surrounding yard (30 centimeters of dark grayish brown sandy loam over subsoil). Adjacent shovel test ST 6 yielded window glass, several chunks of coal, a corroded motor assembly, pick axe, and tongs from similar soils. Several cinderblock fragments were observed in the vicinity, and adjacent negative shovel tests to the south revealed a compacted gravel area (likely a driveway). Shovel Test 5 yielded modern materials, including plastic, vinyl, and a wire nail, suggesting the structure remained in use until fairly recently.
