KENTUCKY HISTORIC RESOURCES INVENTORY

1. Historic Name(s) <i>Bondurant house</i>		22. ADD/County <i>Getaway / Montgomery</i>	
Original Owner <i>not known</i>		23. U.S.G.S. Quadrant (15/75) <i>Mt. Sterling v.c.</i>

2. Present Name <i>Rock House / Getwood farm</i>		24. UTM Reference Zone <i>17</i> Easting <i>245880</i> Northing <i>4218920</i>	
3. Location <i>N. side Stepstone Rd at Howards Mill Rd.</i>		25. Coordinate Accuracy <input type="checkbox"/>

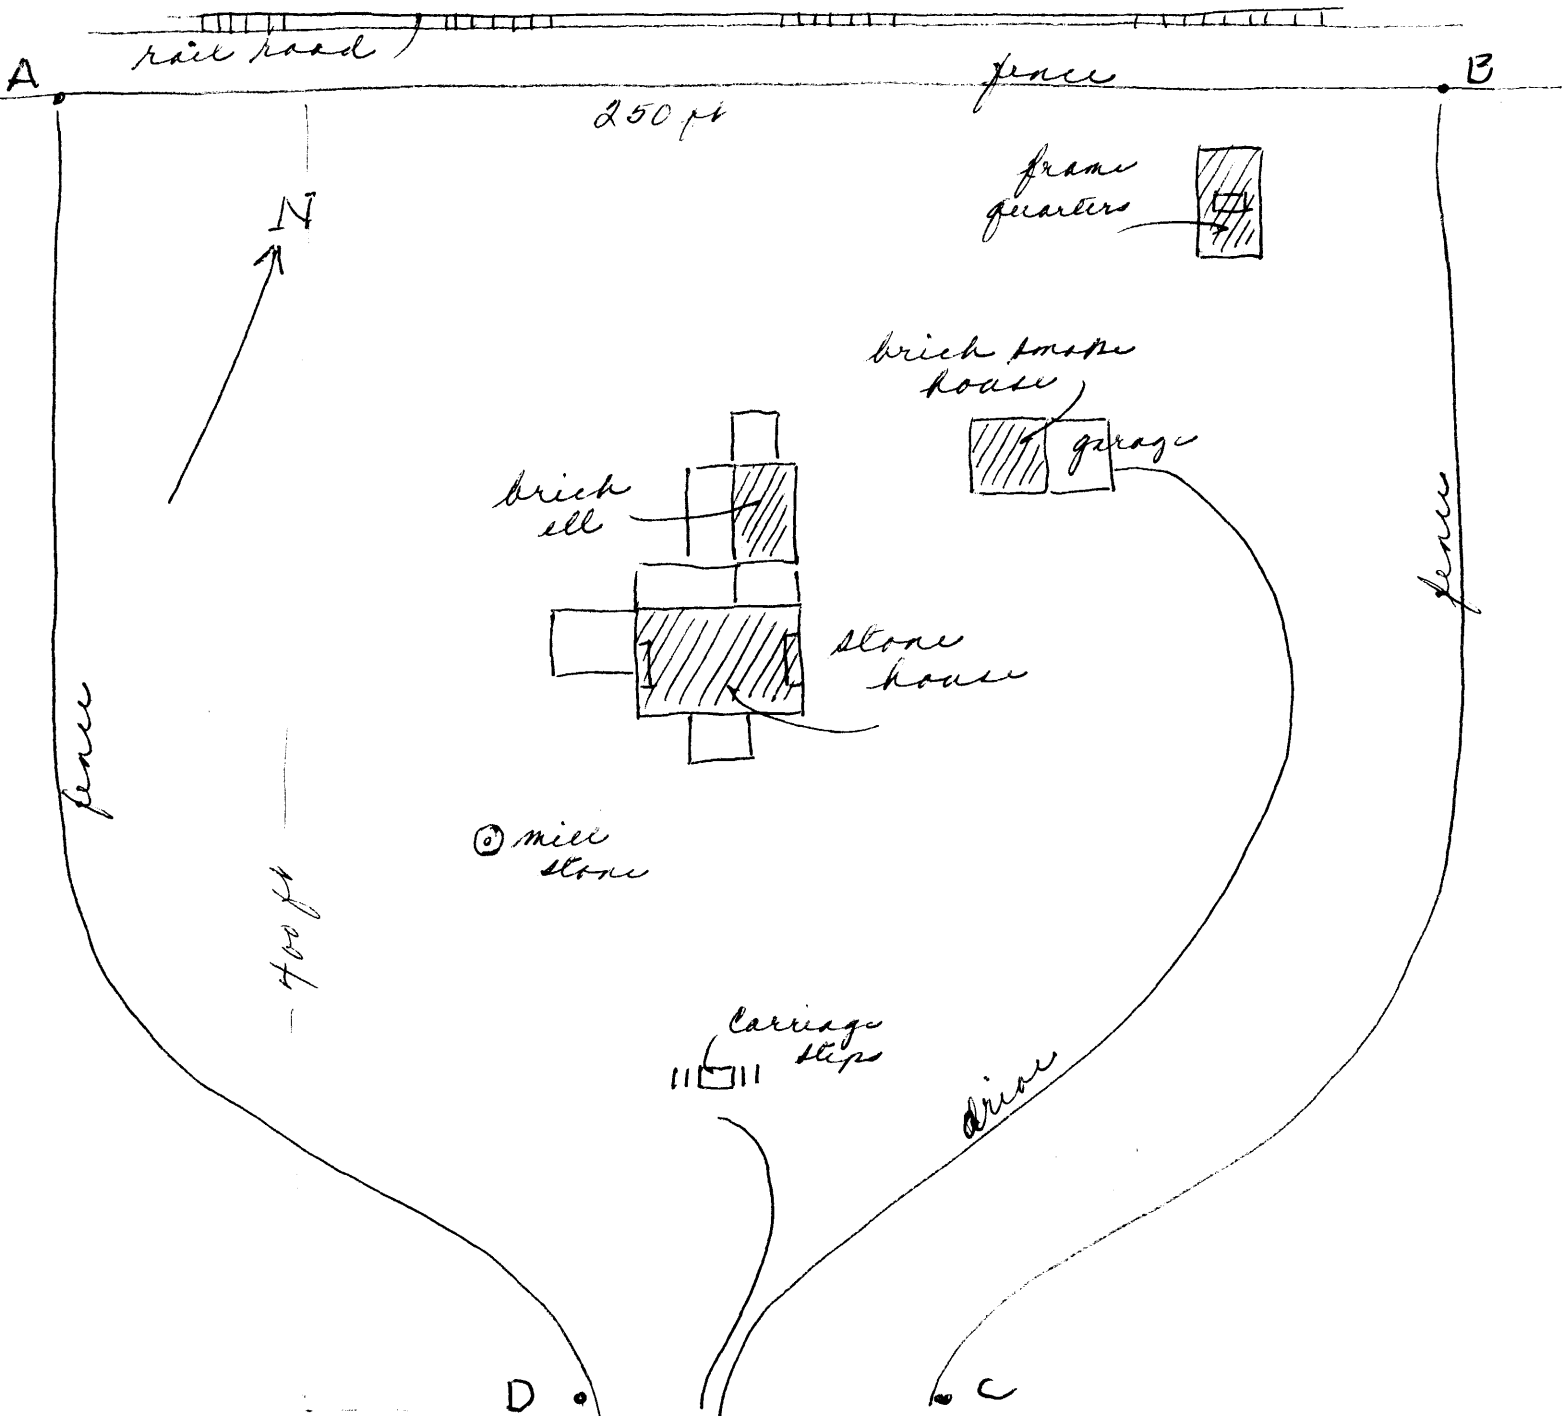
SKETCH MAP OF SITE SHOWING BOUNDARIES AND KEY BUILDINGS AND FEATURES WITH NORTH ARROW.

Beginning at A in the NW corner of the yard, thence E 250 ft to B, thence S along fence to a point 400 ft perpendicular to rear fence to C, thence across drive to D at the fence, thence with fence to the beginning, containing the house, stone house, addition to house, quarters and carriage mount. 2 1/4 acres
