KENTUCKY HISTORIC RESOURCES INVENTORY

1. Historic Name(s) <b>Pendleton County Courthouse</b>		22. ADD/County <b>NKADD/Pendleton</b> <span style="border: 1px solid black; padding: 2px;">096</span>	
Original Owner		23. U.S.G.S. Quadrant (15'/75') <b>Falmouth</b> <span style="border: 1px solid black; padding: 2px;">1,3,7</span>

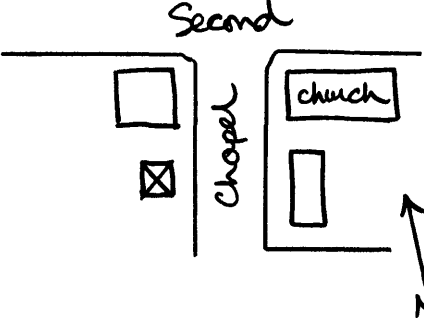
16. Present use office	
		17. Condition good <input checked="" type="checkbox"/>	
18. Description Low coursed rubble foundation; full basement. Horizontal shaped log construction, V-notching, plaster nogging. Three bay, modern door with plain surround and glass transom. Windows have plain wood surrounds, no sills or lintels. Double hung, 2/2. Upper windows are double hung 6/6. Two stone steps lead to front door. North and south facades have weatherboard (Continue on Back) (over)		No. Stories 2 stories <input checked="" type="checkbox"/>	
		Single Pile Double Pile <input checked="" type="checkbox"/> NA	
		Floor Plan double cell w/shed <input checked="" type="checkbox"/>	
		Structural Fabric log, frame A. <input checked="" type="checkbox"/> B. <input checked="" type="checkbox"/>	
		Decorative Fabric V-notching A. <input checked="" type="checkbox"/> weatherboard B. <input checked="" type="checkbox"/>

18 continued: in gable ends. Exterior end chimneys on North and South facades; high coursed rubble foundations (north approximately 30" high; south approximately 5' high) and irregular bond brick with weathering. Gable roof has wooden shingles and plain box cornice on Chapel St. slope, asphalt shingles on rear slope. Frame addition on rear dates to c.1860--weatherboard with shed roof. Interior was originally double cell with rear stair; now double cell with center stair and addition to rear. Interior fireplaces intact; first floor south chimney has ashlar stone face and first floor north chimney has brick face. Both have carved wooden mantels. Second floor has fireplace at south end; basement has fireplace at north end. Completely restored, exterior and interior.
