National Register of Historic Places Registration Form

historic name Monson Community Church

other names/site number Monson Baptist Church, Monson Congregational Church

street & number 19 Greenville Road

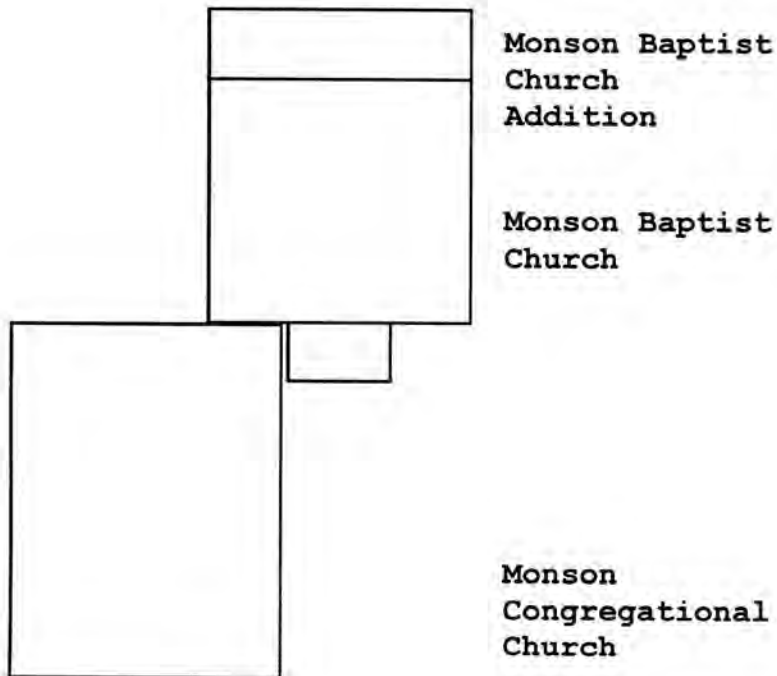
Monson Community
Church, Combined
Plan

The first floor was extensively renovated in 1961 to serve as the educational section of the yoked churches. Only the entry vestibules, and the room between the vestibules retain their original painted metal ceilings and plans, but these spaces, as well as some of the exterior walls, also retain painted wainscot below tin walls. At the east end of each vestibule a short set of stairs lead to what had been the building's sanctuary; in the south vestibule these stairs have been converted into a ramp. The southern two thirds of the former sanctuary has been divided into two large classrooms, while on the north side of the building are a smaller meeting room and library, both accessed from a longitudinal hall. At the east end of the hall is another set of stairs/ramp which gain access to a transverse hall which is elevated on what is more than likely the original podium. This back hall also contains a staircase to the basement (one wall of the staircase has a tin finish), and a couple of cupboards. At the south end of the back hall is the connection to the north wall of the Baptist church vestibule.
