1. Name of Property			
Historic name: Creaser Building			
Other names/site number: Cooks on Main, Judy's Cupboard, Colonial Shop, JB Lyon Women's Wear Clothing, First National Building, 32WI740			
women's wear Clothing, First National Building, 32 W1/40			
Name of related multiple property listing:			
(Enter "N/A" if property is not part of a multiple property listing N/A

2. Location Street & numbers 224 Main Street			
Street & number: 224 Main Street City or town: Williston State: ND County: Williams			
Not For Publication: Vicinity:

Narrative Description

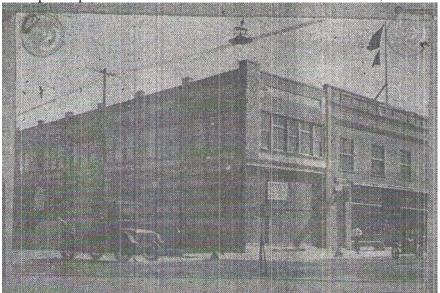
Published in Section 4 on page 1 of the Williston Herald Progress Edition 1927 June 23.

The north side of the Creaser building is pictured the morning after the big fire. The ladder leaning on the wall was the only means of access to the second floor, the regular stairs facing Main Street having been destroyed. In back is the telephone building which was saved with only small smoke damage.

On December 27, 1925, the Creaser Building suffered damage from a fire that began in the building adjacent to it to the south, the Jarrell-Johnson Hardware. While the fire started around 2:00 A.M. in the Jarrell-Johnson Hardware Store, it quickly spread to the Creaser Building even though the shared second-floor hallway was equipped with a large metal fire door that was supposed to release when the safety wire would reach a certain temperature. The fire department was not able to determine if the fire spread through the fire door or from the shared roof. Despite the Creaser Building receiving over \$100,000 in damage from smoke and fire, the Creaser family reopened the store after it had been renovated.

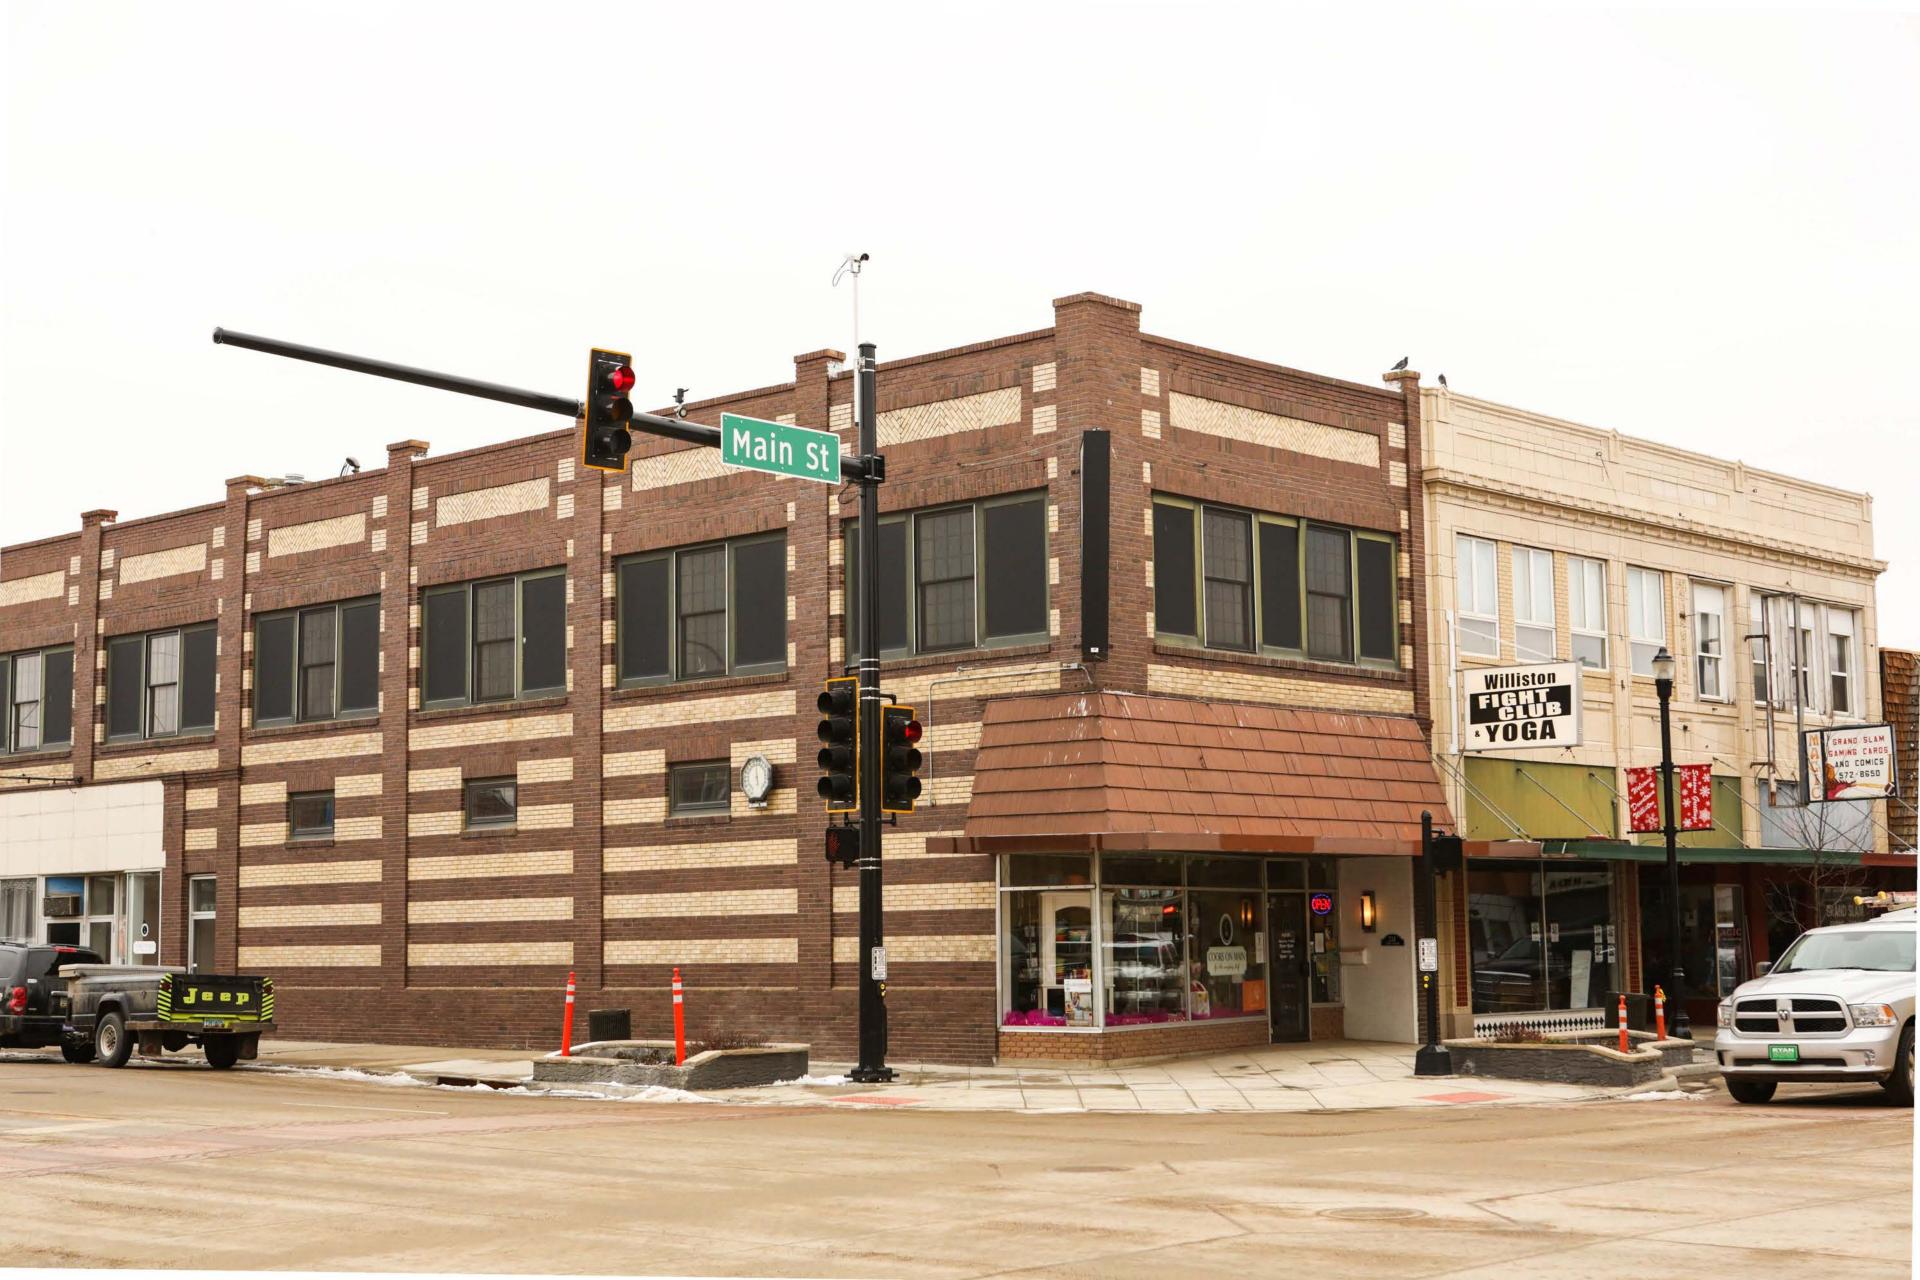
1 of 6

Main Street and Broadway Façade (northwest)

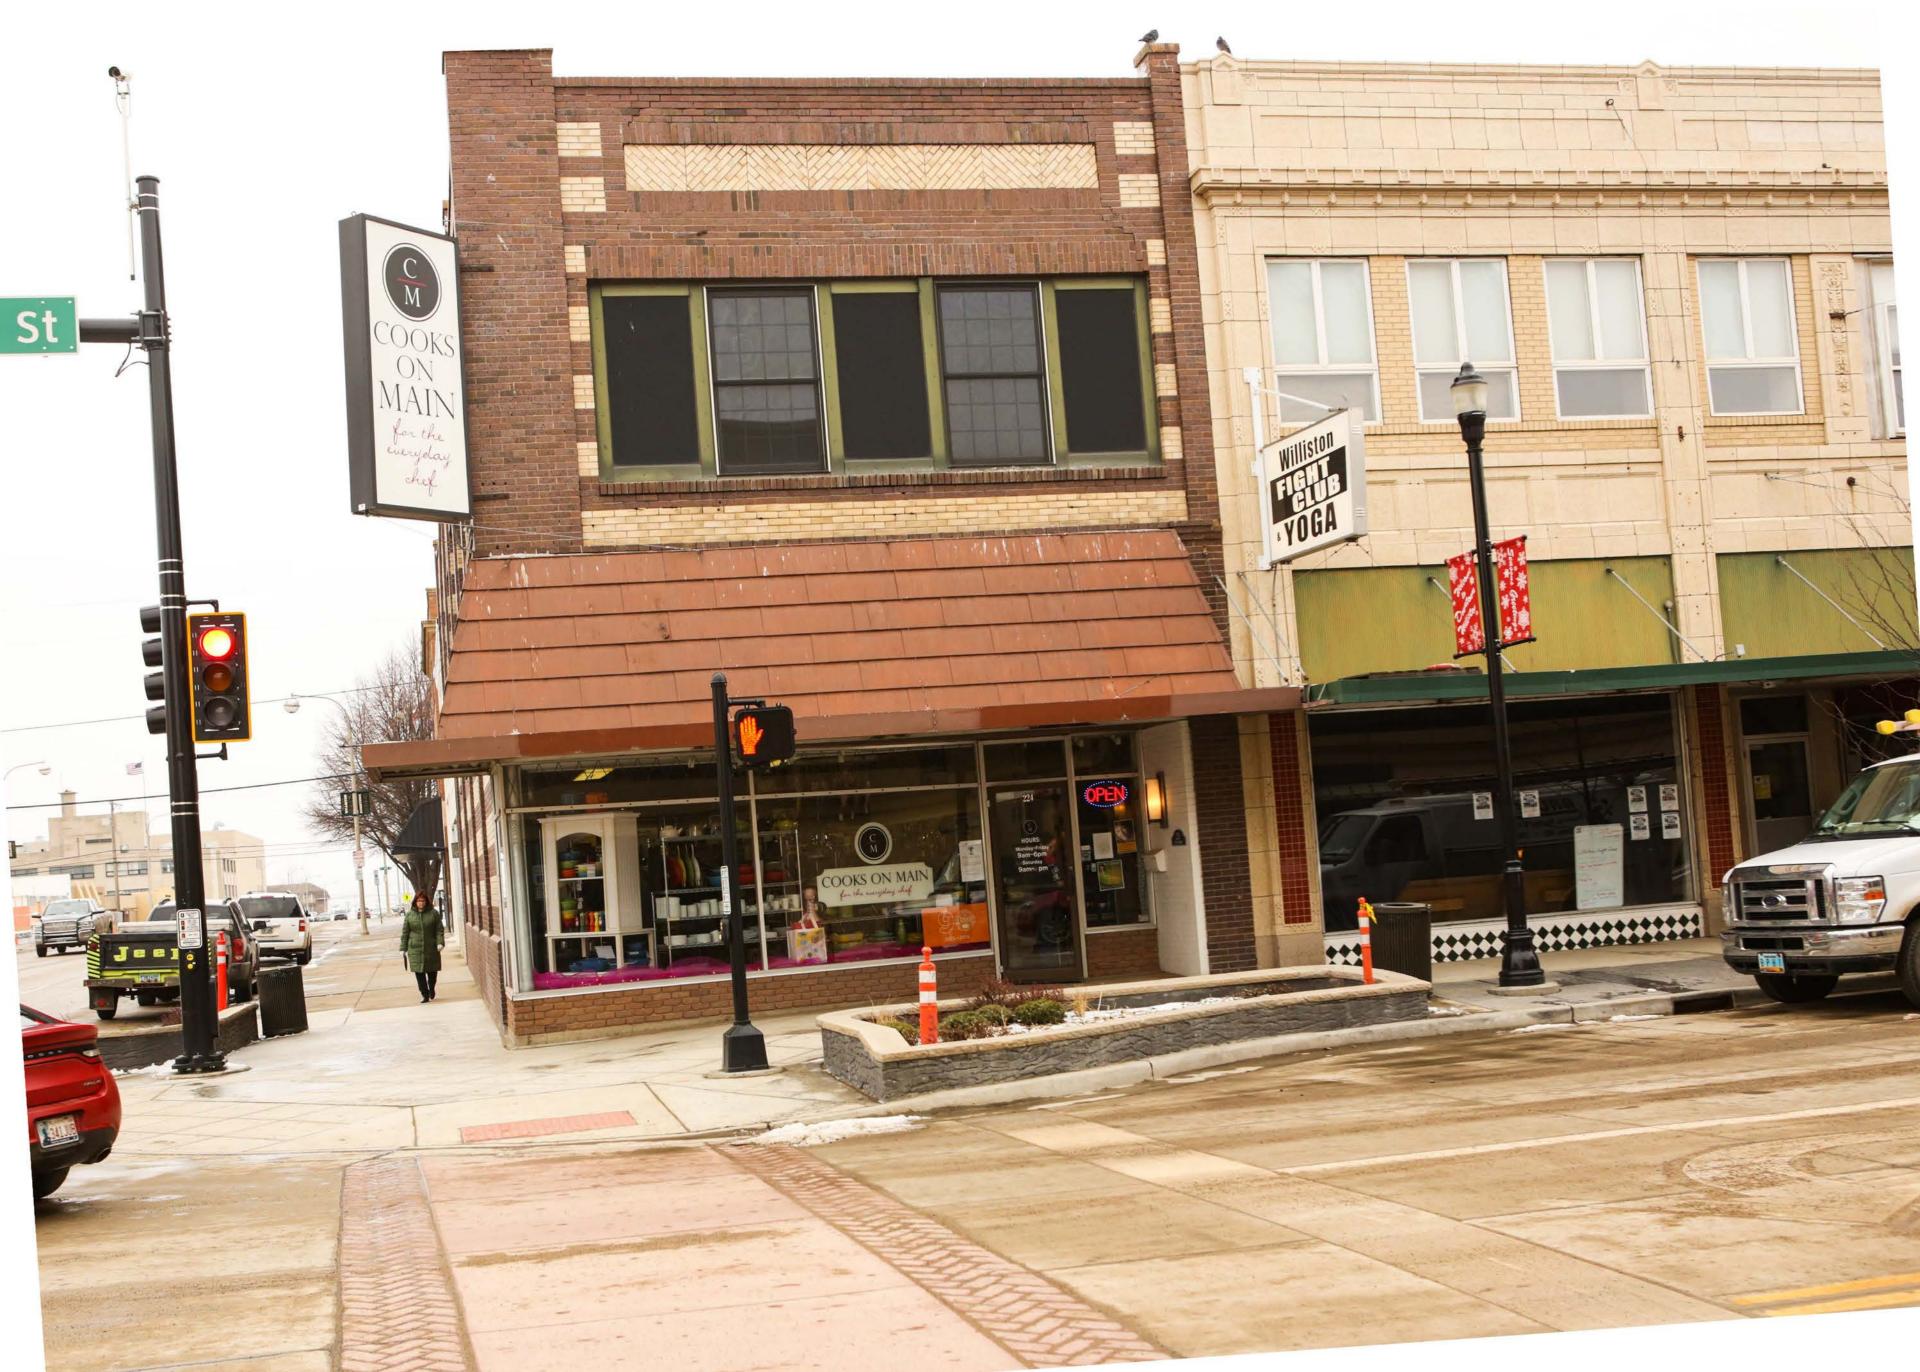
2 of 6

Main Street Façade (west)

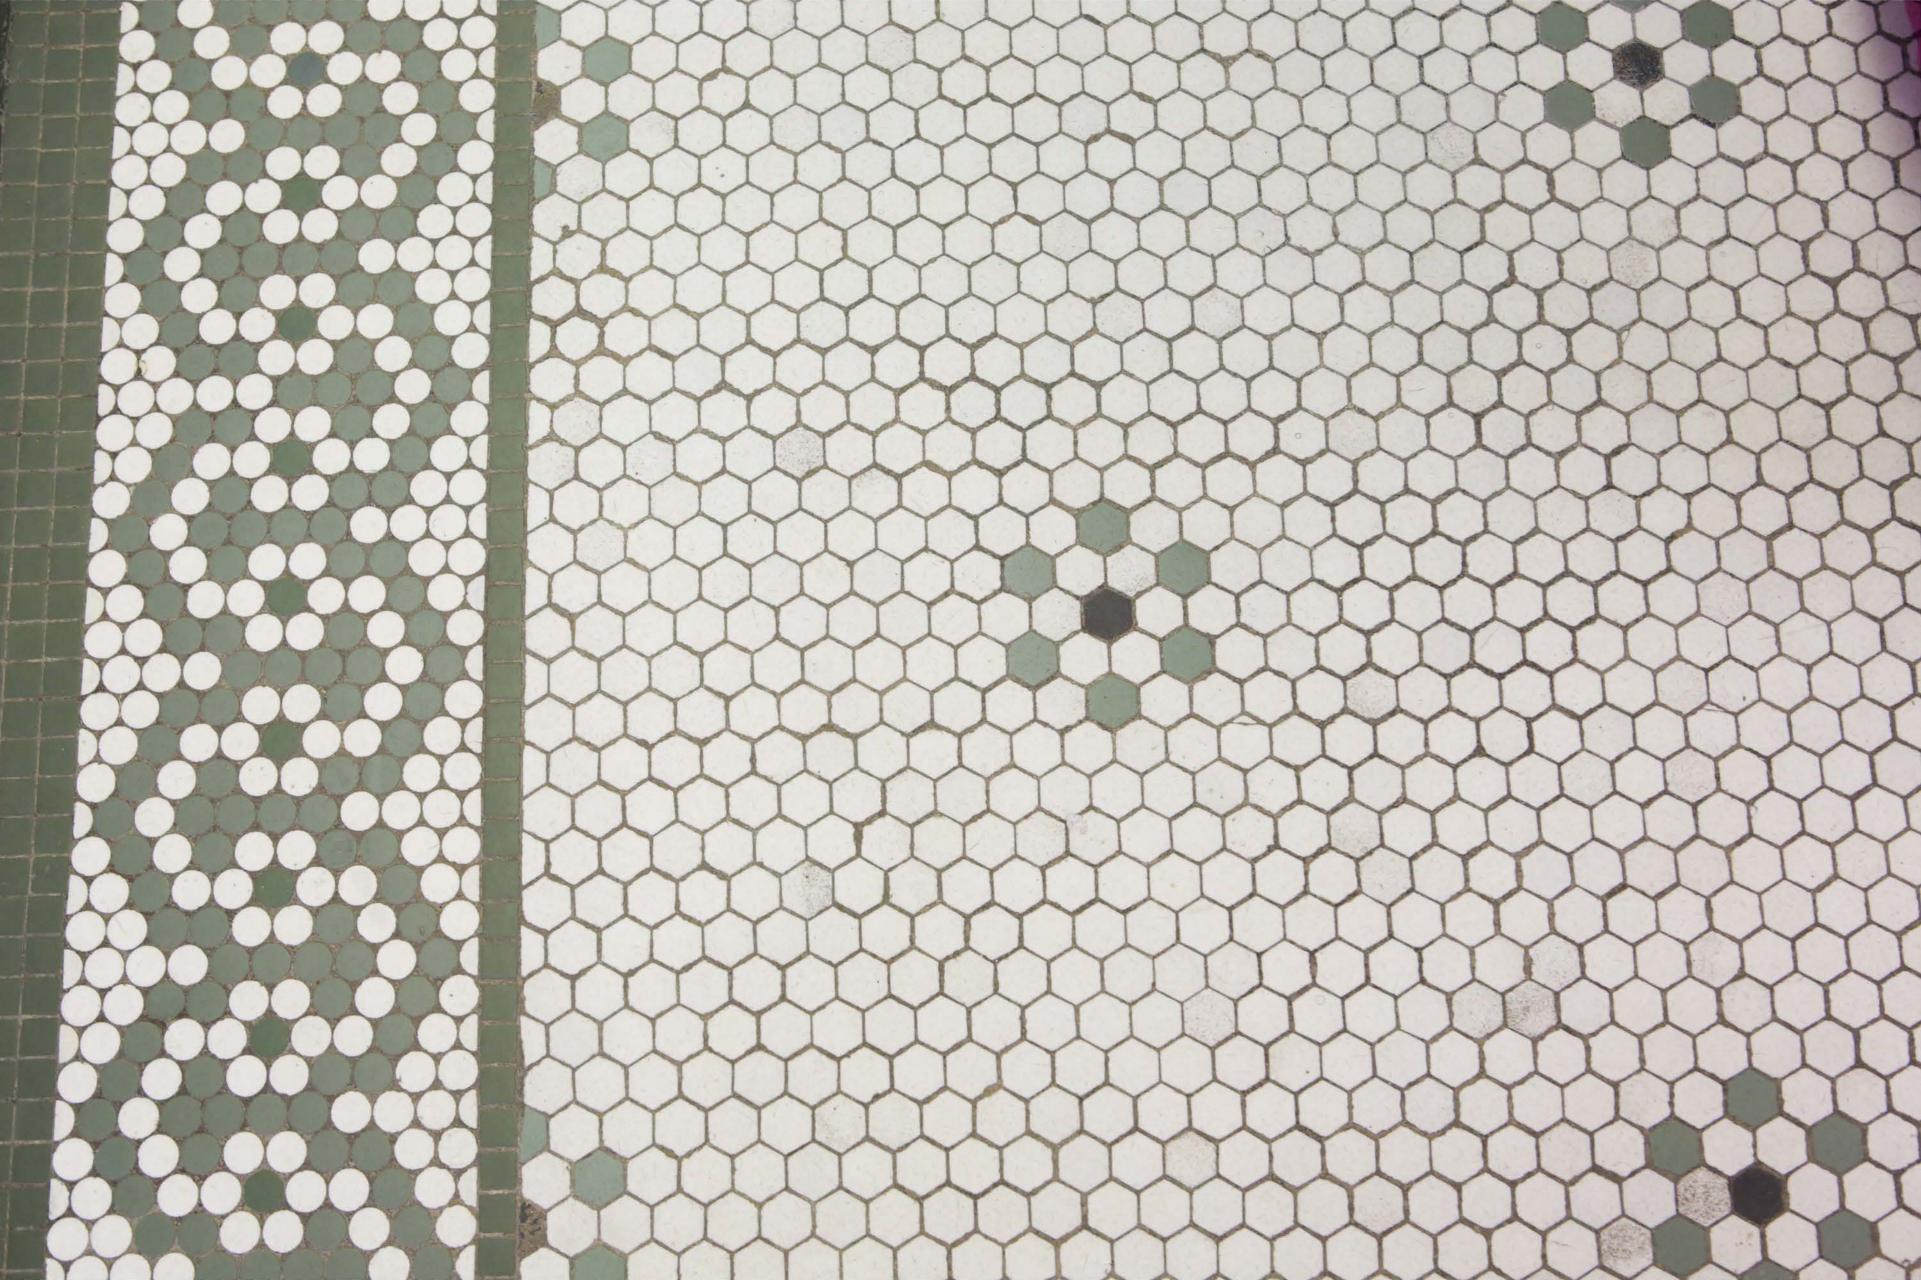
3 of 6

Historical Green and White Tiles on the 1st Floor Retail floor

The ground floor street level includes a large 24'x50' commercial space opening west to Main St., commercial kitchen and separate 24'x15' commercial space opening north to Broadway. Original tile and wood floors have been maintained in the large commercial space. The high-volume first floor has its wood grid ceiling set at 14'. Aluminum storefront matching the design of the building in the 1940s still stands on the west and north elevations, but is in poor condition.

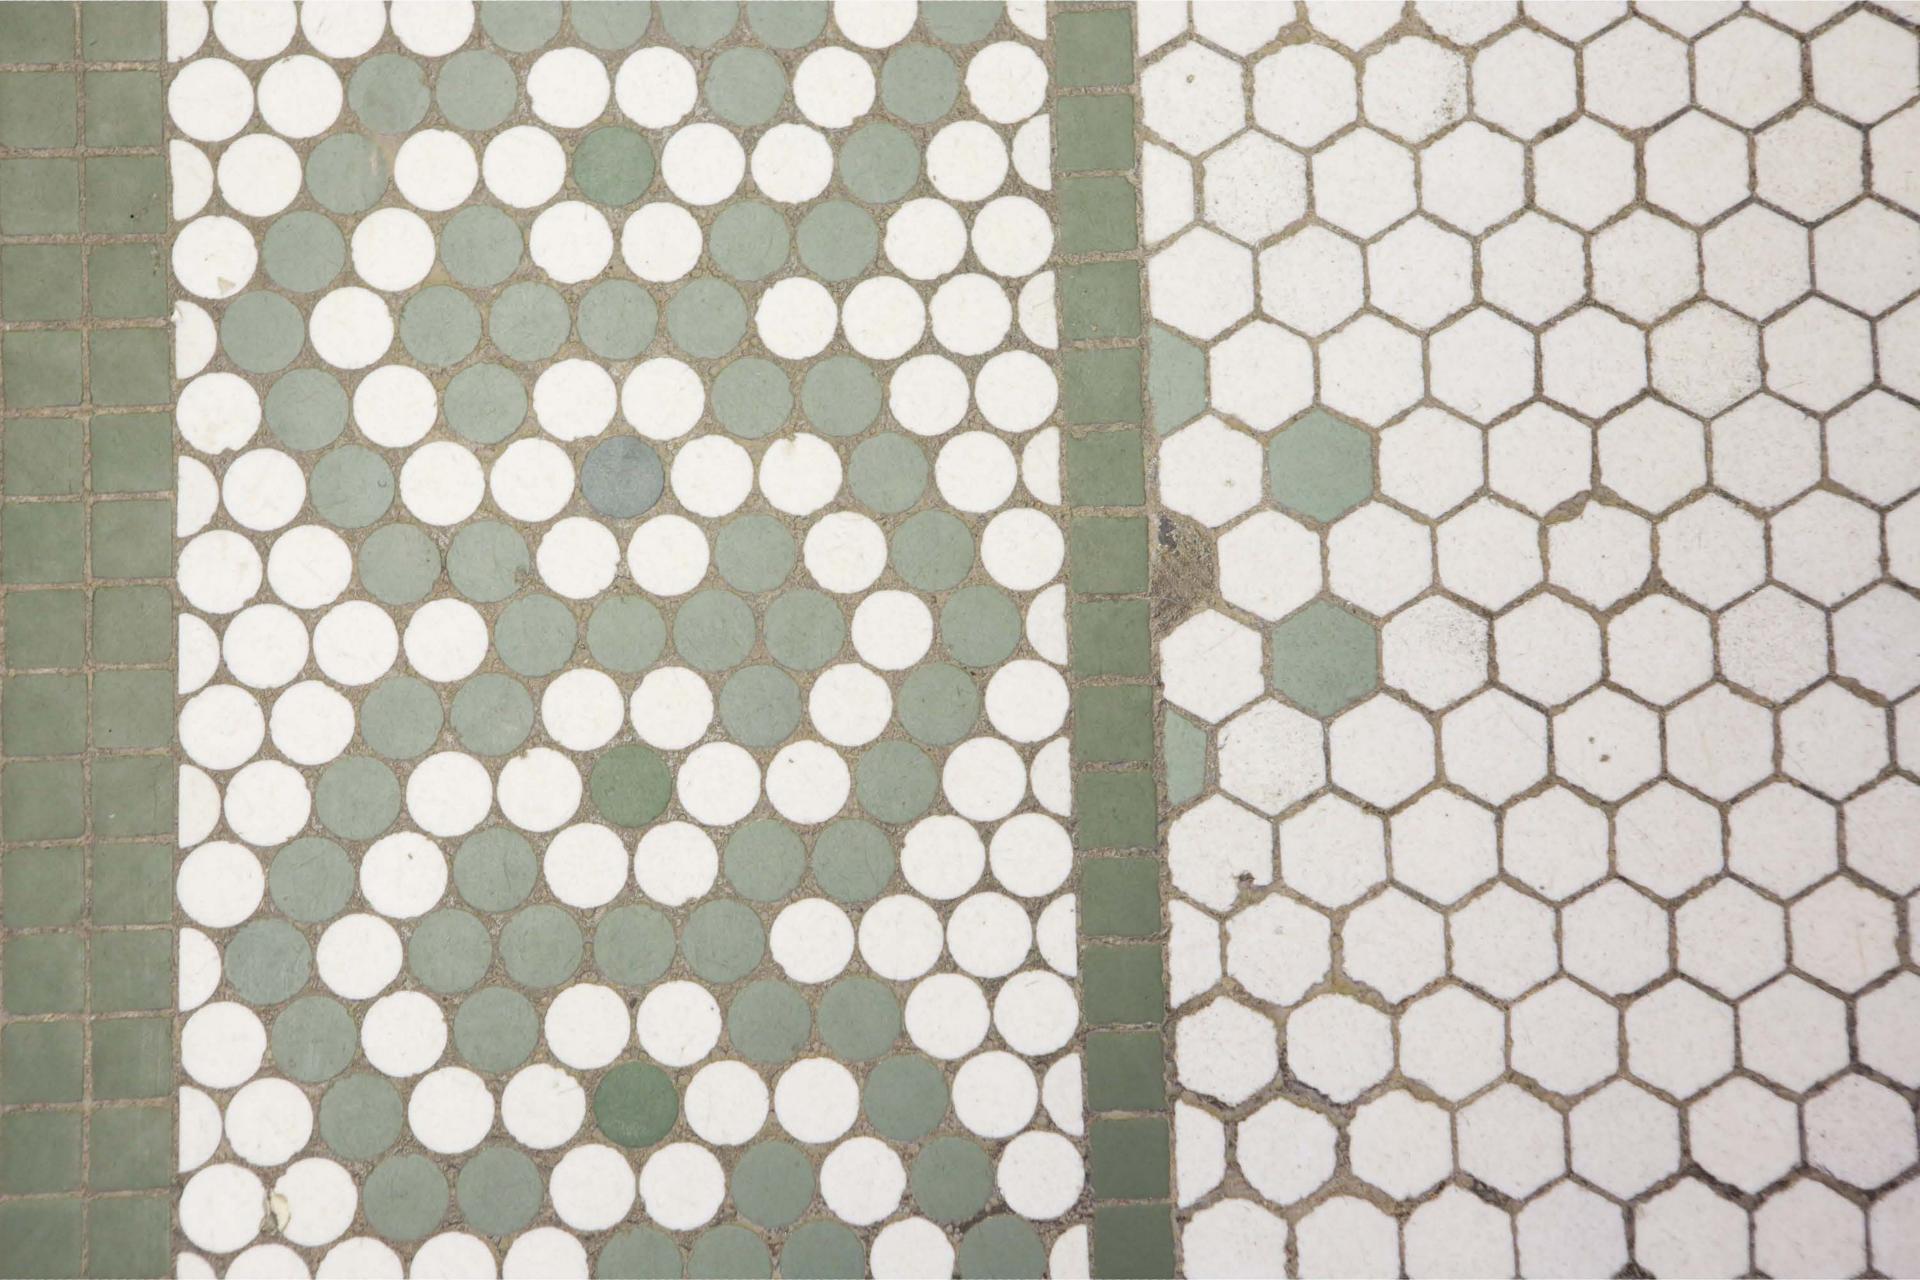
5 of 6

Historical Green and White Tile border close-up

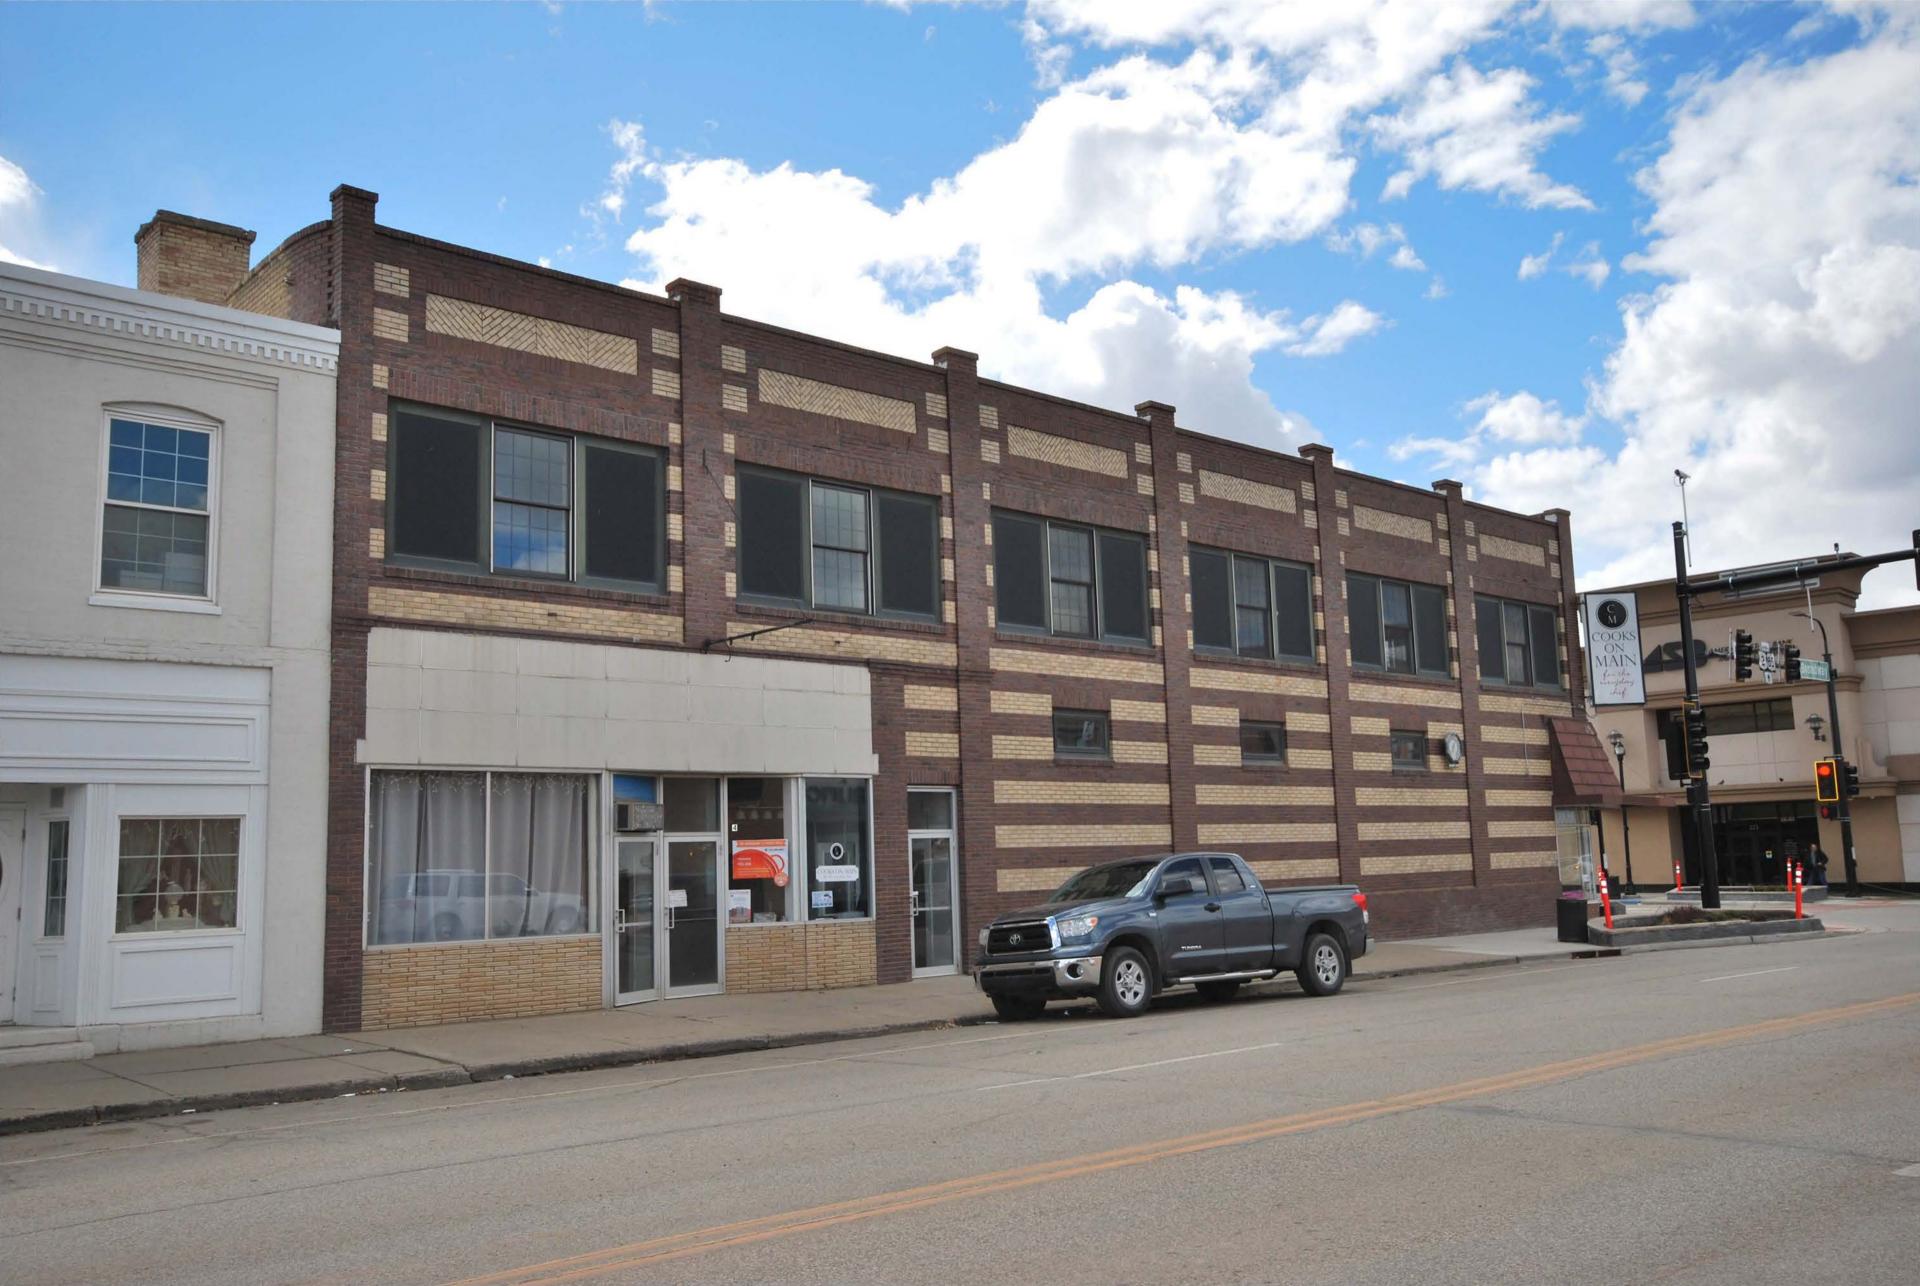
Lorna Meidinger 5 April 2016 Broadway Facade (north from northeast corner) 6 of 6

The storefront on the north elevation is along the east end of the building and deviates from the regular pattern of the building. Bordering red brick pilasters provide framework to the approximately 26'x18' storefront opening. Currently, a buff colored concrete panel in poor condition above the length of the storefront is where signage once hung for the commercial space. Separate doors at this north storefront with an angled entrance provide the only access for the second floor and the commercial space. A base of blonde brick approximately matching the color, but not texture of the rest of the building separates the sidewalk and storefront.
