The Hunter-Dulin Building
SAN FRANCISCO, CALIFORNIA

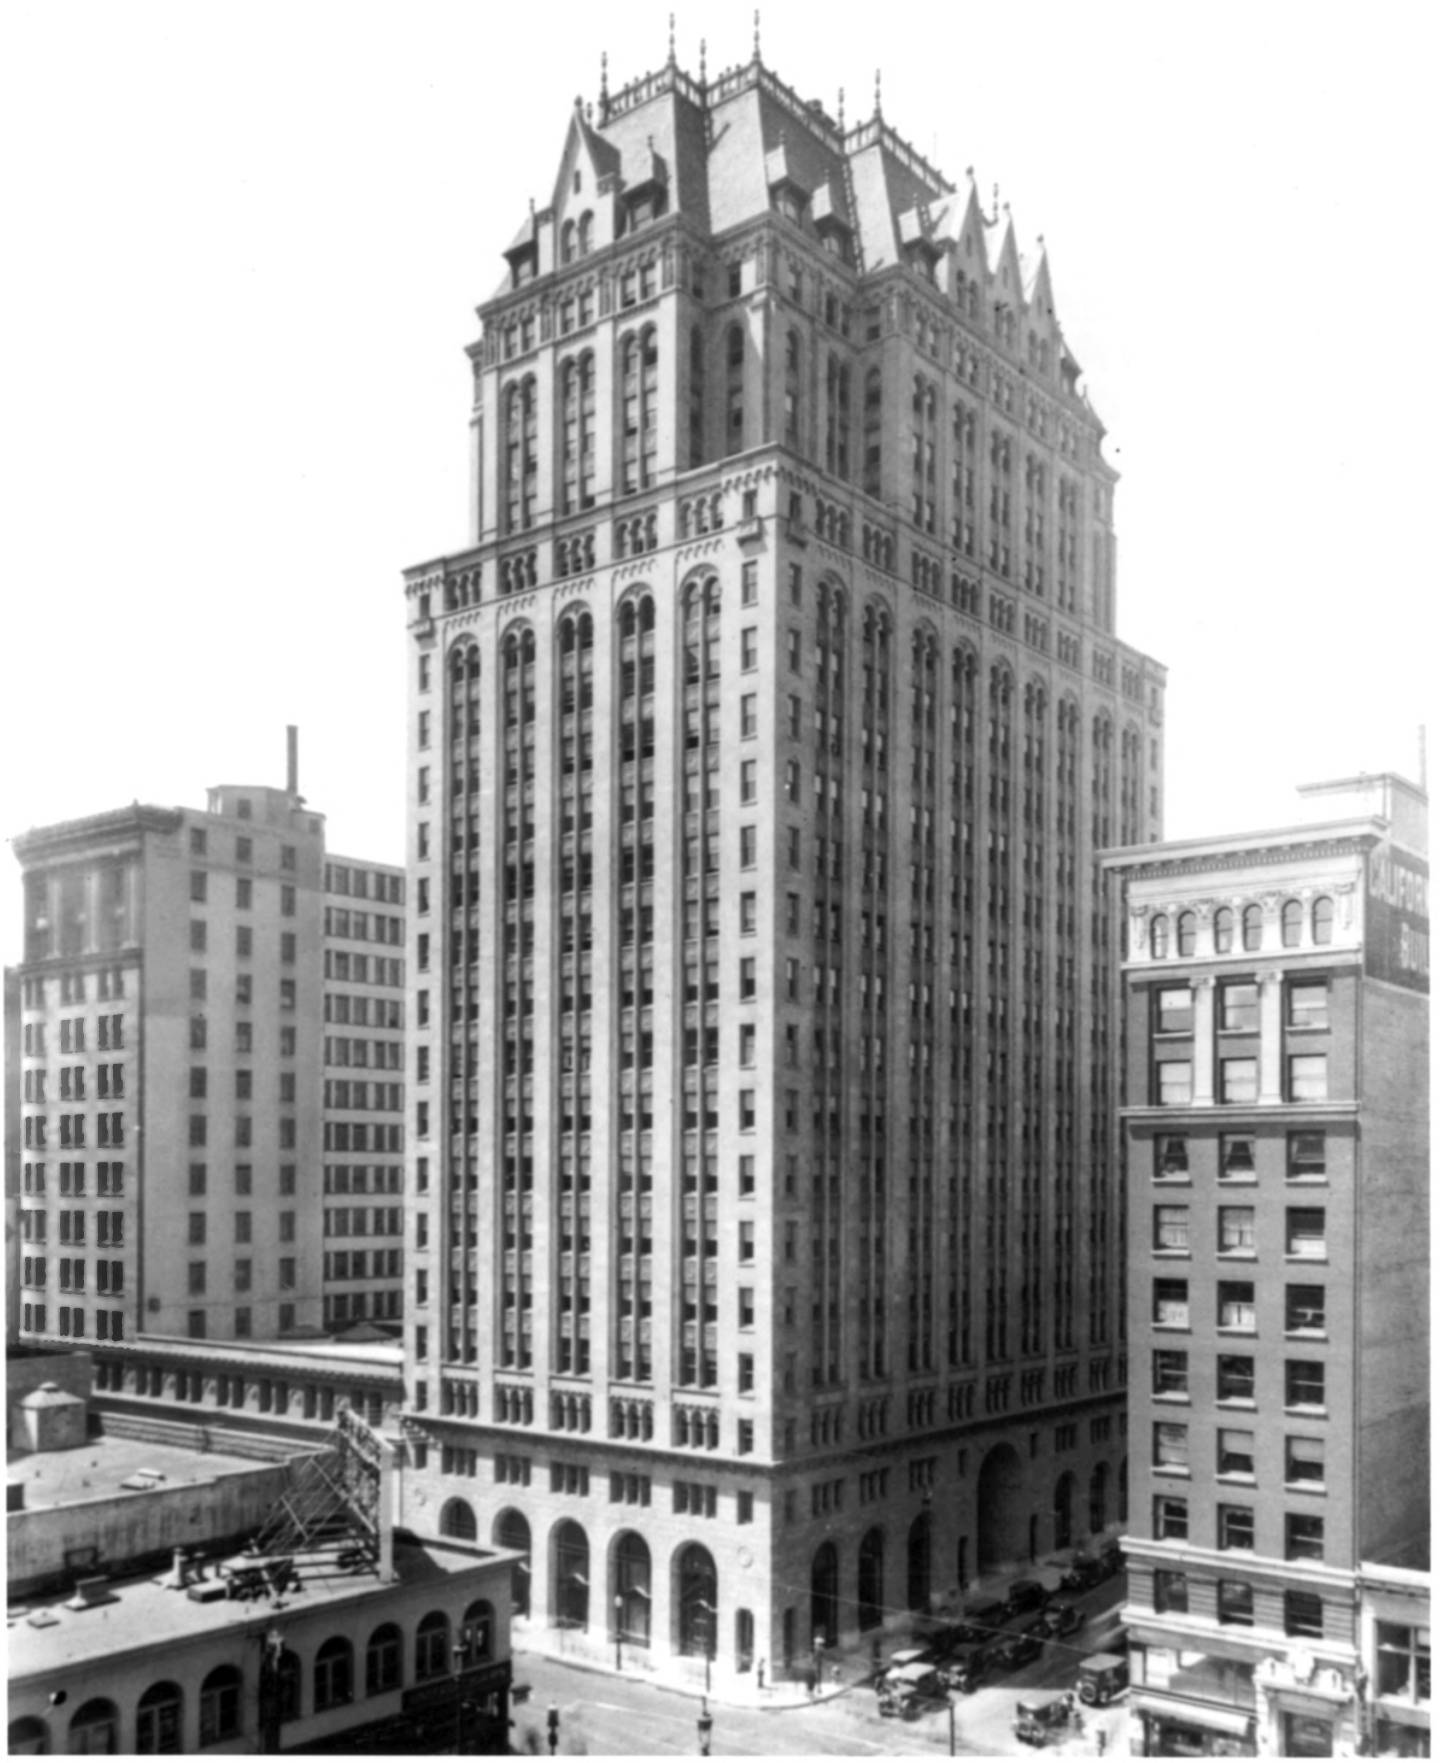
Photo One
Circa 1930

Looking Southwest at the NORTHEAST CORNER of the Building, the 160' long Sutter Street elevation with its 2-STORY CENTRAL ENTRY ARCH is ON the Right. The 100' long Montgomery Street elevation is visible in the foreground and to the left, and shows the ORIGINAL GROUND FLOOR STORE FRONT design.

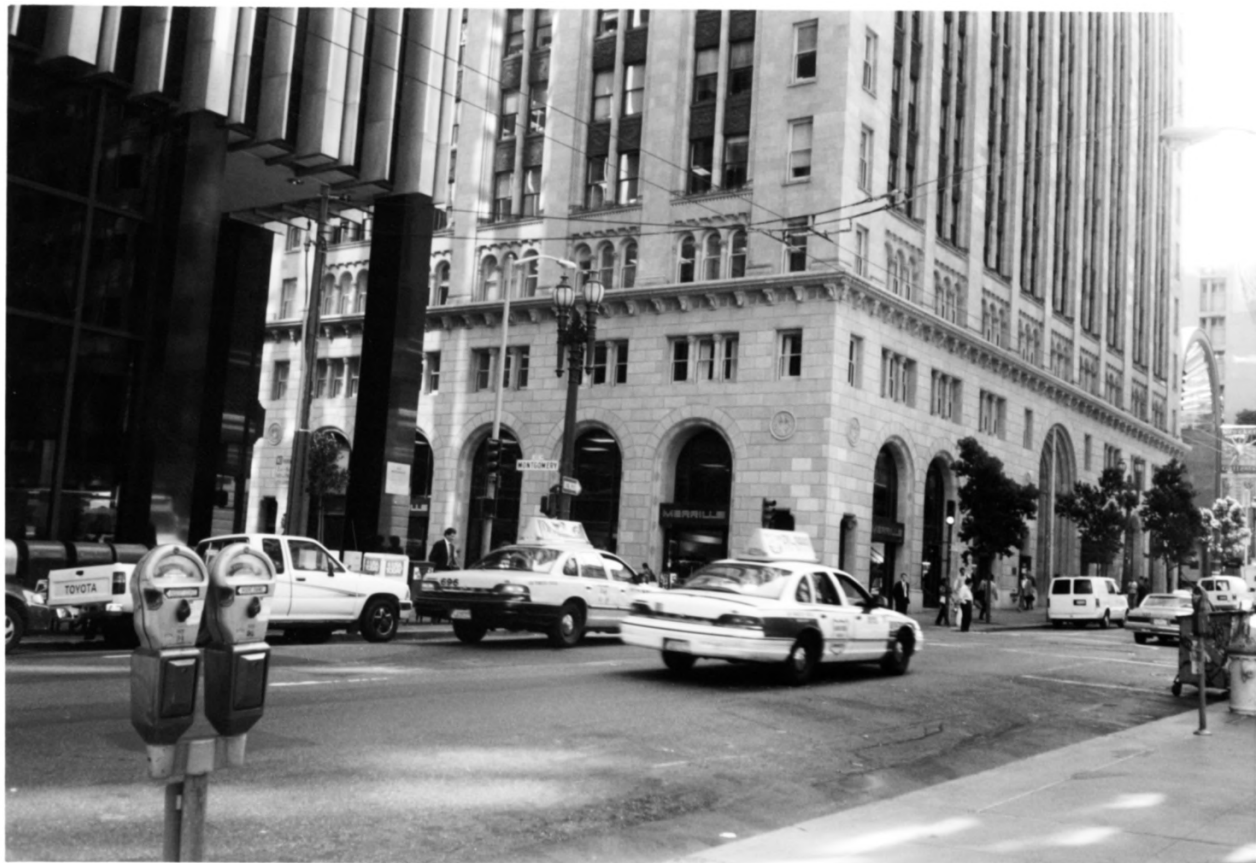
Photo 2

Looking Southwest AT THE Northeast corner of the Building today. Street trees are visible along SUTTER Street, right, with the DARREL-Vaulted CONTEMPORARY GLASS CROCKER GALLERIA just west of the Building. The 1960's 44 Montgomery Street is PARTIALLY visible ON THE FAR left of the photo.

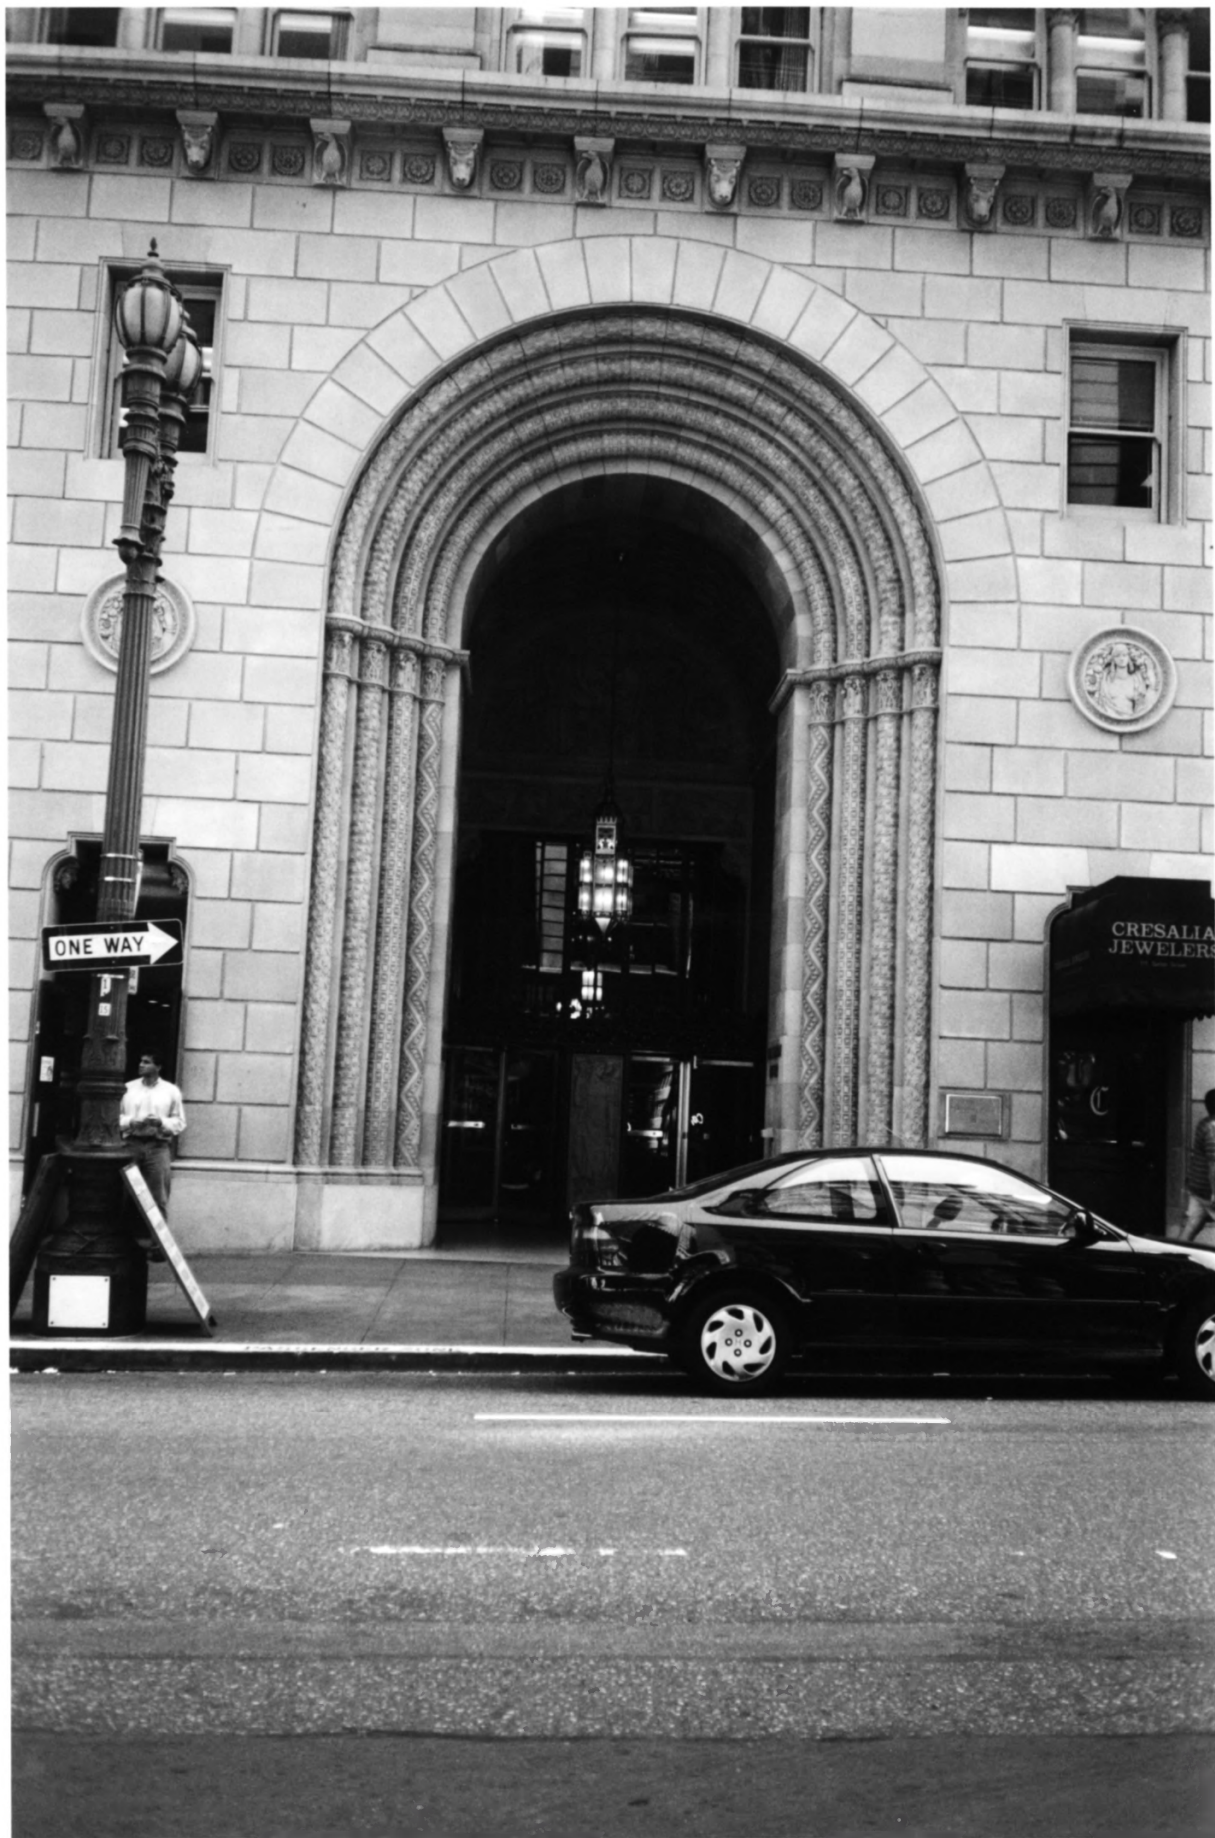
Photo 3

Looking South across Sutter Street at the central entry arch of the Hunter-Dulin Building. Note small openings on either side leading to commercial spaces; above each is a medallion representing one of the four seasons. Windows above medallions are at the second floor, the space originally occupied by Hunter, Dulin & Company. The entry vestibule with its hanging chandelier is visible beyond the arch. SEE Photo 6.

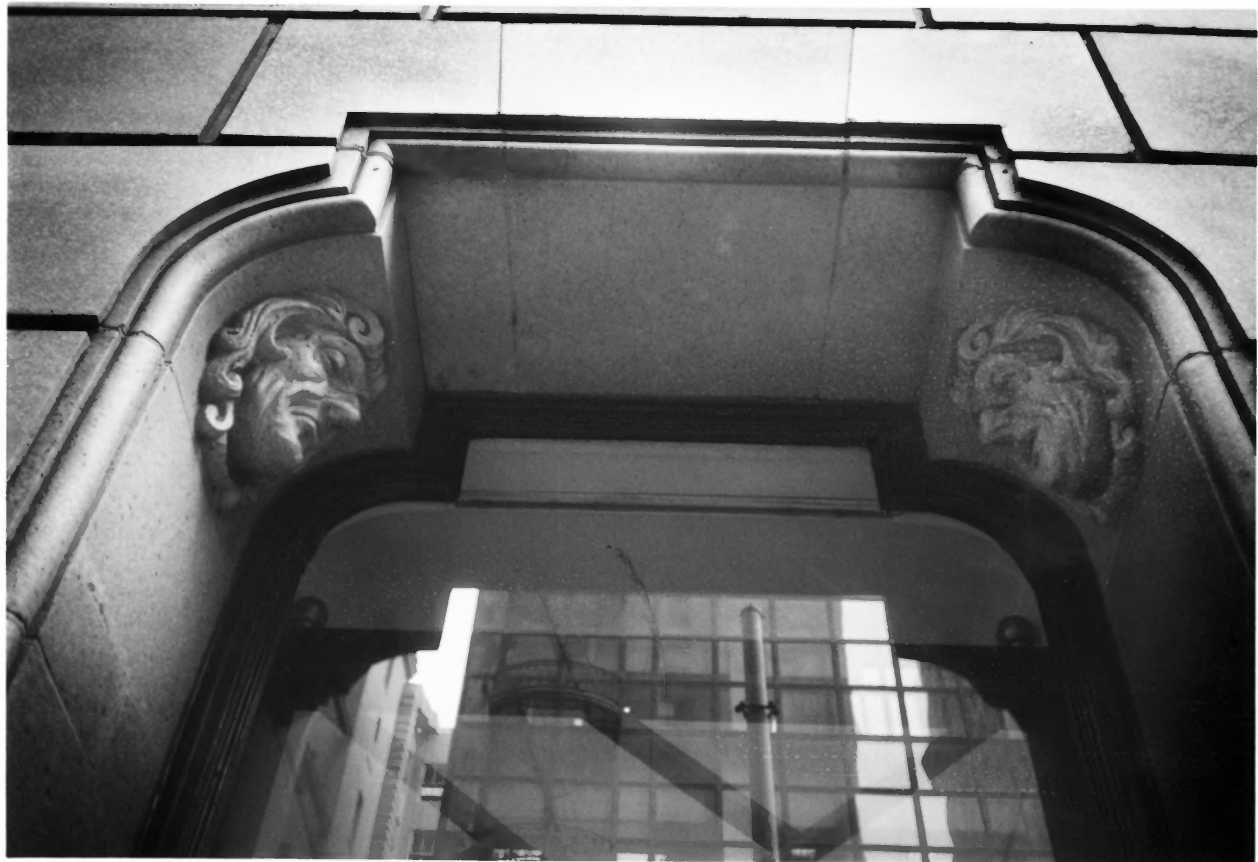
Photo 4

Close-up of a typical small opening with flat header. Of particular interest are the two men's faces in terra cotta that look across the opening at one another.

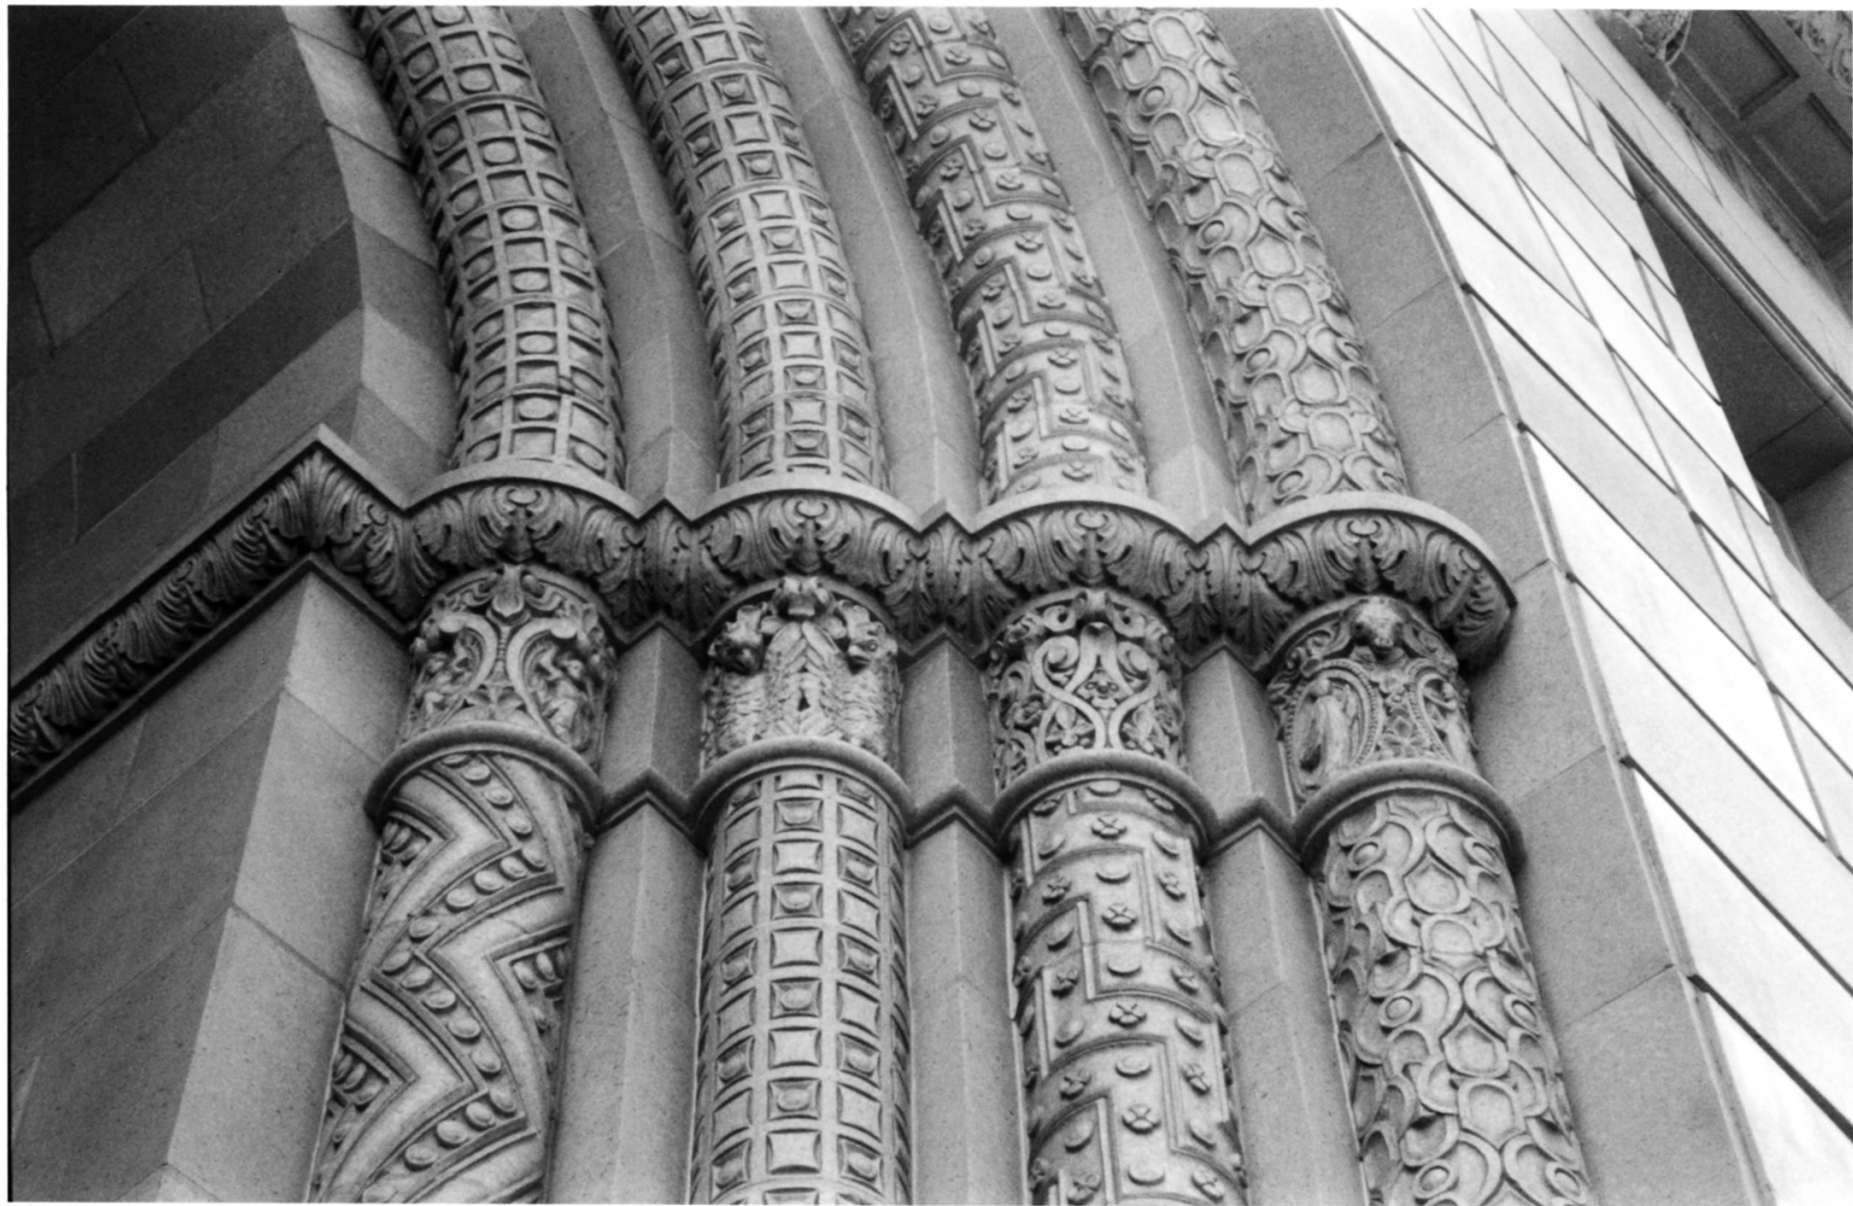
Photo 5

Looking Southwest at the WESTERLY PORTION of the CENTRAL ENTRY ARCH. This Close-up View highlights the different but compatible pilaster patterns, each with a different and intricate Capital. Note that the pattern of the inner-most pilaster changes above the Spring line while patterning of the others continues above.

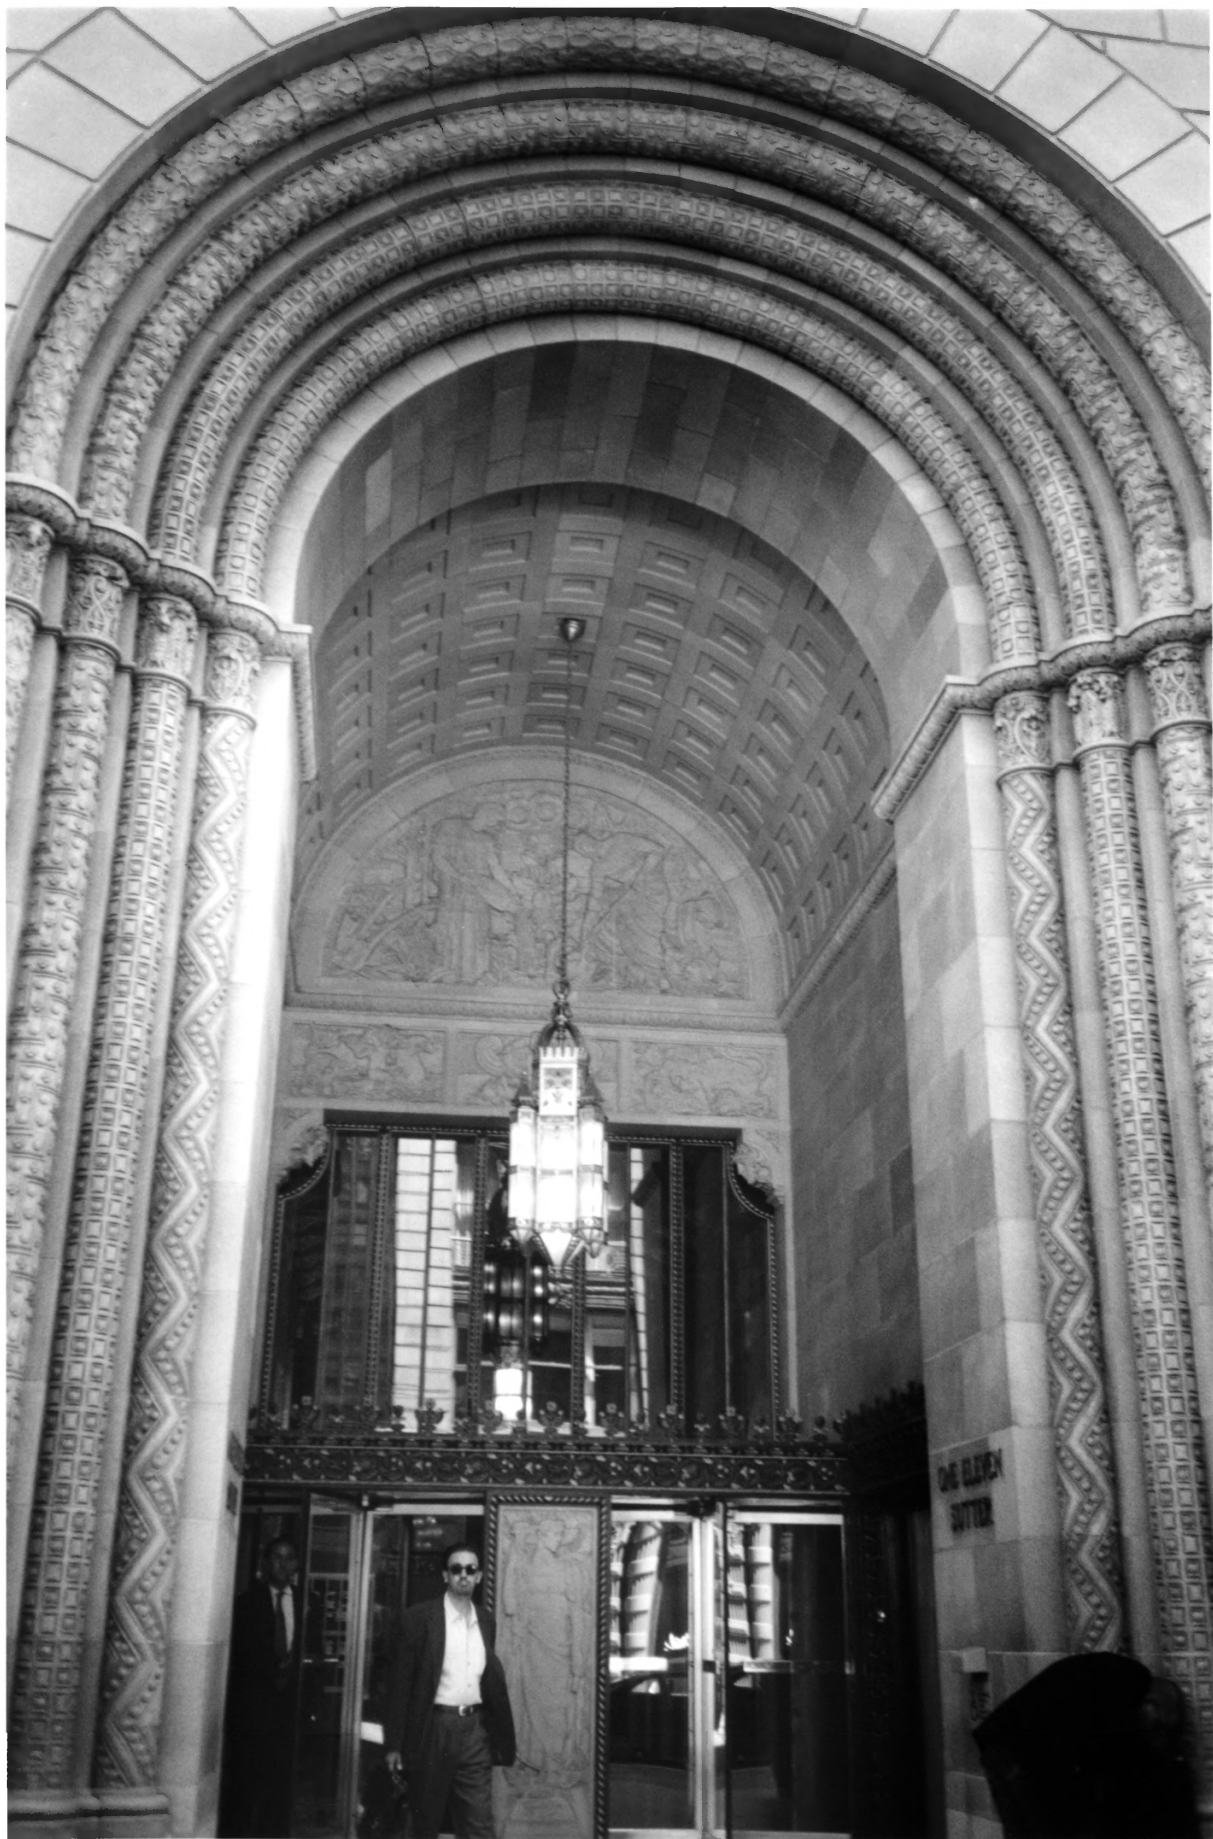
Photo 6

Looking South through the CENTRAL ENTRY ARCH to the PARREL-VAULTED COFFERED CEILING of the entry vestibule from which the MULTI-FACITED GLASS AND BRONZE ENAMELED LIGHT FIXTURE HANGS. Note the CRESTED METAL ENFRAMEMENT ABOVE the REVOLVING DOORS that CONTINUES along the SIDE WALLS. ABOVE and somewhat RECESSED is a FACITED BRONZE AND GLASS element that MAKES the EXTERIOR VISIBLE FROM and BRINGS light to the LOBBY. See PHOTO 20. Note that this element is pulled back at the TOP of each side to allow for the HEAD of a man used AS a BRACKET.

The TYMPANUM AND TRI-PARTITE PANEL beneath ARE IN RELIEF, and are the SAME COLOR, MATERIAL and DESIGN PATTERN AS the RELIEF PANEL of MERCURY SEPARATING the REVOLVING DOORS.

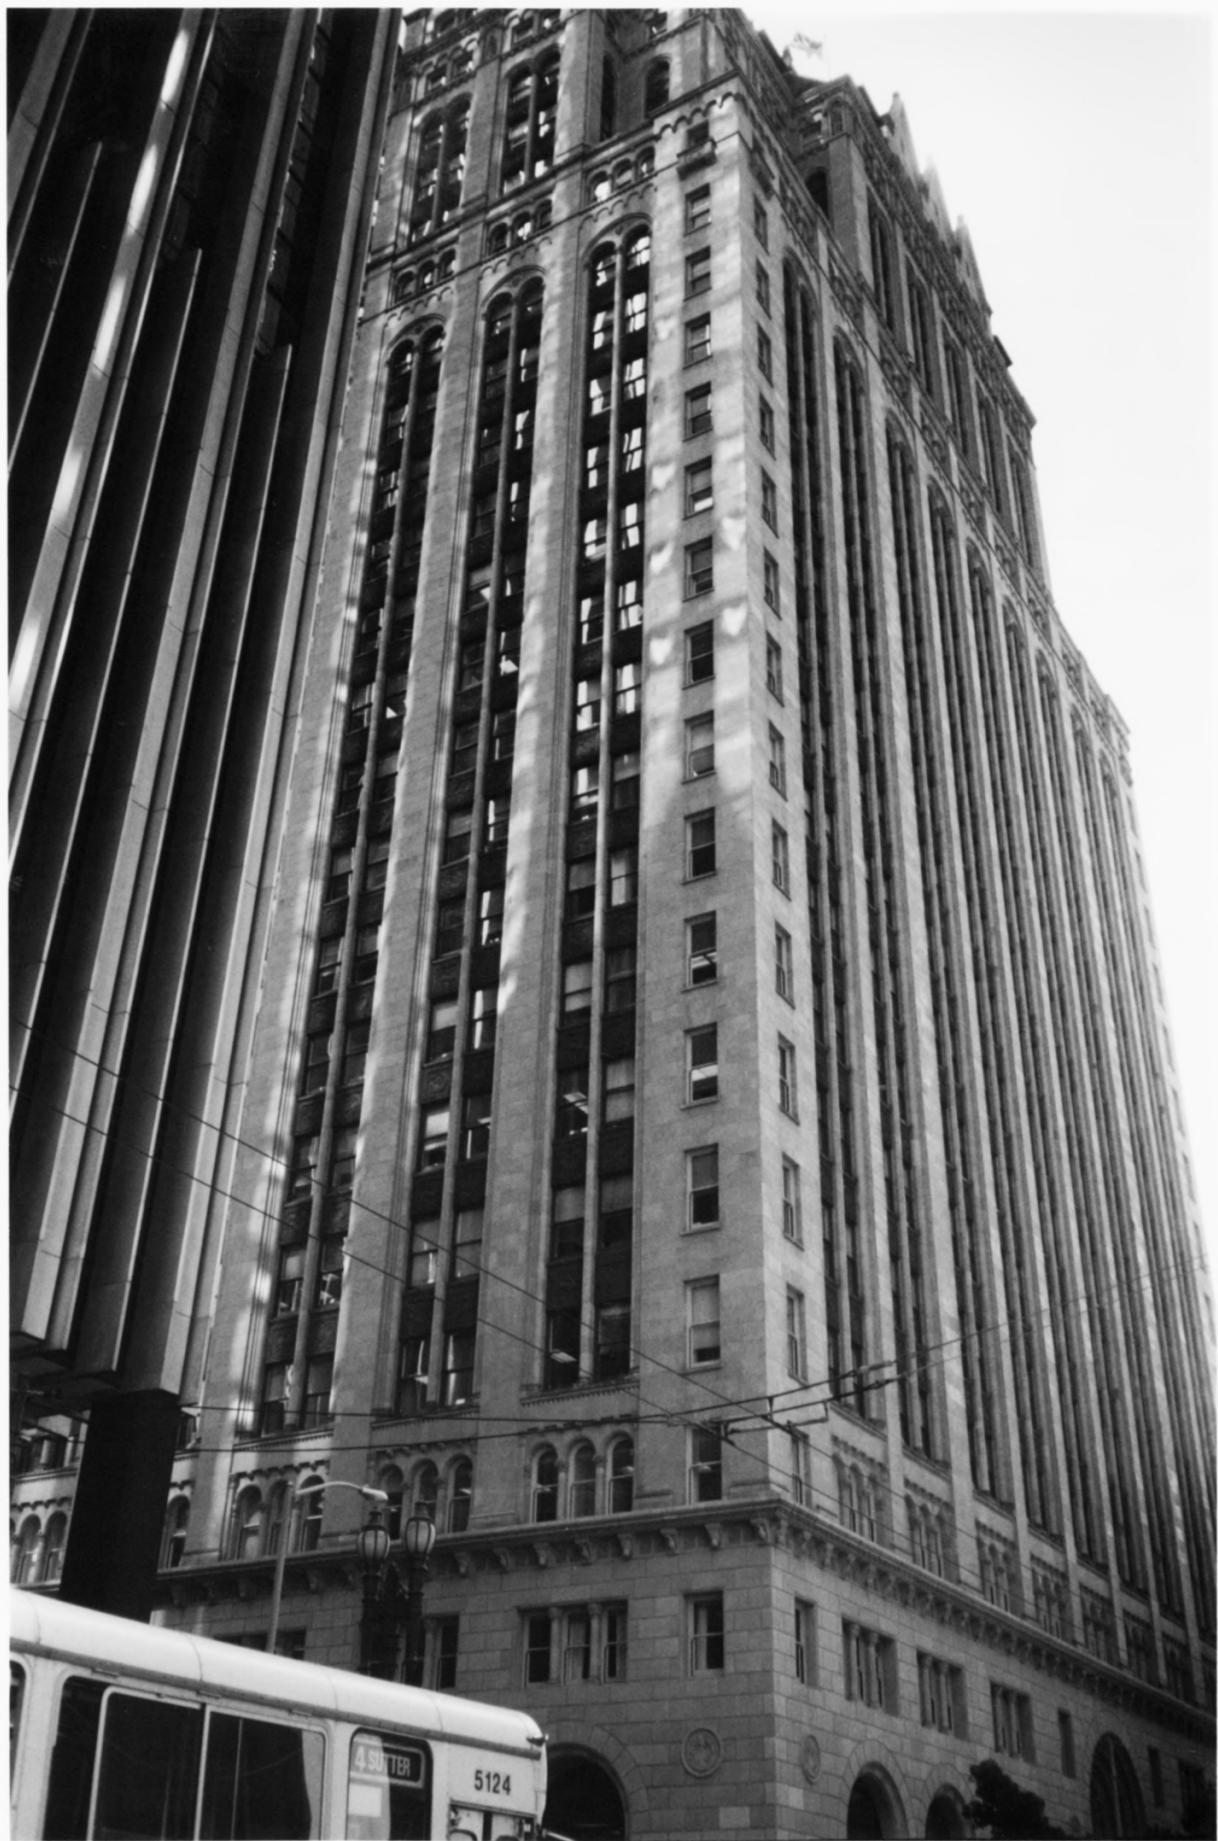
Photo 7

Looking South West AT the NORTH (Right) OR SUTTER Street Facade, and a PORTION of the MONTGOMERY Street (EAST) Facade which is PARTIALLY interrupted. by the 1960's 44 MONTGOMERY, ~~Street~~. ACROSS the Street. Photo Shows PORTIONS of the SECOND FLOOR which is PART of the Building's BASE, but Emphasizes the Building's 13-STORY Shaft in Floors 3 through 17. PORTIONS of the Building's PARTIALLY-RECESSED CAPITAL are also visible.

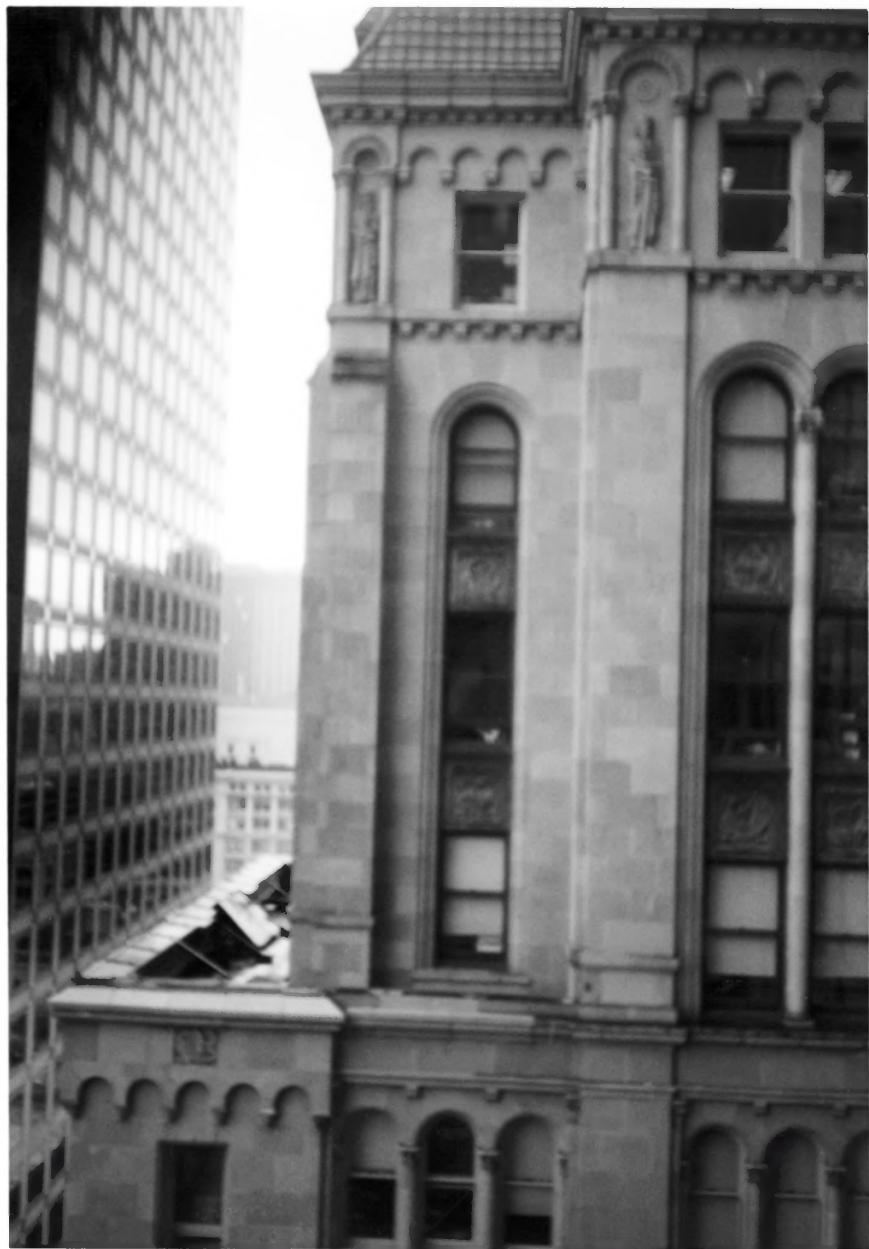
Photo 8

Close-up showing typical wide CORNER
PIER PIERCED with a SINGLE WINDOW, AND
TRIO of ROUND-ARCHED WINDOWS AT
the 17th FLOOR, the TOP of the Building's
Shaft. Photo also shows a PORTION of
the Building's RECESSED CAPITAL with
typical ORNAMENTATION.

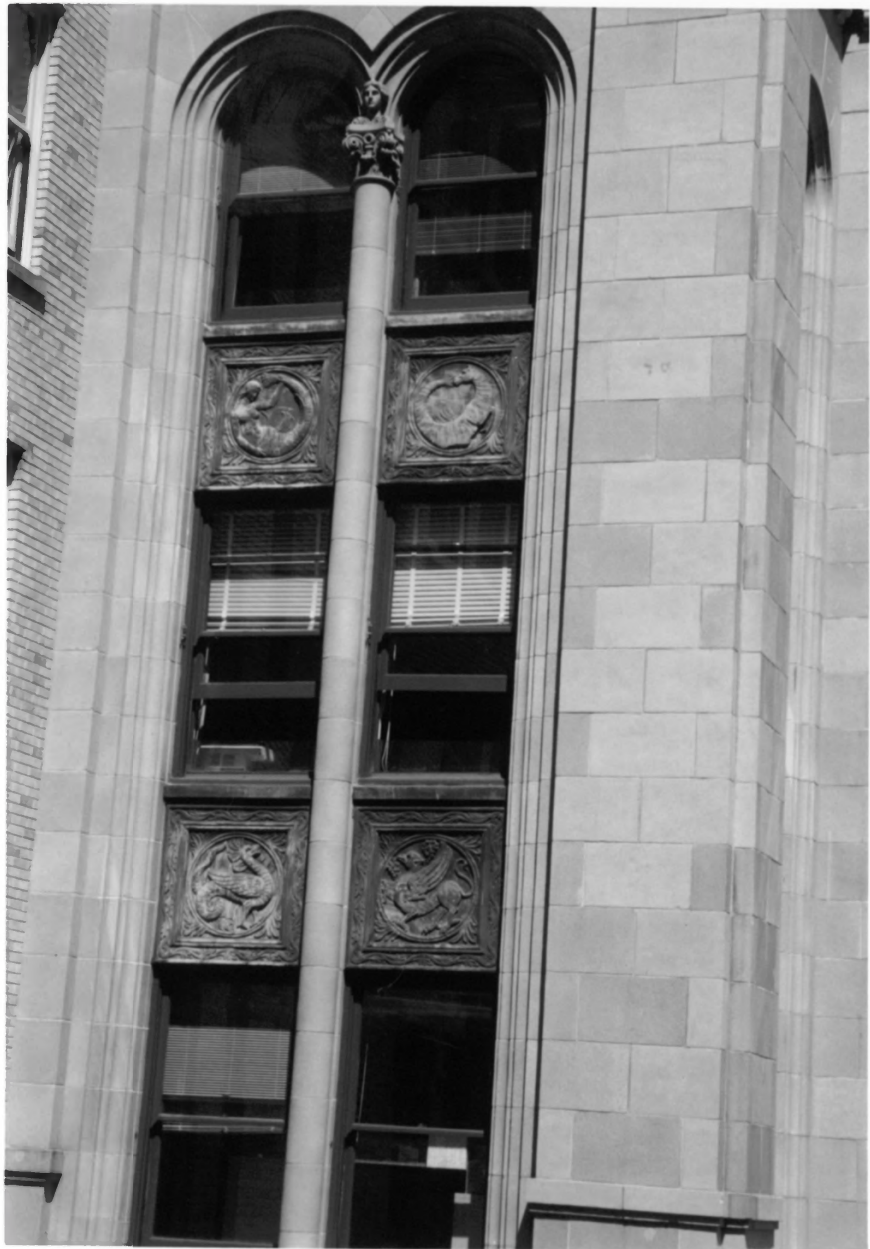
Photo 9

LOOKING NORTHEAST AT THE WEST
FACING WALL OF THE EASTERLY WING OF
THE BUILDING TO OBTAIN A CLOSE-UP VIEW
OF THE FOUR DIFFERENT GRAY-BLACK,
LEAD-COATED, COPPER SPANDREL PANELS
IN RELIEF THAT SEPARATE WINDOWS IN
EACH BAY FROM ONE ANOTHER ALONG
THE PRIMARY ELEVATIONS, AND ABOVE
THE 17TH FLOOR ON SECONDARY ELEVATIONS.

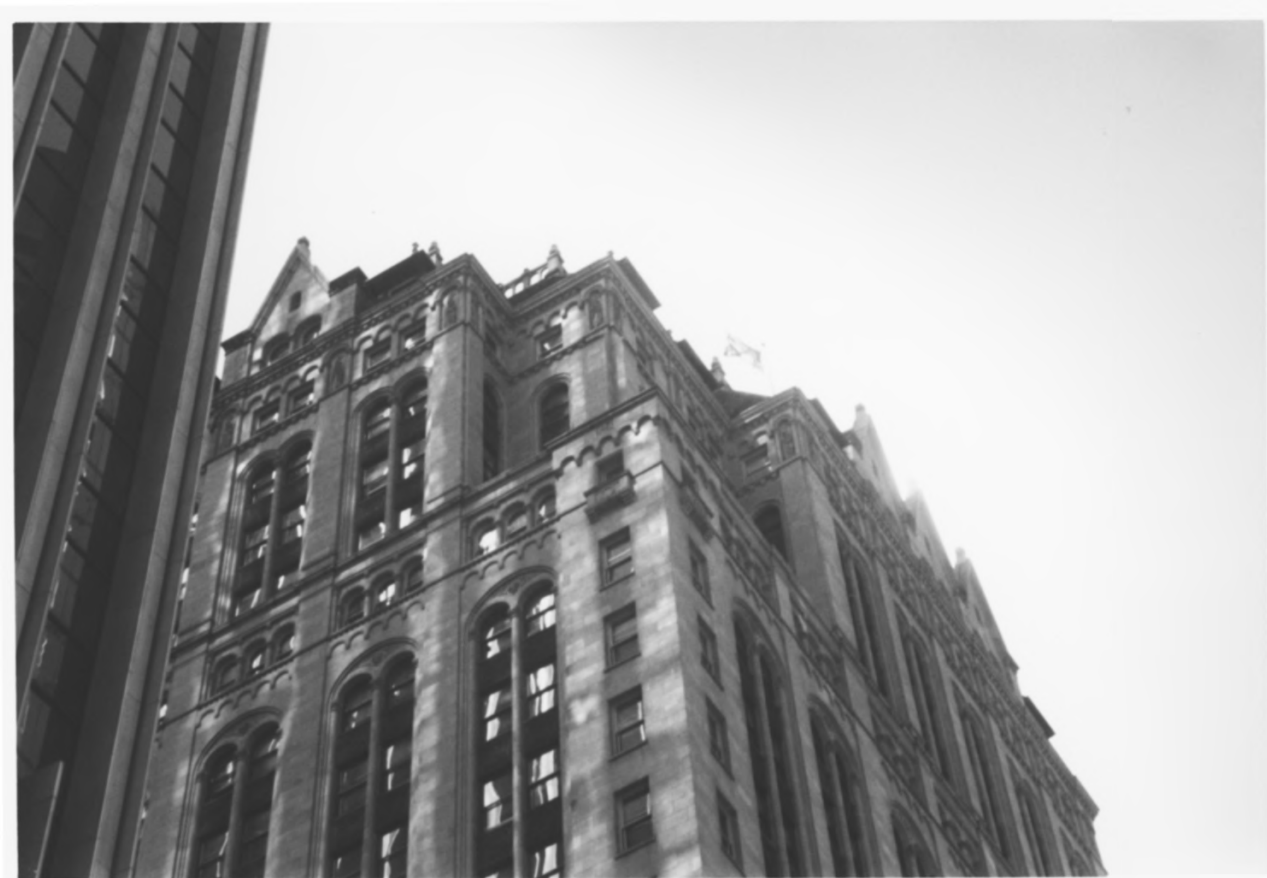
Photo 10

Looking Southwest at the East (Montgomery Street)
and North (Sutter Street) elevations, showing
detailing in Floors 13 through 17, and in the building's
PARTIALLY RECESSED Capital.

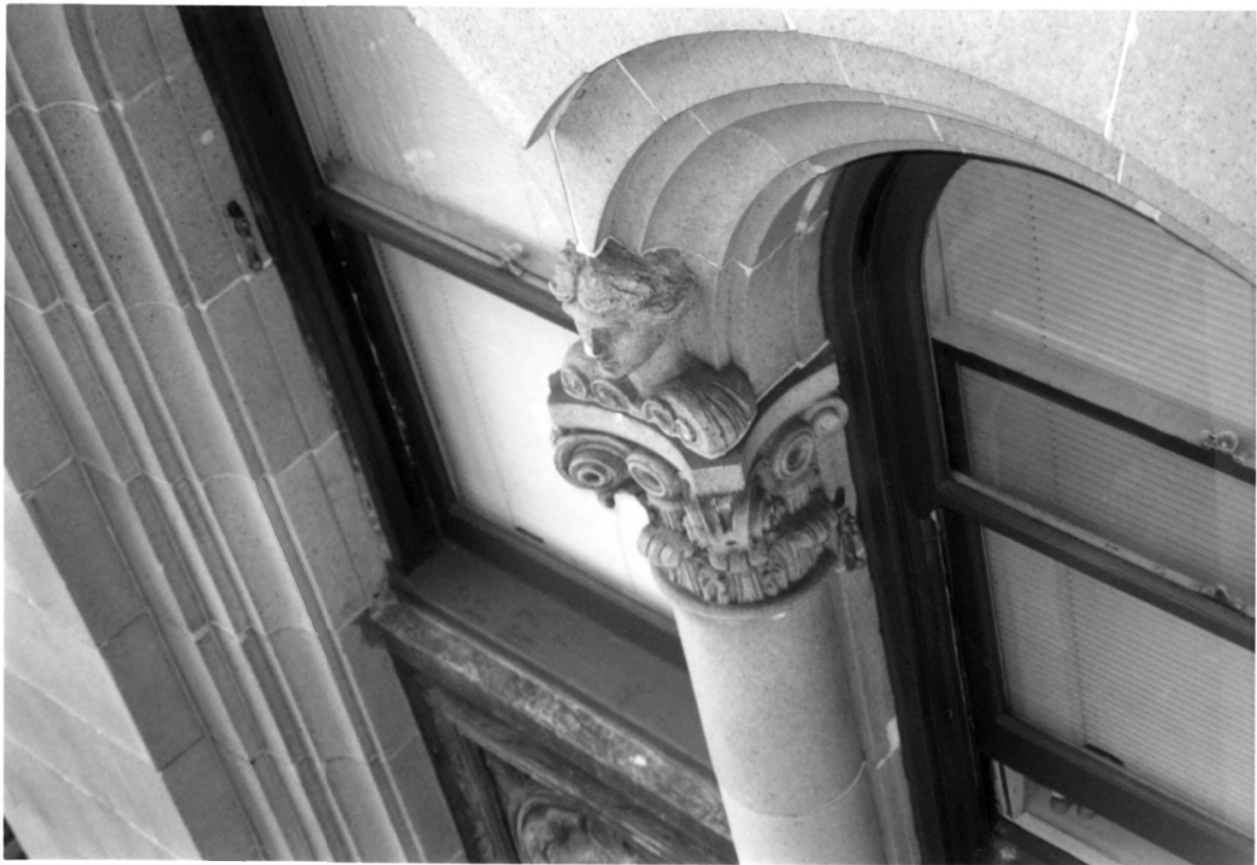
Photo 11

Detail (typical) of woman's head surmounting
ORNAMENTAL PILASTER CAPITAL in 20th Floor
Arched window which signifies completion of this
DAY TIER.

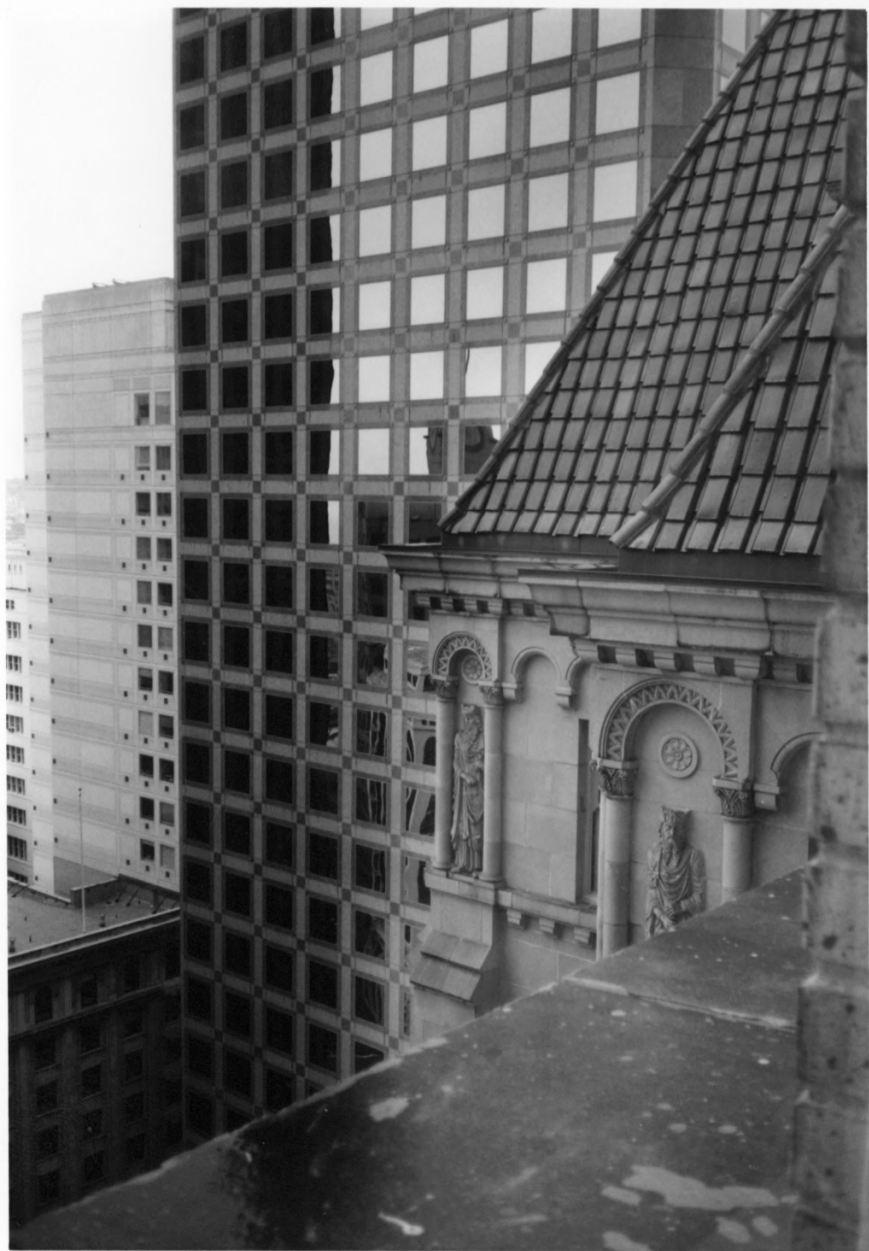
Photo 12

Looking Southwest at the EAST
Facing wall of the West wing of the
Building at the 21st Floor, showing
two of the CROWNED MEN standing on
Pier caps and ENFRAMED by ORNAMENTAL
ARCHES SUPPORTED BY PROJECTING
PILASTERS WITH HIGHLY ORNAMENTED
CAPITALS. Note also a PORTION of the
steeply pitched, TERRA COTTA CLAY
MANSARD ROOF. Beyond is a PORTION of
the 1980's CROCKER/PACIFIC TELEVISION
Building.

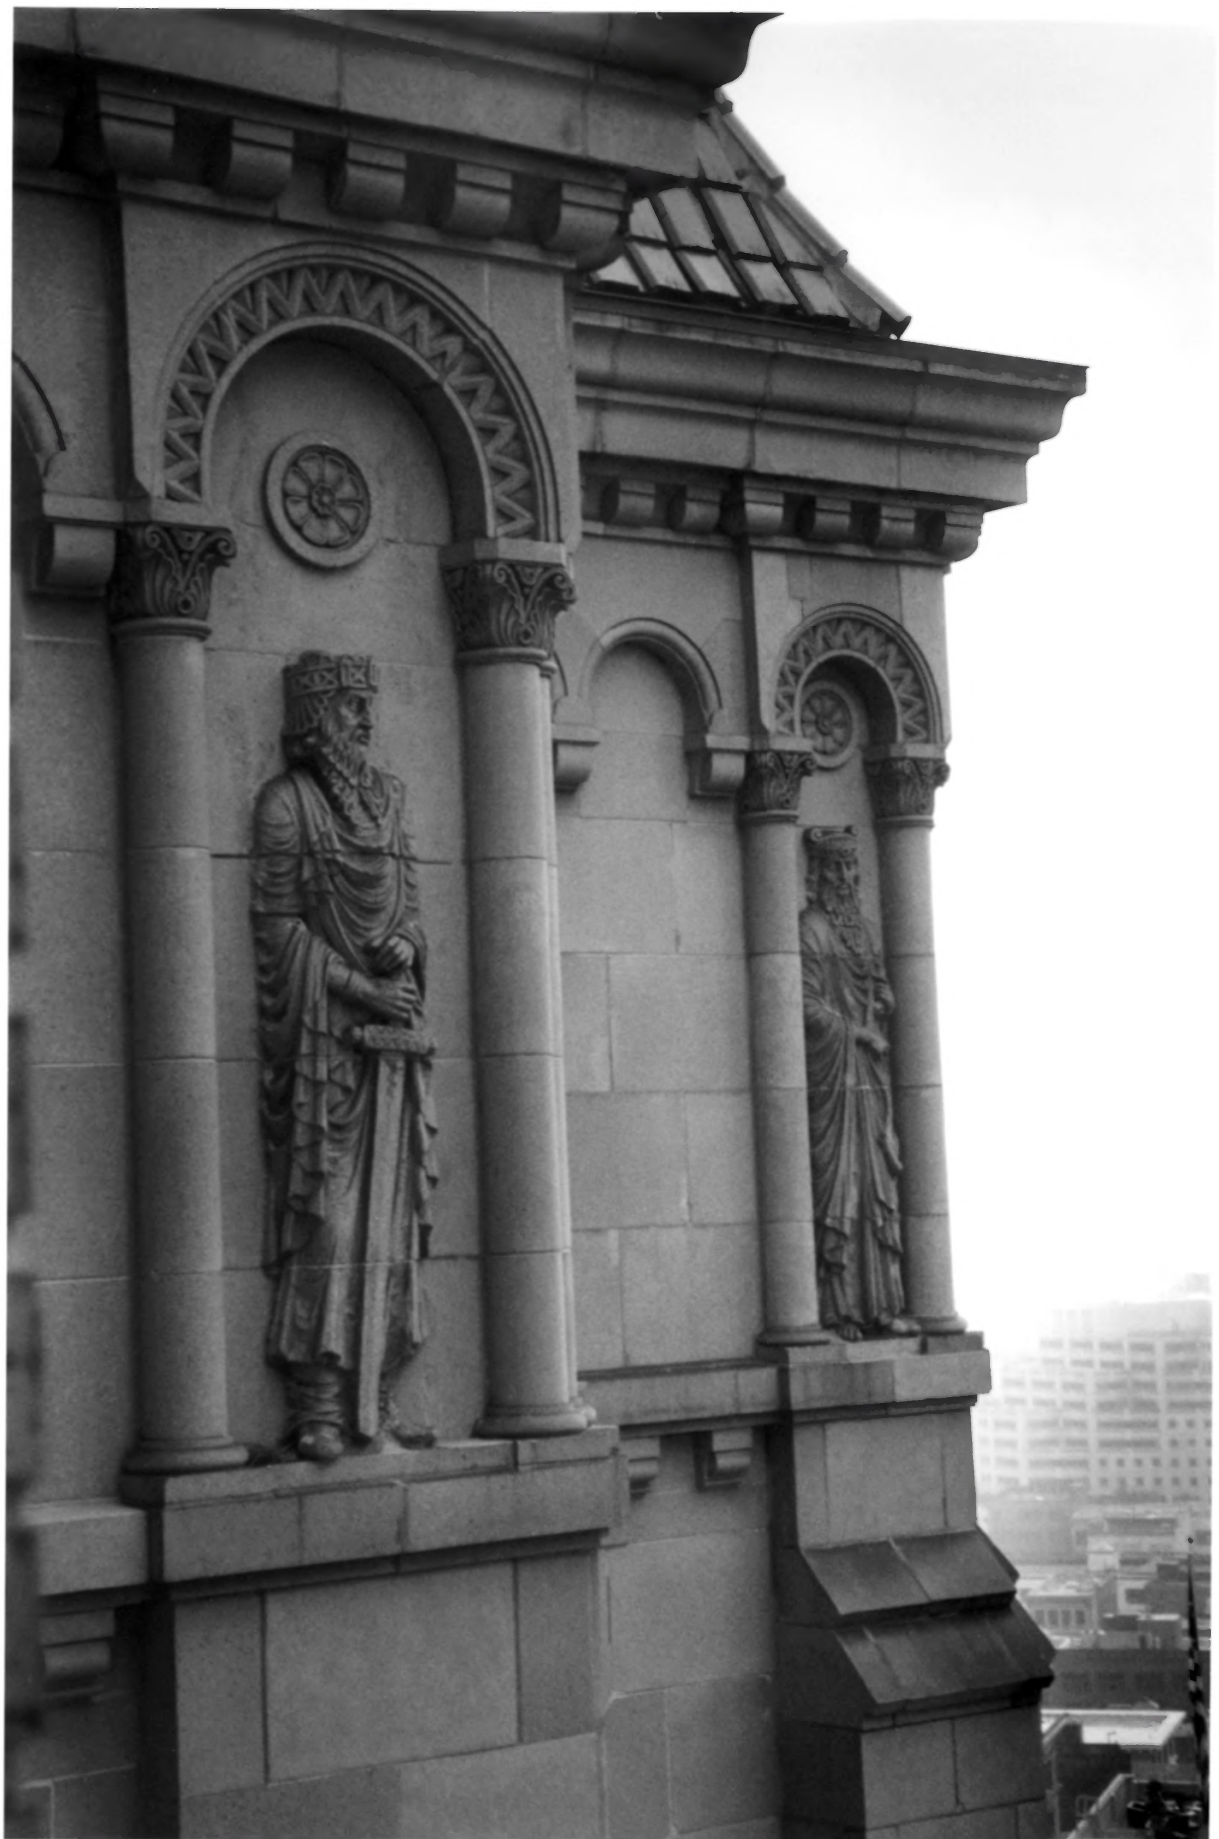
Photo 13

Looking SOUTHEAST at the West face of the EAST
Wing of the Building's 2ND FLOOR, Showing the Crowned
MEN at Close RANGE.
