The Hunter-Dulin Building
SAN FRANCISCO, CALIFORNIA

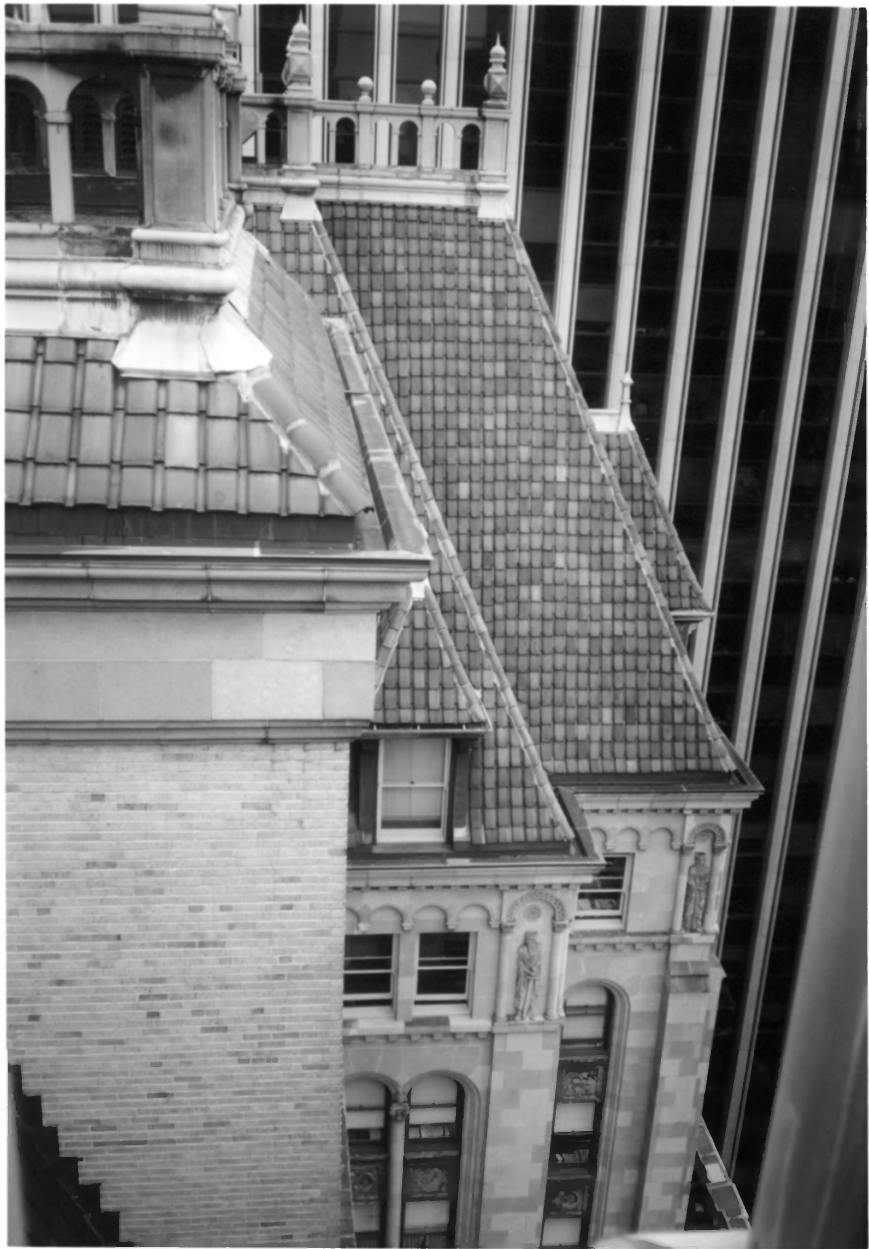
Photo 14

Looking EAST From the roof of the West wing at the steeply-pitched glazed terra cotta mansard roof surmounted by round arched parapet with finials, all of which are coated in a richly patinated verdigris copper. Also visible are window bays on floors 18 through 20, and the richly ornamented 21st floor with the crowned figures.

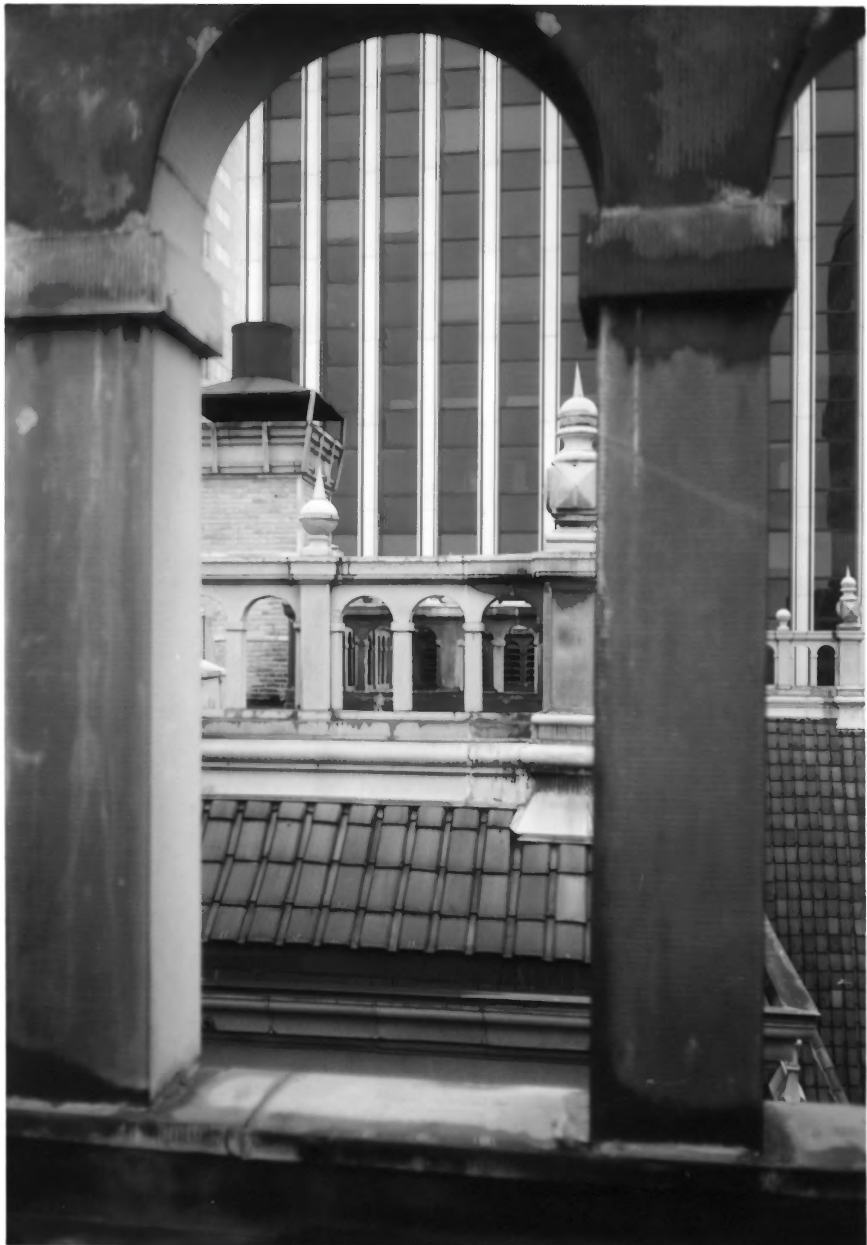
Photo 15

Looking EAST THROUGH COPPER-
COVERED ARCH ACROSS ROOF TO OTHER
PORTIONS OF THE COPPER CLAD PARAPET
SURMOUNTED BY COPPER-CLAD FINIALS
OF VARIOUS SHAPES AND SIZES.

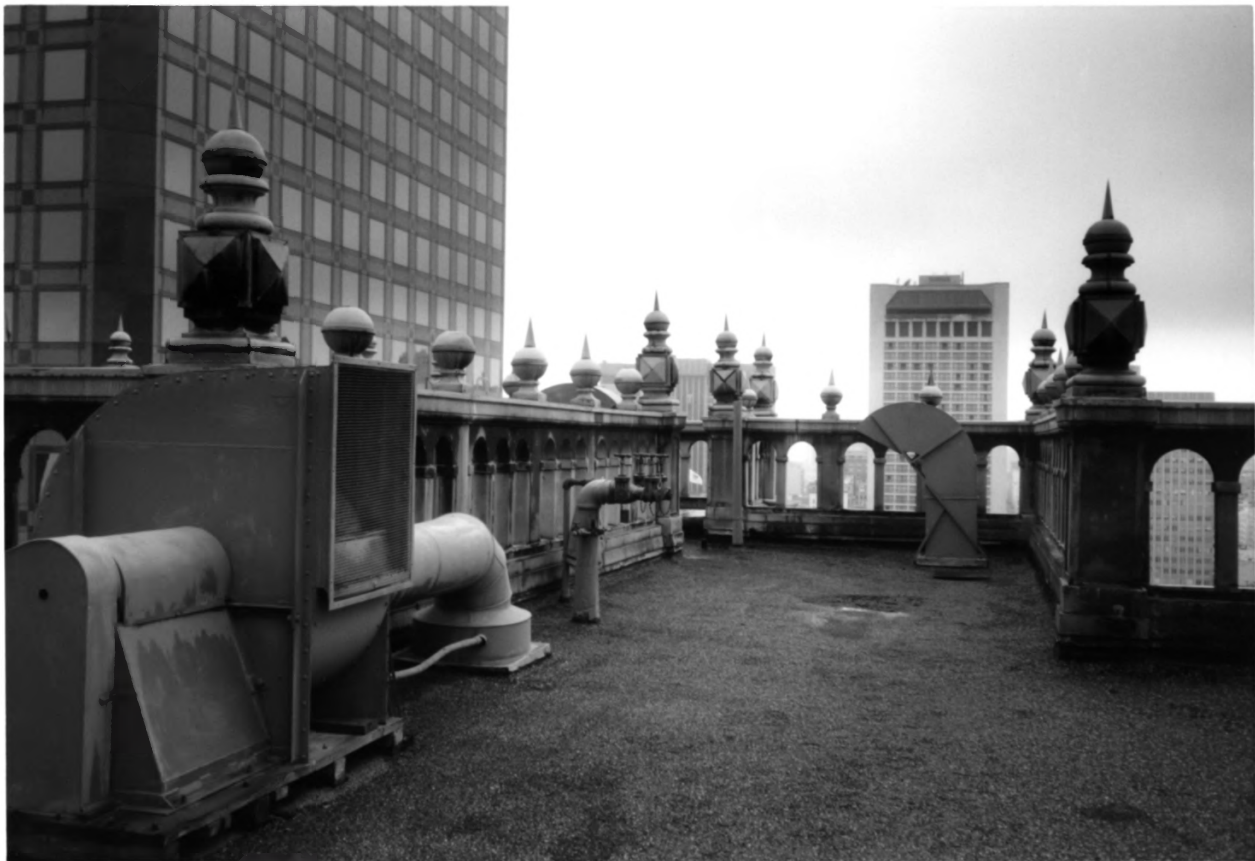
Photo 16

Looking West across roof at copper-clad arched parapet and variously shaped finials. Mechanical vents are concealed behind parapet.

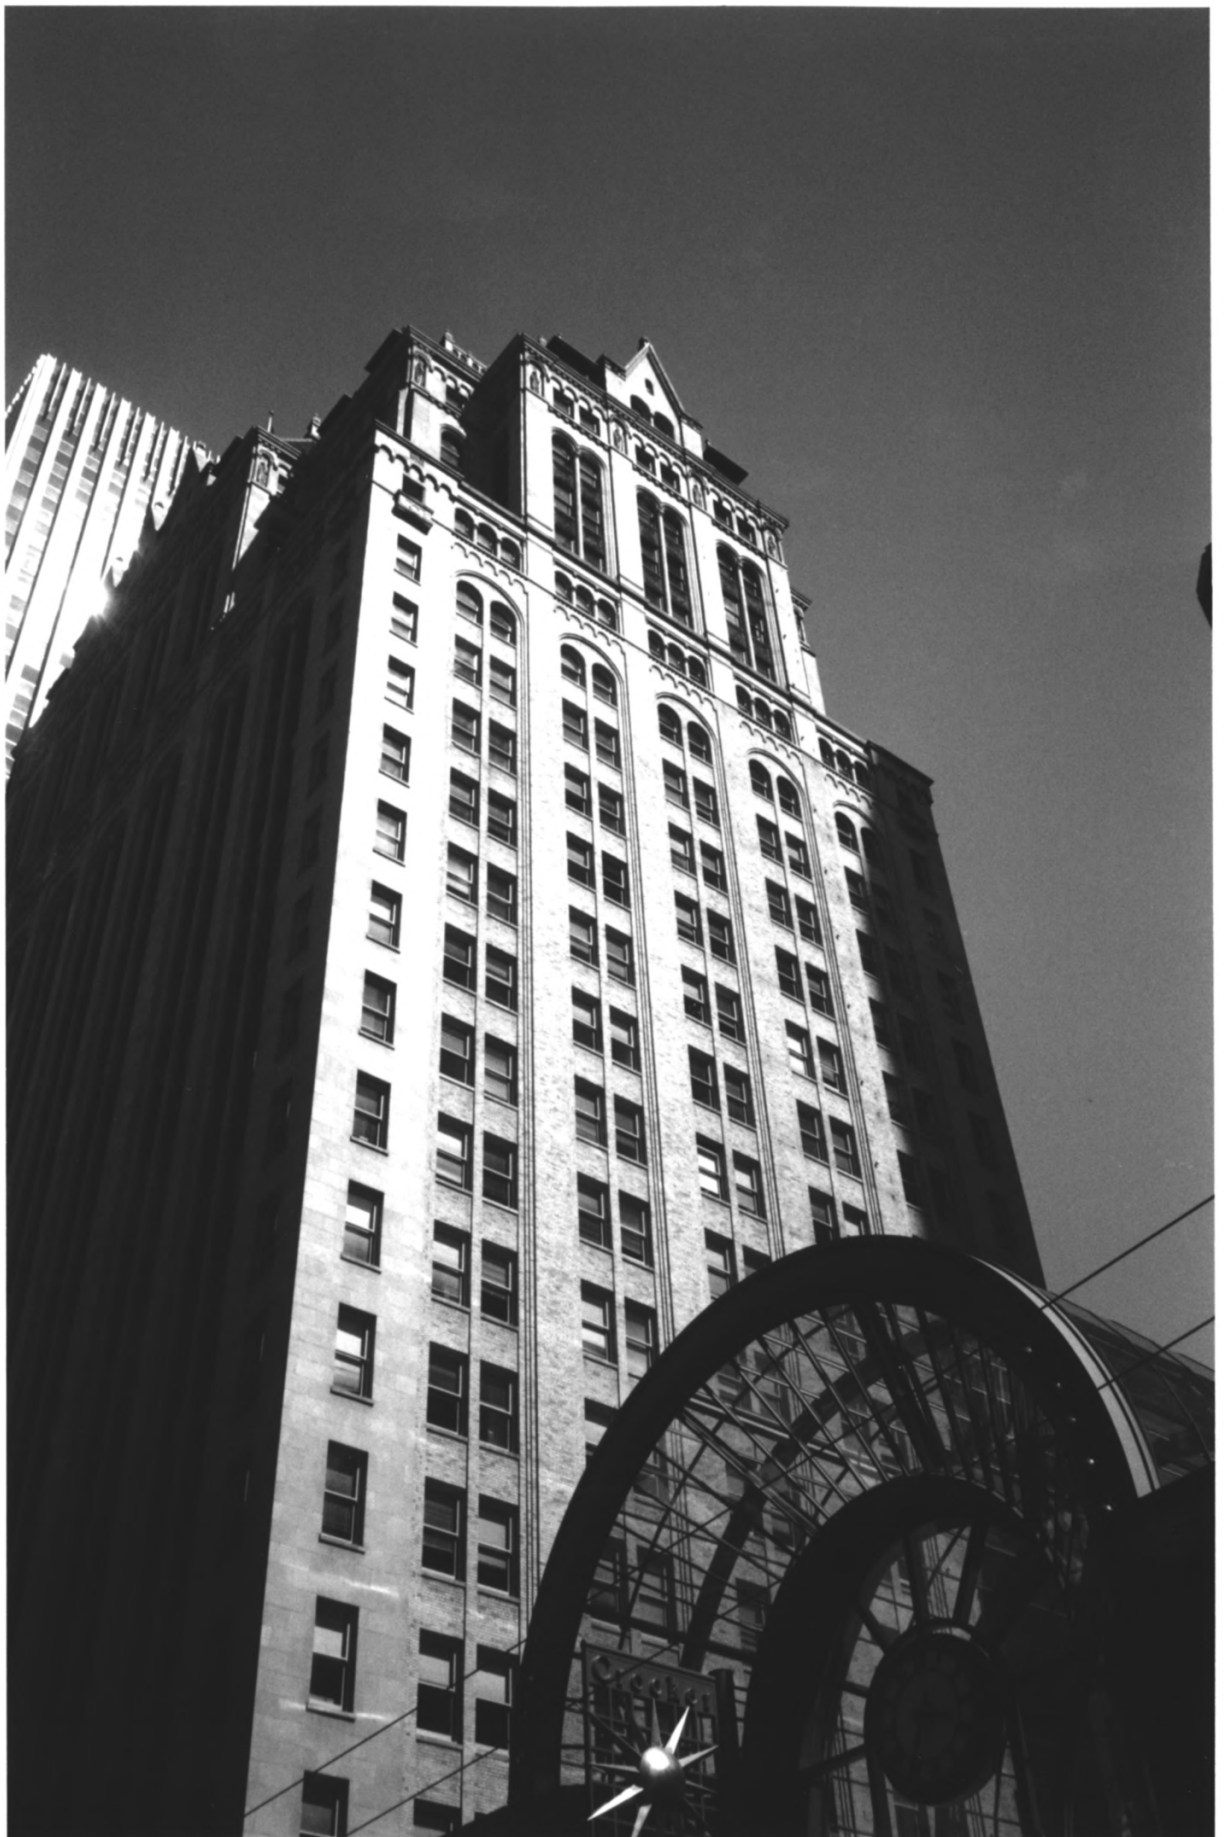
Photo 17

Looking Southwest at the West facade of the building, a secondary elevation. Note that terra cotta cladding is used only at corner bays while arched center bays are clad in "Library Gray Coated Brick". Note, too, that there are NO SPANDREL PANELS here below the 18th Floor. The barrel-vaulted glass element in the foreground (right) is the 1980's CROCKER GALLERY.

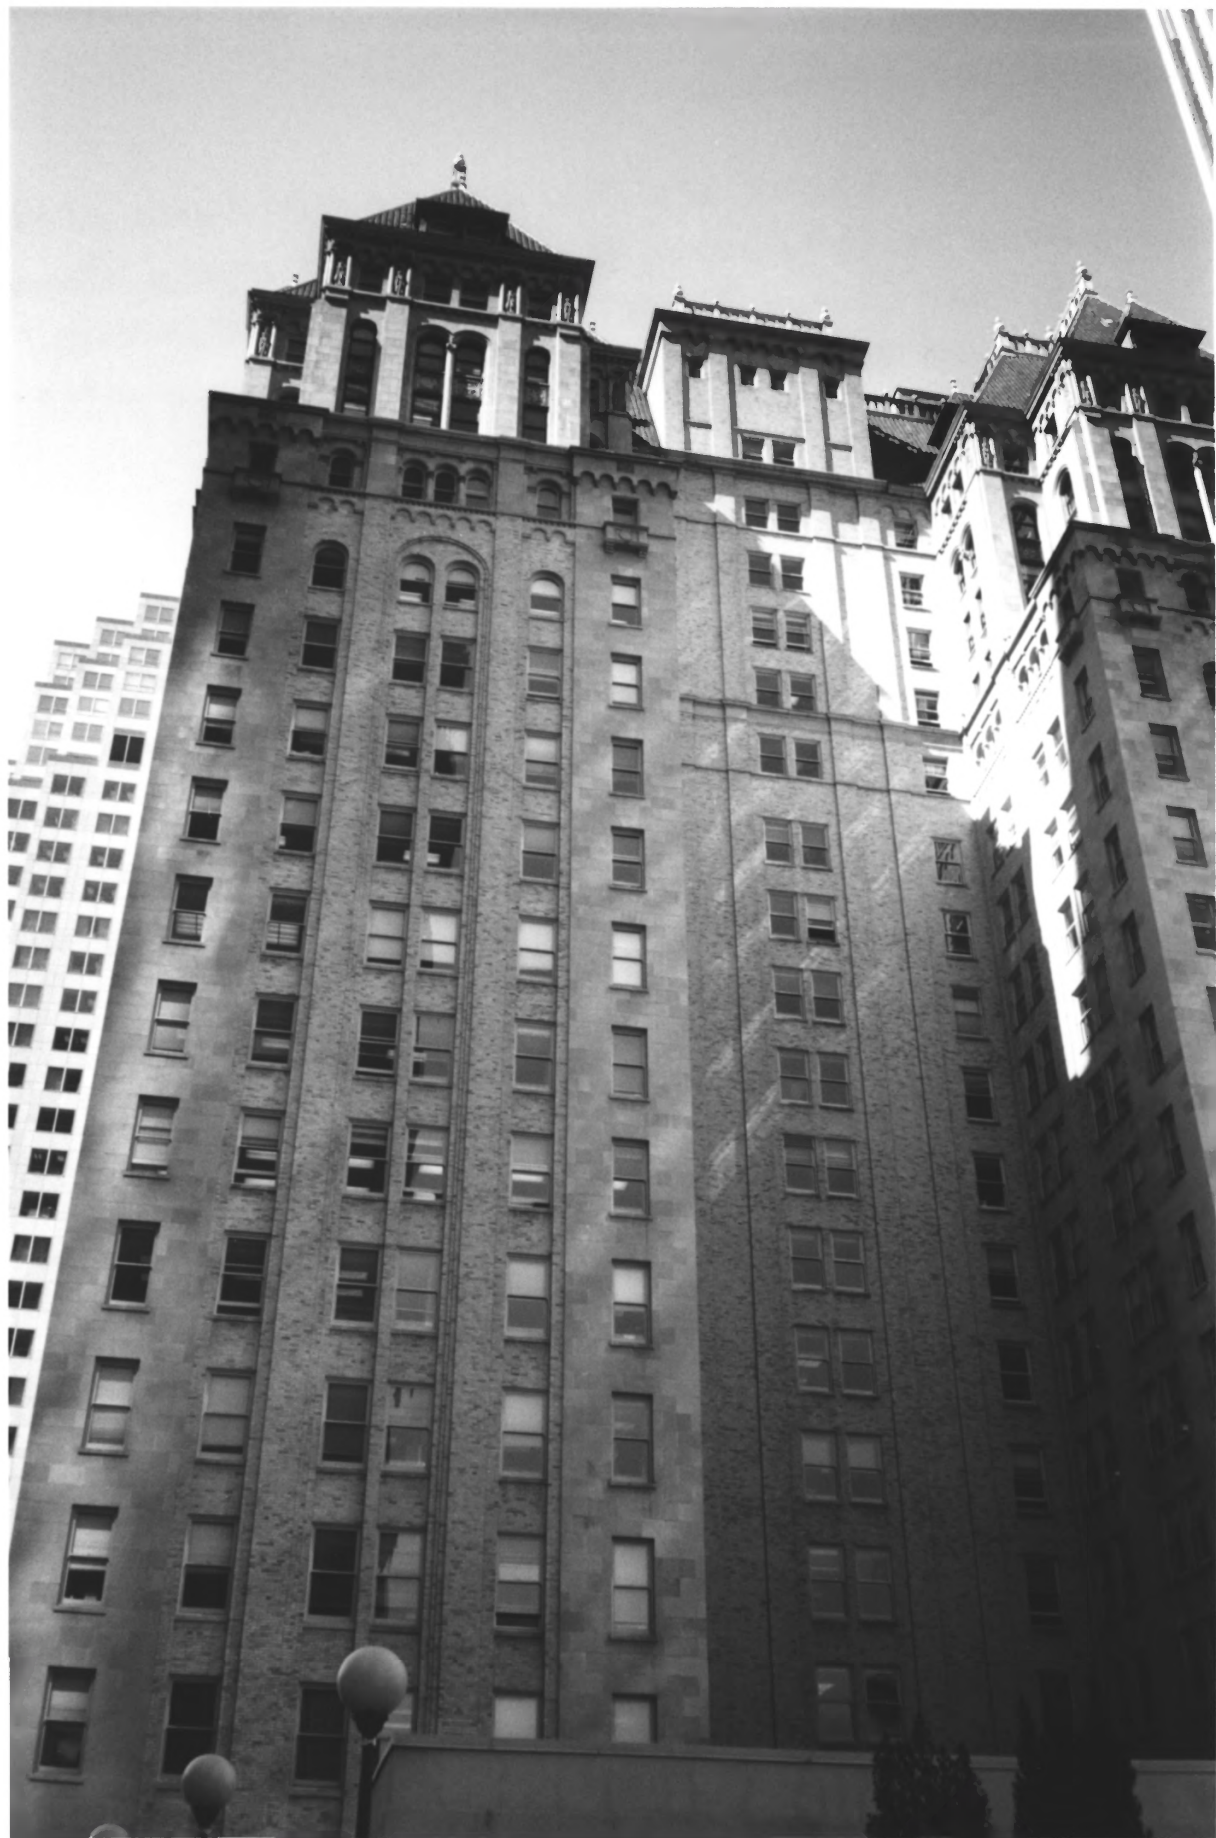
Photo 18

Looking Northeast at the rear elevations of the building with its projecting East and West wings. Cladding is "Library Gray Coated Brick". There are no spandrel panels beneath the 18th floor on this secondary elevation.

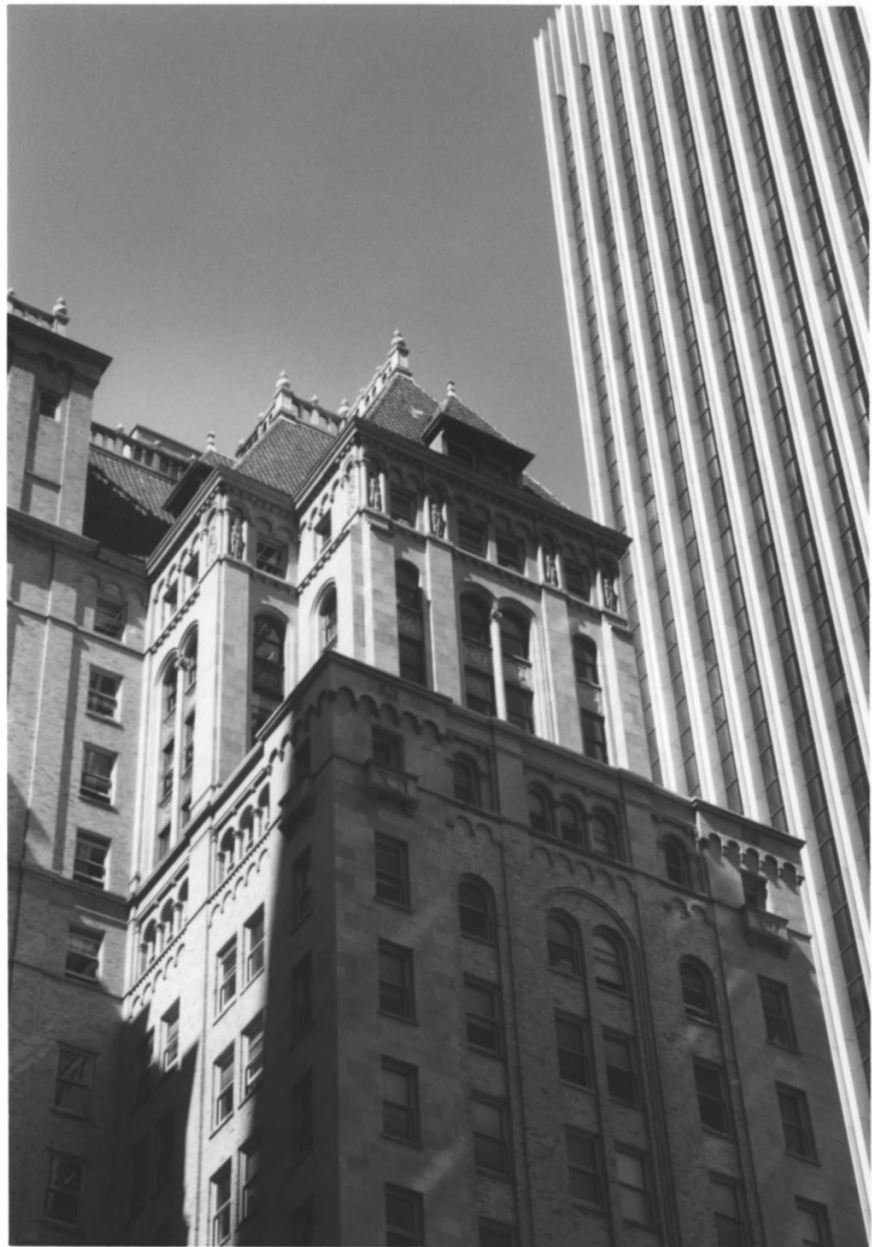
Photo 19

Looking NORTHEAST AT THE SOUTH and
WEST FACADES of the EAST projecting
WING AT the REAR elevation. This
Close-up View Shows the Building's
CAPITAL set BACK AND SURMOUNTED
by complex MANSARD ROOF FORMS
with pierced, CRESTED PARAPETS.

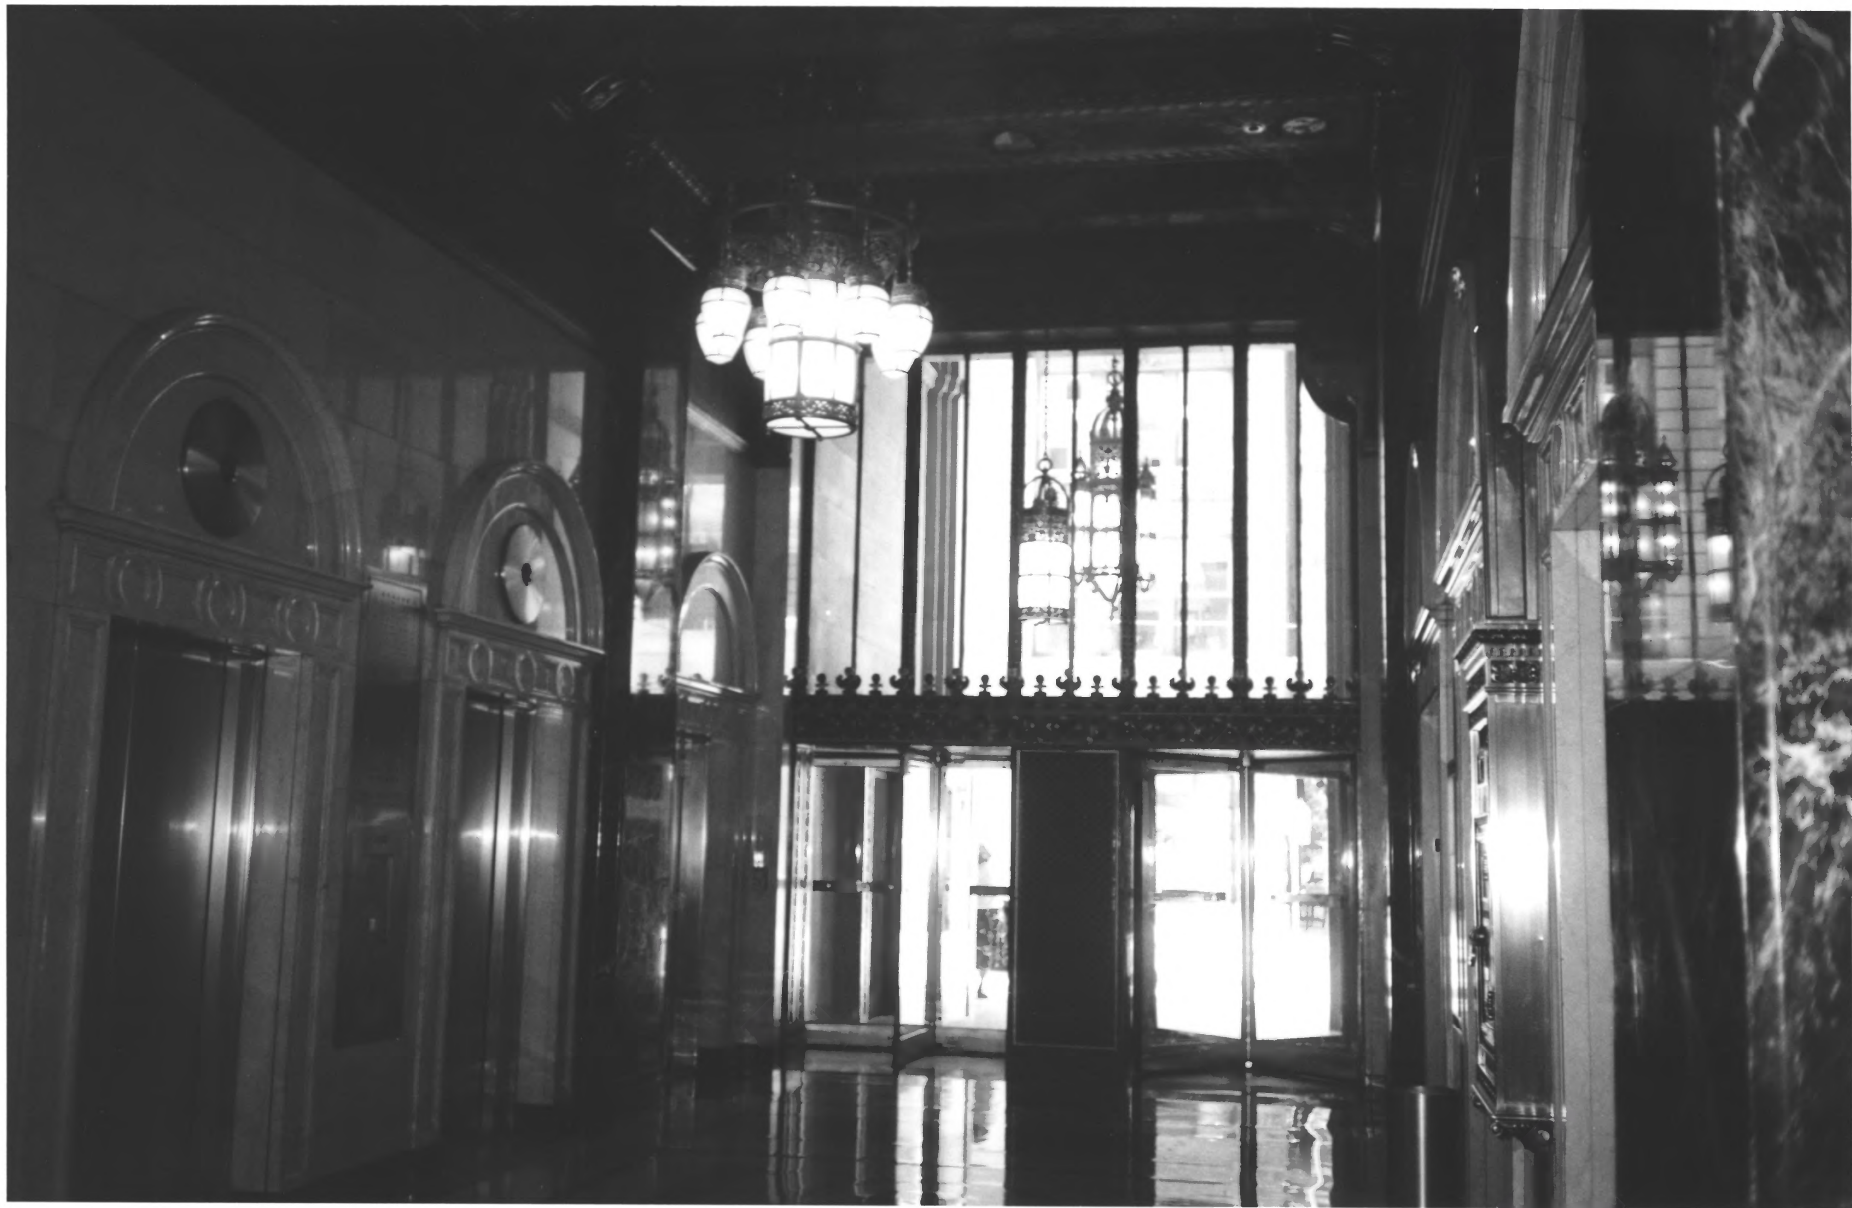
Photo 20

Looking Northwest Across Building's ORNATE lobby AT the main entry as SEEN from the interior. ONE BANK of elevators is visible ON the left. Two of the three visible CHANDELIERS HANG from the lobby's HANDPAINTED Coffered Ceiling. Centered ON the Right wall, between the elevators, is the ORIGINAL MAIL BOX.

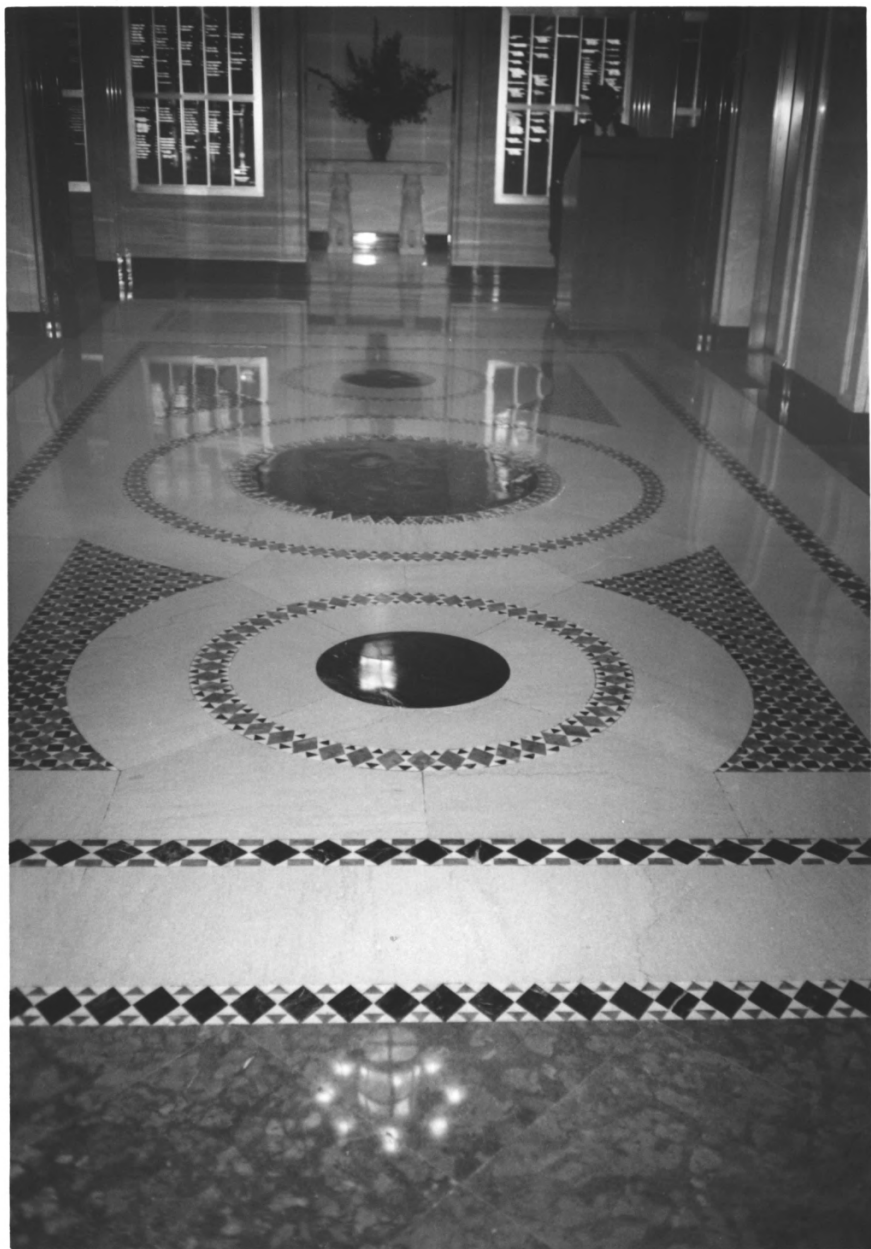
Photo 21

Looking South to the Rear of the lobby across the richly patterned marble floor. Centered in the rear wall is the original opening, allowing access to Crocker/Wells Fargo Bank. Reflections off the highly-polished marble are deceiving; the marble table, seemingly original, with vase of flowers is actually situated against the far wall of the corridor leading to the bank. The building directories, while compatible, probably date to a 1970's remodeling. The portable wood guard's desk is a more recent addition.

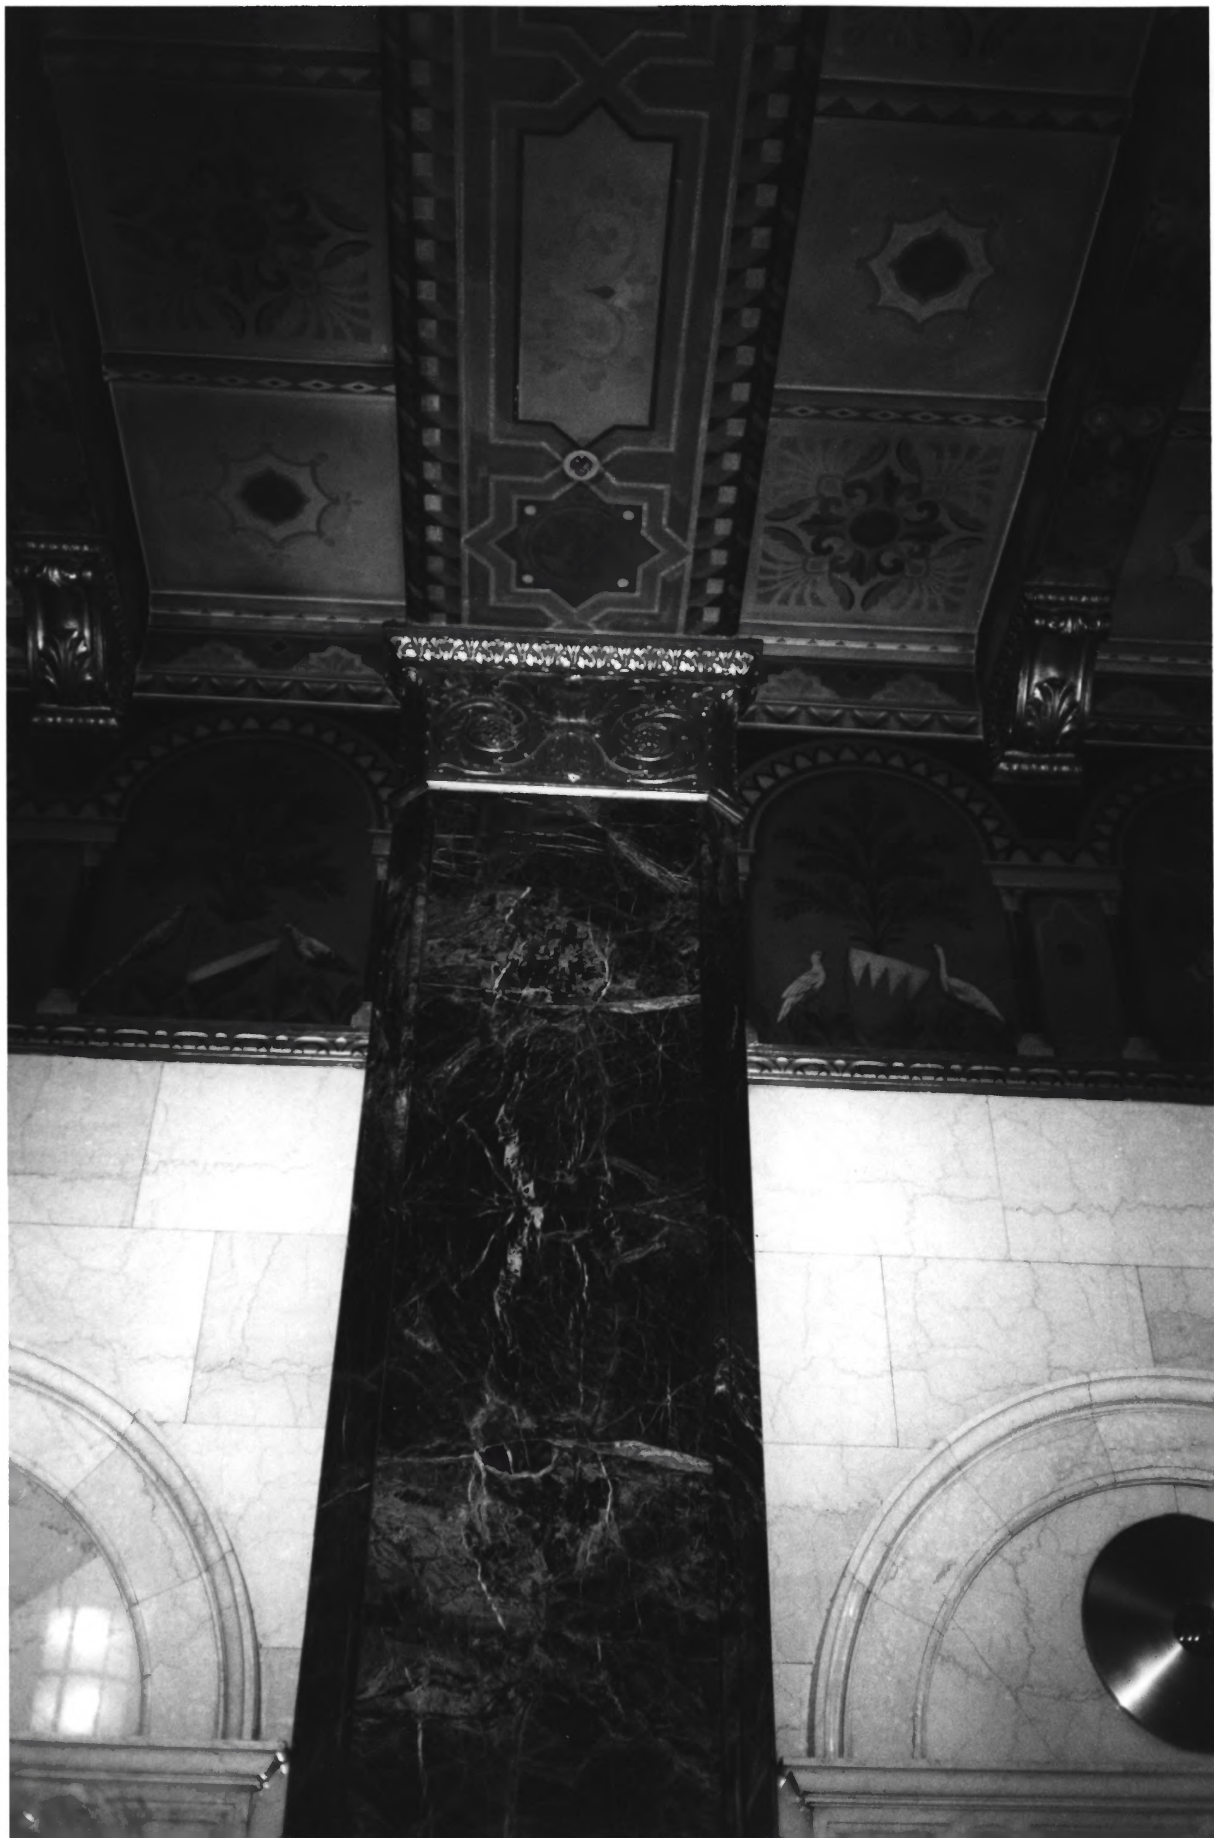
Photo 22

Looking at the lobby's West Wall at a GREEN
MARBLE PILASTER whose Capital lends support to
the HAND-painted COFFERED ceiling with frieze below.
