NATIONAL REGISTER OF HISTORIC PLACES REGISTRATION FORM

historic name: Blooming Grove
other names/site number: Mandeville-Rogers House

street & number: East end of Rogers Court, off Pocket Road
city, town: Florence (X) **vicinity of**
county: Florence **code:** 041
state: South Carolina **code :** SC **zip code:** 29506

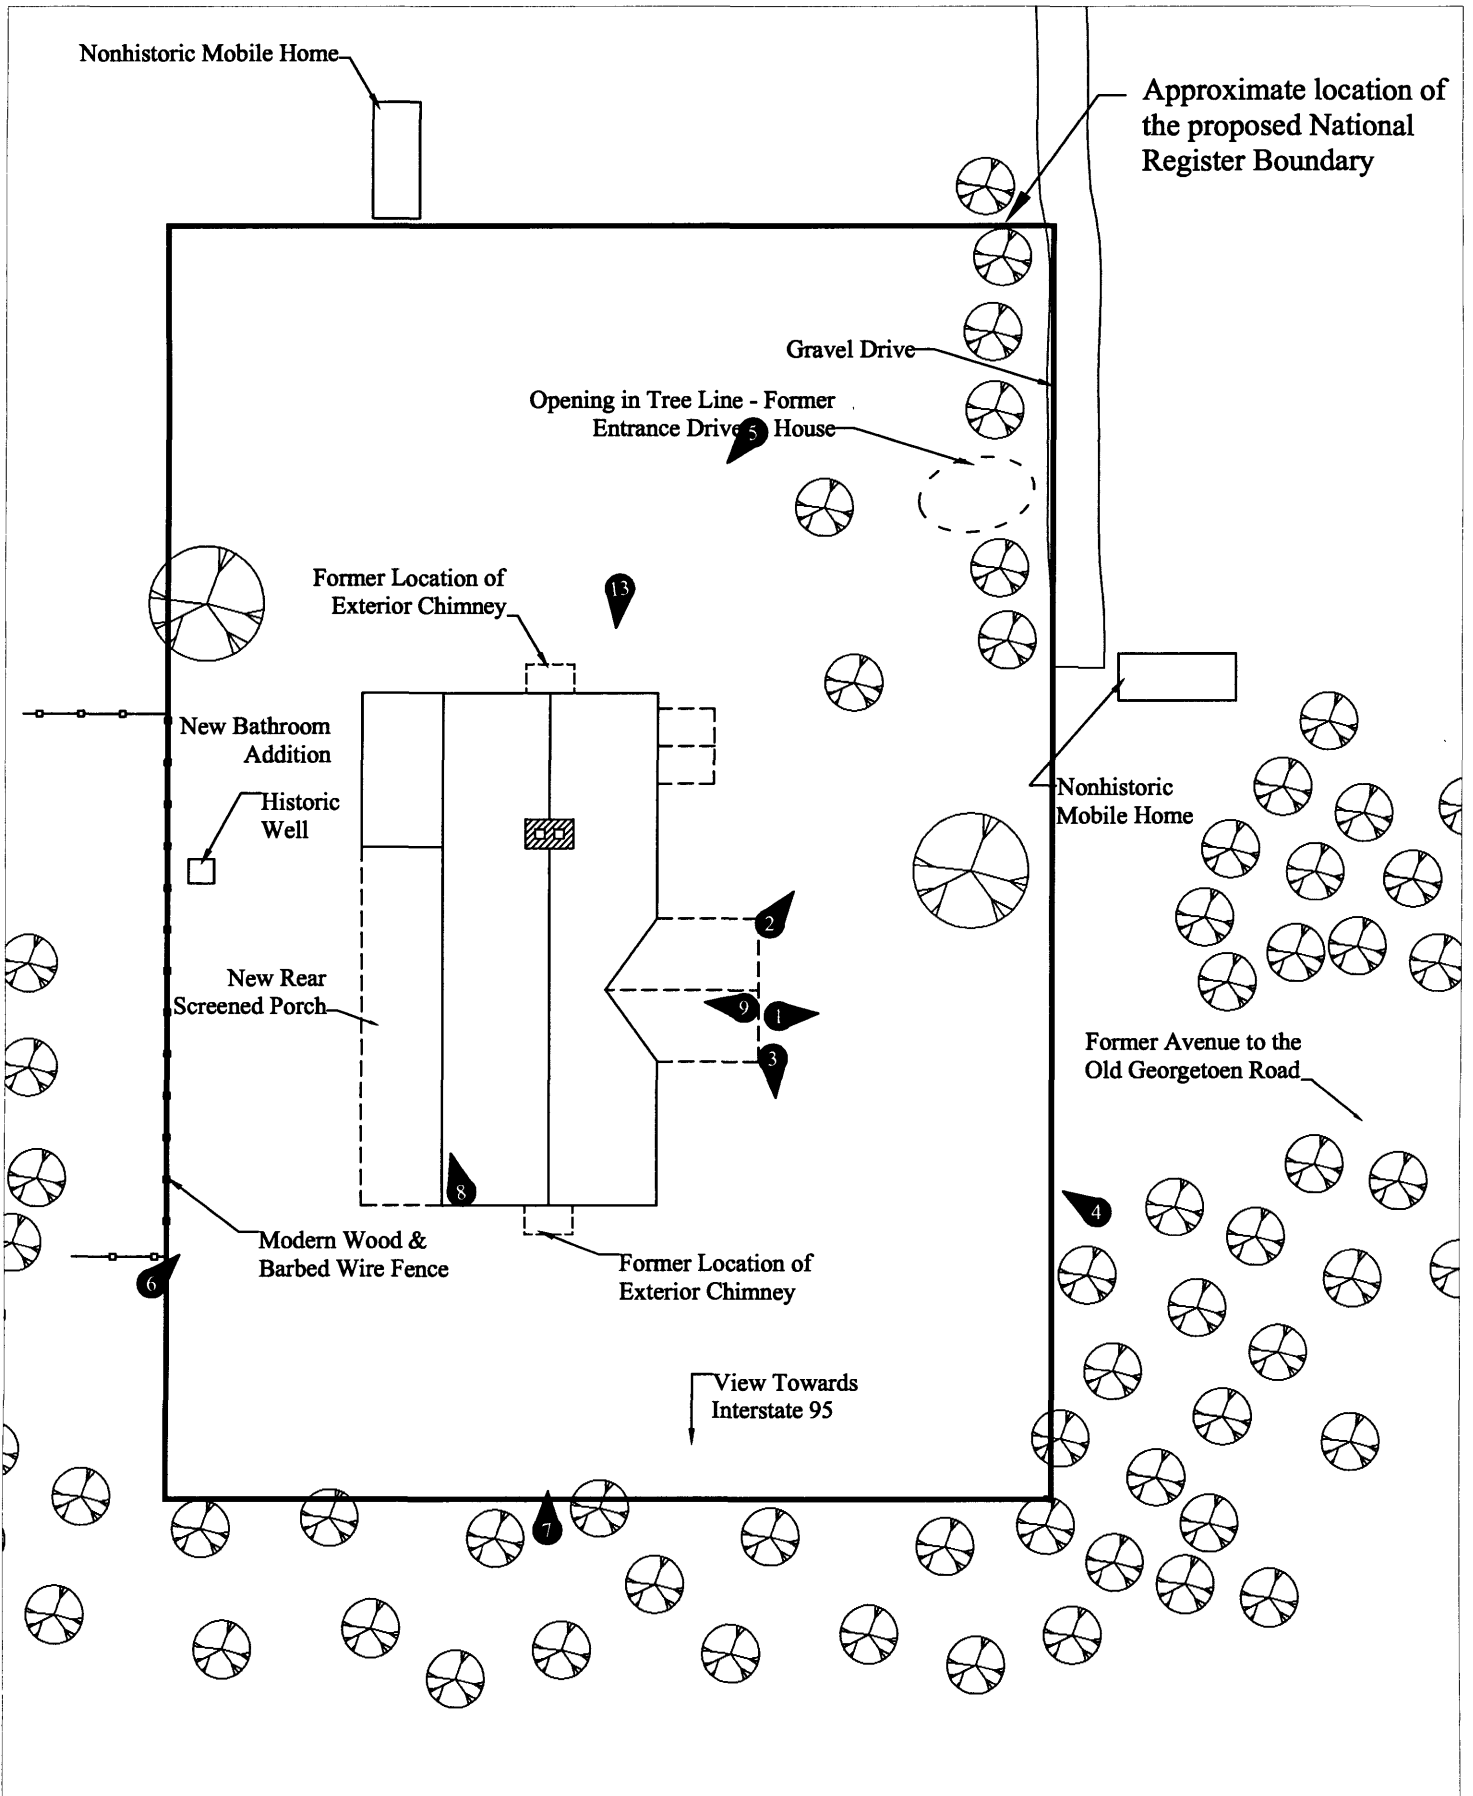
SITE PLAN SKETCH
 Photo Key

BLOOMING GROVE
NATIONAL REGISTER NOMINATION
 Florence, South Carolina

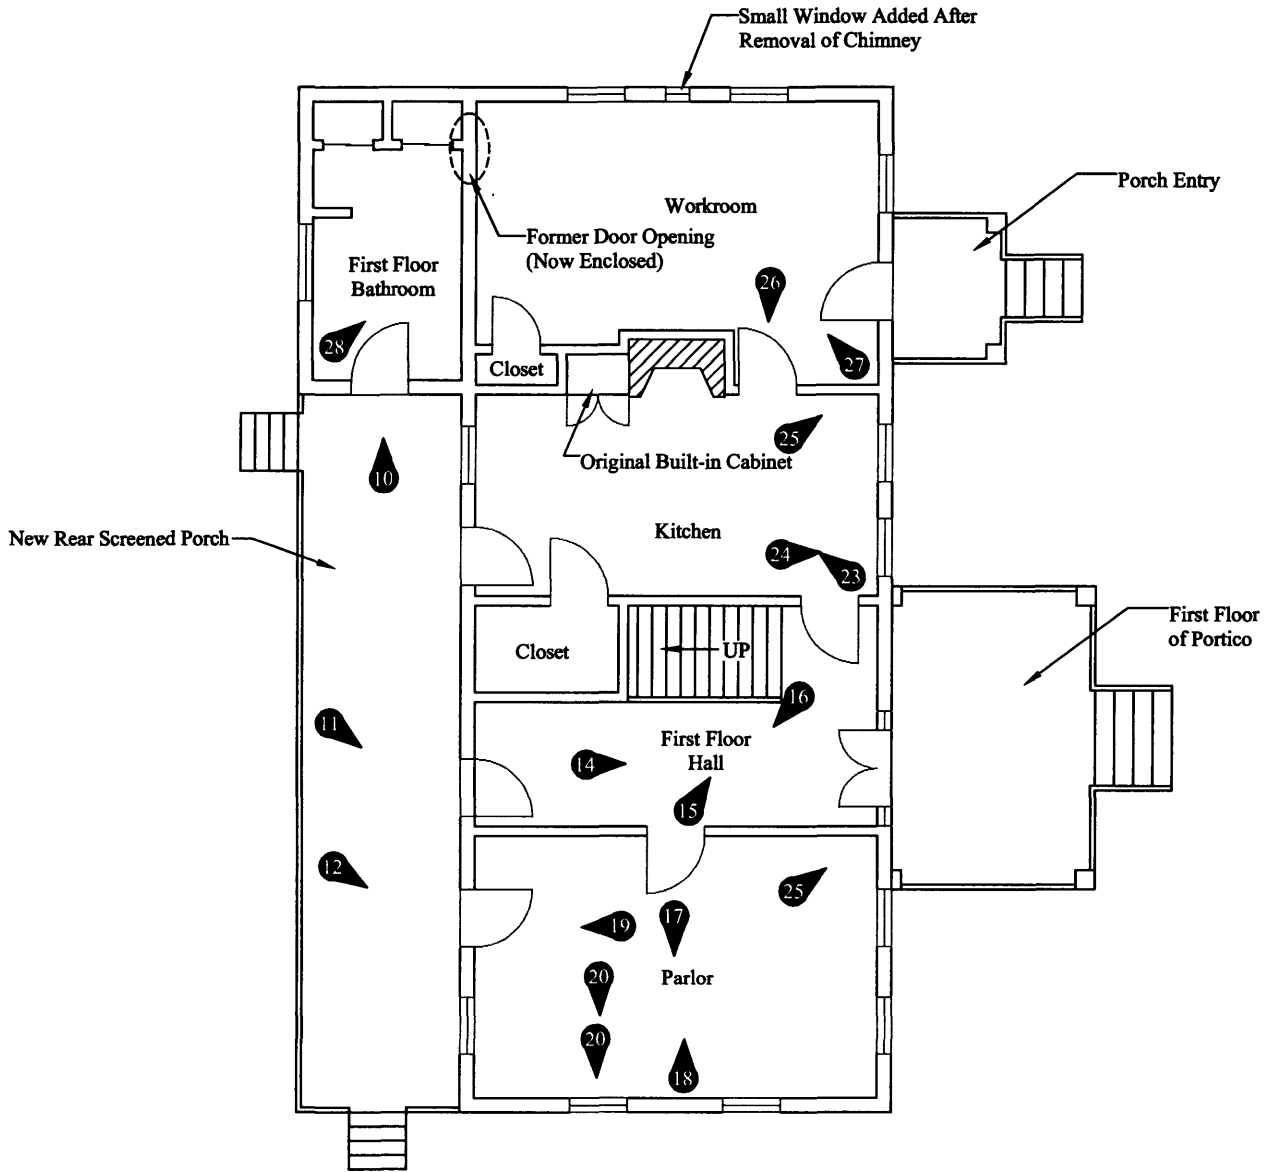
FIRST FLOOR PLAN
 Photo Key # ▶
 Not to Scale

BLOOMING GROVE
NATIONAL REGISTER NOMINATION
 Florence, South Carolina

The first floor of the house contains five rooms (the bathroom addition makes a total of six rooms) and the second floor contains six rooms. The first and second floor plans of the house feature wood floorboards that are approximately 5 1/2" – 6" wide and held in place with cut nails. The flush ceiling boards are 5 1/2" – 6" in width on the first floor, but increase to 9" – 12" wide on the second floor. The ceiling boards have a bead detail where they abut one another. All of the interior walls in the historic part of the house have retained the original split and sawn lath on framing with remnants of original plaster in places. All of the doors found in the house are original, unless otherwise noted, and have a "double cross" pattern. Similarly, the windows of the house are nine-over-nine, double-hung sash windows. All interior rooms, unless otherwise noted, feature a baseboard, wainscoting, chair rail and cornice molding with dentils.

The first floor, central entrance hall of the original ca. 1790 house (see photographs #14 -16) is accessed from the portico on the house's façade. The door at the end of the hall connects to the screened porch being constructed on the rear of the house. A stair to the second floor landing is found on the right side of the room with a door into the kitchen located at the first floor landing of the stairs. A door on the left leads to the parlor. The stair stringer features original delicate scrollwork underneath the ends to each tread of the stair. The balusters and newel post are rectangular in design, and the banister is elliptical in section. The chair rail and wainscoting continue from the first floor, up the staircase, and to the second floor.

The parlor (see photographs #17-22) features wainscoting with individual dado panels beneath the windows. Some of the plank wood panels of the wainscoting have become detached from the wall and will be reinstalled during restoration of this room. The mantel for the room is intact. The plaster on the walls, like much of the rest of the dwelling, has fallen from the walls and has been in such disrepair that the remaining plaster and the split lath in this room has been recently removed and replaced with gypsum board. A door at the back of the room leads to the screened porch at the rear of the house.

The kitchen is located to the right of the central hall (see photographs #23-25) and features wainscoting with individual dado panels beneath the windows. A door on the rear wall connects to the screened porch and a door on the north wall connects to the early nineteenth century two-story addition. The fireplace in the room is in severe disrepair and its mantel has been removed for restoration. A built-in cabinet with paned-glass doors and two drawers, and a closet associated with the early nineteenth century addition, is to the left of the fireplace. An original closet, currently lined with shelves for use as a pantry, is located on the south wall of this room and fits under the central hall stairs. This room was utilized as a kitchen during a period from the 1940s through the 1950s, as evidenced by the pantry and a sink located on the west wall.

The first floor room of the early nineteenth century addition (see photographs #26-27) is known as the workroom. A door on the east wall accesses the one-story front porch of this addition. There is a closet on the interior with wood wall pegs for hanging clothes, believed to be original to the room. A pair of windows flanks a small, fixed, four-light window centered in the north wall and there is a window on the east wall. A ca. 1950 partition wall recently divided the rear of the room, but has been removed. The original fireplace and chimney were destroyed in 1886 and not replaced; the chimney opening was filled and the whereabouts of the fireplace mantel is unknown. The detailing of the room, including the "double-cross" doors and similar moldings and wainscoting, suggest that historic addition was constructed not long after the original house was built.

The first floor bathroom is a modern addition on the northwest corner of the house (see photograph #28) with no access to the workroom; it is accessible from the rear screened porch. This small addition is unobtrusive and serves to prevent new plumbing from having to run through the house. The wall treatments in the bathroom will be gypsum board, with a simple baseboard molding and window surrounds. A fixed, transom-like window is found in the western wall of this addition.
