KENTUCKY HISTORIC RESOURCES
Individual Inventory Form

Resource # 7
Shelby County

1. Name of Resource:
Simpsonville Methodist Church

5. Location:
First Street, Simpsonville, KY

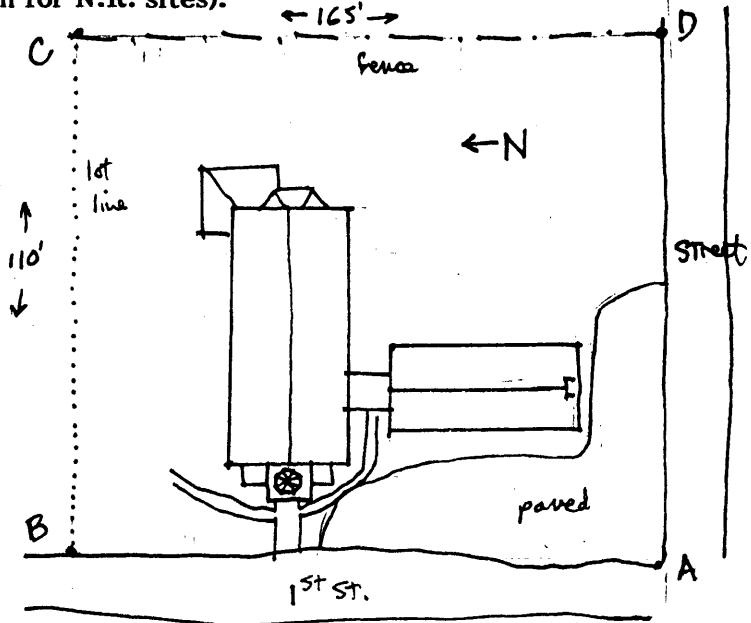
44. Site Plan (and boundary description and justification for N.R. sites):

Beginning at Point A, which is at the intersection of the east edge of First Street with the northern edge of a street defining the southern extent of the lot, north 165 feet along the east edge of First Street to lot line; east 110 feet along lot line to fence line at rear edge of lot; 165 feet south along fence line to the north edge of street; 110 feet west along edge of street to point of origin. Boundaries were chosen to incorporate the church and the lot it occupies.

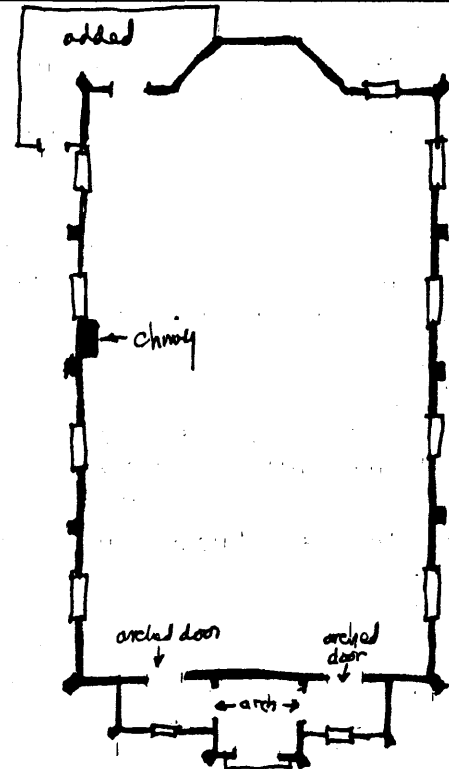
45. Description and House Plan:

1-story, brick Victorian Gothic 4-bay deep nave plan with central projecting square entry tower with low hipped roof and octagonal polychrome slate spire containing four pointed arch louvres. Tower flanked by shed-roofed (standing seam metal) blocks containing a single lancet window each and a gablet over each window. Side lancets are set in recessed panels divided by two-tiered buttress strips with stone caps. Lancets have brick drip molds. Corbel molds frame each side bay. Dentilled brick cornice. Projecting 3-sided apse on east wall. Tower has recessed panels and buttresses like those on sides of sanctuary. Central lancet window on tower has been bricked in. Small shed-roofed pastor's study added to northeast

corner at the rear of the church. A 1955 brick veneer gable-roofed parish hall is appended to the south of the church. Bands of polychrome roof slates are highlighted by chevron and diamond-shaped patterns.

Pointed arches lead from entry tower to side vestibules. Interior largely intact. Original pews.
