KENTUCKY HISTORIC RESOURCES INVENTORY

| 1. Historic Name(s) <u>Watson Store (F.M.R.A.),</u> Original Owner <u>George and James Watson</u> | | 22. ADD/County <u>NKADD/Pendleton</u> 096 | |
| 2. Present Name <u>504 W. Shelby Street</u> | | 23. U.S.G.S. Quadrant (15'/75') <u>Falmouth</u> 137 | |

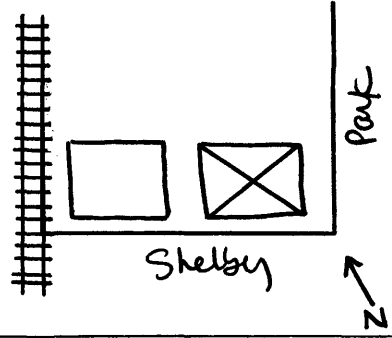
| 18. Description <u>Original stone foundation has been replaced with concrete. Western portion of building is one story, with shed roof, one door and one window on Shelby, one door at rear. Exterior of west facade is board and batten. Rest of building sheathed in beveled siding. Eastern portion is two story, with gable end roof. Lower level has two plate</u> (Continue on Back) (over) | | 28. Significance Evaluation <u>National Register</u> <input checked="" type="checkbox"/> 29. Status <input type="checkbox"/> Date National Landmark <input type="checkbox"/> National Register <input type="checkbox"/> Landmark Certificate <input type="checkbox"/> Kentucky Survey <input type="checkbox"/> Local Landmark <input type="checkbox"/> HABS/HAER <input type="checkbox"/> 30. Historic Theme Primary <u>commerce</u> <input checked="" type="checkbox"/> Secondary <u>Architecture</u> <input checked="" type="checkbox"/> Other <input type="checkbox"/> 31. Endangered Yes <input type="checkbox"/> No <input checked="" type="checkbox"/> 32. Preservation Project Status <input type="checkbox"/> Actual Cost in \$1,000s <input type="checkbox"/> | |

18 continued : glass windows and one door; two 8 over 8 double hung windows above. Red standing seam metal roof, chimney at rear, box cornice with return and brackets in the front gable end. Porch across 2 story portion on Shelby St. side; stairs originally on east facade, now new stairs installed at rear. Interior lower level is two long rooms divided by row of turned posts. Apartment on second floor has original woodwork, windows, and molded baseboard.
