# National Register of Historic Places Registration Form

historic name South Pass City Historic District (boundary increase, additional documentation, and name change)

other names/site number South Pass City State Historic Site, 48FR434

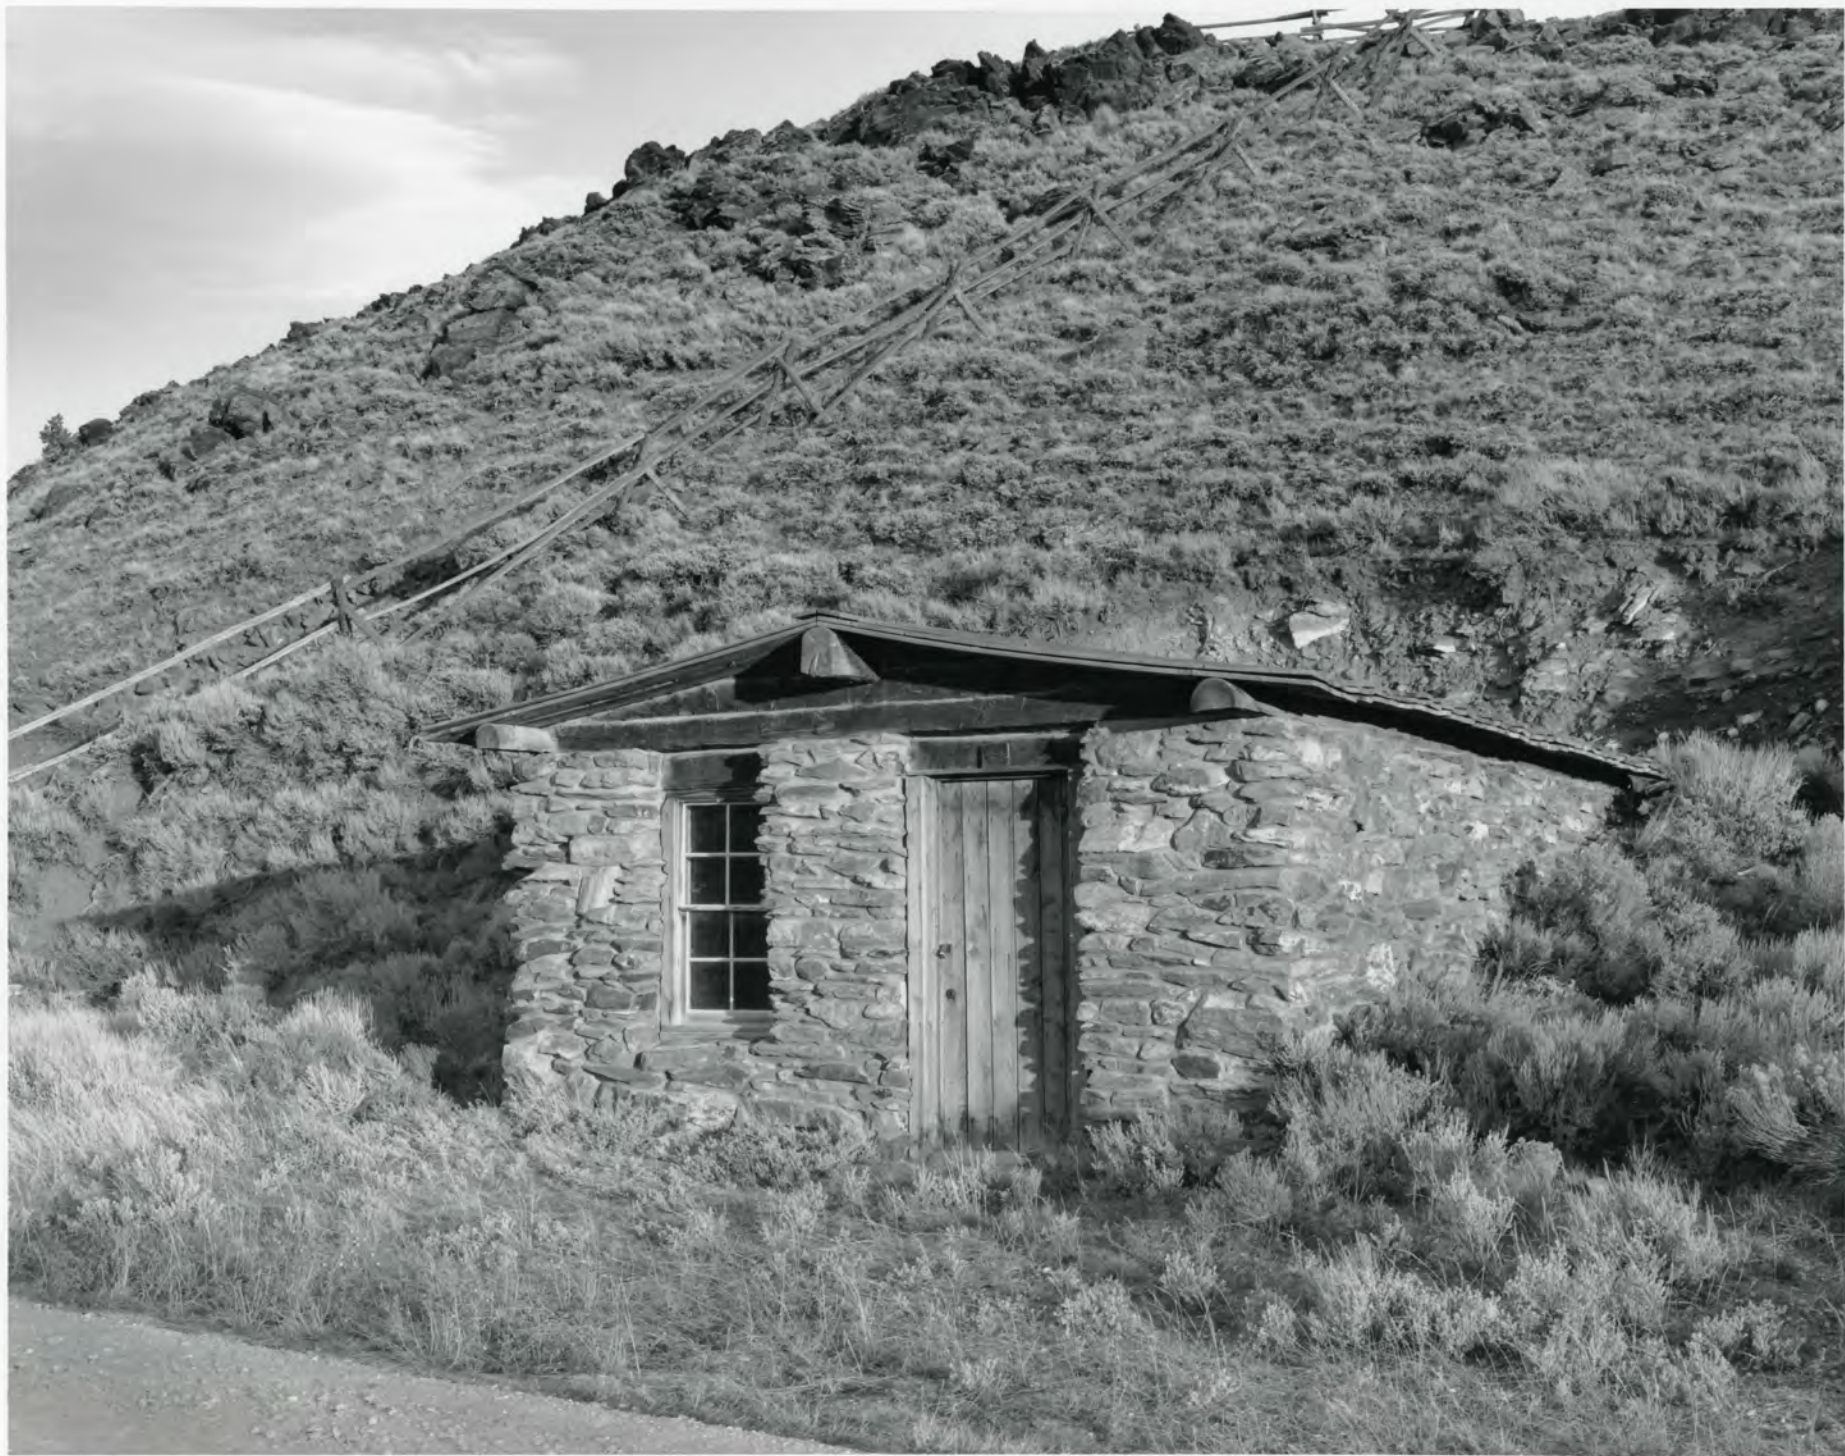
South Pass City Historic Site, Rock House (1)

This one-story building was constructed with random rubble walls with cement mortar. It represents stone vernacular or folk architecture. It rests on a stone foundation with no basement and measures 15'6" NS by 23' EW by 7'5" height. The roof is a shallow front gable consisting of two layers of milled lumber with wood strips and has log purlins and ridgepole. There are hewn logs in the gable ends. There is a vertical slab door with log lintel on the west (facade). Windows consist of one 4/4-light double-hung window with log lintel on the west and one 4-light fixed window on the north. The building has been rehabilitated.

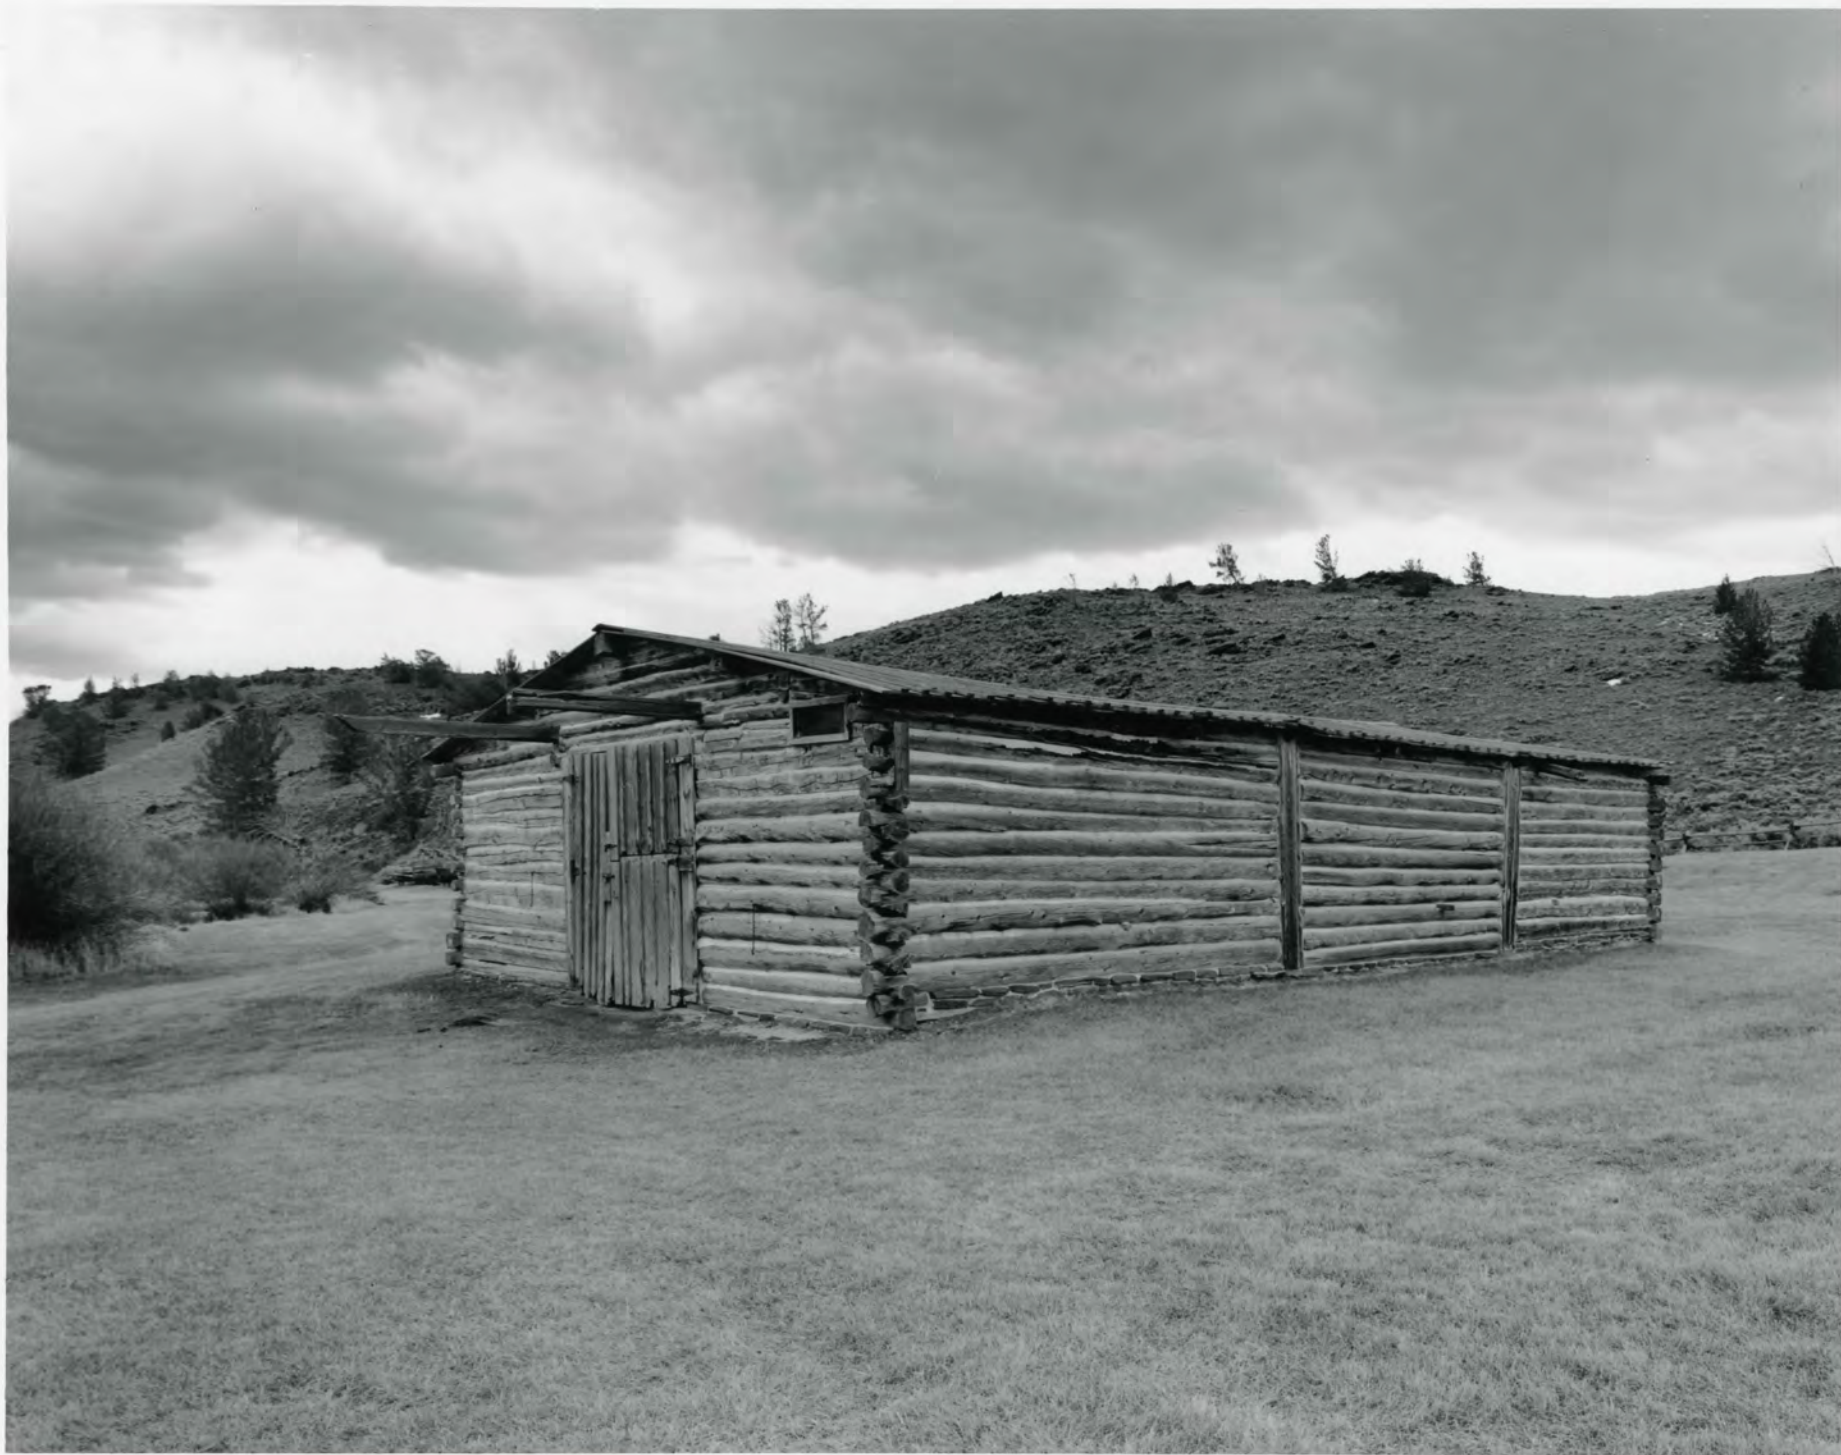
South Pass City Historic Site, Livery Stable (21)  
Located at South Pass City Historic District, Wyoming  
Fremont County  
View to SE  
Photographer: Richard Collier

This is a one-story front-gabled log barn (40' NS by 26'8" EW) resting on a mortared stone foundation with no basement. The gently-pitched gable roof is covered with board and batten and has purlins and ridgepole, exposed on the ends. The walls are constructed with full round logs (three segments on the long sides, two on the rear) with cement chinking and square and/or saddle notching. The joints are described as slot and cleat panels that are spiked but outwardly resemble piece-sur-piece construction. The logs on the south wall are flat hewn. The entrance is located on the facade (north side), which consists of large doors that swing outward; the west door is Dutch-style; the east door is a single swinging panel constructed of vertical planks nailed to inside "Z" bracing. Two ceiling rafters extend 3-4 feet above the barn doors. There is a small 1-light fixed window high on the wall at the west end of the north wall, providing light for the tack room. The interior has plank flooring and flat-hewn logs. The space is divided into a central isle, five stalls, feed troughs and a

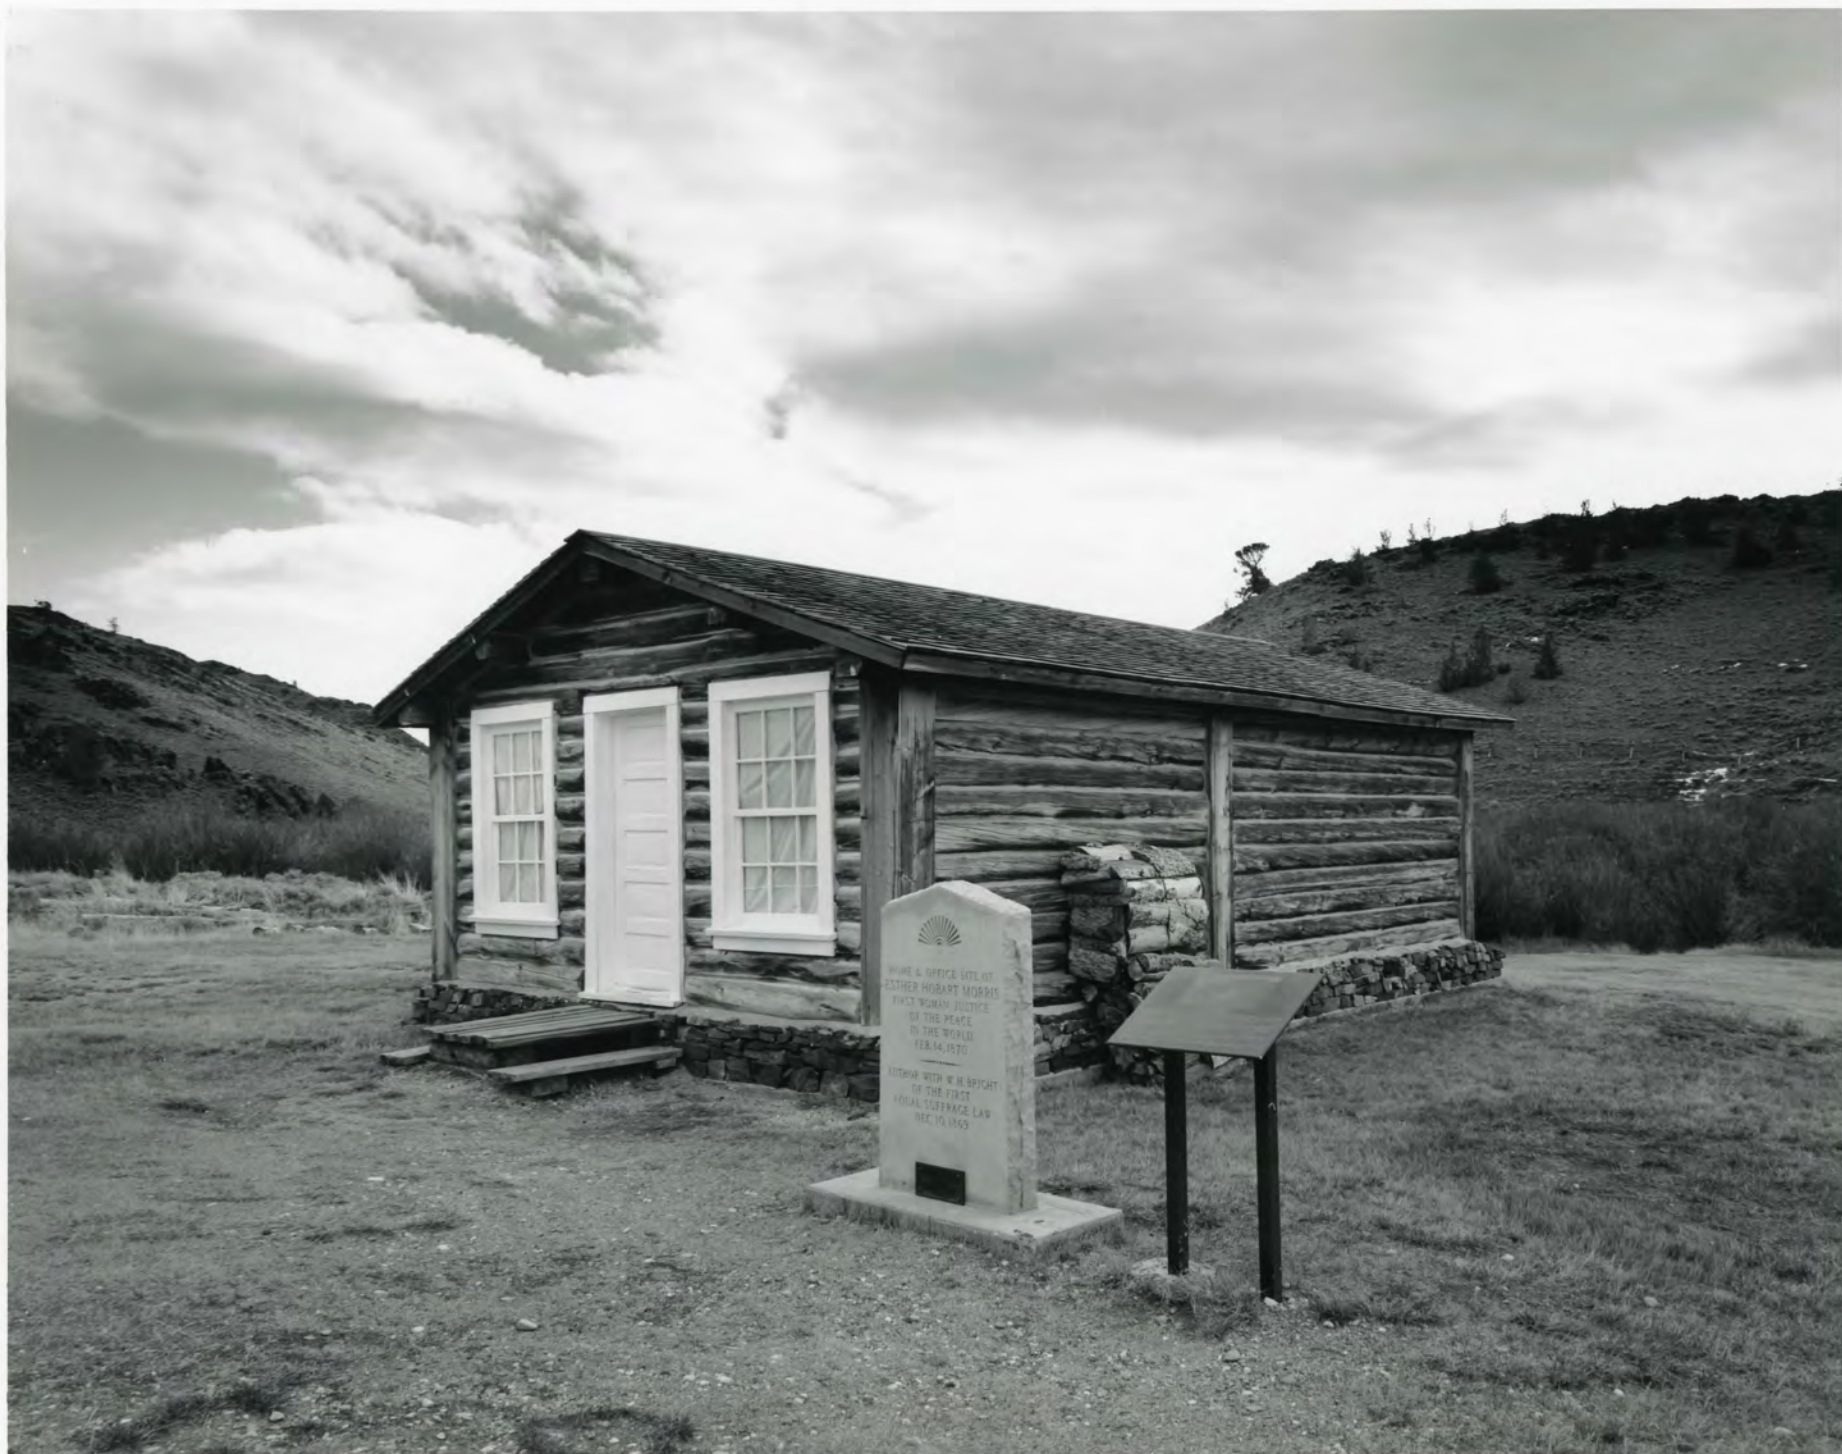
South Pass City Historic Site,  
Slack/Ester Hobart Morris Cabin + Monument (14, 56)  
Located at 38 South Pass Avenue,  
South Pass City Historic District, Wyoming  
Fremont County  
View to SE  
Photographer: Richard Collier

This is a modern reconstruction of a historic-era cabin. It is a one-story front-gabled log building resting on a two-foot concrete foundation with mortared native stone facing; there is no basement. It measures 27'2" NS by 16'9" EW. The shallow gabled roof is covered with wood shingles and has log ridgepole and purlins with exposed log ends. The exterior walls are constructed with round logs with fiberglass insulation and joint/daubing compound; the logs are joined with corner posts. The entrance is centered in the facade (north side) and consists of a 5-panel wood door. It is flanked by 6/6-light double-hung windows with wood sash and surrounds and narrow wood strip sills. The rear (south) and east sides each have a rectangular fixed light window with similar surrounds and sills, and there is a wood door entrance accessed by steps and a small stoop on the south side. The interior is divided into two rooms with wood floor and drywall. It has been interpreted as a printing office and contains E.A. Slack's original printing press used to print the *South Pass News*. East of the site is an interpretive sign about Esther Morris, whose original cabin was located near this cabin.

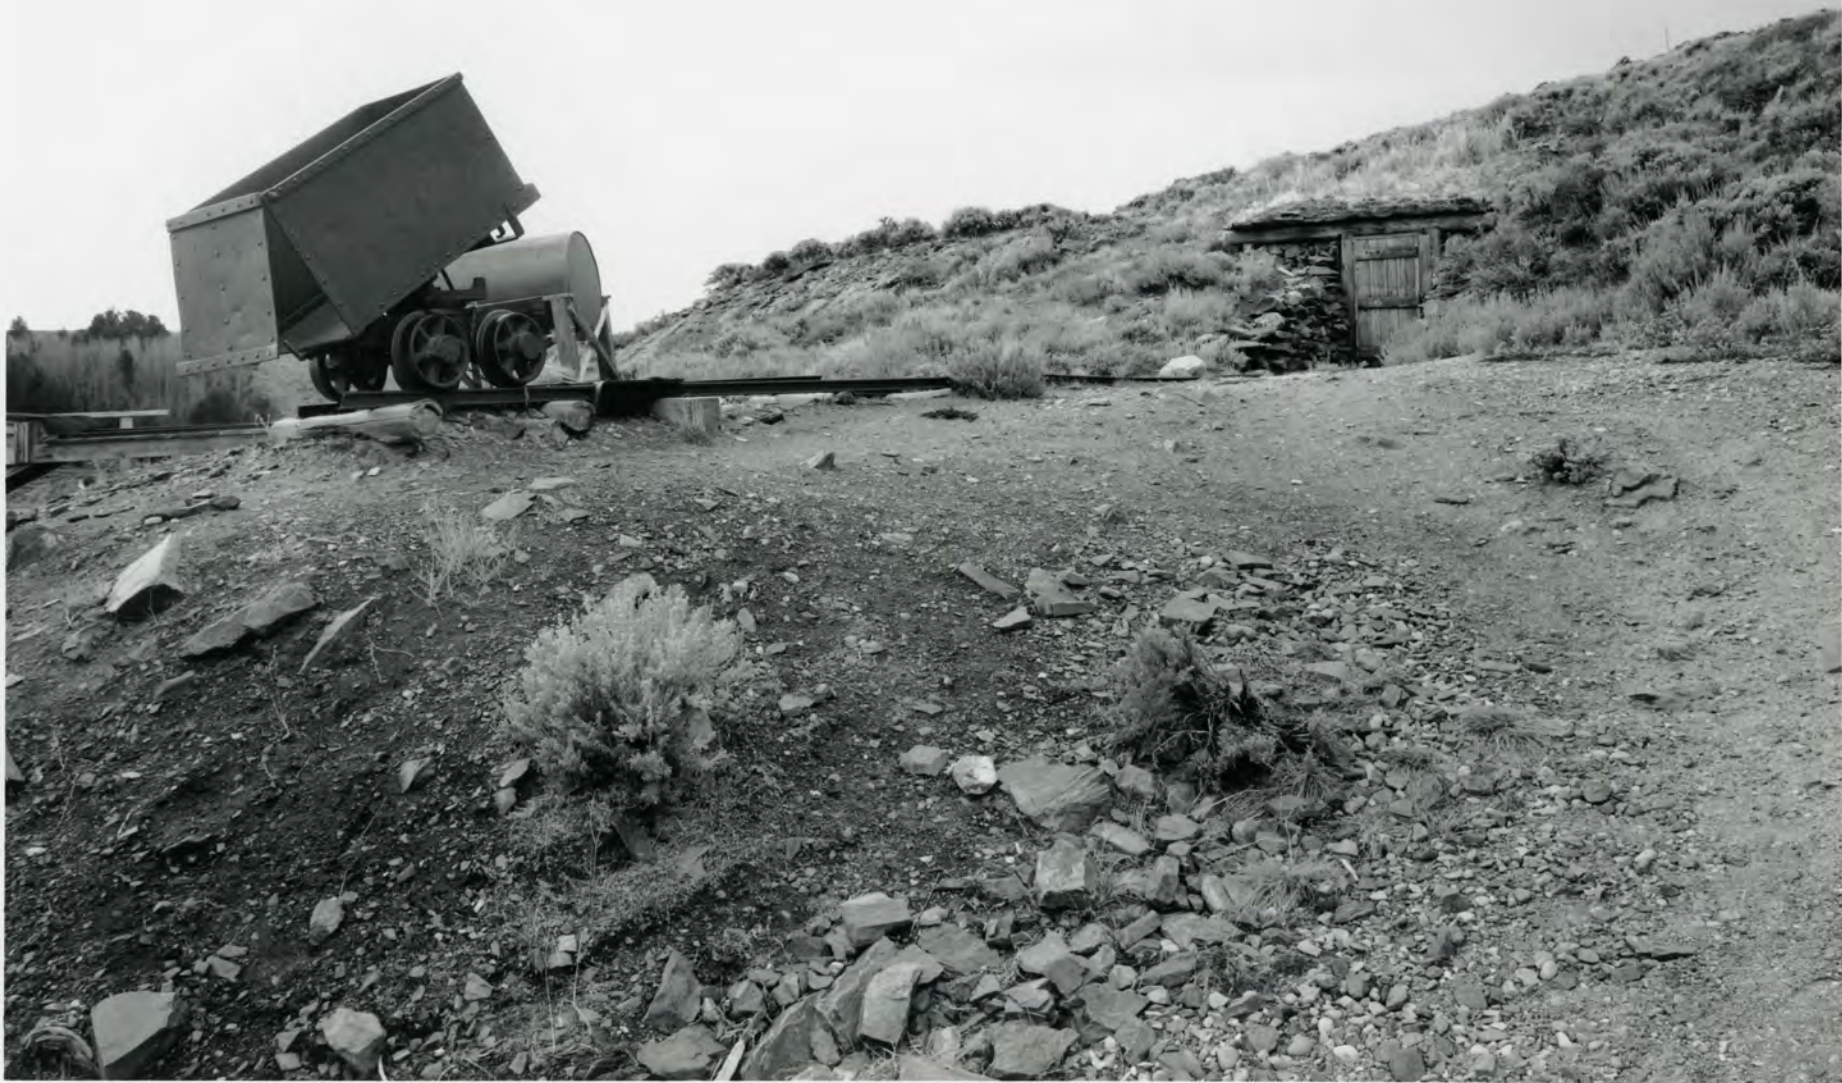
South Pass City Historic Site, Wolverine Mine Adit & Ore Cart (53)

The Wolverine Mine Adit consists of a timbered mine adit that is approximately 75 feet long. In 1996, the adit portal was altered by SPSHT for interpretive purposes. The portal is lined with dry laid stone on both sides, a timber roof covered with soil, and a wood slab door. Narrow gauge tracks and ties have been laid on the floor of the adit, exit the adit, and a ore car placed on them. The Wolverine Adit is within the Wolverine mining claim that became a part of the group of claims that constituted the Carissa mine. However, this adit was never seriously developed. In 2001, a one-half scale five-stamp mill was erected outside the entrance. All changes are recent and not necessarily historically accurate, and substantially alter the historic integrity of this resource.

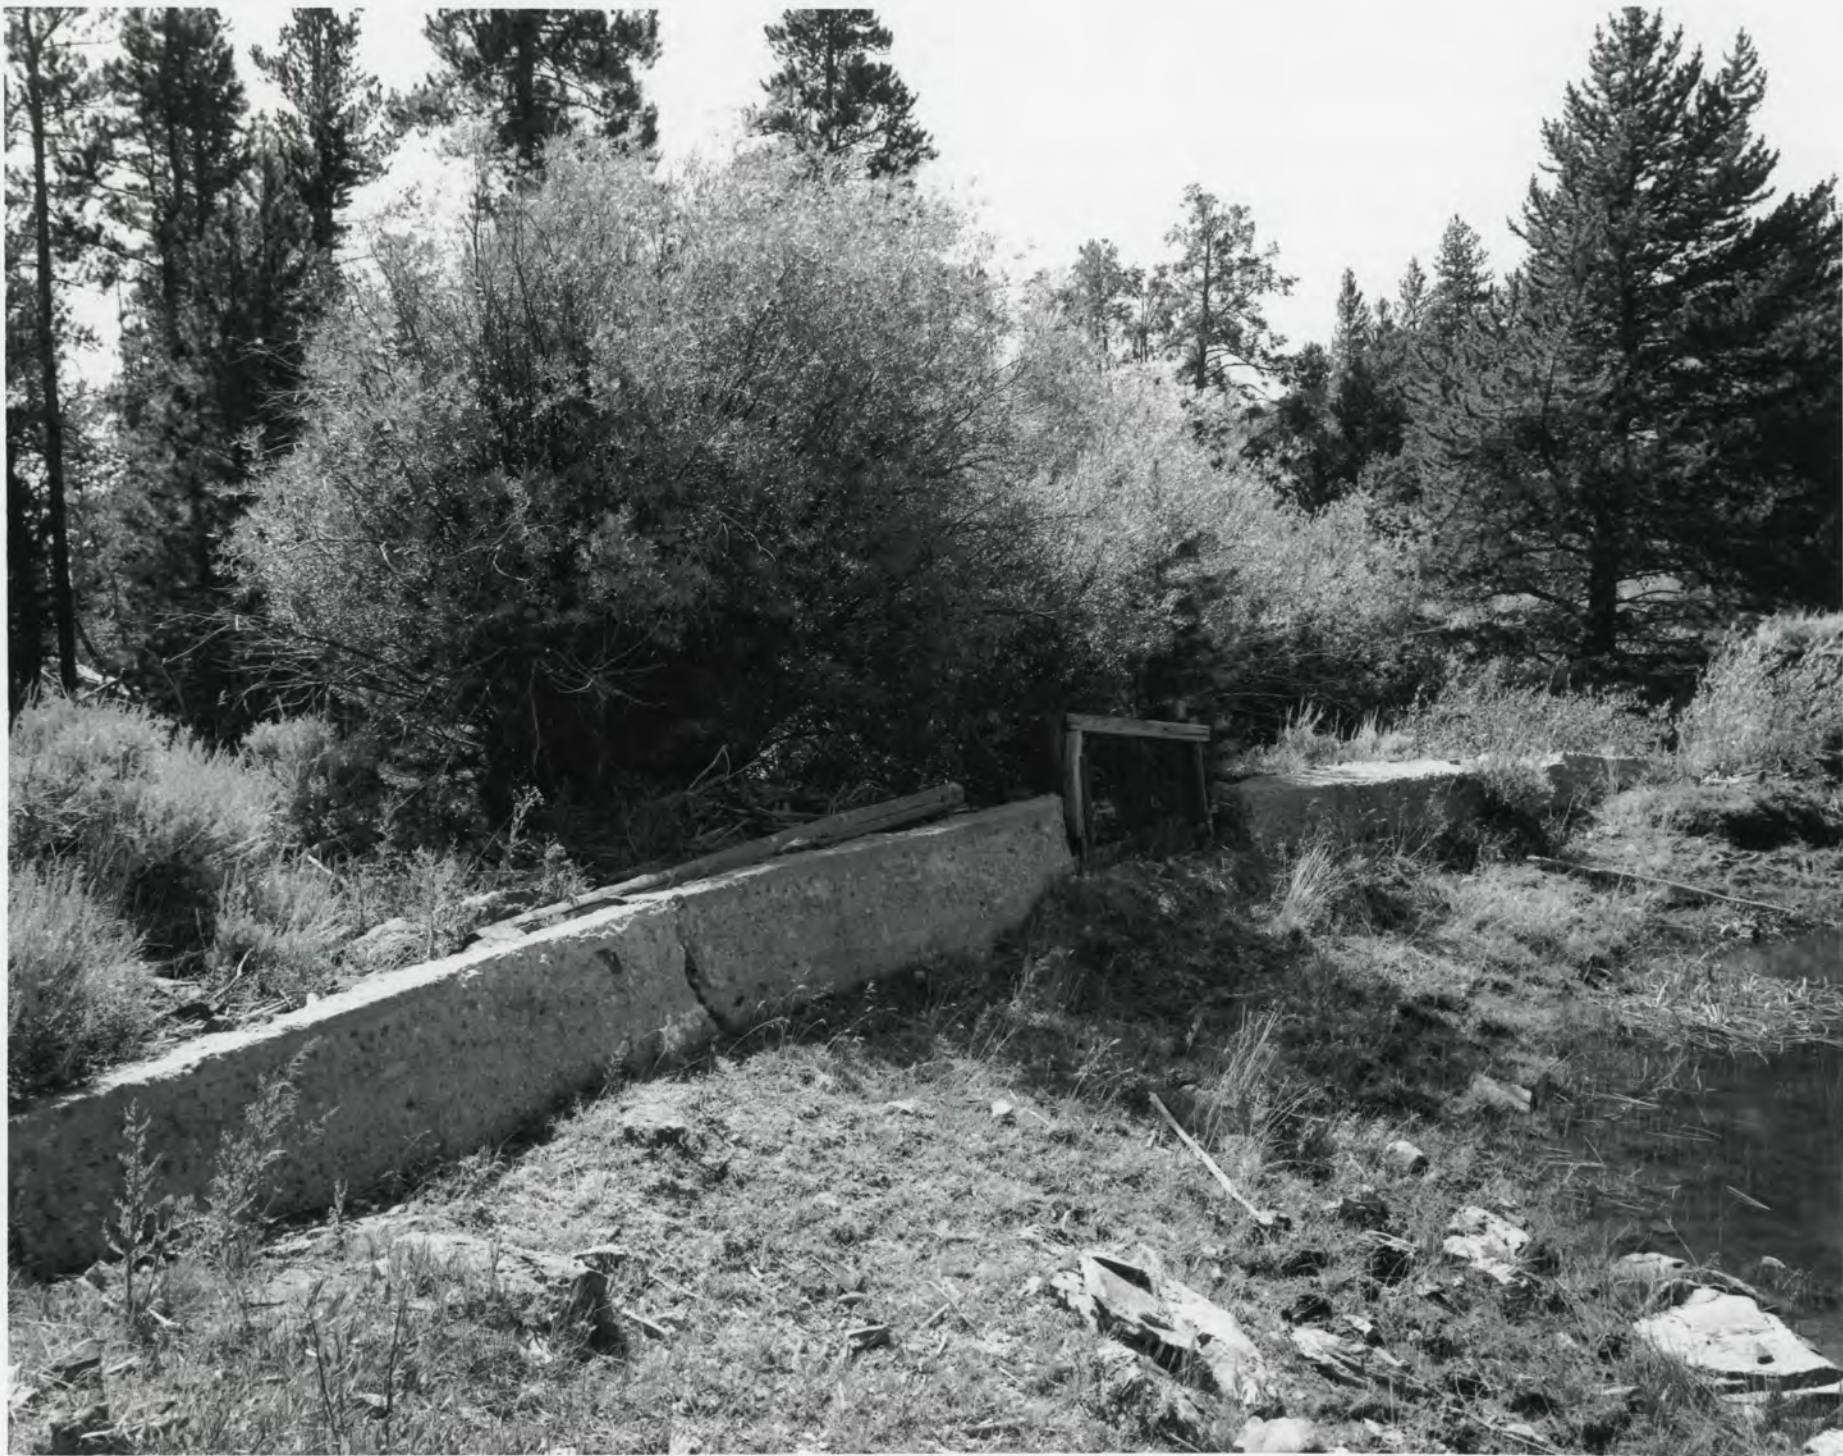
Carrisa Mine, Dam & Headgate (78)

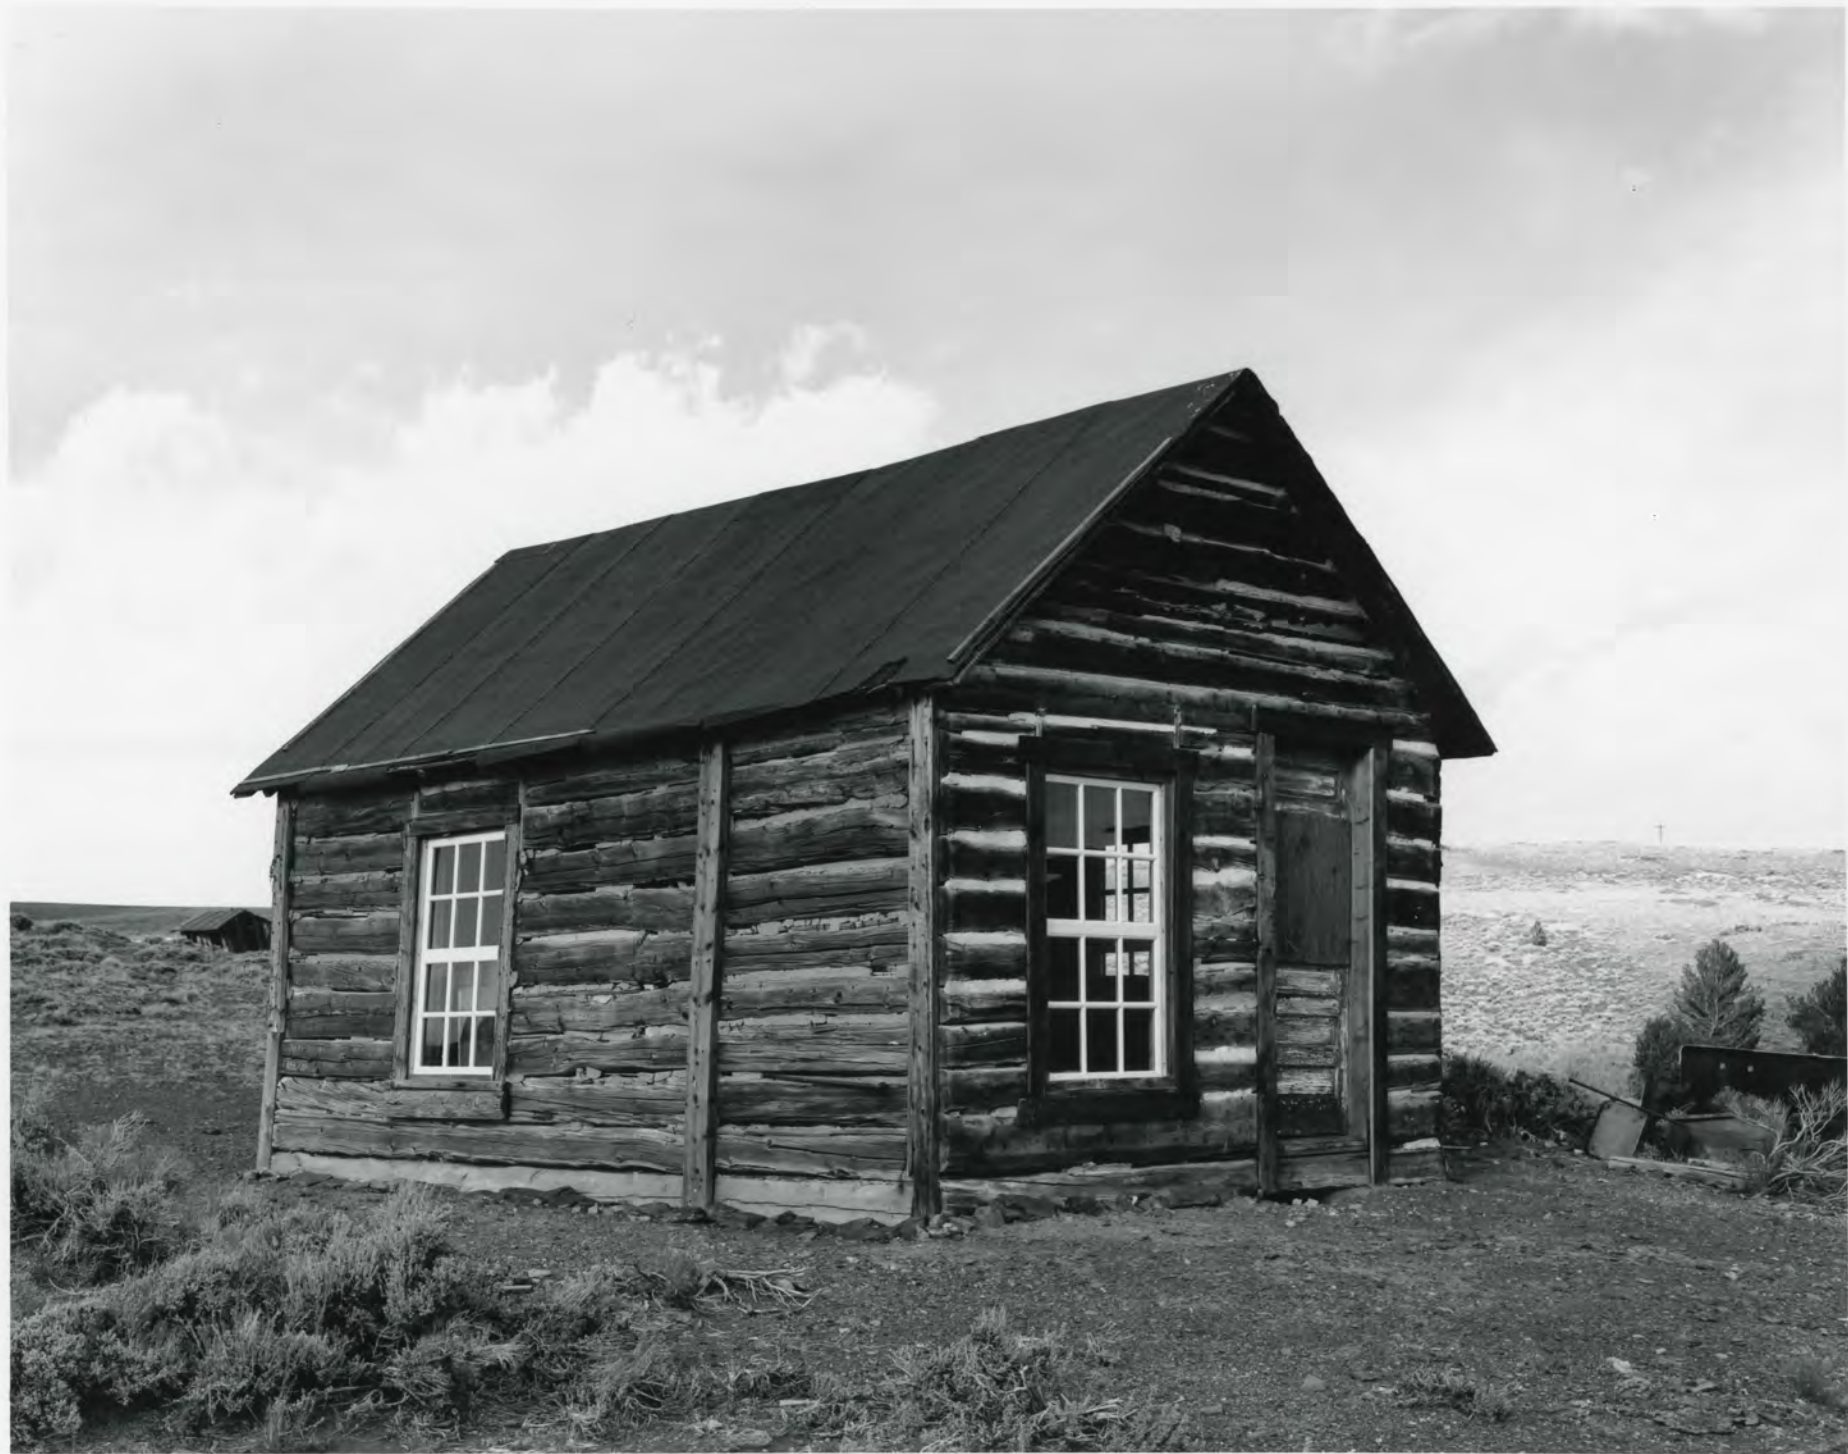
Carrisa Mine & Mill Complex, Log House (67)  
Located at South Pass City Historic District, Wyoming  
Fremont County

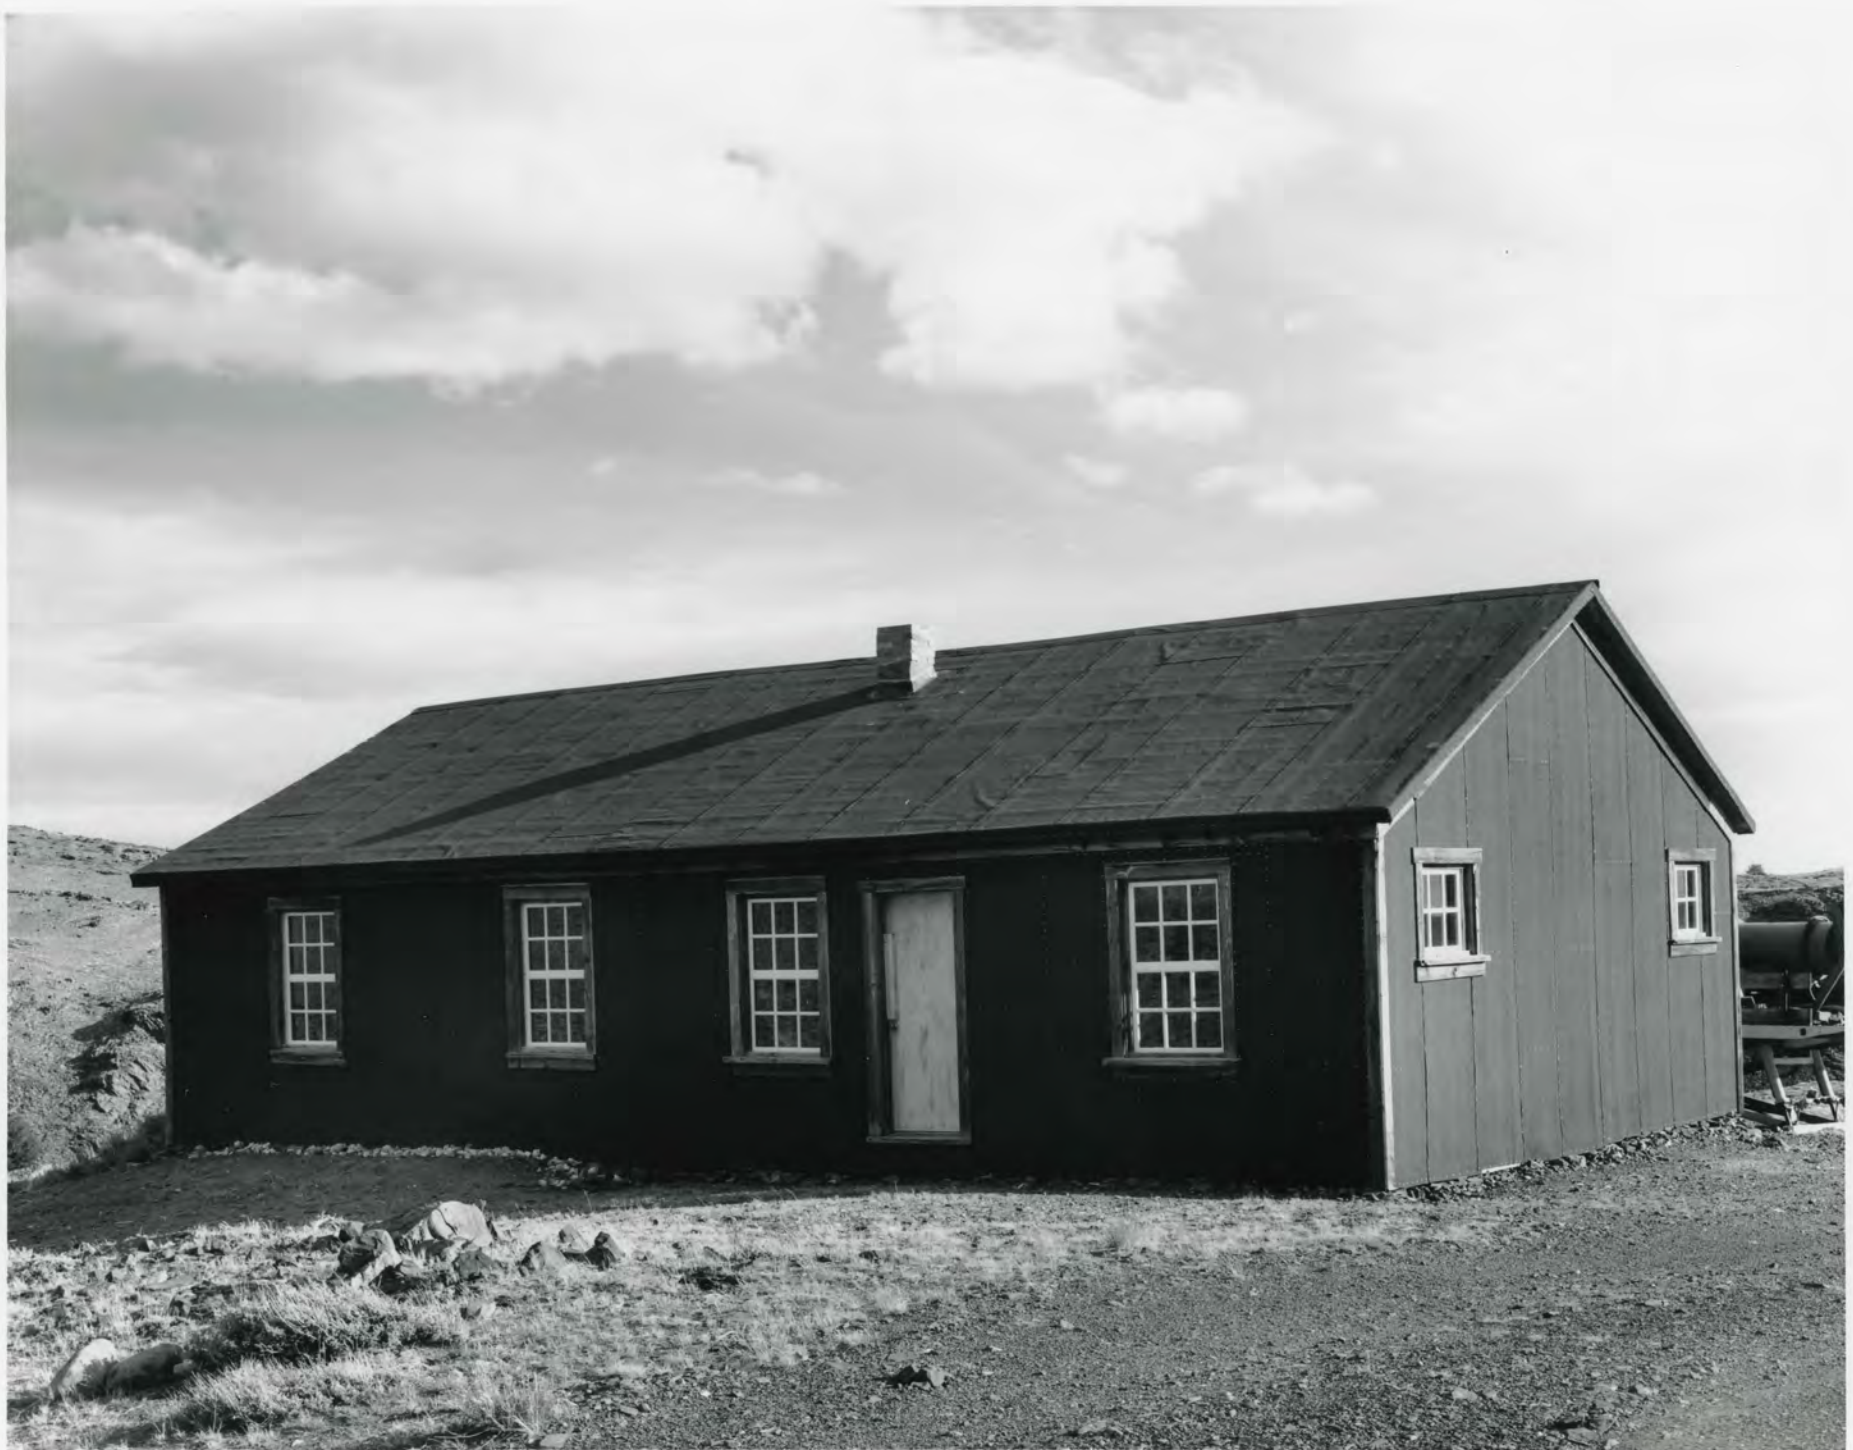
Carrisa Mine + Mill Complex, Bunkhouse (48)

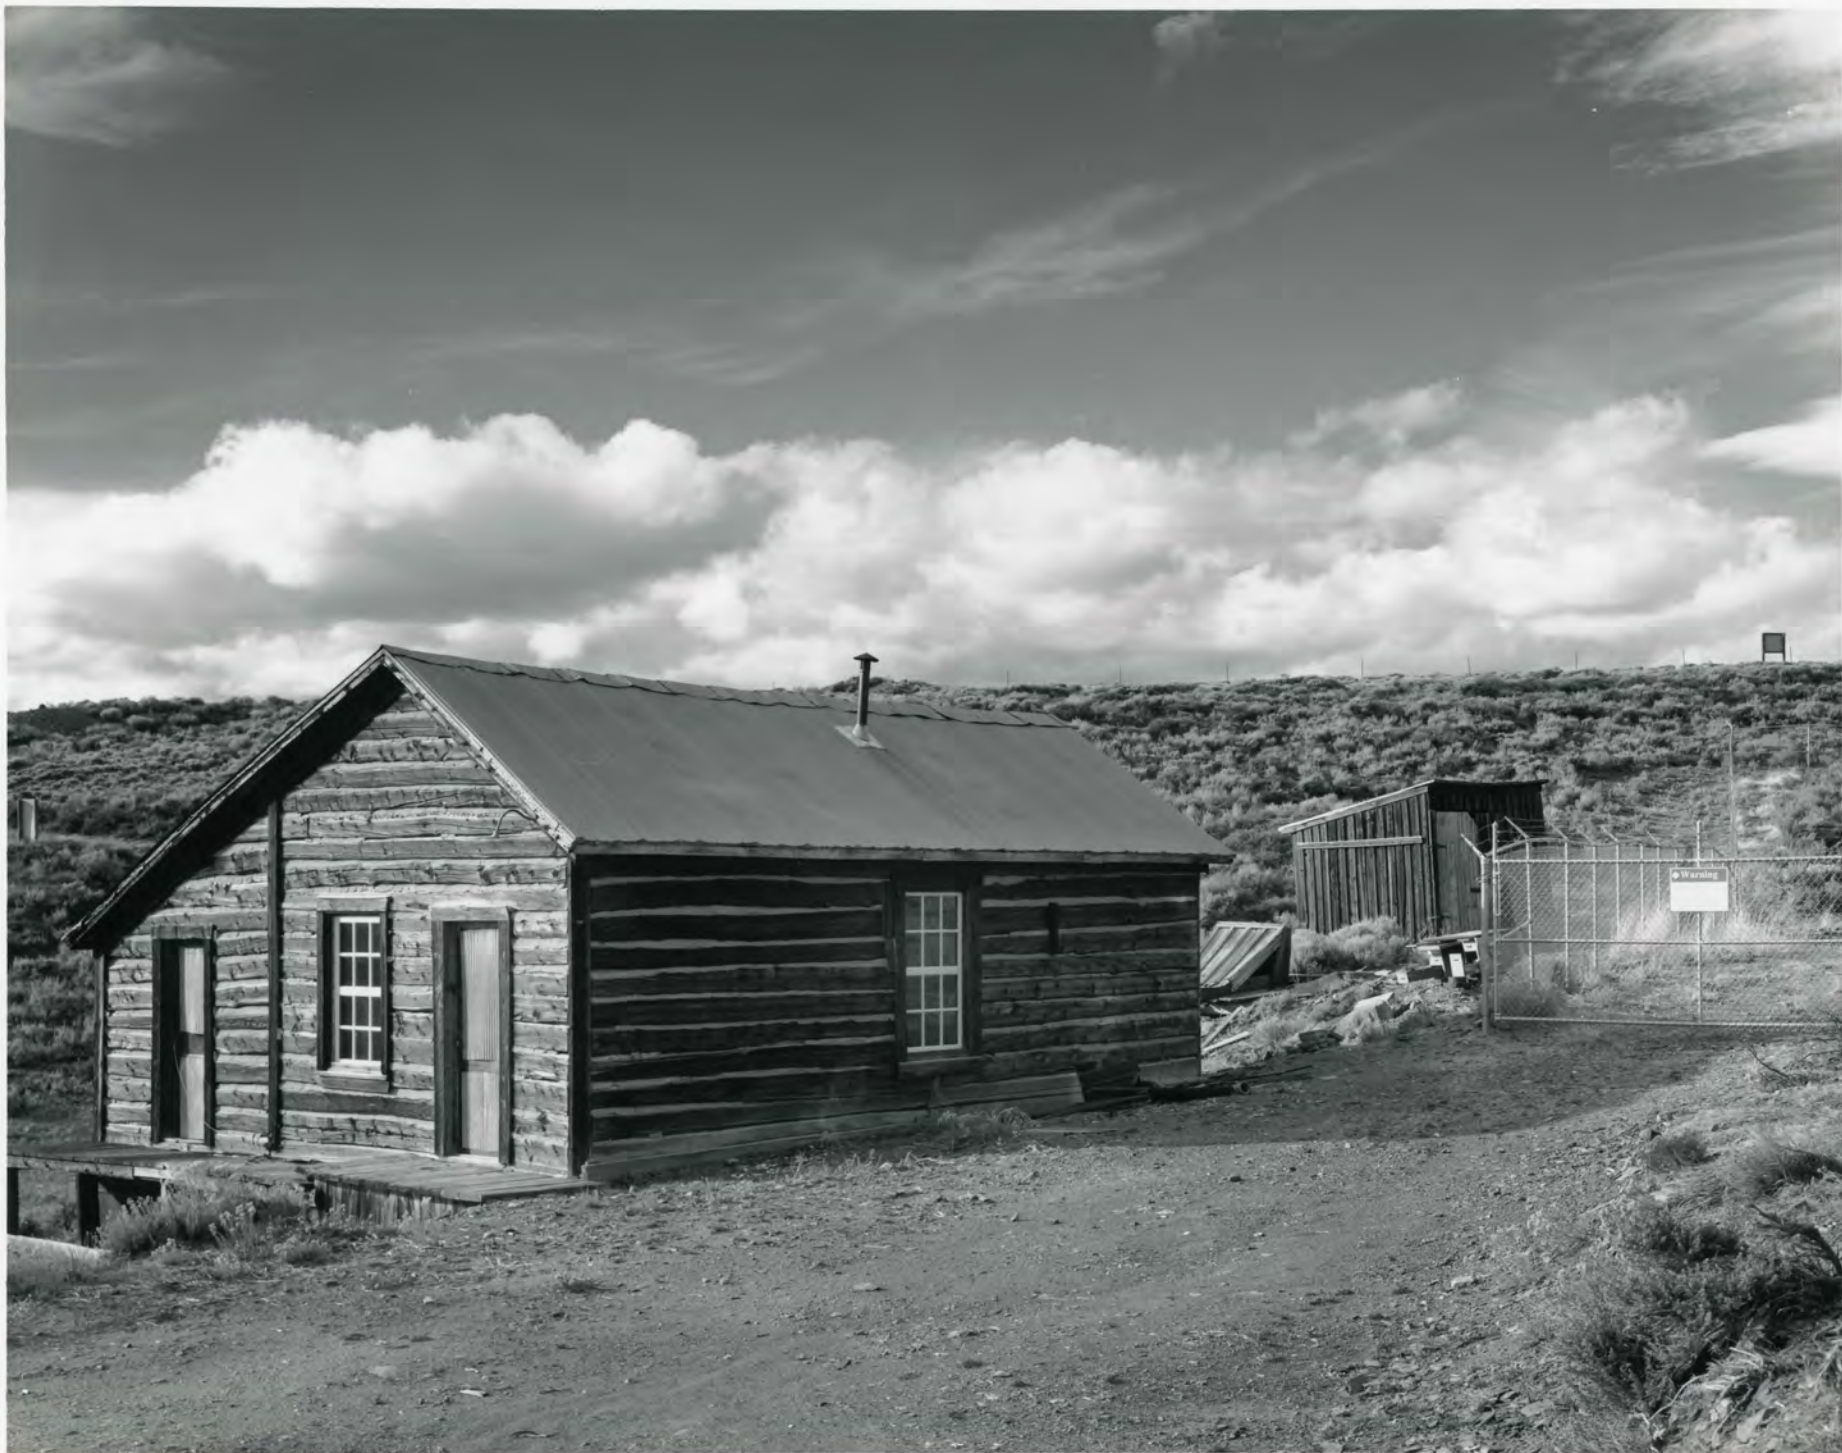
Carissa Mine & Mill Complex, Mill office & Reagent Shed (44 & 45)
