# National Register of Historic Places Registration Form

historic name South Pass City Historic District (boundary increase, additional documentation, and name change)

other names/site number South Pass City State Historic Site, 48FR434

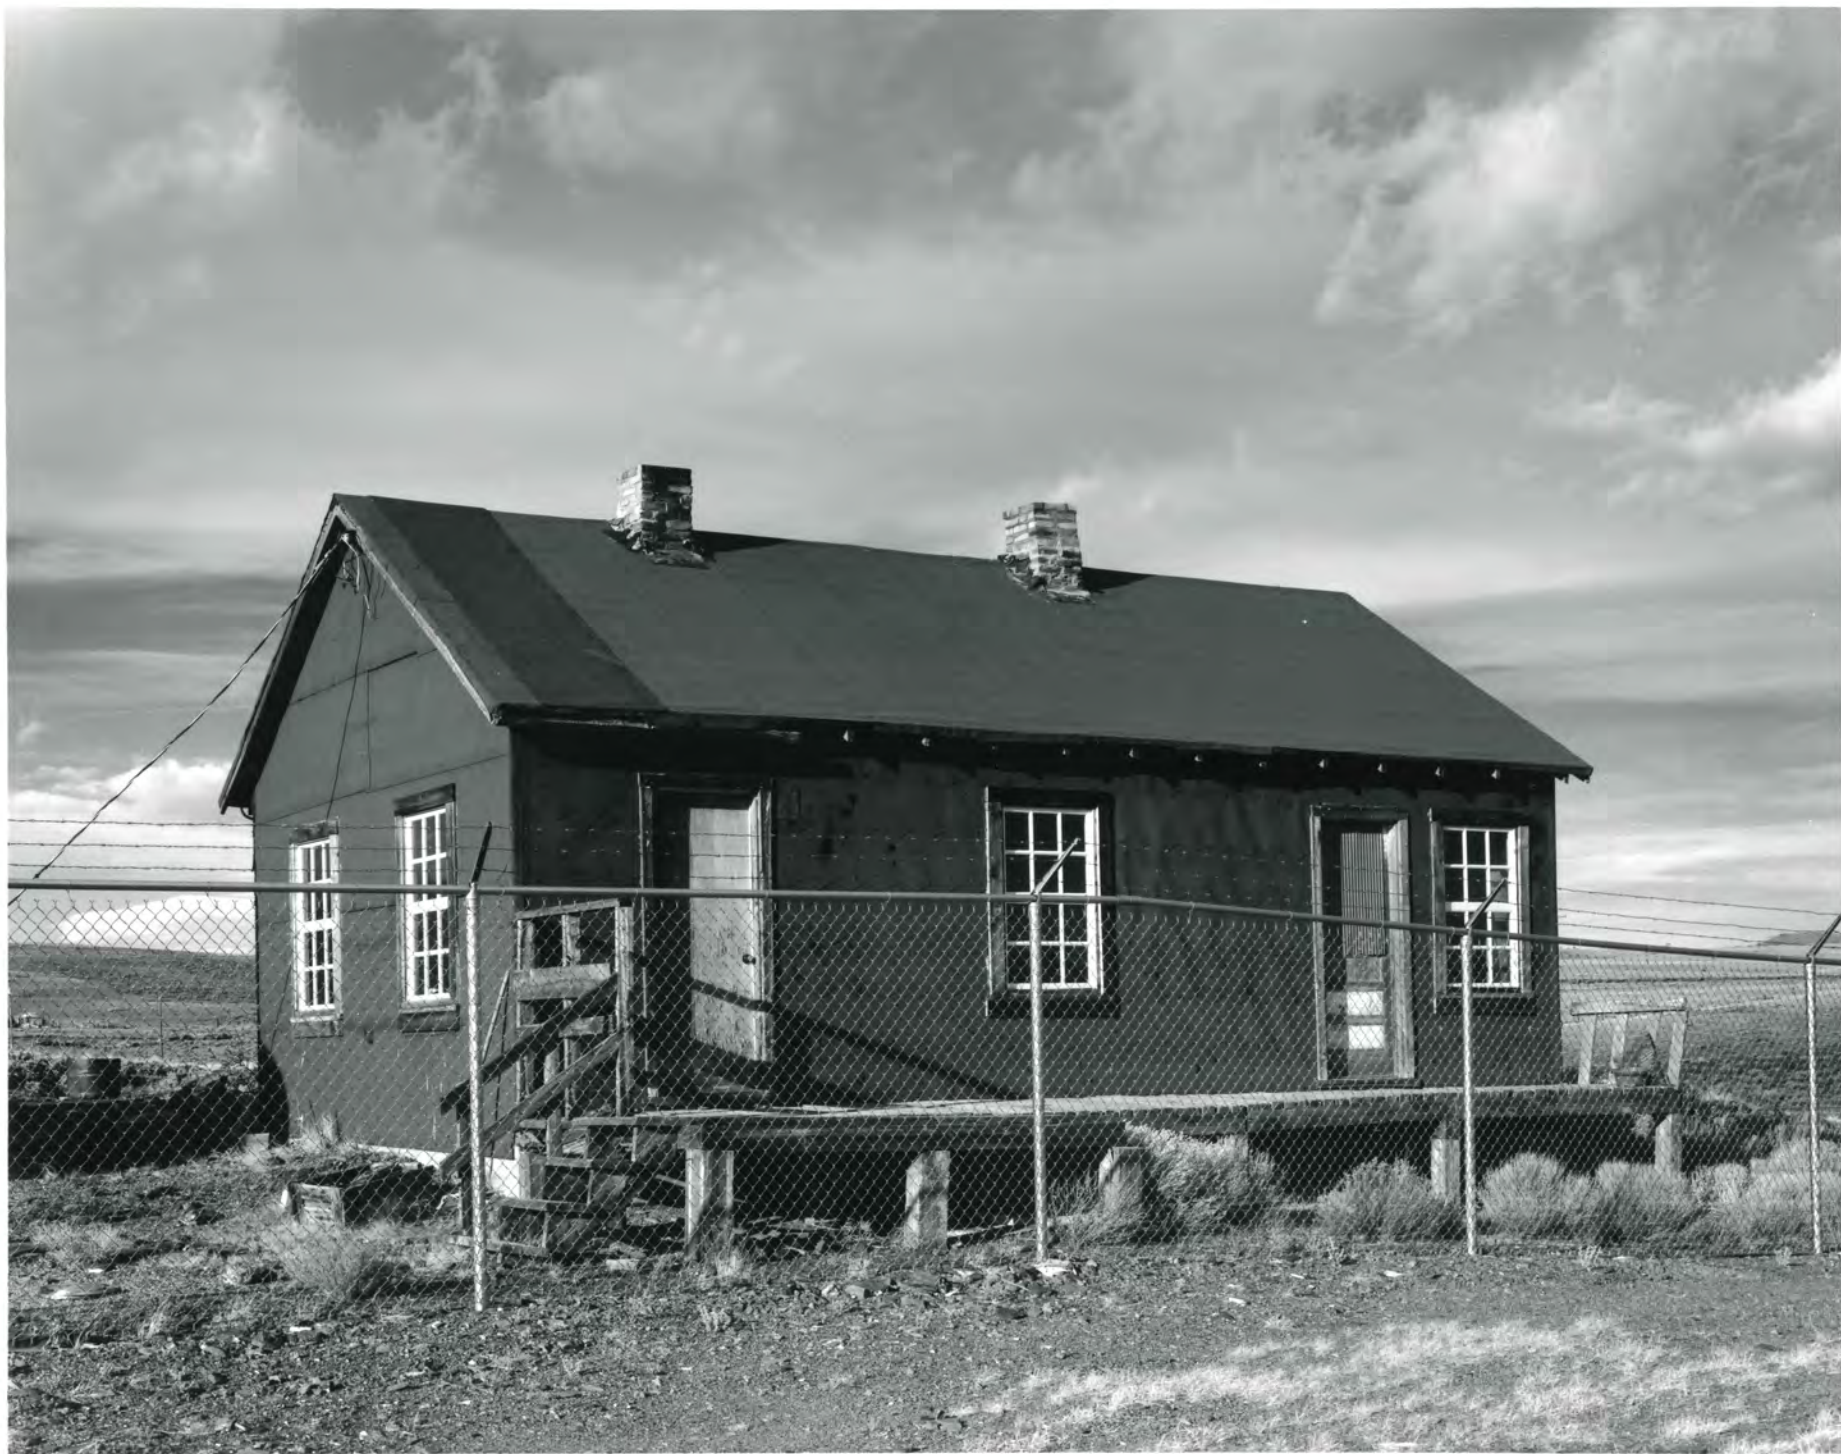
Carrisa Mine + Mill Complex, Mine Office (69)

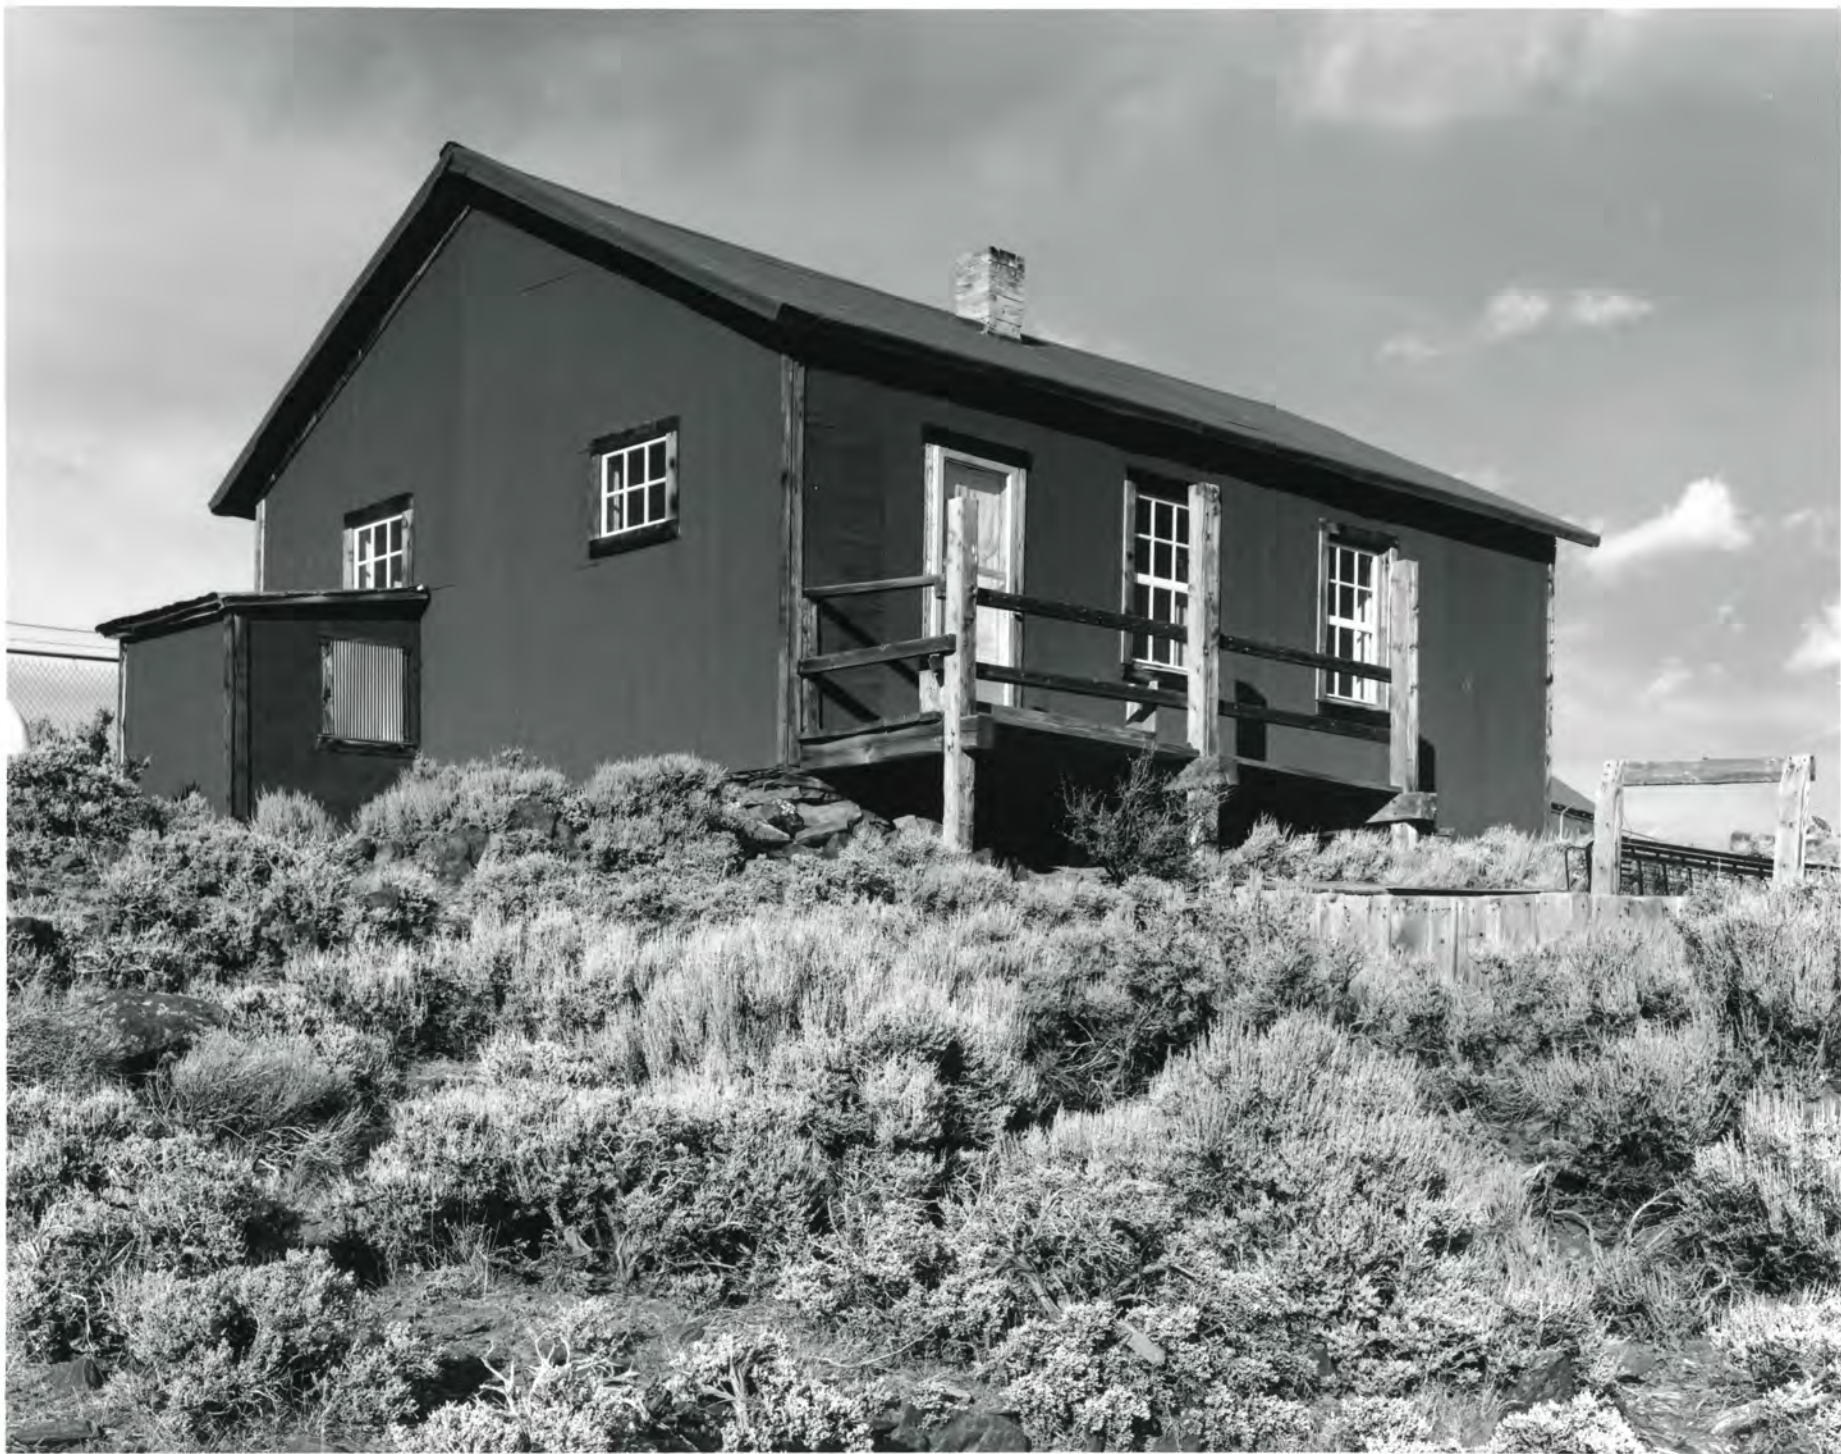
Carissa Mine + Mill Complex, Cook House (66)
