## JORDAN HOUSE

Carthage, Leake County, Mississippi

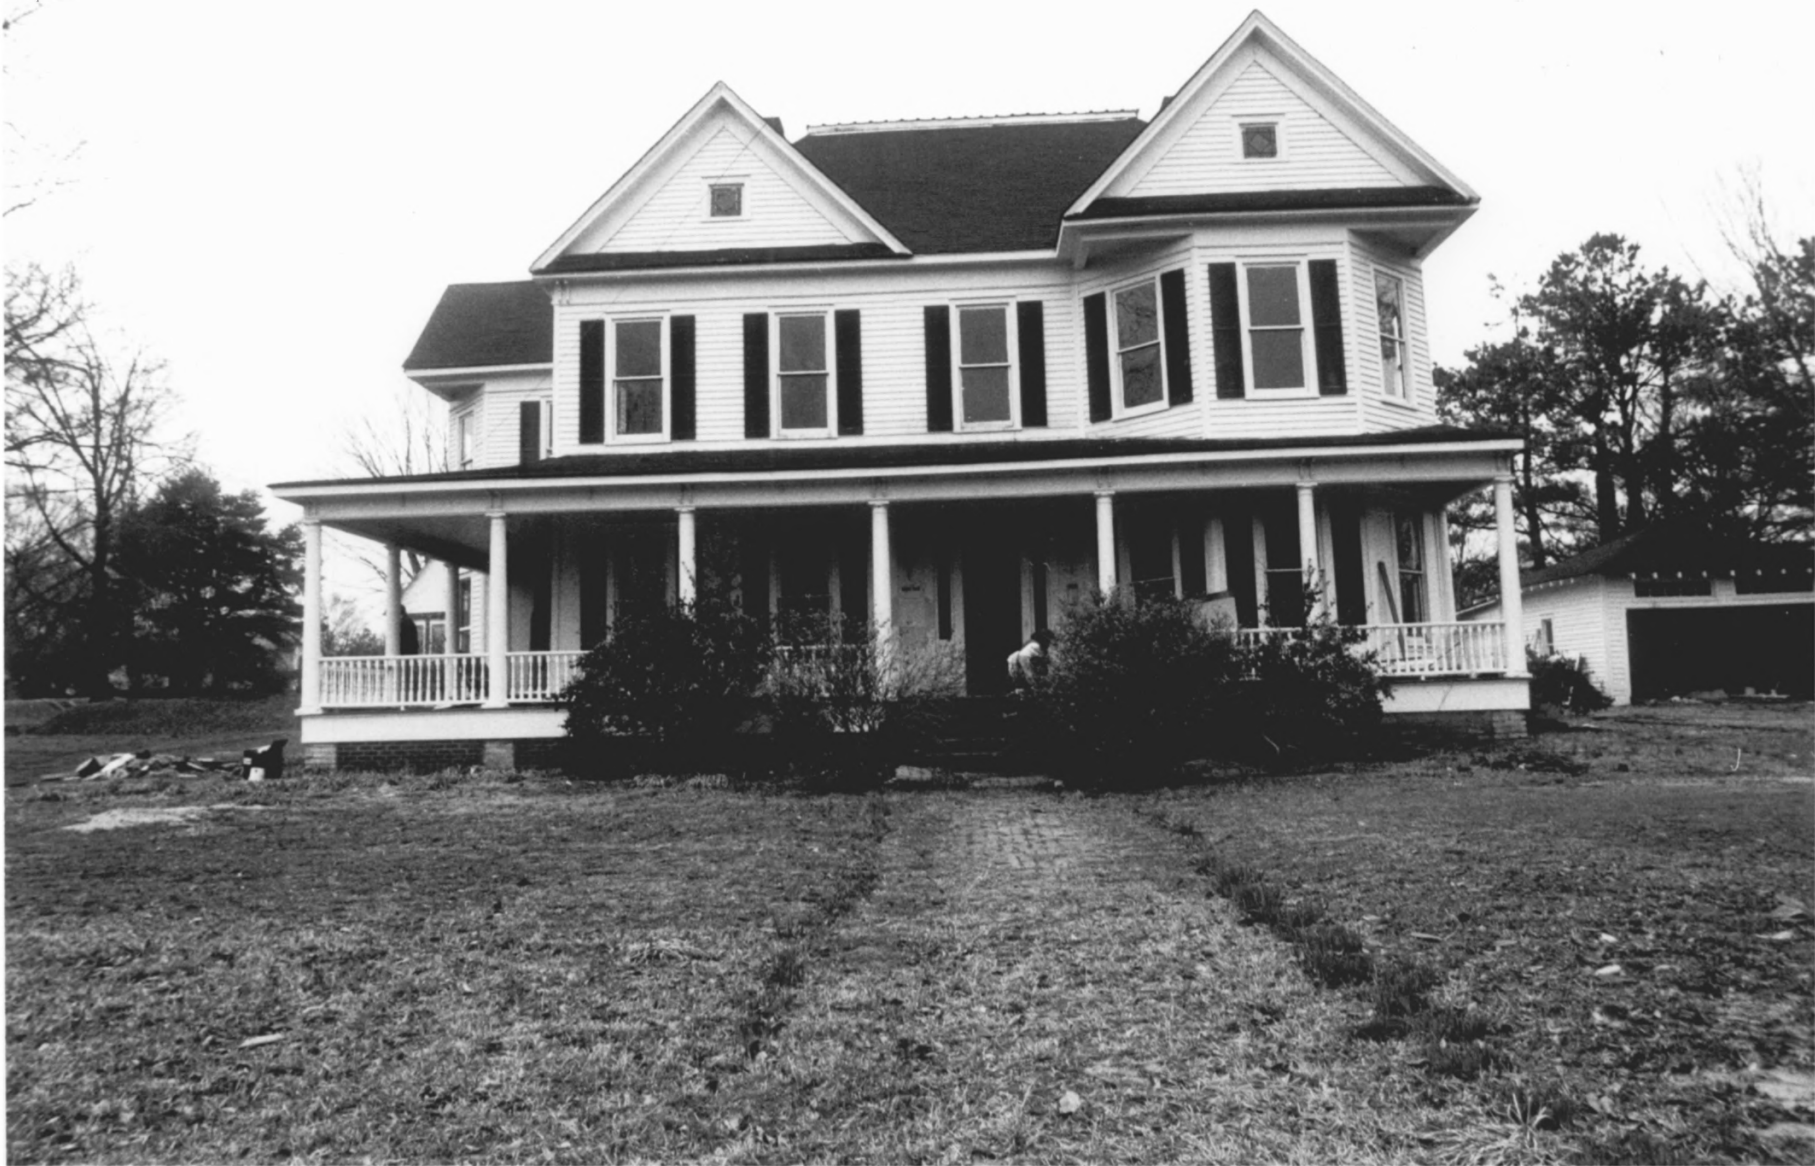
Looking northerly, the southerly facade of the Jordan House during restoration. Restoration plans call for the removal of the plastic shutters, the removal of the brick infill between the supporting piers, and the installation of a new iron railing on the deck of the hipped roof.

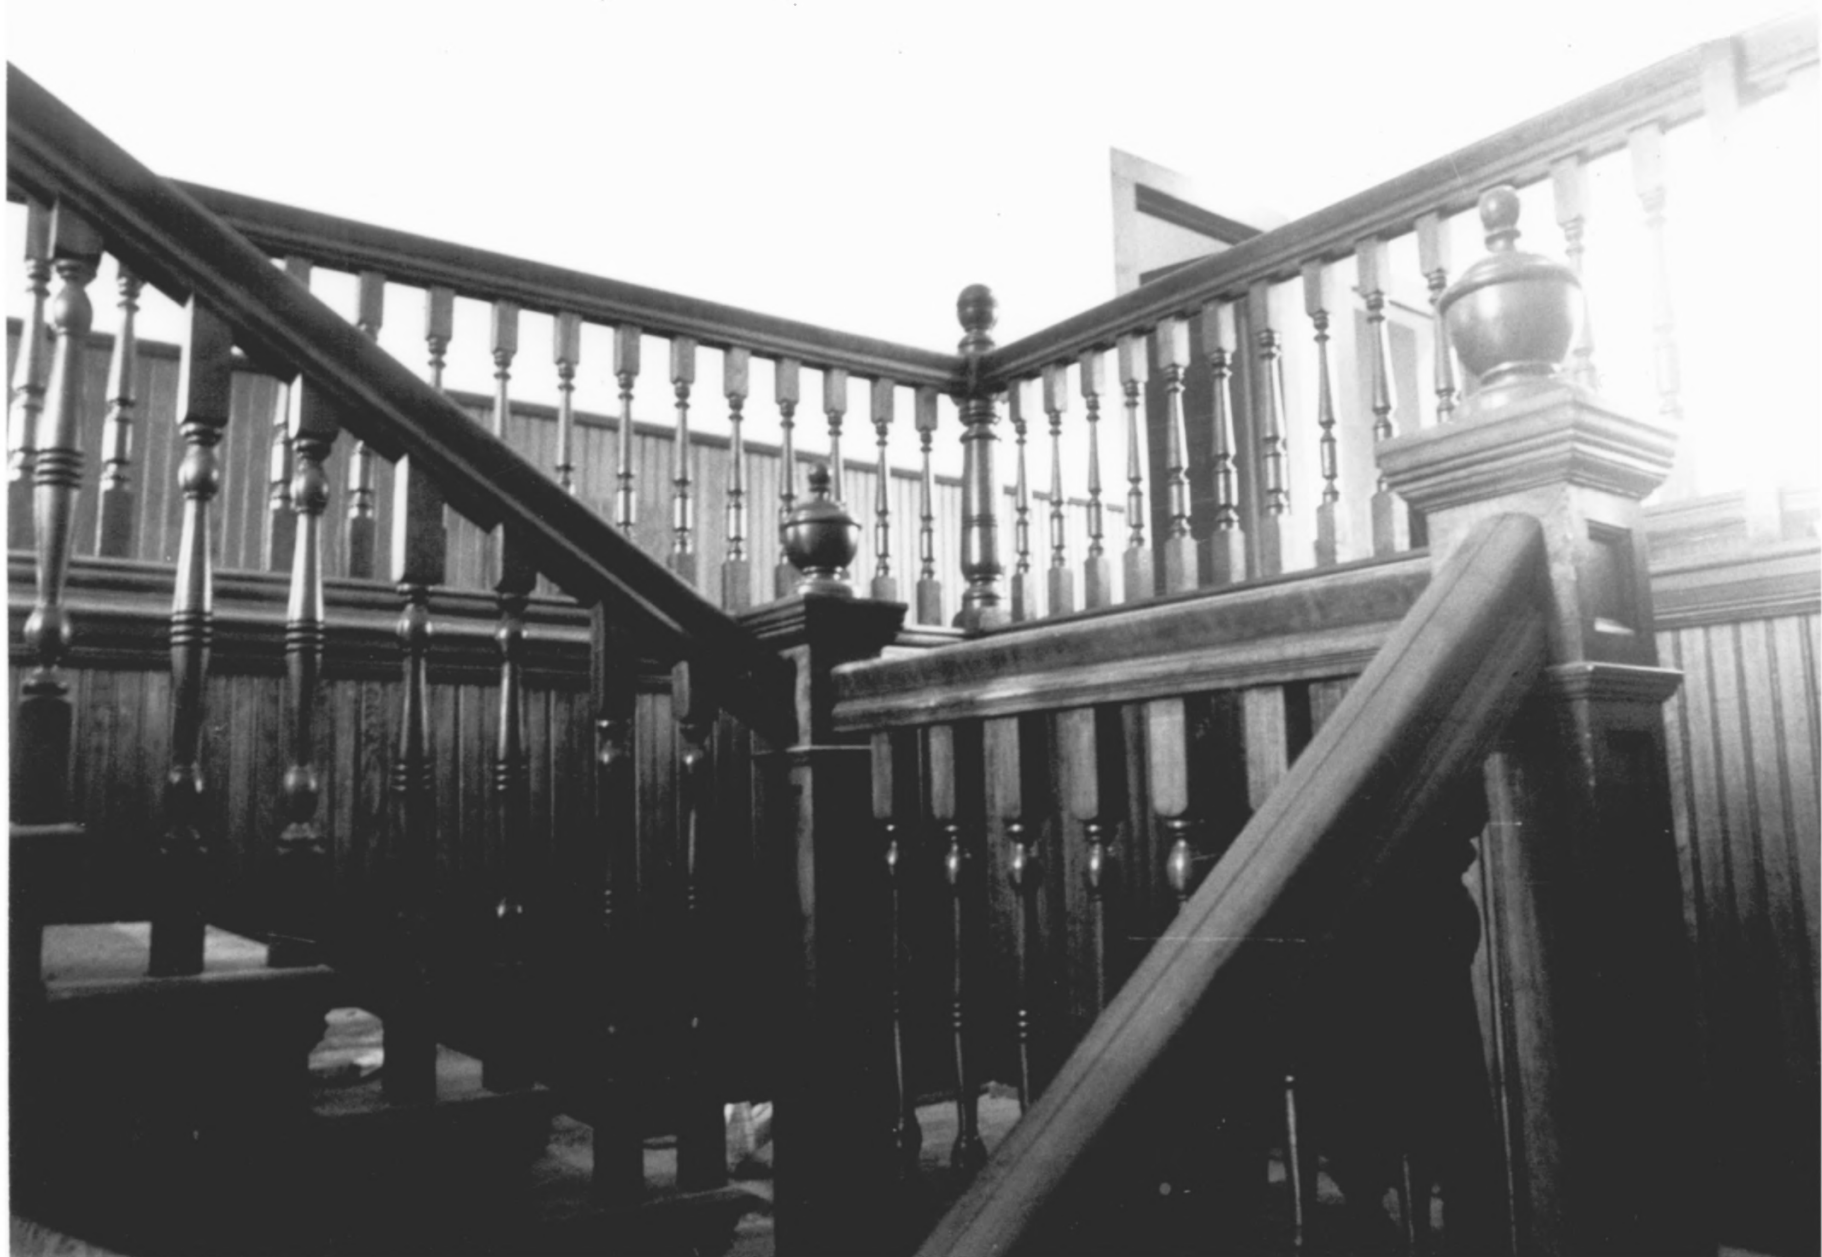
Photo 2 of 4

Looking northwesterly, the stairway and the second-story hallway of the Jordan House showing the millwork after removal of later paint layers.

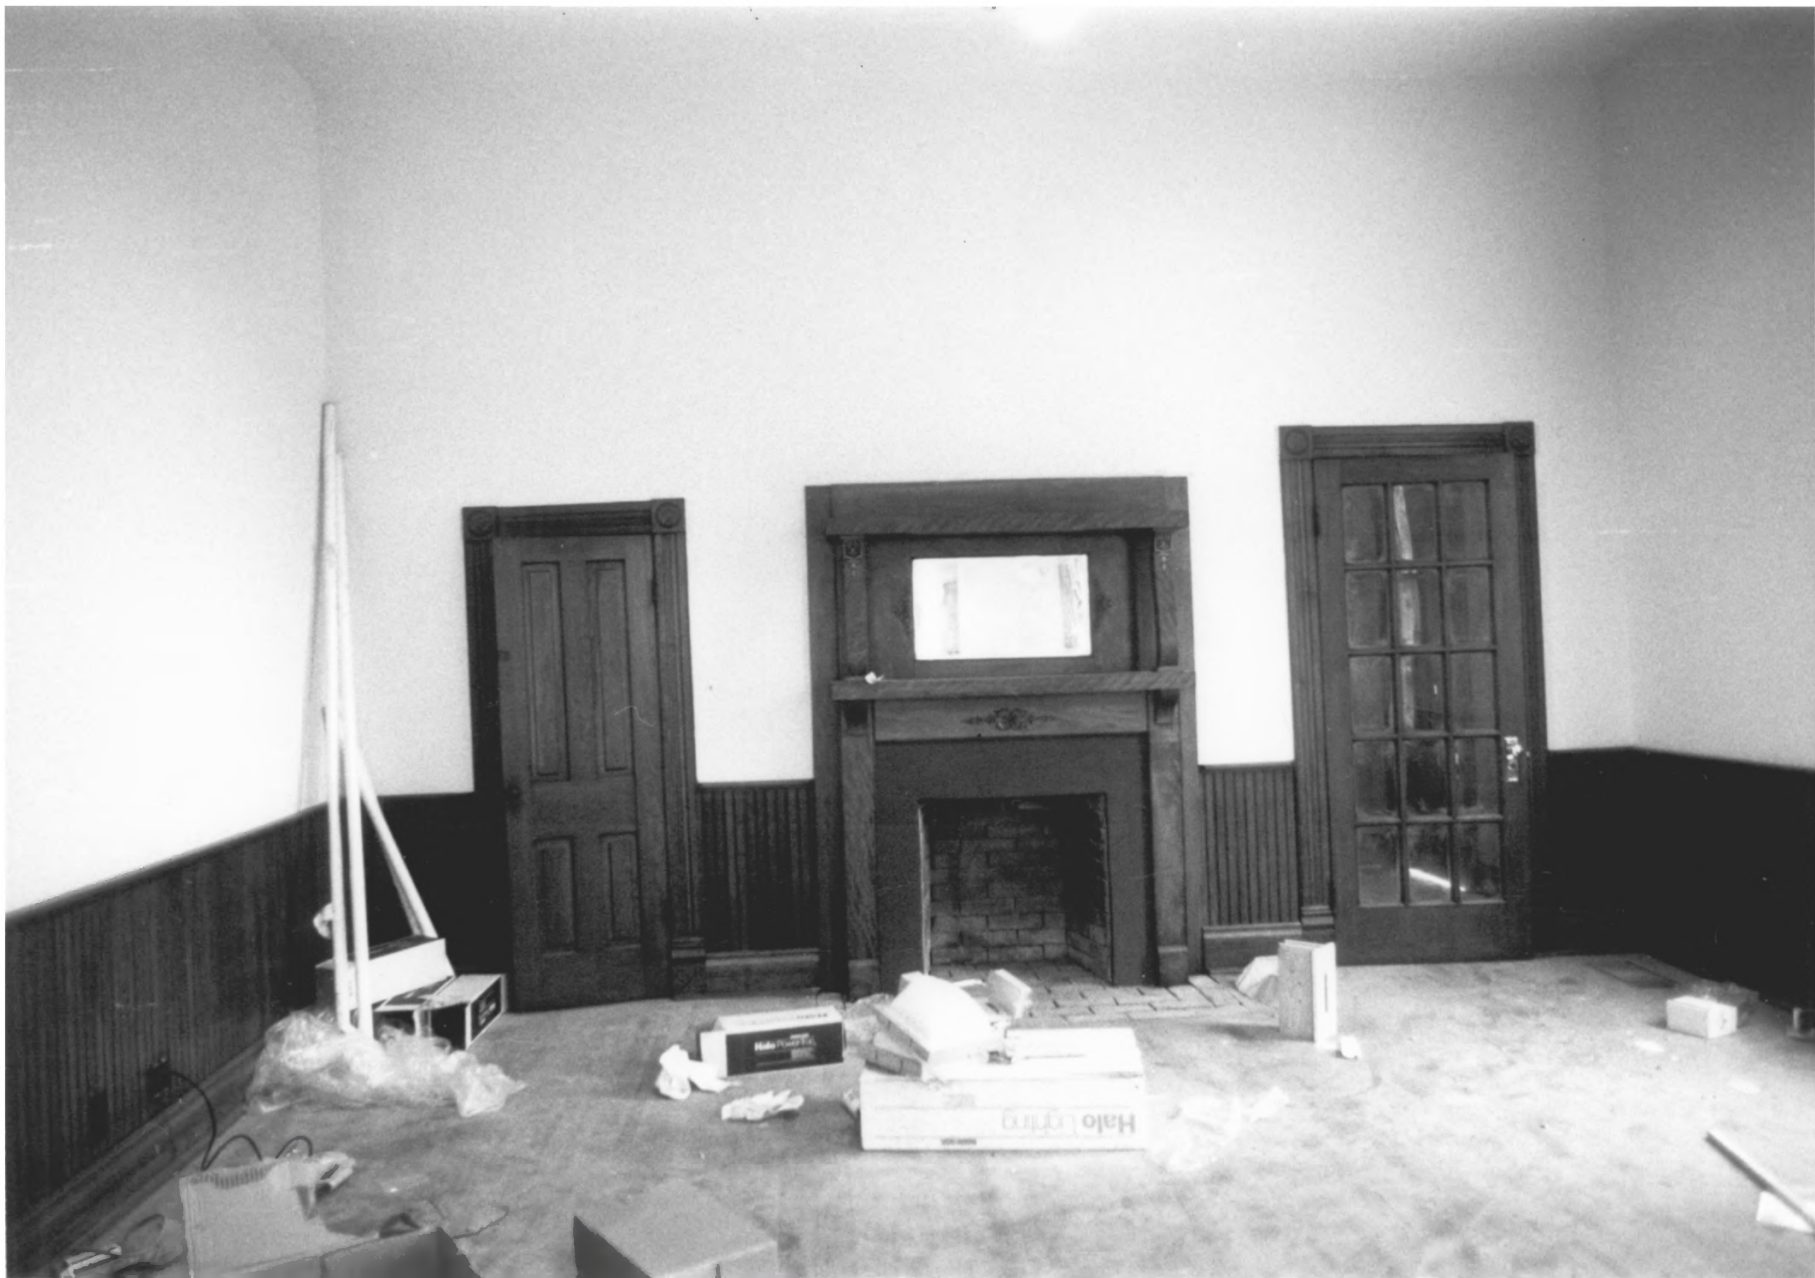
Photo 3 of 4

Looking northerly, the easterly front downstairs room showing the stripped and re-finished millwork.

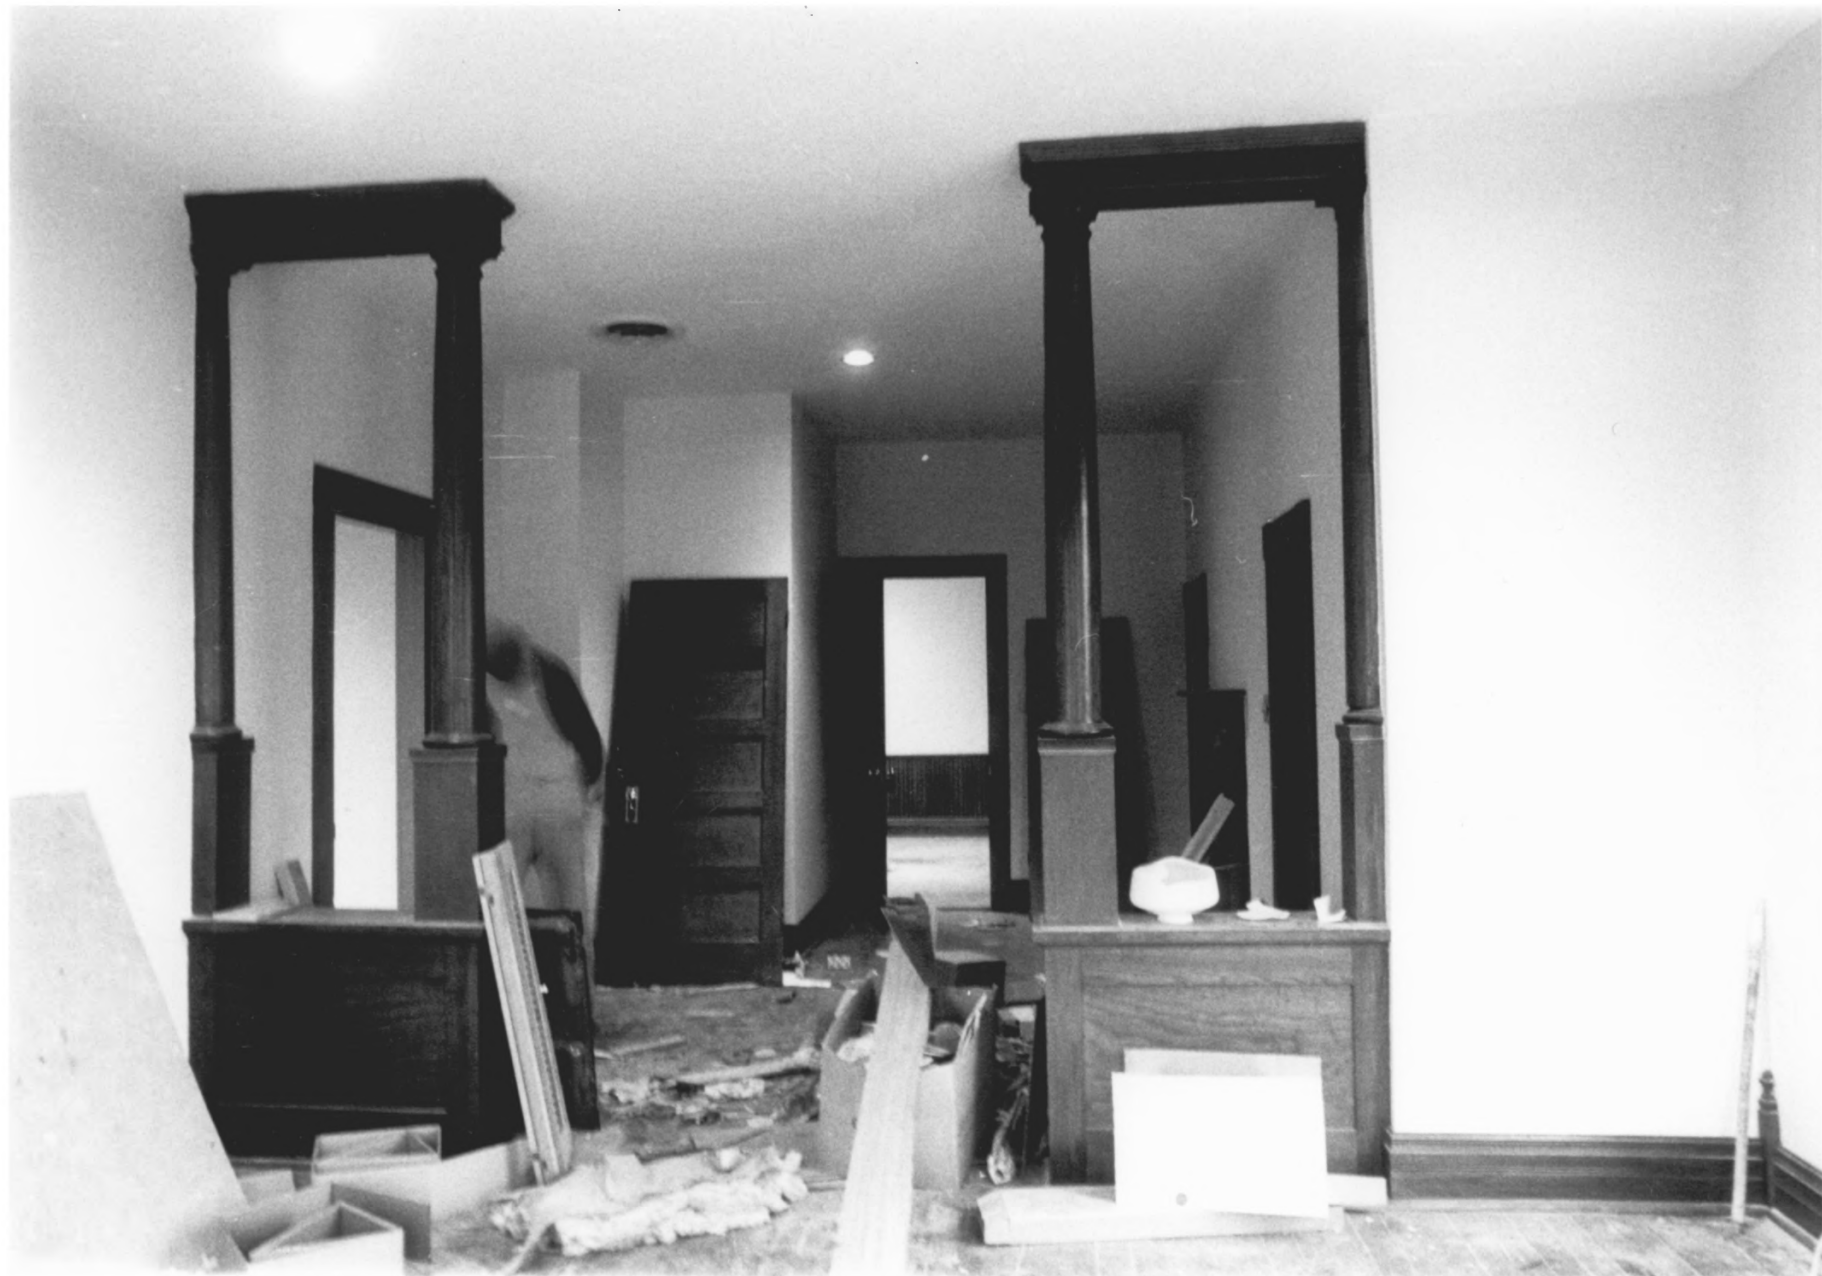
Photo 4 of 4

Looking easterly, the columned divider  
of the northwestern second-story bedroom.
