# National Register of Historic Places Registration Form

historic name Baldwyn Historic District

city or town Baldwyn

state Mississippi code MS county Lee, Prentiss code 081, 117 zip code 38824

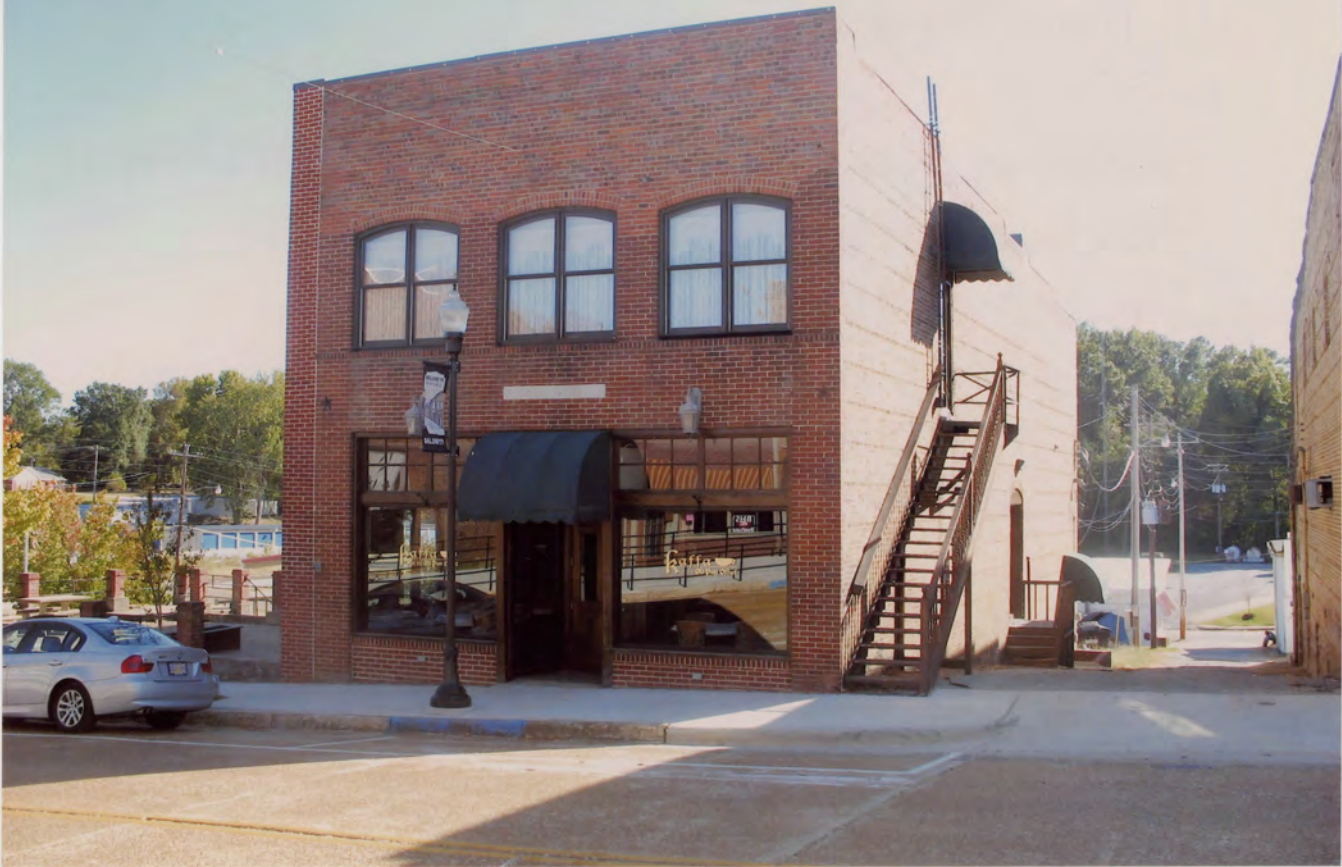
111 Main Street, East  
# 37

Rectangular one-story frame one-part commercial block row building with a monopitch roof concealed by a flat parapet at its façade and stepped side parapets; extends on sloping site along a vacant lot to the east, and abuts an adjacent building to the west; single storefront system at façade with an entrance at its east side flanked by a double wood framed display window on low frame bulkhead, modern flat aluminum canopy; roll composite siding in a brick pattern; continuous concrete foundation. Building has been heavily altered. [Photo # 5]

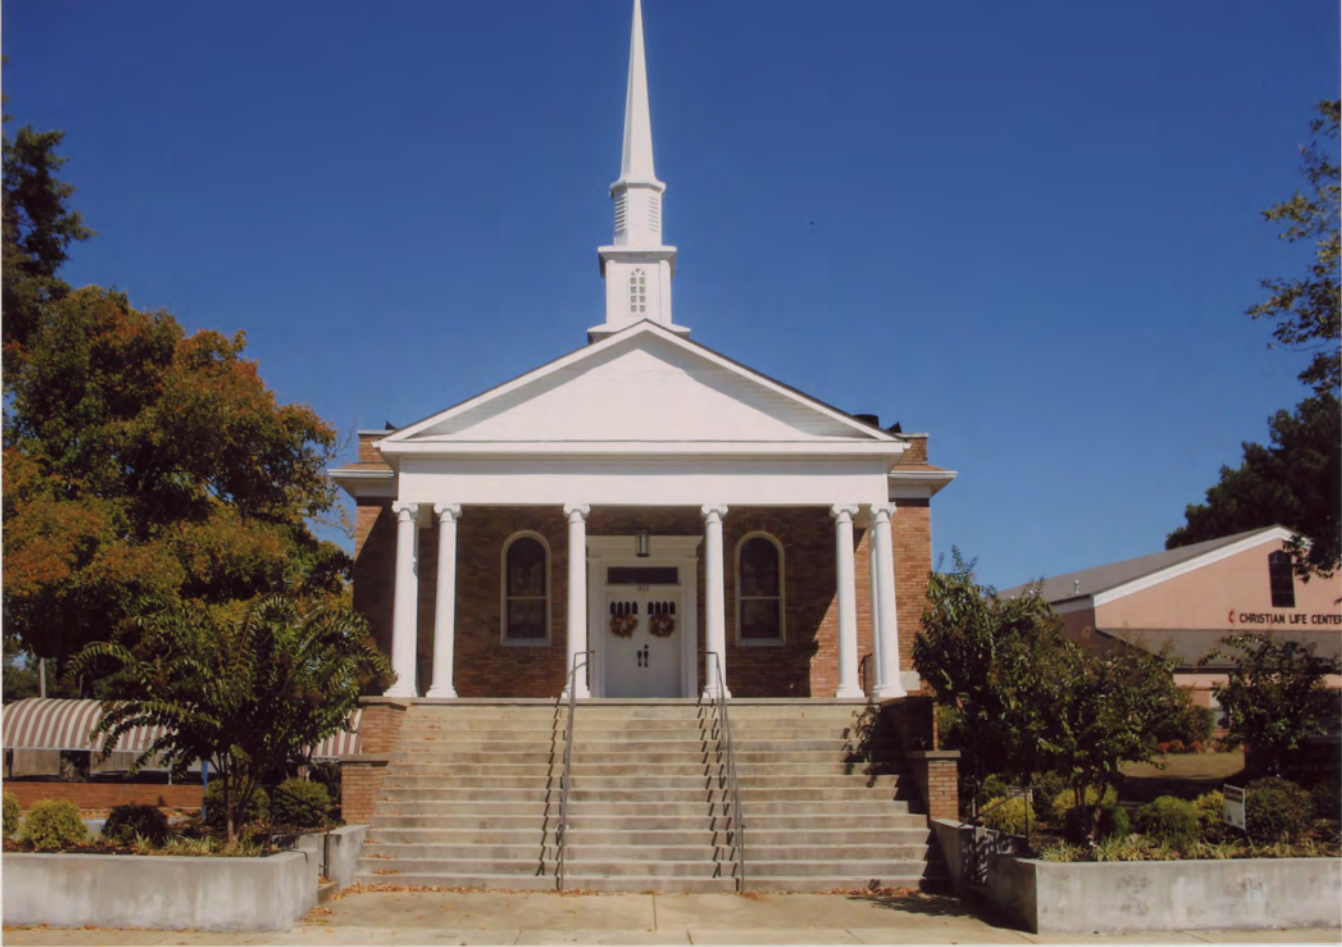
First United Methodist Church  
312 Main Street, West  
#67

One-story brick church building with a front-facing gable composition shingle roof with a spire; three-bay rectangular core with slightly projecting side pavilions at the front bays of the side elevations; less than full facade pedimented portico with Corinthian columns; central entrance at facade with a trabeated surround with double leaf doors and transom flanked by single arched window openings with stained glass windows, similar windows at side elevations with rectangular 6/6 windows corresponding at the basement level; exposed brick veneer exterior walls; detached one-story brick veneer ancillary building to rear with a hipped industrial metal roof joined by a covered walkway to a second ancillary stucco and brick Christian Life Center building with a front facing gable industrial metal roof; alterations include the application of vinyl siding at the portico and the steeple appears to be modern. Datestone reads: First Methodist/Church/1925." [Photo # 8]

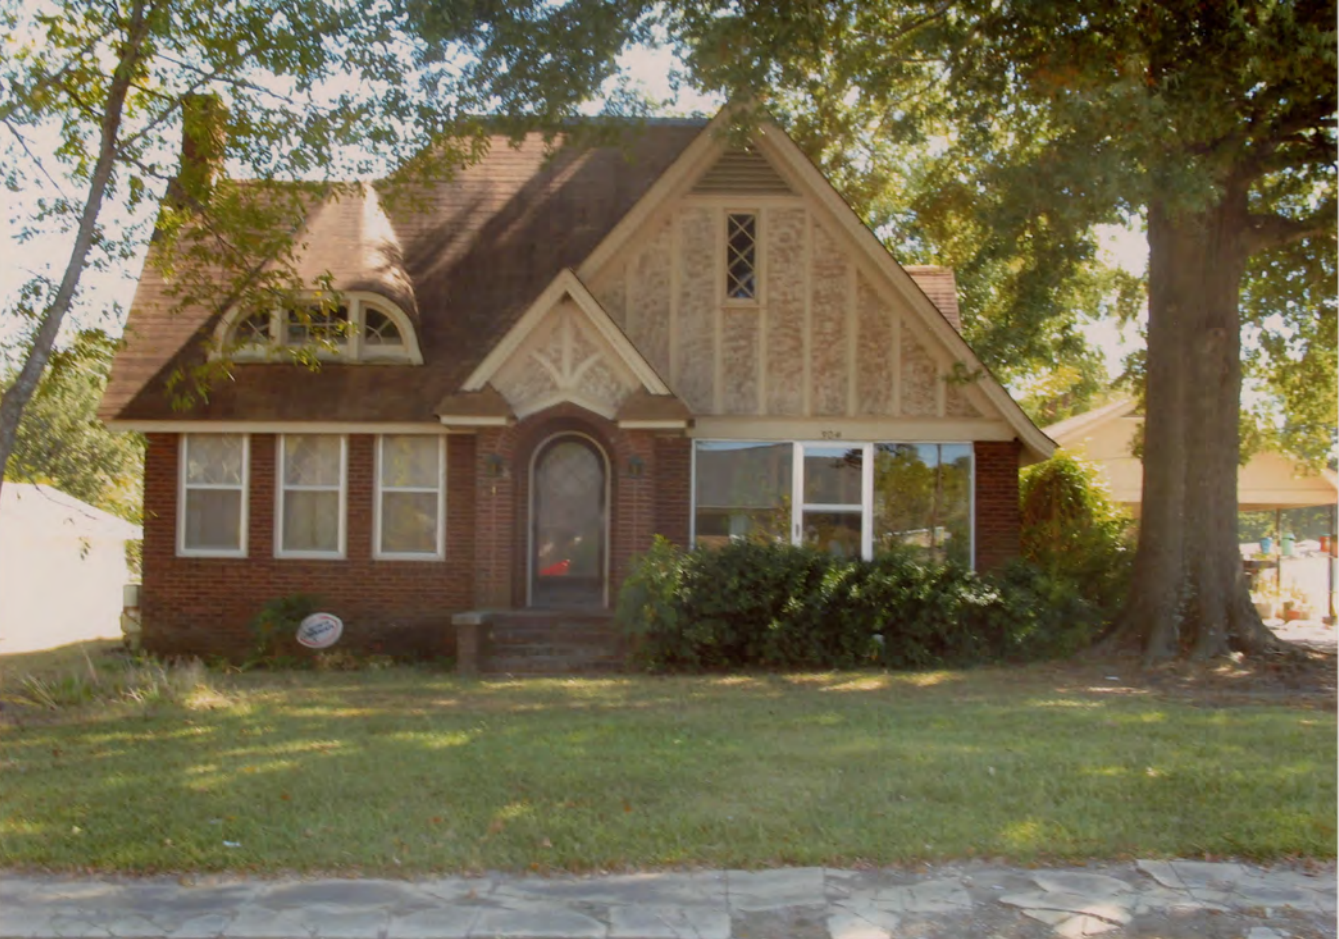
Photo 10 of 14

**91a. (C) 304 Second Avenue, North c. 1925 Tudor Revival**  
One-story brick veneer Tudor Revival style dwelling with a hipped composition shingle roof with cross gables, arched decorative dormer, one end brick chimney and one interior brick chimney; three-bay rectangular core recessed corner porch at south bay of facade now glassed in, off-center entrance bay with recessed entrance flanked to the west by a triple window with patterned upper sash, similar single and double windows at side elevations, half timbered gable ends; exposed brick veneer exterior walls set in stretcher bond; brick veneer at foundation. [Photo # 10]

The Tudor Revival style was used in Baldwyn, although it was not as popular as the Craftsman style as not many were built. Excellent examples of the style are located at 304 North Second Avenue (#91a) [Photo # 10], 455 South Third Avenue (#194) and a simplified version at 505 North Second Avenue (#103). All are sided in brick and feature typical Tudor characteristics such as higher pitched roofs, asymmetrical façades, cross-gables, and use of multi-paned windows.

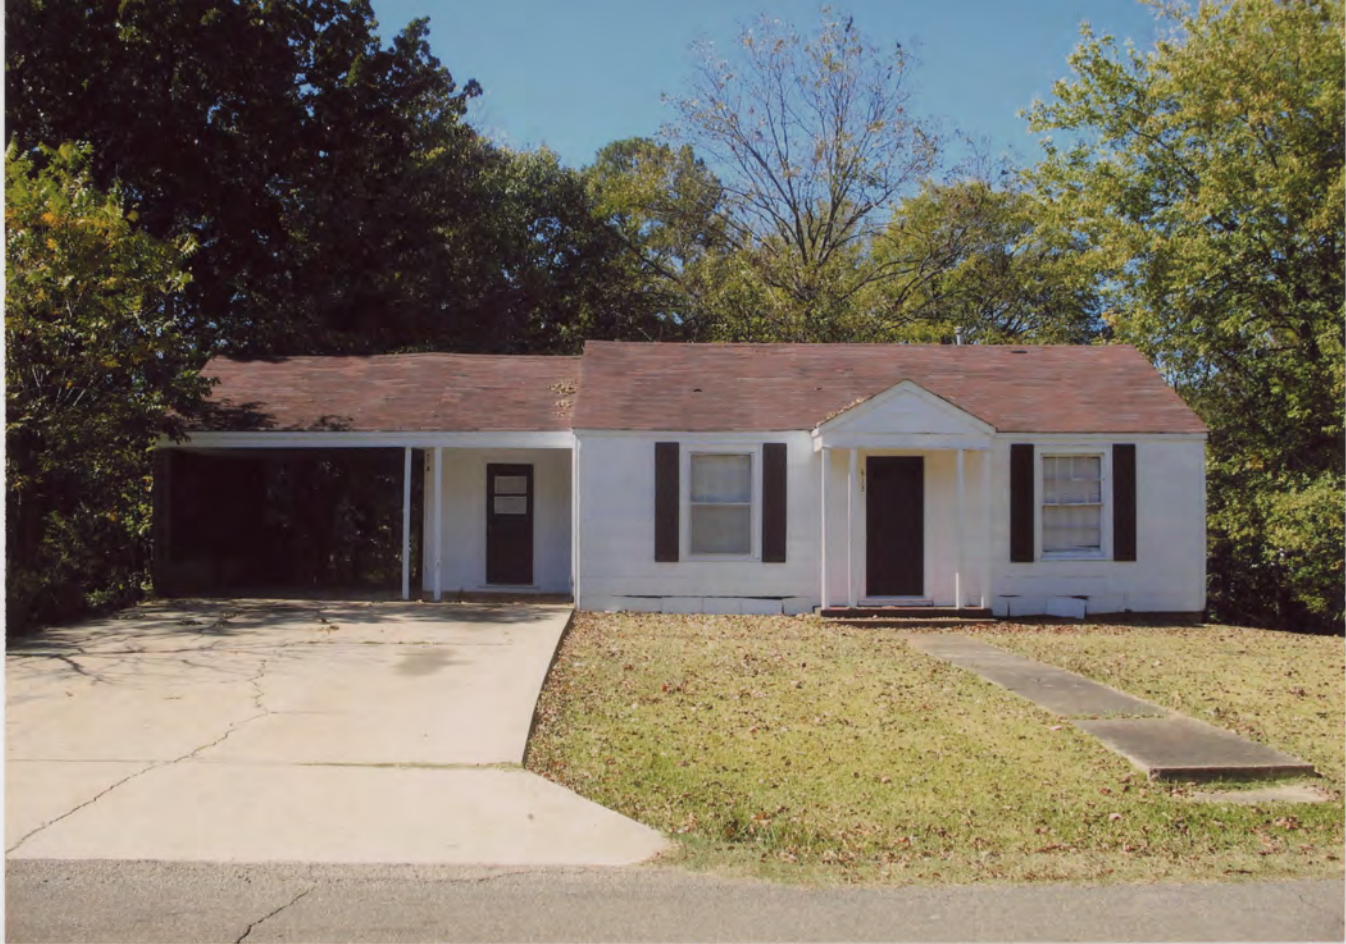
Photo 13 of 14

One story frame dwelling with a cross gable composition shingle roof; four-bay rectangular core with an attached carport to the south; less than full facade shed porch with columns; off-center entrance at facade flanked by single and double synthetic 6/6 windows, similar windows at side elevations; composition board siding with vertical siding within the porch; continuous brick foundation. [Photo # 13]
