National Register of Historic Places  
Inventory—Nomination Form

1. NAME: Minot Industrial Historic District
2. LOCATION: Generally bounded on the north by the Souris River and the north edge of the Burlington Northern railroad yards; on the east by the Souris River and an oxbow of the river; on the south by First Avenue and Front Street, and on the west by Broadway. All of four blocks and parts of four others in the St. Croix, Bayou, and Ramstad's First additions of Minot and centered on Burlington Northern and Soo railroad lines.

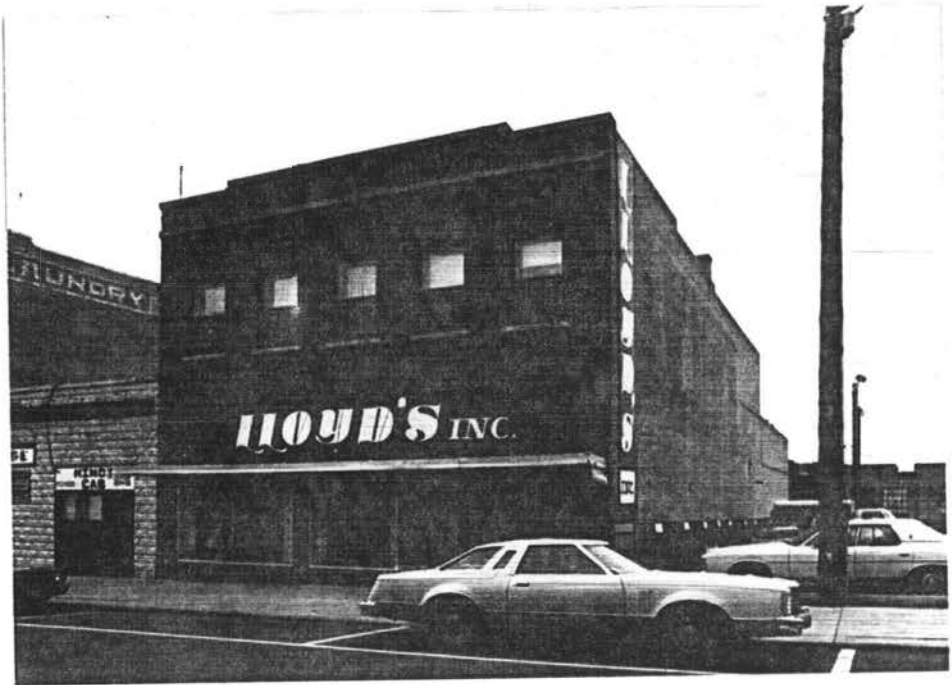
SITS Number 32WD591

FEATURE DESCRIPTION: The store front of this 2-story commercial block was remodeled to its present condition in 1959 (City Assessor's Card). Since then, aluminum sash windows have been placed in the upper level openings. Intact details on the facade (west), which is laid in running bond, include: a parapet with a single step which frames a painted sign reading, "National Warehouse Co."; a corbeled brick cornice which supports a drip course of stone block; and stone block lugsills set in the upper level openings. Brick corner pilasters on a marble base, and corbeled courses of brick which frame the store front remain intact as well. The north, south and east (rear) elevations are all laid in American bond. The east portion of the structure drops to a single story. Three warehouse casement windows, set above a basement level garage door, pierce the rear wall.

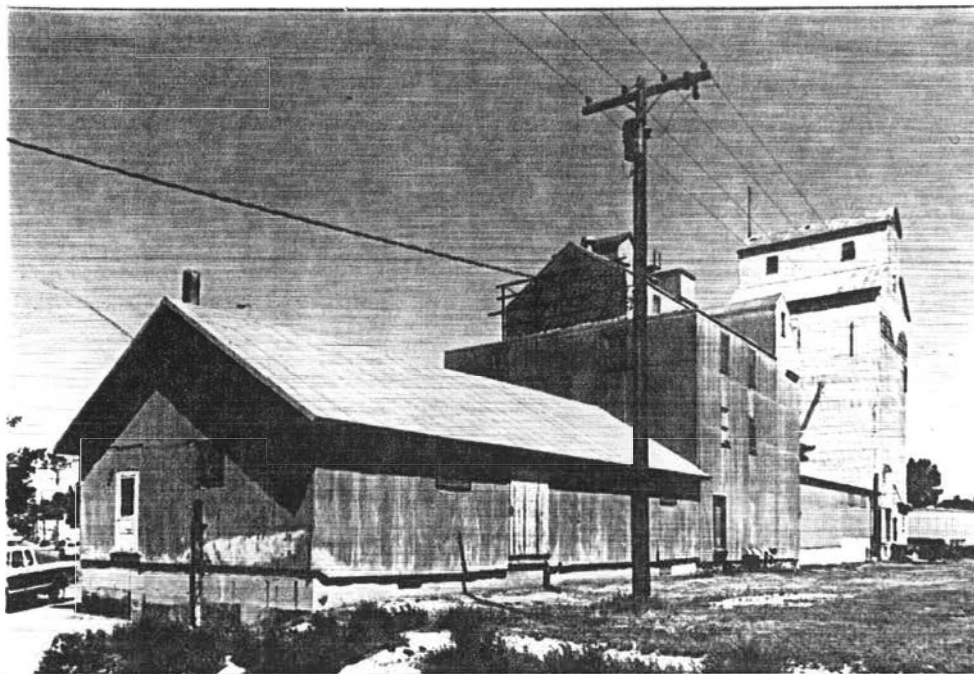
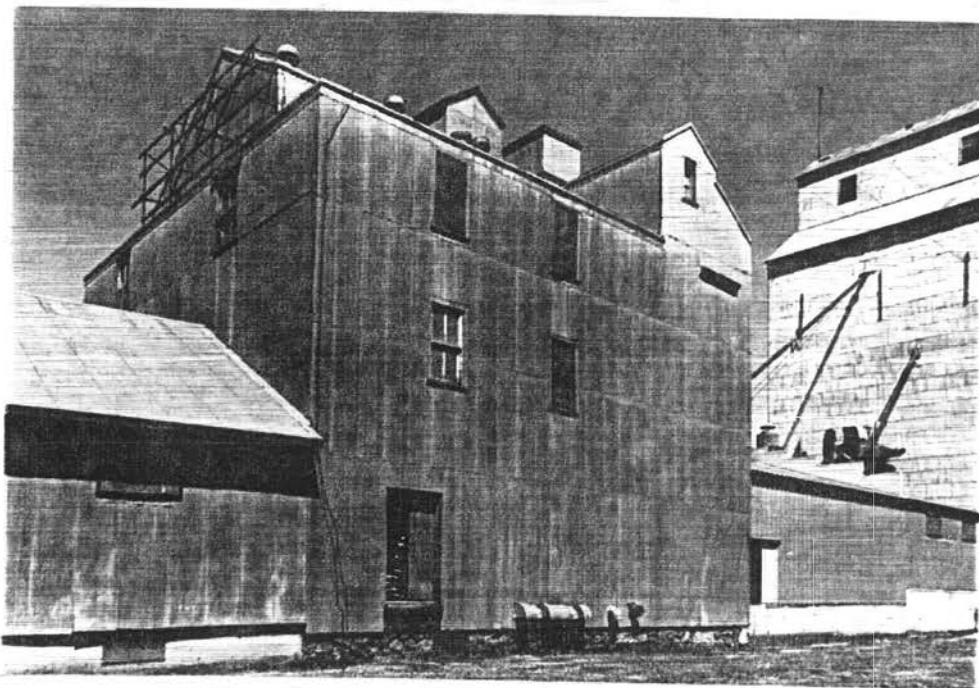
SITS Number 32W0652

FEATURE DESCRIPTION: This mill consists of a central 4-story building flanked on the east and west by 1-story warehouse extensions. The central building is a rectangular block 3 stories tall, with the 4th floor consisting of a smaller intersecting gable roof story. Two elevator legs, one under a gable roof enclosure, rise above this 4th story. Windows are double-hung 2/2. On the south side a rubble stone shows, but on the north side a modern 1-story addition (offices) has covered the base of the older building. The flanking warehouse wings have gable roofs and concrete foundations.

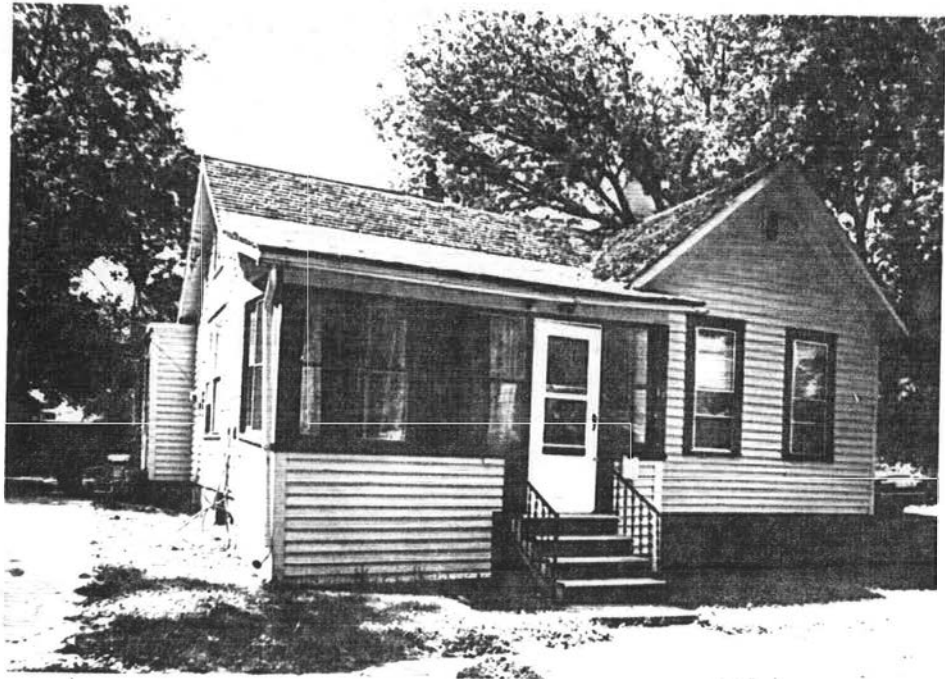
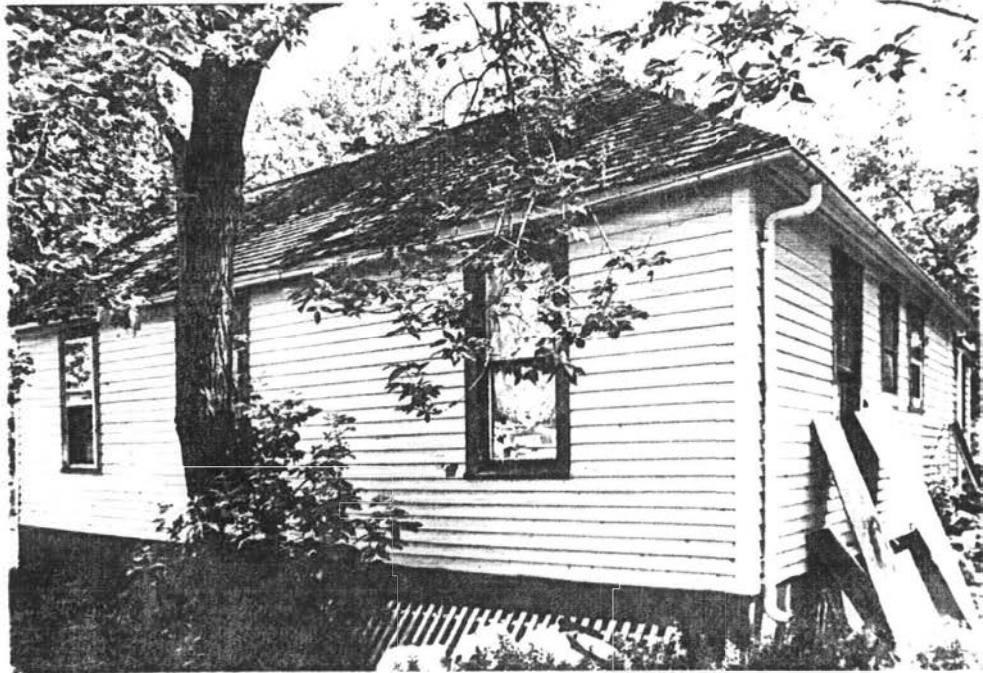
SITS Number 32WD676

FEATURE DESCRIPTION: This 1-story rectangular shaped house with a cross-gable roof in front with both wood and asphalt shingles and a rolled hipped roof in rear has a poured concrete foundation and is wood frame with beveled lapped siding. Windows are predominately 1/1 double-hung with wood sash and aluminum storms. There is 1 brick chimney; interior, north ridge. The front porch, inset in the L, appears to be an addition, and is enclosed by ribbon casement windows. A flat roof entry, enclosed by wood siding, is inset in the rear L (south-west corner).

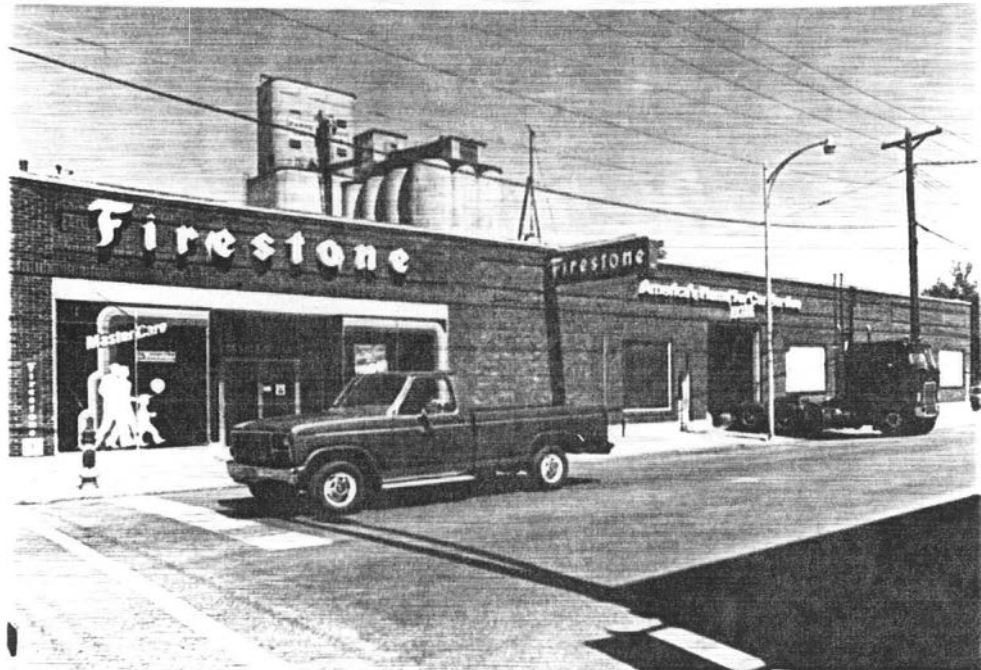
SITS Number 32 W0817

FEATURE DESCRIPTION: This 1-story auto repair facility has a tire display and customer service room in the SW corner; the rest of the building is devoted to the auto repair shop and tire and parts storage. The store front on the south and west facades was remodeled in 1957 and included filling some window openings with brick and concrete block (City Assessor's card). The rest of the building (facade walls above the store fronts, other walls) are relatively unchanged. The roof of this building is comprised two side-by-side barrel roofs supported by wood warren trusses with curved upper chords.

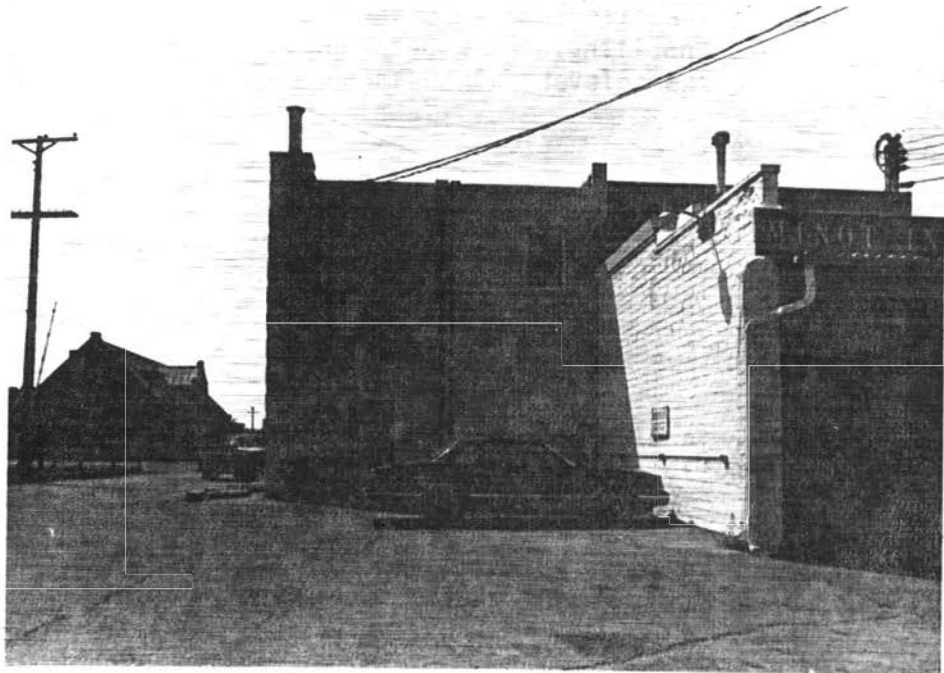
B.W. Photo I.D. Code RTI85MT-Roll 33 Frame 11A

FEATURE DESCRIPTION: The top floor of this abandoned, 2-story brick building has been faced with vertical aluminum siding, the remaining walls have been painted, and several window openings boarded. Intact elements on the main level facade (west), which features a 4-bay configuration, include: 2 wooden frame doors (outer bays) with transoms (north filled with an air conditioner); and 2 wood sash Chicago-like windows with hoppers, set in rectangular openings and connected by a continuous flat arch lintel of soldier brick and a continuous stone sill. Remnants of the original stone cornice, which spanned the facade, are exposed on the western edges of the north and south elevations. These skewed walls are due to the proximity of Soo Line tracks and have double-hung and fixed windows (most with wood sash) as well as freight openings. A single loading dock is situated on the short rear (east) wall.

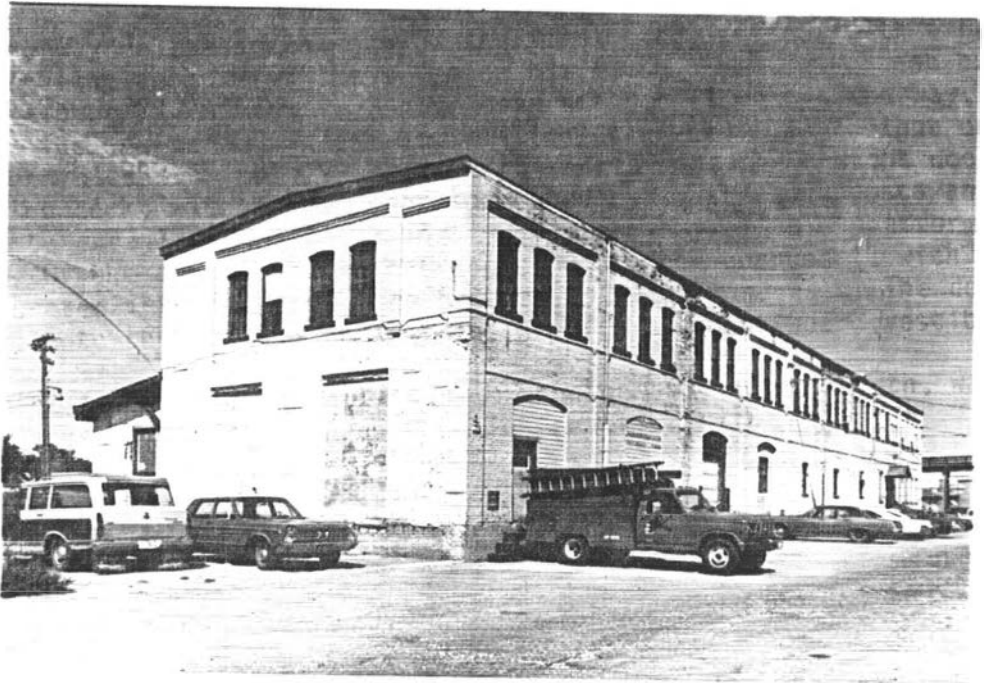
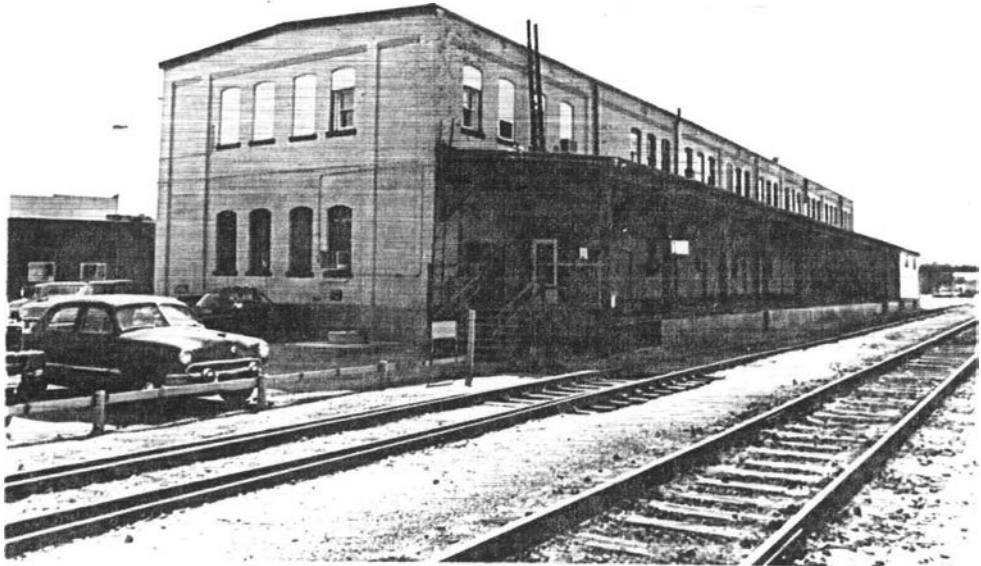
SITS Number 32W0849

FEATURE DESCRIPTION: This railway station is 9 bays (on north and south sides) by 1-1/2 bays (on east and west sides), has a low-pitch gable roof, and walls of brick in common bond. The second story is all offices; the first story has offices in the two eastern bays and freight warehouse space in the other seven bays. The bays are recessed wall panels with corbelling at the top. Windows are 6/6 double-hung under segmented arches. Many windows have been altered: boarded up, adapted for air-conditioners, or made into smaller aluminum-framed double-hung 1/1. (continued)

The western portion of this building, a 1-story extension of the same width, was torn down in 1979. Only some of the concrete foundation remains.
