1. GENERAL CLINTON HOUSE - HABS - 719500
2. MOUNT LAUREL, NEW JERSEY
3. PHOTO BY: NAN PILLSBURY, Ph.D. (Burlington County)
4. TAKEN, SEPT, 1988
5. NEG. WITH: NAN PILLSBURY, Ph.D.
 401 MILL ST.
 MOORESTOWN, NJ. 08057
 (609) 235-6080

1. GENERAL CLINTON HOUSE - HABS NJ-504
2. MOUNT LAUREL, NEW JERSEY (Burlington County)
3. PHOTO BY: NAN PILLSBURY, Ph. D.
4. TAKEN APRIL 11, 1988
5. NEG. WITH: NAN PILLSBURY
 401 MILL ST
 MOORESTOWN, NJ 08057
 (609) 235-6080
6. FRONT OR EASTERLY FACADE OF
 GENERAL CLINTON HOUSE

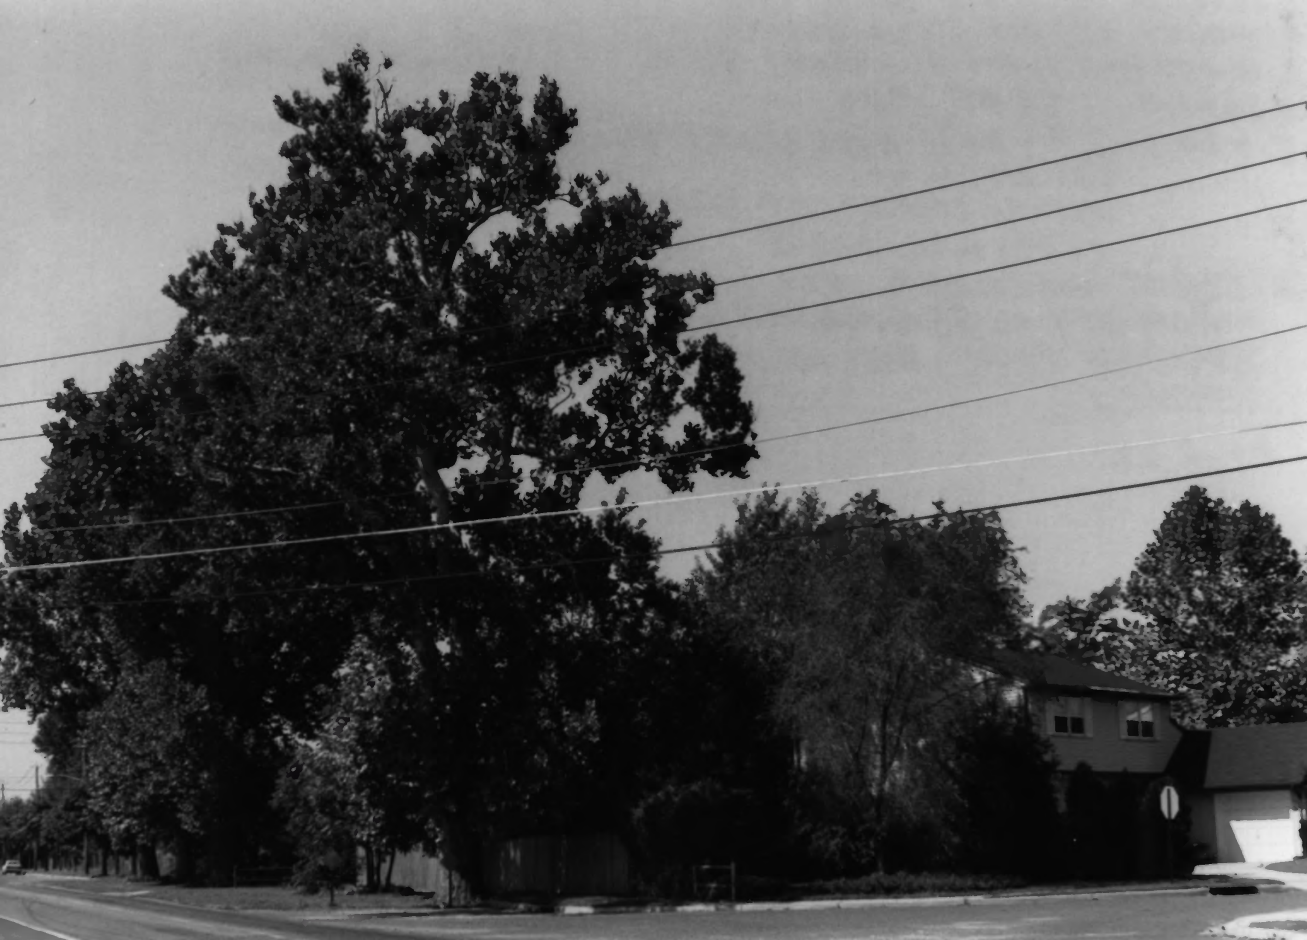
#1 of 22

6. GIANT SYCAMORE TREE LOCATED ON ADJACENT PROPERTY TO GEN. CLINTON HOUSE ON

~~PROPERTY~~ PORT - MT. LAUREL RD

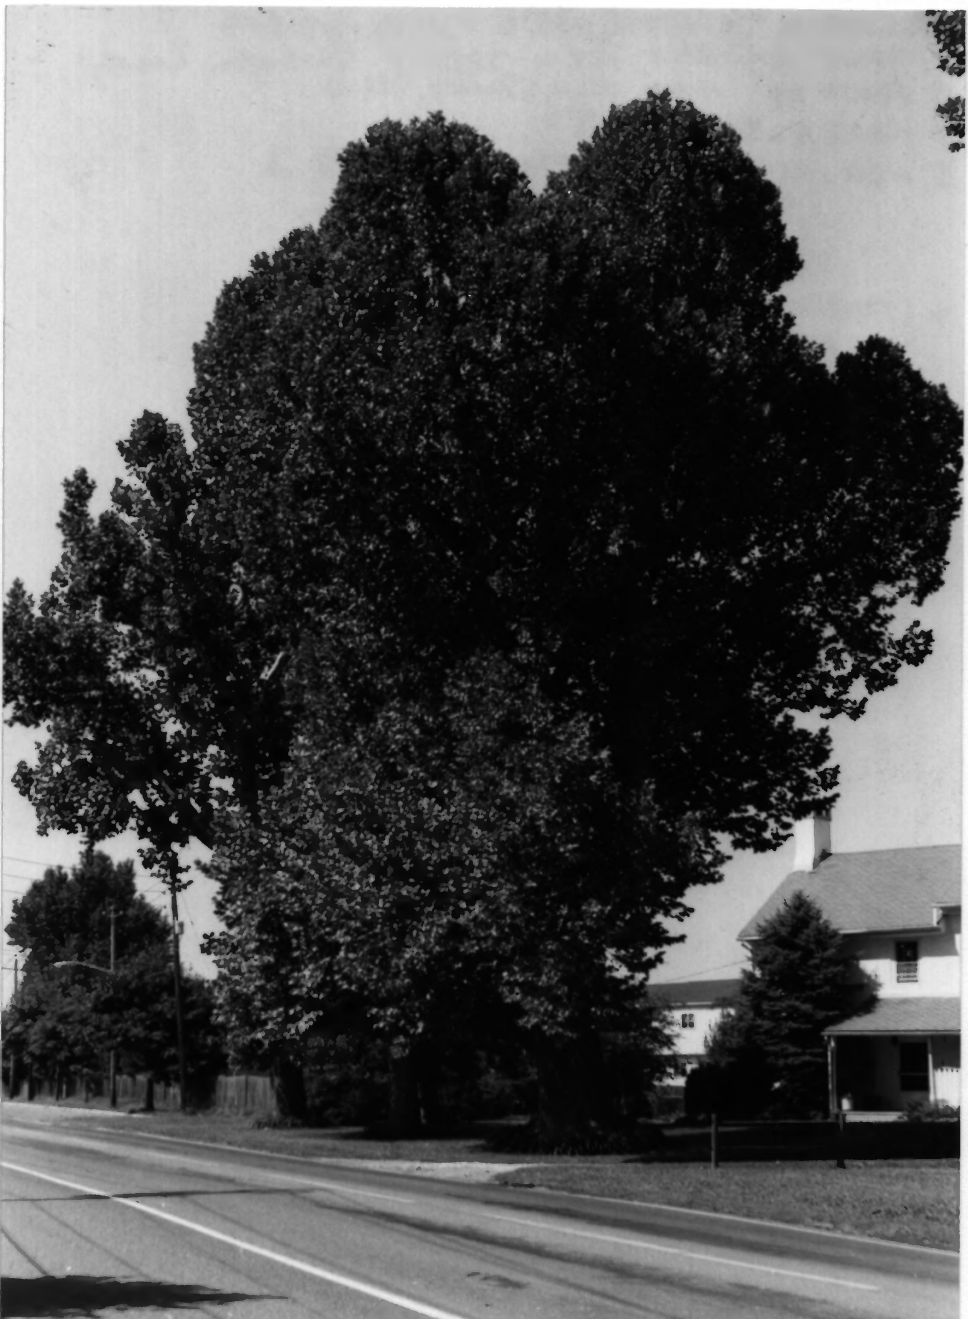
#2 of 22

1. GENERAL CLINTON HOUSE - HABS - NS.504
2. MOUNT LAUREL, NEW JERSEY (Burlington County)
3. PHOTO BY: VAN PILLSBURY, PH.D.
4. TAKEN - SEPT. 1988
5. NEG, WITH: VAN PILLSBURY, PH.D.
401 MILLSBURY
MOORESTOWN, NJ 08057
(609) 235-6080
6. THREE GIANT SYCAMORE TREES
in FRONT OF GEN. CLINTON HOUSE.
LARGEST. 225-250 YEARS OLD.

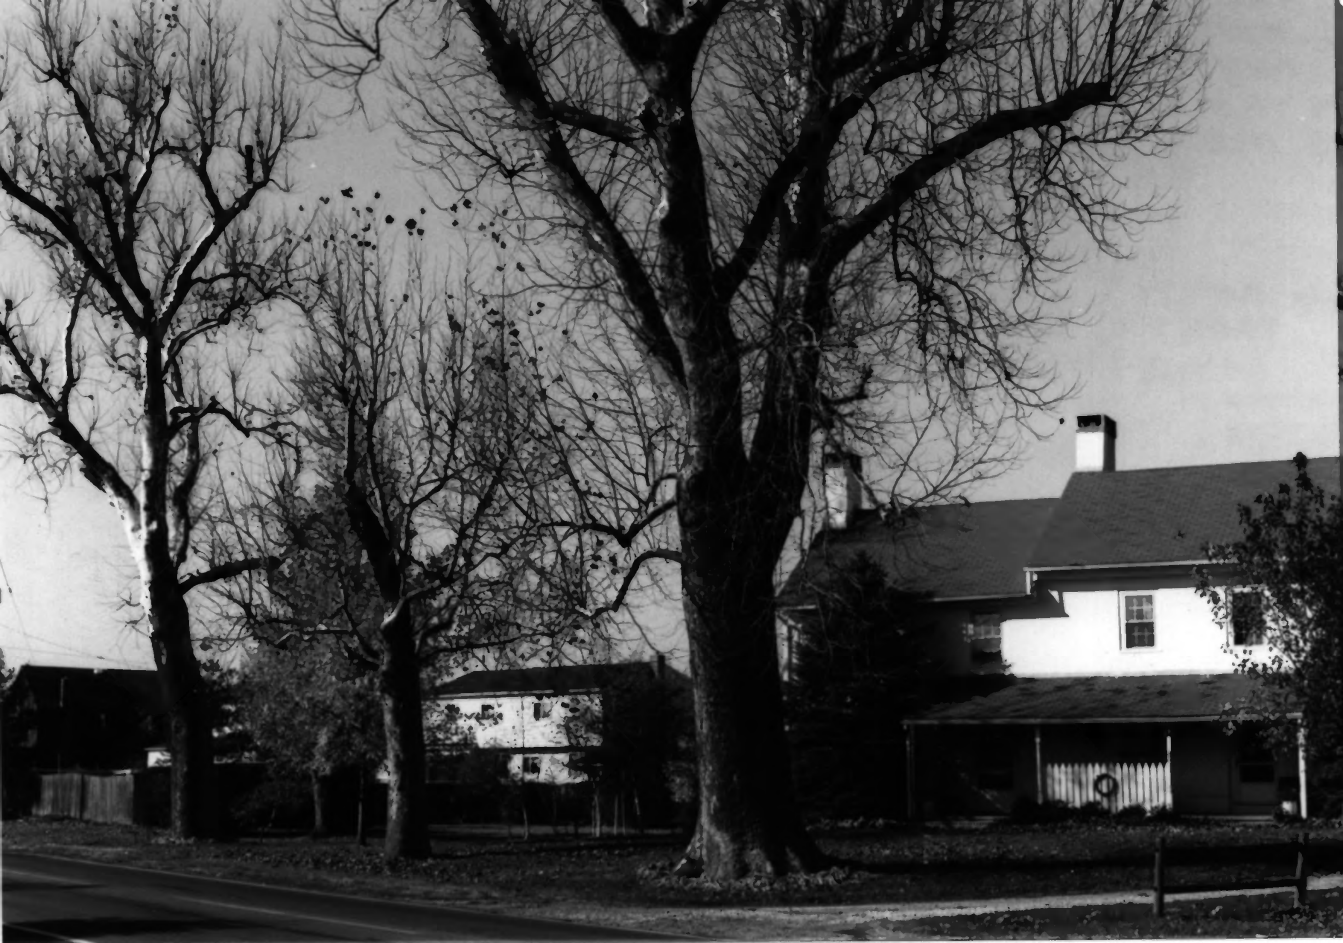
#3 of 22

6. ANCIENT SYCAMORE TREES IN
FRONT OF GEN. CLINTON HOUSE.
HAINESPORT ROAD.

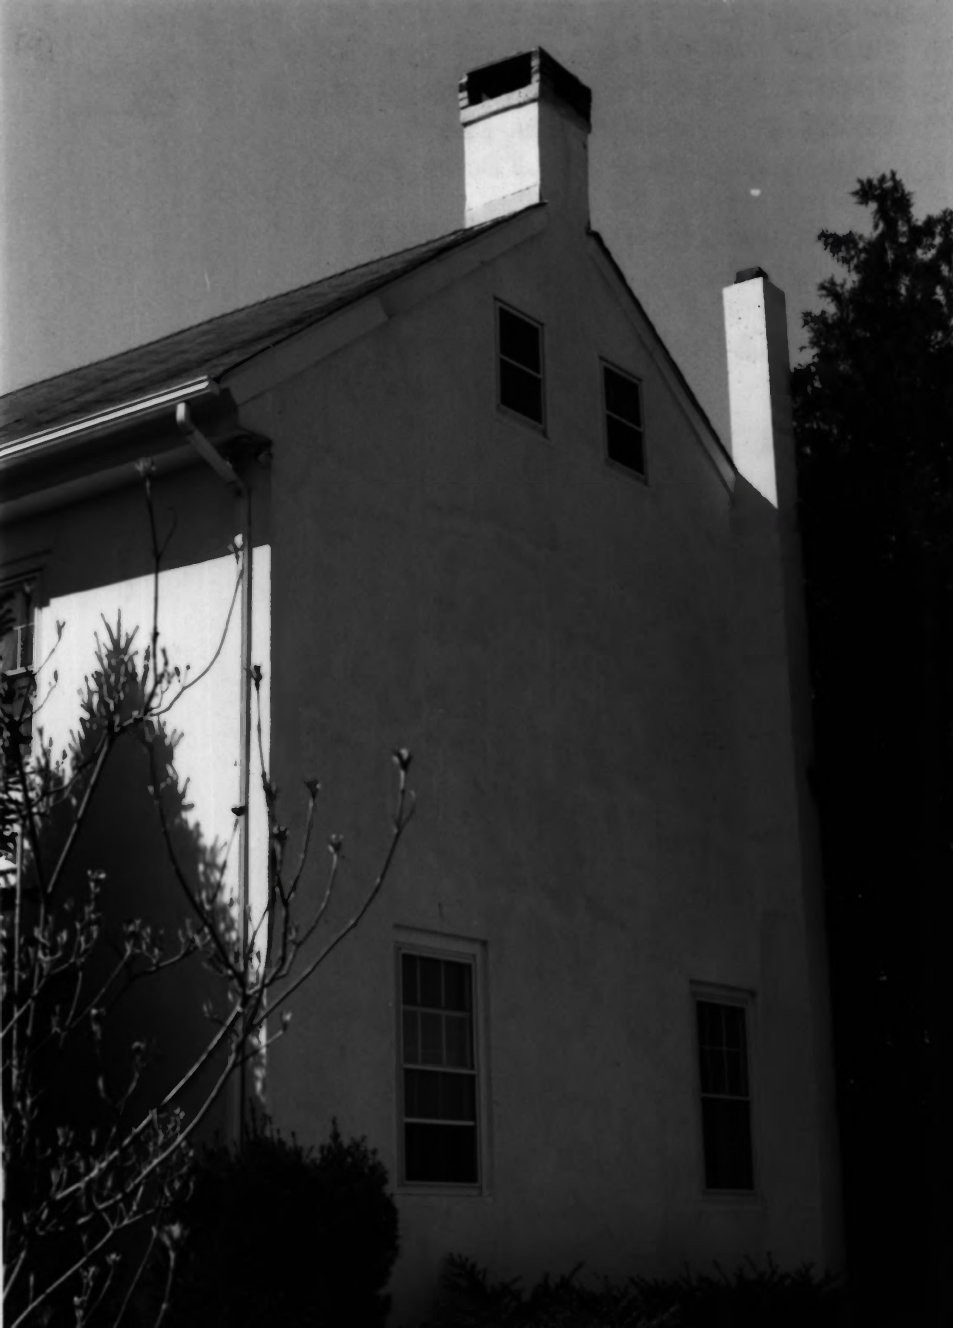
#5 of 22

1. GENERAL CLINTON HOUSE - HABS. NJ-504
2. MOUNT LAUREL, NEW JERSEY (Burlington County)
3. PHOTO BY: NAN PILLSBURY, Ph.D.
4. TAKEN APRIL 11, 1988
5. NEG. WITH: NAN PILLSBURY, Ph.D.
401 MILL ST.
MOORESTOWN, NJ 08057
(609) 235-6080
6. NORTHERLY FACADE OF BUILDING.

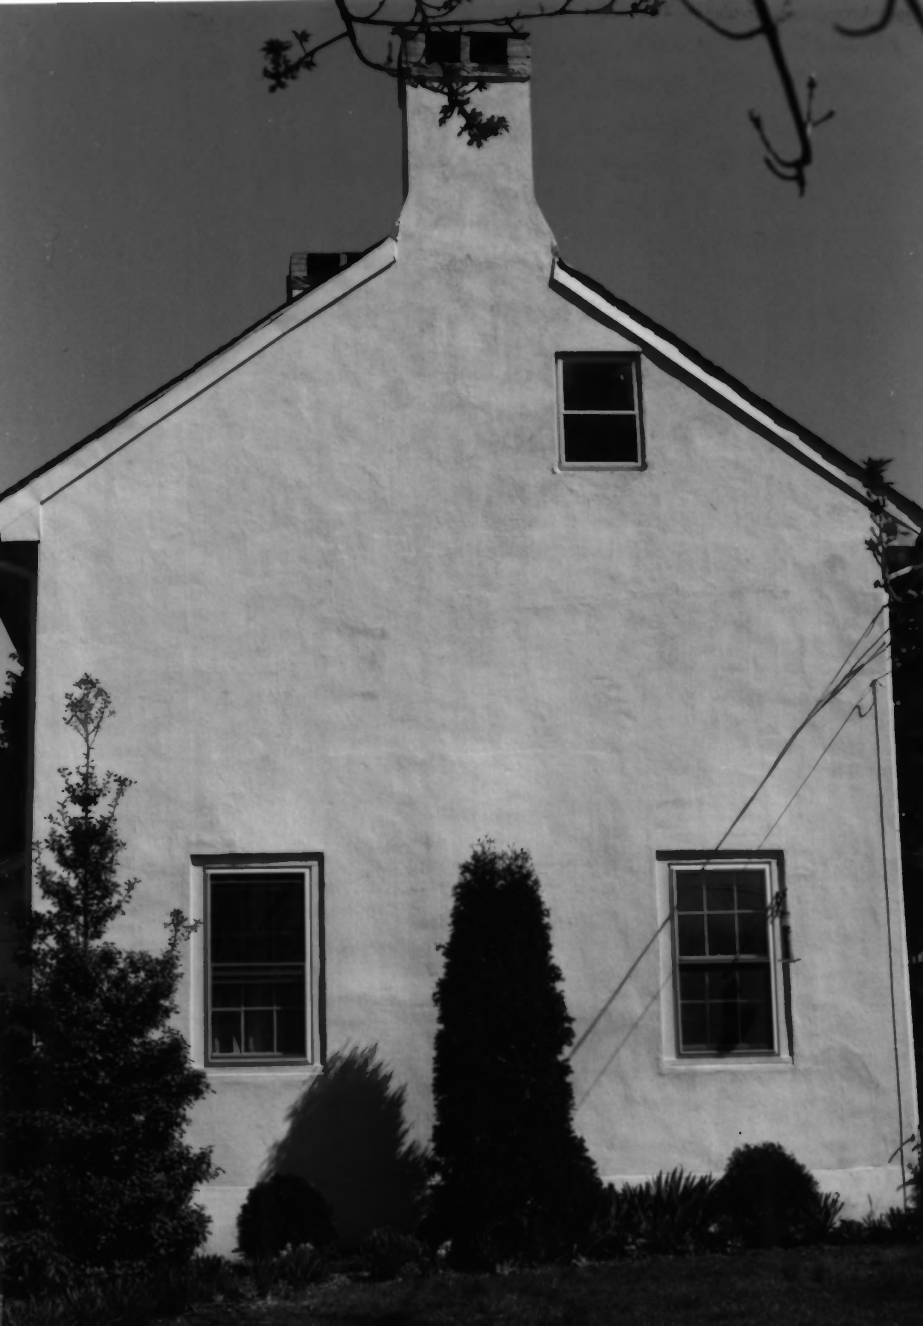
#6 of 22

1. GENERAL CLINTON HOUSE . HABS -79504
2. MOUNT LAUREL, NEW JERSEY (Burlington County)
3. PHOTO BY: NAN PILLSBURY, Ph. D.
4. TAKEN APRIL 11, 1988
5. NEG. WITH: NAN PILLSBURY, Ph. D.
401 MILL ST.
MOORESTOWN, NJ 08057
(609) 235-6080
6. SOUTHERLY FACADE
GENERAL CLINTON HOUSE,

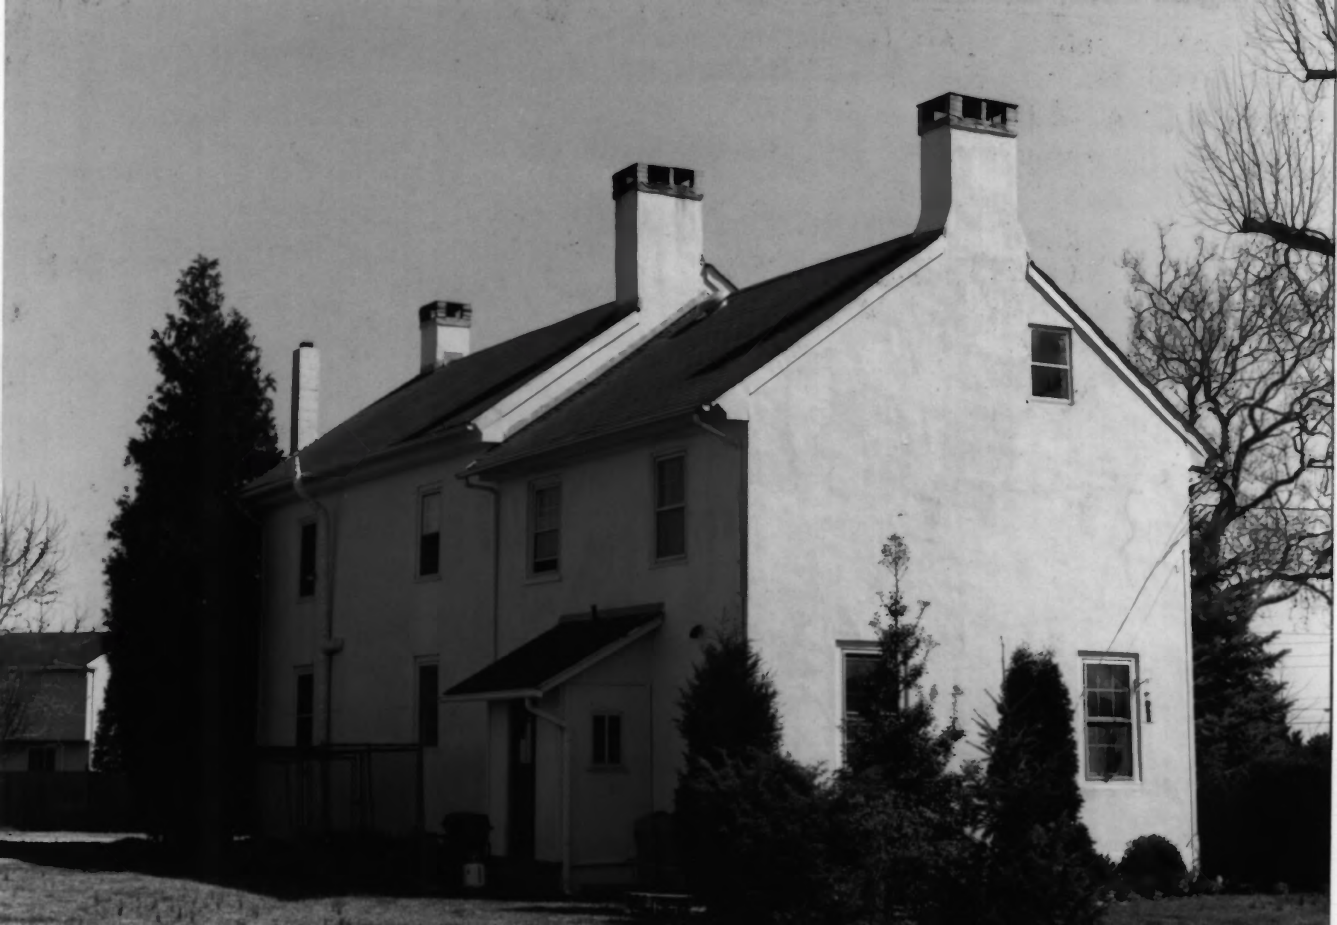
#7 of 22

1. GENERAL CLINTON HOUSE. HABS - N J-504
2. MOUNT LAUREL, NEW JERSEY
3. PHOTO BY: NAN PILLSBURY, Ph.D. (Burlington County)
4. TAKEN APRIL 11, 1988
5. NEG. WITH: NAN PILLSBURY, Ph.D.
401 MILL ST.
MOORESTOWN, NJ 08057
(609) 235-6080
6. WESTERLY (BACK) and SOUTHERLY (END)
FACADES of GEN. CLINTON HOUSE

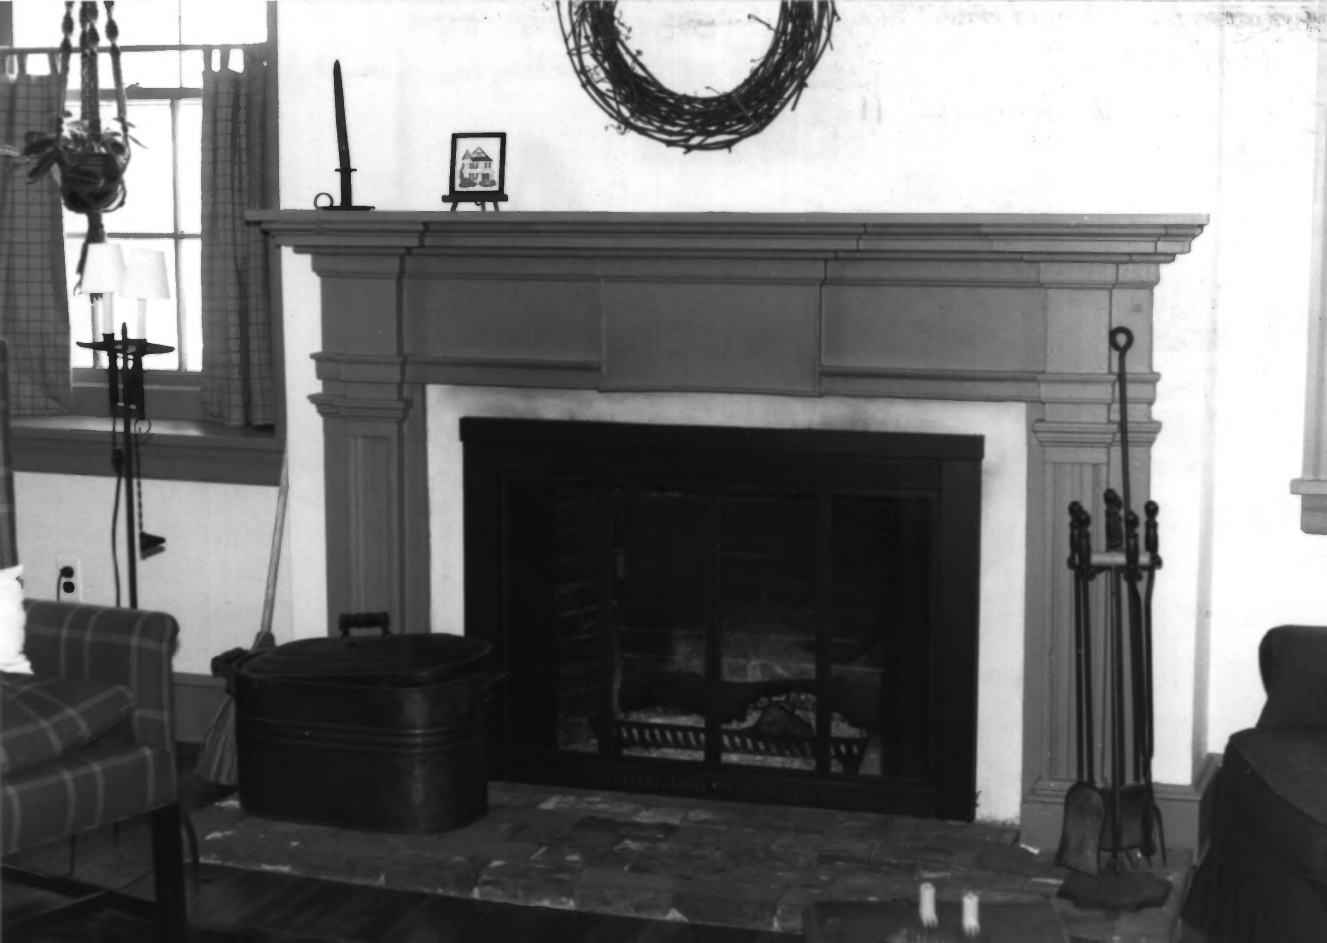
8 of 22

1. GENERAL CLINTON HOUSE - HABS - NJ-504
2. MOUNT LAUREL, NEW JERSEY
3. PHOTO BY: NAN PILLSBURY, Ph.D. (Burlington County)
4. TAKEN APRIL 11, 1988
5. NEG. WITH: NAN PILLSBURY, Ph.D.
401 MILL ST.
MOORESTOWN, NJ 08057
(609) 235-6028
6. LIVING ROOM, FIREPLACE - N.E. END.
OF ROOM "A", FIRST FLOOR

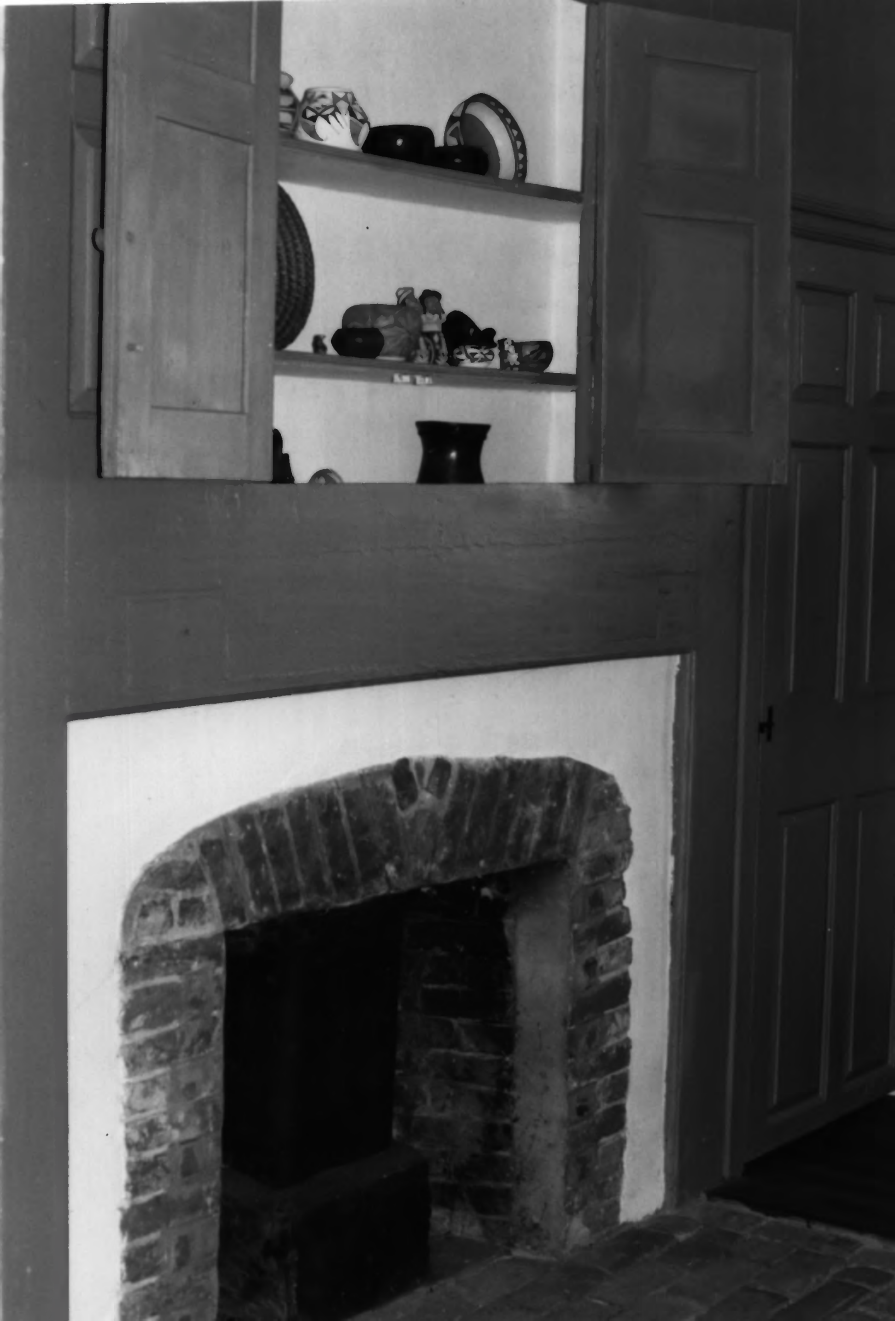
#9 of 22

1. GENERAL CLINTON HOUSE. HABS. NJ-504
2. MOUNT LAUREL, NEW JERSEY (Burlington County)
3. PHOTO BY: NAN PILLSBURY, PH.D.
4. TAKEN APRIL 11, 1988
5. NEG. WITH: NAN PILLSBURY, PH.D.
401 MILL ST.
MOORESTOWN, NJ 08057
(609) 235-6080
6. FIREPLACE IN DINING ROOM WITH
PANEL-DOOR CUPBOARDS ABOVE.
S. END, ROOM "B", FIRST FLOOR.

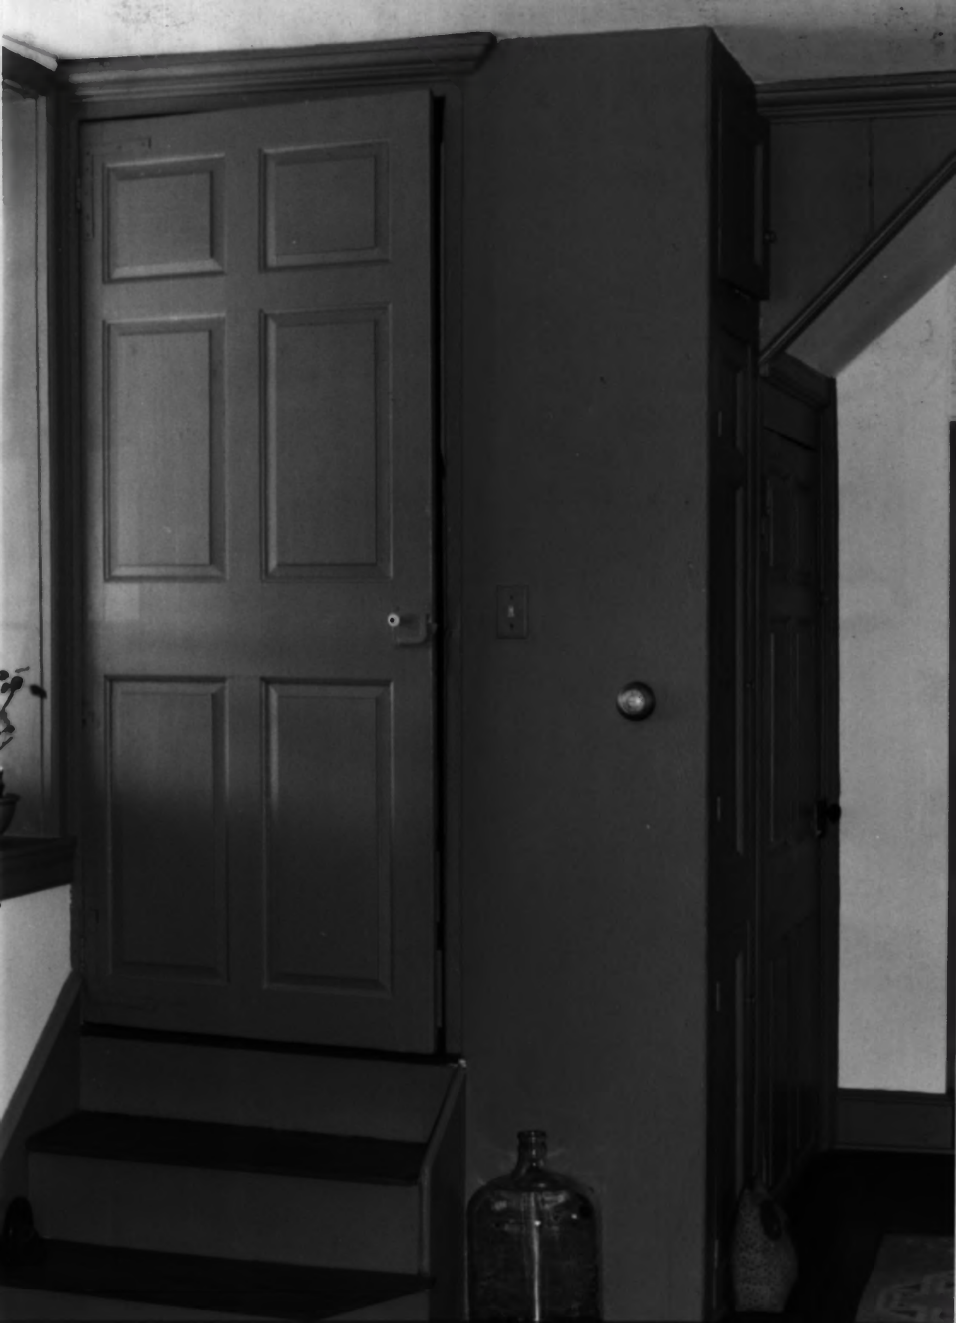
#10 of 22

1. GENERAL CLINTON HOUSE
2. MOUNT LAUREL, NEW JERSEY (Burlington County)
3. PHOTO BY: NAN PILLSBURY, Ph.D.
4. TAKEN APRIL 11, 1988
5. NEG. WITH: NAN PILLSBURY, Ph.D.
401 MILL ST.
MOORESTOWN, NJ 08057
(609) 235-6080
6. PANEL DOOR LEADING FROM
DINING ROOM TO SECOND FLOOR
CLOSET UNDER STAIRS.
ROOM "B", FIRST FLOOR
OLD LATCH, HABS Page 16/167

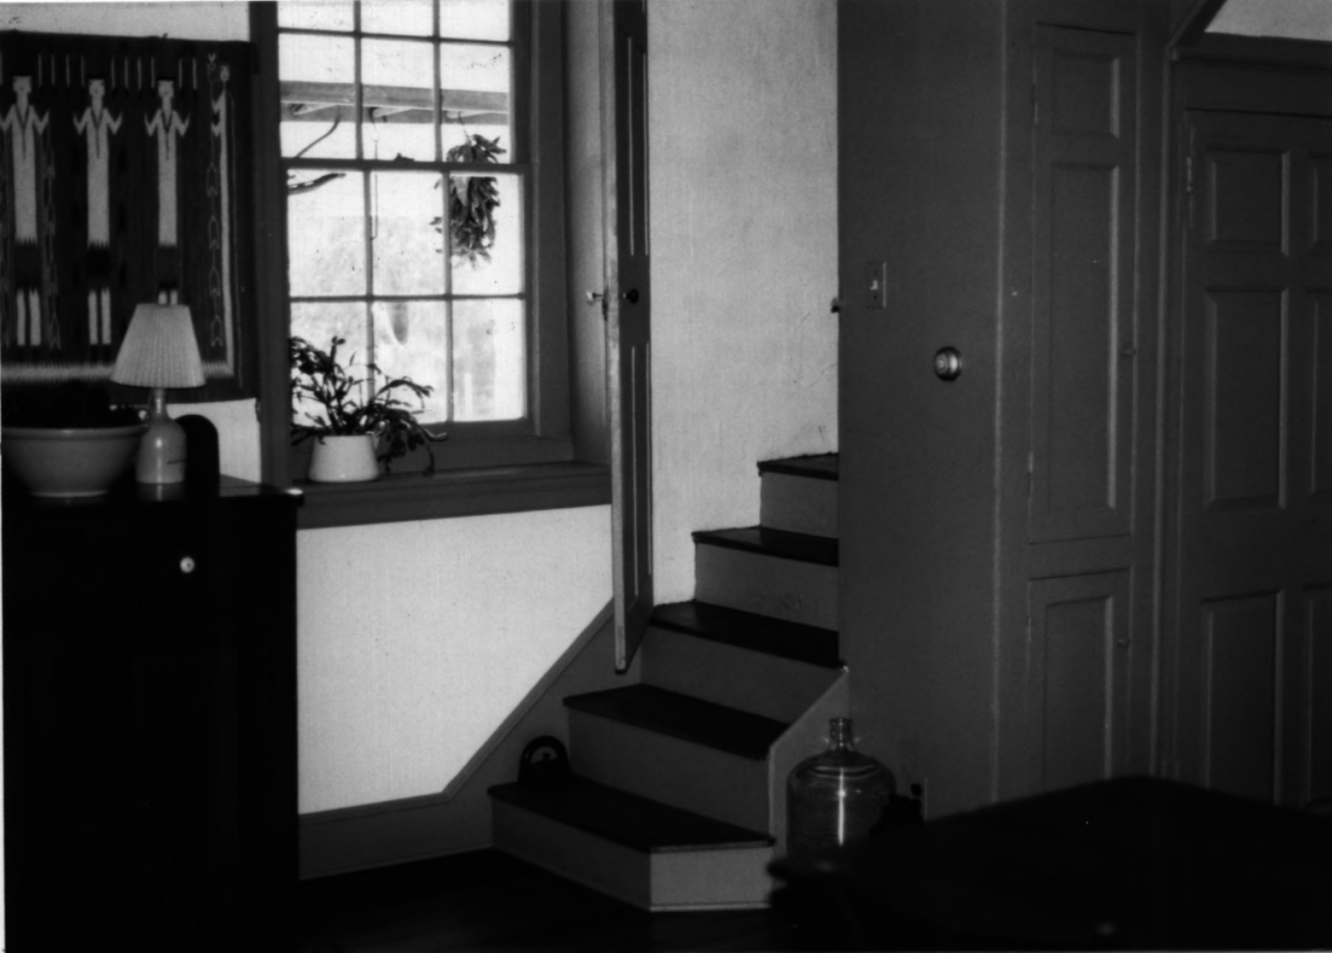
#11 of 22

6. CLOSETS, STAIRS to 2nd FLOOR
and WINDOWS AT SE CORNER of
1st FLOOR ROOM "B", or DINING
ROOM

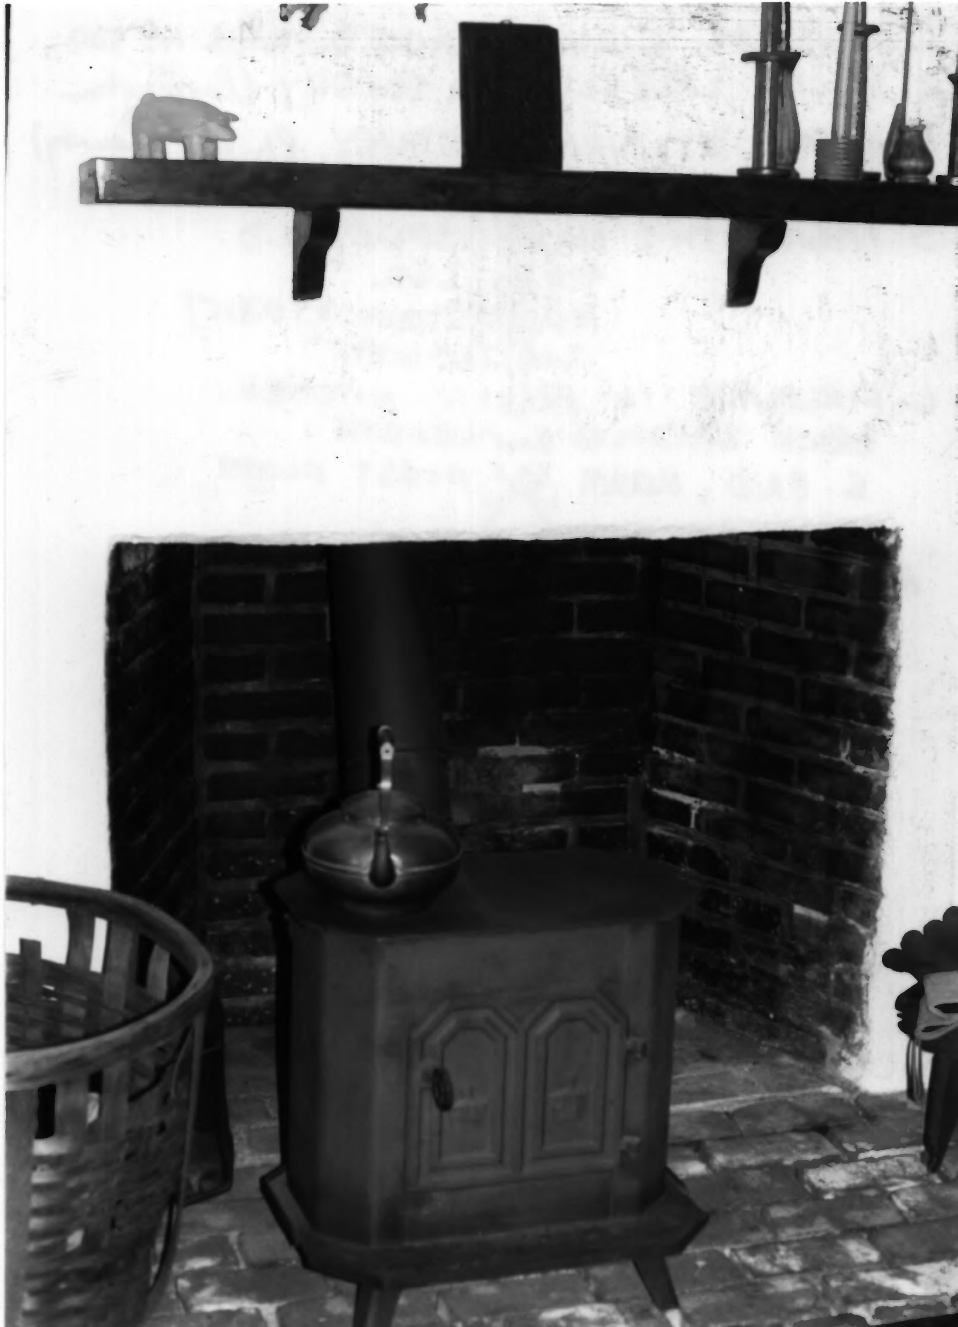
#12 of 22

1. GENERAL CLINTON HOUSE HABS-NS 504
2. MOUNT LAUREL, NEW JERSEY (Burlington County)
3. PHOTO BY, NAN PILLSBURY, Ph.D.
4. TAKEN APRIL 11, 1988
5. NEG. WITH: NAN PILLSBURY, Ph.D.
401 MILL ST.
MOORESTOWN, NJ 08057
(609) 235-6080
6. FIREPLACE IN PRESENT KITCHEN.
BRICK BACKING and HEARTH
S. END, ROOM "C" FIRST FLOOR

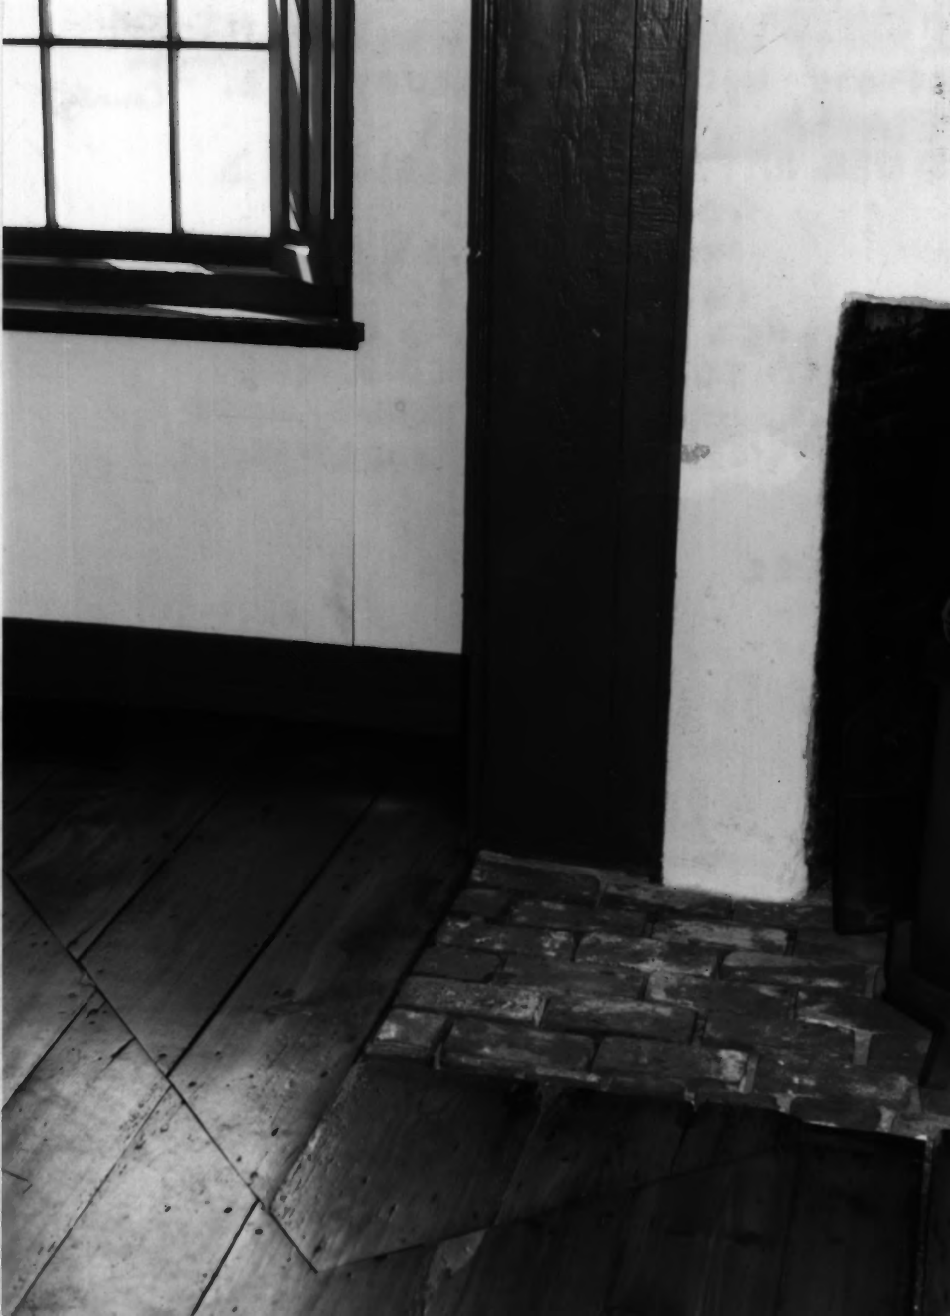
#14 of 22

1. GENERAL CLINTON HOUSE - HABS. NJ. 504
2. MOUNT LAUREL, NEW JERSEY
3. PHOTO BY L. NAN PILLSBURY (Burlington County)
4. TAKEN APRIL 11, 1988
5. NEG. WITH: NAN PILLSBURY, Ph.D.
401 MILL ST
MOORESTOWN, NJ 08057
(609) 235-6080
6. FIREPLACE IN S. WALL OF SW
BEDROOM, SHOWS FLUE LEADING
FROM BACK OF HOUSE, ONCE
ATTACHED TO REMOVED BLDS.
ROOM "F", SECOND FLOOR.

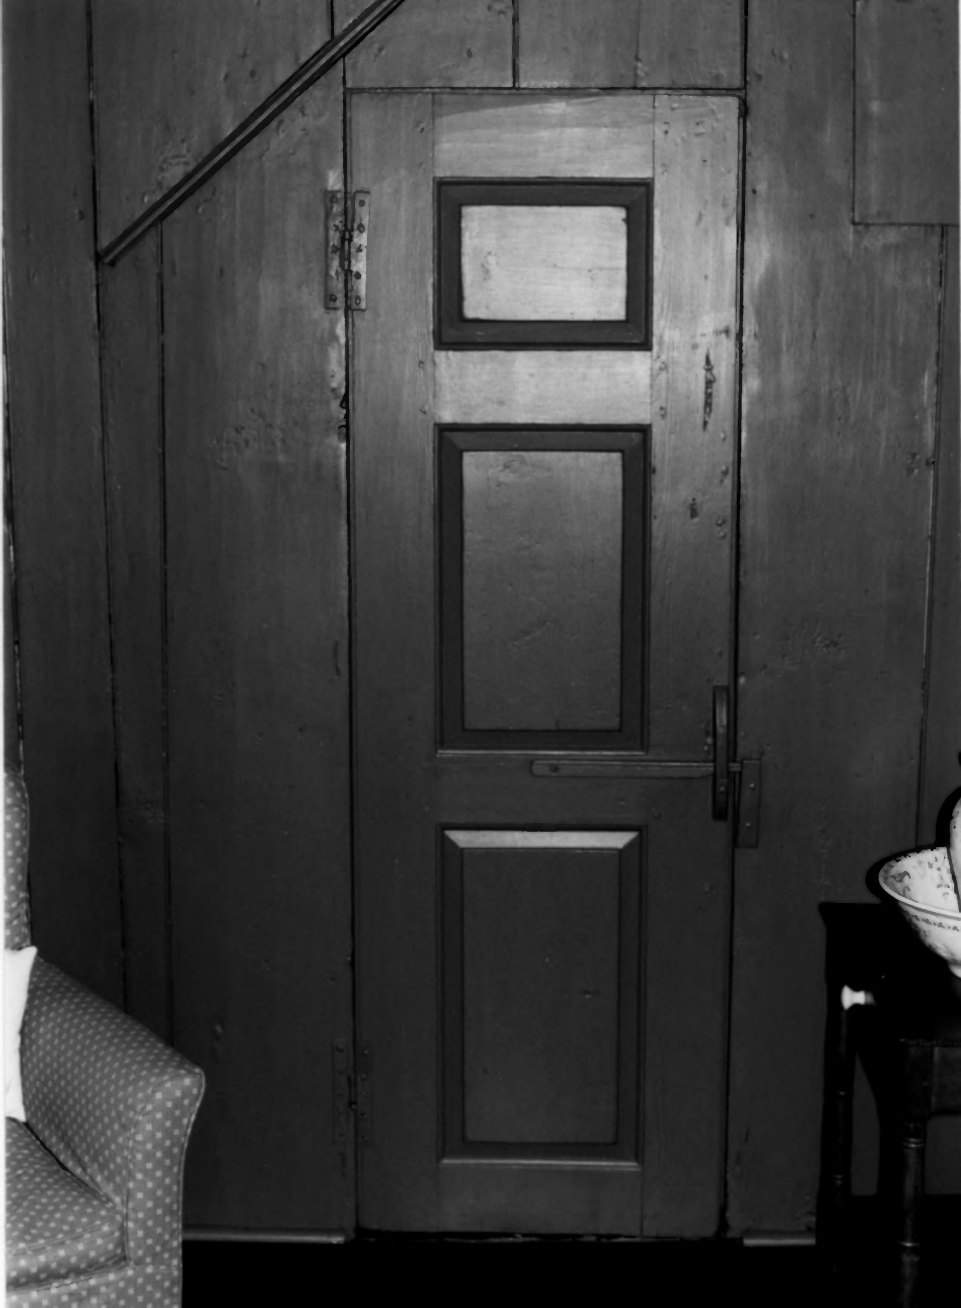
#15 of 22

1. GENERAL CLINTON HOUSE - HABS NJ. 504
2. MOUNT LAUREL, NEW JERSEY. (Burlington County)
3. PHOTO BY: NAN PILLSBURY, Ph. D.
4. TAKEN APRIL 11, 1988
5. NEG. WITH: NAN PILLSBURY, Ph. D.
401 MILL ST
MOORESTOWN, NJ. 08057
(609) 235-6080
6. CLOSET DOOR IN SECOND FLOOR
OFFICE. S. END, W. SIDE.
"H" HINGES AND ORIGINAL WOODEN
LATCH, KEEPER AND HANDLE.
ROOM "E", SECOND FLOOR
(OLD LATCH, HABS page 16/16)

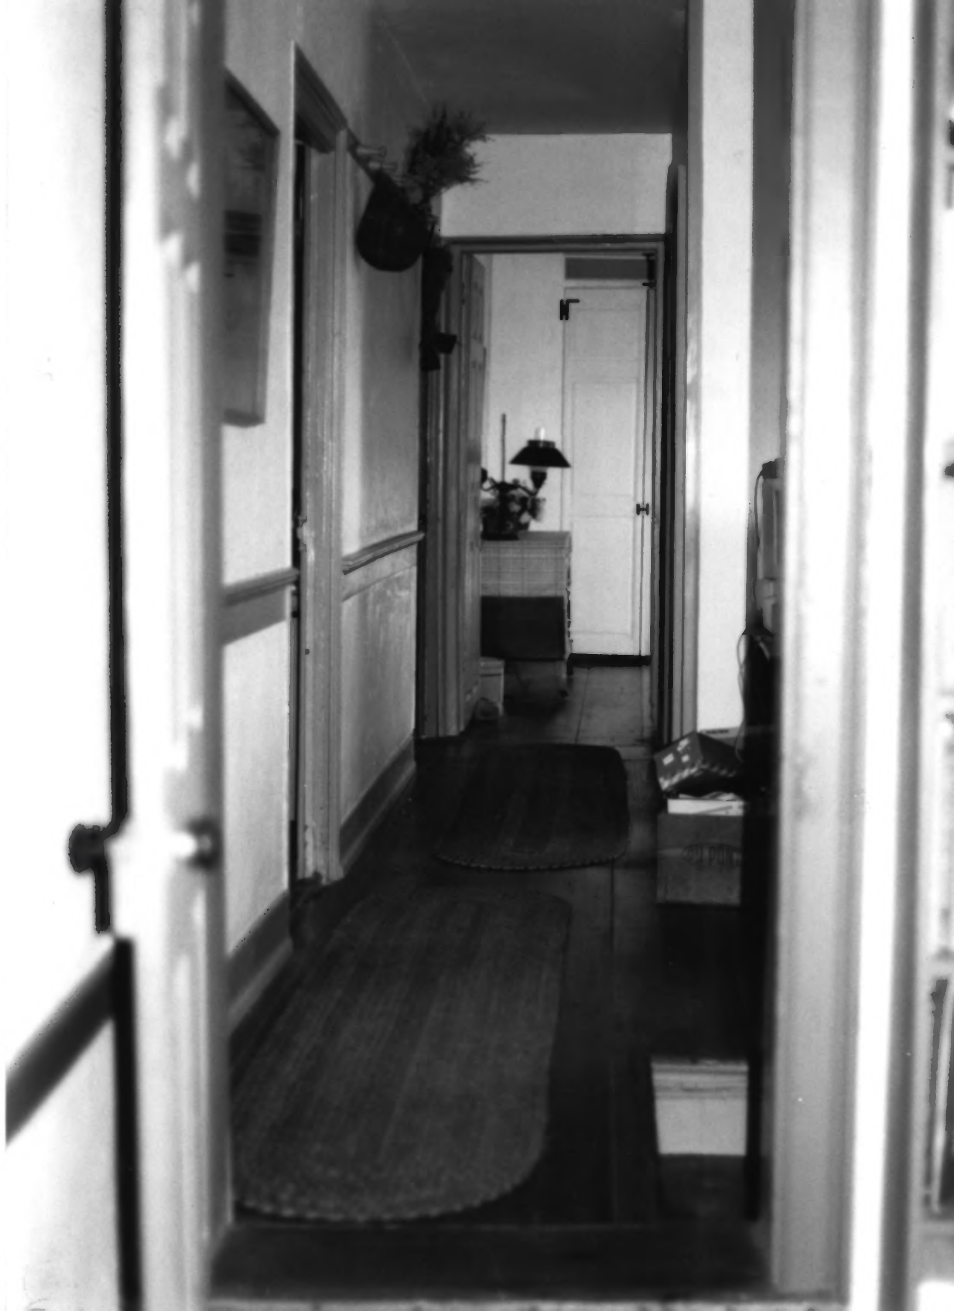
1. GENERAL CLINTON HOUSE - HABS. NS 504
2. MOUNT LAUREL, NEW JERSEY (Burlington County)
3. PHOTO BY: NAN PILLSBURY, Ph.D.
4. TAKEN APRIL 11, 1988
5. NEG. WITH: NAN PILLSBURY, Ph.D.
401 MILL ST.
MOORESTOWN, NJ 08057
(609) 235-6080
6. 6-PANEL DOOR LEADING TO STAIRS
OF NORTH END ATTIC ORIGINAL
HARDWARE. AREA B, SECOND FLOOR
(OLD LATCH, HABS page 16/16).

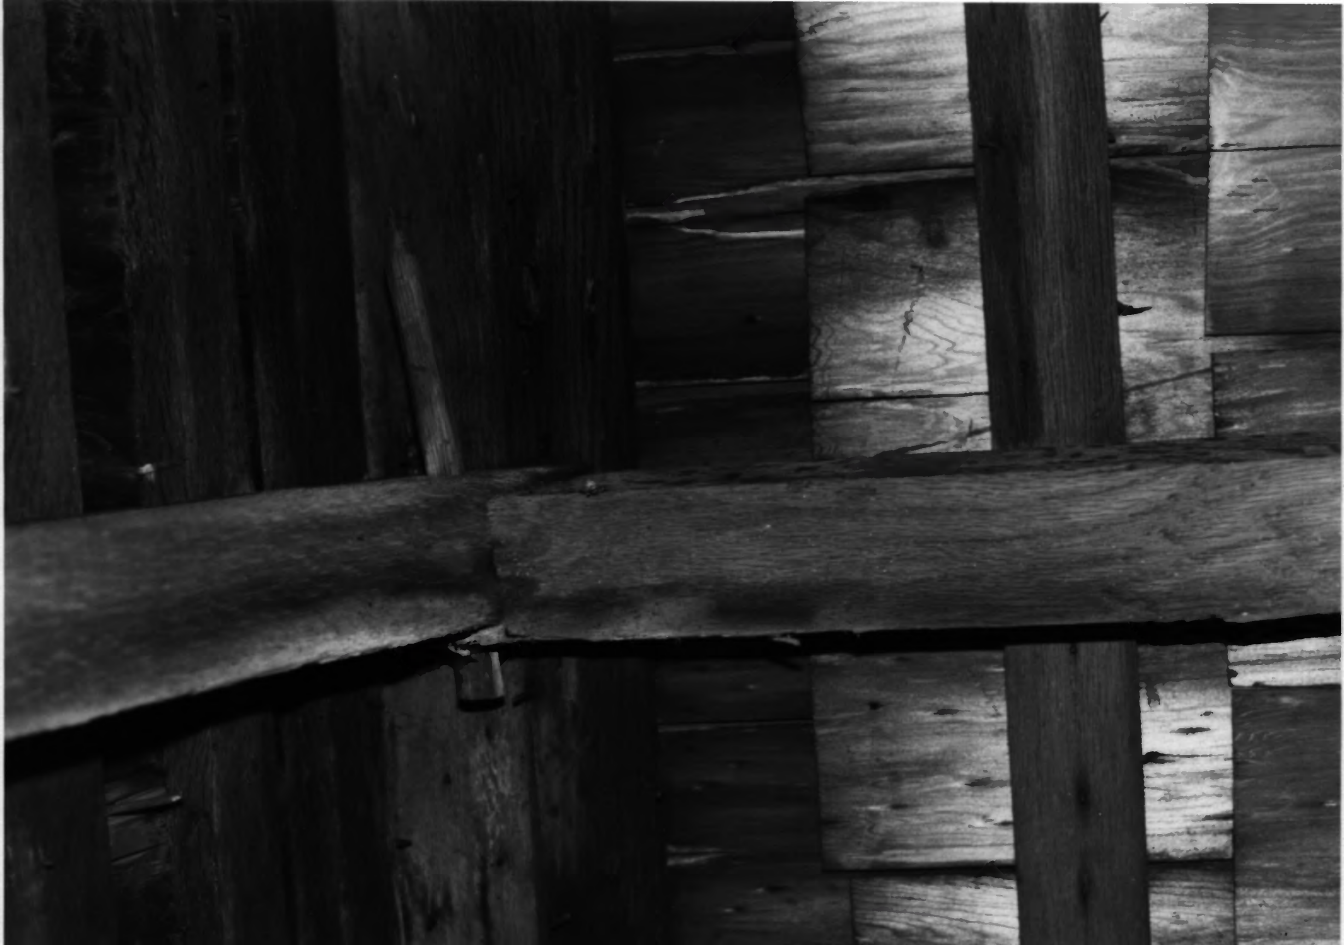
#18 of 22

1. GENERAL CLINTON HOUSE, HABS. NJ-504
2. MOUNT LAUREL, NEW JERSEY (Burlington County)
3. PHOTO BY: NAN PILLSBURY, P.R.D.
4. TAKEN APRIL 11, 1988
5. NEG. WITH: NAN PILLSBURY, P.R.D.
401 MILL ST
MOORESTOWN, NJ 08057
(609) 235-6080
6. PEGGED RAFTERS IN NORTHERN
ATTIC. CAN SEE OLD SHAKES, NOW
UNDER COMPOSITE ROOFING.

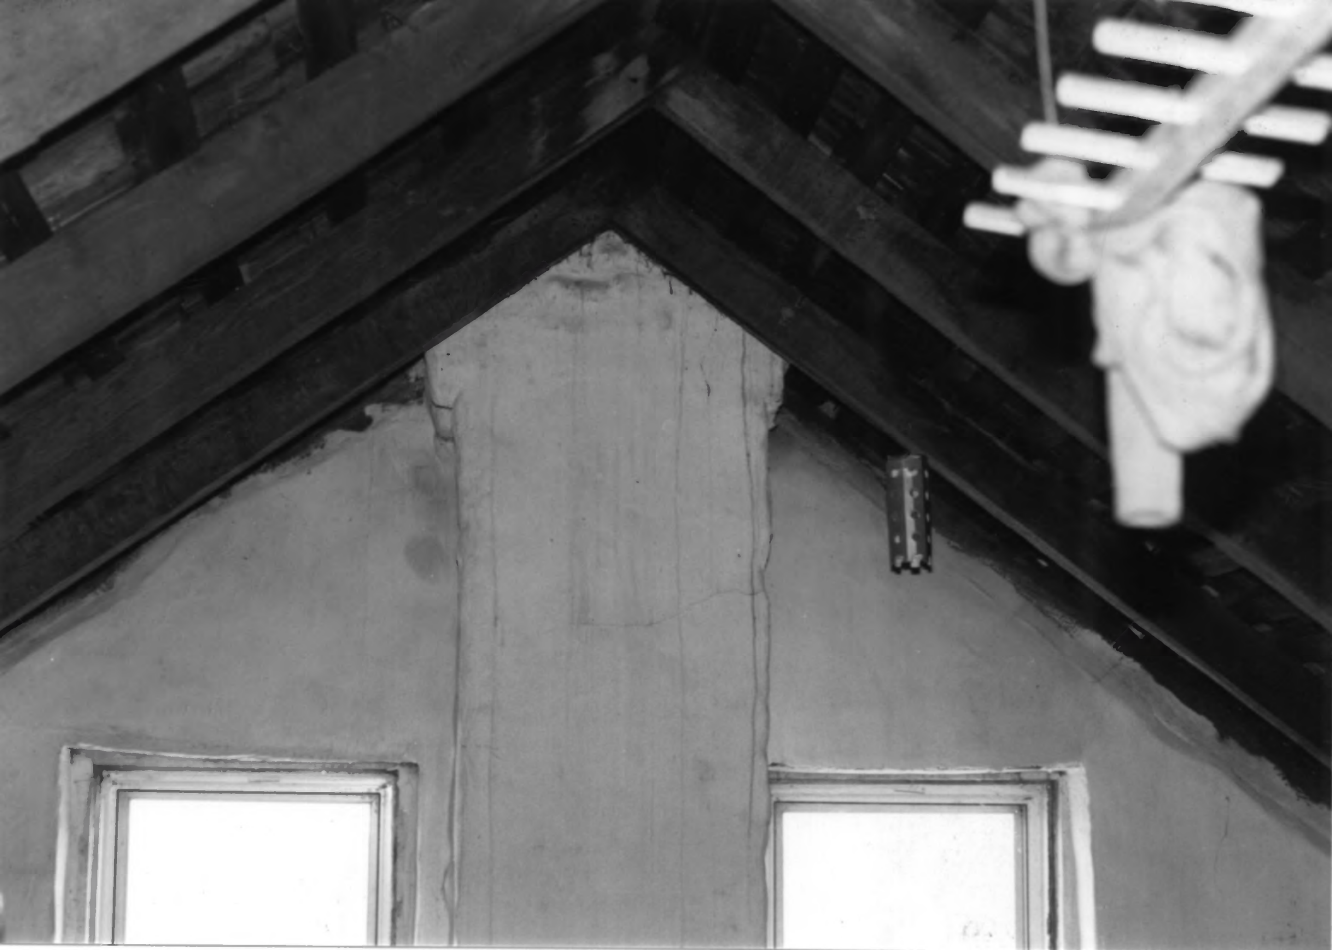
#19 of 22

1. GENERAL CLINTON HOUSE - HABS. N.J. 504
2. MOUNT LAUREL, NEW JERSEY (Burlington County)
3. PHOTO BY: NAN PILLSBURY, Ph.D.
4. TAKEN APRIL 11, 1988
5. NEG. WITH: NAN PILLSBURY, Ph.D.
401 MILL ST.
MOORESTOWN, N.J. 08057
(609) 235-6080
6. NORTHERLY WALL OF N SIDE ATTIC
FIREPLACE FLUE BETWEEN MODERN
WINDOW & STAIRS.

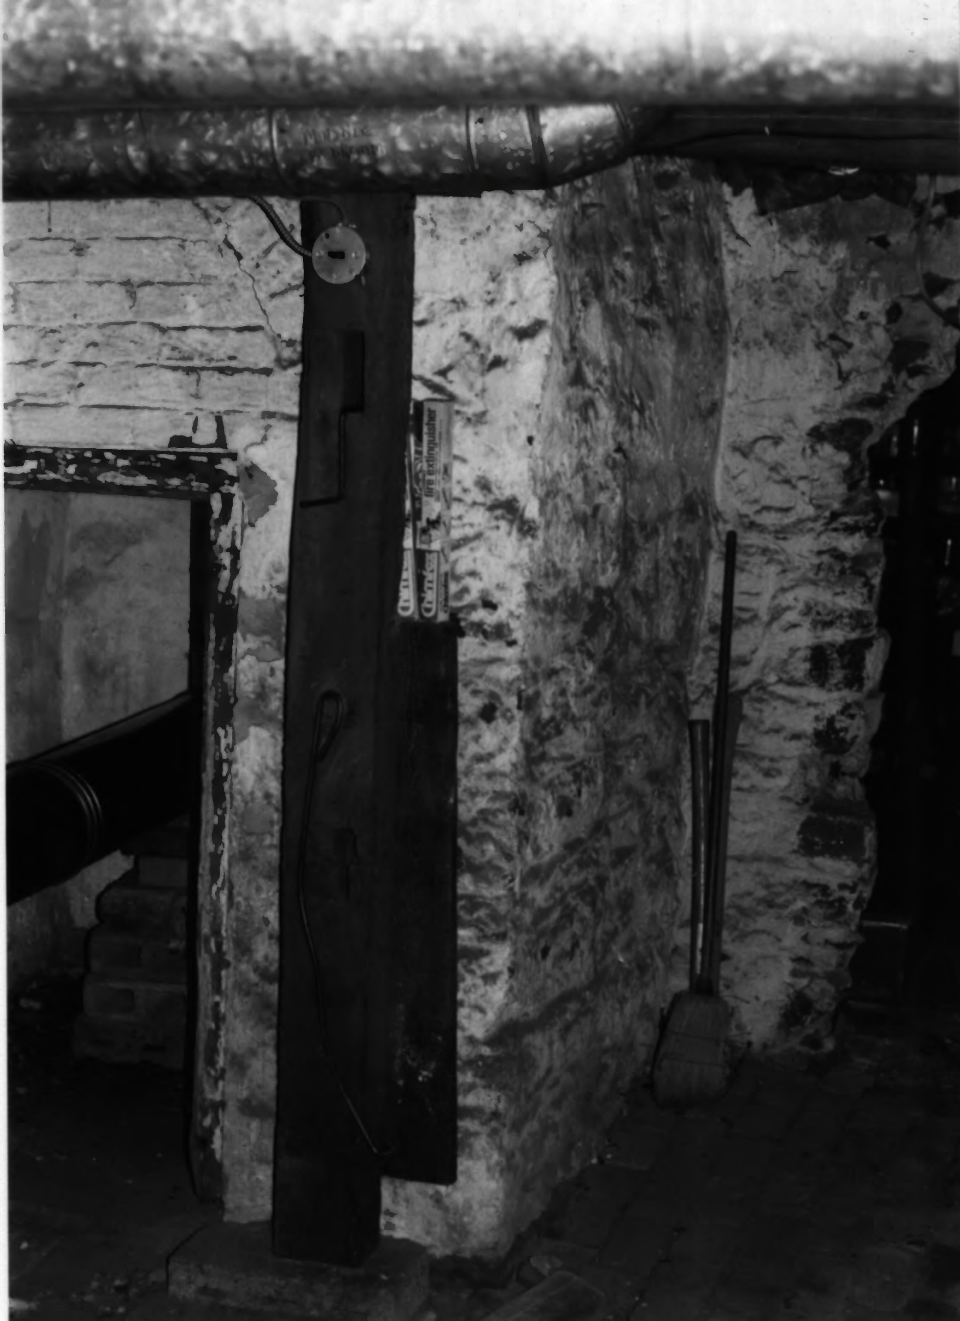
20 of 22

1. GENERAL CLINTON HOUSE HABS. NJ. 504
2. MOUNT LAUREL, NEW JERSEY (Burlington County)
3. PHOTO BY: NAN PILLSBURY, Ph.D.
4. TAKEN APRIL 11, 1988
5. NEG. WITH: NAN PILLSBURY, Ph.D.
401 MILL ST
MOORESTOWN, NJ 08057
(609) 235-6080
6. SUPPORT JOY MID-HOUSE FIREPLACES.
ON RIGHT, PASSAGE THROUGH ORIGINAL
OUTSIDE WALL TO S. END OF BASEMENT
