1. GENERAL CLINTON HOUSE - HABS - 719500
2. MOUNT LAUREL, NEW JERSEY
3. PHOTO BY: NAN PILLSBURY, Ph.D. (Burlington County)
4. TAKEN, SEPT, 1988
5. NEG. WITH: NAN PILLSBURY, Ph.D.
 401 MILL ST.
 MOORESTOWN, NJ. 08057
 (609) 235-6080

1. GENERAL CLINTON HOUSE - HABS NJ-504
2. MOUNT LAUREL, NEW JERSEY (Burlington County)
3. PHOTO BY: NAN PILLSBURY, Ph. D.
4. TAKEN APRIL 11, 1988
5. NEG. WITH: NAN PILLSBURY
 401 MILL ST
 MOORESTOWN, NJ 08057
 (609) 235-6080
6. FRONT OR EASTERLY FACADE OF
 GENERAL CLINTON HOUSE

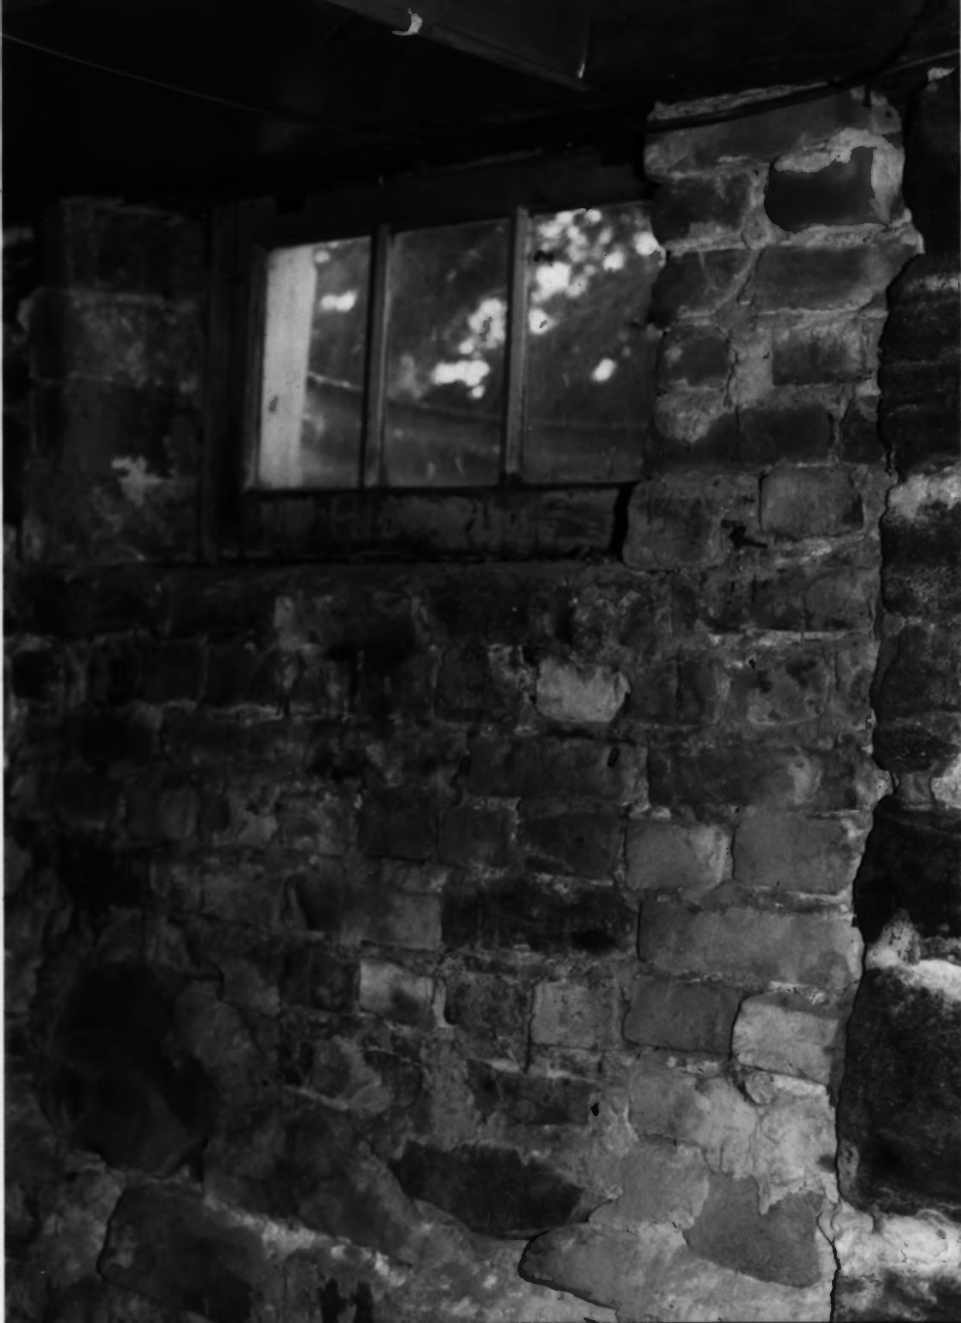
21 of 22

1. GENERAL CLINTON HOUSE - HABS - 79-504
2. MOUNT LAUREL, NEW JERSEY (Burlington County)
3. PHOTO BY: NAN PILLSBURY, Ph.D.
4. TAKEN APRIL 11, 1988
5. NEG. WITH: NAN PILLSBURY, Ph.D.
401 MILL ST.
MOORESTOWN, NJ 08057
(609) 235-6080
6. BASEMENT WINDOW OF EASTERLY WALL, N. END. NEW BRICK AREA UNDERNEATH WAS ONCE BASEMENT ENTRY STAIRWAY.

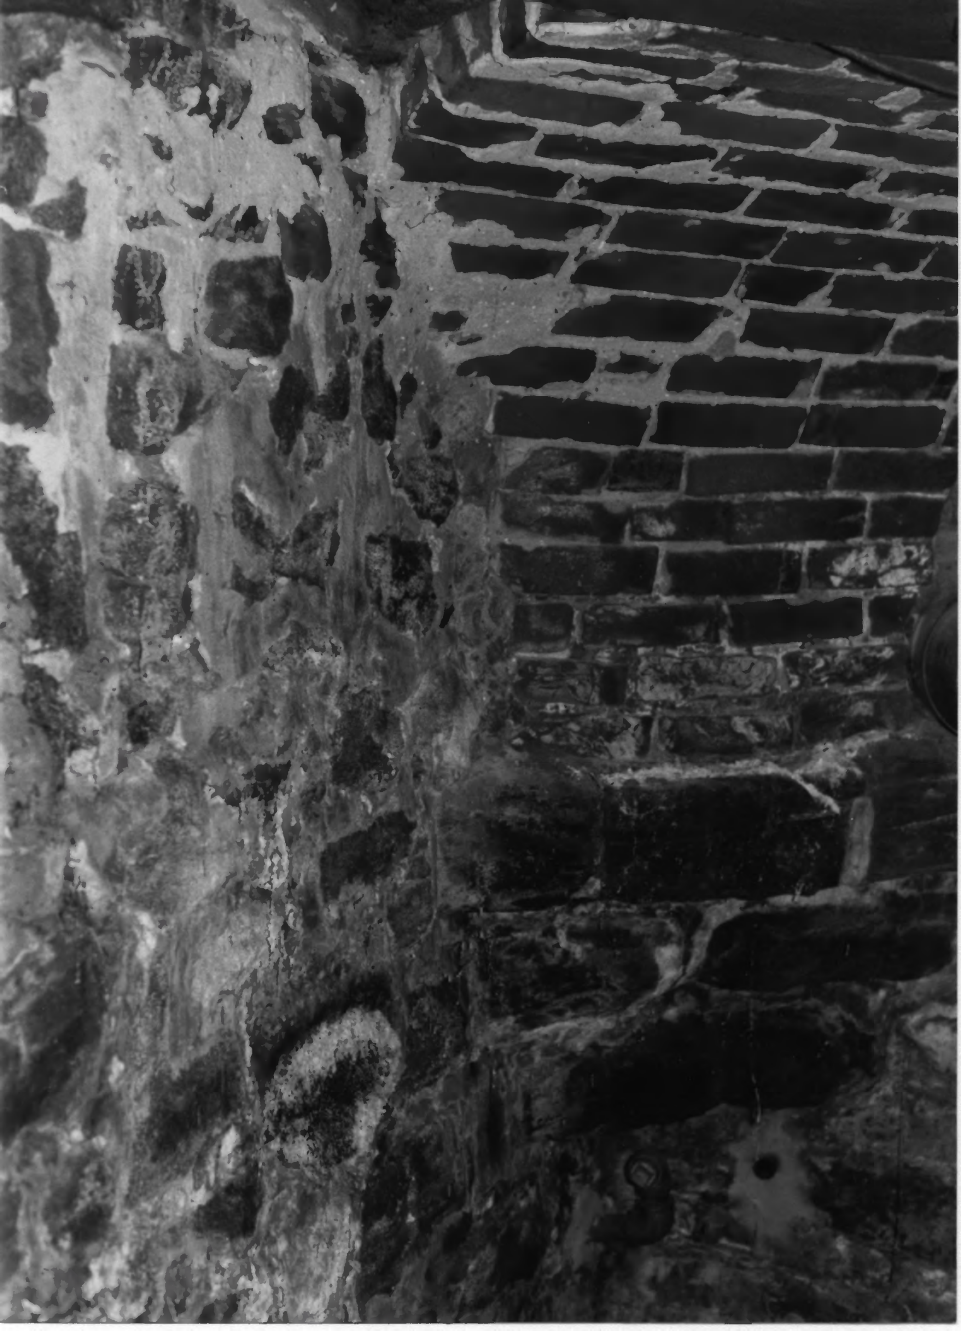
#22 of 22

1. GENERAL CLINTON HOUSE. HABS. N.J. 504
2. MOUNT LAUREL, NEW JERSEY (Burlington County)
3. PHOTO BY: NAN PILLSBURY, Ph.D.
4. TAKEN APRIL 11, 1988
5. NEG. WITH: NAN PILLSBURY, Ph.D.
401 MILL ST
MOORESTOWN, NJ 08057
(609) 235-6080
6. CORBELING AND FIELDSTONE FOUNDATION
NW CORNER OF BASEMENT.
FIREPLACES ON FIRST AND SECOND
FLOORS REMOVED.
