National Register of Historic Places Registration Form

historic name Hampton County Jail

other names/site number Old Hampton County Jail, Hampton County Museum

street & number 702 First Street West not for publication

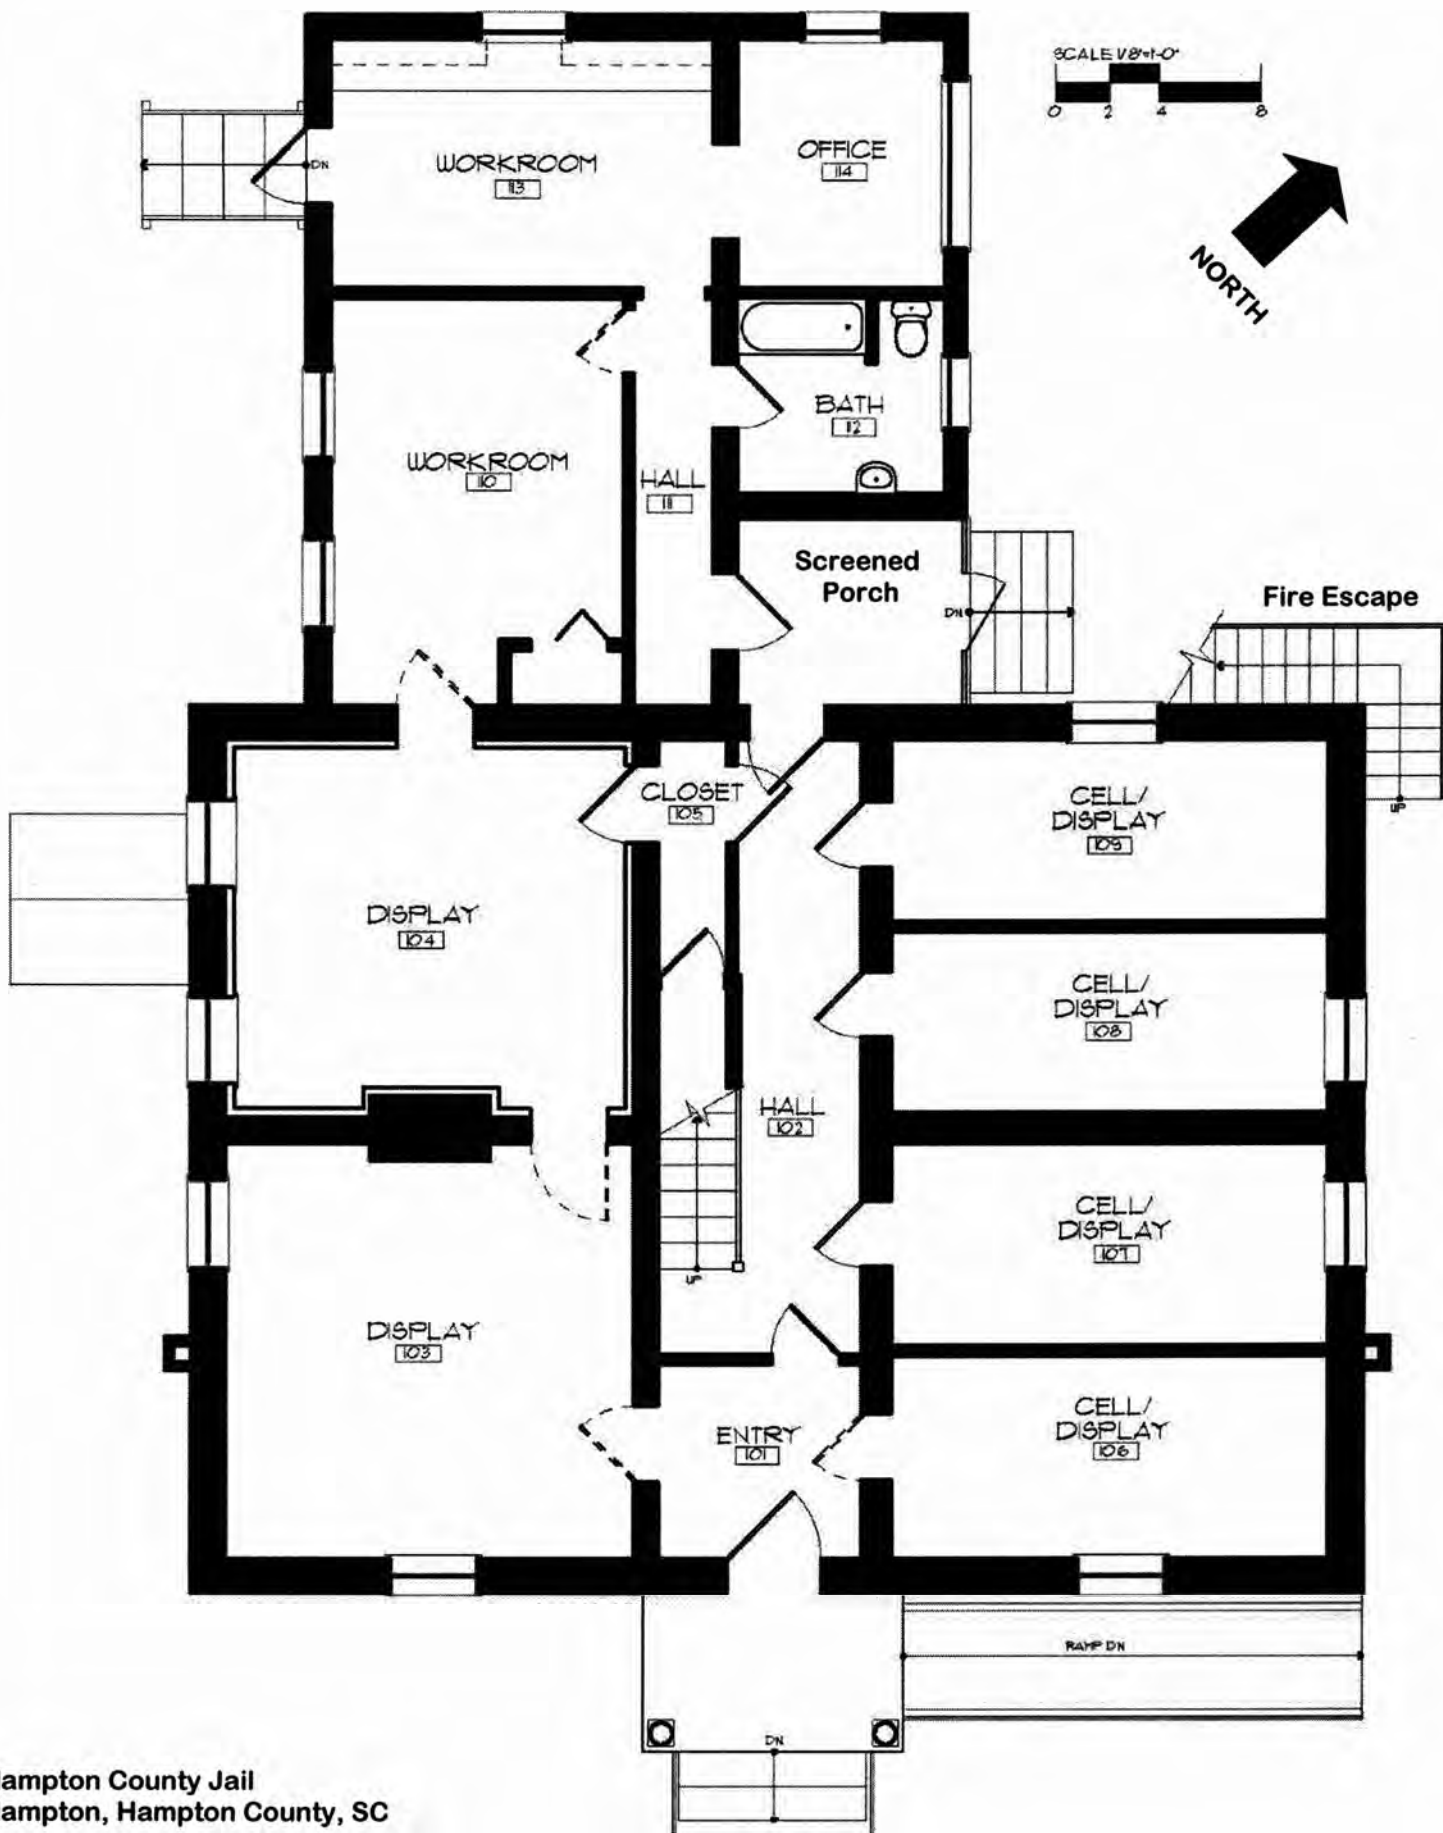
Hampton County Jail
 Hampton, Hampton County, SC

Existing First Floor Plan
 Harris Architects PLLC, July 2009

for the original building—opens onto the screened porch in the rear addition, although this door now remains locked and obscured to museum visitors. Museum staff believe that the oak tongue-and-groove floors in this central hall were added in 1925, and they bear evidence of fire damage—perhaps from spilled coals—near at least two of the four entrances to the 1960s-era jail cells along the northeast side of the first floor. These rooms—numbered 106 to 109 (front to rear) by Harris Architects (whose numbering scheme for the building is followed here)—each possess the iron jail doors (with the exception of Room 106) installed in the 1960s when these rooms, which had originally been the jailer's living room at the front of the jail and the white women's cell at the rear, were divided and converted to the four jail cells found at present. These jail doors still retain the small viewing and food door at the upper center, a decorative series of vent holes on the right and left upper sides of the doors, and the impressive double-bolt locking hardware on the exterior of these doors. A simplistic crown molding follows the outer long walls of the stair hall. Walls and the ceiling in the stair hall appear to be plaster, with the exception of a weatherboard wall that encloses the area under the staircase as a storage closet. Floors in Rooms 106 to 109 are different forms of vinyl tile, three of them subsequently painted. Outer walls and the wall between Rooms 107 and 108 appear to be plaster over brick, while the partition walls between Rooms 106 and 107 and Rooms 108 and 109—which were added in the 1960s—are of either sheetrock or plywood decking covered by sheetrock. All of these rooms have a simplistic crown molding surround and simple molded window surrounds. Ceilings appear to be of drywall. The original fireplaces between the two larger rooms that originally occupied the southeastern side of the first floor are no longer visible and are believed to be partially obscured by the addition of these partitions.¹⁰ All four rooms are currently used as display or office space.

Room 103—the first floor room occupying the southernmost corner of the original building—has served most prominently as a test room for the museum as it engages in a lengthy preservation and restoration plan for the jail. Here, the original tongue-and-groove wood ceiling has been exposed (although a track lighting system is now attached to it for museum purposes) and the oak floors (which are not original) have been exposed from beneath the vinyl tile that was once in this room and refinished. Explorations along the northwest wall of this room (shared with Room 104, to the rear of Room 103) have also uncovered the original fireplace hearth for this room, although in subsequent renovations, this hearth was recovered with drywall, even though its prominent, columnar intrusion into the room from the northwest wall is still visible. This room also includes the same simplistic molding along the perimeter that is found elsewhere on the first floor. Room 104, meanwhile, which served as the jailer's children's room in 1920, also has its oak floors restored, although there is absolutely no evidence of damage or scarring to these floors in the western corner of this room—where the 1920 bathroom is presumed to have been located—suggesting that repair or replacement of the 1925 oak floors in this room was completed to coincide with the removal of this bathroom in the 1960s. The molding for the old high bathroom window—which has been boarded—is however still visible on the southwestern wall. Walls in this room, which were covered with a dark oak plywood paneling as late as 2009, have been painted, with the upper wall above the paneling stuccoed and painted; the picture rail evident in pictures from 2009 remains.¹¹ The ceiling here, which has not been uncovered, appears to be stuccoed drywall.

From Room 104, a deep doorway (with no affixed door), located where a window was once located on the original, pre-1920 addition jail building, opens into Room 110, which once served as the 1920 and 1960s dining room. Walls in this space, which were once dark plywood paneling (as in Room 104) have been painted, apparently directly over the paneling. As in Room 104, the prominent picture rail above the paneling remains. The oak floors from Rooms 103 and 104 continue uninterrupted into this room as well. A built-in closet with pine louvered folding doors occupies the eastern corner of this room. Track lighting runs along the center of this room's ceiling, which is believed to be of drywall.¹² A doorway (also without a door, although hardware scarring is evident) at the northeast corner of the room opens into a narrow hallway (apparently added in the 1960s) with oak tongue-and-groove flooring that leads southeast to a second exit to the screened porch and northwest to the former kitchen, labeled by Harris Architects as Room 113. Kitchen cabinetry, a sink, and other indications of this use dating to at least the 1960s are clearly visible, although doors have been removed from the upper cabinets, thus leaving exposed shelving. The floor consists of a vinyl covering that appears to date to the 1980s. Another doorway (with no door) on the northeast wall of the kitchen opens into a small square room in the second component of the rear addition, an area that was originally part of a screened porch in 1920, then bricked in during the 1960s to create a breakfast room. Walls and ceiling are painted drywall, and this area is presently used for storage. Immediately southeast of this room (and accessible only from the previously mentioned kitchen hallway) is a small full bathroom with large square tiles along the bottom half of the wall and a repeating mosaic tile floor. Like the breakfast room (Room 114), this bathroom was originally part of the screened porch and was enclosed in the 1960s.

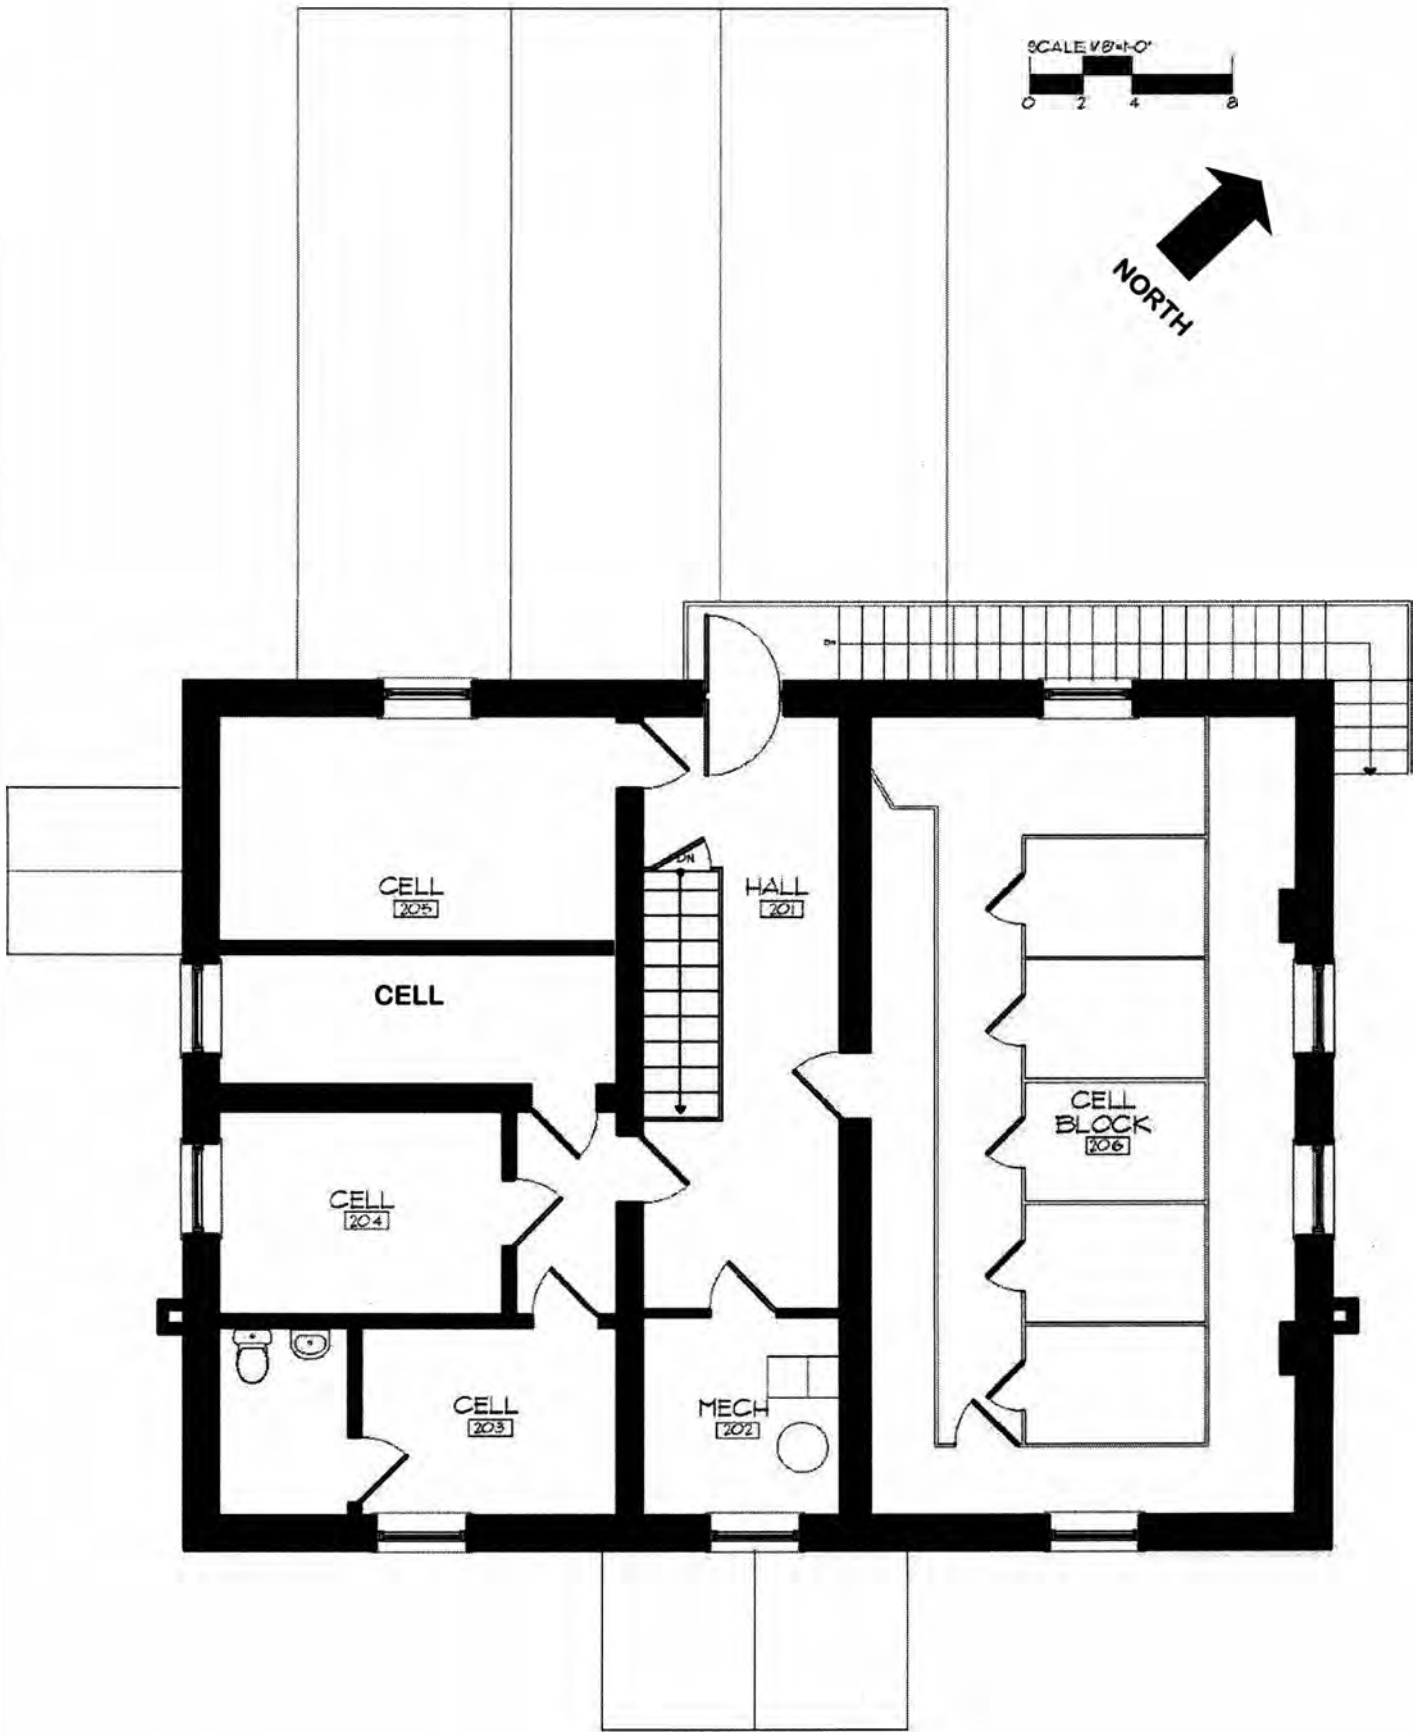
Hampton County Jail
Hampton, Hampton County, SC

Existing Second Floor Plan
Harris Architects PLLC, July 2009

By far, the interior portion of the Hampton County Jail with the most impressive surviving integrity is the second floor of the original jail building. Upon ascending the staircase in the original building, one is confronted with an impressive iron cage that is remarkably large in its gauge (each slat is nearly an inch wide and perhaps one quarter inch thick, thus rendering cage openings perhaps only two inches square). This cage is floor to ceiling and fully encloses the opening of the staircase. A heavy iron cage door that locks from the stairwell side and swings open into the second floor space controls access to the stairwell. Outside this cage, the original hallway space is defined by load-bearing brick walls that correspond to the first floor footprint. At the southeastern (front) end of the building, the original hallway space is now divided by a drywall wall with a wooden door, which leads into a small room that now houses the HVAC system and water heater (labeled on attached plan as "Mech 202" for Mechanical Room 202). Narrow slat tongue-and-groove flooring, similar to that found on the first floor, covers the hallway floor and the floor in this room, although it is now badly water damaged in the HVAC room and buckling here and in the hallway as a result. Heavy iron doors, which open outward into the hallway from the two cell areas on the southwestern side of the building and the large caged cell area on the northeastern side of the building, remain in place, although they differ slightly in design from those found on the first floor, with three ventilation patterns on the upper part of the three paneled door, slide bolts at the top and bottom panels, and a food doorway with flip-down door in the center panel. An interior wooden screen door separates the interior second floor space from the deep threshold leading to the heavy iron door at the top of the exterior fire escape at the rear of the building.

The large, single room on the northeastern side of the second story originally served as the six-cell cellblock for black male prisoners from at least as early as 1916, when the State Board of Charities completed an inspection. Their report confirms the existence of what is now described as a "triple-lockdown" system: an outer cell door to the room (described previously); an elaborate cage system, identical in material to the cage used to enclose the stairwell, with a single outer locking gate controlling access to the cage corridor and cells; and a corridor and line of five individually-locking cells, at the end of which is an irregular-shaped latrine area where there was once a sink, toilet, and shower.¹³ This entire cage complex is ceiled with the cage material at approximately seven feet in height, leaving an additional three feet of vertical space between the top of the cage complex and the plywood ceiling for the room itself. Walls between the individual cells are solid iron with no cage grating. Some cells still contain a simplistic portable iron cot.¹⁴ The entirety of this cage complex, meanwhile, is surrounded on the southwestern, southeastern, and northeastern sides by a narrow corridor within the room. Floors are painted tile—perhaps asbestos in composition—and outer walls of the room are painted brick.

On the opposite side of the second floor is an area that was originally comprised of two large cells with the same footprint as the rooms directly below this area, minus the fireplaces. The second floor room in the westernmost corner of the building was originally used as the black women's cell, with its door opening just outside the stairwell cage at the rear of the building. This space was later divided—presumably in the 1960s, at the same time the first floor cells were divided—into two rooms. The first of these is accessible through the original doorway at the top of the stairwell and contains partition walls of the same material found in the first floor cells, with the exception of the wall on which the door is affixed, which is brick. This room appears to have contained a toilet and sink at one time, as outlets for this plumbing and an old mirrored surface attached to the wall are still present.¹⁵ Meanwhile, the original southern corner room at the front of the building—which was once used as the white men's cell when it had the same footprint as the jailkeeper's living quarters directly beneath it—is now divided into three separate cell areas, all accessed from a tiny vestibule just inside the main doorway to the room. The first of these cells (Room 205) lies to the northwest of this vestibule and occupies the other half of the previous western corner room (described above). The wall between this cell and Room 204 (to the southeast and directly ahead as one enters the vestibule in this area) is of brick, reflecting the original dividing wall in this area, as is the inner wall on the northeast side of the room, but the two other walls and the ceiling are of the same partitioning material described previously in the other cells. Again, in this cell, an old mirror and sealed plumbing outlets for a sink and a toilet are still extant, although the fixtures themselves have been removed. Room 204 is somewhat smaller (because of the vestibule area), but like Room 205 it has a combination of partition wall material (southeastern and northeastern walls) and brick wall (northwestern wall), and a partition material ceiling. The mirror and plumbing outlets are also visible here. Finally, Room 203, to the southeast of Room 204, has nearly the same features as Room 205, with the exception that its plumbing

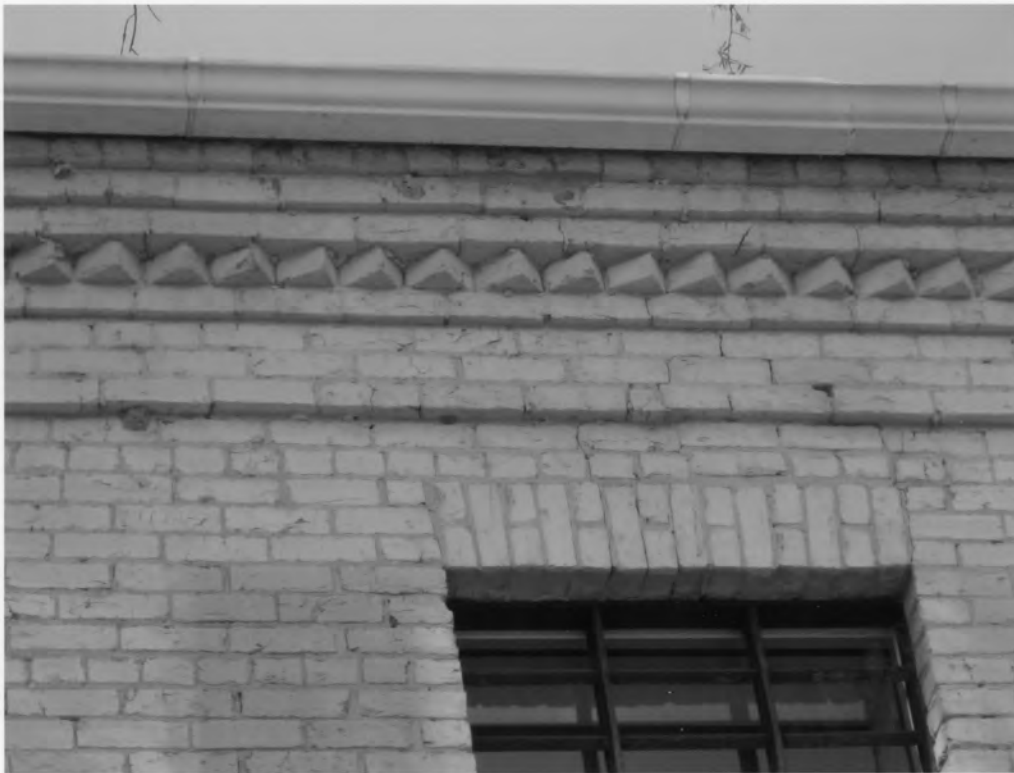
2. Hampton County Jail
701 1st Street West, Hampton
Hampton County, South Carolina

Southeast Elevation, Cornice Detail

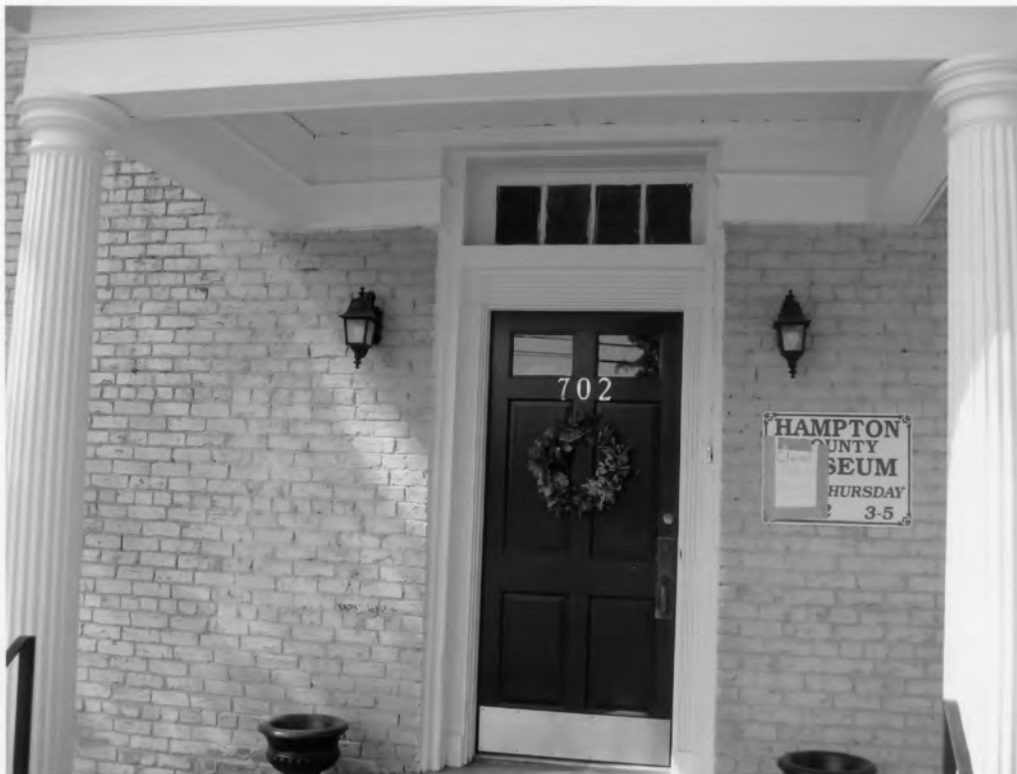
12. Hampton County Jail
701 1st Street West, Hampton
Hampton County, South Carolina

Southeast Portico and Entrance Detail

The front entrance, meanwhile, is reached via two brick steps leading to a central porch with brick foundation, a tile inlay, and a pedimented portico of the Tuscan order but supported by two fluted Doric order columns that feature capitals consisting of torus moldings in place of a classical echinus and abacus. The tympanum and its raking cornices are unadorned. The ceiling of this porch is simple painted tongue and V-groove planks, with the unadorned features of the Tuscan order continuing on the interior of the portico. The main entrance, meanwhile, has a heavily fluted surround with smooth corner blocks and a prominently recessed four-light transom. The door itself is a traditional single-leaf, six-paneled wooden door with the uppermost two panels glazed and what appears to be some original hardware and a newer brass kickplate, although the door itself may not be original to the building.⁴ This temple front porch, which is covered with an asphalt shingle roof, likely dates to the 1920s, although it is clearly not the original front porch for this building, as evinced by the ghost pattern of the original porch against the original brick. This earlier porch appears to have extended laterally just beyond the outer edge of the two lower story windows and may have contained a porch swing, although no images of this earlier porch have been found.⁵ A wooden handicap accessibility ramp, added sometime after 1975, slopes away to the right of the main entrance.

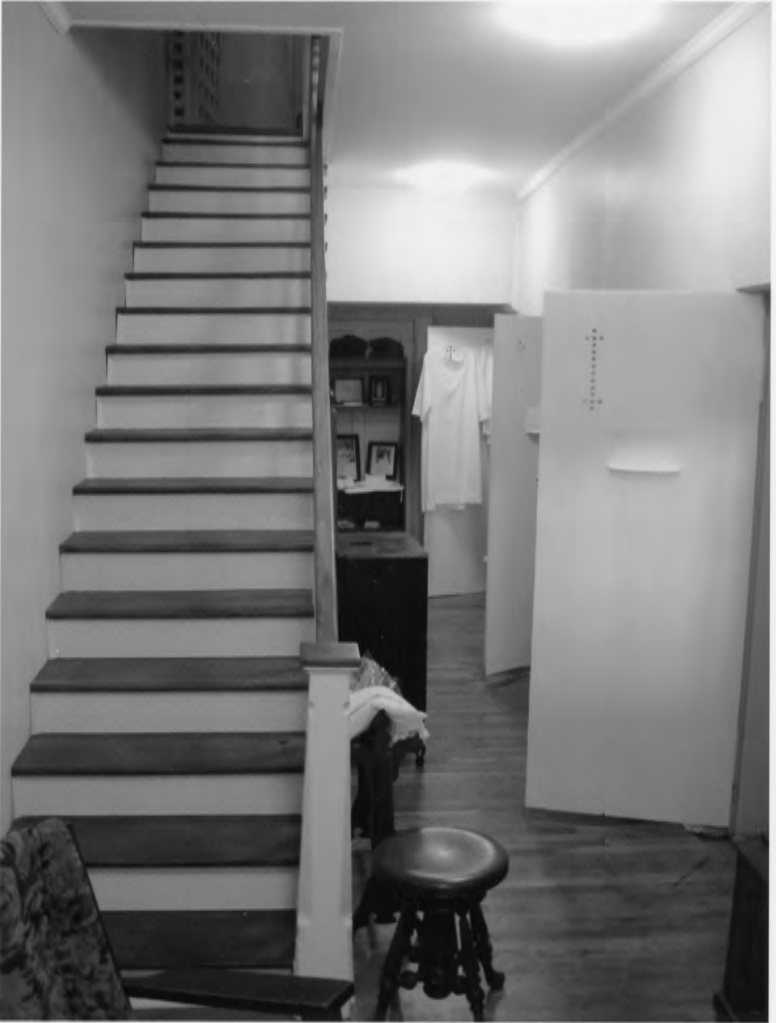
13.

Central Staircase and Hallway, Looking Northwest

The interior of the original jail building, meanwhile, includes a small square entry and an impressive center stair hall with a narrow staircase along the northwest wall of the hall that rises to the original jail cell area. This staircase includes a decoratively beveled, flat-topped newel post with wooden balustrade, as well as wide pine risers and treads, the latter of which remain exposed. A doorway at the northwestern (or rear) end of this hallway—believed to be the original rear door

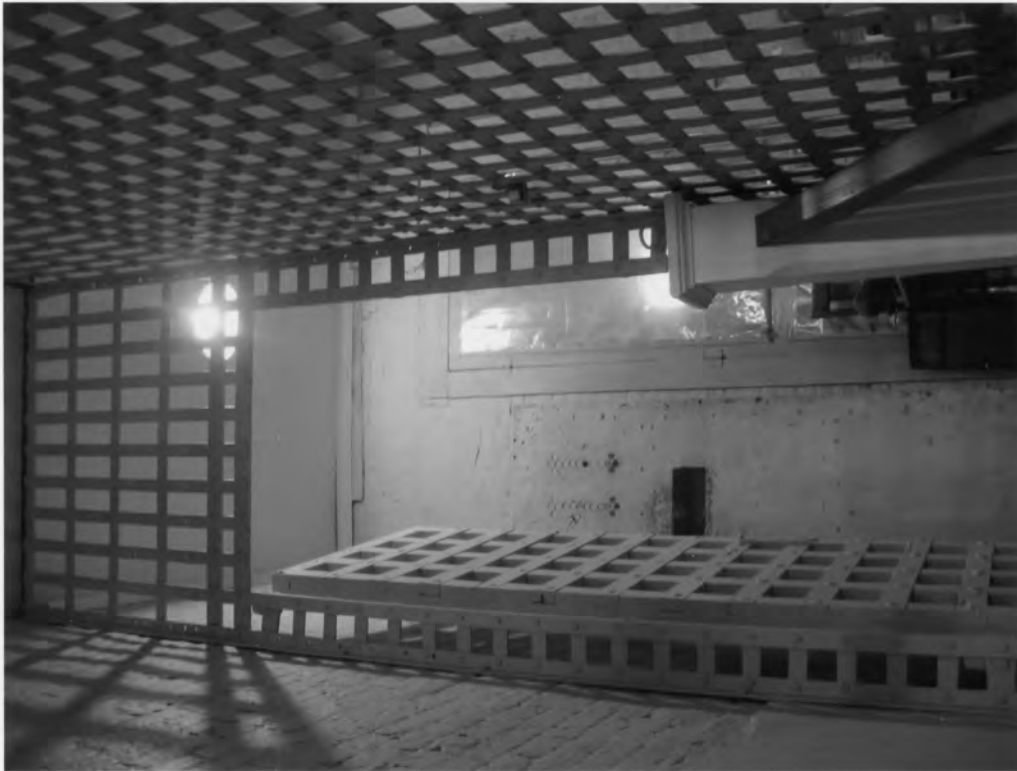
17. Hampton County Jail
701 1st Street West, Hampton
Hampton County, South Carolina

Cage Around Stairwell, Looking Up and Northwest

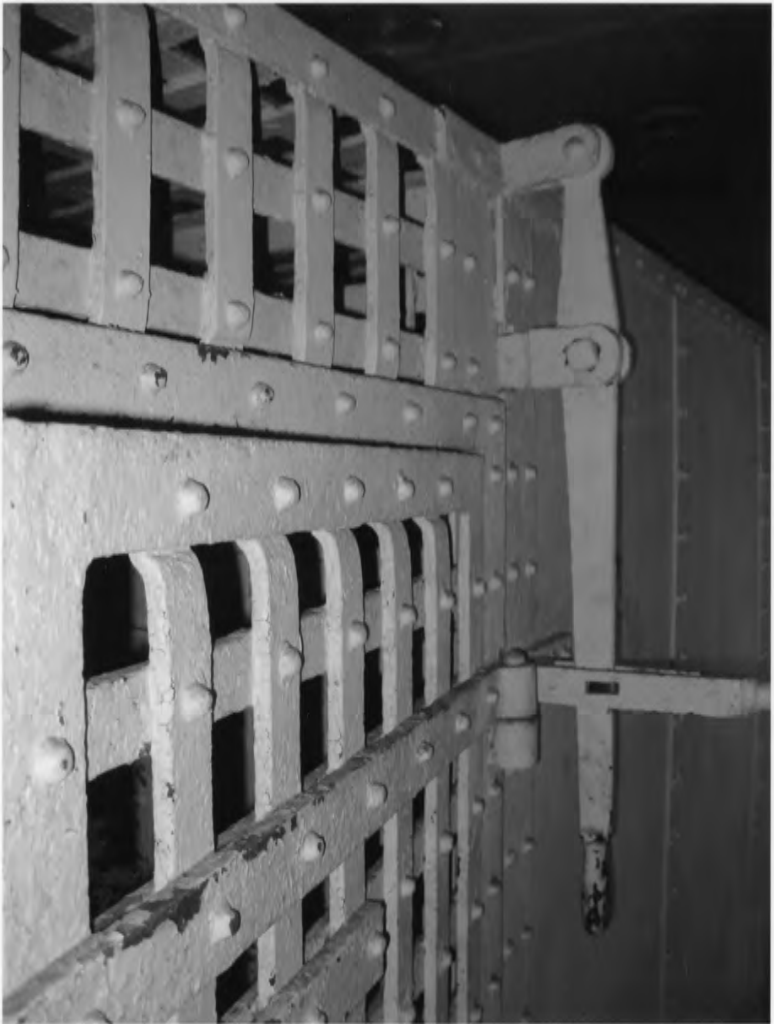
24.

Room 206, Cell Block Locking Mechanism Detail

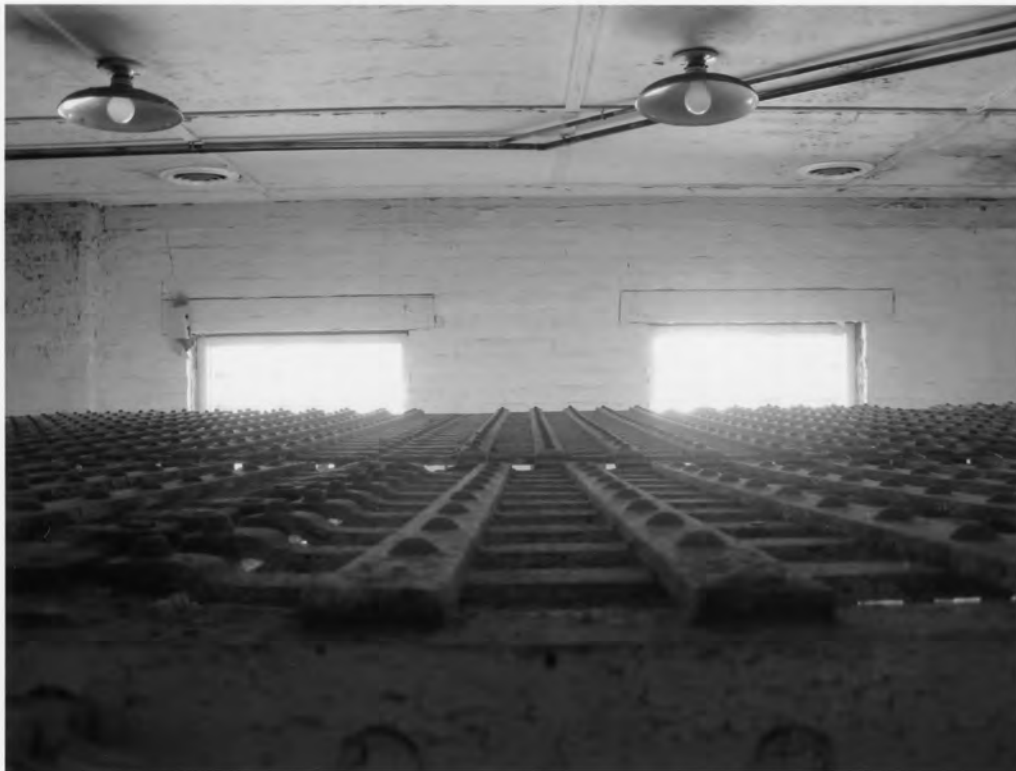
26. Hampton County Jail
701 1st Street West, Hampton
Hampton County, South Carolina

Room 206, Top of Cell Block, Looking Northeast

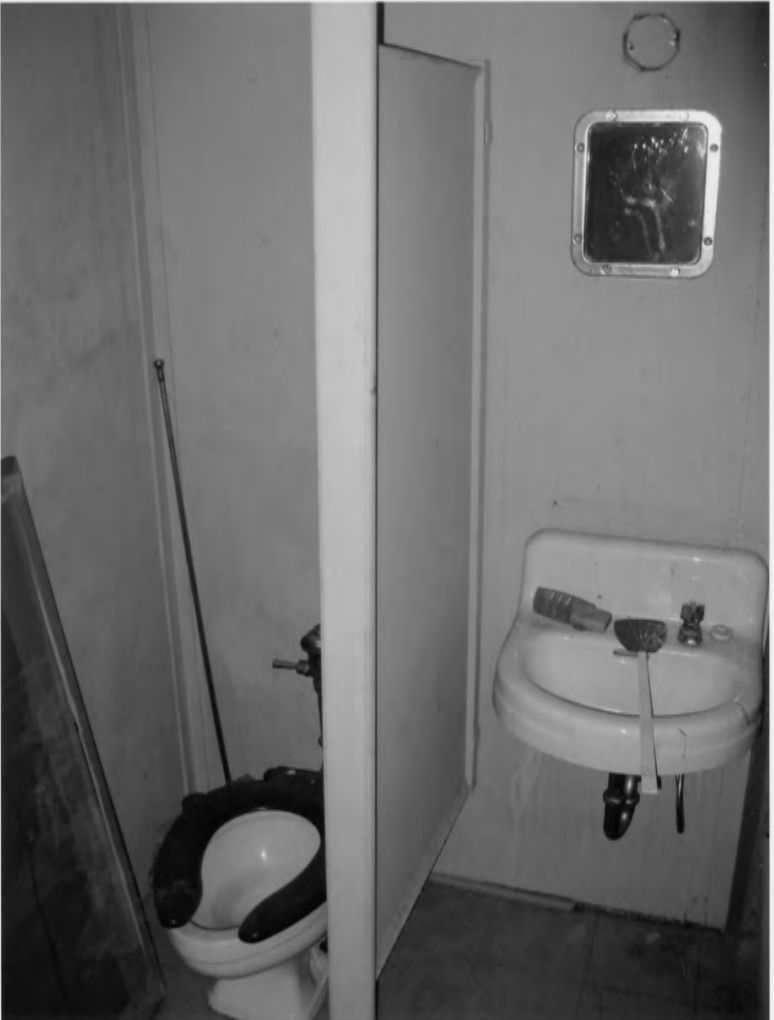
28.

Room 203, Latrine Area
