National Register of Historic Places Registration Form

historic name Hargreaves Homestead Rural Historic Landscape
other names/site number Hargreaves Farm, 5PL.24

The Hargreaves Homestead Rural Historic Landscape District occupies the west half (320 acres) of Section 8 in Township 7N, Range 44W in Phillips County. The farm has been owned by the Hargreaves family since its establishment in the 1880s; single family ownership dating back to the nineteenth century is an extremely rare occurrence in Phillips County. Henry Hargreaves, an emigrant from Liverpool, England, filed a pre-emption claim on the southwest quarter of the section in spring 1887 and constructed a sod house and other farm buildings on the property. By the end of the year, he had broken twenty-four acres, seventeen of which had been planted. Henry Hargreaves received official title to the land in 1890. He expanded his property through a homestead claim on the northwest quarter of the section which he received title to in 1895. Unlike many of Phillips County's early settlers who failed to make it through the drought and depression of the 1890s, Henry Hargreaves developed a highly successful farming and ranching opera

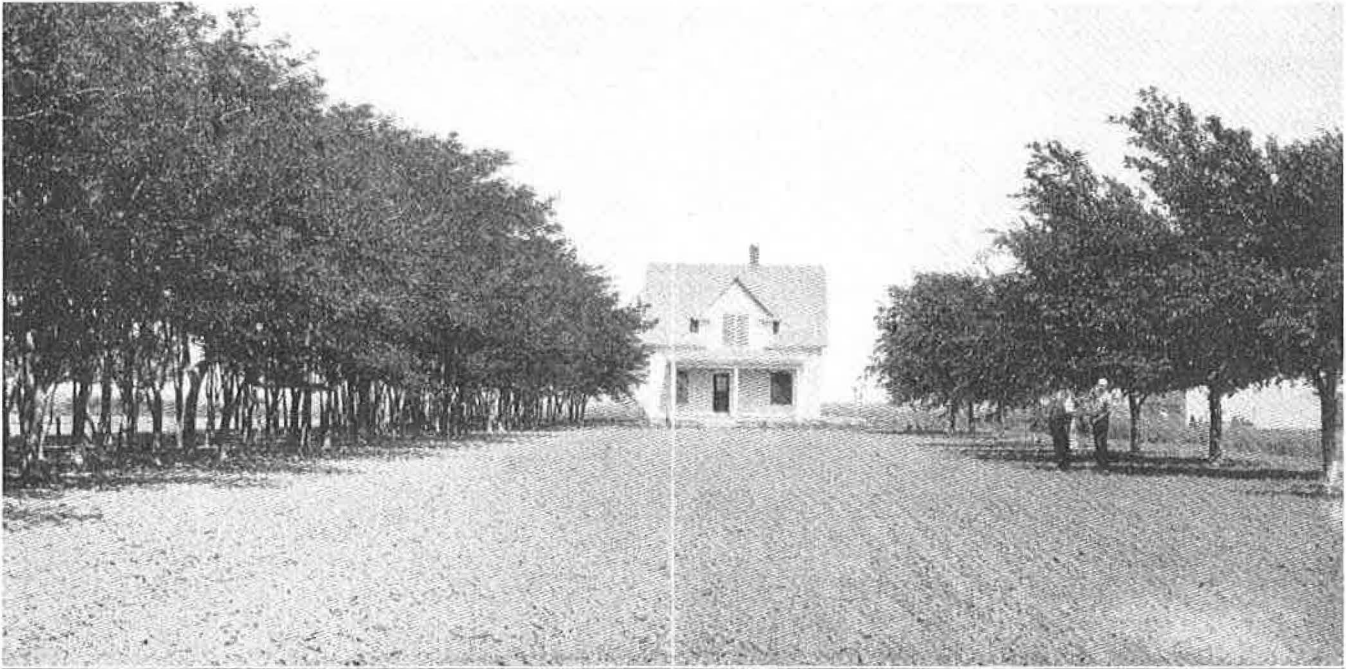
Trees can be grown very successfully by thorough, clean cultivation. Many farm homes in Phillips County have fine shade trees, orchards and wind breaks produced without irrigation.

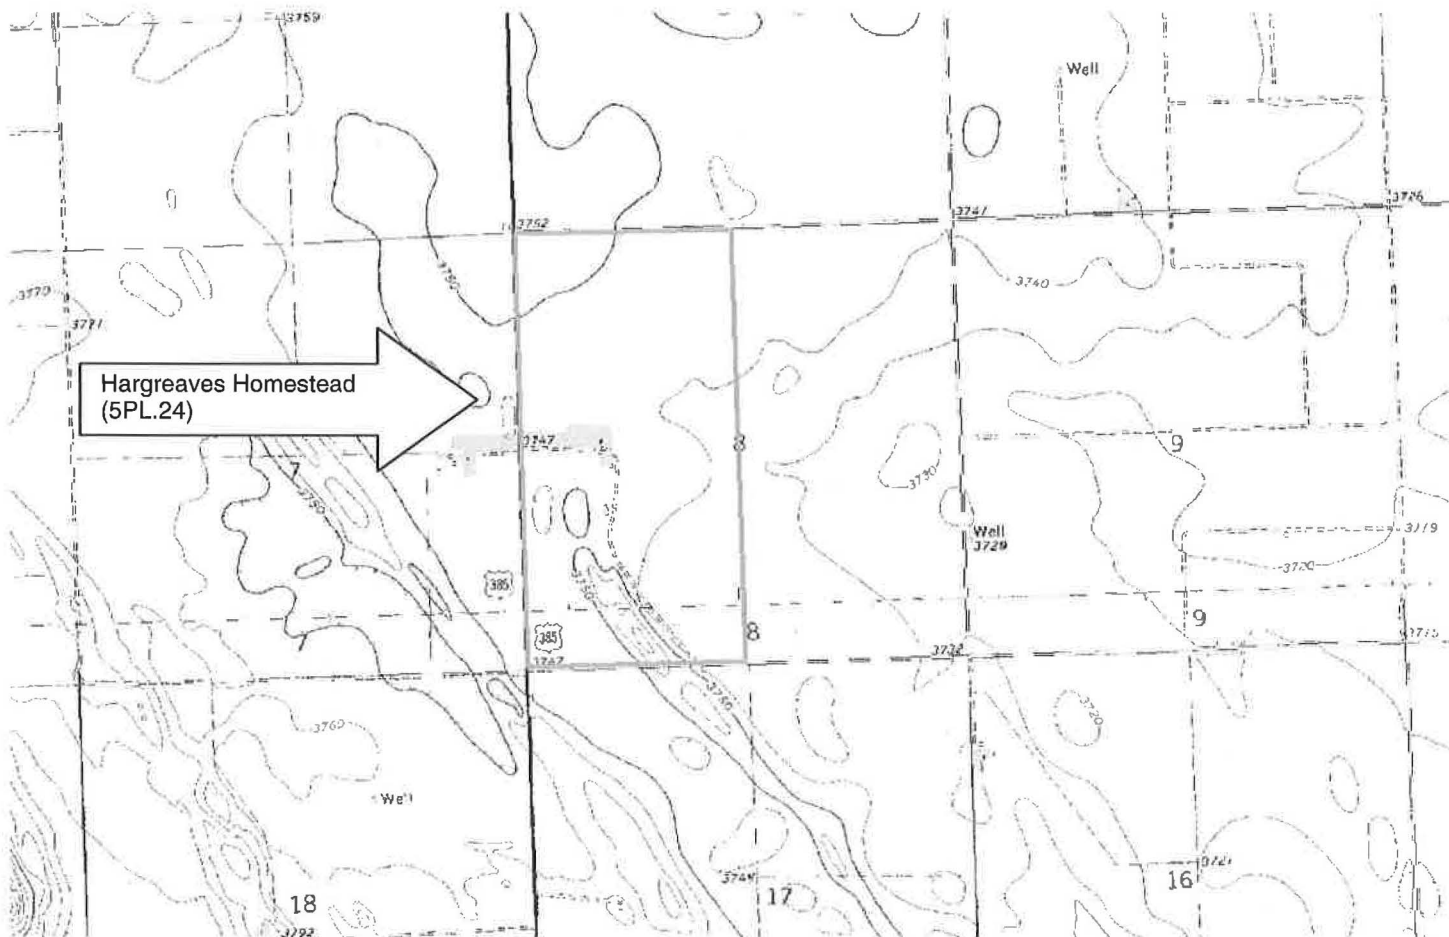
USGS Holyoke Quadrangle (7.5 Minute Series)
W ½ Section 8, Township 44N Range 6W
UTMs 13; 728636mE; 4488154mN (NAD83)
13; 7294381mE; 4488170mN
13; 729491mE; 4486566mN
13; 728682mE; 4486543mN
