Property Name: Hargreaves Homestead Rural Historic District

National Register of Historic Places Registration Form

historic name Hargreaves Homestead Rural Historic Landscape
other names/site number Hargreaves Farm, 5PL.24

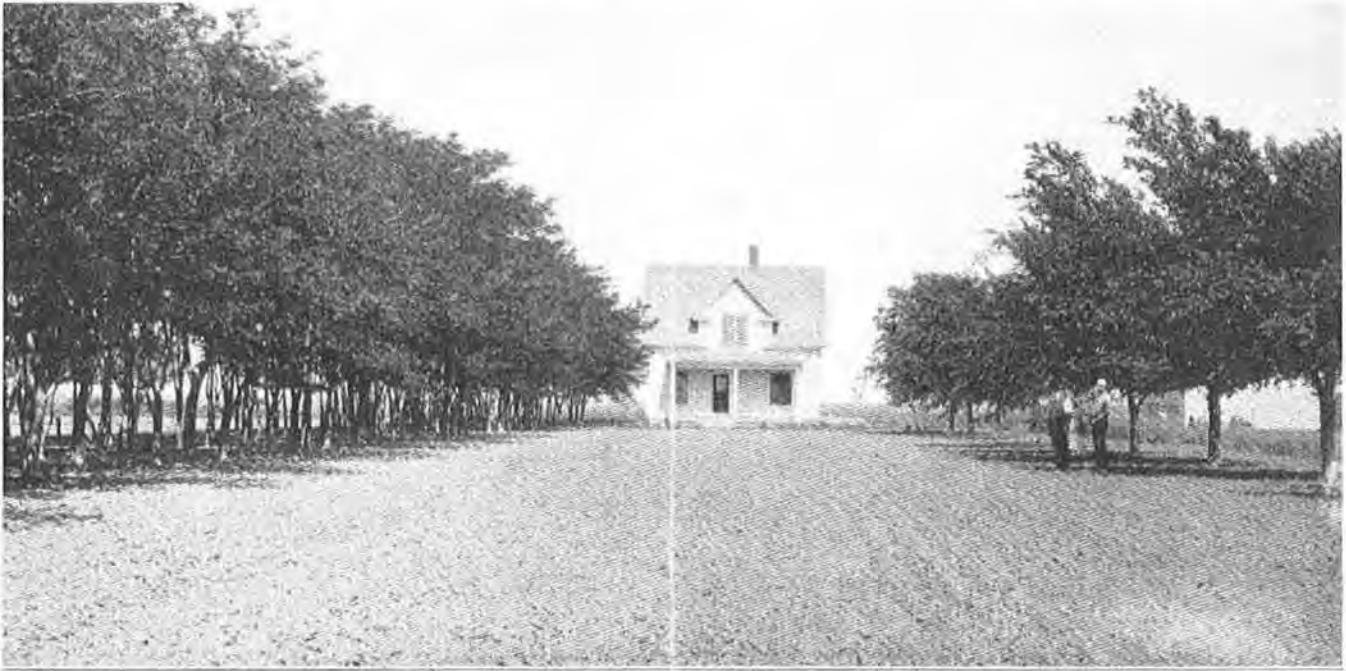
Trees can be grown very successfully by thorough, clean cultivation. Many farm homes in Phillips County have fine shade trees, orchards and wind breaks produced without irrigation.
