National Register of Historic Places Registration Form

Historic name U.S. Inspection Station—Orient, Maine
Other names/site number Orient Border Station

*U.S. Inspection Station—Orient Aroostook
County, Maine*

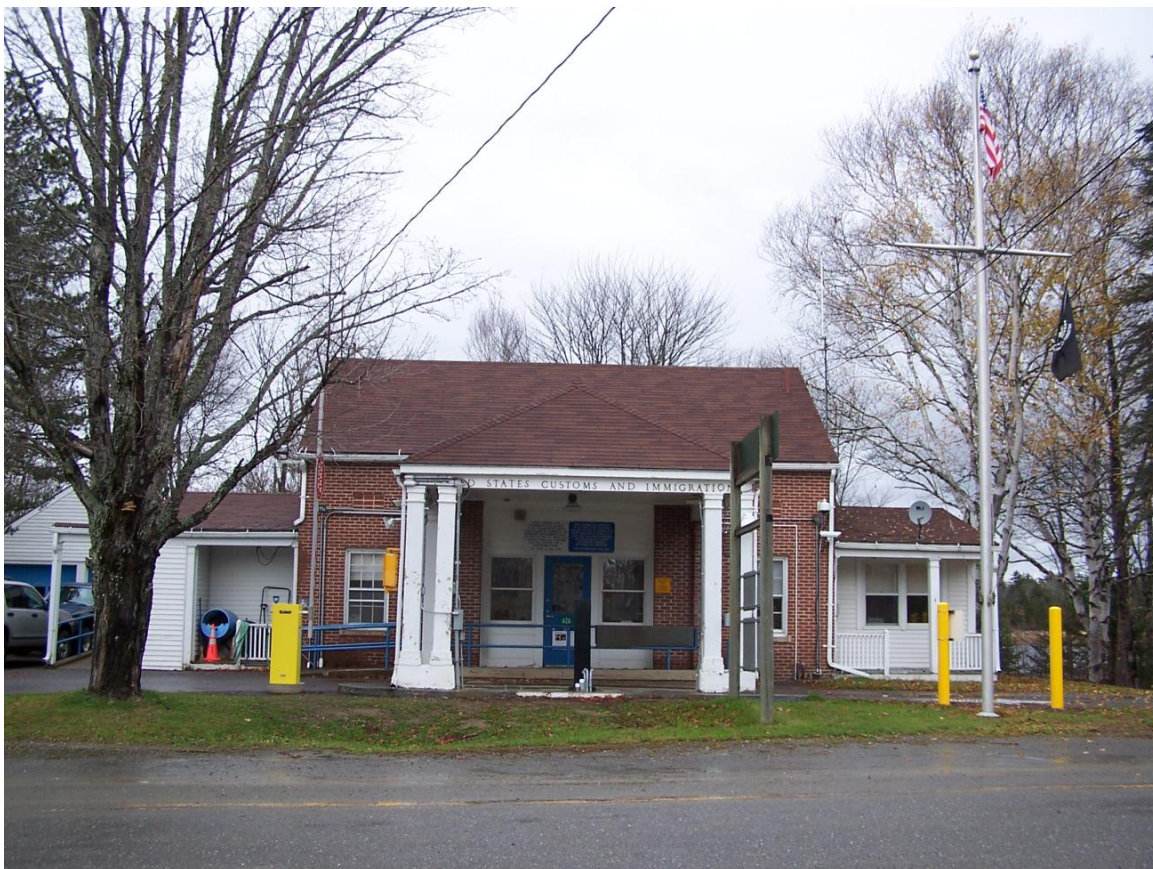
Photo number: ME_AroostookCounty_OrientBorderStation1.tiff

Description of view: front elevation, view facing north

The U.S. Inspection Station—Orient is a 1½-story rectangular plan Colonial Revival building with a medium pitch side gable roof. Affixed at either end of the building (also called the primary building) are 1-story Colonial Revival wood-frame wing additions that are similar in character and scale to small houses. Though both wings were added later, they do appear to be over 50 years old. A hipped roof porte-cochere fronts the primary building.

The primary building's elevations are of running bond brickwork. 6/6 and 1/1 wood-frame, double-hung windows underscored with concrete sills are part of the design, as are 8-unit fixed rectangular windows inset into the lunettes present at either gable end. Symmetry is a strong design feature of the primary building. Its front elevation is of three bays. The front elevation's side bays are identical in program with 6/6 wood-frame, double hung windows topped by an inset 9-part grilled attic vent. The front entry is in the center of the middle bay, and features a glass panel door flanked on either side by recent, 1/1 vinyl-frame double hung windows. This program is contained in a white painted, wood-paneled façade framed by two engaged brick columns. In front of the middle bay of the primary building, and corresponding in place to the two engaged brick columns, is a molded, hipped roof, one lane porte-cochere supported by squared classical columns topped with an abacus and a molded hypotrachelium. The columns at the outer portion of the porte-cochere are in two pairs of two and have classically delineated bases. Each pair of columns rests on a low, tapered concrete pier. The two inner columns of the porte-cochere are singular; feature the same upper portion details as the other columns, but no base or pier at their bottom, resting instead on a concrete slab porch. The porte-cochere appears to be original, which is a relatively rare condition, when compared to the extant inspection stations.

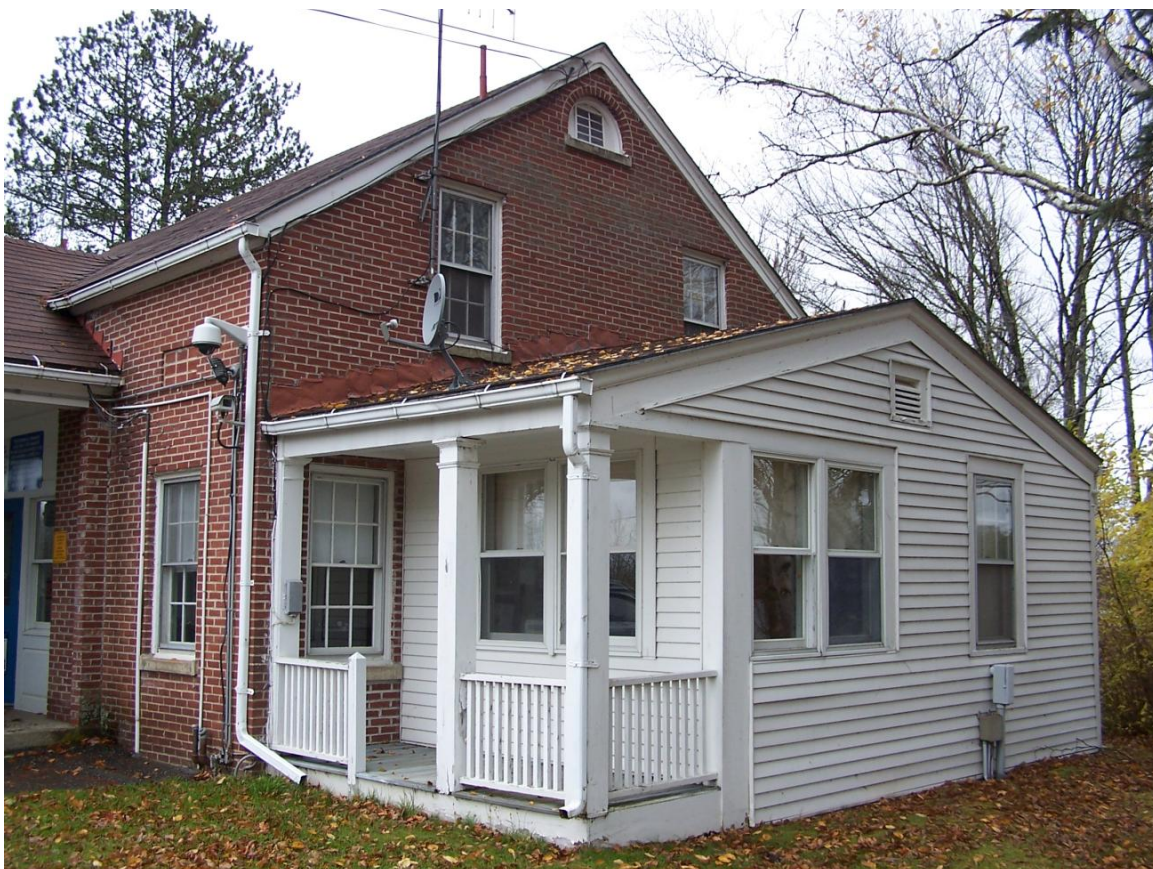
Photo number: ME_AroostookCounty_OrientBorderStation2.tiff

Description of view: front and side elevation, office wing, view facing northwest

Affixed to the east end of the primary building is a 1-story, square plan, Colonial Revival office attachment wing. Its white painted wood clapboard cladding is in contrast to the brick cladding of the primary building. It features an eaveless side-gabled roof of a low to medium pitch that is underscored by fascia boards affixed to the elevations at the gable ends. Both wide and narrow corner boards are part of the design. A small porch with squared, classical columns and enclosed with a simple wood baluster is present at the south-facing elevation. However, this porch and the attachment itself have no entry and are instead accessed through the inside of the primary unit. Paired and single 1/1 and 6/6 wood frame double hung windows are part of the design and are framed in flat wood plank.

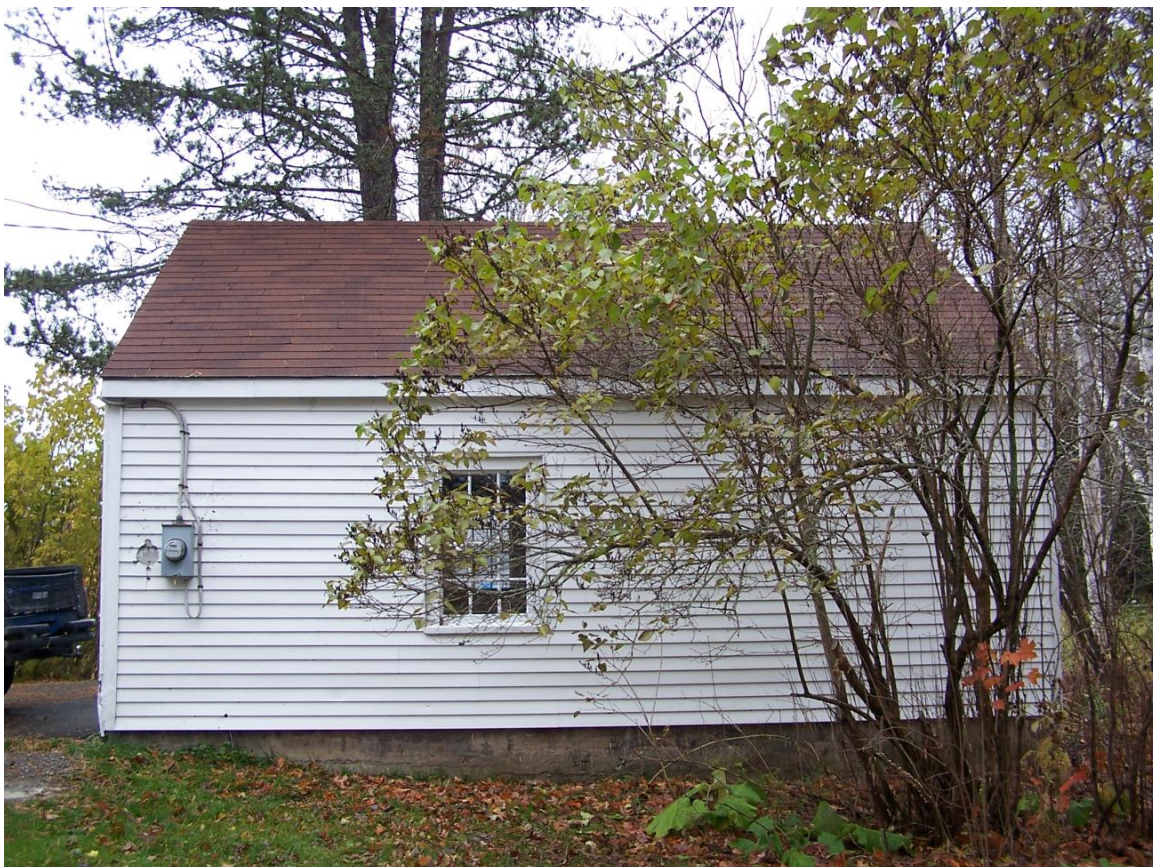
Photo number: ME_AroostookCounty_OrientBorderStation3.tiff

Description of view: side elevation, garage, view facing west

A medium pitch front gabled garage is located at the northwest section of the property. The tall gable is clad with clapboard siding. The garage building is highly symmetrical, comprised of two adjacent bays that occupy almost the entire lower portion of the front elevation. The garage is most likely original, as it is indicated on the original site plan found at the National Archives and Record Administration (NARA).³ The garage appears to be intact, including its original doors. Similar to the wings that came later to either side of the primary building, the garage also features attached fascia boards below the roofline, and features minimal eaves.

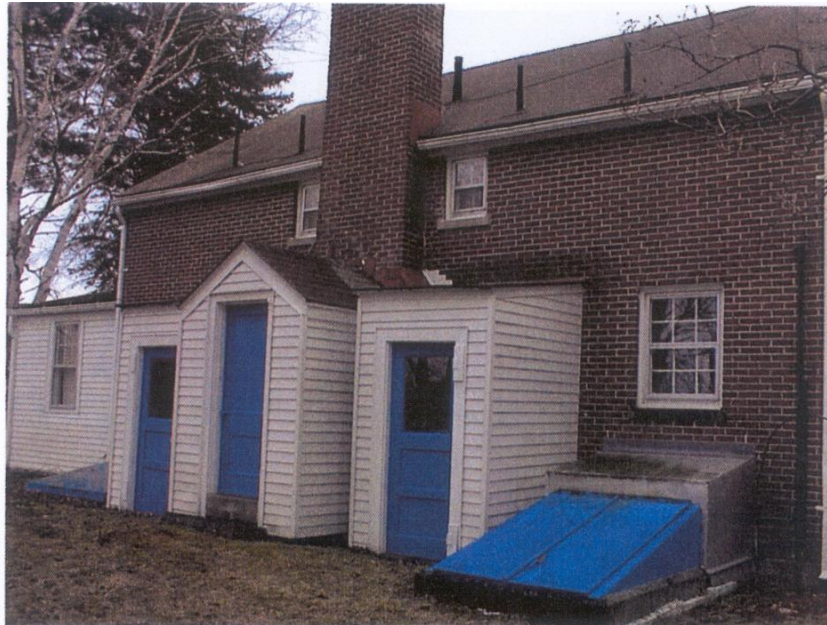
Photo number: ME_AroostookCounty_OrientBorderStation4.tiff

Description of view: rear elevation, view: southeast

The rear of the primary building features a centered, running course brick chimney. On either side of the chimney flue are small, 1/1 wood frame double hung windows with marble sills. Affixed to the chimney is a wood clapboard clad, medium gable shed which is small, and dominated in scale by the entryway that encloses a two-panel wood door within it. Immediately adjacent on either end of this shed are two shed roofed lean-tos affixed to the primary building

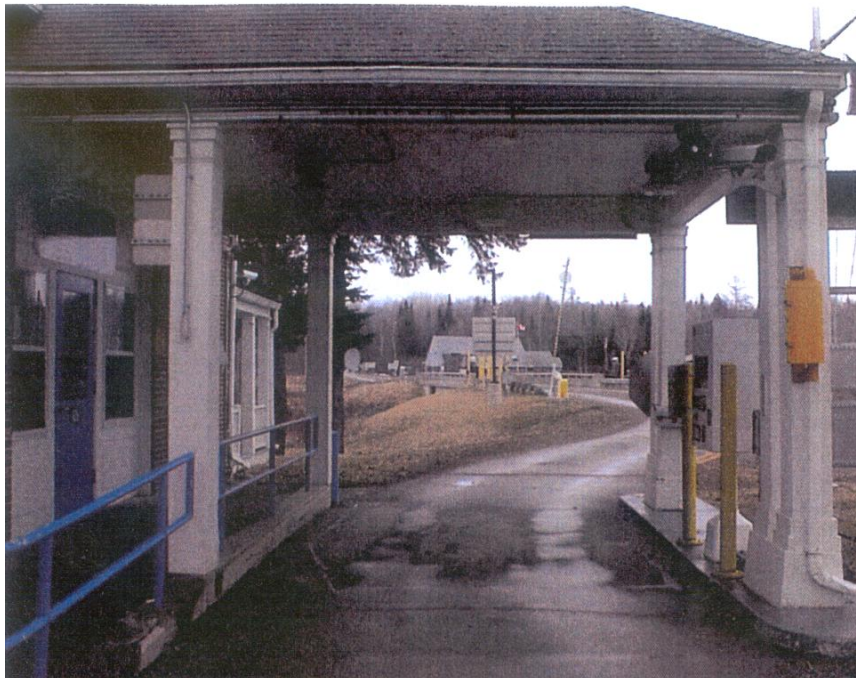
Photo number: ME_AroostookCounty_OrientBorderStation5.tiff

Description of view: porte-cochere, view: east

At Orient, the porte-cochere was not altered, either by increasing the height or lane capacity, which is a relatively rare condition among the extant border stations. The wing additions do not detract from the overall design integrity of the station, and are offset by its retention of many original features, such as the wooden windows, exterior brick wall surface, and interior elements.

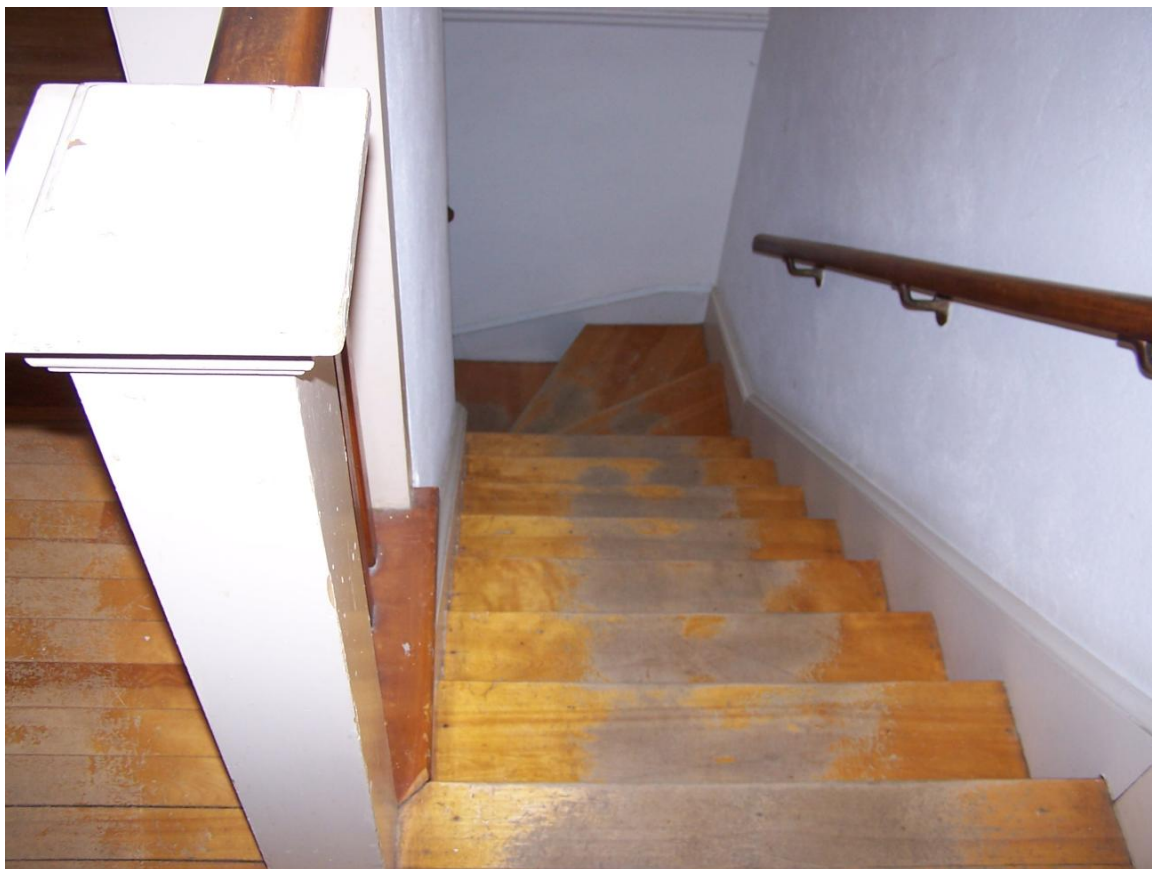
Photo number: ME_AroostookCounty_OrientBorderStation6.tiff

Description of view: interior, second floor staircase, view facing downstairs

The interior layout of the primary building is largely symmetrical. The front entry opens into a vestibule, and on either side of it are offices each backed by a kitchen. Two adjacent stairwells are located in the middle of the program. At the second floor the symmetrical scheme is of foursquare offices (originally the living quarters), and two adjacent restrooms at the center rear of the floor behind the stairwells. A basement also exists beneath the structure and is one continuous space around the stairwells and contains electrical and mechanical equipment. Though the two wings of the primary structure are loosely symmetrical in dimension, form and scale, the interior functions of each are varied, as are the floor plans. The east wing contains two offices, and the west wing contains two public restrooms. In the interior of the primary building are three original light fixtures: two on the first floor and one on the second. These fixtures are circular, each of a different Moderne-inspired design.

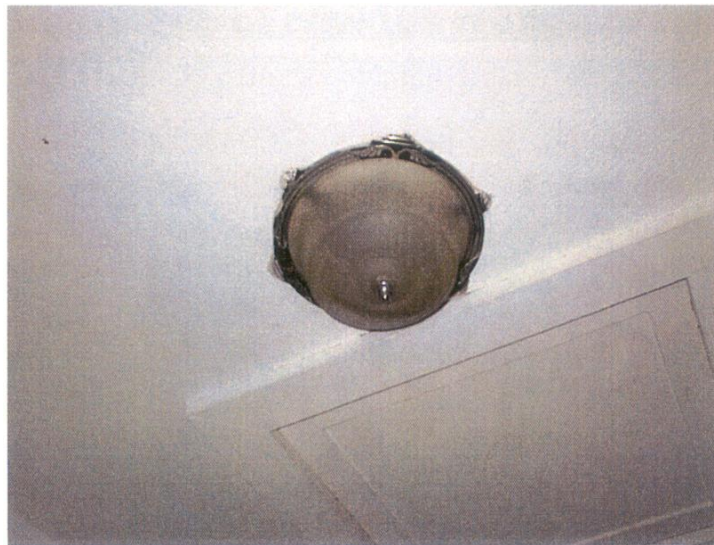
Photo number: ME_AroostookCounty_OrientBorderStation7.tiff

Description of view: second floor original light fixture

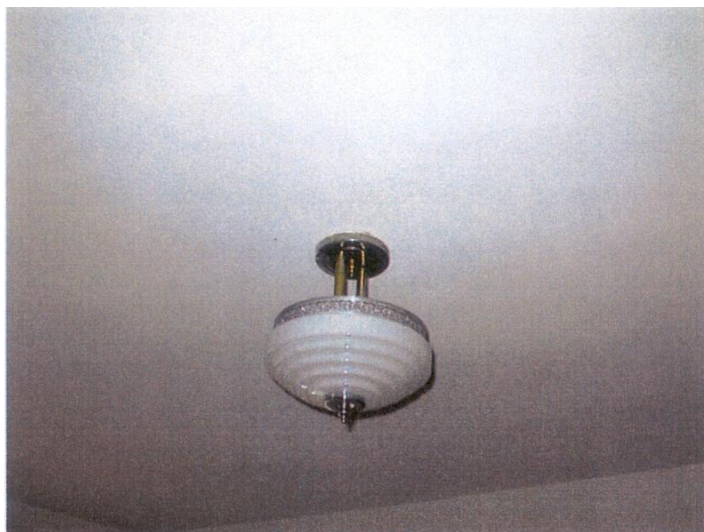
Photo number: ME_AroostookCounty_OrientBorderStation8.tiff

Description of view: first floor original light fixture

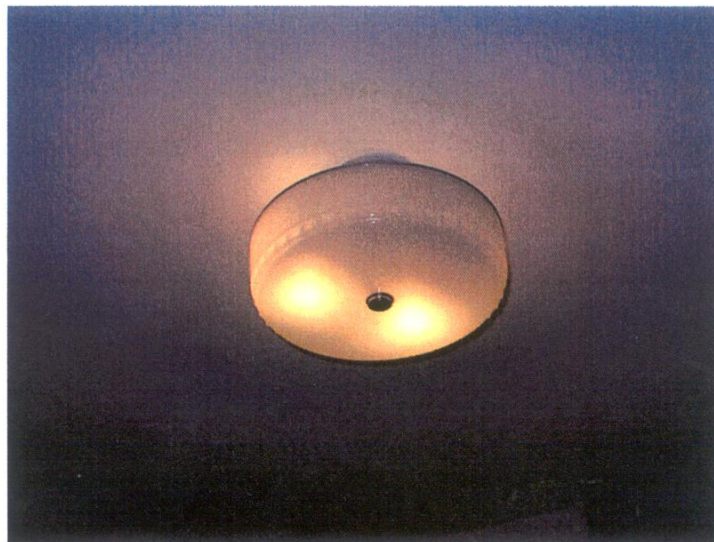
Photo number: ME_AroostookCounty_OrientBorderStation9.tiff

Description of view: first floor original light fixture

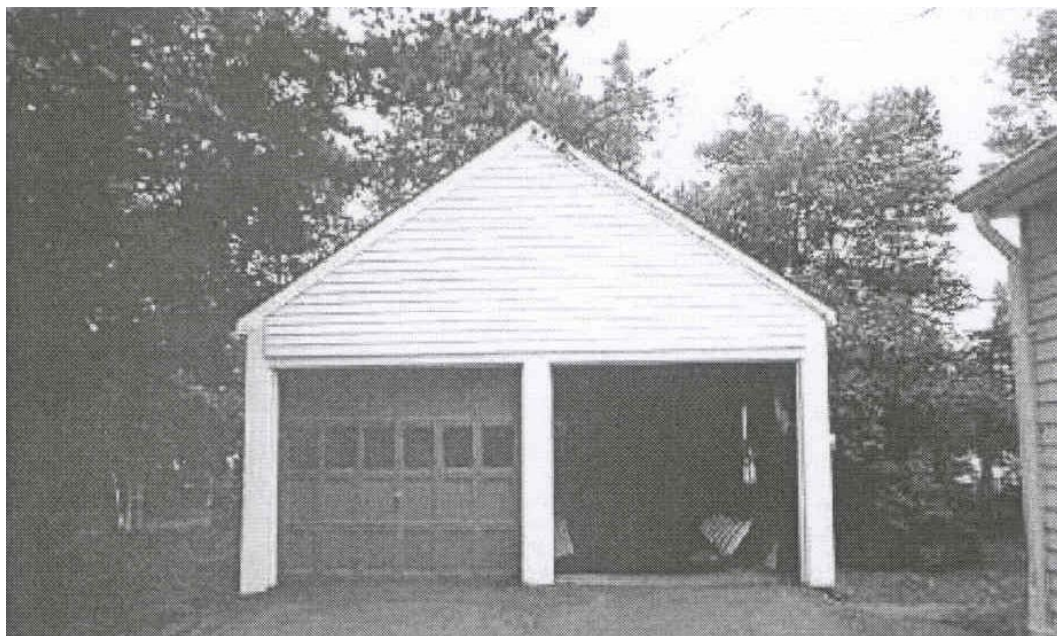
Description of view: garage, view facing north

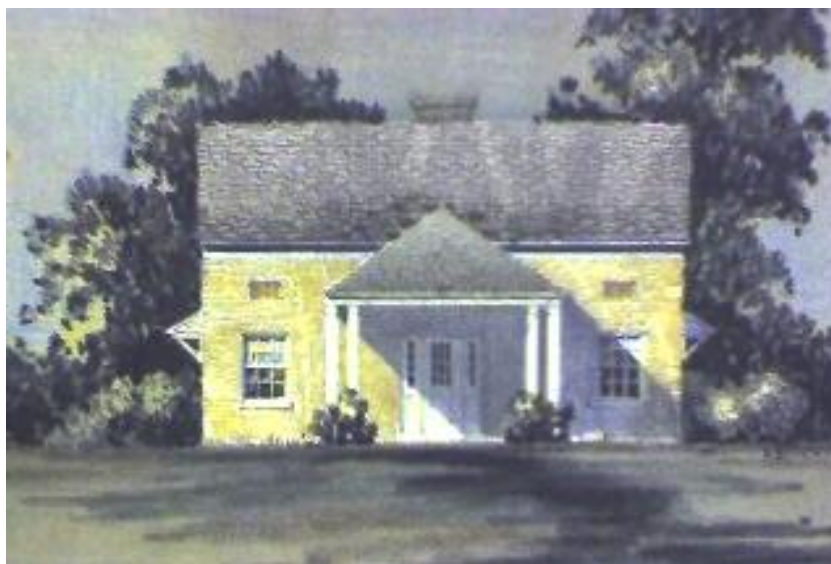
Description of view: front (south) elevation, view: north

The renderings for the U.S. Inspection Station—Orient can still be found at the National Archives and Records Administration (NARA). The primary building, as currently extant, possesses many features originally depicted in the front elevation rendering.⁶ These include the wood frame, multi-glazed double hung windows each topped by a 9-part inset grill vent, paired columns at the edge of the porte-cochere, and strong symmetry further reinforced by the triangulated straight on view of hipped roof porte-cochere placed directly under the centered chimney protruding from behind the building. Two other inspection stations were identical in design with the one constructed at Orient, Maine: Danville, Washington and Porthill, Idaho. Of these three, the Orient Inspection Station is the only one that remains still in use and under federal ownership.
