National Register of Historic Places Registration Form

historic name Barrio Santa Rosa

other names/site number Barrio Santa Rosa Historic District

city or town Tucson vicinity

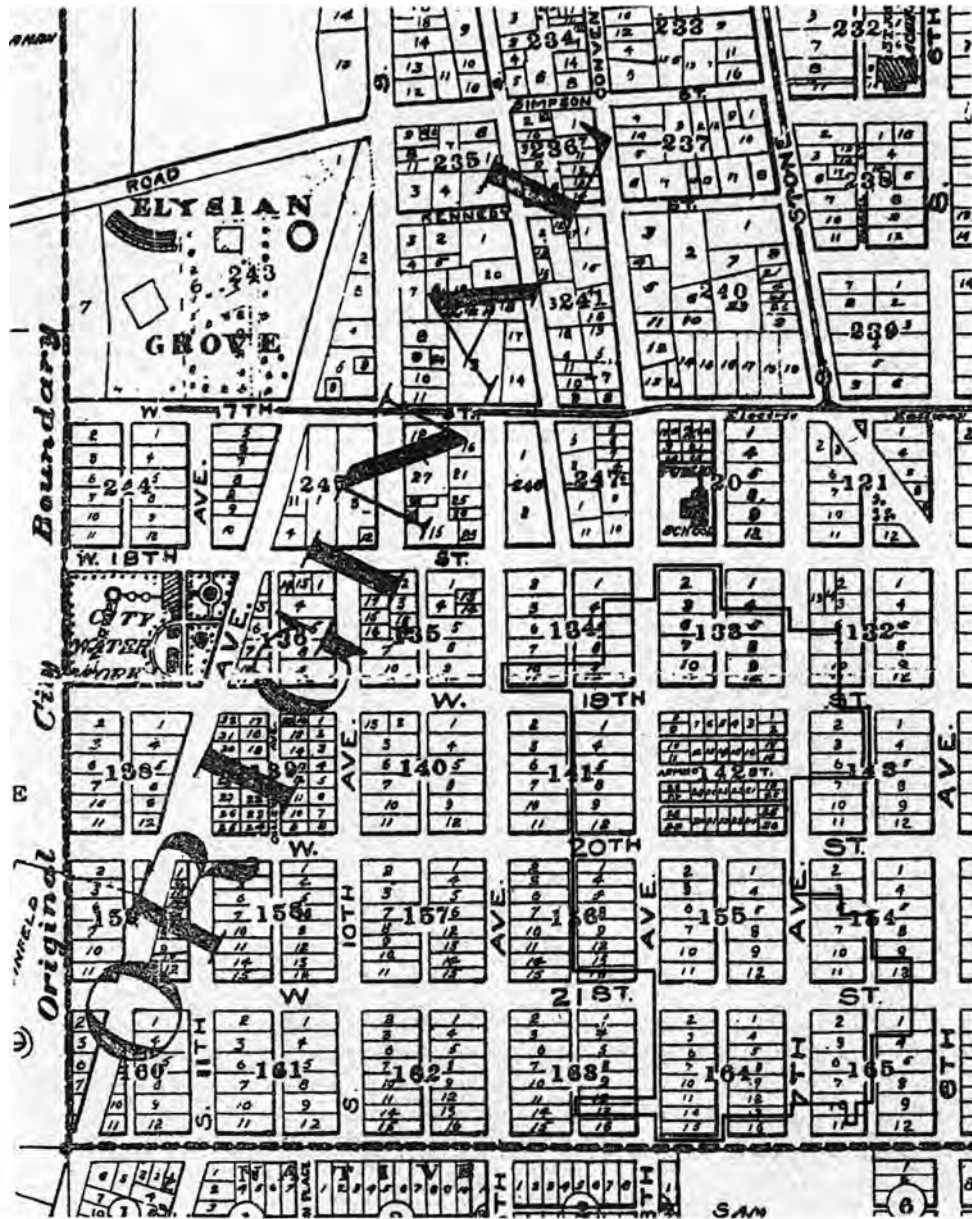
Figure 1. Portion of 1906 city map (courtesy Arizona State Historical Society Library), with approximate boundary of Barrio Santa Rosa Historic District.

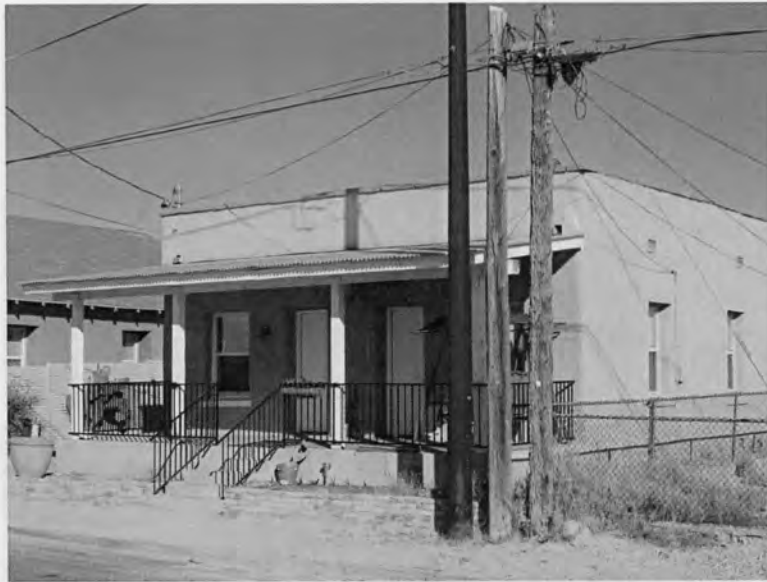
Photograph 3. 1023-1025 S. Meyer Ave.; view east-northeast.

Of the 98 buildings in the district that were constructed during the neighborhood's period of significance, 29 date to the initial phase of development, from the 1890s up to 1920, and 40 date to the second phase, from 1920 to the Depression. A dozen date to the brief period of economic recovery prior to World War II, and 17 date to the immediate postwar period. With the exception of a store and dwelling built in 1936 and a Catholic mission built in 1946, all of these buildings are one-story single- or multiple-unit dwellings, and almost all are constructed of adobe. Just over half of these buildings represent the continuation of the Hispanic vernacular building tradition known regionally as Sonoran. (Until the United States' invasion of Mexico and the subsequent treaties of Guadalupe Hidalgo in 1848 and La Mesilla in 1854, what is now southern Arizona was northern Sonora.) The predominant building type in Tucson's old Hispanic urban core was the Sonoran row house, an adobe multiple-unit dwelling built flush or almost flush to the street. The Sonoran row house tradition continued in Hispanic neighborhoods like Barrio Santa Rosa that first developed beyond the old urban core. Examples are 827-835 8th, with five units (Photograph 1) and 1015-1019 Meyer, with three units (Photograph 2). Two-unit versions of the row house, as well as single-unit dwellings, gradually became more prevalent; a typical two-unit example is 1023-1025 Meyer (Photograph 3).

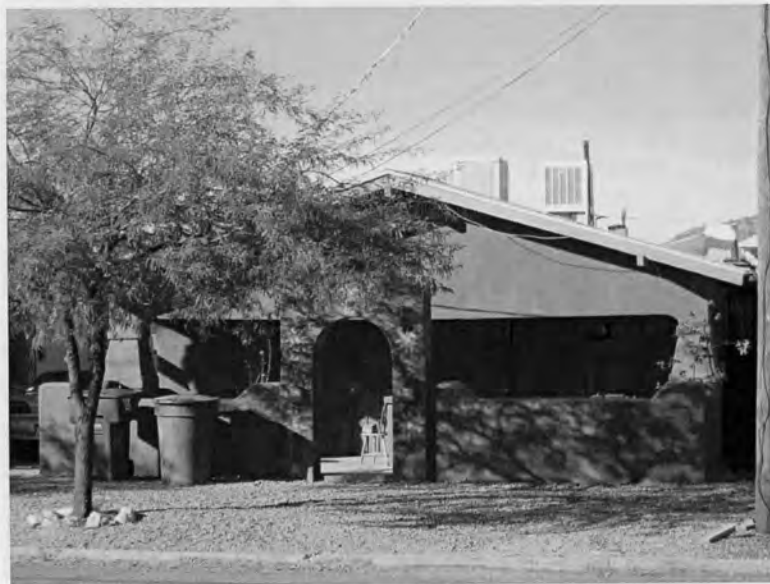
Photograph 6. 928 S. 8th Ave.; view west-southwest.

The other buildings constructed in the neighborhood during the period of significance represent contemporaneous Anglo-American styles. These dwellings are all one-story and relatively modest in size and scale. At the turn of the twentieth century, they were limited to the Queen Anne style, in a simplified version that has a hipped roof with a lower cross-gabled wing on one side and a front porch, as seen at 121 19th (Photograph 4). The Craftsman/Bungalow style appeared in the 1910s. The initial form of this style in the neighborhood is front-hipped with a centered gabled porch (Photograph 5, 125 19th). The later forms are front-gabled with a full-width integral porch (Photograph 6, 928 8th) and front-gabled with an

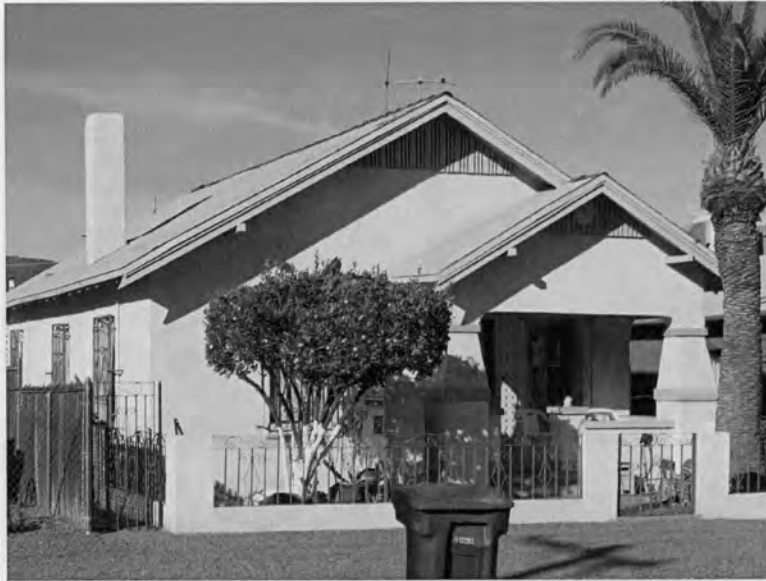
Photograph 7. 930 S. 8th Ave.; view west-northwest.

offset porch (Photograph 7, 930 8th). These Craftsman/Bungalow dwellings are identical to those constructed of brick in Tucson's Anglo-American neighborhoods except that here they were usually constructed of adobe. The same is true of Mission Revival, the other Anglo-American style that appears in the neighborhood. This is a very simplified form of Mission Revival, characterized by stepped parapets and the use of Mission or Spanish tile as accents. The style persisted in the barrios from the 1910s until World War II. A typical example is 126 Armijo (Photograph 8)

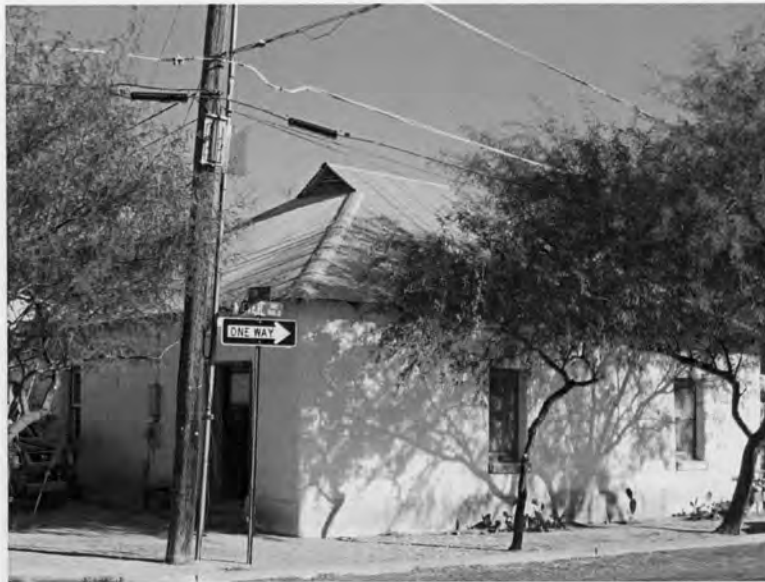
Photograph 11. 901 S. Meyer Ave.; view east-southeast.

Building placement on lots is variable. Many of the older dwellings are built flush to the front of the lot, in the traditional Hispanic urban tradition (Photograph 11, 901 Meyer). Most of the others have a minimal front setback, with a low fence or wall enclosing a small front yard (Photograph 12, 821 Rubio). This contrasts with the conventional Anglo-American suburban dwelling, where the setbacks are uniformly deeper and the front yard is an unfenced, largely symbolic lawn (or, today in Tucson, xeriscape). The neighborhood's trees are mostly local species such as mesquite, palo verde, and desert willow, with a few imports such as date palm, juniper, citrus, and ailanthus. Native cacti—particularly *nopal* (prickly pear)—are present in many yards. Besides single- and multiple-family dwellings, Barrio Santa Rosa had several stores; typically, these buildings housed both store and dwelling. The only remaining example of this building type in the neighborhood is at 863 9th; the store is currently vacant (Photograph 13).

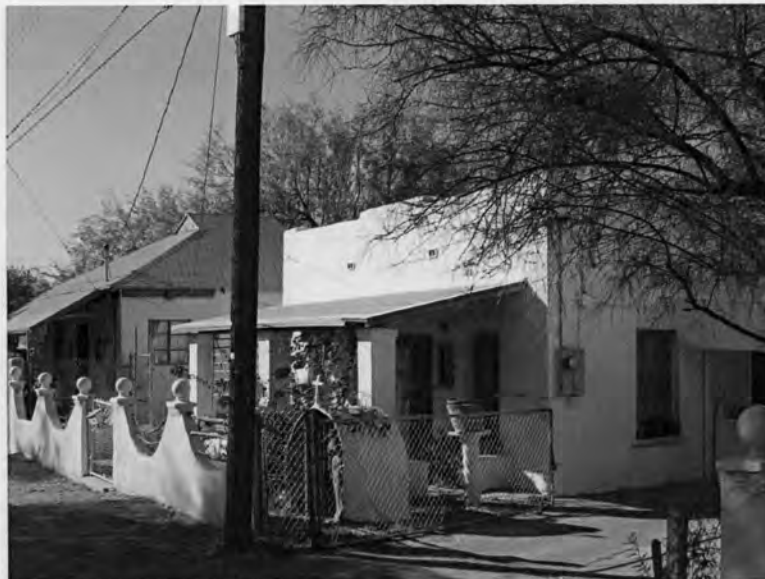
Photograph 12. 821 S. Rubio Ave.; view south-southwest.

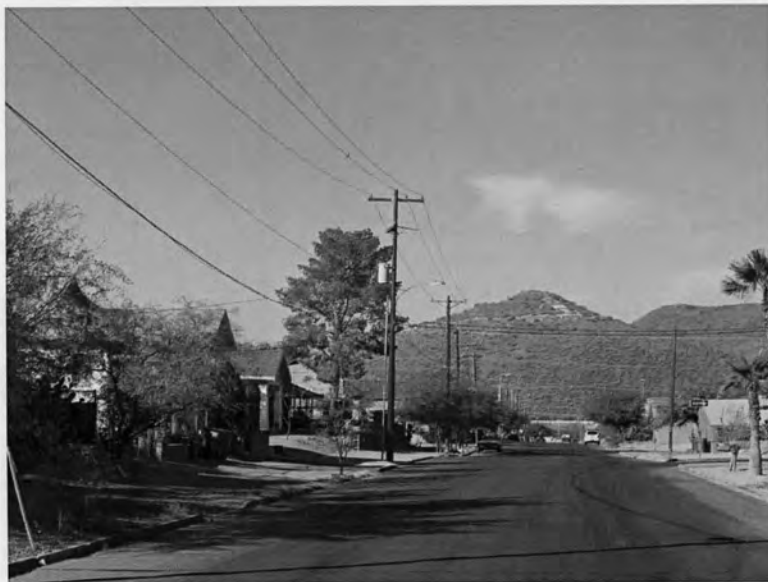
Photograph 14. W. 19th St. at S. 7th Ave.; view west.

The neighborhood's streetscapes are varied, ranging from the broad numbered east-west streets and north-south avenues (Photographs 14 and 15) to the narrow north-south alleys. Meyer was a major commercial thoroughfare in the old urban core. South of 18th it was platted as an alley in the townsite grid, but the portion between 19th and 20th still has an urban density (Photograph 16). Rubio and Russell were also platted as alleys and later were designated as avenues; they have their own small-scale character (Photographs 17 and 18), as does Armijo (Photograph 19). All of the streets are paved, but most do not have curbs or sidewalks. The street lights, which are mounted on utility poles, are minimal.

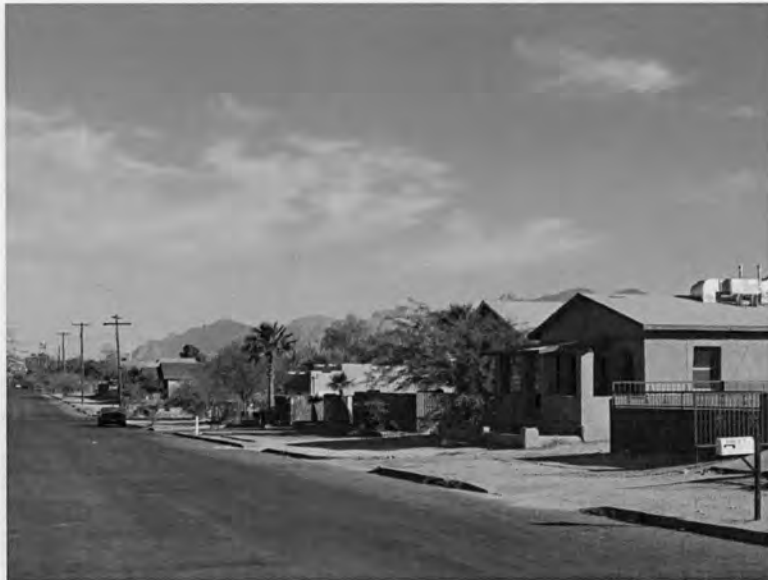
Photograph 15. S. 7th Ave. at W. 22nd St.; view north-northeast.

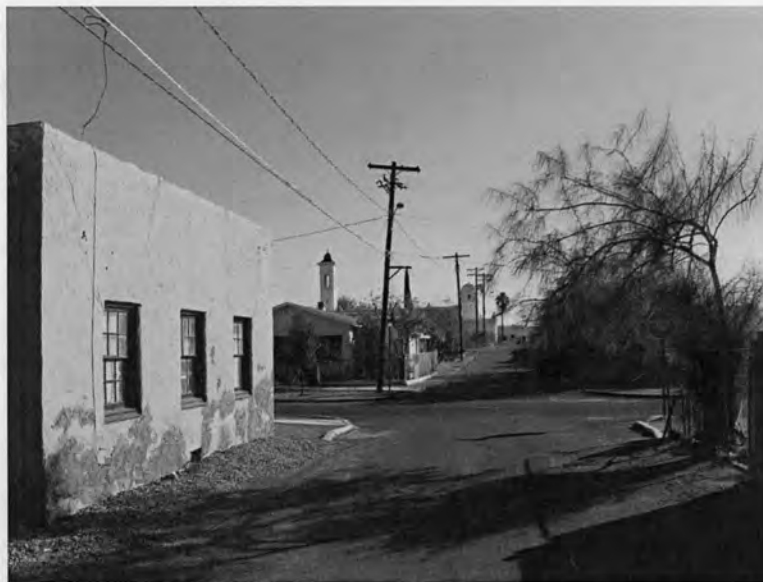
Photograph 20. S. Russell Ave. at W. 21st St.; view south-southeast.

"Neo-Traditional"; a characteristic example is 860 Meyer (Photograph 20). Barrio Santa Rosa thus retains considerable integrity of design.

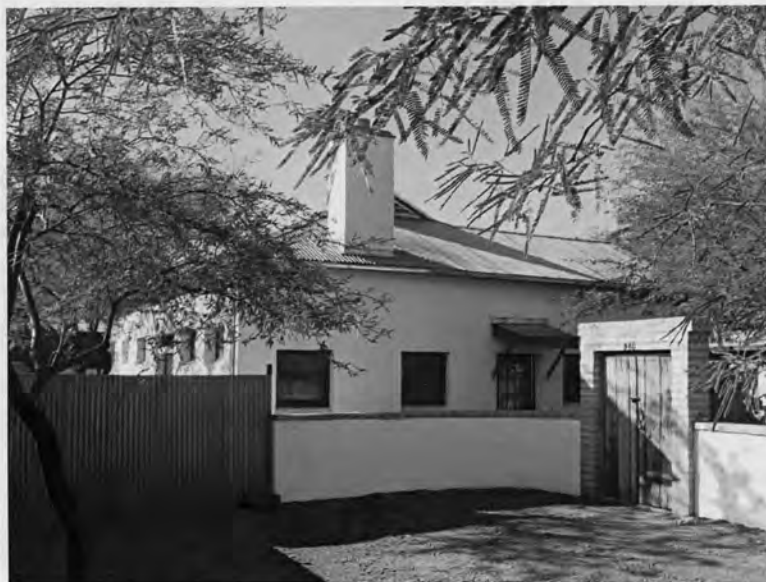
Photograph 22. 950 S. 8th Ave.; view west-northwest.

"the primary façade must have a majority (51 percent) of its features intact, and at least 75 percent of all exterior walls must be present." Four of the noncontributors are in this category; a typical example is 950 8th, where extensive additions have recently been made to the front of the dwelling (Photograph 22).

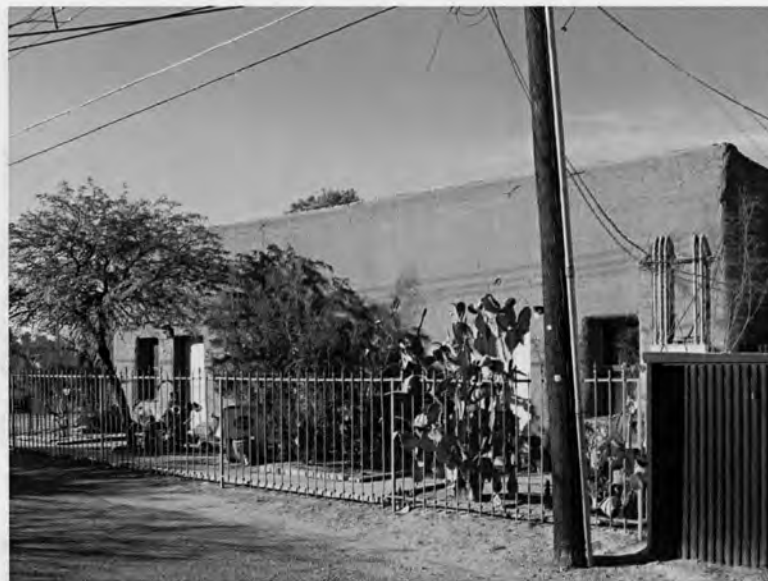
Photograph 24. 1010-1014 S. Rubio Ave.; view west-southwest.

This model has since become standard for explaining architectural developments in Tucson, and has been used in guidebooks for the general public, such as the *Tucson Preservation Primer* (Giebner 1981) and, most recently, *A Guide to Tucson Architecture* (Nequette and Jeffery 2002). Sobin's model does effectively describe the development of Tucson's Anglo-American architecture during the Territorial period, wherein cultural hybrids are simply a brief intermediate phase prior to the wholesale importation of late-nineteenth century architectural fashion from the Eastern U.S. But, as Husband (1988) points out in her study of Tucson's suburban row houses (i.e., row houses in barrios outside the old Hispanic urban core), this mid- to late-nineteenth-century sequence is inadequate for describing the early twentieth-century architecture of these barrios. To document the survival of the Sonoran Tradition into this period, cultural geographer Eliza Husband (1988:17-30) uses a simplified typology of the basic forms: parapeted Sonoran and pitched-roof (hipped or gabled) Sonoran. Typical examples are 1010-1014 Rubio (Photograph 24), 904 8th (Photograph 25), and 821-823 8th (Photograph 26)

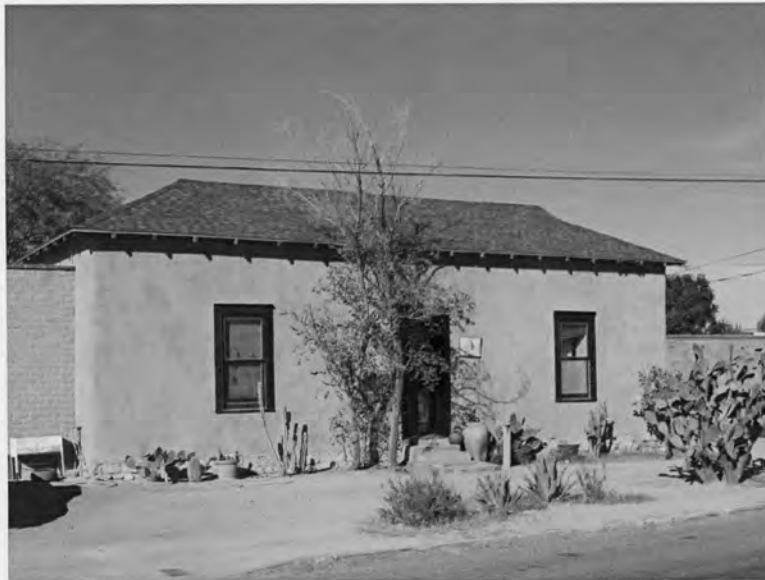
Photograph 25. 904 S. 8th Ave.; view west-northwest.

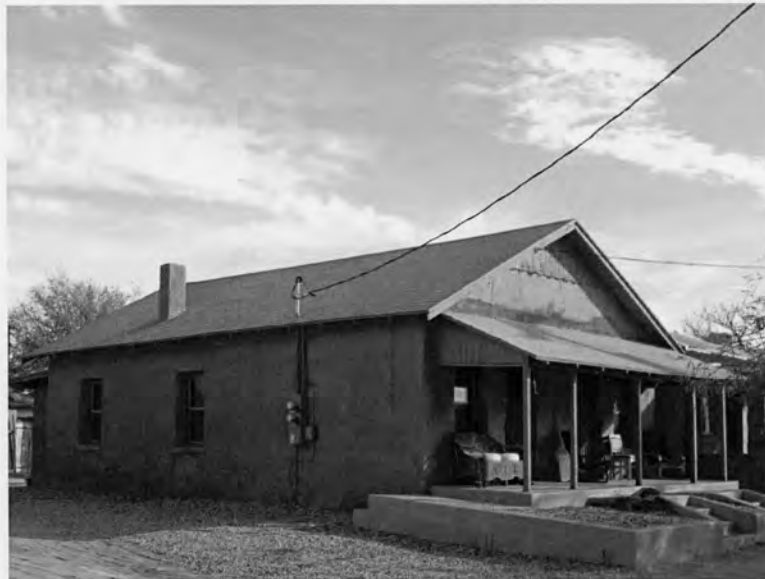
Photograph 26. 821-823 S. 8th Ave.; view southeast.

time (Photograph 11). From the late 1910s, gabled roofs became more common, with a lower pitch and slatted gable vents showing influence of Craftsman/Bungalow models (Husband 1988) (Photograph 26).
