National Register of Historic Places Registration Form

historic name Santiam Pass Ski Lodge
other names/site number Santiam Organization Building, Santiam Lodge
Name of Multiple Property Listing N/A
(Enter "N/A" if property is not part of a multiple property listing)

street & number 64405 Highway 20, Willamette National Forest not for publication
city or town Sisters vicinity
state Oregon code OR county Linn code 043 zip code 97759

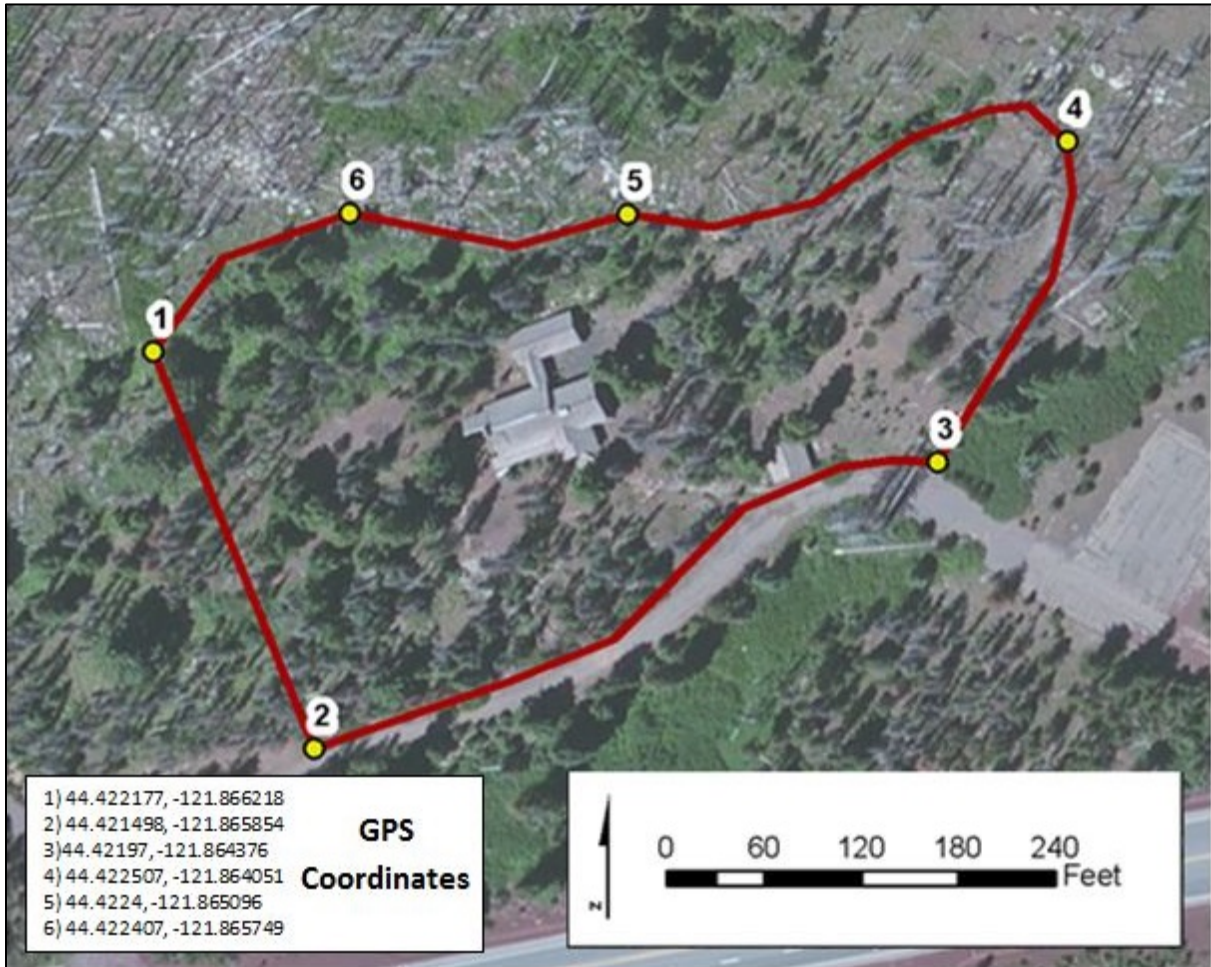
Figure 3: Boundary with GPS points (1–6) labeled at corners

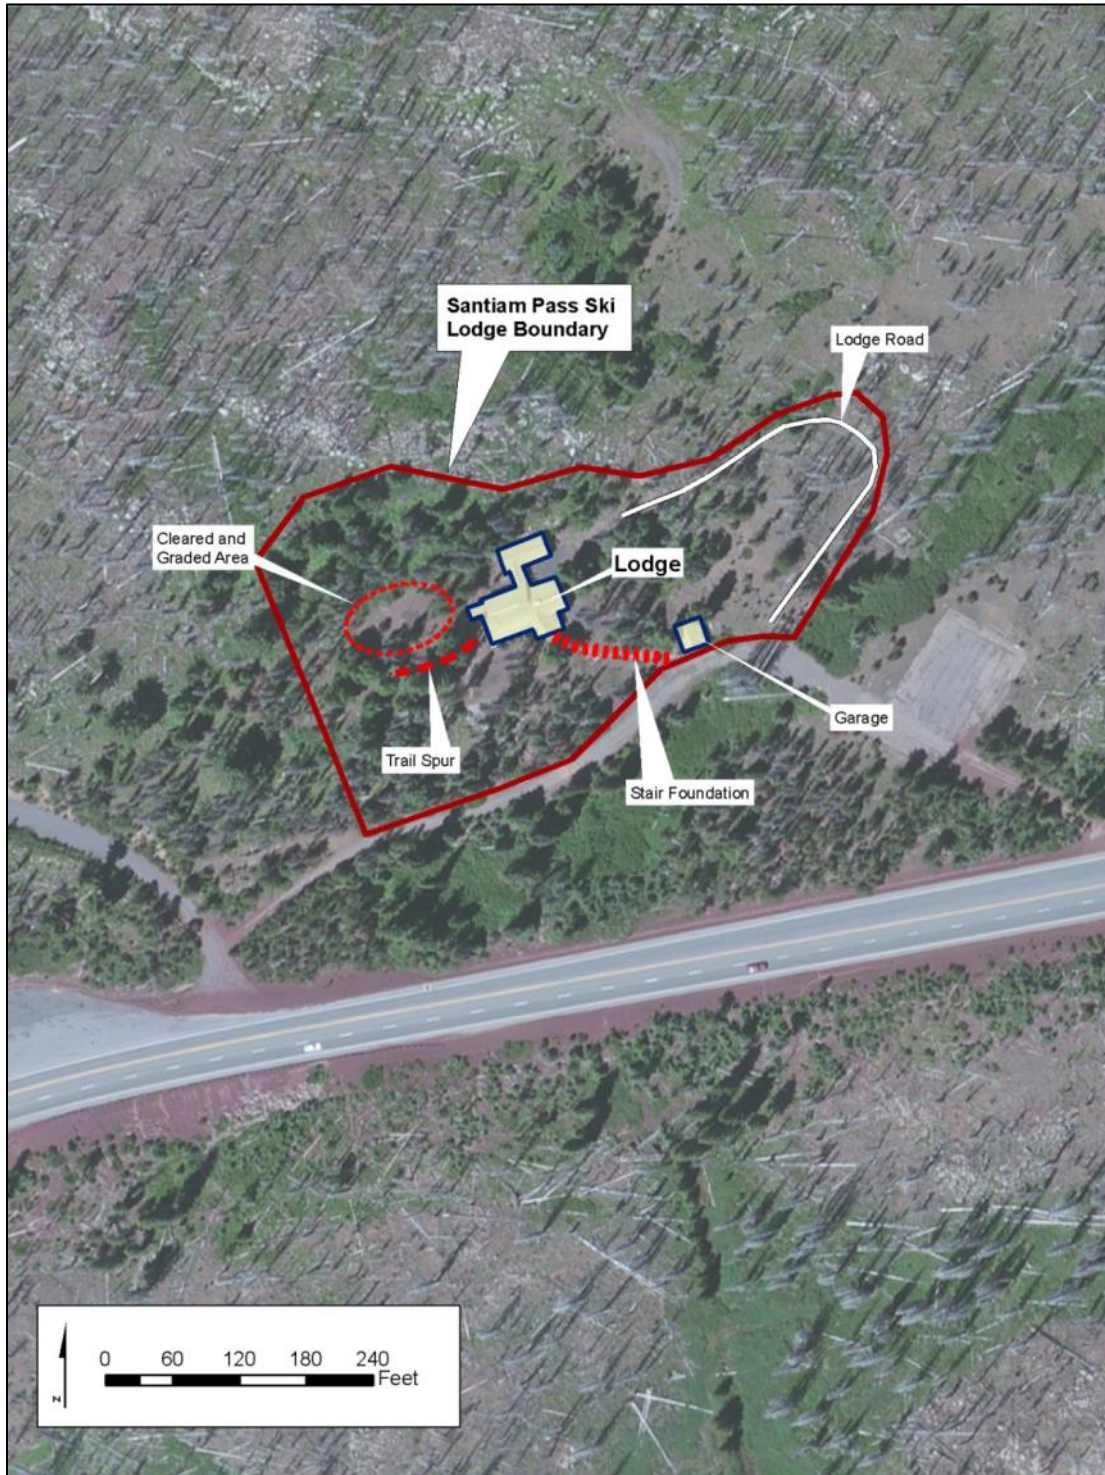
Figure 4: Santiam Pass Ski Lodge Boundary and Site Plan

The boundary includes the resources historically associated with the property, the lodge, garage and adjacent parking area, stair foundation, trail spur, cleared and graded area and the original lodge road and the surrounding trees to communicate the forested character that is cohesive with the rustic style design of incorporating the natural landscape. Because the setting is integral to the integrity of the property, the pedestrian approach to the lodge (although currently in a ruinous state), immediate landscape, and the open slope upon which it sits are included in the boundary.

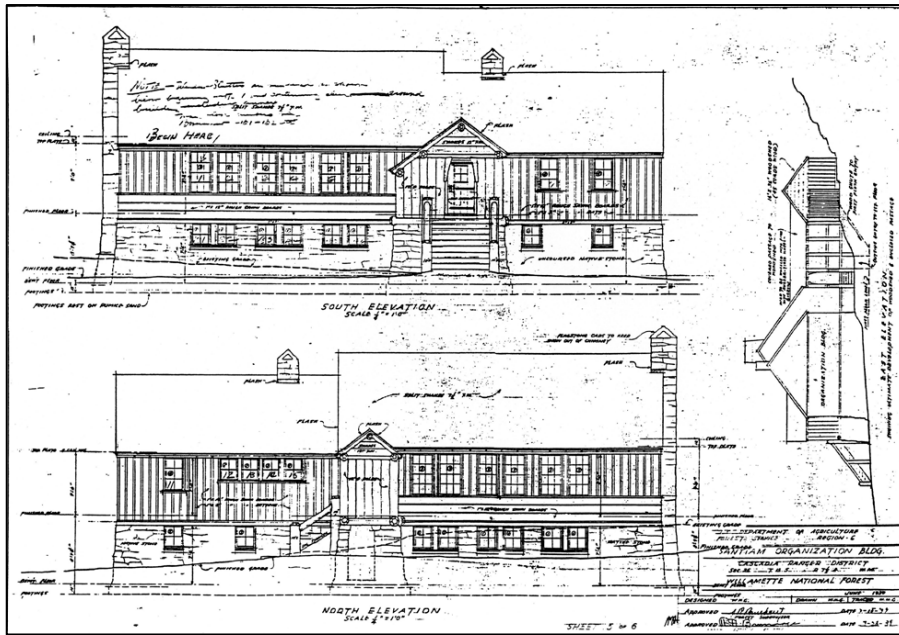
Figure 5: Santiam Organization Building: North and South Elevations and Proposed Wood Shed (1939). From Catherine Lindberg-Muir, "Santiam Pass Ski Lodge: An Evaluation of Historic Significance," (Eugene, Oregon: USDA, Willamette National Forest, July 1989), Figure B-5.

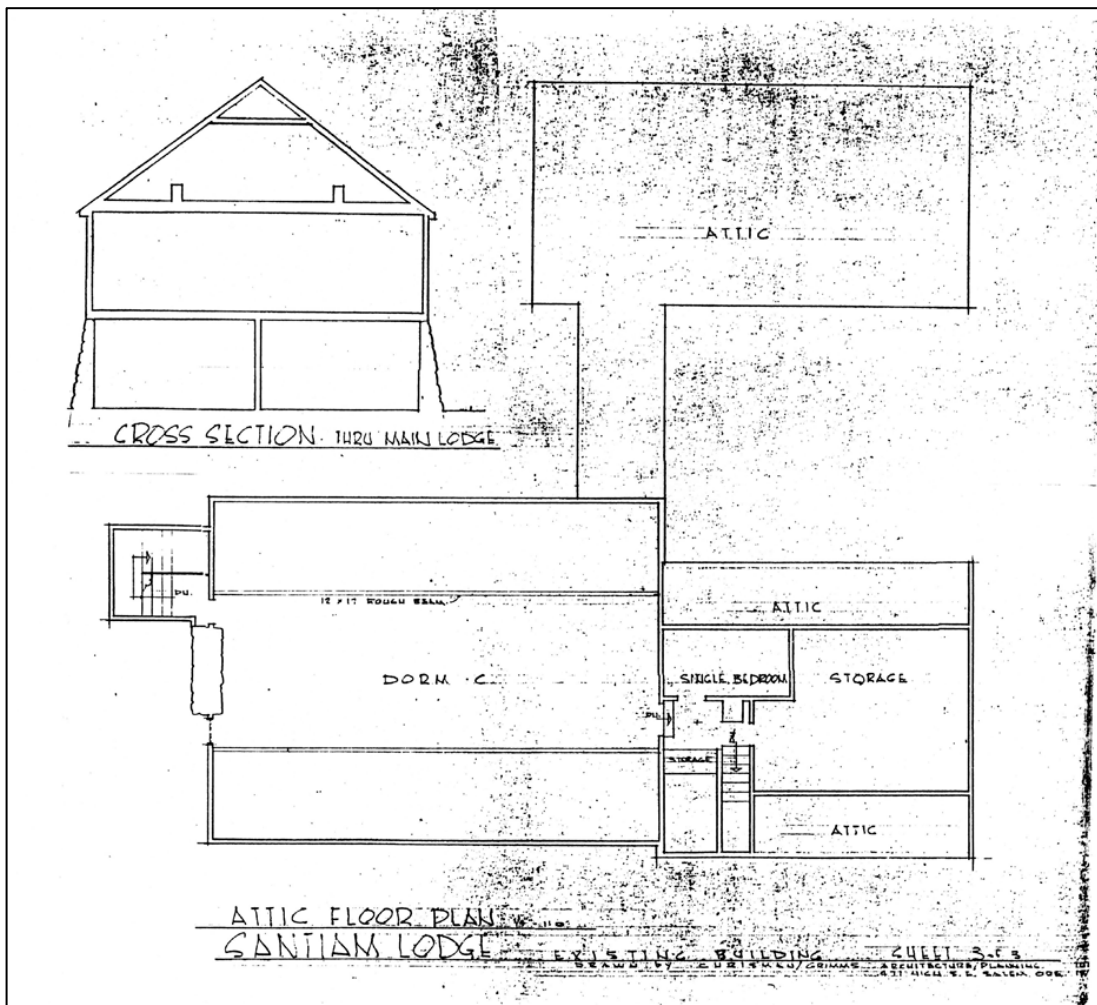
Figure 9: Santiam Lodge: Attic Floor Plan of existing building in 1974. From Catherine Lindberg-Muir, "Santiam Pass Ski Lodge: An Evaluation of Historic Significance," (Eugene, Oregon: USDA, Willamette National Forest, July 1989), Figure B-9.

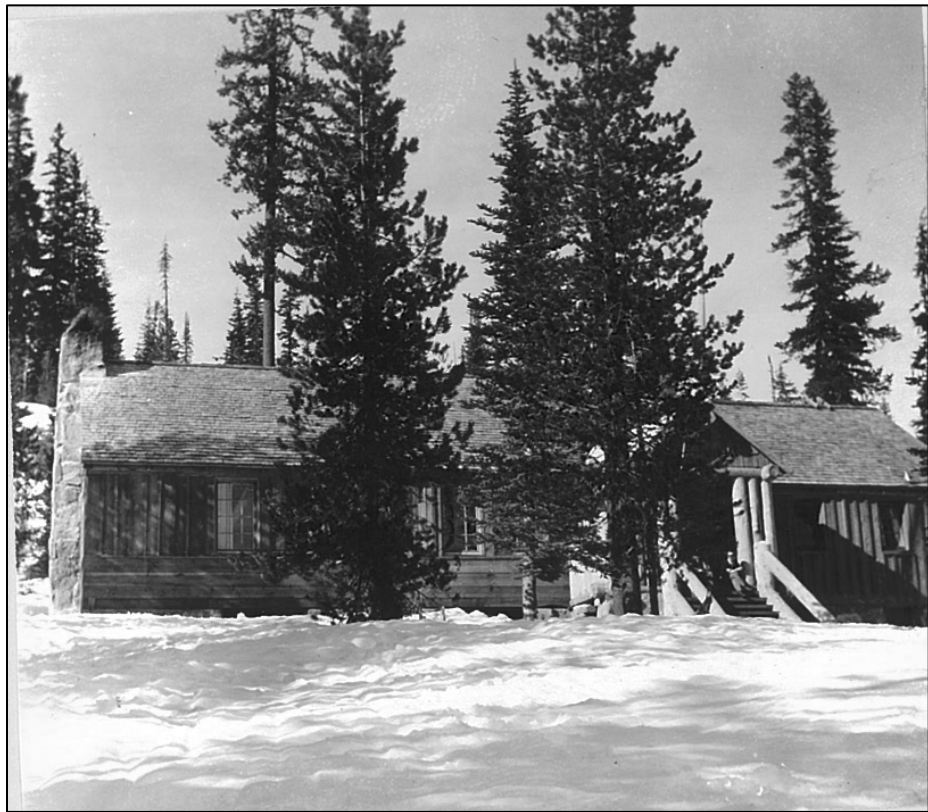
Figure 11: Santiam Ski Lodge 1940. South Elevation

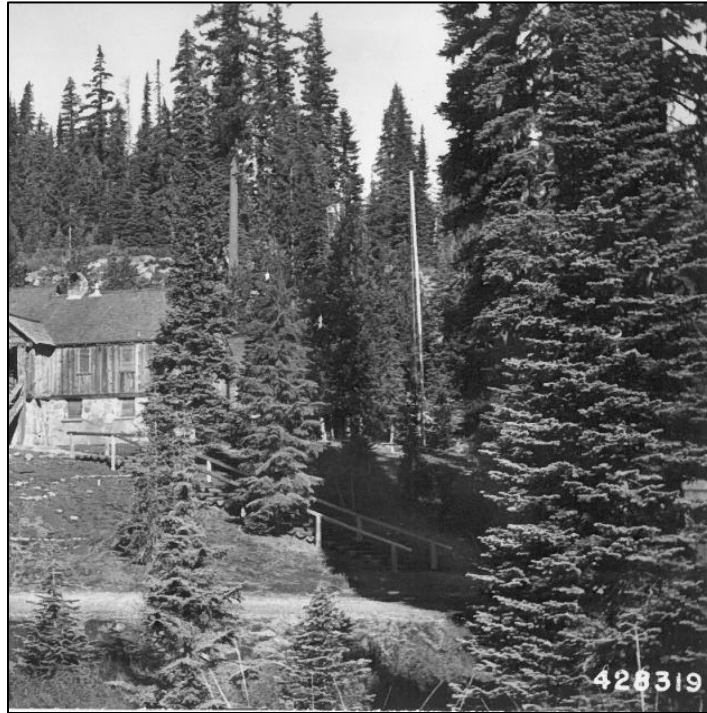
Figure 12: View North with access road in foreground, half round log stairs and east side of front elevation.

Another prominent feature associated with the lodge, but no longer extant, was a wide staircase leading from the garage to the main entrance of the lodge. This staircase was originally constructed of large, half-logs approximately six feet in length for the steps, with smaller timber poles for railings (Figure 11).³⁰ Later, the half round logs were replaced with wooden planks³¹. The footings for the stairs remain in a

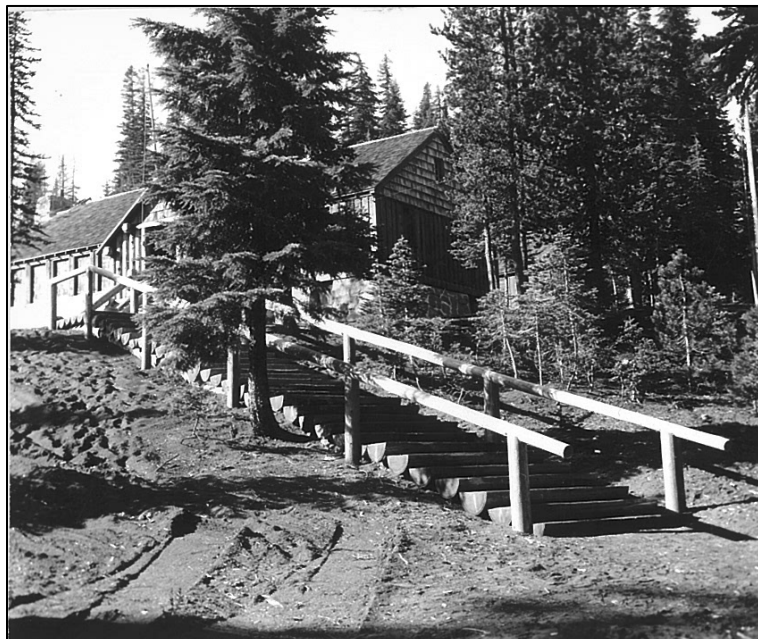
Figure 13: Santiam Ski Lodge 1941. Of half round log stairs. Southeast facing aspect of the lodge in the background.

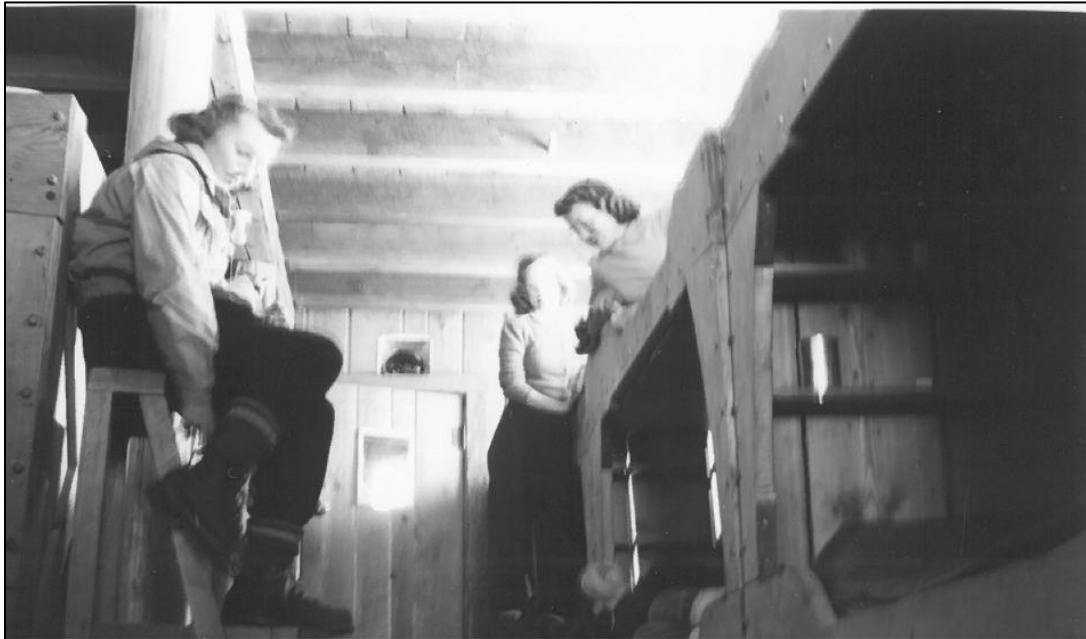
Figure 14: Women's dormitory with CCC-crafted bunks 1940

Dormitories: The dormitories (A and B) are adjacent and parallel to each other on the west side of the basement level. They are communal rooms as the name would suggest and were occupied according to gender divisions during the period of significance.¹⁸ Both rooms have permanent bunk beds lining the walls as well as rows of bunks projecting from the wall. Also present in these rooms are dismantled bunk beds that were removed from the Attic Dormitory when the attic stabilization effort occurred in 2002. The permanent bunk beds are built in an unmistakable spare, but finely-crafted, Rustic style. Each set of bunks is a stack of two. The top bunk is open but the bottom bunk has a crafted curved enclosure that has ornament of construction elements that include: wooden pins, hammered iron brackets, narrow interior shelves, and two sliding drawers in the base of the bed. Although some of the drawers have replacement handles, most have original hammered iron handles. Although historic documentation on the construction of the interior furniture has not surfaced in archival searches, these rows of comfortable bunks, situated in the communal spaces of gendered sleeping quarters are cohesive with the overarching objective to facilitate public access to outdoor recreation activities.^{19,20} Emergency exits in the dormitories were added post construction replacing original windows on the west side.

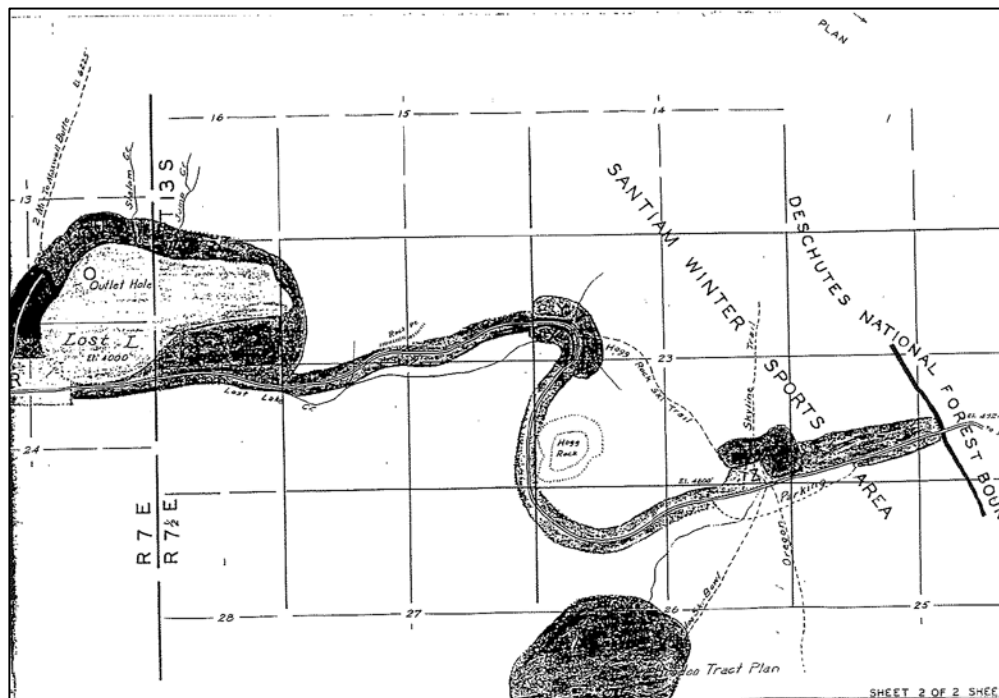
Figure 15: Blueprint of Santiam (Three Fingered Jack) Winter Sports Area adapted from Parke 1938. As shown in Lindberg-Muir 1989 Page 24.

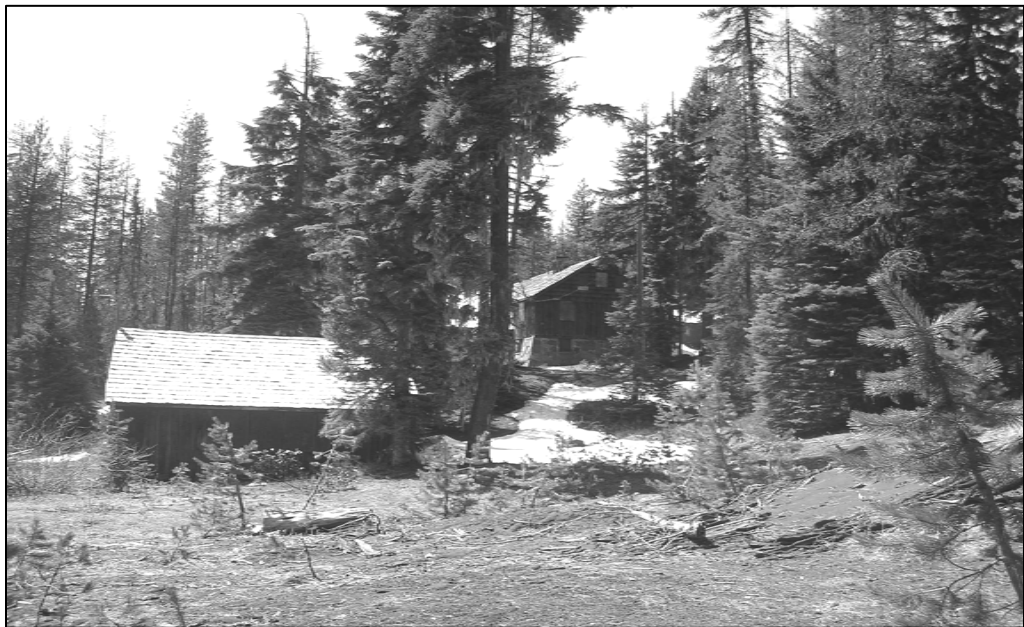
Figure 17: Overview of Santiam Lodge and garage, looking west from near the pump house remains. Facing west.

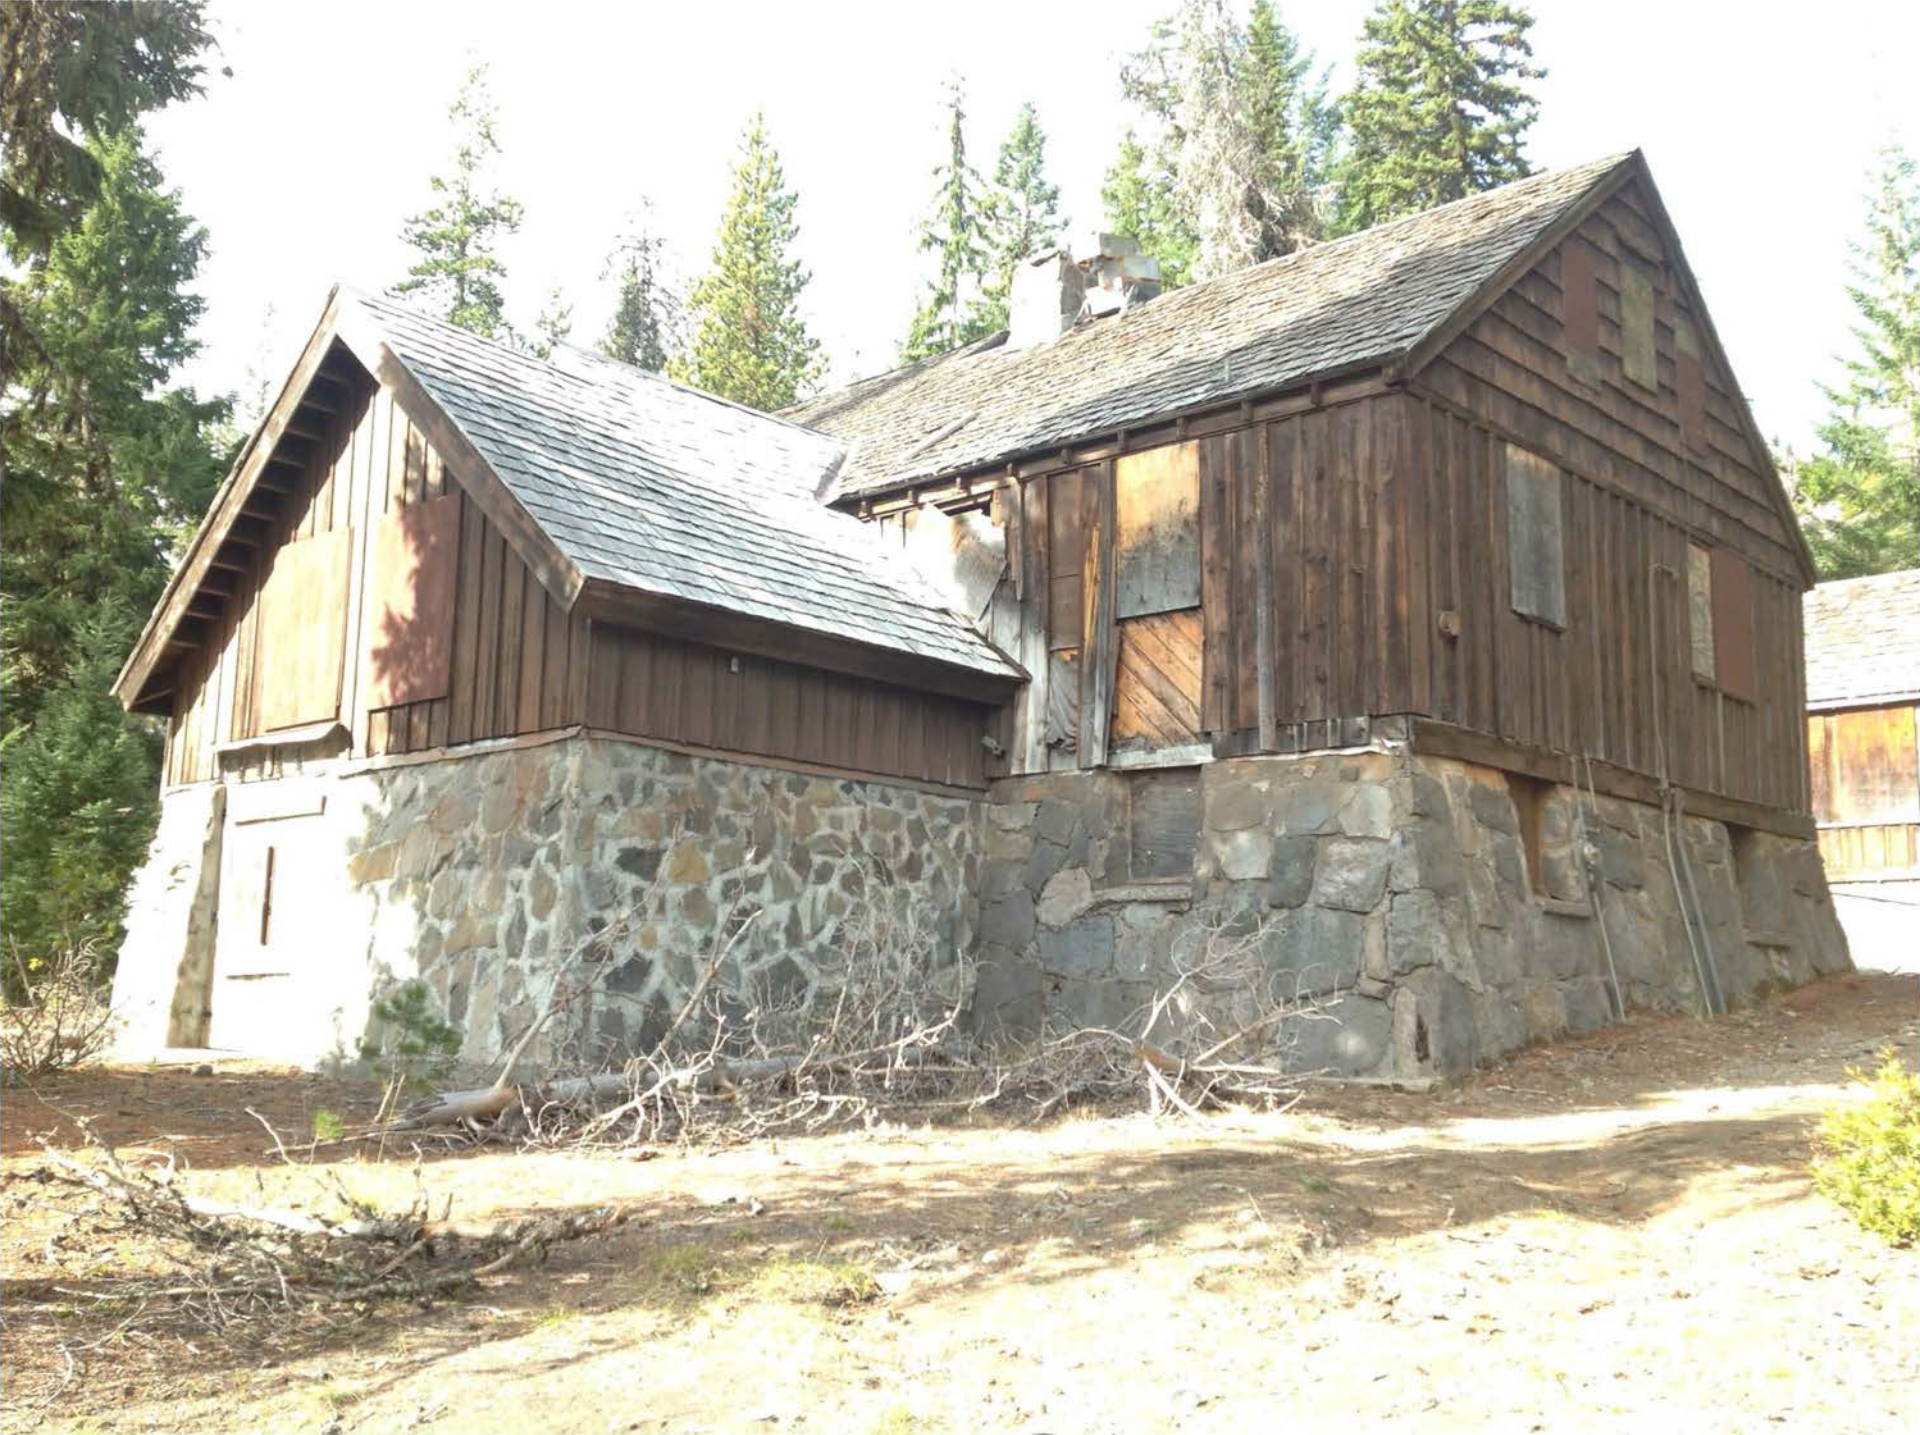
A photograph of a weathered wooden building with a shingled roof. The building has a mix of dark brown wood siding and stone masonry at the base. A sign is posted on a door that is partially obscured by a wooden plank. The sign reads: "NO ENTRY - BUILDING CLOSED - TRESPASS - CITED UNDER - CFR 2619E". The building is surrounded by a gravel area and some small evergreen trees. In the background, there are tall pine trees under a clear sky.
