Property Name: Glasco Downtown Historic District

# National Register of Historic Places Registration Form

Historic name: Glasco Downtown Historic District

Glasco Downtown Historic District  
Cloud County, Kansas

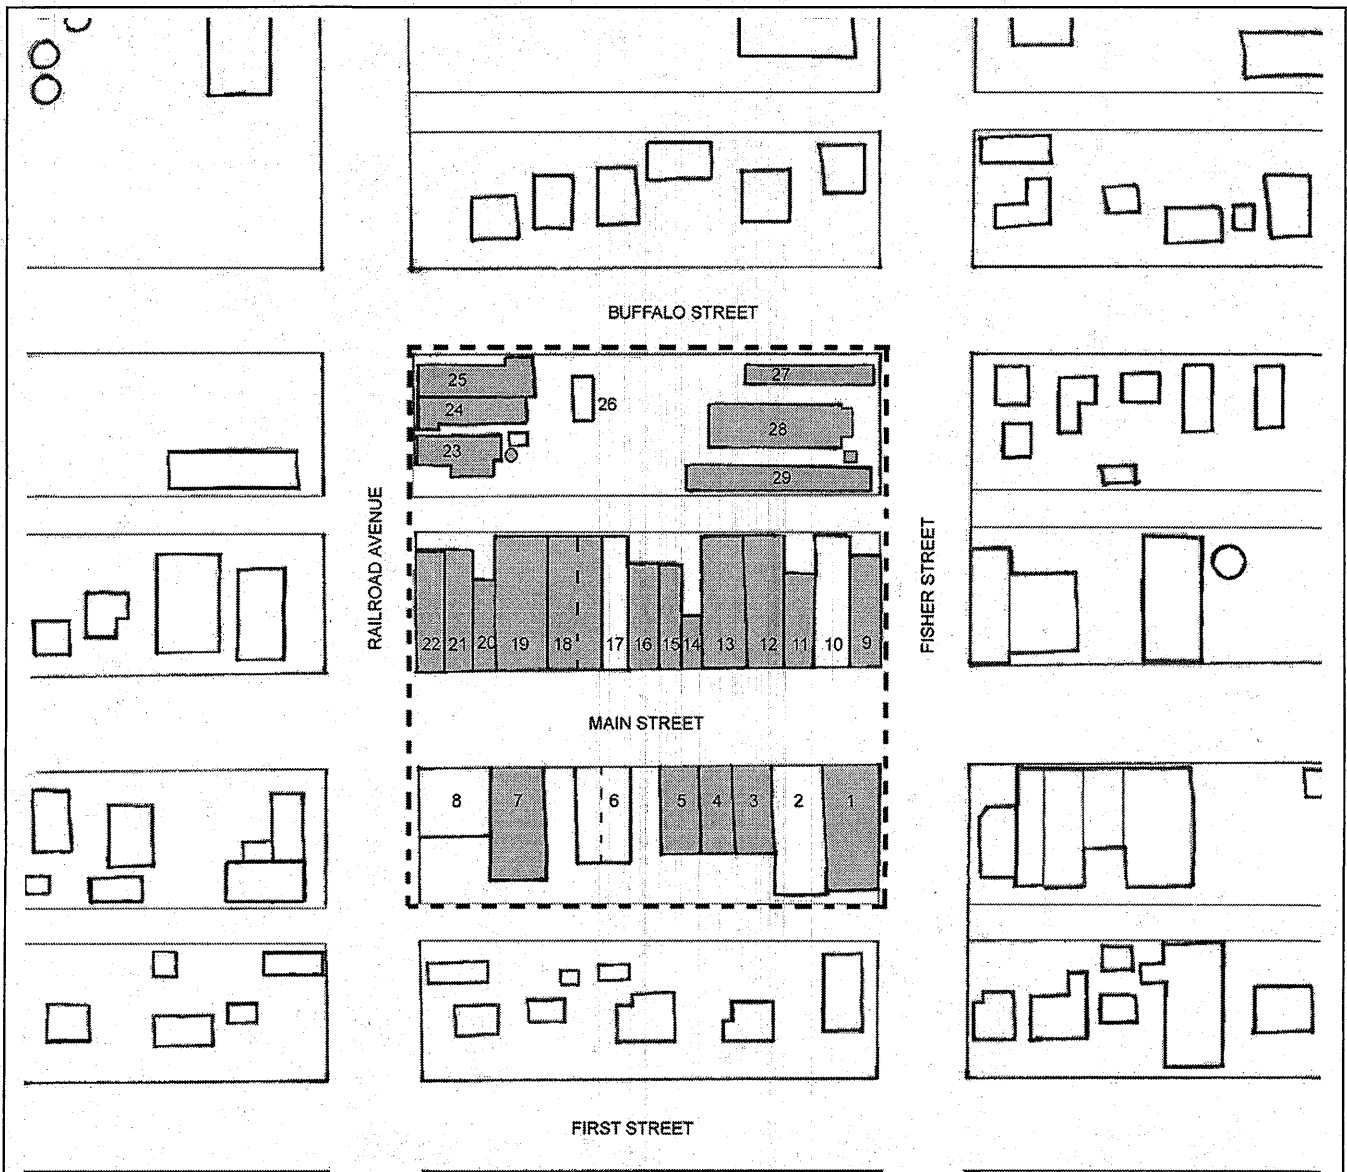
**GLASCO DOWNTOWN HISTORIC DISTRICT BOUNDARY MAP**

The 3.87-acre District is a rectangular area generally bounded by Buffalo Street on the north, Fisher Street on the east, Railroad Avenue on the west, and the alley directly south of Main Street on the south. The District includes 22 contributing buildings, one contributing structure, and six non-contributing buildings. With only two vacant lots, one of which has been vacant since at least 1917, the District retains its historic density. The other lot was converted to a "pocket" park in the early 1970s (Photograph #4, 6).<sup>1</sup>

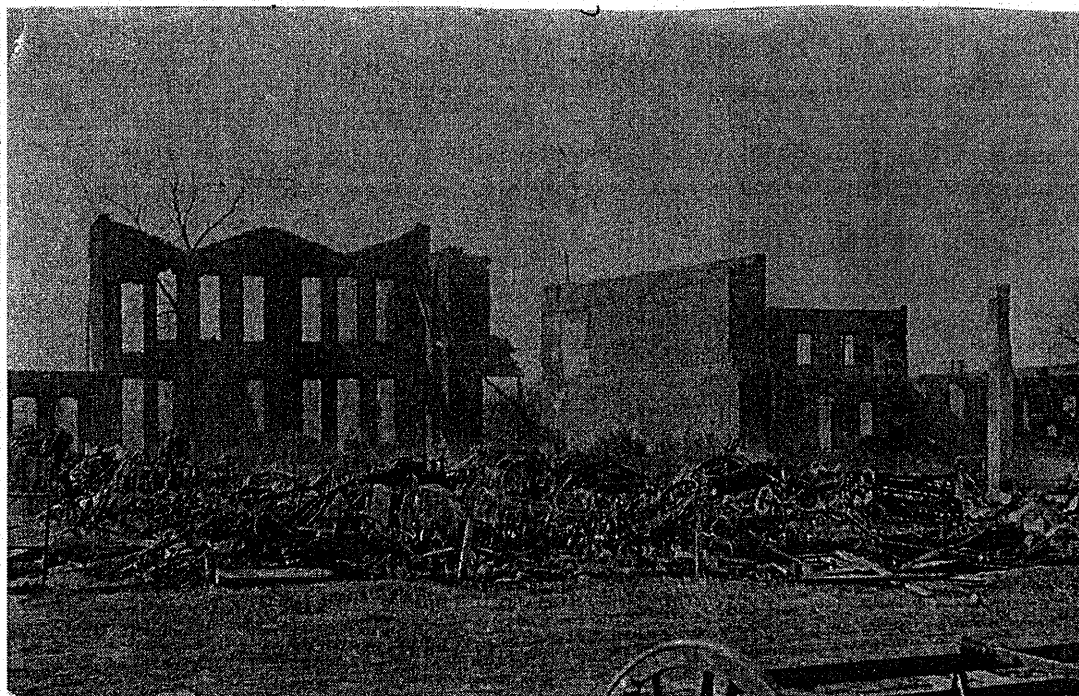
**B: Main Street, 1911 fire ruins, looking south from Buffalo Street**

Although the size of downtown Glasco remained about the same, its appearance changed drastically during the second decade of the twentieth century. The reason was a devastating fire along Main Street in 1911, which destroyed more than half of both the north and south sides of the block between Railroad Avenue and Fisher Street, including the opera house and the impressive Davidson Block (Historic Photo Documentation, p.37). Although a fire company existed, it was "no more than a bucket brigade," and with no city water system, the nighttime fire burned almost out of control.<sup>26</sup> The estimated damages were approximately \$225,000, with only \$40,000 of insurance coverage.<sup>27</sup> While the loss of so many buildings at the heart of a lesser town could have proven devastating, Glasco's transportation resources and economic stability facilitated a rapid rebuilding campaign. Nine new one-story limestone commercial buildings with visually cohesive brick facades quickly replaced the ruins on the north side of Main Street (Buildings #14-22, Photograph #1, 10-12). They included a new theater (Building #21), an auto service garage (Building #19), and several new retail businesses.

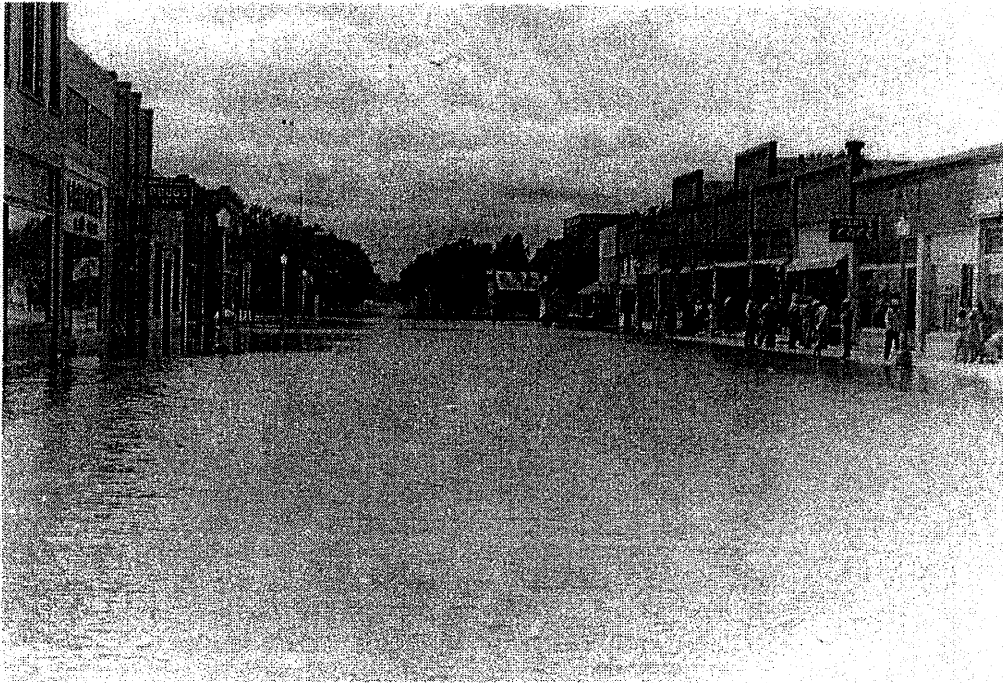
**E: Main Street, 1951 flood, looking west**

During the second half of the twentieth century, several insubstantial changes occurred in the District. In 1951, the Solomon River swelled over its banks and brought about 18" of water to Main Street, resulting in superficial damage to storefronts and minor, mostly interior, alterations. However, the flood did destroy the 1899 bridge southeast of town and by 1953, it was replaced. Around 1953, cobra-head street lights replaced the c.1920 street lamp posts. In 1956, US 24, was realigned on the north edge of town, effectively diverting through traffic from Main Street. By 1961, the existing post office (Building #8, Photograph #6) was constructed and the one-story building that stood directly east of Building #6 was demolished shortly thereafter. The resulting vacant lot was converted to a park by the Venus Study Club in the early 1970s.
