Swett Ranch

Daggett county

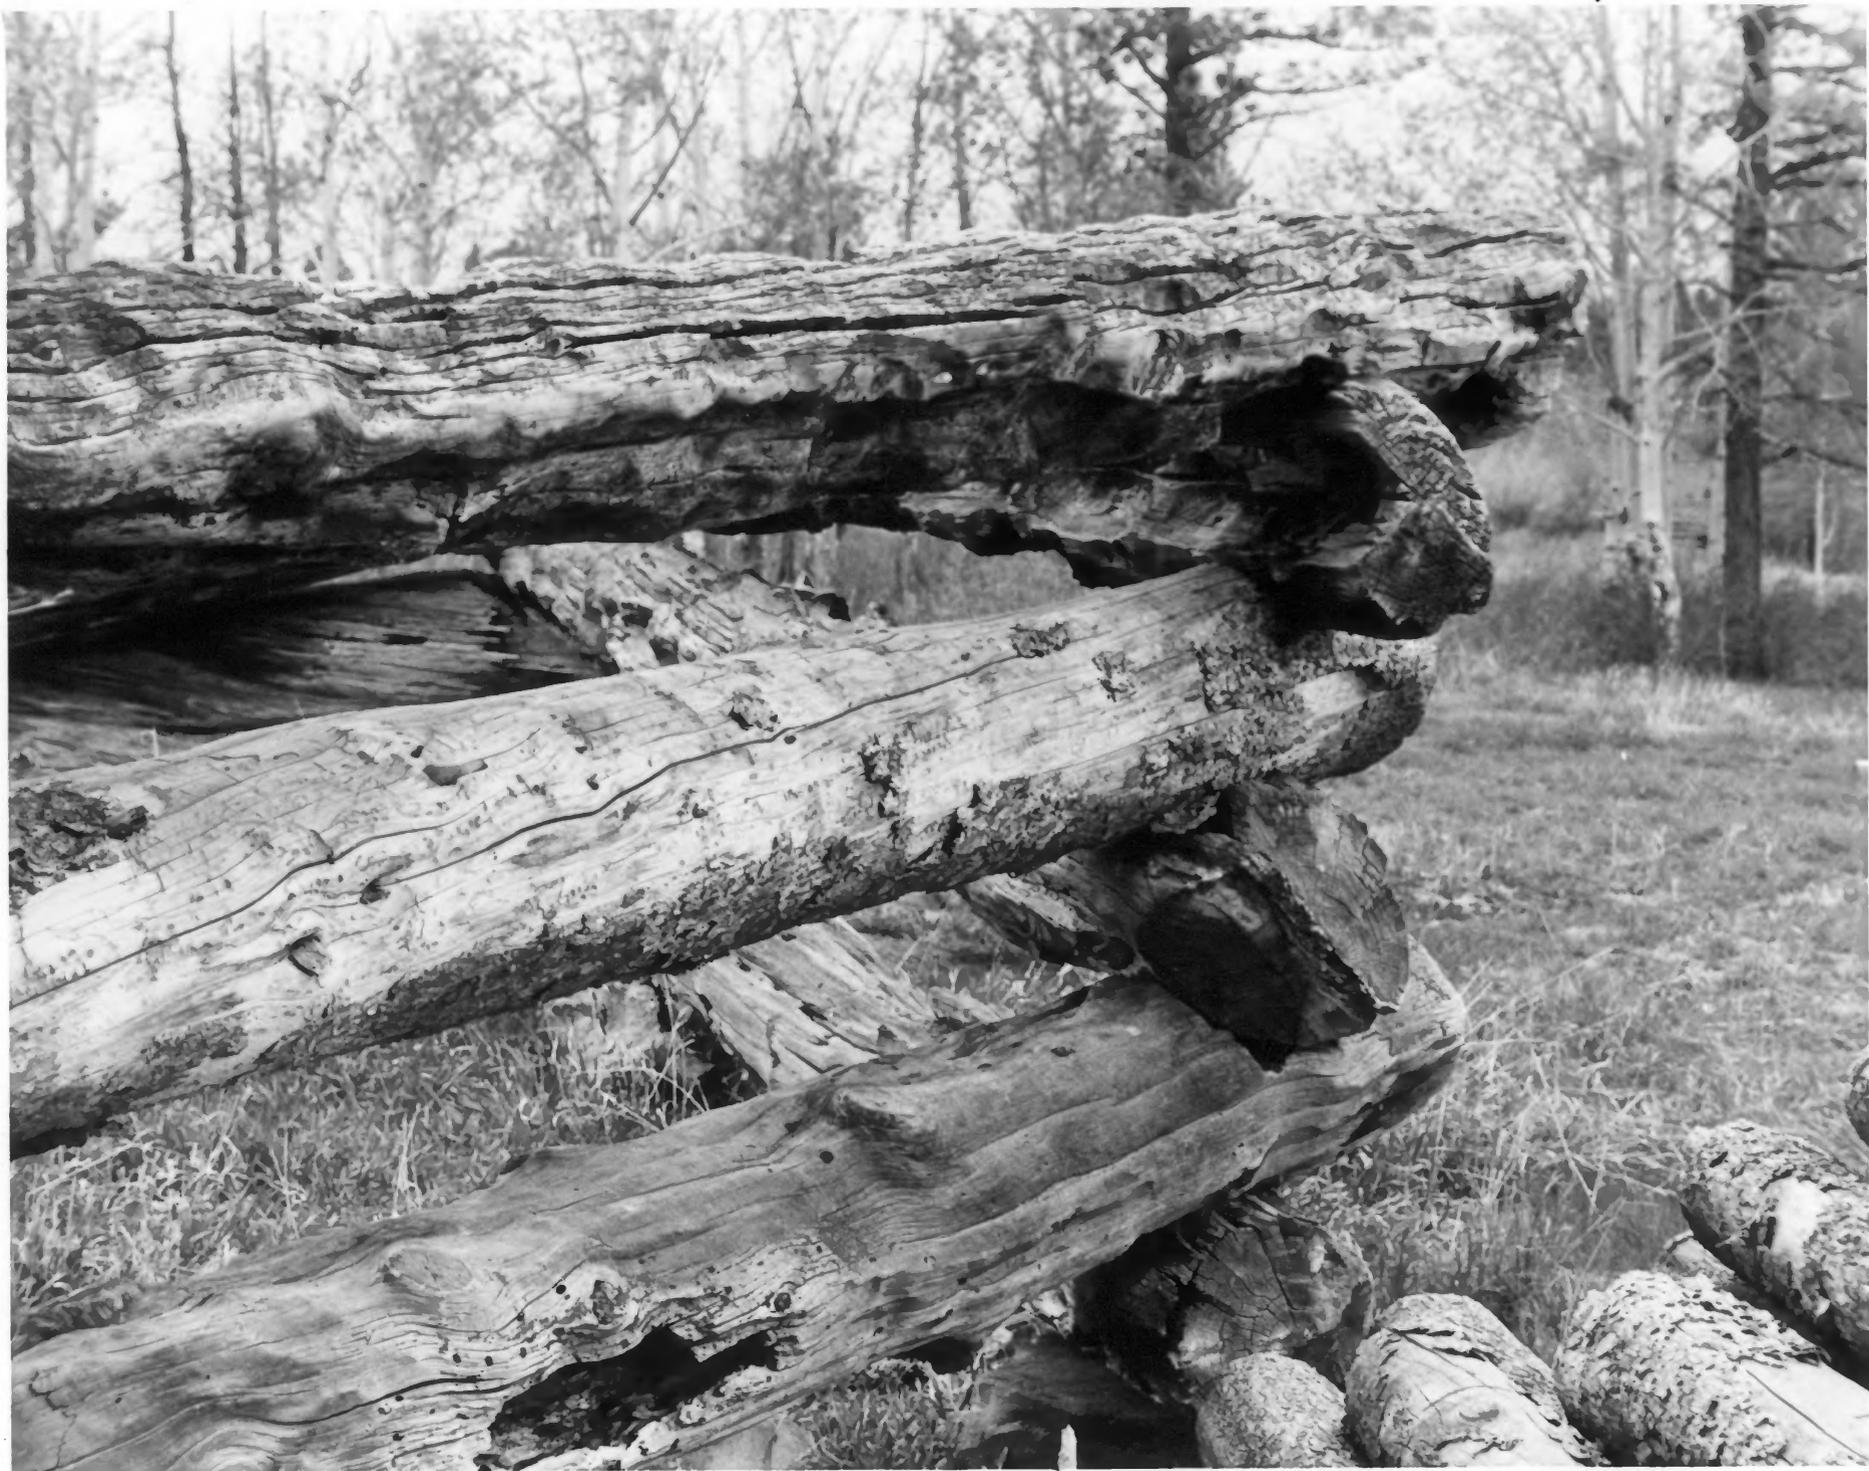
SUBJECT: Section of corral.

VIEW DESCRIPTION: This is a section of the collection corral built in 1905 for Oscar Swett's cattle (before he homesteaded there). It has been repaired over the years, but many of the original logs remain.

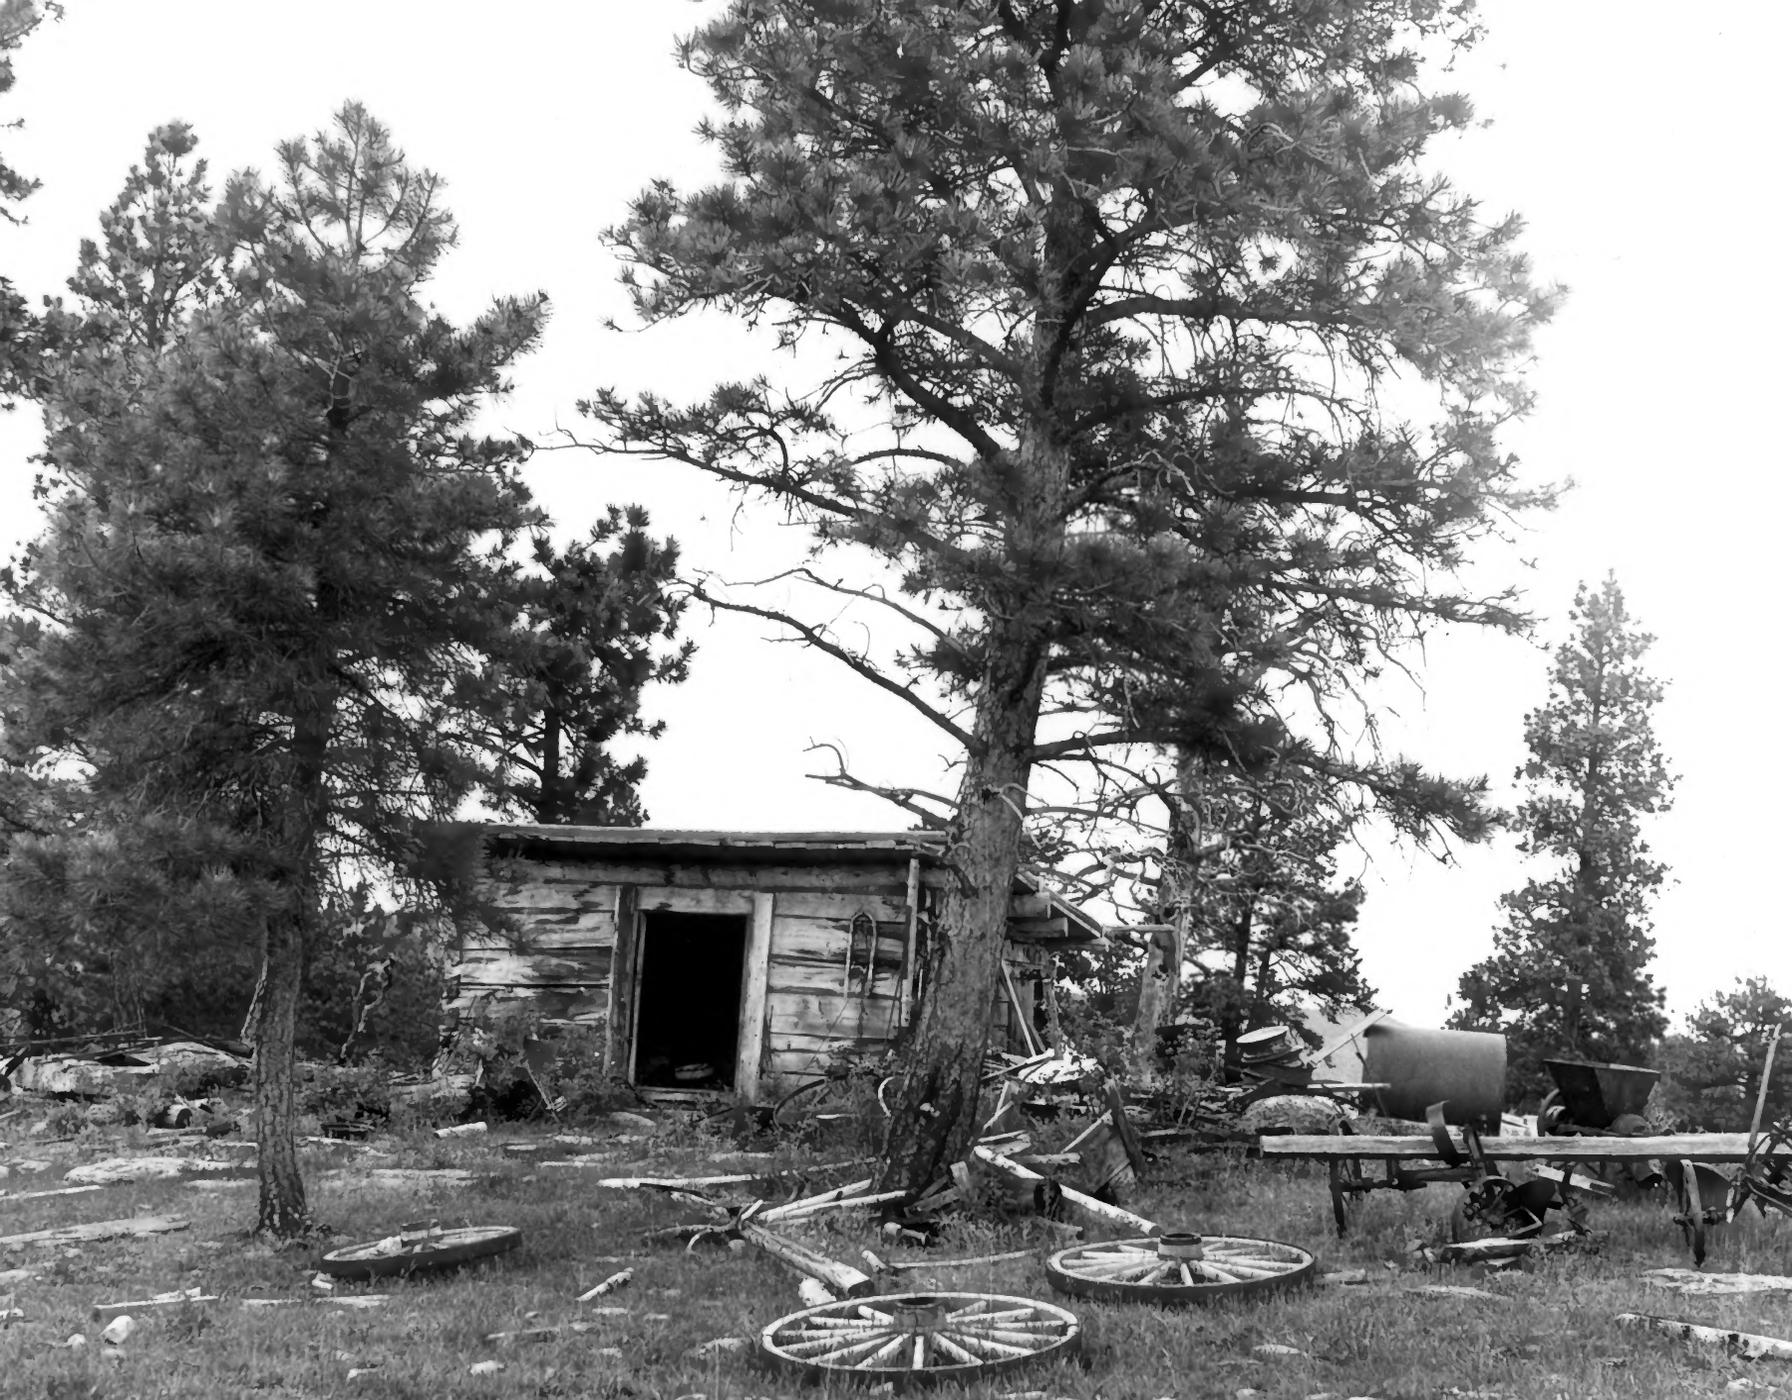
SUBJECT: New blacksmith shop.

VIEW DESCRIPTION: This shop was built to replace the old one in the early 1940's. Oscar Swett did his own blacksmithing.

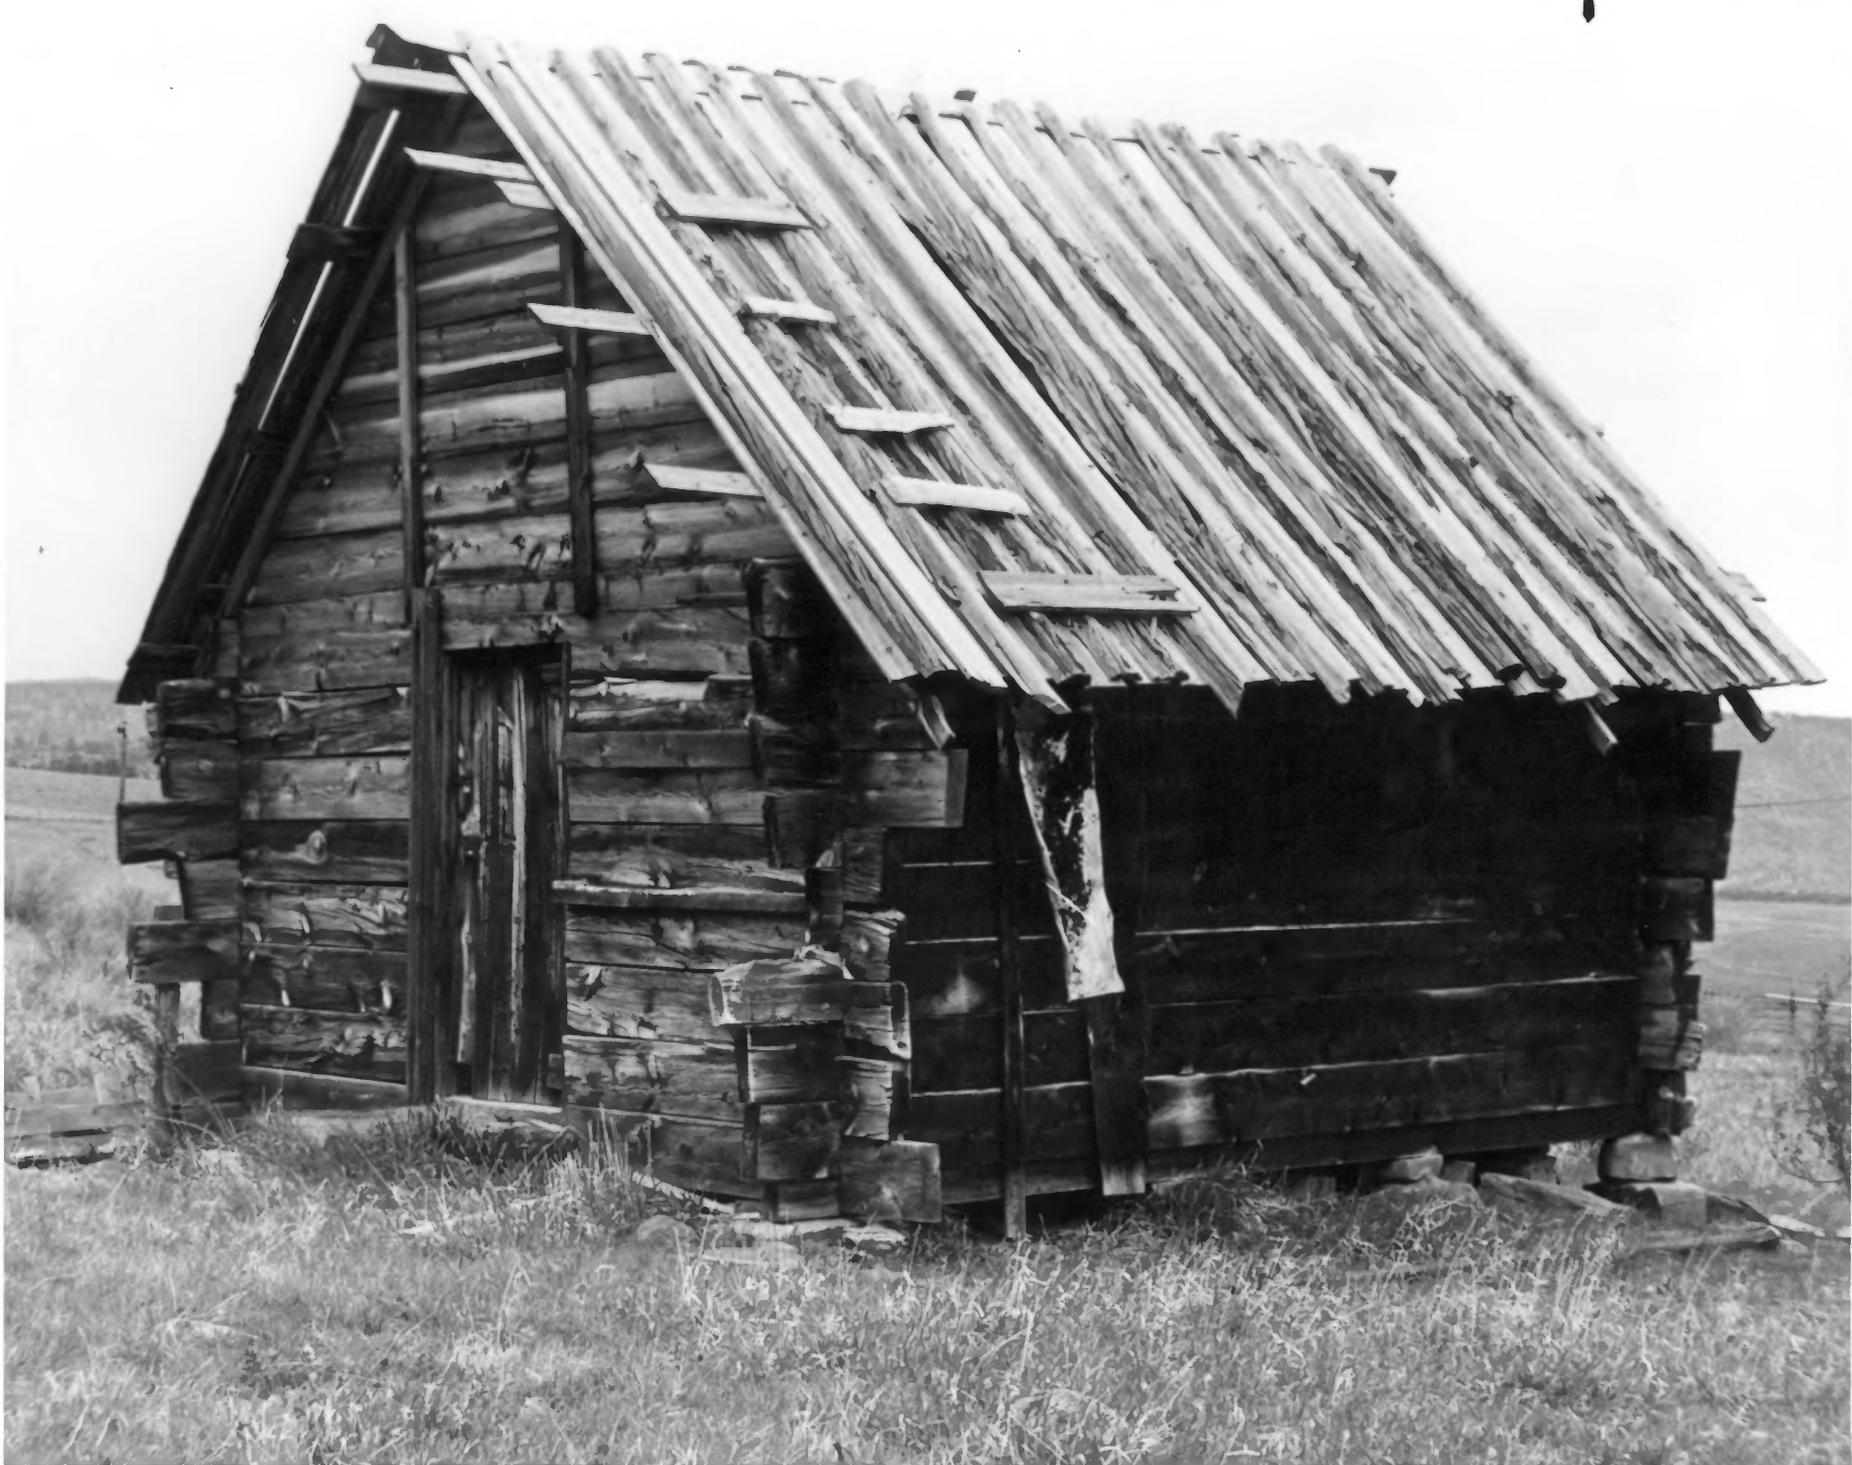
SUBJECT: Granary-tack room.

VIEW DESCRIPTION: It was built in 1935 and has a cut out square in the door for a cat to enter (for rodent control).

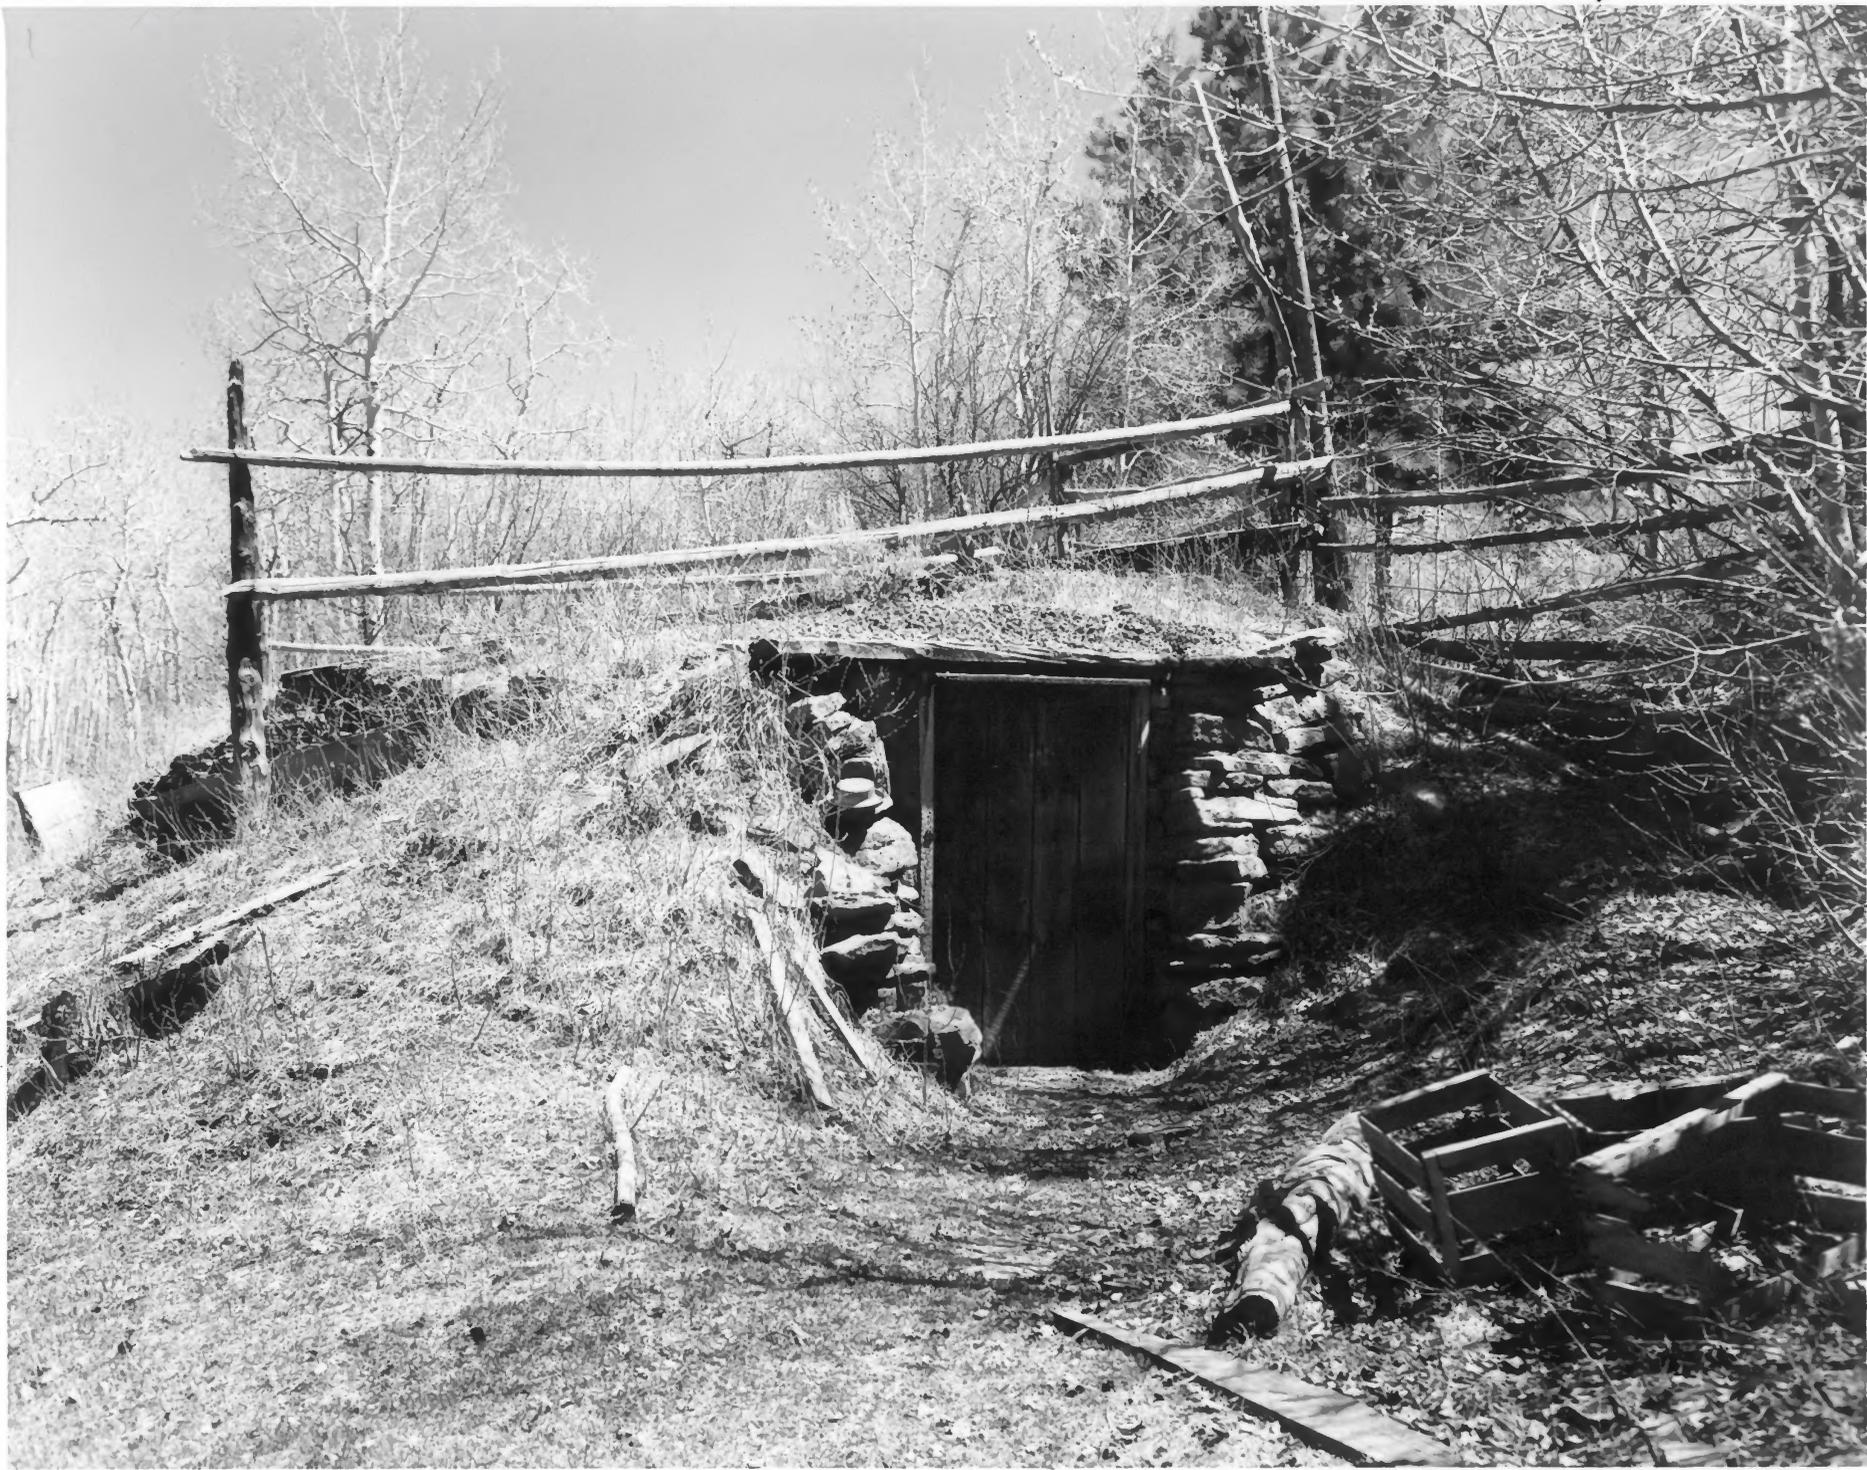
SUBJECT: Root cellar.

VIEW DESCRIPTION: The cellar is located just west of the two room house. It was built in 1935 and used to store potatoes and canned goods.

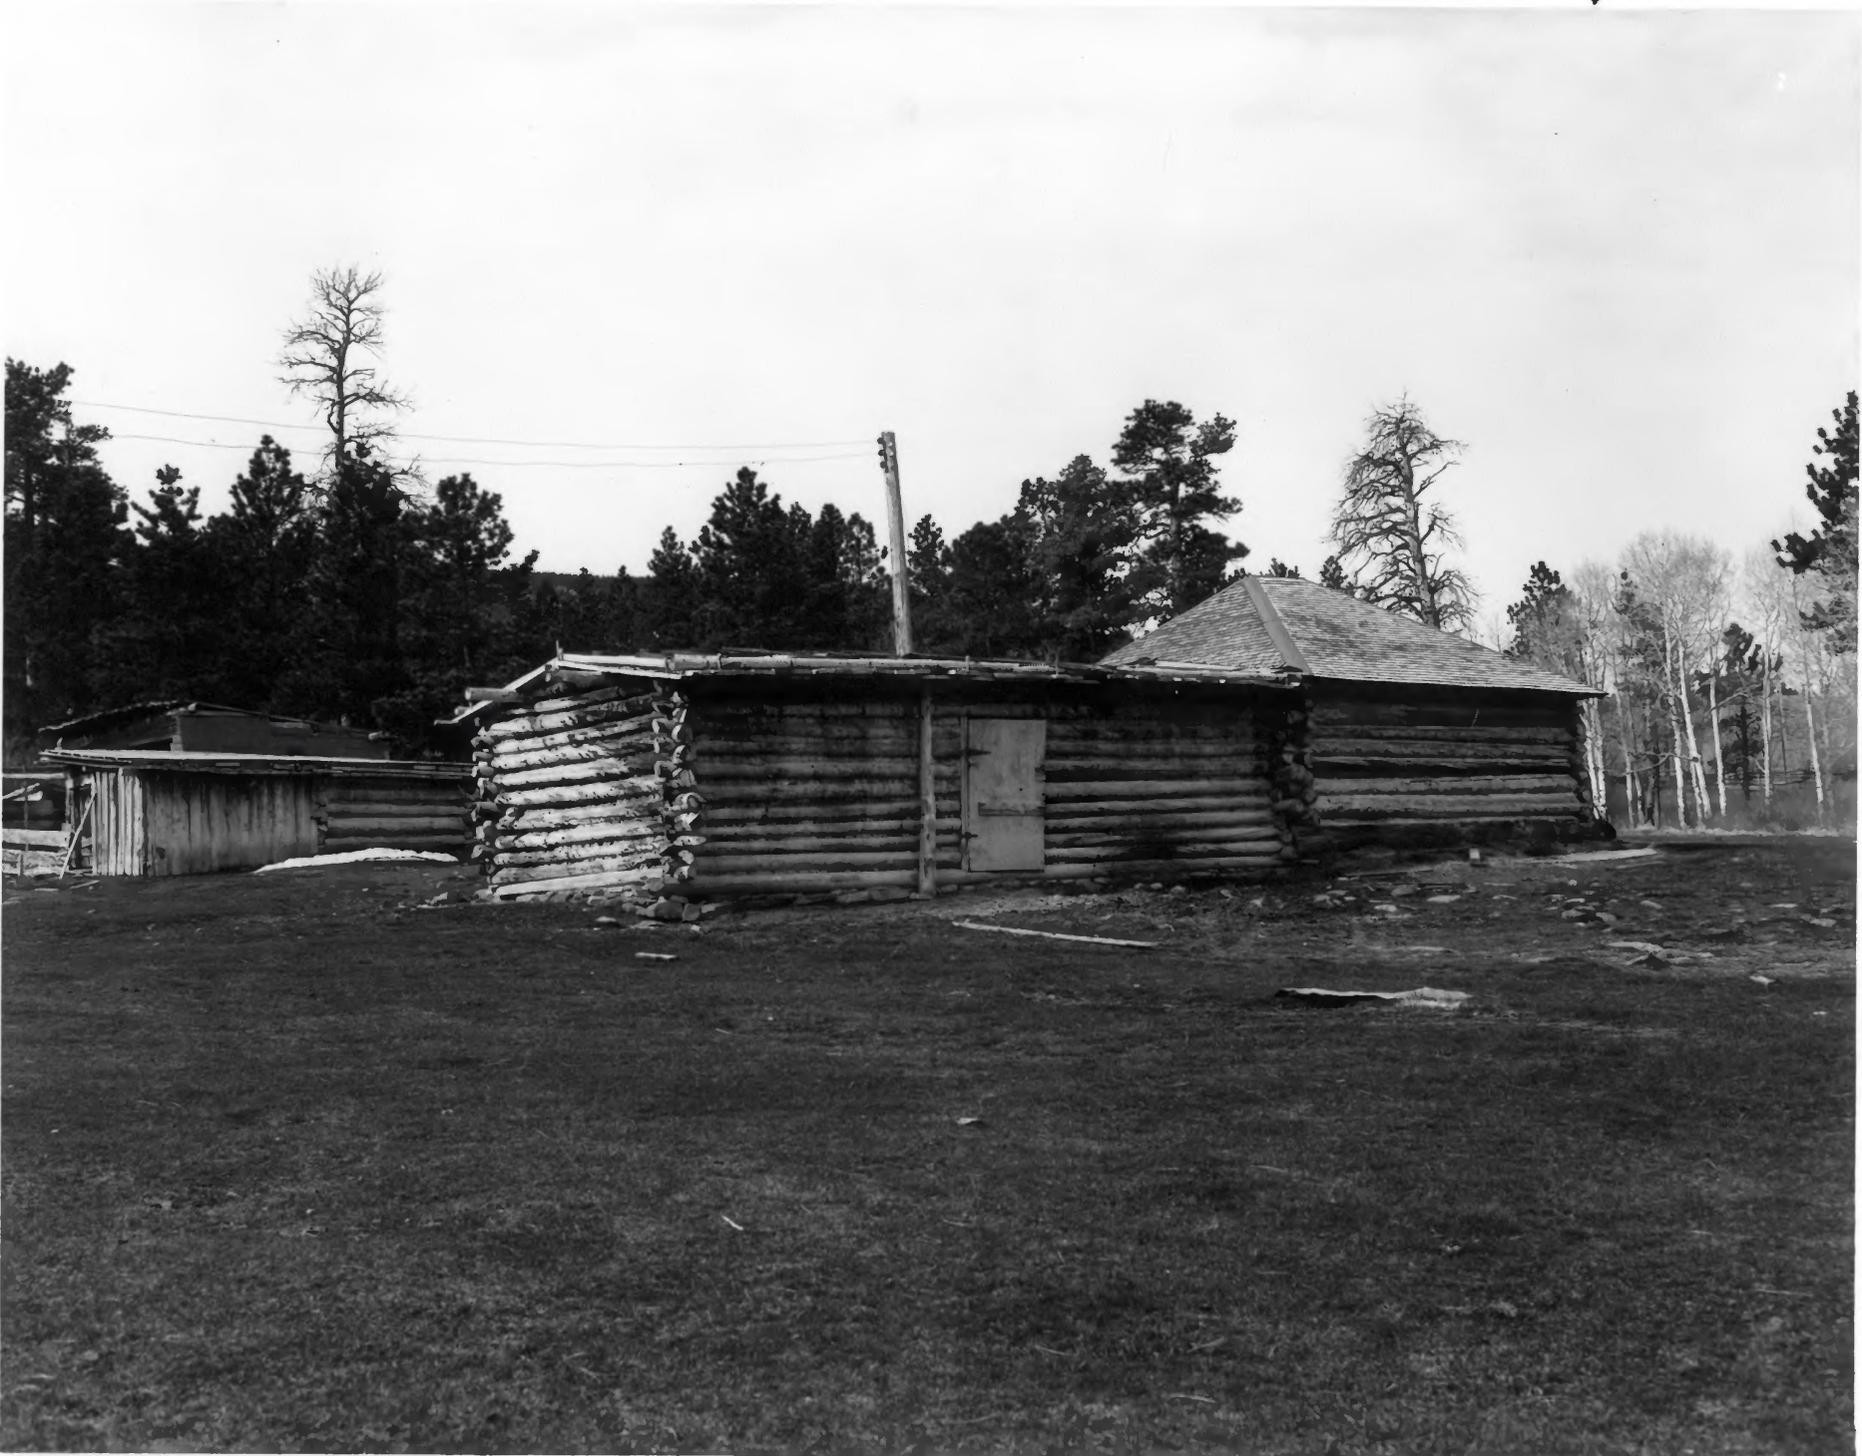
SUBJECT: Workshop-stable.

VIEW DESCRIPTION: The workshop (on the right) is a cut down version of the Greendale School originally built in 1919. The stable (on the left) was added in the late 1940's.

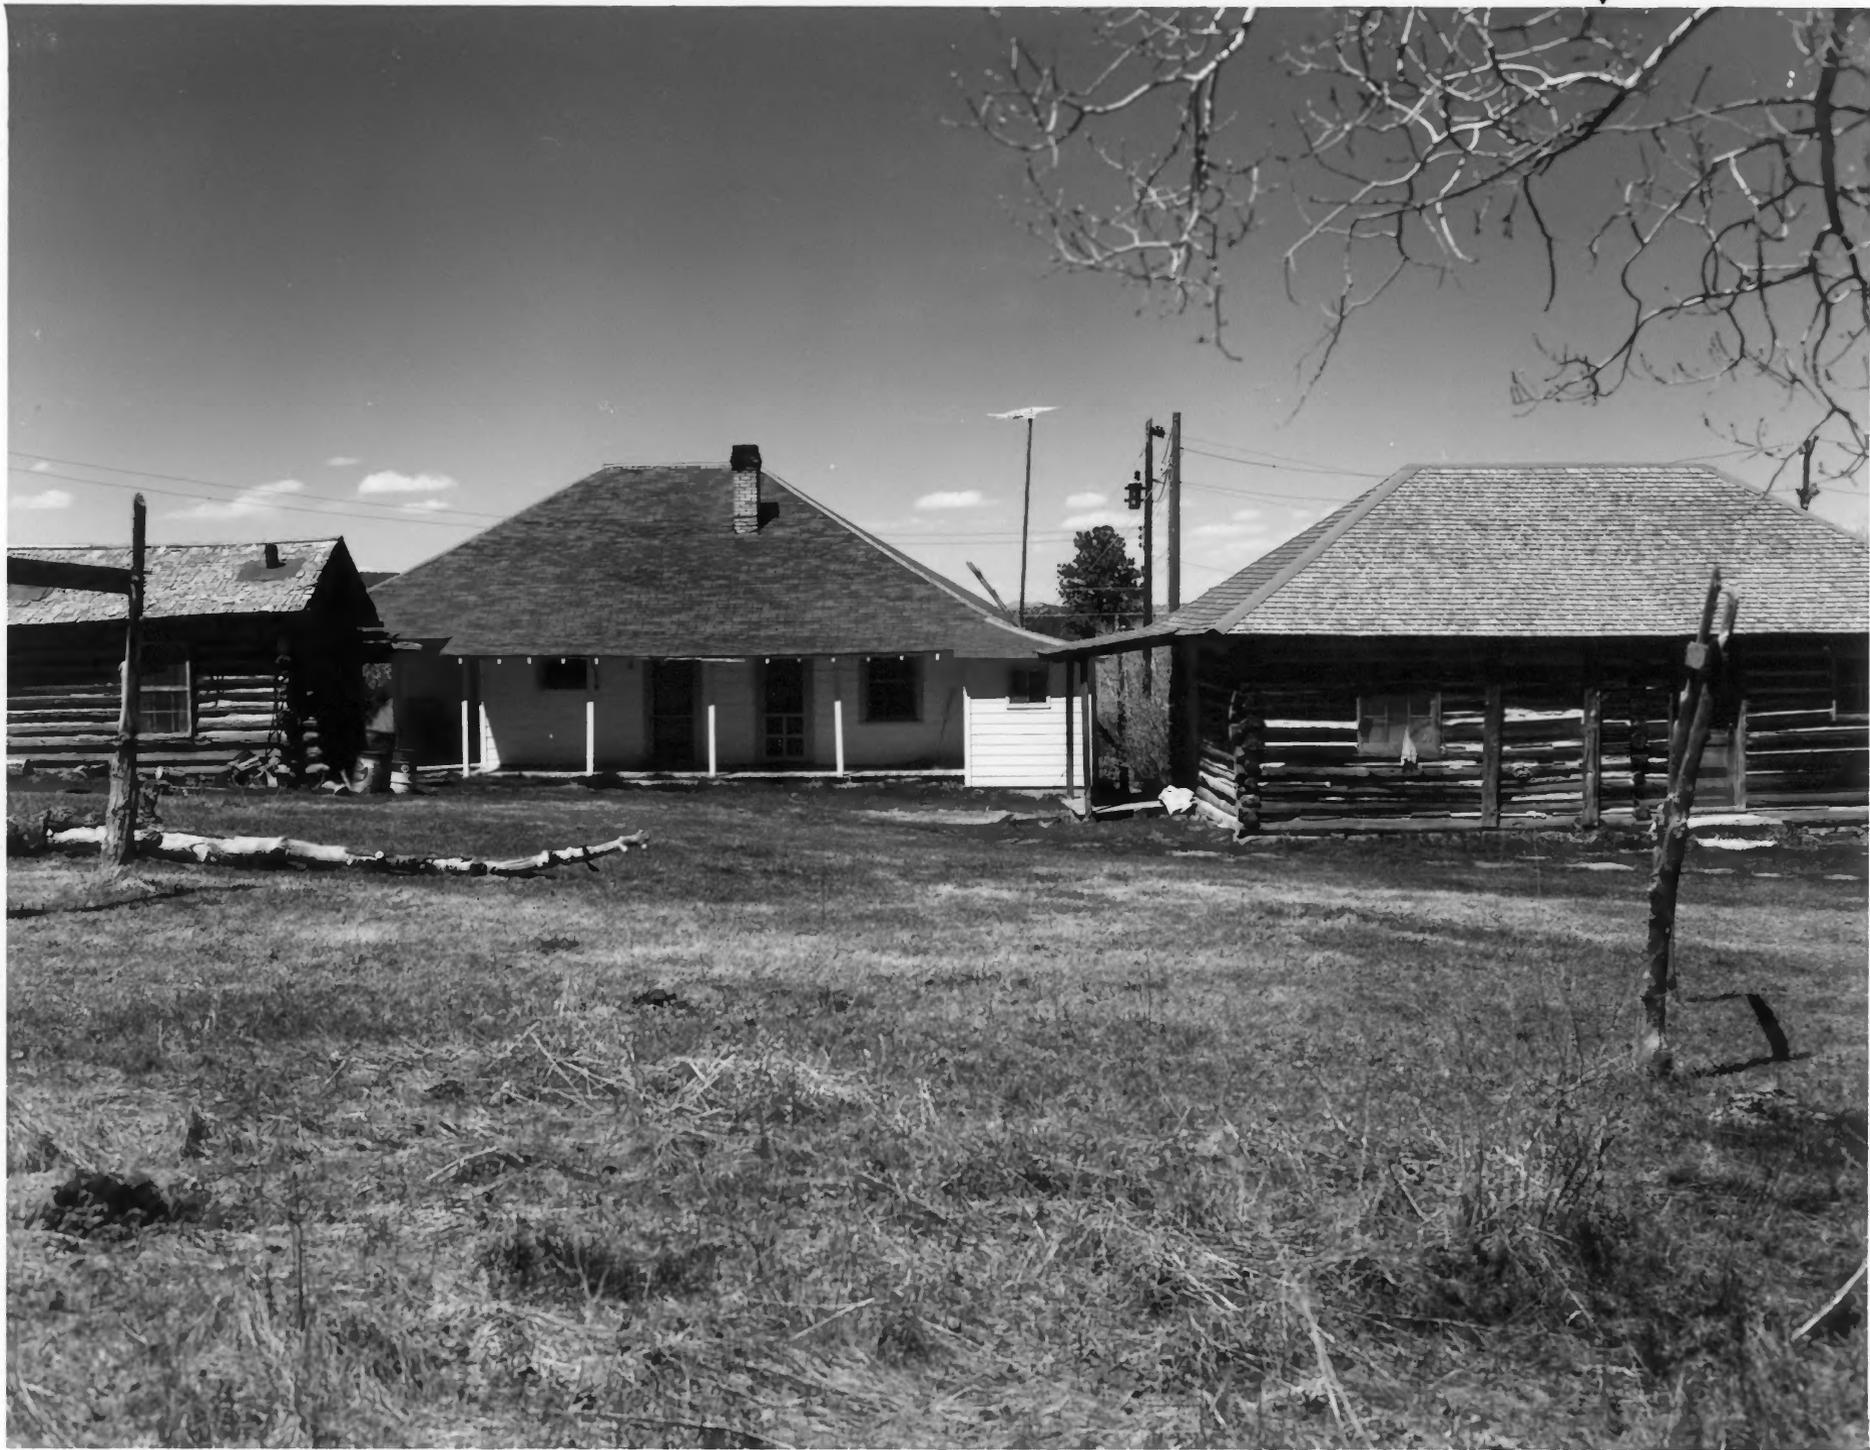
SUBJECT: Three generations of homes on the Swett homestead.

VIEW DESCRIPTION: The cabin on the left is the one room homestead house that was erected on this site in 1912. (It had been moved from another site by horse-drawn wagon.) The middle building is a sawed log five room house that was built in 1929. On the right is a two room cabin that was built in 1920. All were constructed by Oscar Swett and his family.

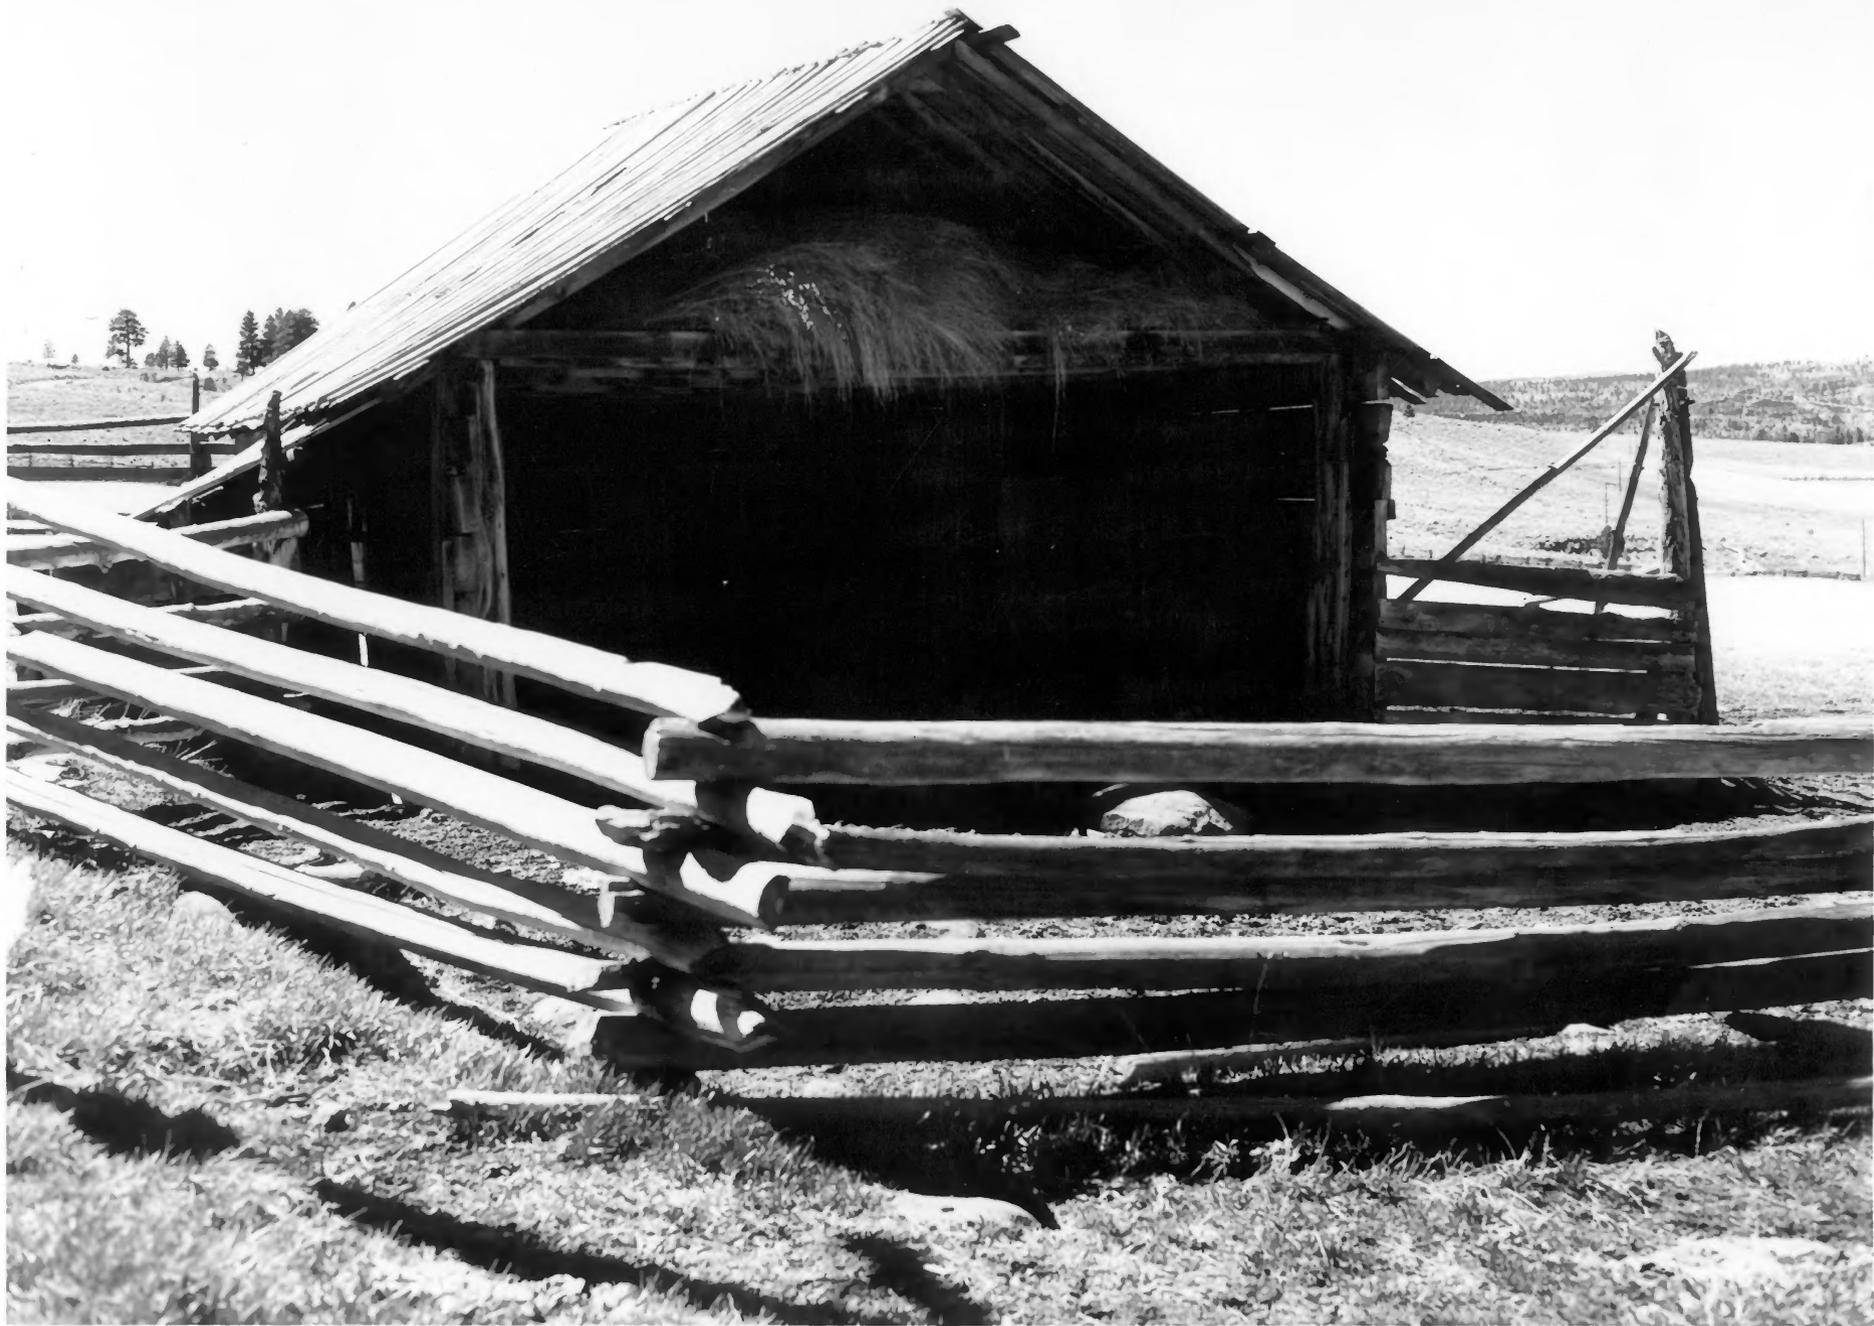
SUBJECT: Milking barn.

VIEW DESCRIPTION: It was built in the early 1940's by Oscar Swett.

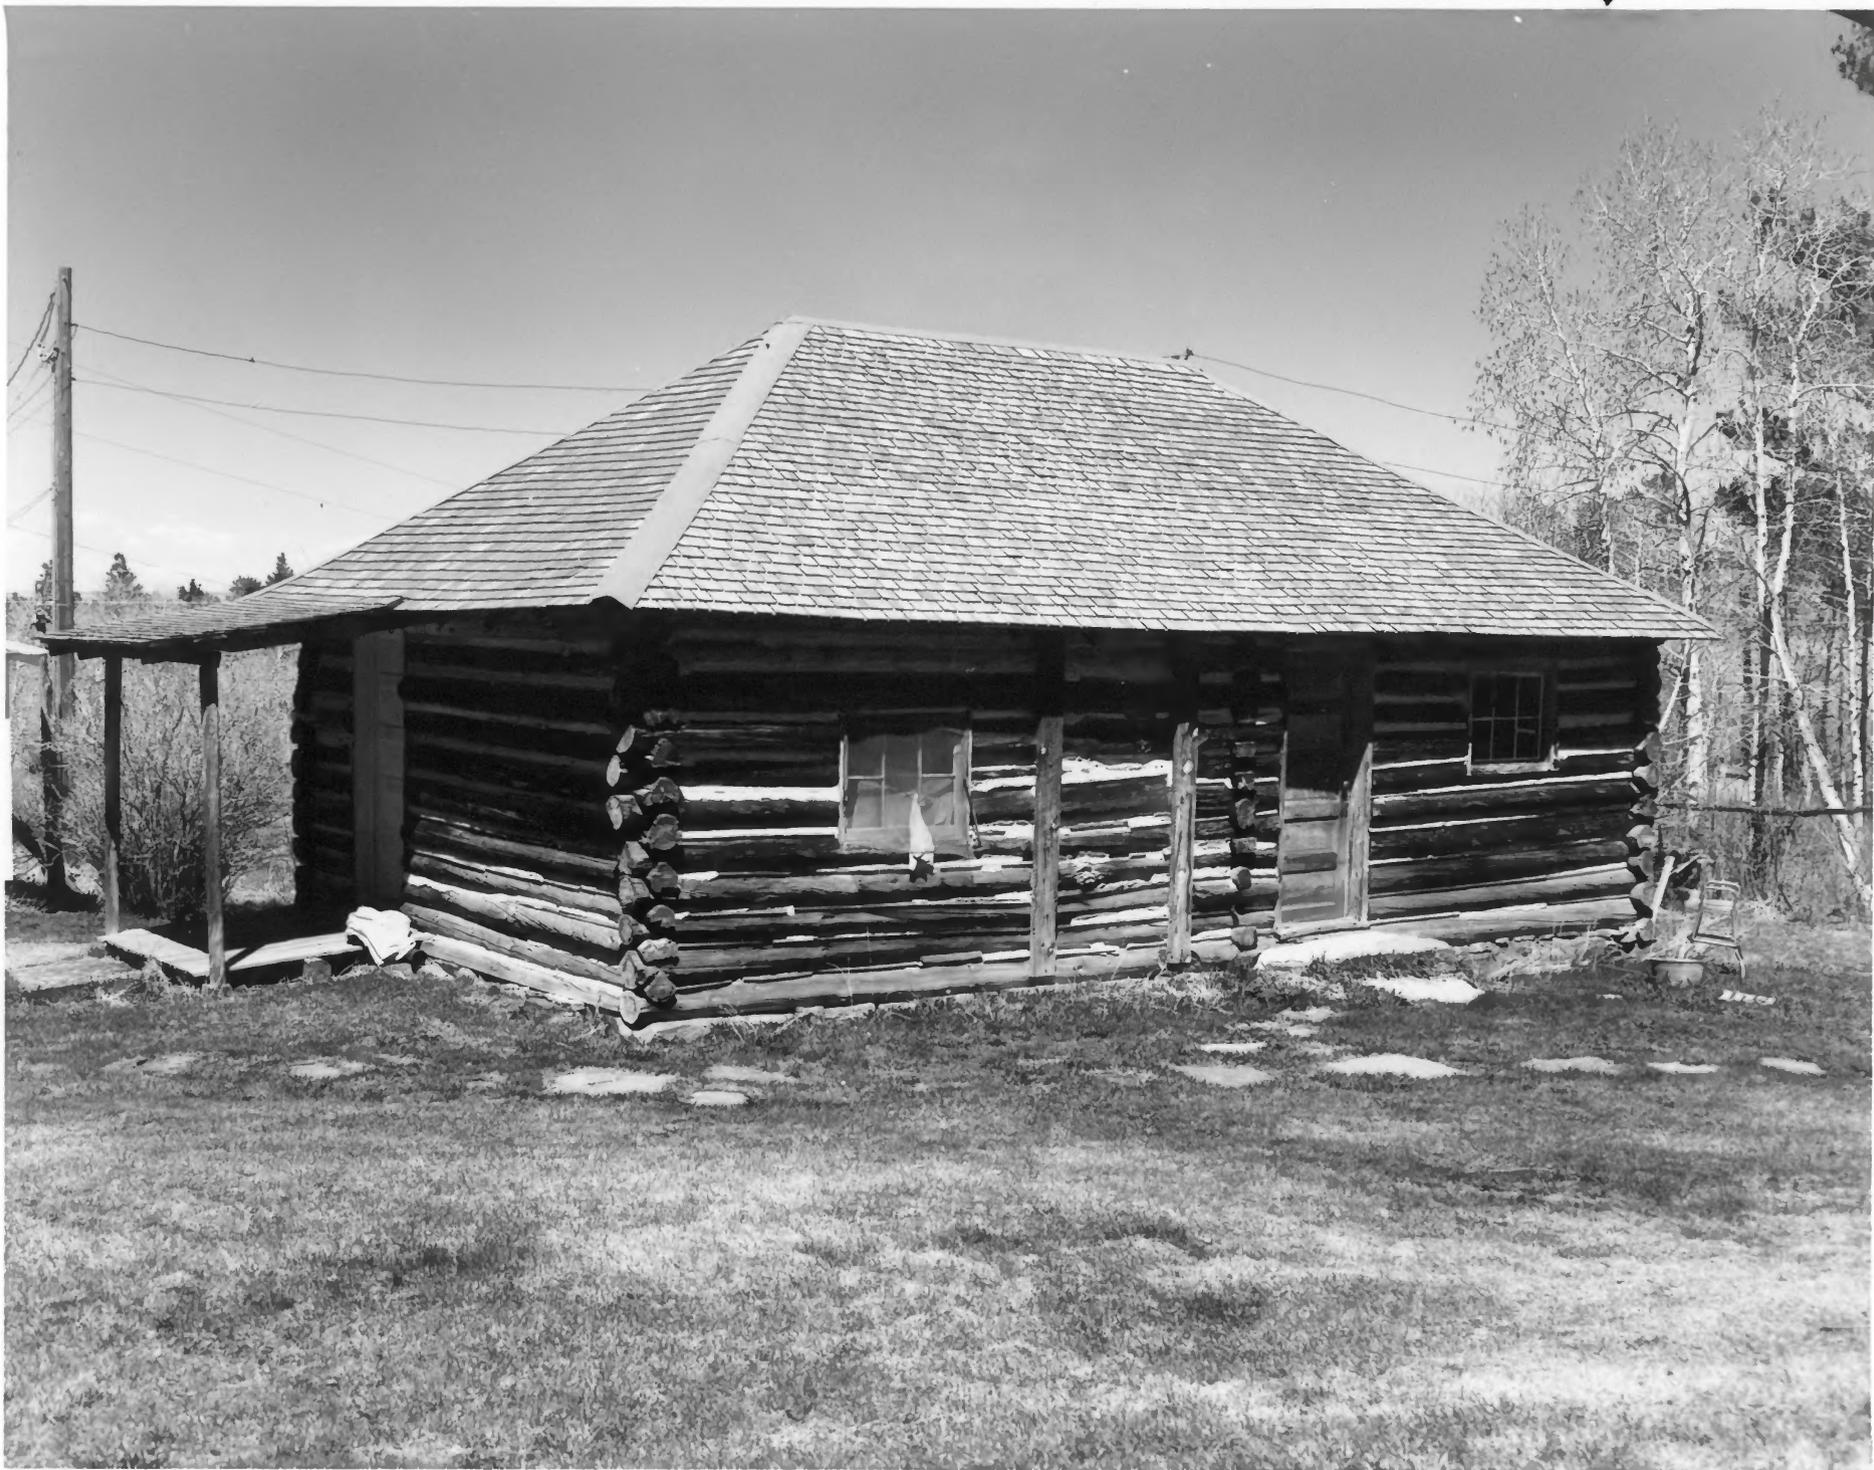
SUBJECT: Two room house.

VIEW DESCRIPTION: The Swett family two room log cabin. It was built by Oscar Swett in 1920. Then it was re-modeled in 1948 by Oscar and his son Louis.
