Swett Ranch

Daggett county

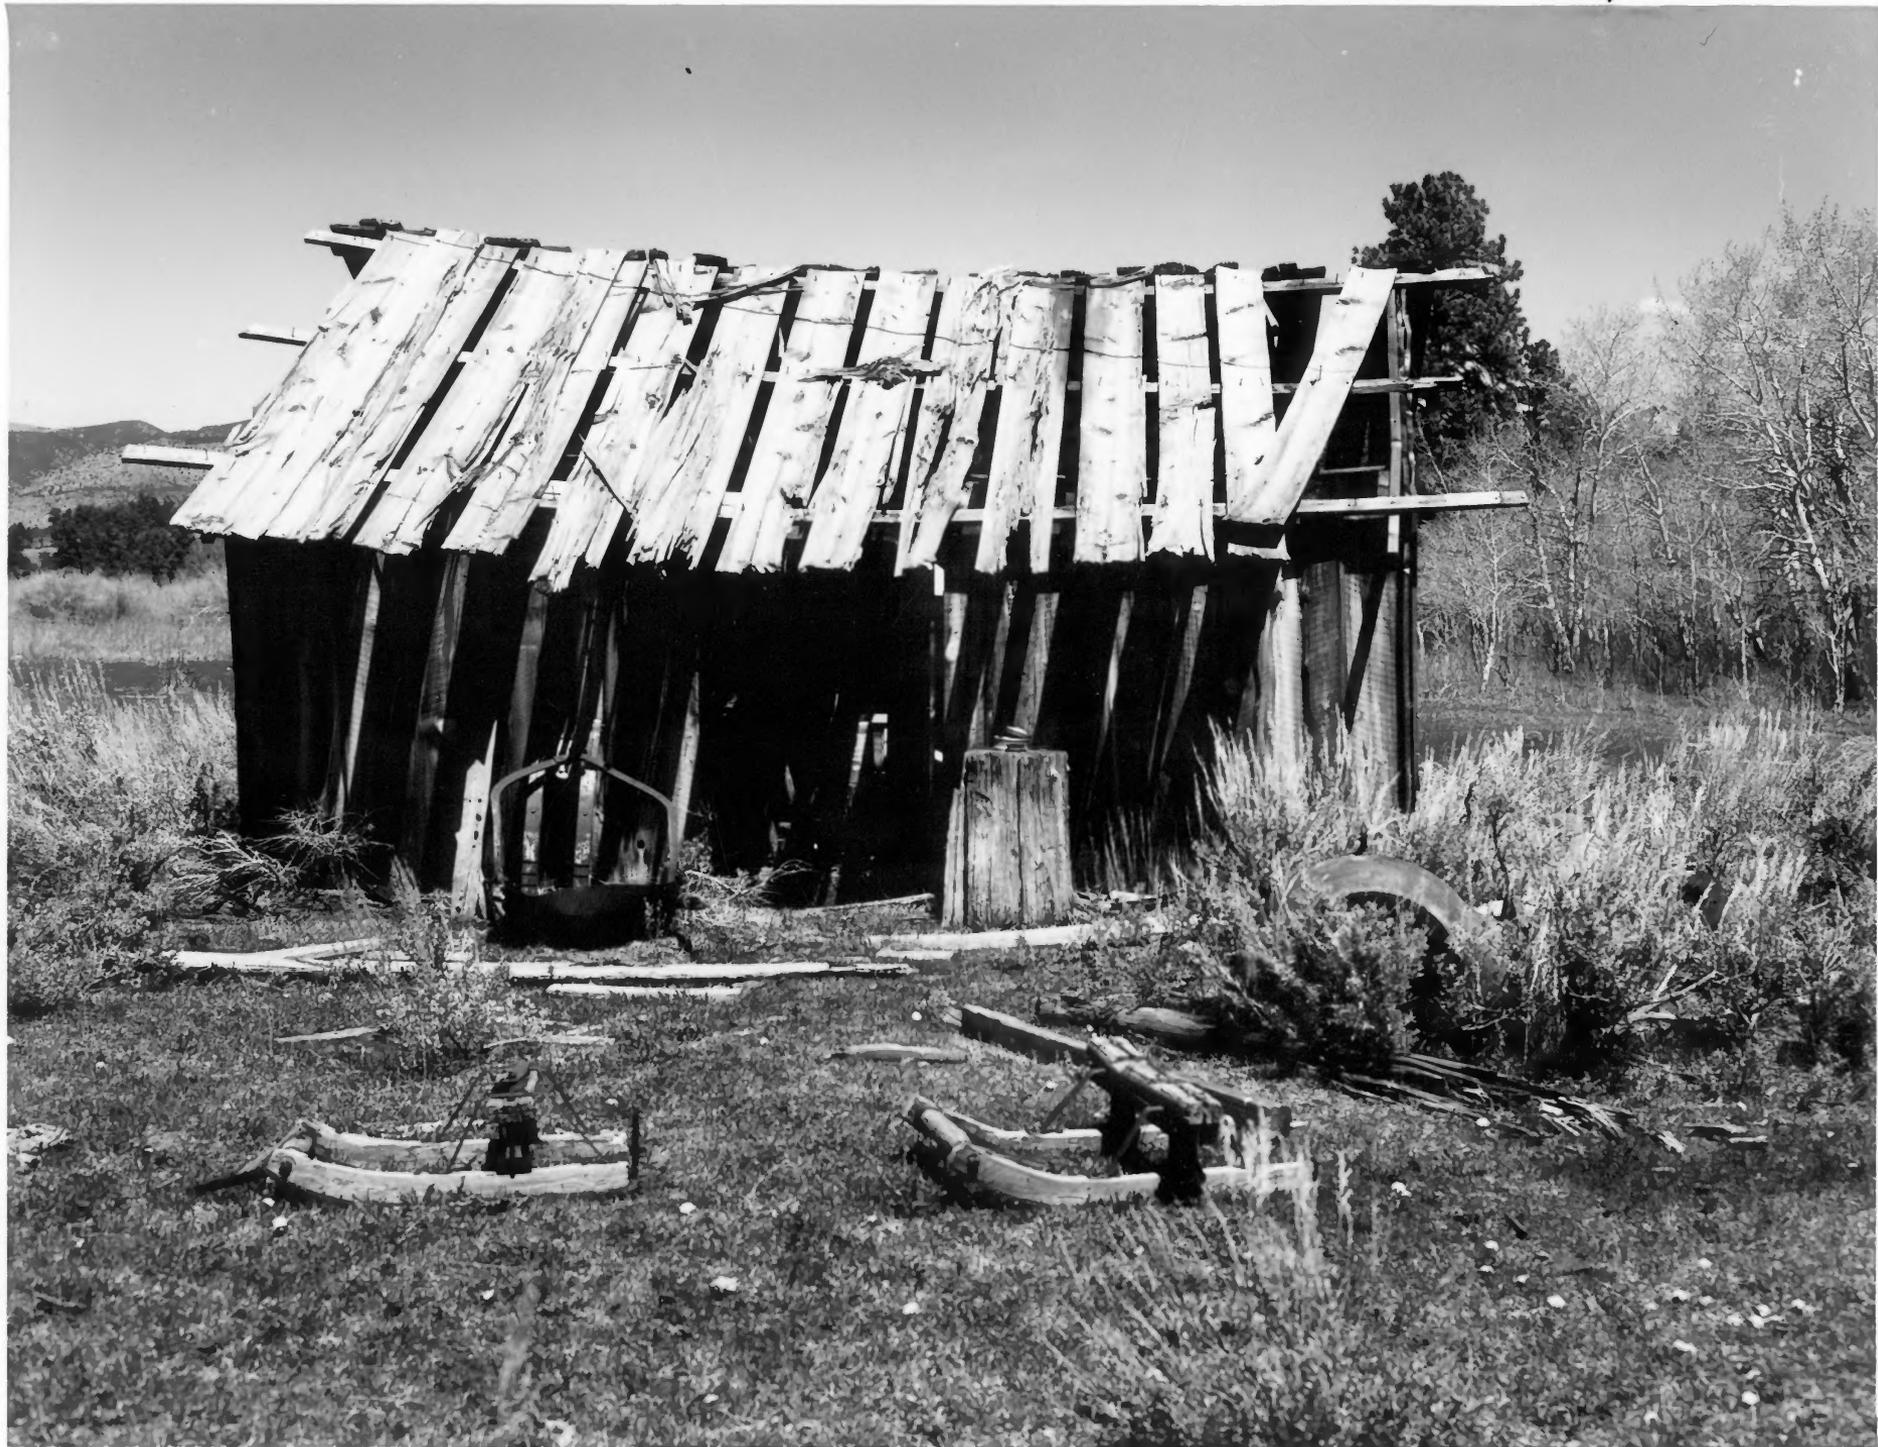
SUBJECT: Old blacksmith shop.

VIEW DESCRIPTION: This shop was built in 1920 with lumber from Oscar Swett's own sawmill. It has a window in it from an old (about 1920) Hudson auto.

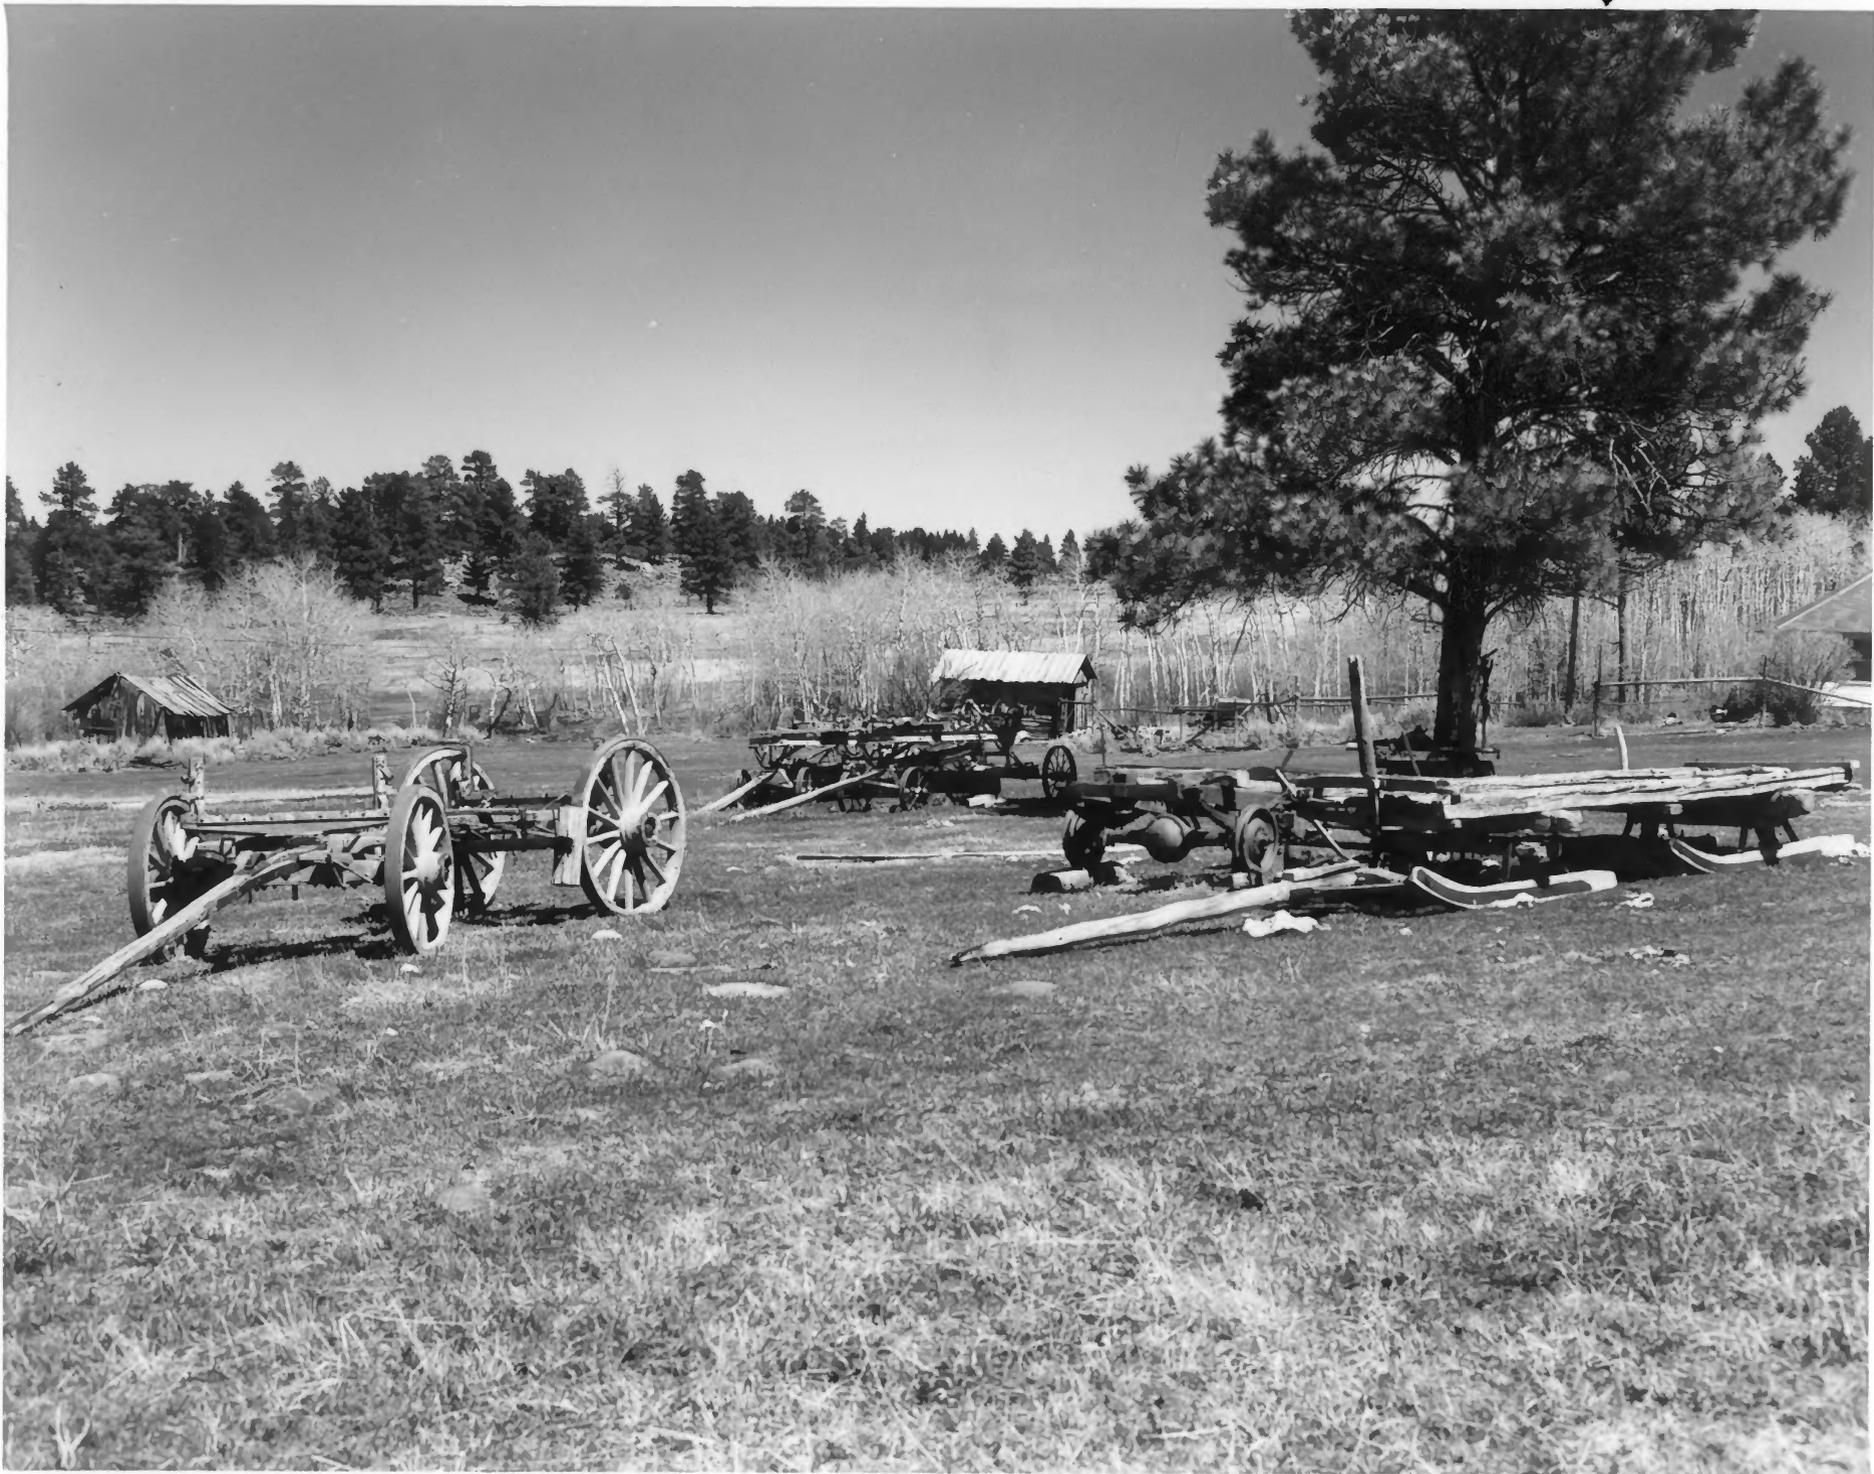
SUBJECT: View of a portion of the ranch grounds.

VIEW DESCRIPTION: This is a portion of the Swett ranch grounds showing (from left to right rear) the old blacksmith shop, a woodshed, and the five room house. The left to right front of the view shows a Hoover wagon, state road graders, and a bobsled (all horse-drawn) from the early 1900's.

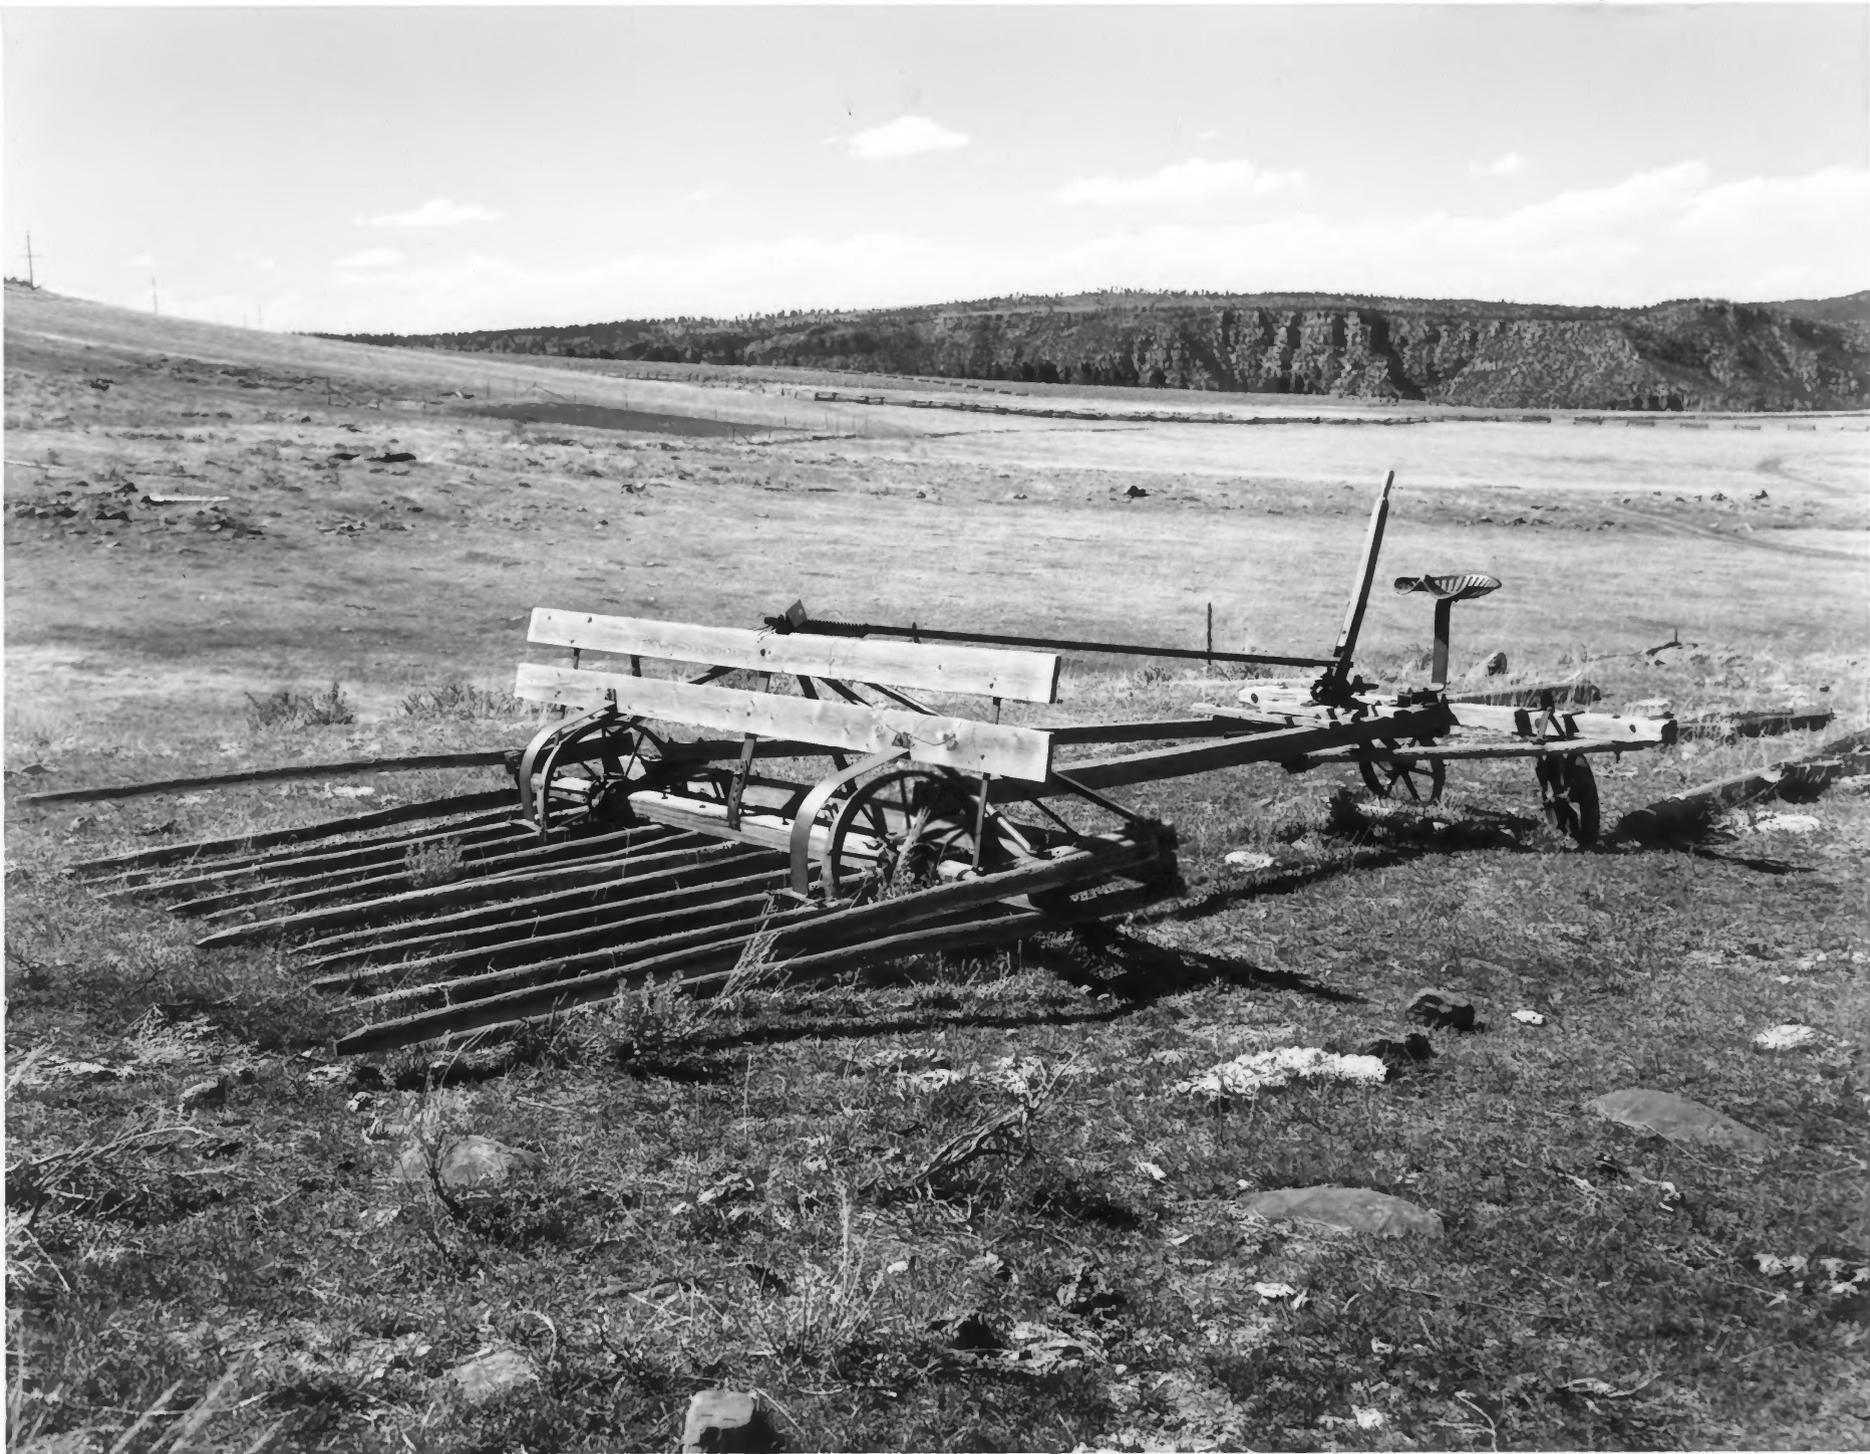
SUBJECT: Bull rake.

VIEW DESCRIPTION: This rake was used in stacking hay. It was horse-powered and is located on the ranch grounds. It is from the early 1900's.

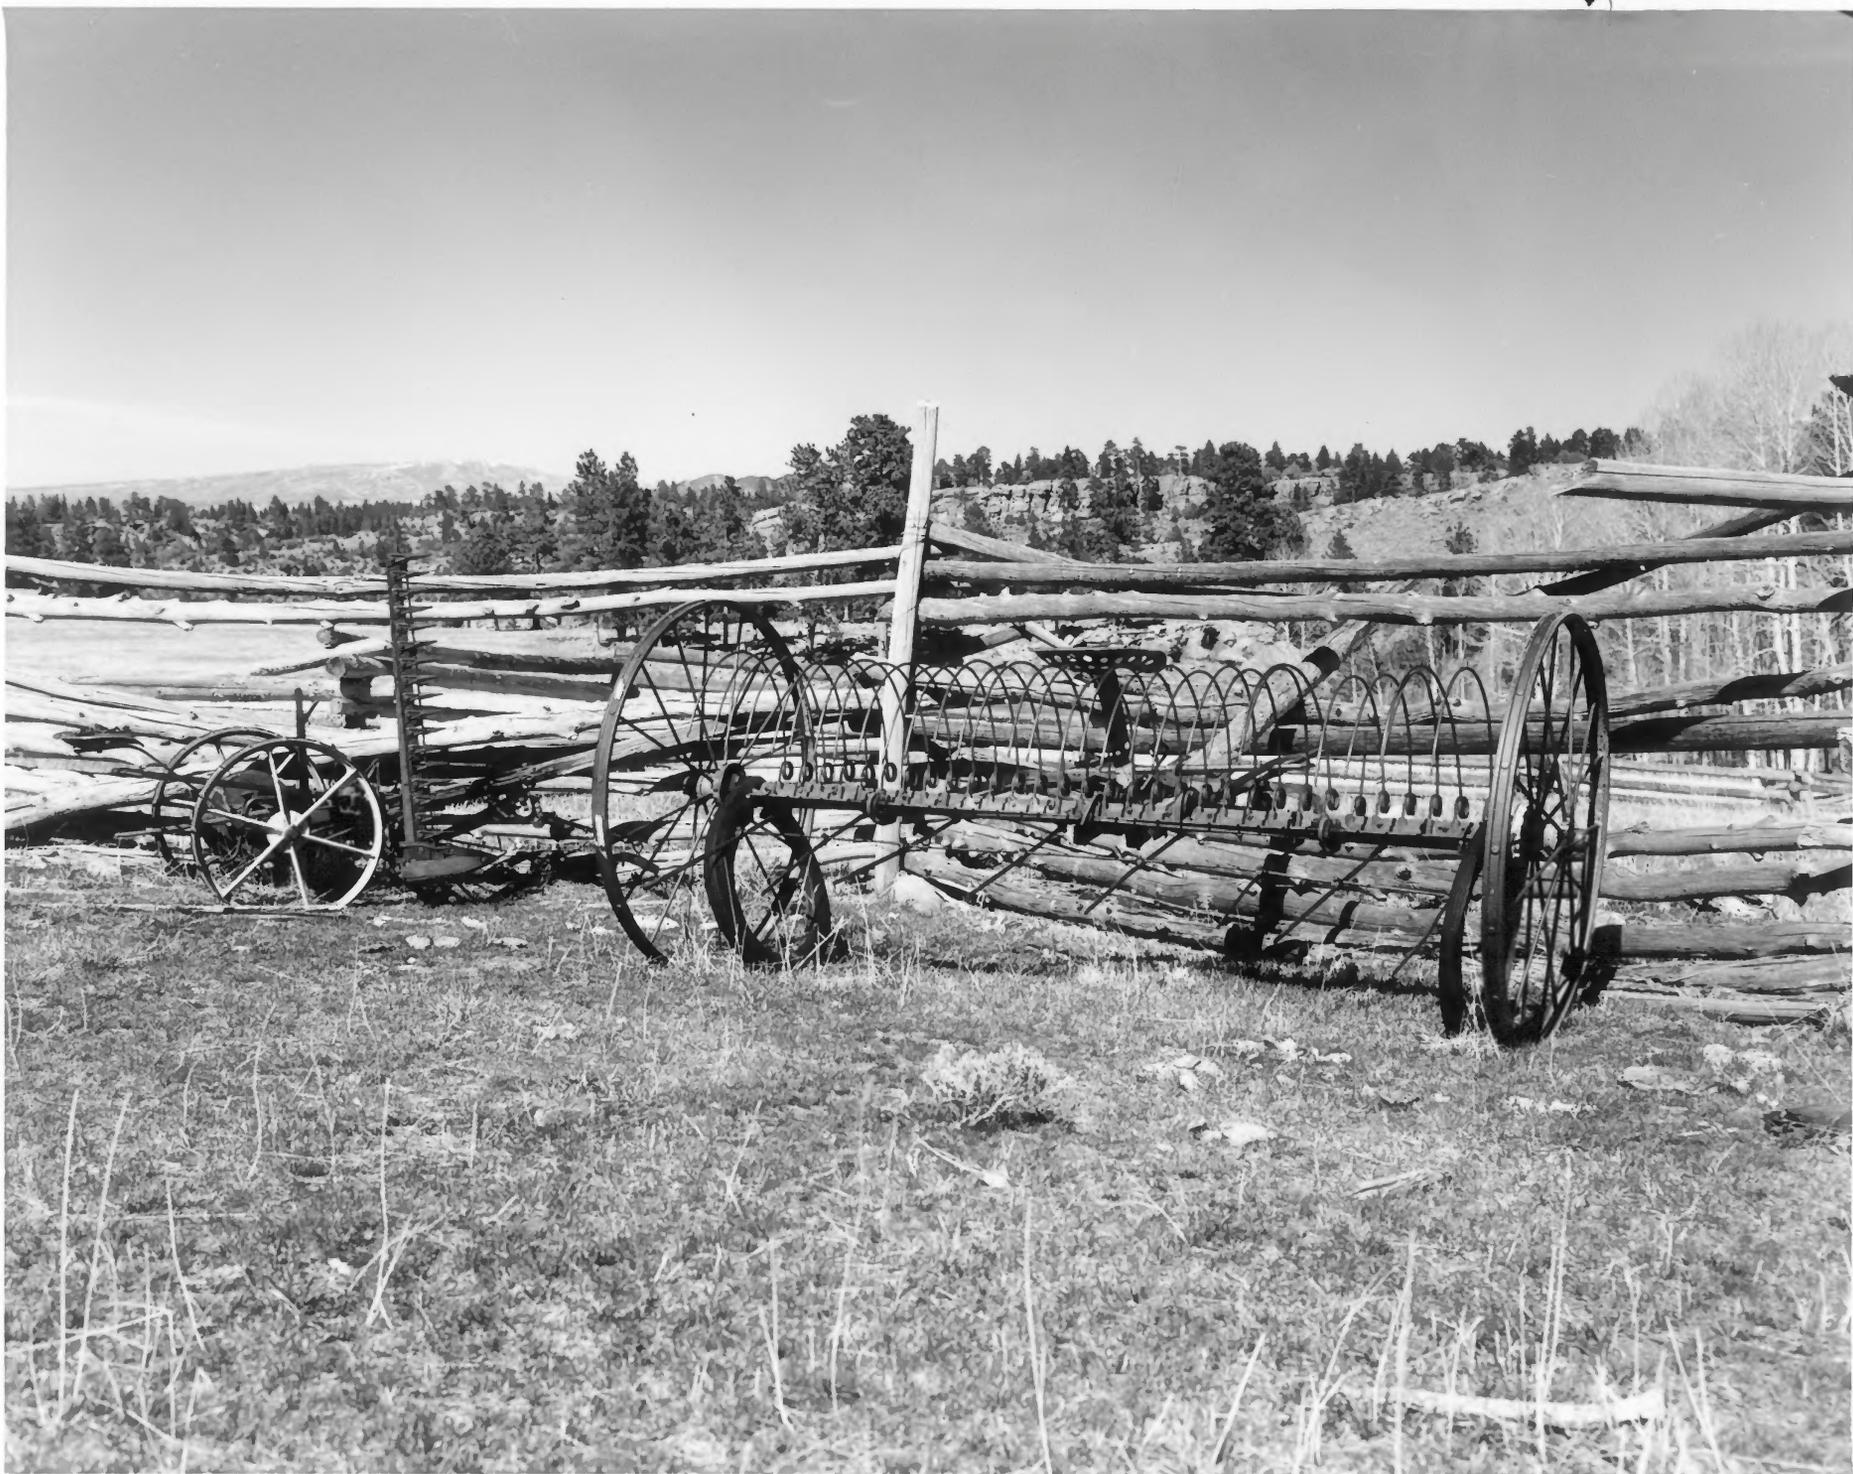
SUBJECT: Mower and rake.

VIEW DESCRIPTION: This shows a hay mower and hay rake. Both were horse-drawn and are located on the Swett ranch grounds. They date back to the early 1900's.

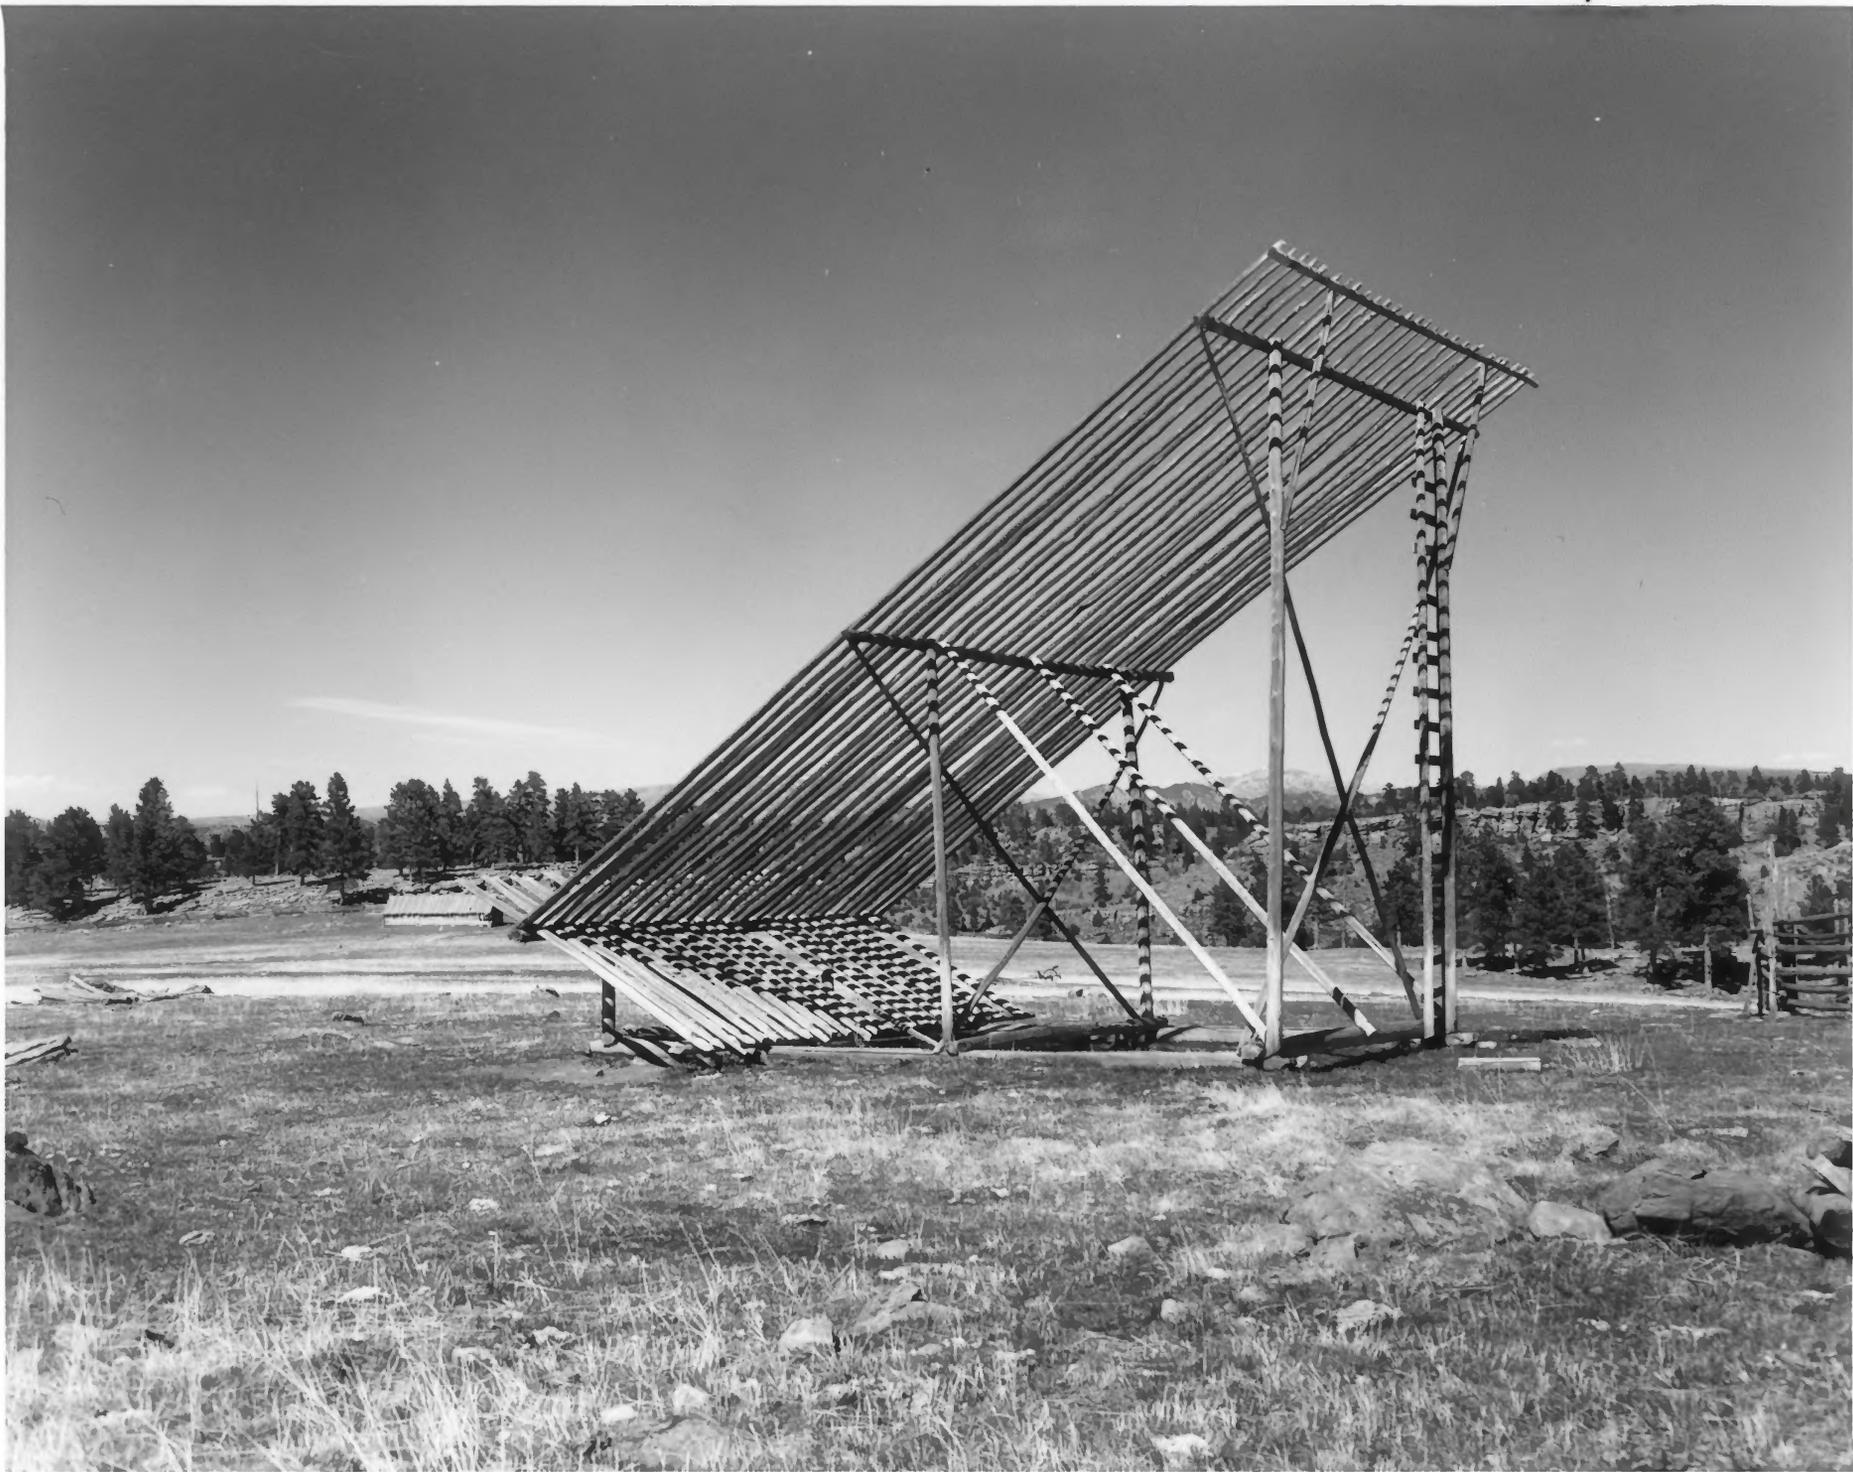
SUBJECT: Hay stacker.

VIEW DESCRIPTION: This hay stacker is the Beaver slide type. It was used in conjunction with a bull rake and plunger pole to make a rounded hay stack. It is wooden with metal nuts and bolts to join the pieces. It is located on the Swett homestead and dates from the early 1900's.

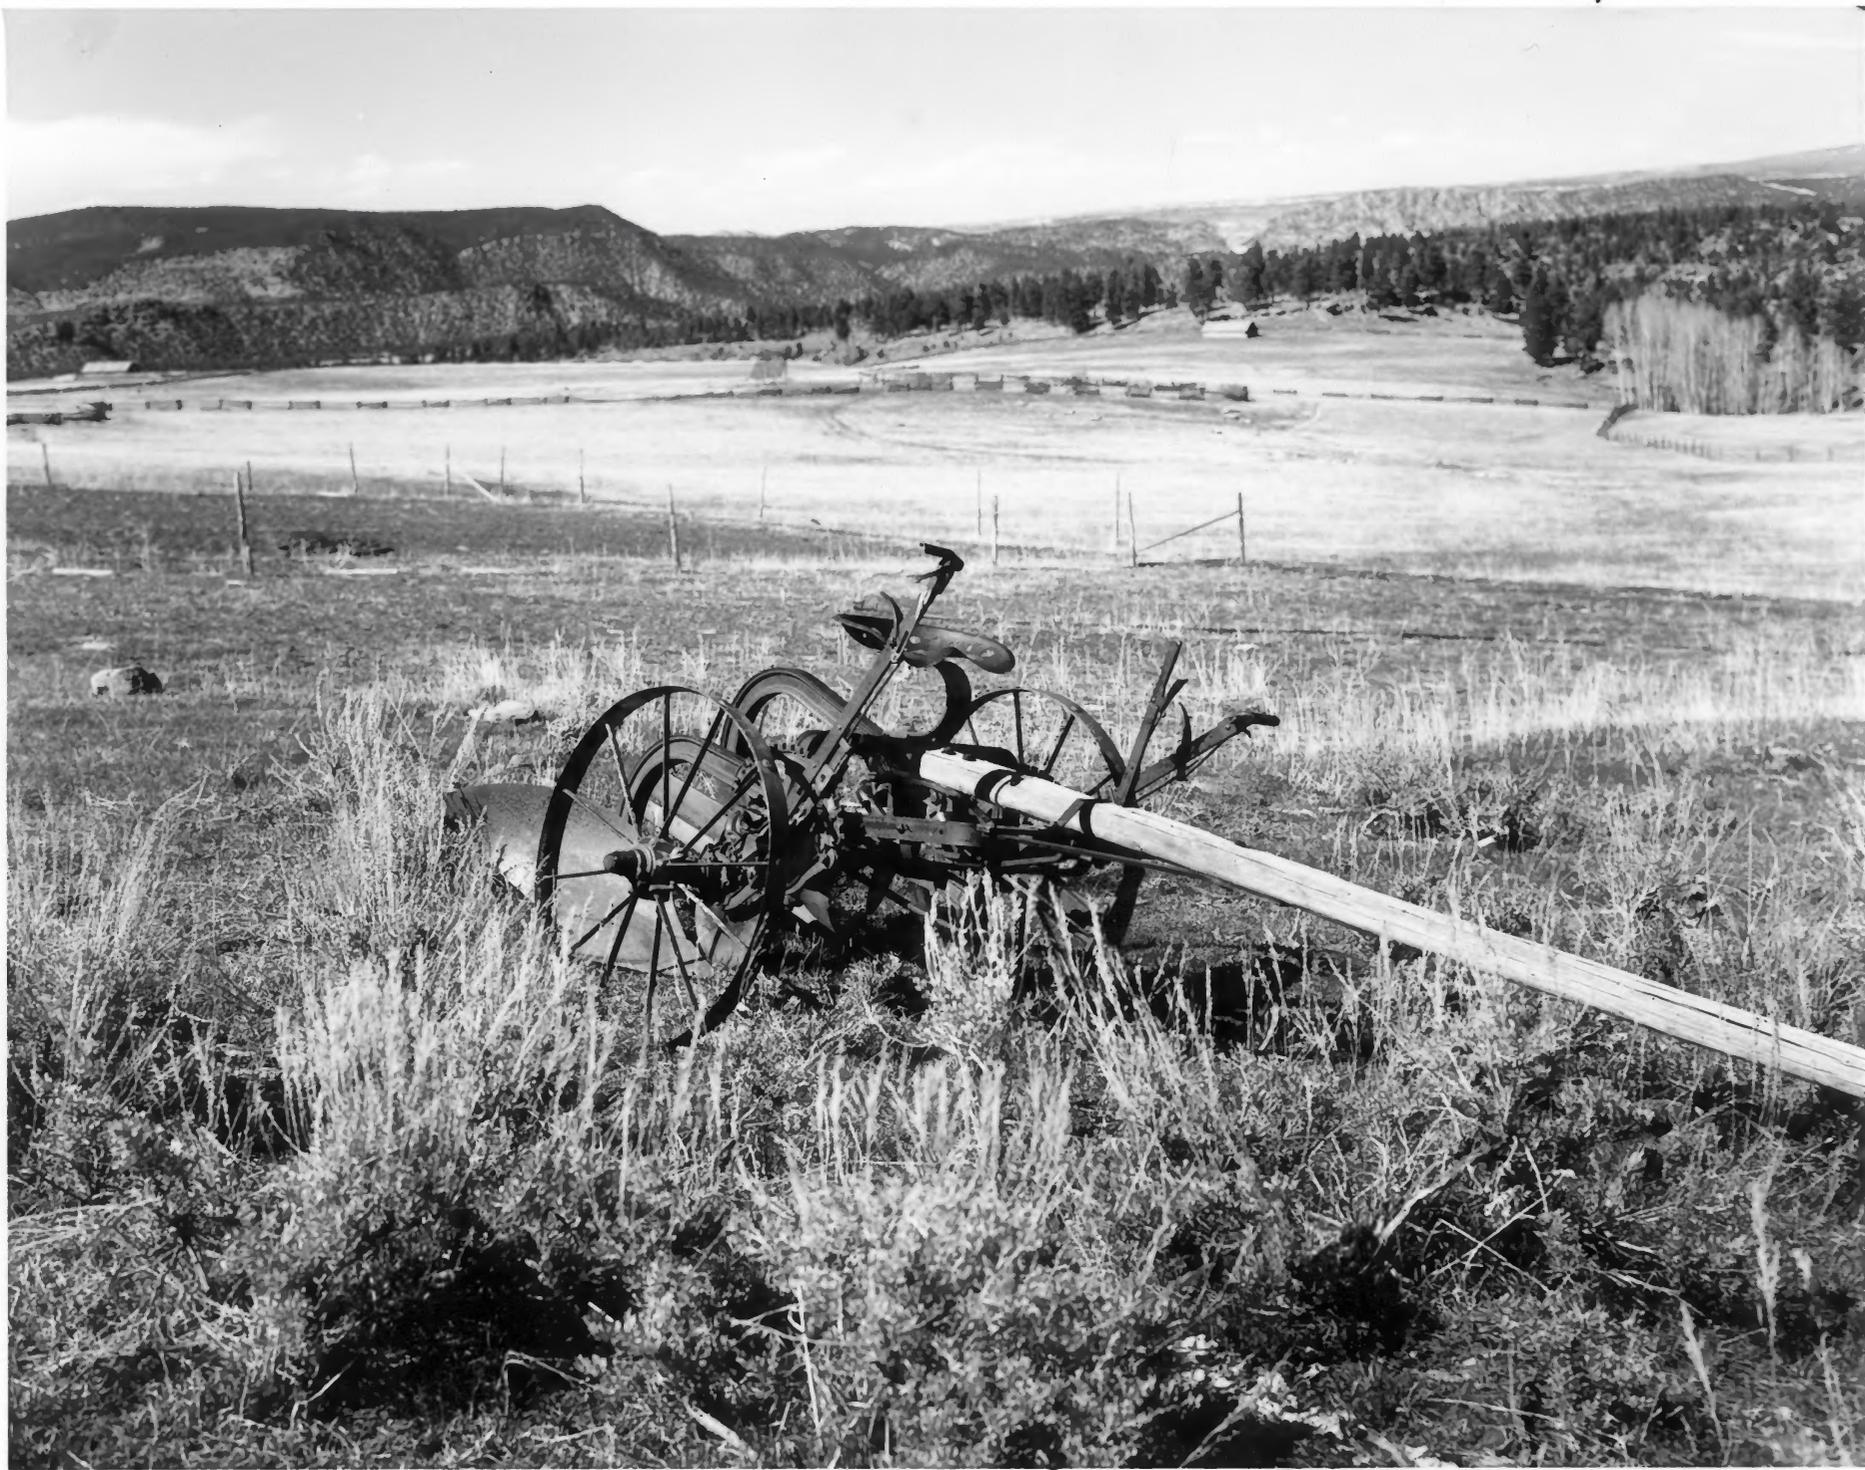
SUBJECT: Two-way plow.

VIEW DESCRIPTION: This is a horse-drawn two-way plow located on the Swett homestead from the early 1900's.

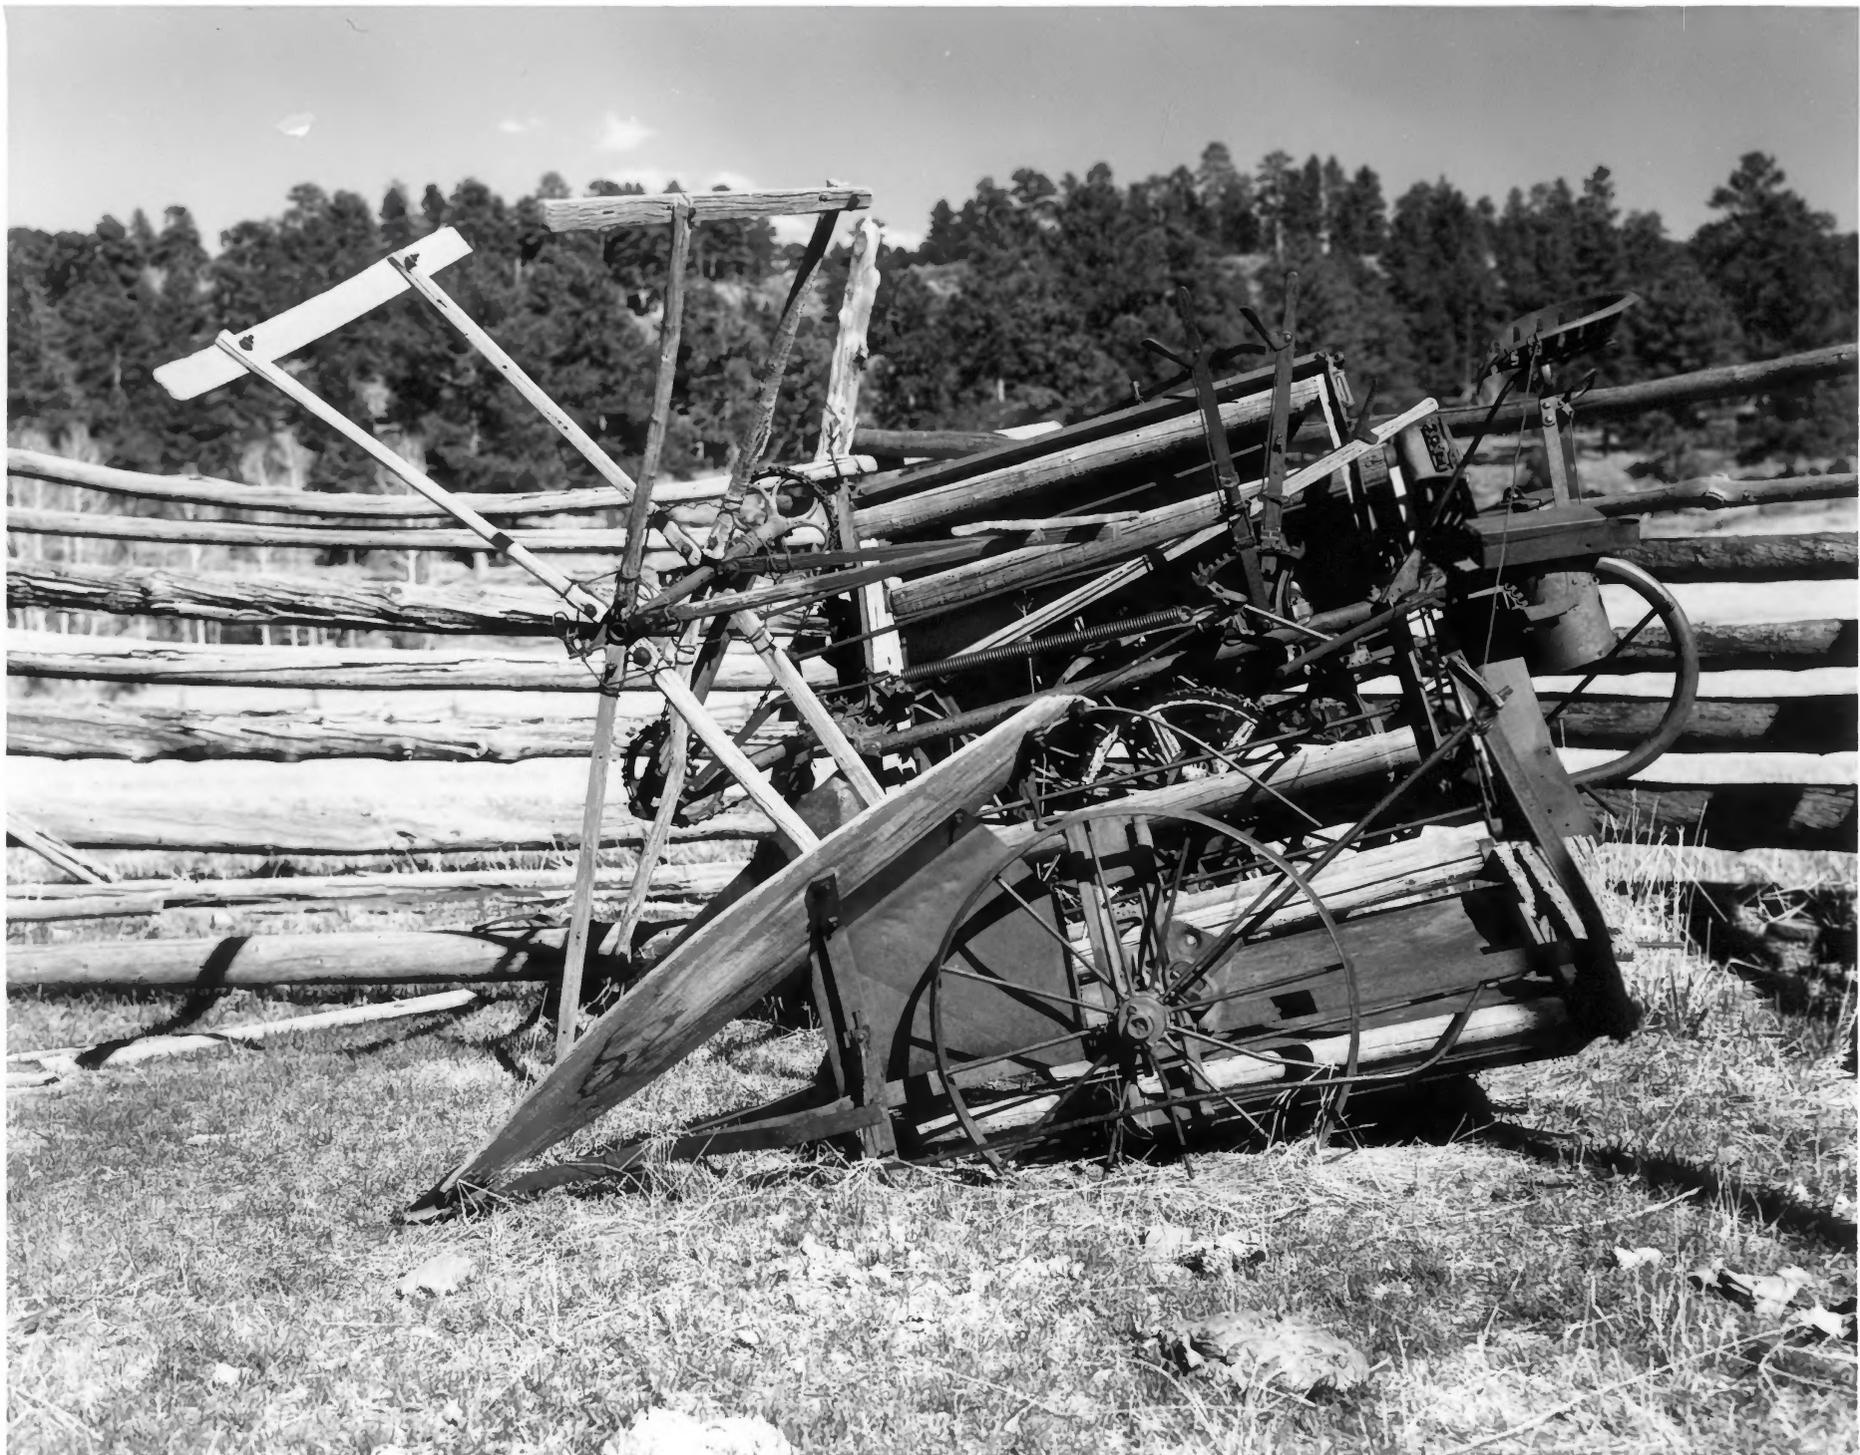
SUBJECT: Binder.

VIEW DESCRIPTION: This binder was used for tying harvested grain.
It is located on the Swett ranch and is from the
early 1900's.
