National Register of Historic Places Registration Form

historic name Government Mineral Springs Guard Station

other names/site number GMS Guard Station #1051

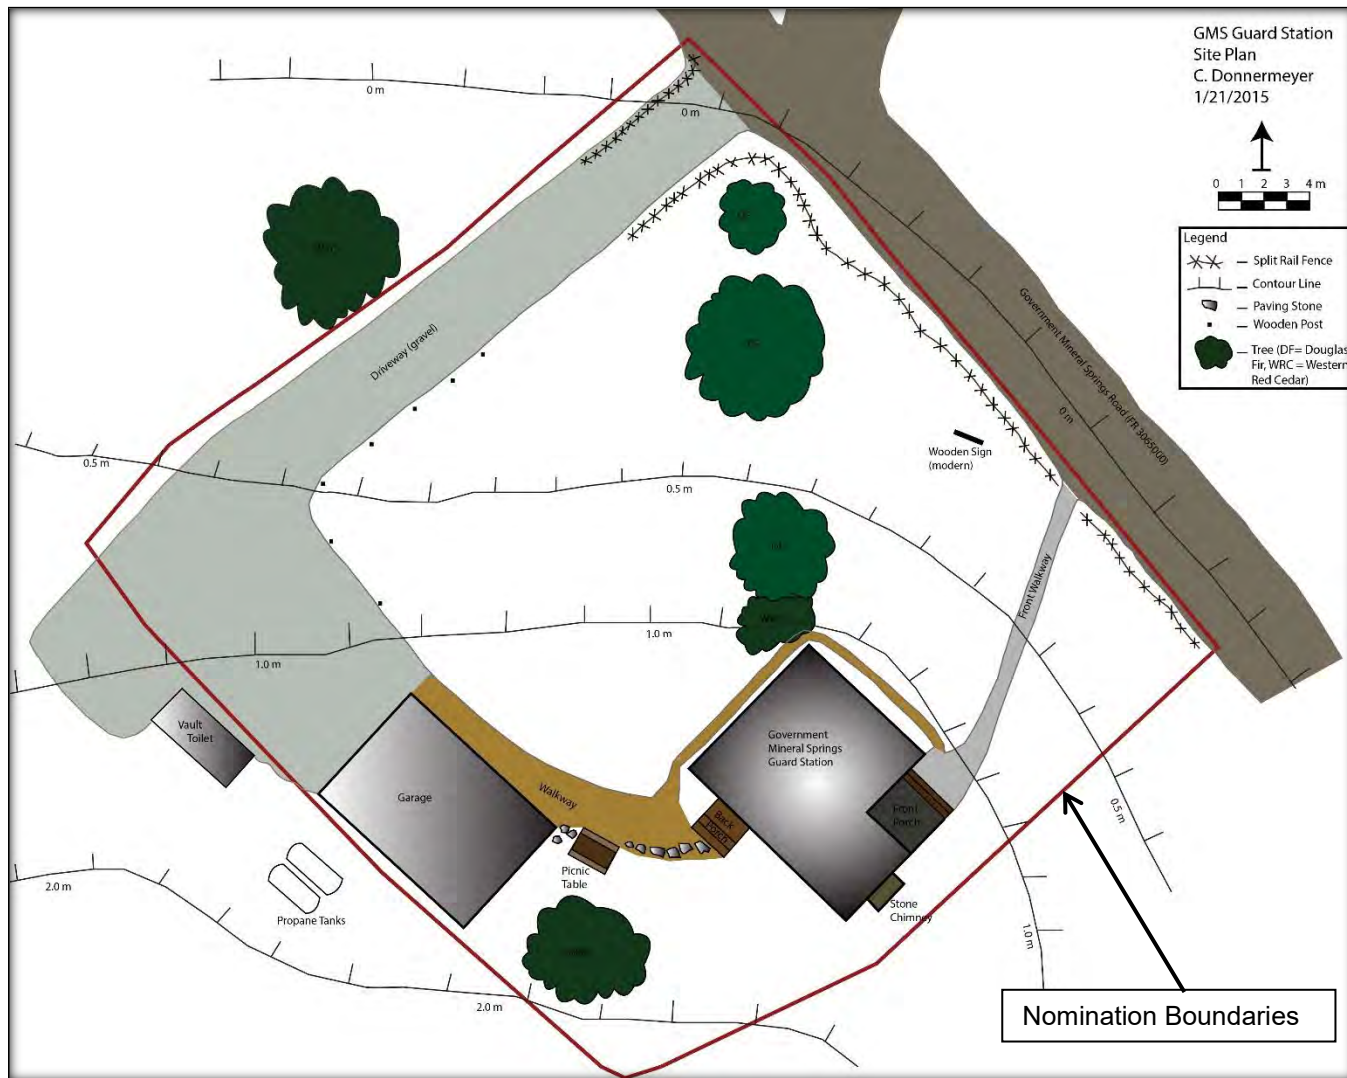
Government Mineral Springs Guard Station
Site Plan showing the boundary of the nominated area (in red).
Drawn and digitized by Chris Donnermeyer, 2015.

The Government Mineral Springs Guard Station #1051 is located on federal land administered by the Gifford Pinchot National Forest near the unincorporated community of Stabler, Washington, and approximately fifteen miles north of the town of Carson, Washington. The site is at an elevation of 1,200 feet above mean sea level (amsl). The surrounding forest is dominated by old growth Douglas-fir and western red cedar trees. Trapper Creek, a tributary of the Wind River, is located approximately 350 feet northeast of the Guard Station. The Wind River Highway and Forest Service Rd 3065 (Government Mineral Springs Road) provide access to the site. A short driveway, 24 meters in length, is located on the northwest end of the property and provides direct access. Facing the main road is a modern wood sign that reads, "Government Mineral Springs/ Guard Station/ Built 1937/ By/ Civilian Conservation Corps/ Company 944 – Camp Hemlock/ Restored 2001-2002". The historic property also includes a garage. Please refer to Maps section for a site plan map of the property.

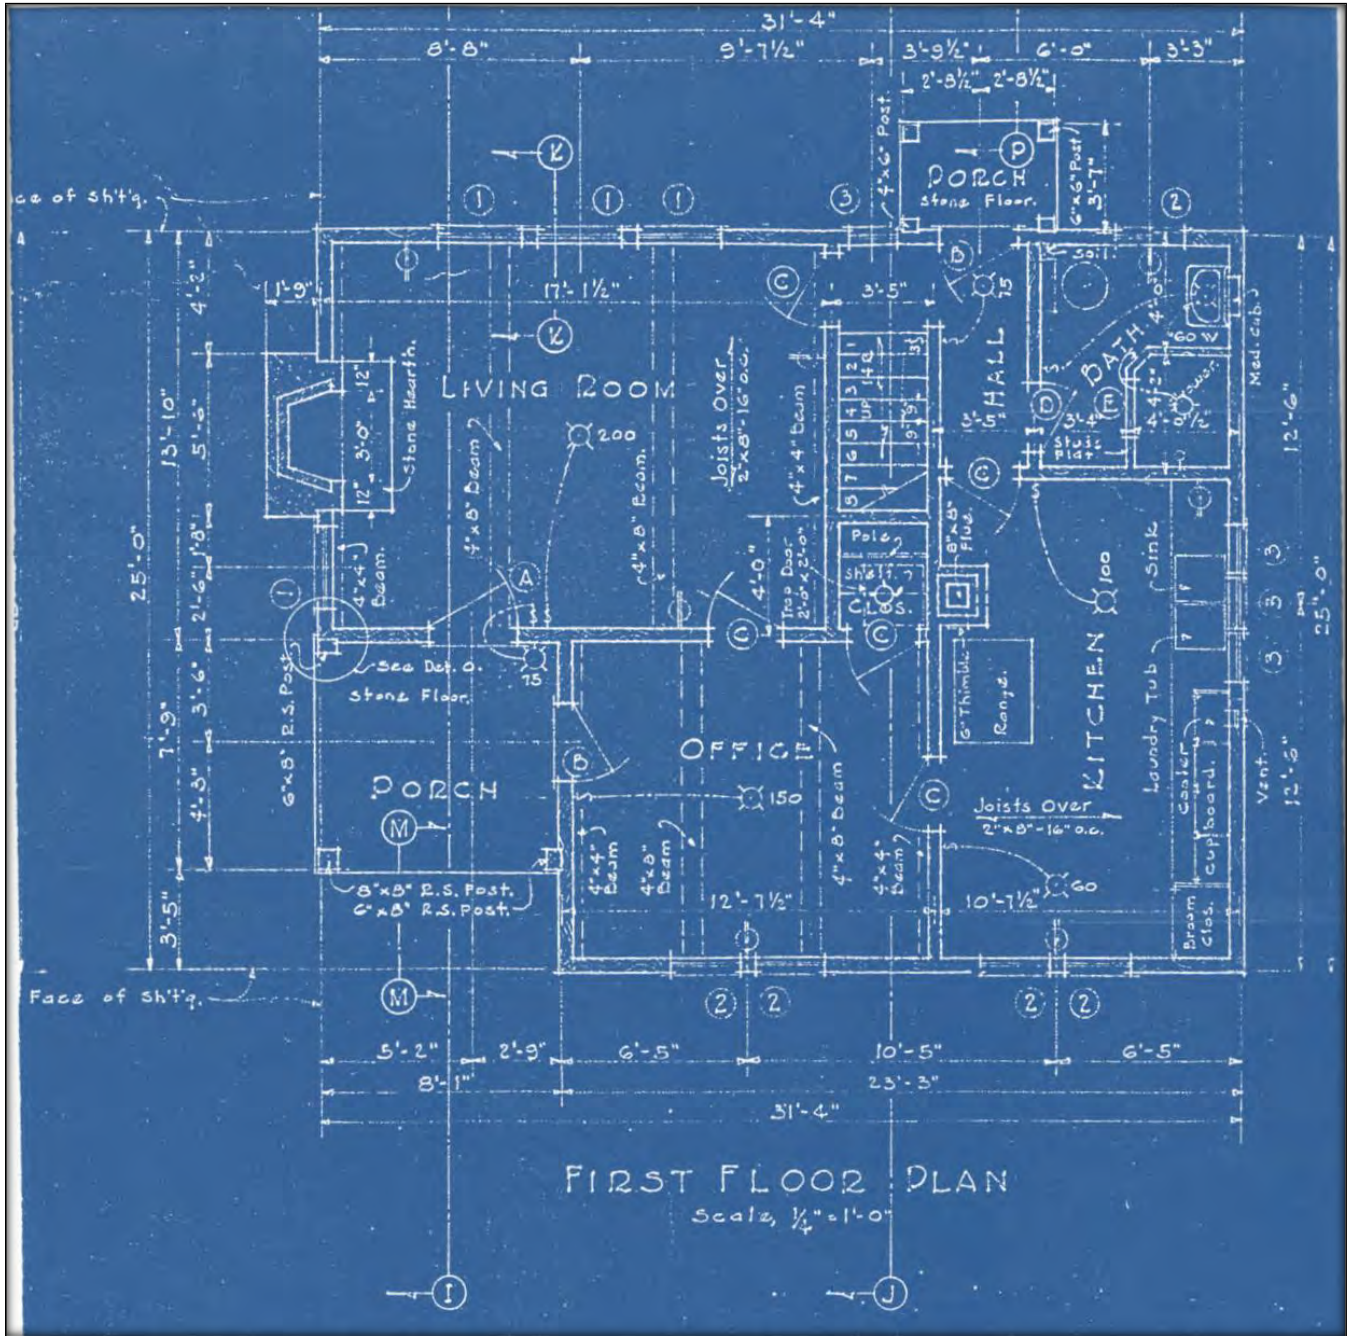
Government Mineral Springs Guard Station
Floor Plan – First Floor
From original plan
3/31/1937

The Guard Station is a one and one-half story wood-framed structure, irregular in plan, on a poured concrete perimeter foundation with portions of the foundation faced with stone. The structure measures 31 feet by 25 feet, on a northeast/southwest axis. The exterior walls of the first floor consist of horizontal clapboard, while the gabled ends are covered in vertical board and batten siding with an angular cut at the base. There is a coursed rubble stone interior chimney with an arched cap, also called a "Haystack Cap", slightly northwest of center, projecting from the main ridge crest of the roof. In addition, there is an exterior, coursed rubble stone chimney with an arched cap located on the southeast gable end. The roofing material consists of split cedar wood shingles. The southeast section of roof does not extend to the end of the building footprint and finishes with a smaller adjoining gabled roof. The boxed eaves project slightly, and the verge boards project very slightly. Please see the Graphics section, for the original floor plan and elevation drawings.

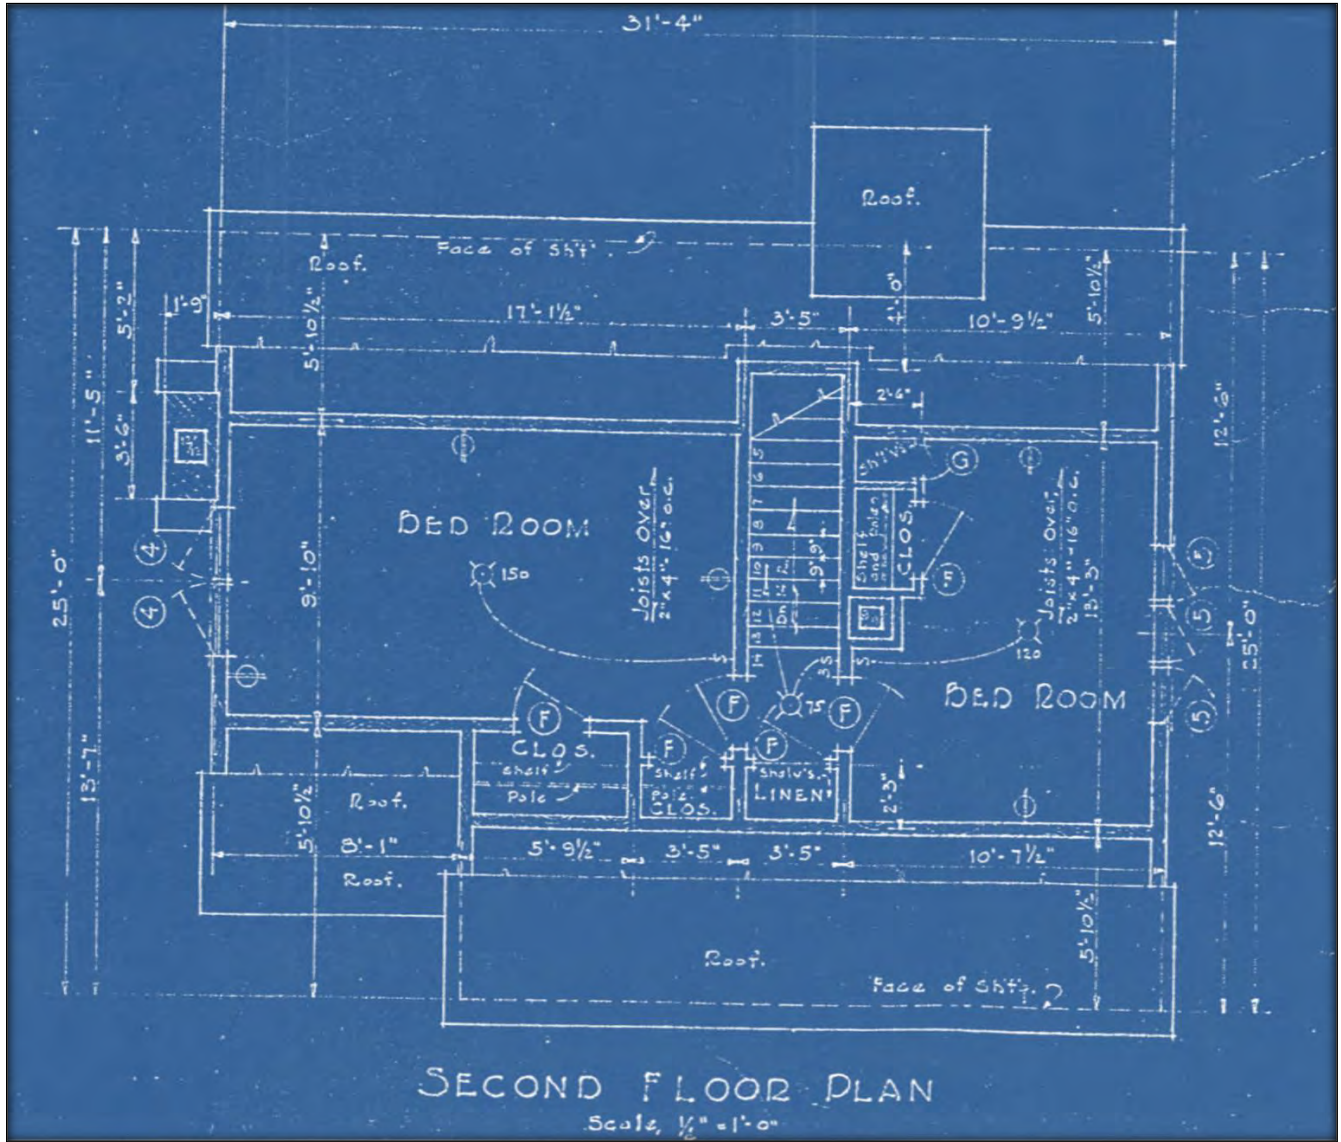
Government Mineral Springs Guard Station
Floor Plan – Second Floor
From original plan
3/31/1937

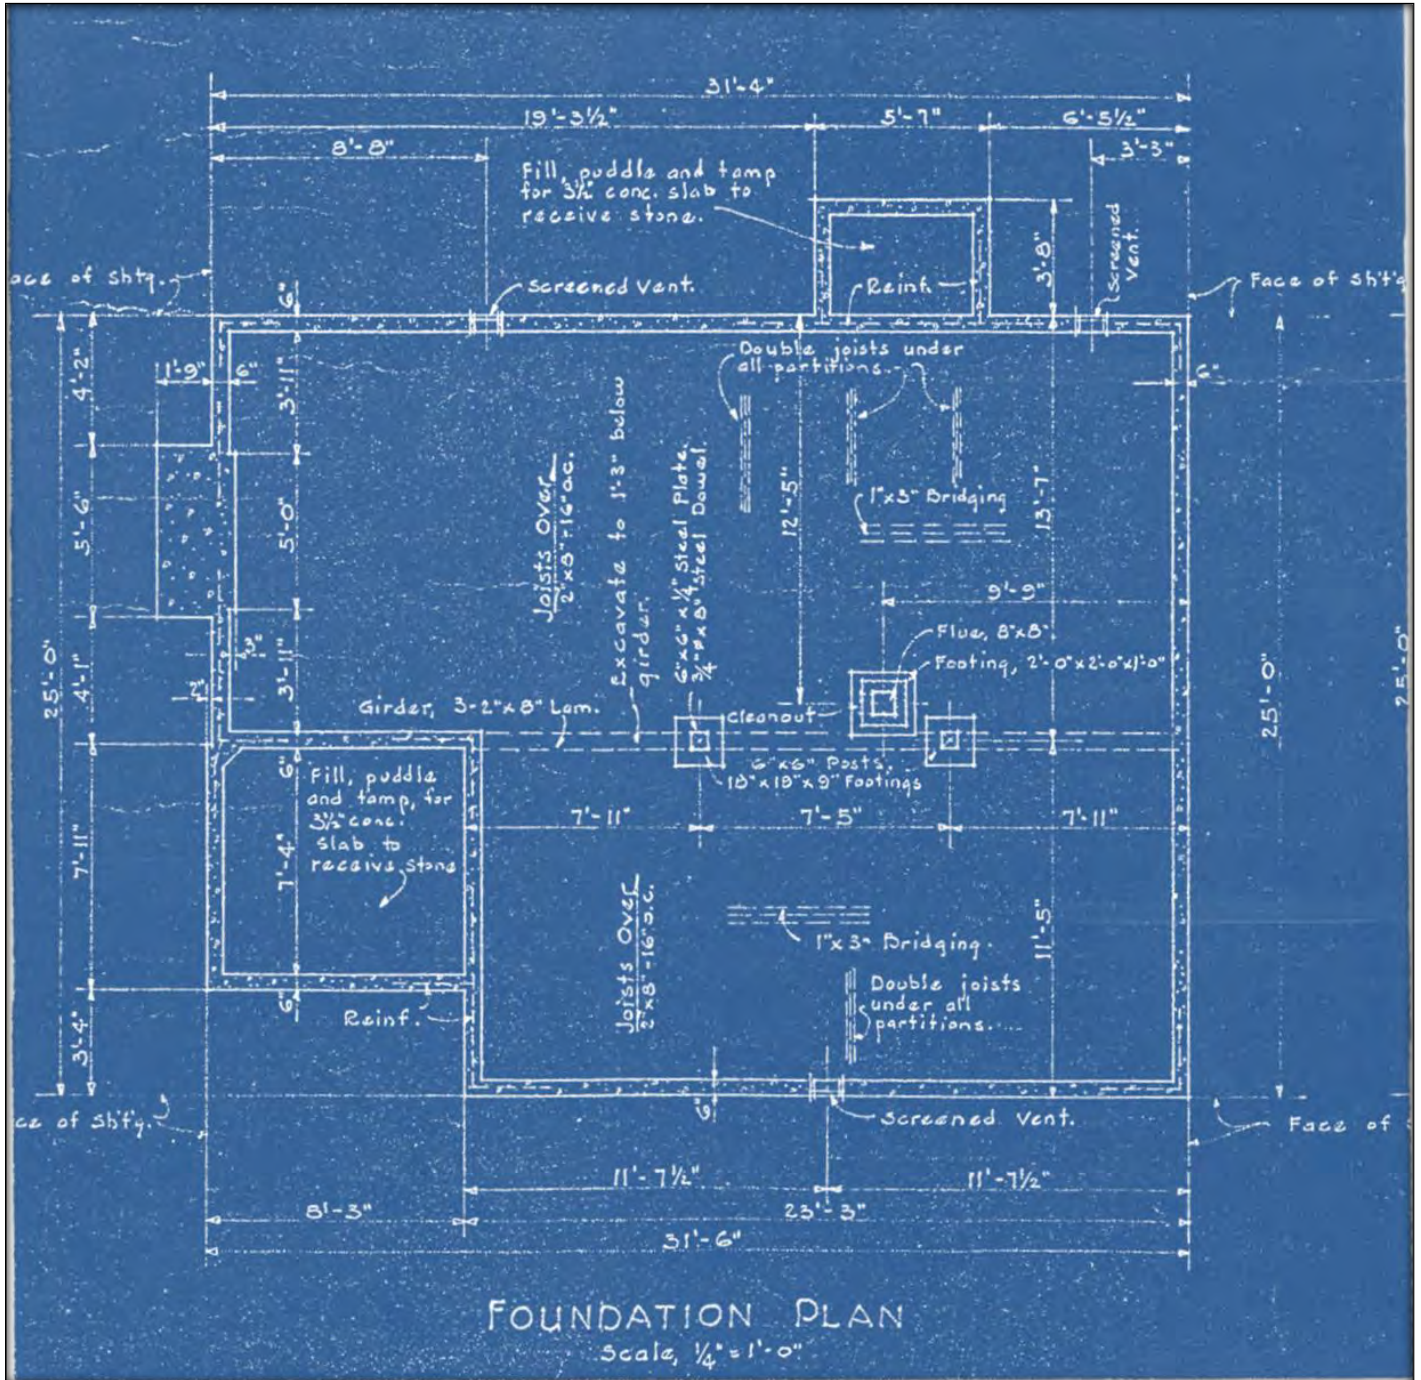
Government Mineral Springs Guard Station
Foundation Plan
From original plan
3/31/1937

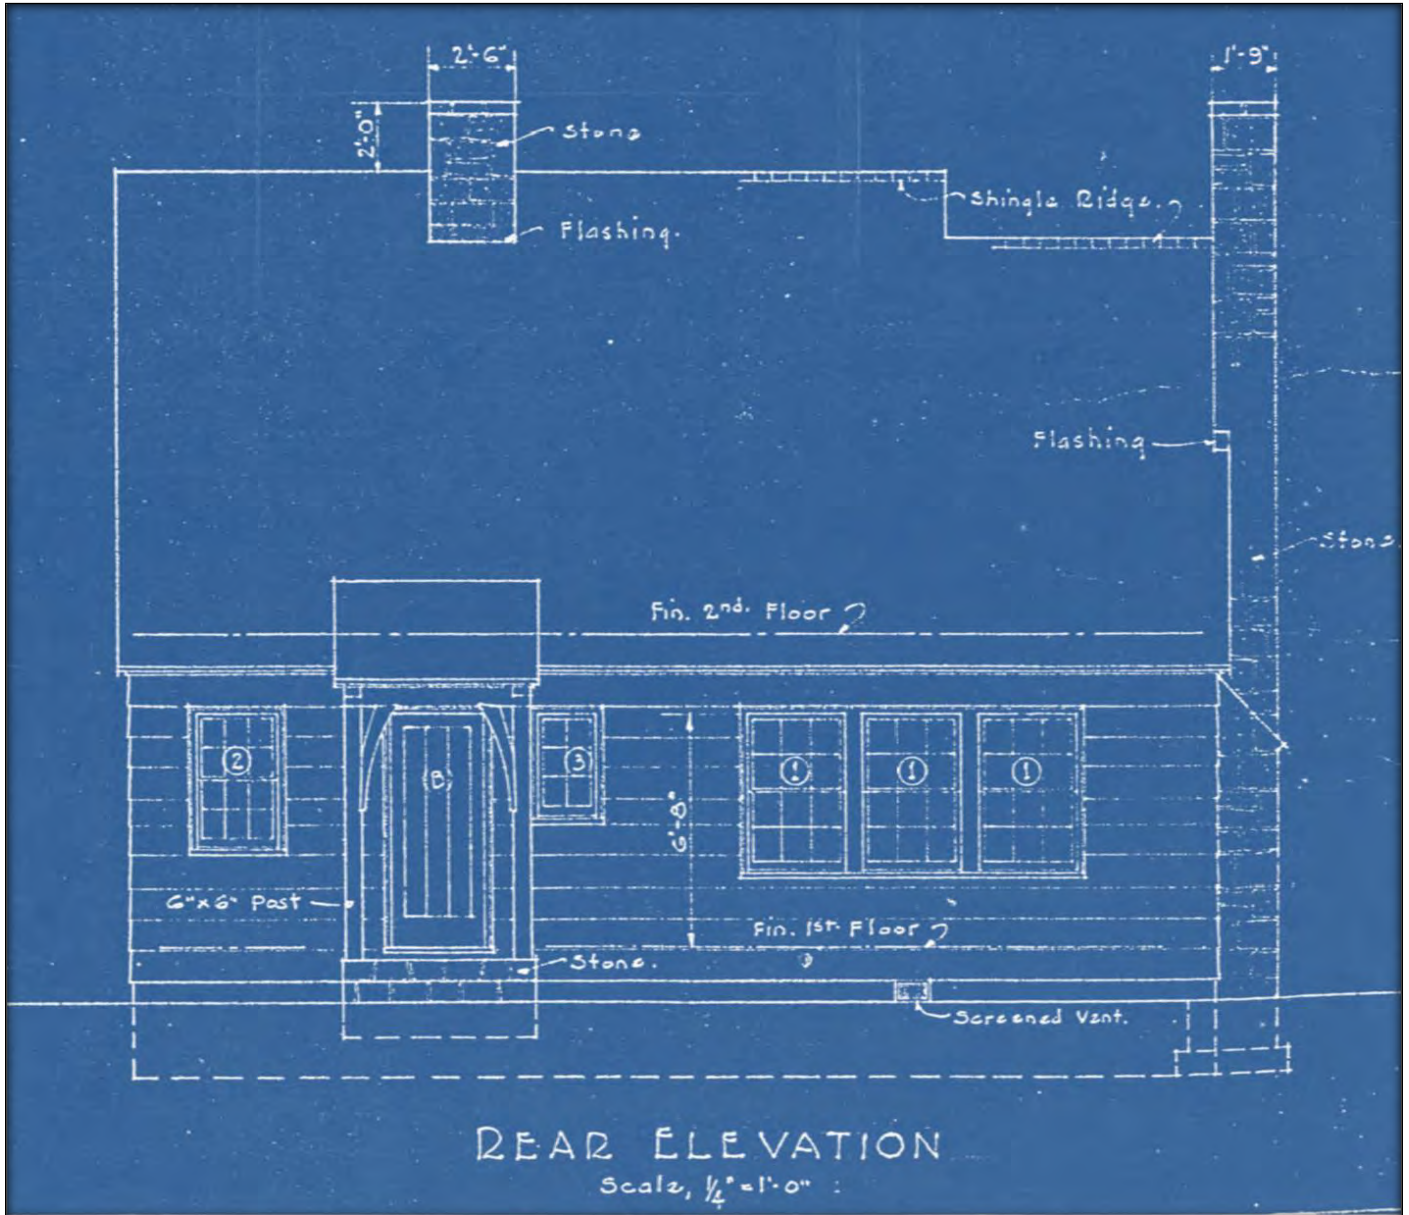
Government Mineral Springs Guard Station
Rear Elevation
From original plan
3/31/1937

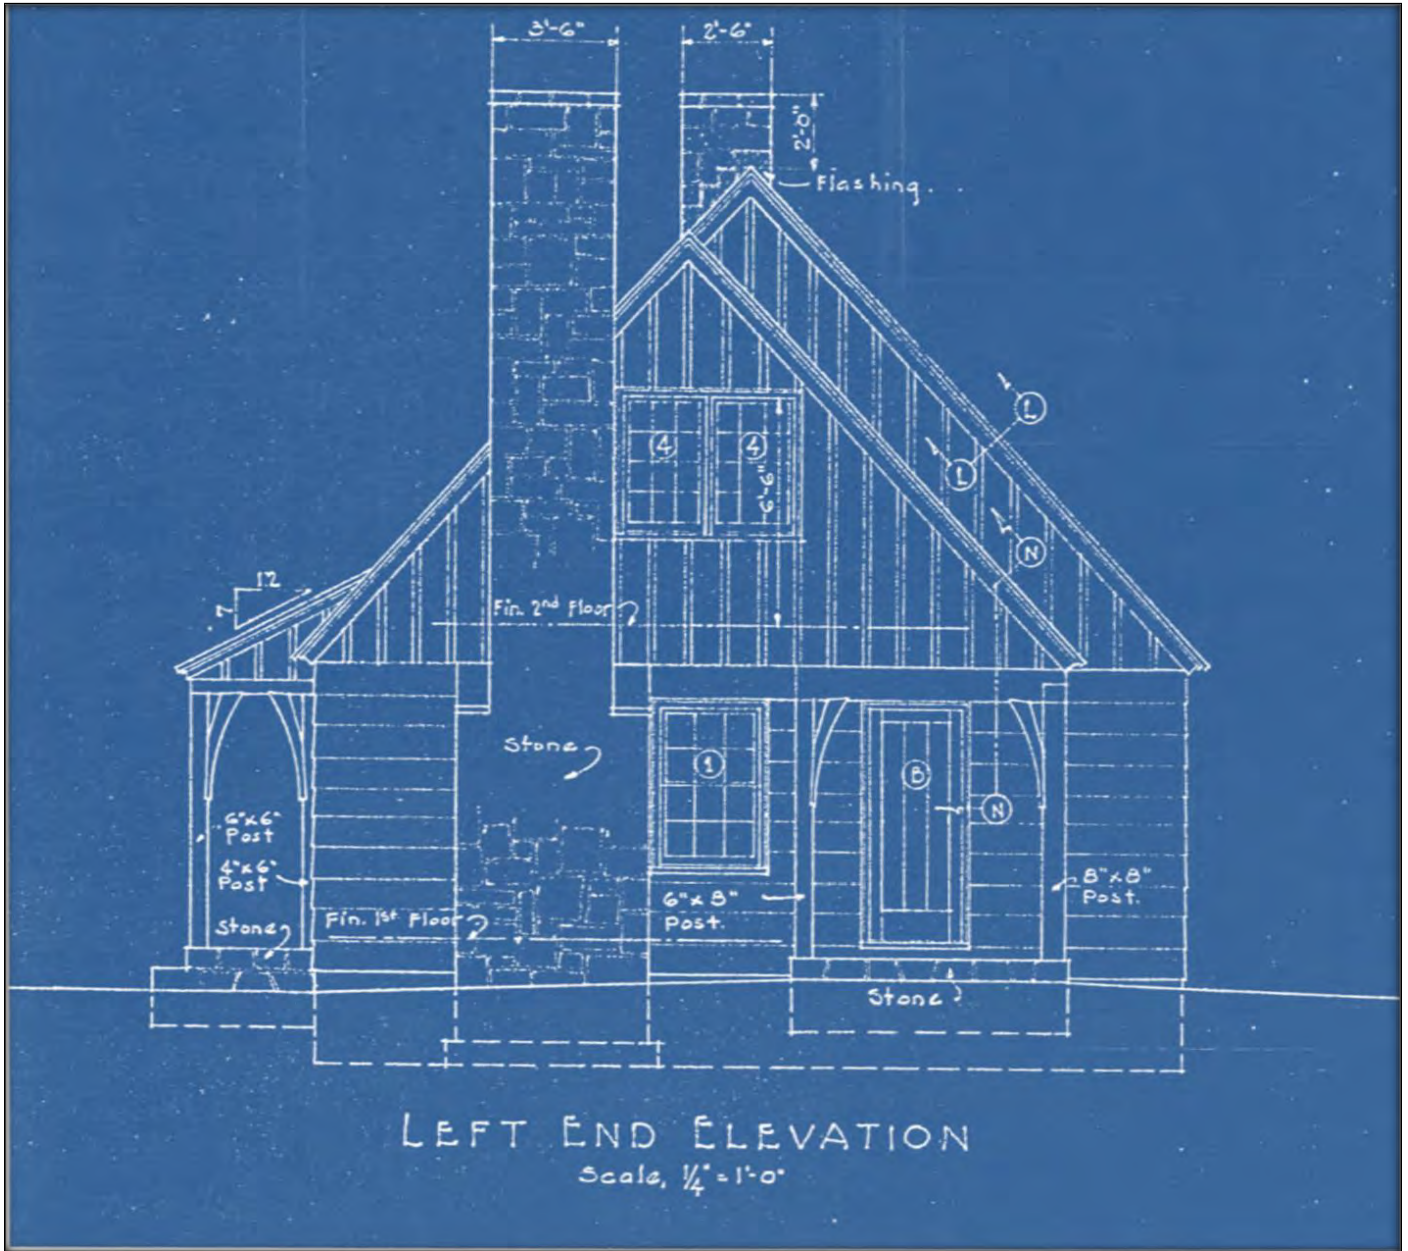
Government Mineral Springs Guard Station
Left (SE) Elevation
From original plan
3/31/1937

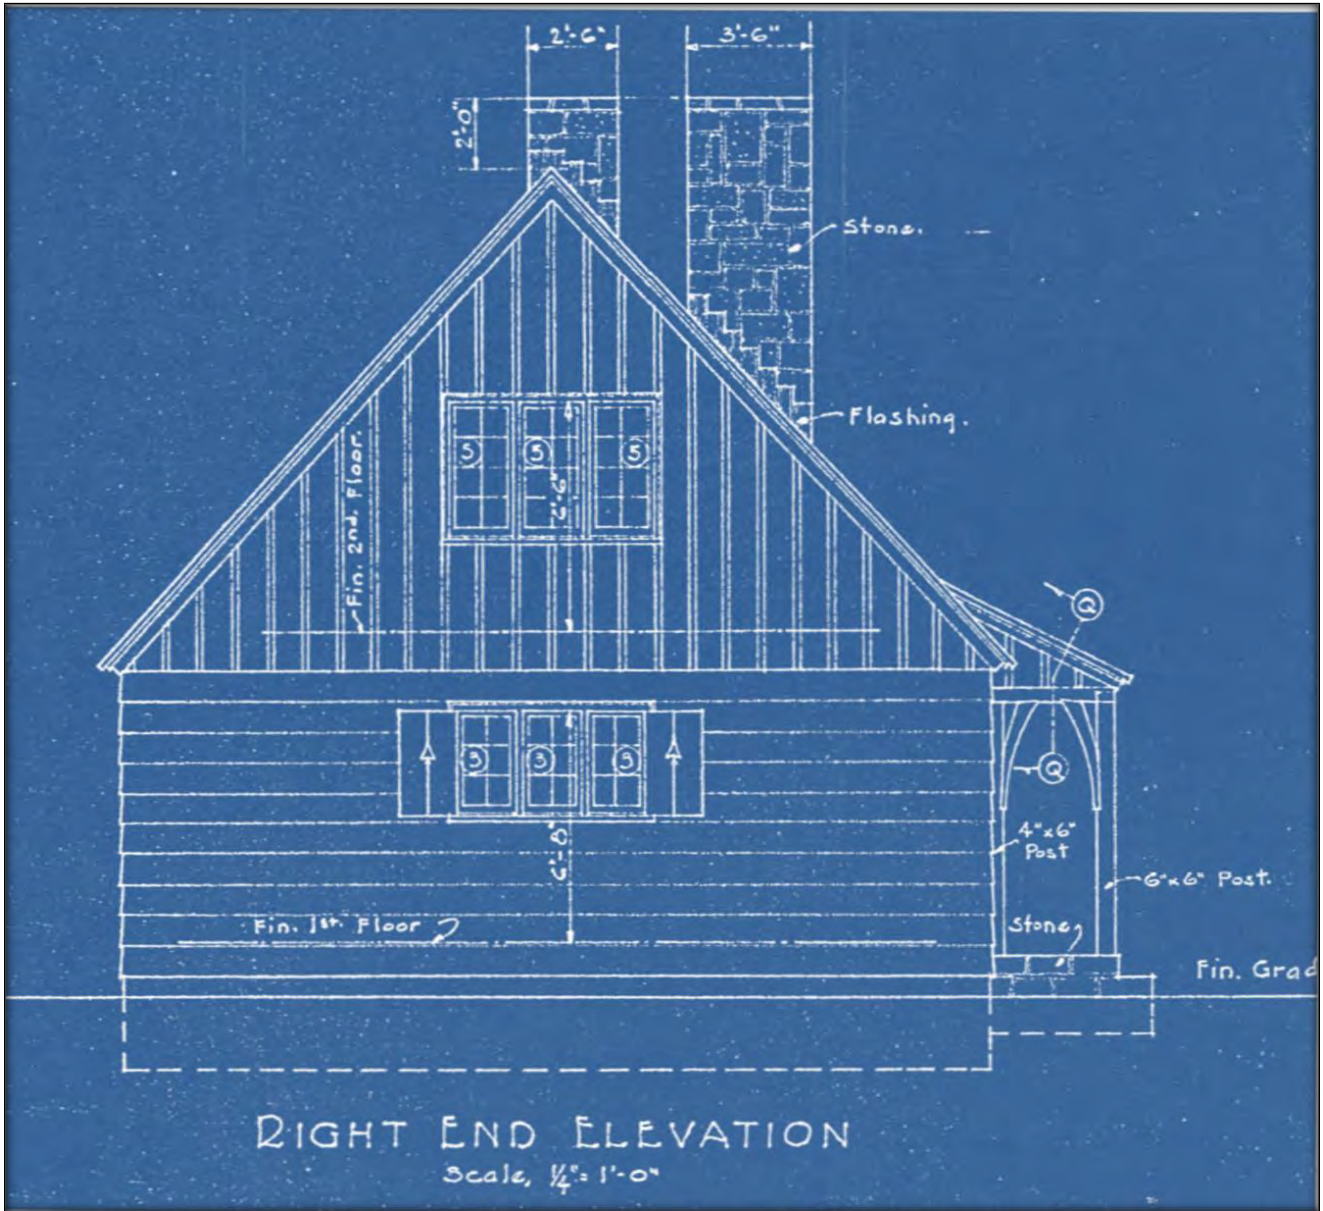
Government Mineral Springs Guard Station
Right (NW) Elevation
From original plan
3/31/1937

The northwest elevation faces the driveway and has a gable end with vertical board and batten siding with an angular cut at the base. The lower level has horizontal clapboard siding. Fenestration on the upper level of the northwest side consists of a combination of three eight-pane casement windows (two across and four down). Decorative pine tree cutouts flank these windows on either side, with another located above, in the peak of the gable. These decorations are cut out of the batten boards, with the flanking cutouts not shown in the building plans. On the lower level of the northwest side, there is a triple six-pane casement window (two across and three down) centered on the façade with a six-over-six double hung sash to the left. The six-over-six double hung sash is not in the original building plan (Graphics section); it is unknown if it was an original alteration or was installed at a later date. Located to the left of the three six-pane casement windows are two vents used to vent the cooler cabinet in the kitchen, currently blocked from the interior. A third vent to the right of the three six-pane casement windows provides ventilation for the bathroom but was not included in the original plans.

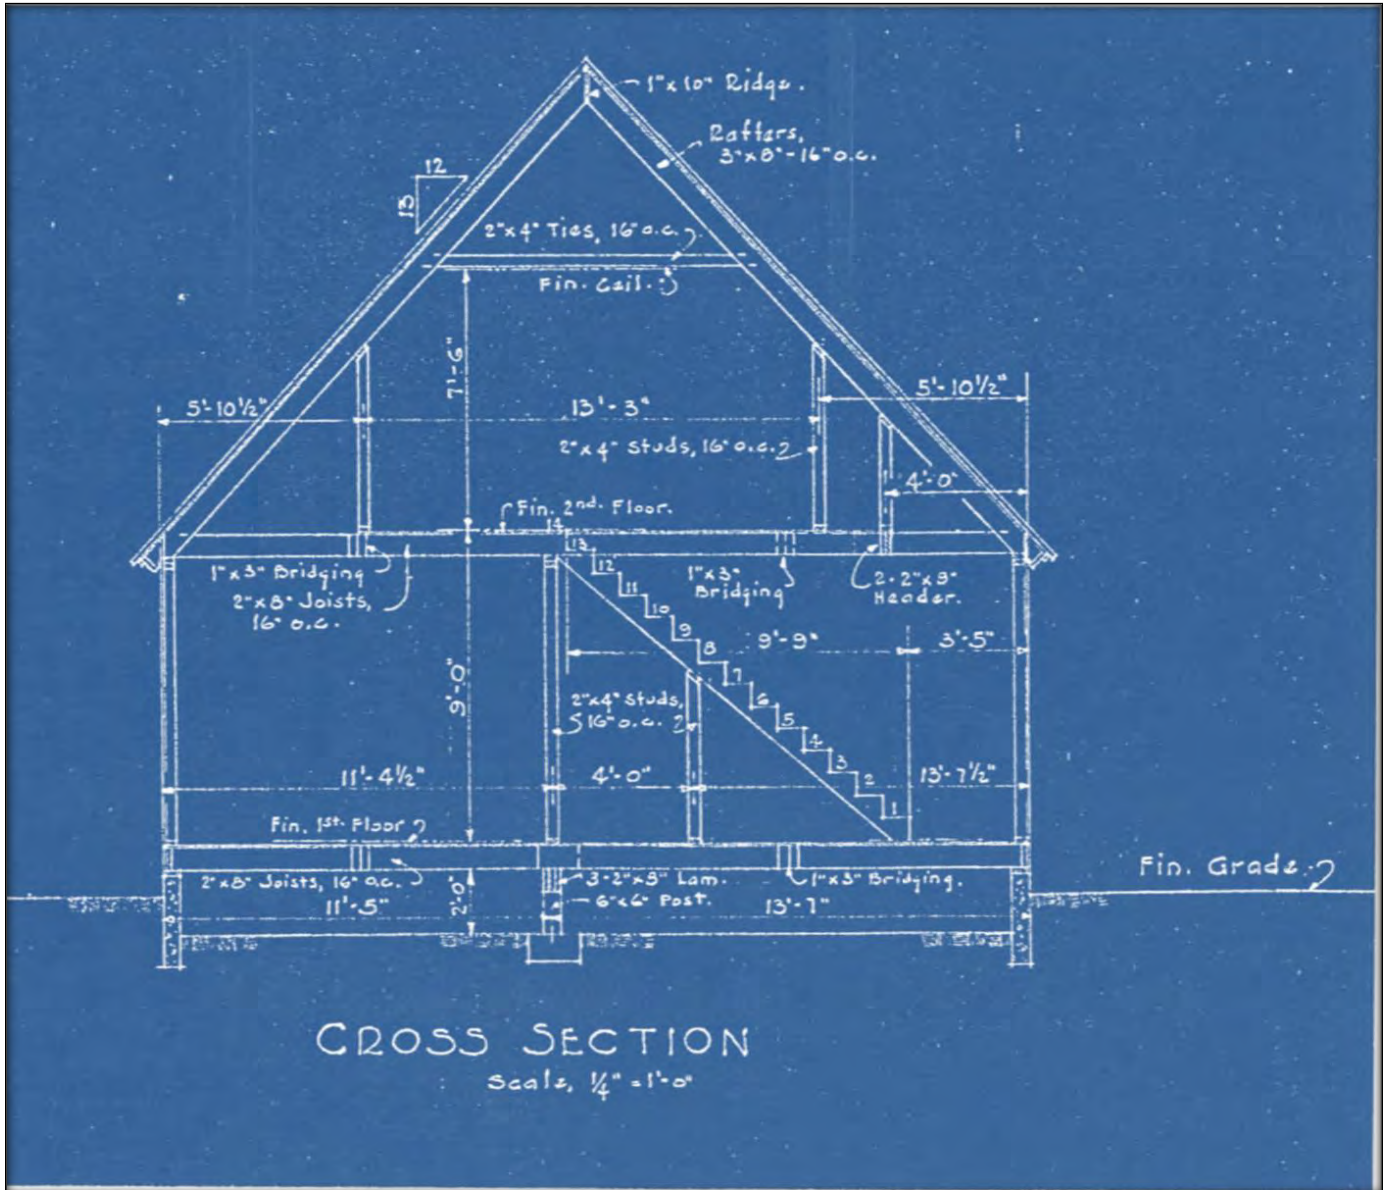
Government Mineral Springs Guard Station
Cross Section
From original plan
3/31/1937

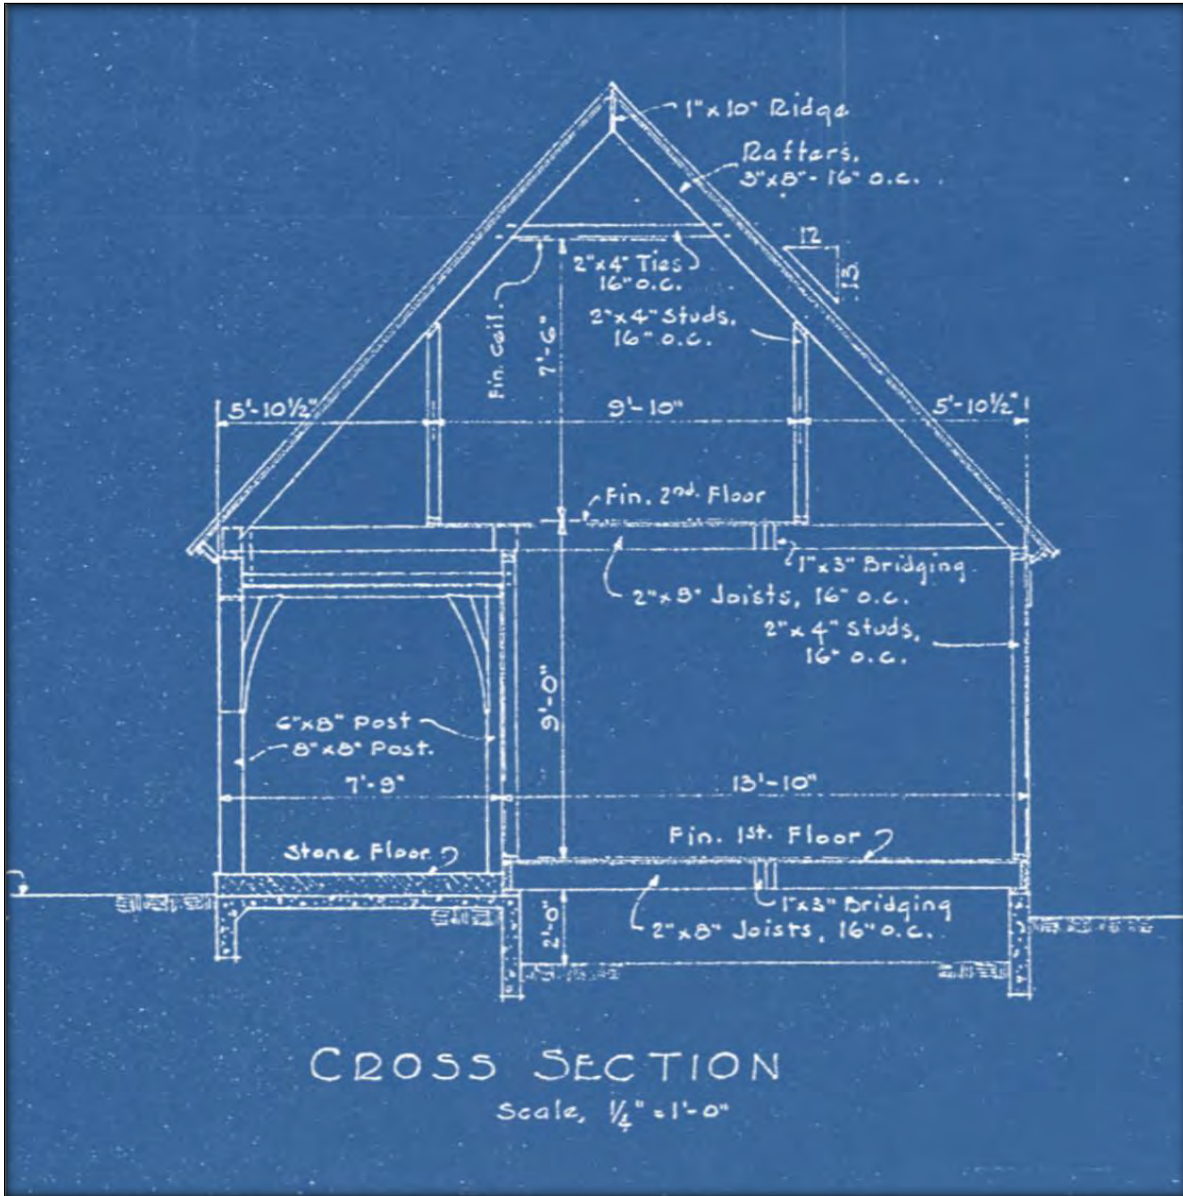
Government Mineral Springs Guard Station
Cross Section
From original plan
3/31/1937

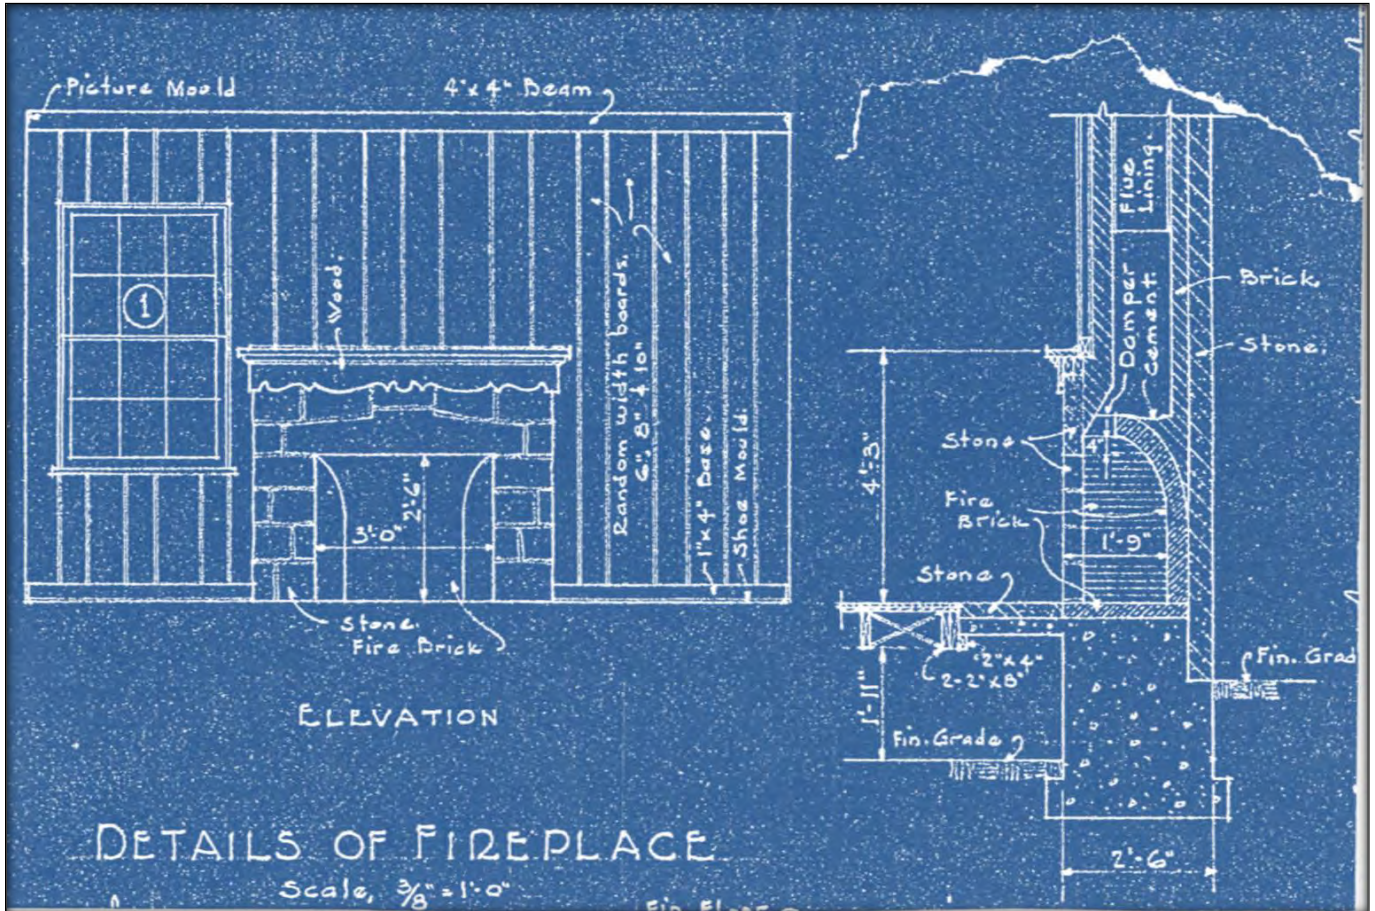
Government Mineral Springs Guard Station
Details of Fireplace
From Original Plan
3/31/1937

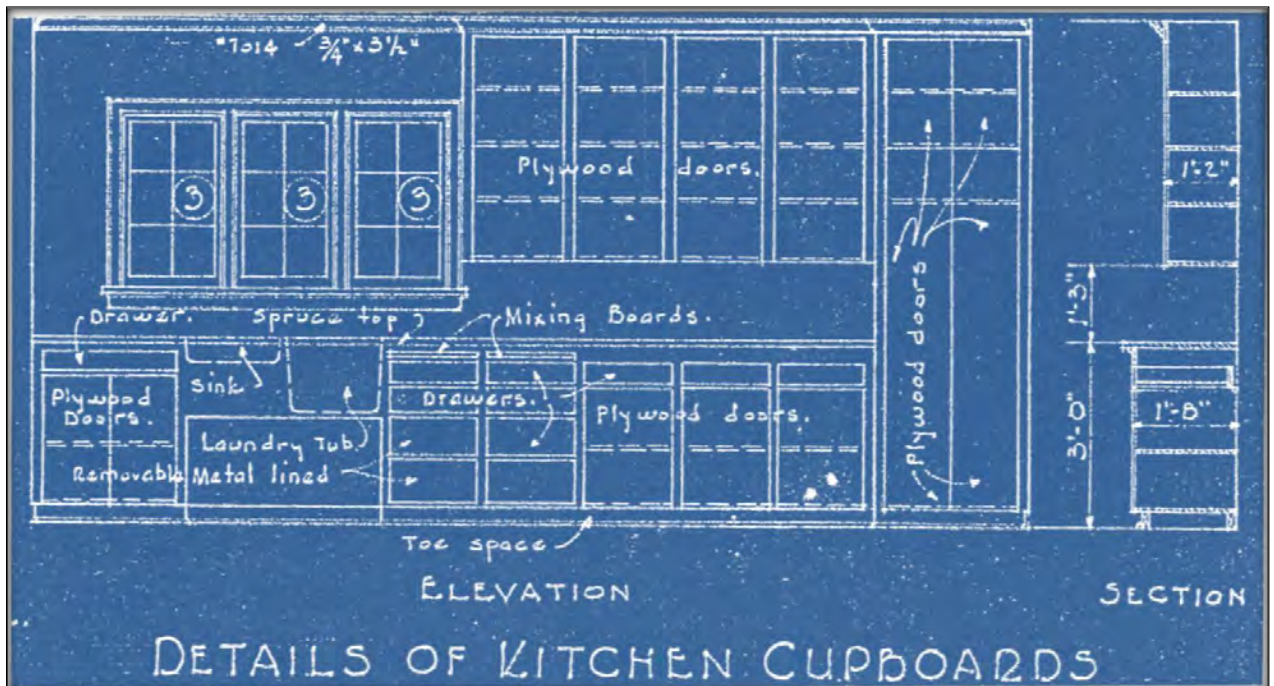
Government Mineral Springs Guard Station
Details of Kitchen Cupboards
From Original Plan
3/31/1937

The kitchen measures 10' 7½" x 17' 0" and can be accessed by two doorways, one from the northwest leading to/from the office, and the other on the northwest wall, leading to/from the hallway. The kitchen floor, which was originally a dark linoleum, was replaced during 2001 and 2002 rehabilitation efforts with a lighter linoleum that matches the original pattern. The walls and ceiling consist of painted plywood. The cabinets along the northwest wall support a counter top with a drop sink and wash tub, with no running water. The original built-in cabinetry above the counter top to the right of the three six pane casement windows was removed in 2001, due to damage. A floor-to-ceiling cabinet at the end of the counter was also removed along with the cabinets, counter, and hung cabinets on the southwest wall. The cooler vents have been plugged.

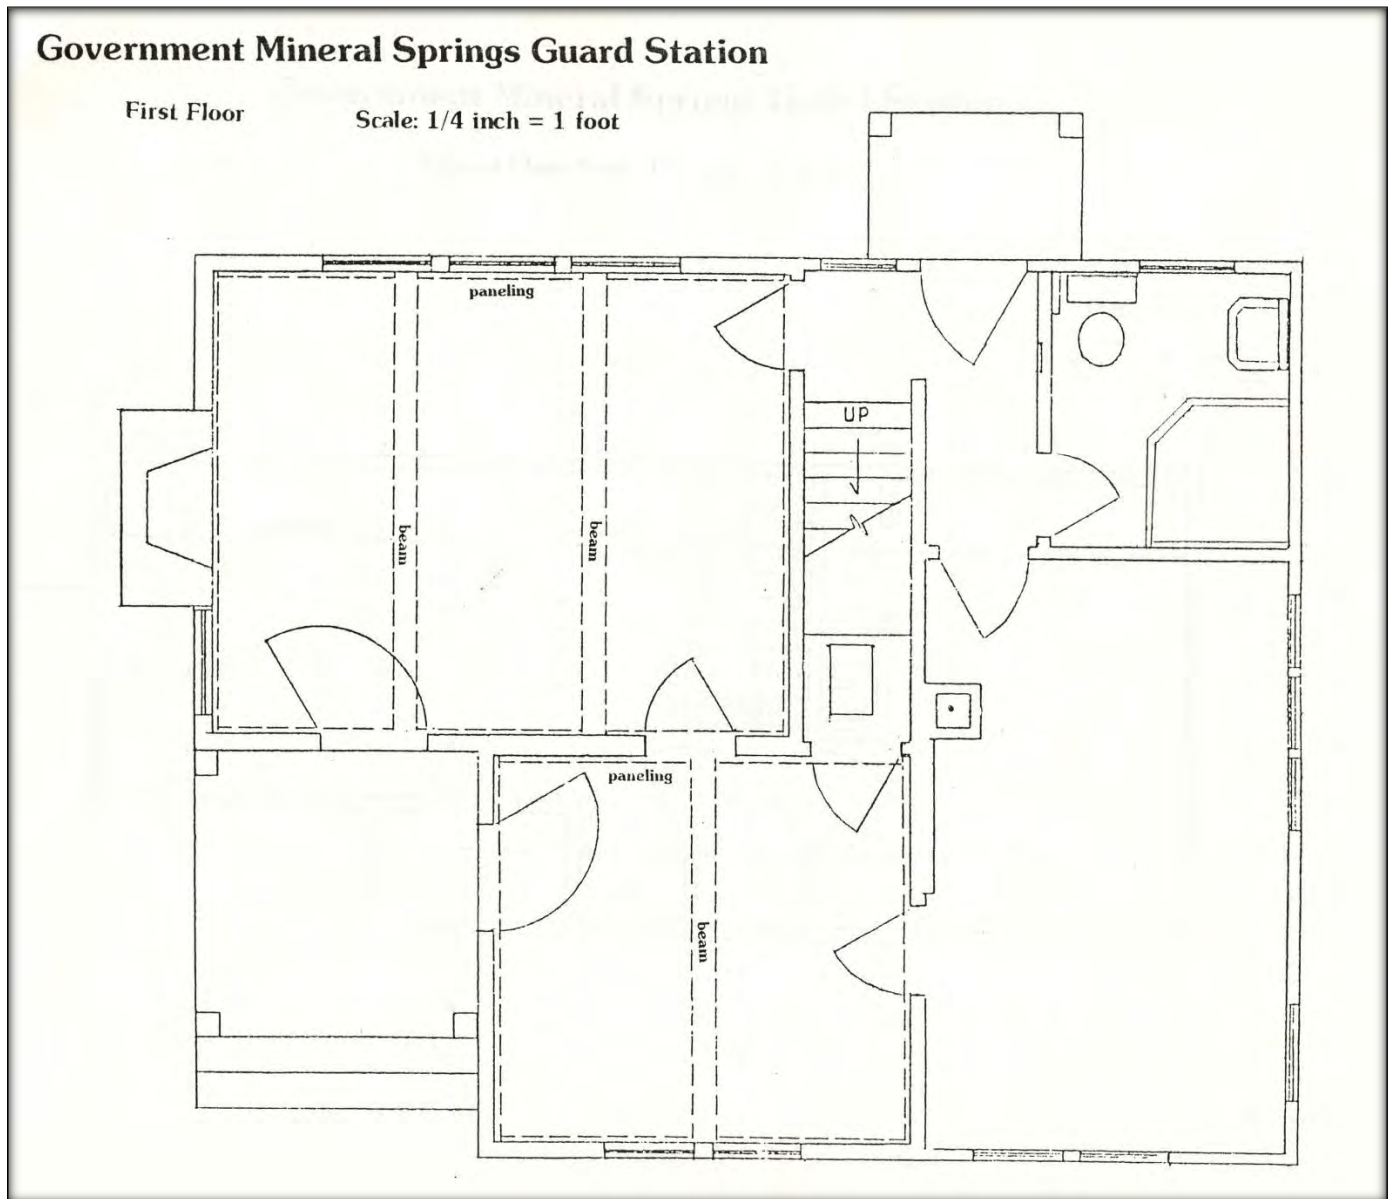
Government Mineral Springs Guard Station
Floor Plan – First Floor
Date unknown

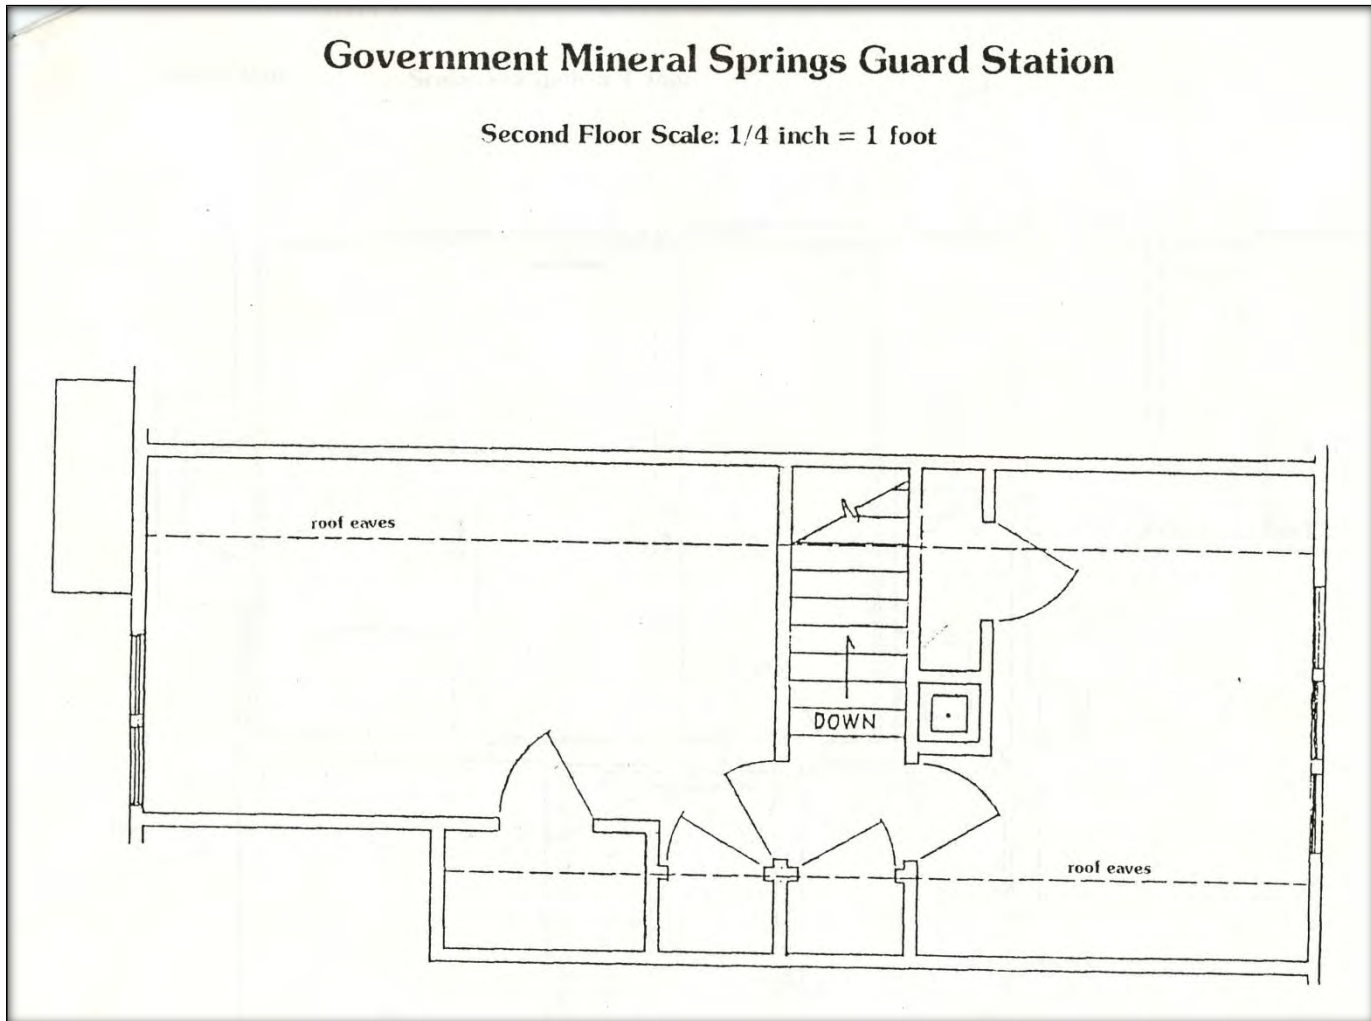
Government Mineral Springs Guard Station
Floor Plan – Second Floor
Date unknown
