National Register of Historic Places Registration Form

historic name Government Mineral Springs Guard Station

other names/site number GMS Guard Station #1051

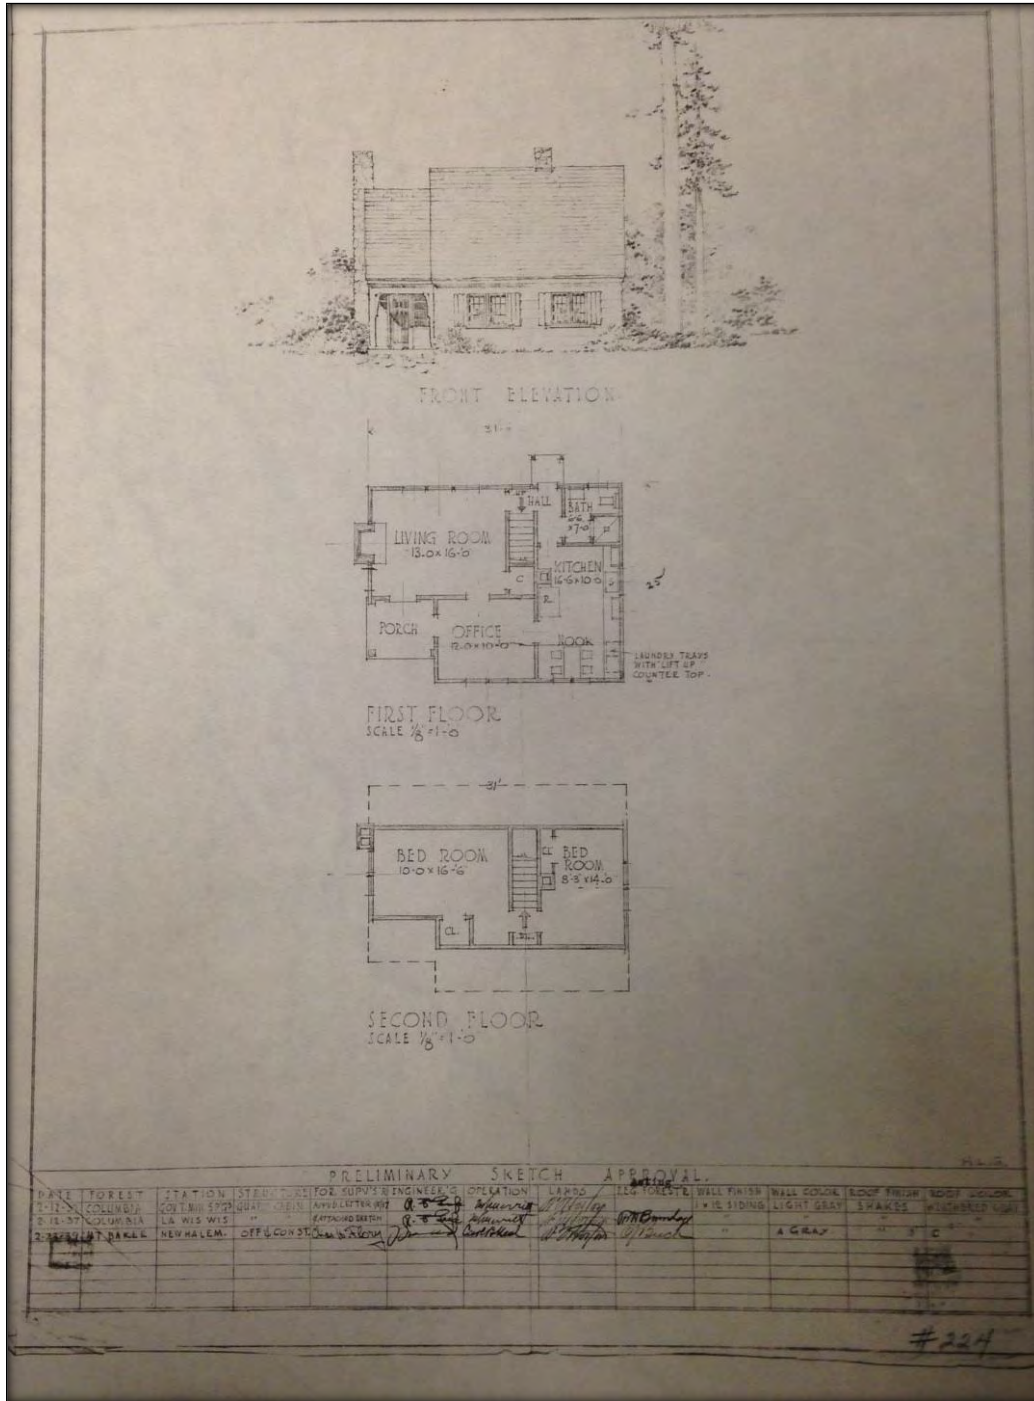
Preliminary sketch for the Government Mineral Springs Guard Station, La Wis Wis Guard Station, and Newhalem Guard Station, which was to be built on the Mt. Baker National Forest.

1. Both building sites are located in large Douglas fir timber.
2. No basements are desired.
3. Steep shake roof desired.
4. Truss for a maximum snow load of ten feet.
5. No, or very little overhanging eaves.
6. Wide rough siding desired.
7. Rustic interior.
8. Lava rock available at Government Mineral Springs for fireplace but not at La Wis Wis.
9. A desirable color would be gray stain walls and brown shutters.
10. Twelve foot studs desired to obtain story and one-half effect.
11. The only existing building in each case is a community kitchen of design similar to Recreation Handbook Plate 12-E-1.

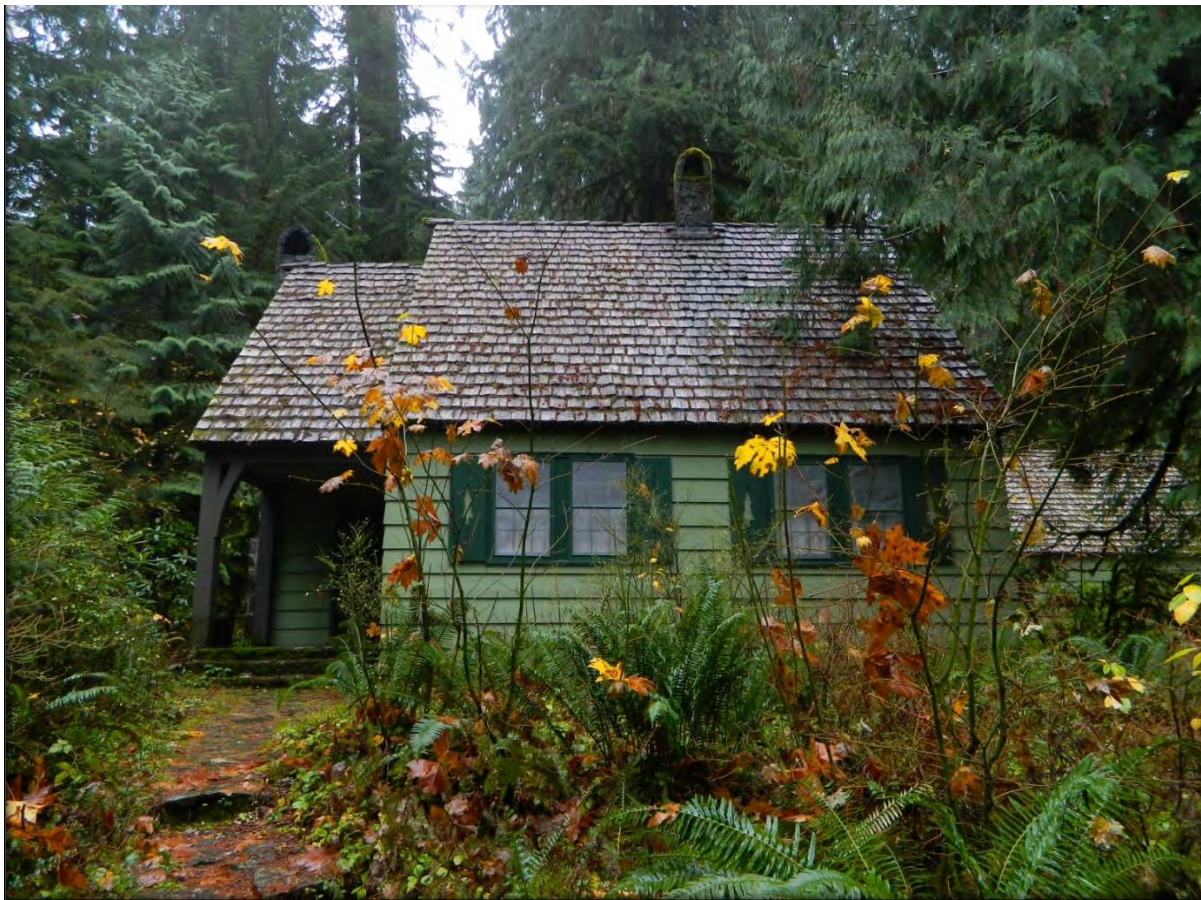
Photograph #1 - Main Façade (northeast elevation) with front porch

The primary entrance on the main façade is on the northeast elevation. There are two primary entrances to the building, both are recessed and located under the adjoining gable roof on the front porch. The northeast (main façade) entrance accesses the living room. The door is constructed of solid wood with knotty pine paneling. The door exterior is painted dark brown to match the exterior trim and the interior panels match the knotty pine paneling pattern of the interior walls. The door handle hardware on each front door consists of a separate dead bolt and non-locking lever latch system. The dead bolt and latch plates at the lever, along with the handle base, are in the shape of a fleur-de-lis. The interior latch is a simple door knob with no plate. There is the outline of a removed plate on the back door.

The inset area of the northeast elevation forms a porch consisting of an open flagstone platform measuring 7' 9" x 7' 11", with three stone steps. The inset is supported on the southeast corner by one 8" x 8" square timber post with short, curving brackets. Siding on this elevation consists of horizontal clapboard and the roofing material is cedar shingle. The main façade has two grouped pairs of six-over-six double hung sashes. These windows are flanked with vertical board faux shutters with two-tiered decorative pine tree cutouts. These windows are original, as shown in the plan for the front elevation (Graphics section). Portions of both chimneys are shown in the elevation, with the open end of the arched caps shown.

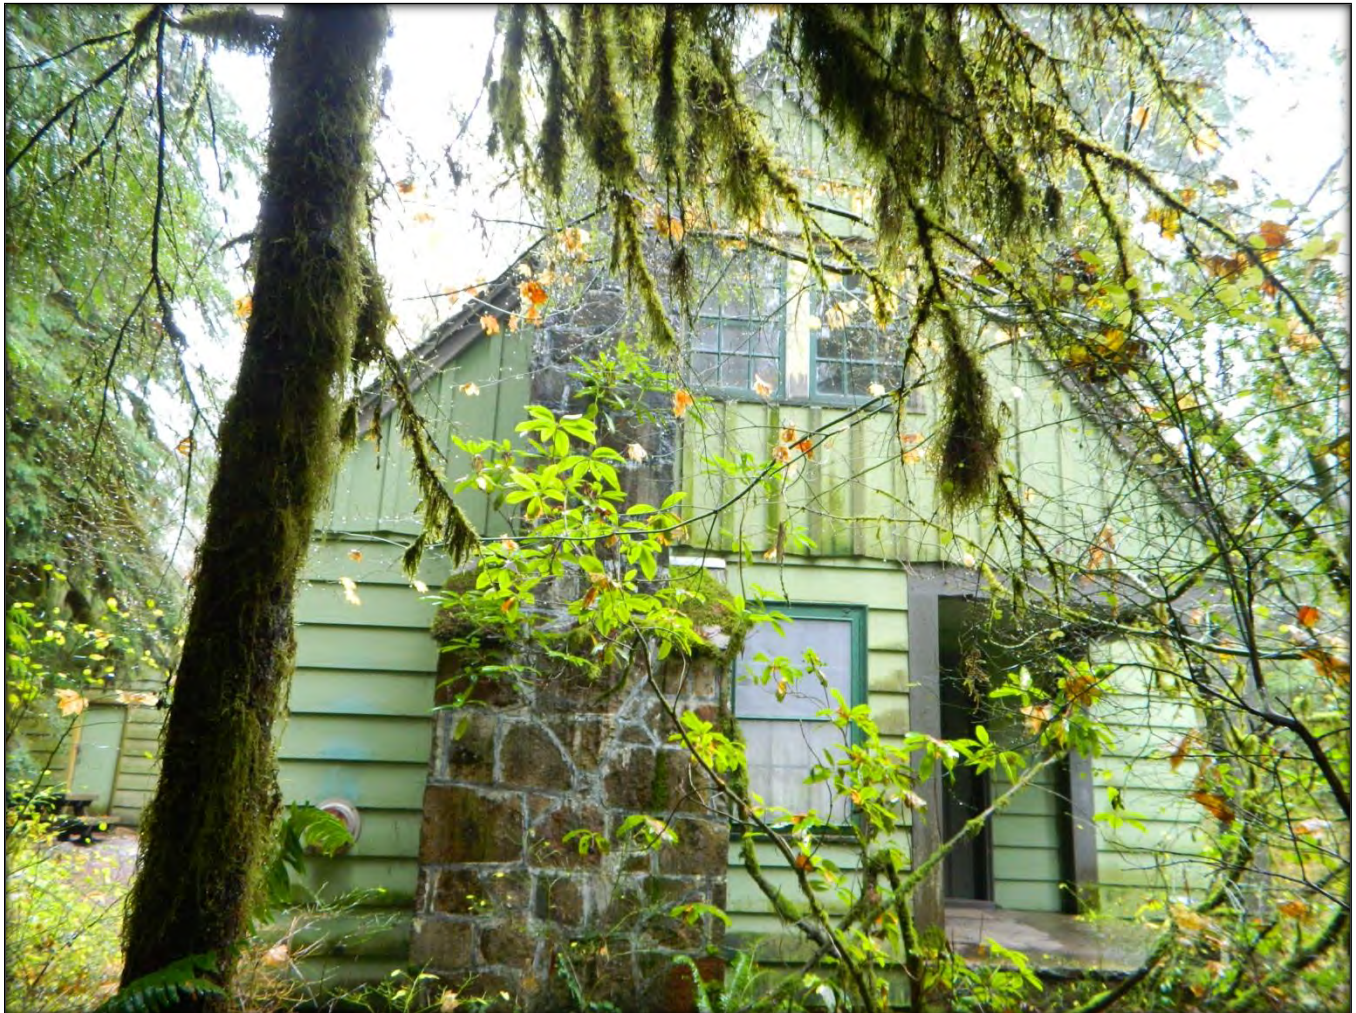
Photograph #3 - Southeast elevation with exterior chimney and front porch

The southeast elevation has the second of the two main entrances in the recessed porch. The door is constructed of solid wood with knotty pine paneling, identical to the other primary entrance. This door accesses the office/dining room. The southeast section of roof does not extend to the end of the building footprint and finishes with a smaller adjoining gabled roof. This gable end has board and batten siding with an

Fenestration on the southeast elevation of the upper level consists of a pair of twelve-pane casement windows (three across and four down) with mullion. These windows are original, as shown in the plan for the front elevation (Graphics section). There is also a single two-tiered decorative pine tree cutout above the window, in the peak of the gable. On the lower level is a single six-over-six double hung sash. A single vent for the gas heater is located to the left of the chimney.

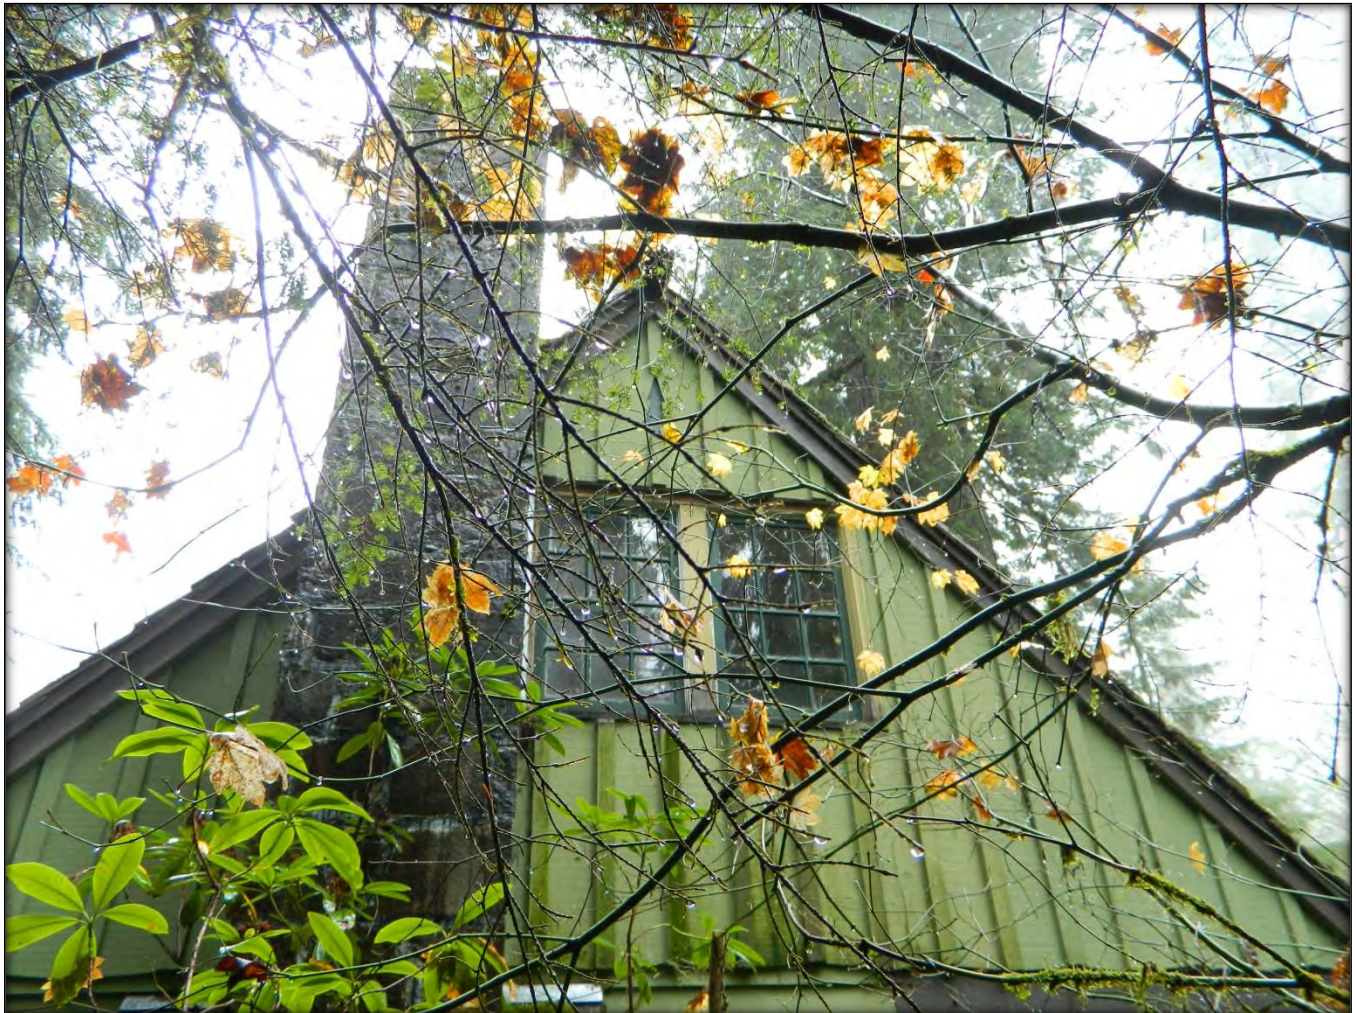
Photograph #4 - Gable portion of southeast elevation

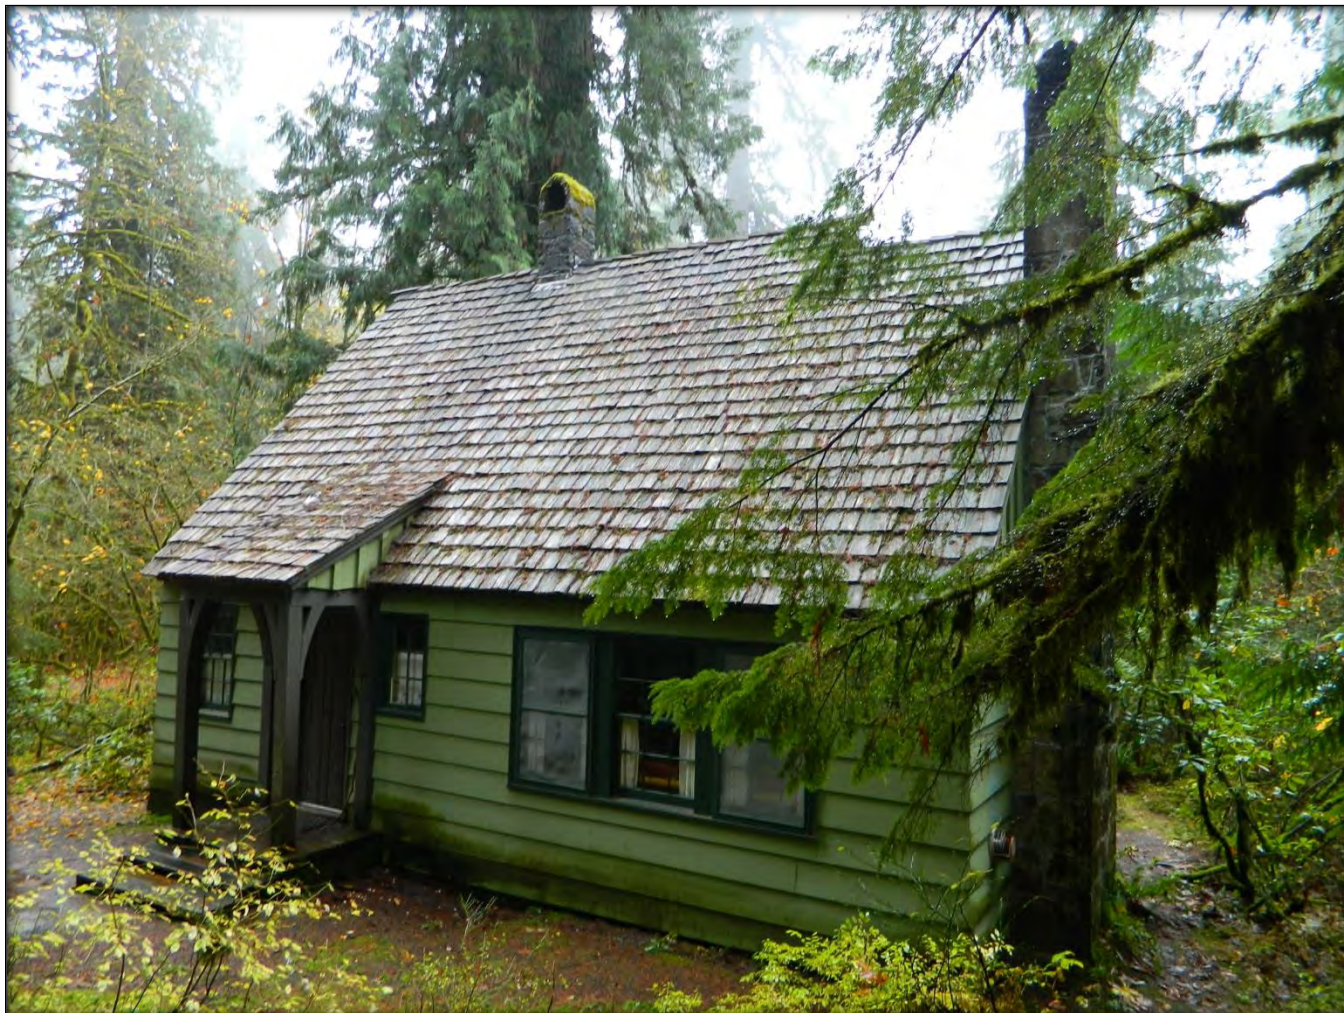
Photograph #5 - Southwest elevation with back porch, exterior chimney (on right), and interior chimney (center top). Photo taken at an angle due to vegetation obstructing a clear perpendicular shot

The southwest elevation is the rear of the building, and contains the rear entrance which is offset to northwest (left if facing the building) of center. It is covered by a small shed roof porch supported by two 6" by 6" square timbered posts with short, curving brackets. The rear door is accessed by a single stone step and an open flagstone platform measuring 3' 7" x 5' 5". The rear door exterior is similar to the front doors, with dark brown-painted knotty pine paneling, with a single, solid wood panel on the interior. The door handle is a separate bolt with no plate and the latch is a door knob with a rectangular plate. Southwest elevation siding consists of horizontal clapboard and the roofing material is cedar shingle. Both chimneys are visible in this elevation. Window types include a single six-over-six double hung sash, located to the left of the rear entrance, and to the right a single six-pane casement window (two across and three down), and three six-over-six double hung sashes. These windows are original, as shown in the plan for the front elevation (Graphics section Section).

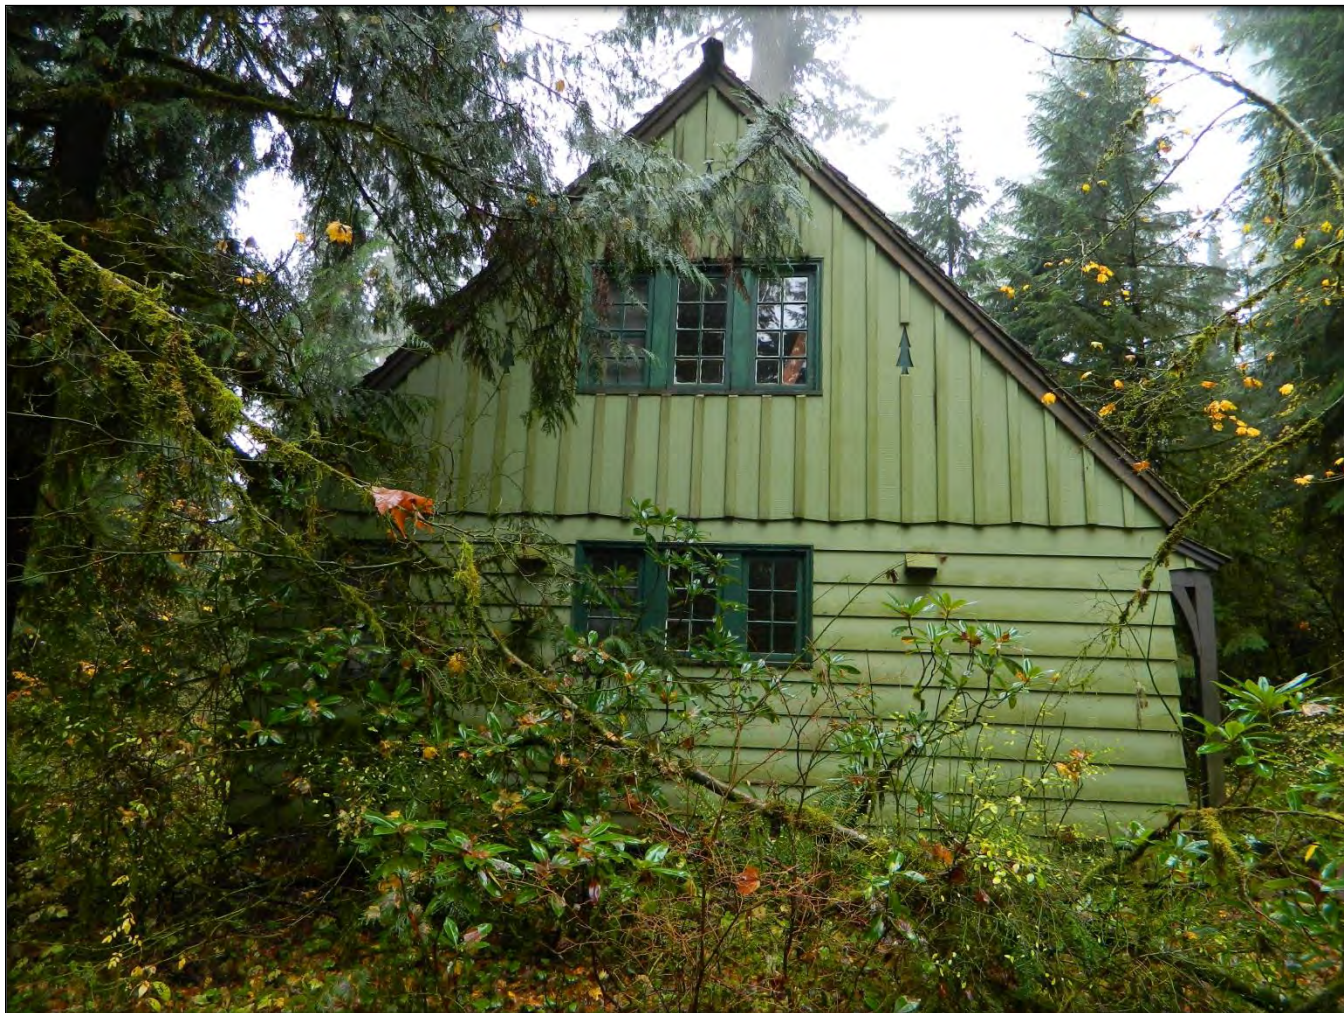
Photograph #6 - Northwest elevation showing gable and windows including window on left not shown on original elevation drawing (Graphics section)

The northwest elevation faces the driveway and has a gable end with vertical board and batten siding with an angular cut at the base. The lower level has horizontal clapboard siding. Fenestration on the upper level of the northwest side consists of a combination of three eight-pane casement windows (two across and four down). Decorative pine tree cutouts flank these windows on either side, with another located above, in the peak of the gable. These decorations are cut out of the batten boards, with the flanking cutouts not shown in the building plans. On the lower level of the northwest side, there is a triple six-pane casement window (two across and three down) centered on the façade with a six-over-six double hung sash to the left. The six-over-six double hung sash is not in the original building plan (Graphics section); it is unknown if it was an original alteration or was installed at a later date. Located to the left of the three six-pane casement windows are two vents used to vent the cooler cabinet in the kitchen, currently blocked from the interior. A third vent to the right of the three six-pane casement windows provides ventilation for the bathroom but was not included in the original plans.

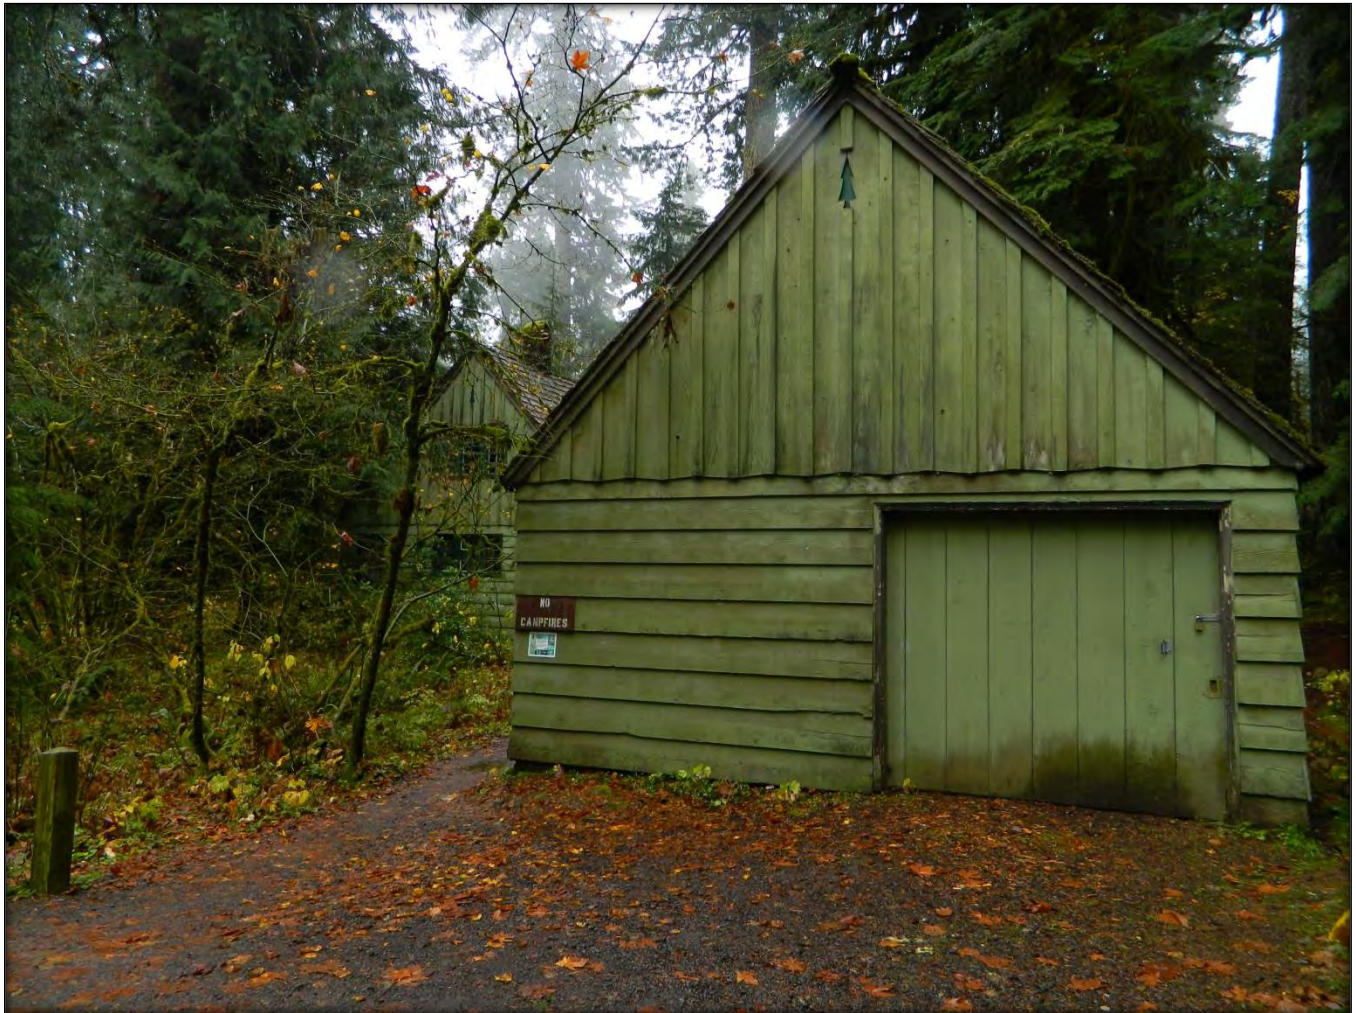
Photograph #7 - Garage - Front (NW) elevation with Guard station in background (left)

The garage is a single story, rectangular, wood-framed structure set to the immediate northwest of the Guard Station. It is oriented northwest/southeast. It has a concrete stem wall foundation and measures 28' 6" x 20' 3", with a height of 19' 2". The exterior walls of the bottom half consist of horizontal clapboard, while the gabled ends are covered in vertical boards and battens with an angular cut at the bottom. The roof materials consist of cedar shingles. The sliding garage door is located on the front façade (northwest side) of the building, right of center. It is solid wood and is set on a horizontal metal rail to slide open. It measures 7' 10" x 7' 1". There is a back door near the east corner, measuring 6' 8" x 2' 8", and is solid wood. Fenestration consists of three windows, two on the northeast elevation, and one on the southeast elevation. All three windows measure 2' 10" x 2' 5" and were likely either casement windows or a single unmovable sash. The sashes were removed at an unknown date. One of the windows on the northeast elevation has plywood placed over the opening and the other two have metal screen installed on the interior.

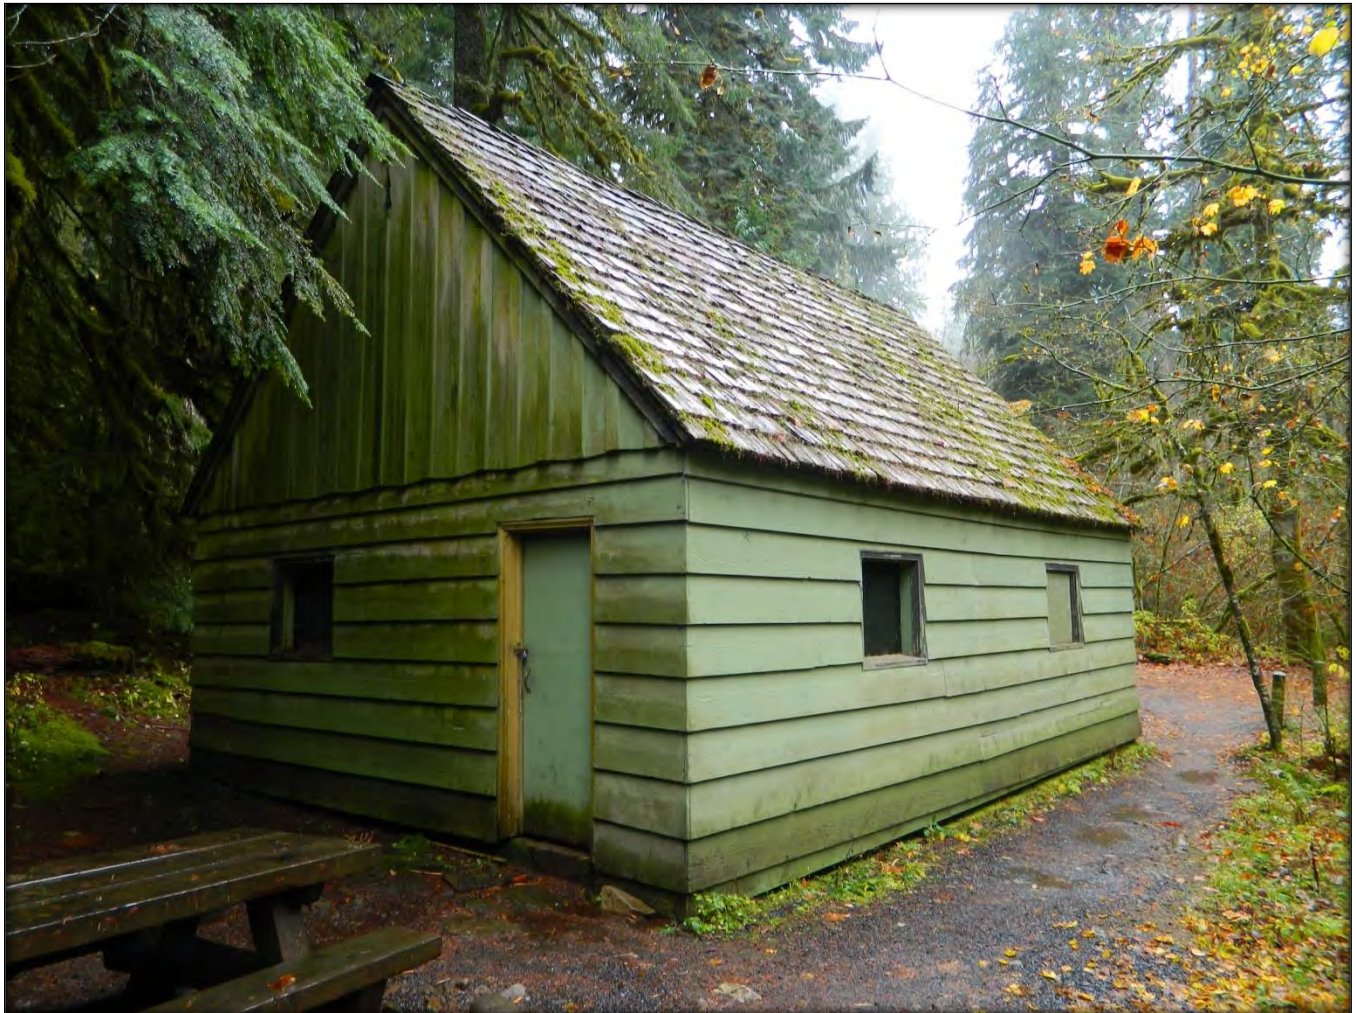
Photograph #8 - Garage - Side and back elevations

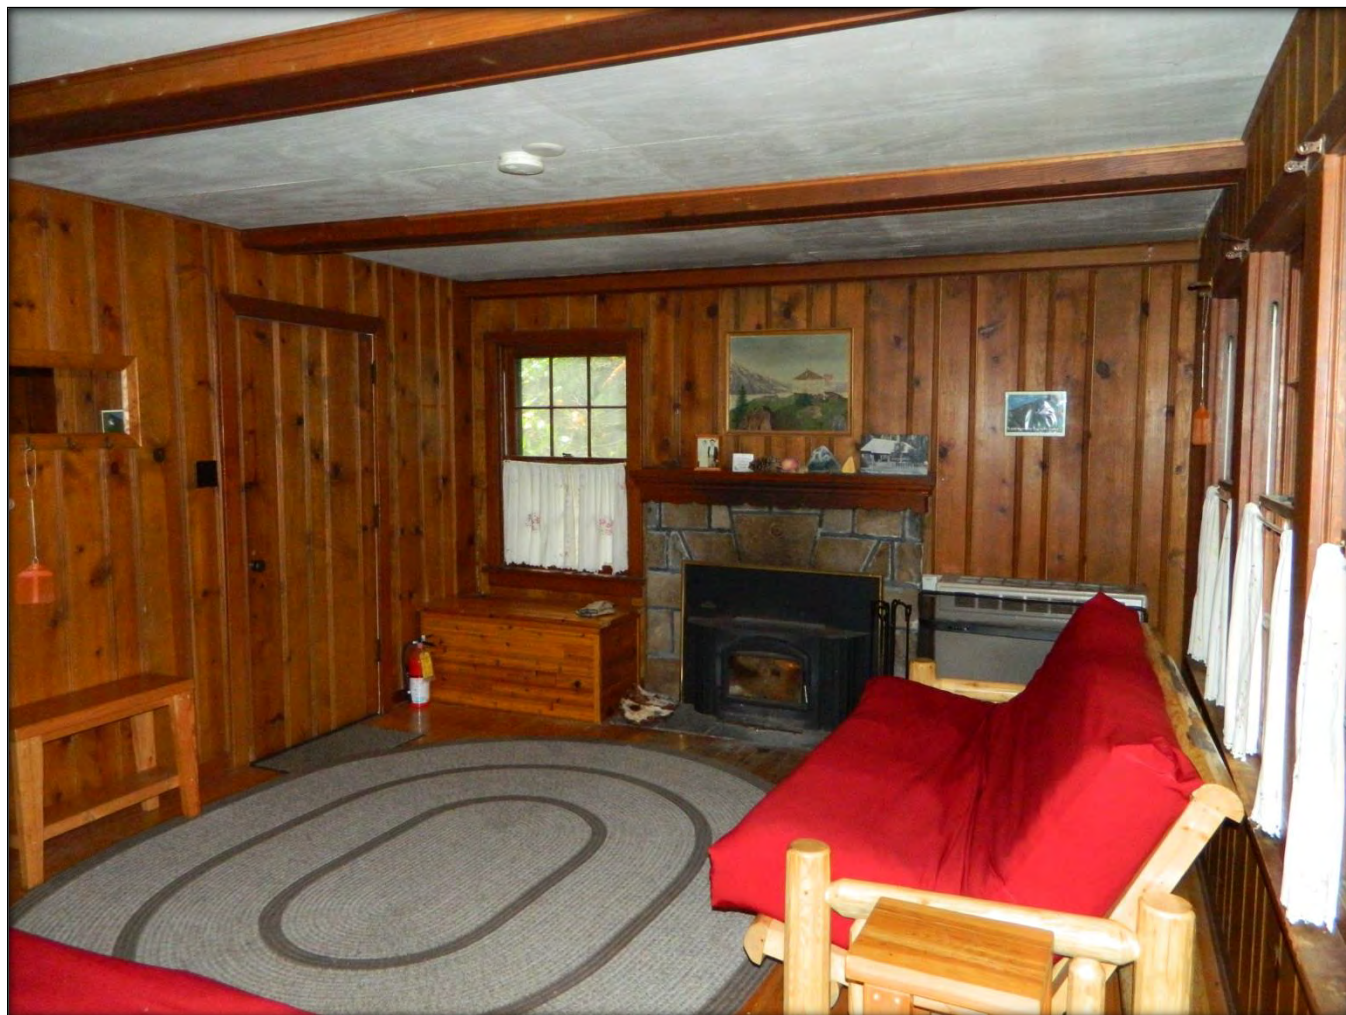
Photograph #11 - Living room with fireplace, knotty pine paneling, four six-over-six wood sash windows, 4"x8" trimmed pine open beams on the ceiling, and furniture

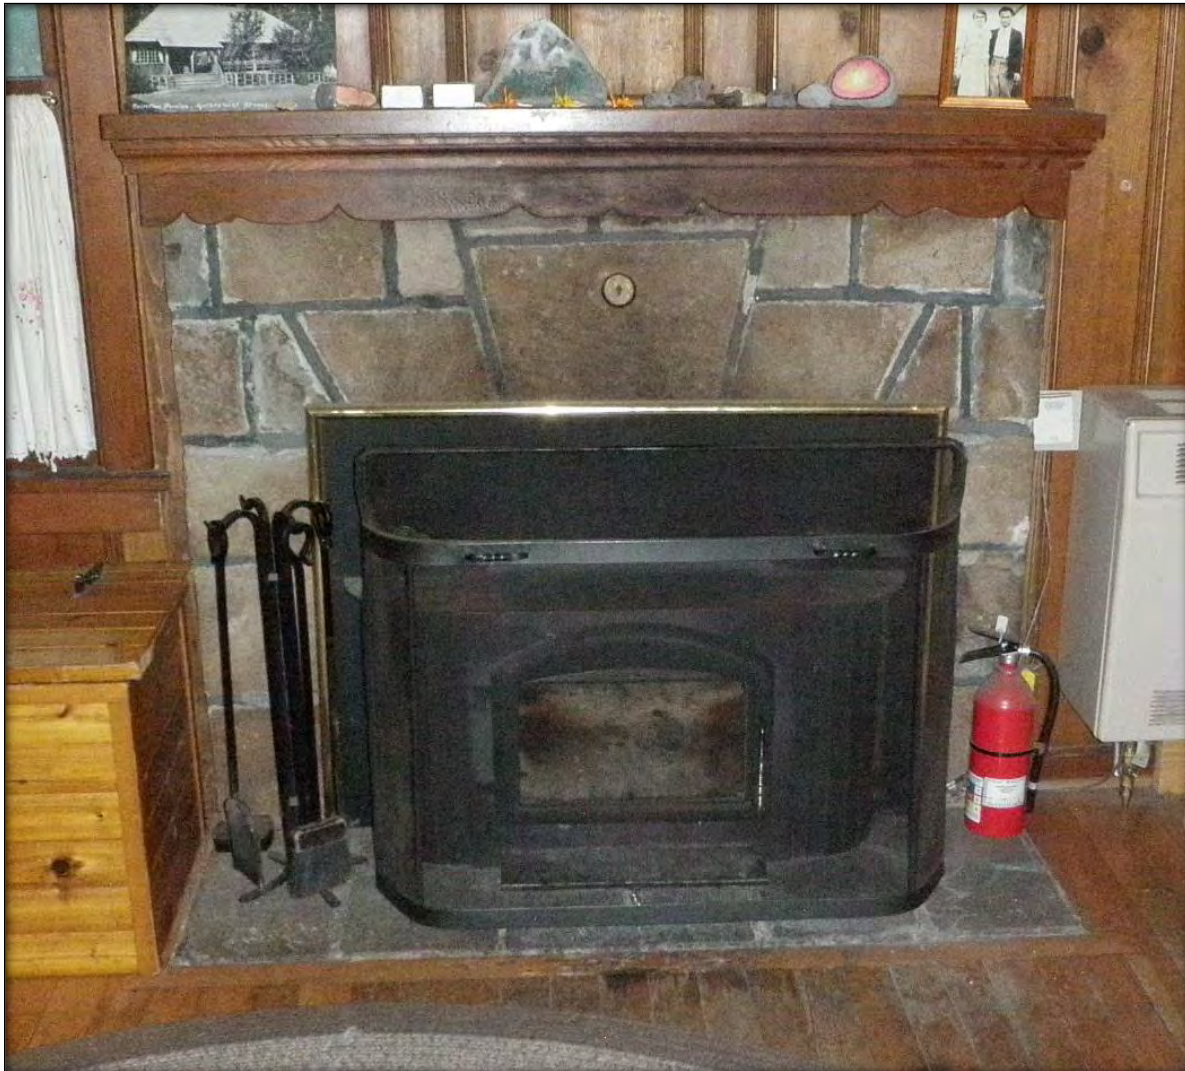
Photograph #13 - Close-up of the stone fireplace with spruce mantle

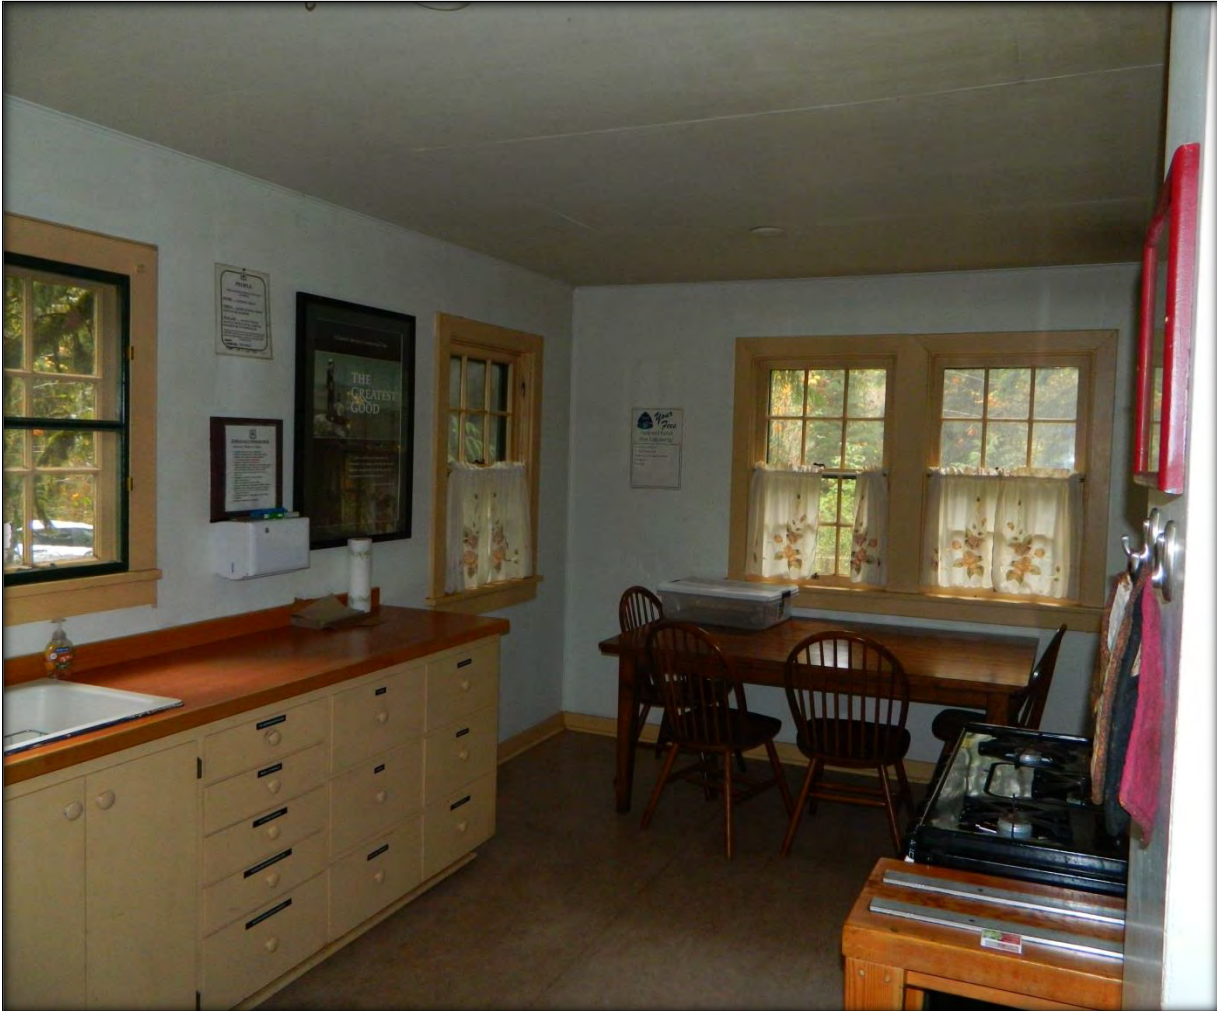
Photograph #16 - Kitchen with table and chairs, range (right) with sink and cupboards (left). Also shown are double six-over-six wood sash windows with mullion above table, single six-over-six wood sash window to left of table, and portion of six-over-six wood sash window above sink

The kitchen measures 10' 7½" x 17' 0" and can be accessed by two doorways, one from the northwest leading to/from the office, and the other on the northwest wall, leading to/from the hallway. The kitchen floor, which was originally a dark linoleum, was replaced during 2001 and 2002 rehabilitation efforts with a lighter linoleum that matches the original pattern. The walls and ceiling consist of painted plywood. The cabinets along the northwest wall support a counter top with a drop sink and wash tub, with no running water. The original built-in cabinetry above the counter top to the right of the three six pane casement windows was removed in 2001, due to damage. A floor-to-ceiling cabinet at the end of the counter was also removed along with the cabinets, counter, and hung cabinets on the southwest wall. The cooler vents have been plugged.

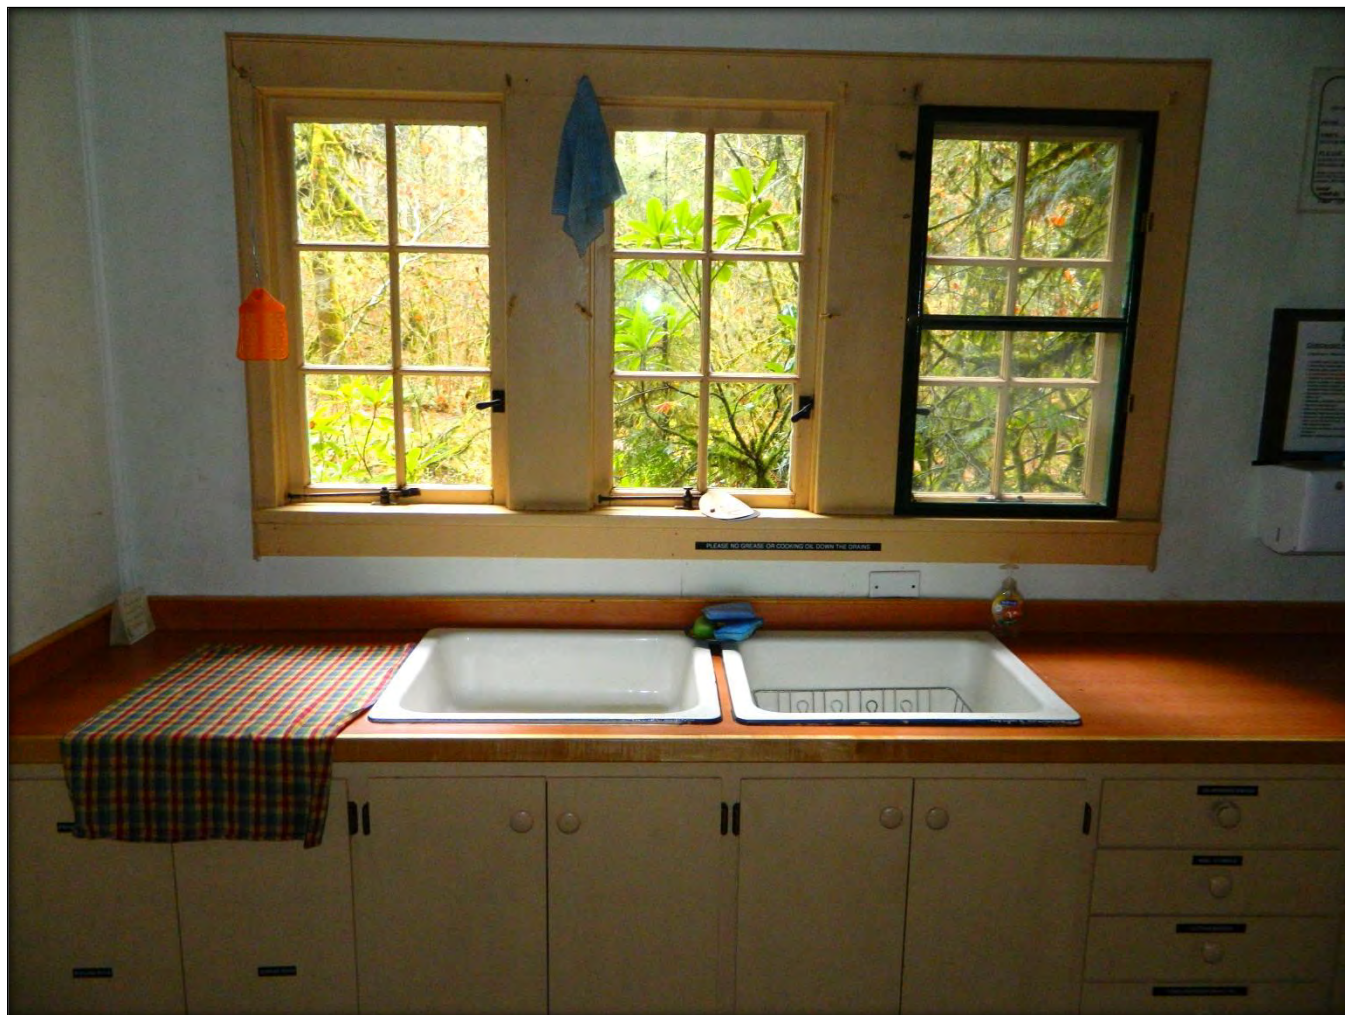
Photograph #18 - Kitchen sink (left) and laundry tub (right) with pine cupboards with plywood doors and spruce counter and back splash. Photo also shows triple six-pane wood casement windows

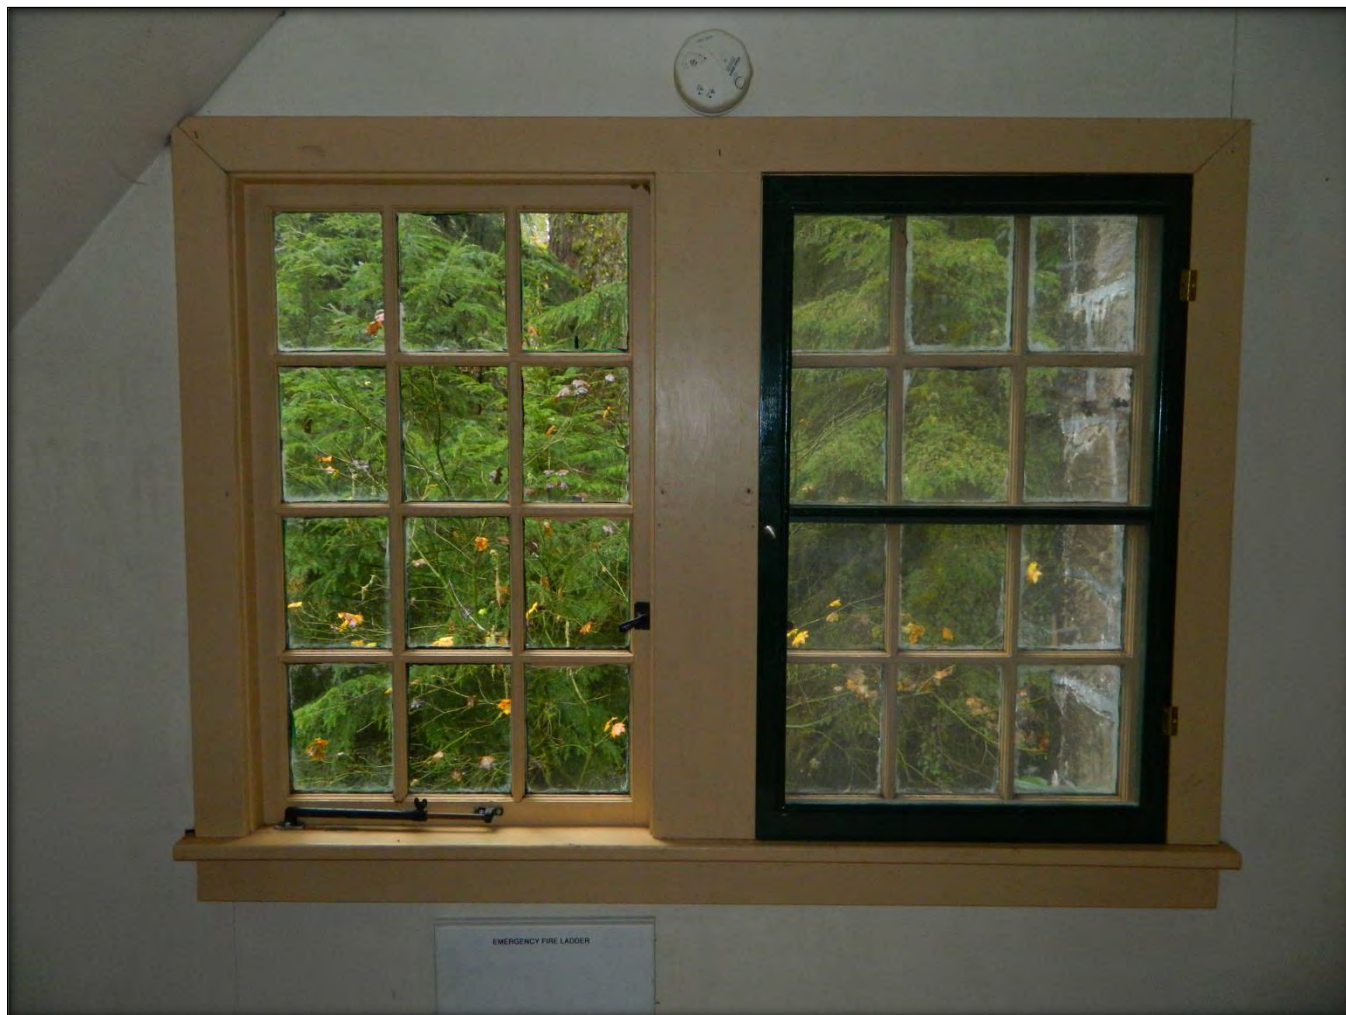
Photograph #24 - Close-up of double twelve-pane wood sash casement windows with mullion. Note the single screen on the right window

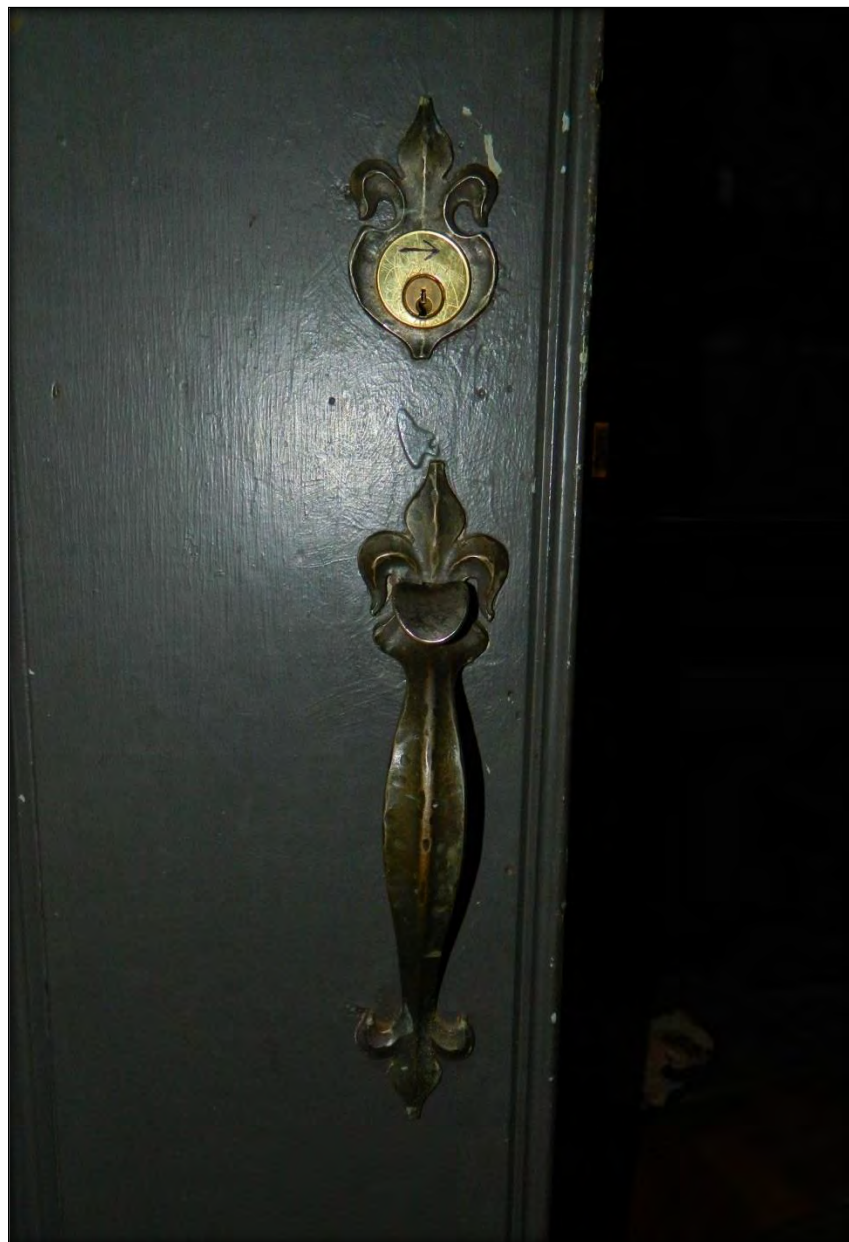
Photograph #28 - Original hardware on front door
