National Register of Historic Places  
Registration Form

historic name Knapp-Calkins Farmstead  
other names/site number Albertus Knapp Farmstead

Section 7 Page 1Knapp-Calkins Farmstead  
Town of Palmyra, Jefferson County, Wisconsin

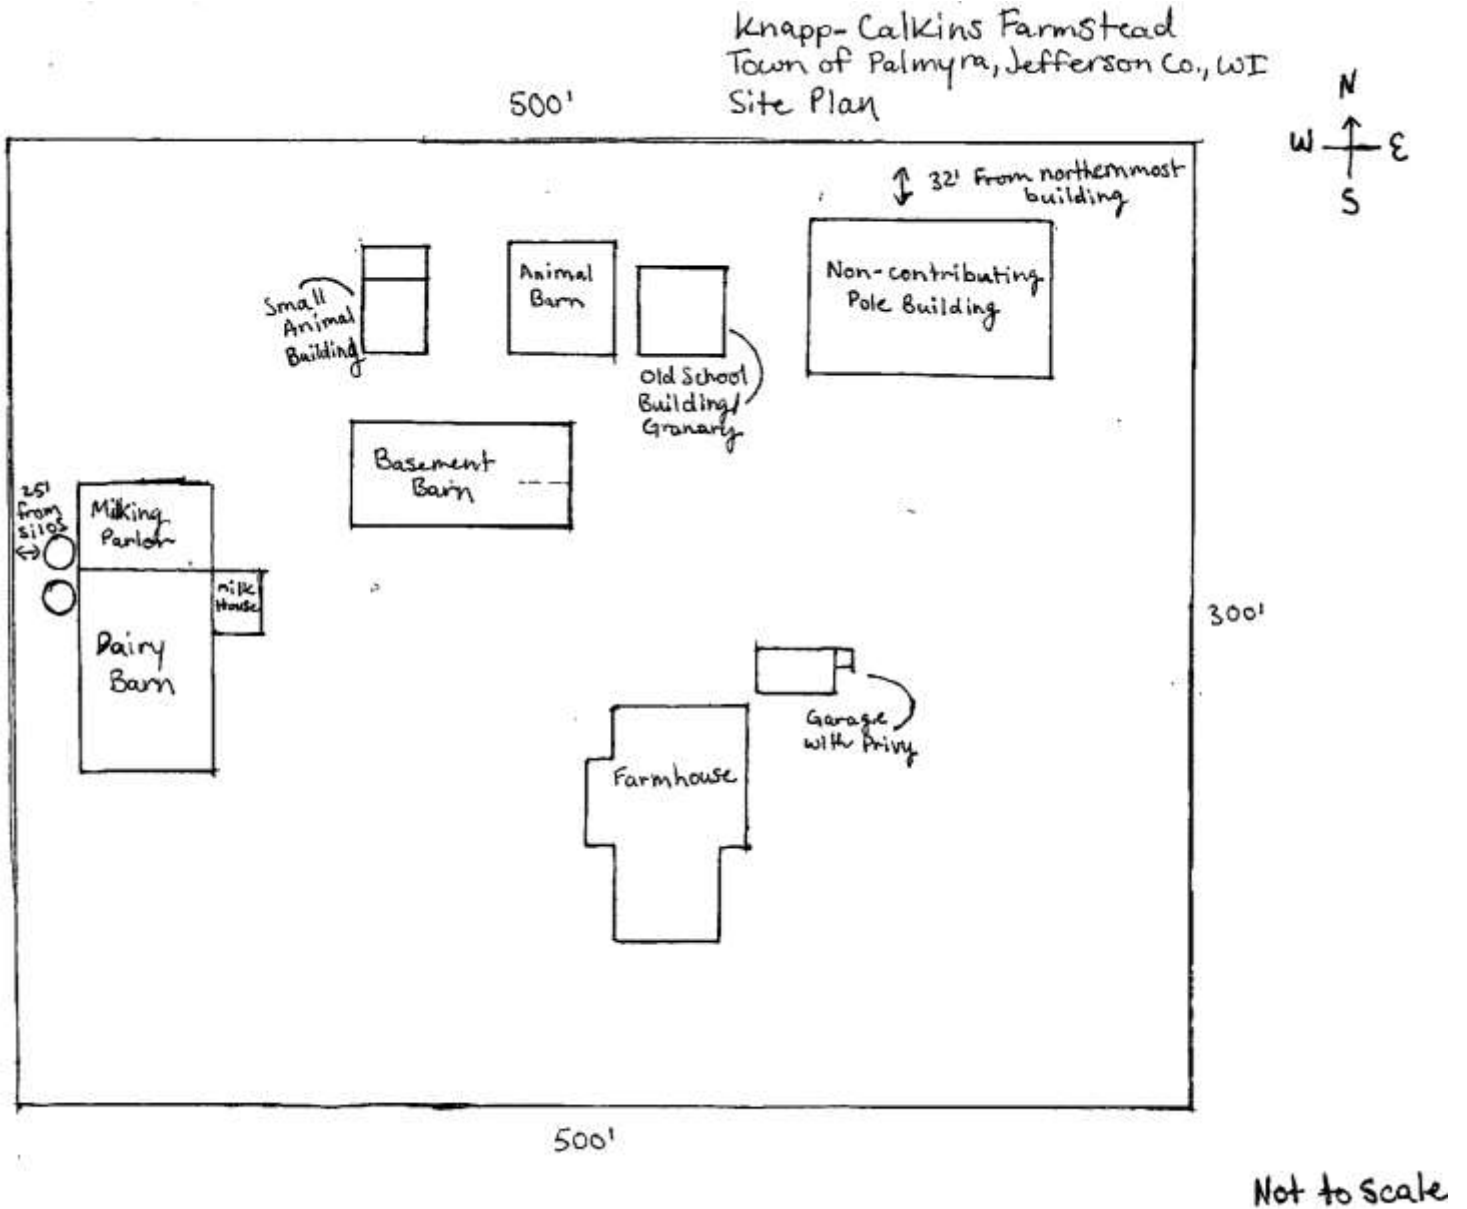
Figure 1: Site Plan – All buildings and structures contributing unless noted

Eight buildings make up the farmstead; seven contribute to the significance of the property, and one is non-contributing. The non-contributing building is northeast of the contributing buildings. Each building will be described below. There are two contributing structures; both are silos.
