## National Register of Historic Places Registration Form

Historic name Reservoir #3

Other names/site number Jersey City Reservoir #3, (part of) Jersey City Waterworks

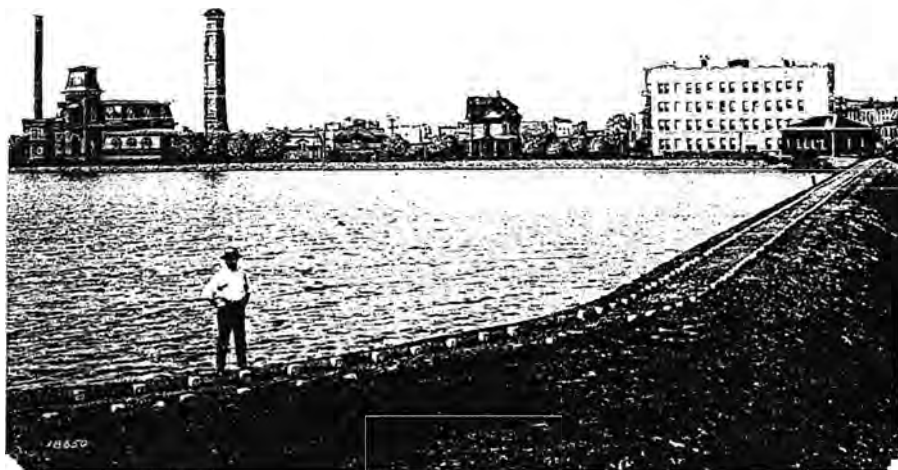
Figure 2. Ca. 1920 postcard of Reservoir #3 (image available online at: Picasa Web Albums, <https://picasaweb.google.com/jcreservoir/JerseyCityReservoir3HistoricPhotosMapsDrawings#>).

The upper portion of the 1881 screen house was originally slightly above the maximum water level of Reservoir #3 (Figure 2). Now much of the brick base and the shaft of the screen house are exposed due to the drop in water level (Photograph 16). Between the base of the building and the shaft, there is a corbelled brick water table. To the southwest, there is a brick influent pipe bulkhead with a stone cap at the base of the building that houses the inlet pipe from the reservoir to the screen house. The shaft of the building was constructed of brick but it has been covered with stucco in the recent past.

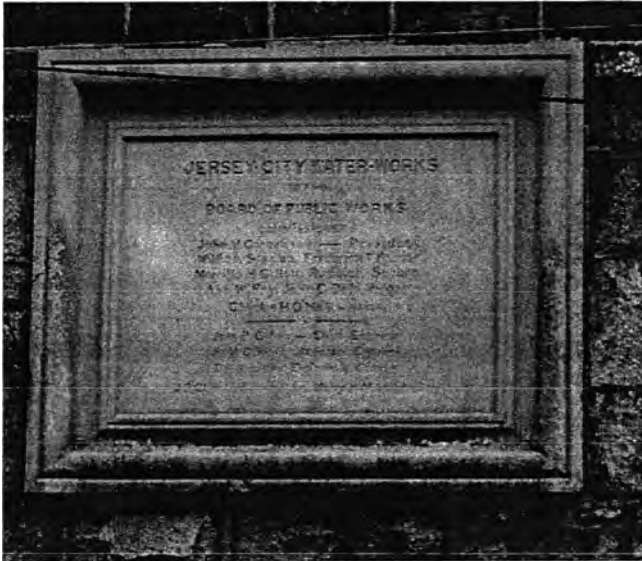
Figure 7. Photograph of builder's plaque, commemorating the construction of the waterworks in 1874. Located on the perimeter wall near Gatehouse #1 (JMA photograph, February 2009).

Smaller scale elements associated with Reservoir #3 include a plaque commemorating the construction of the waterworks in 1874. Placed on the perimeter wall near Gatehouse #1, the plaque identifies city officials, engineers, and contractors involved in the project (Figure 7).

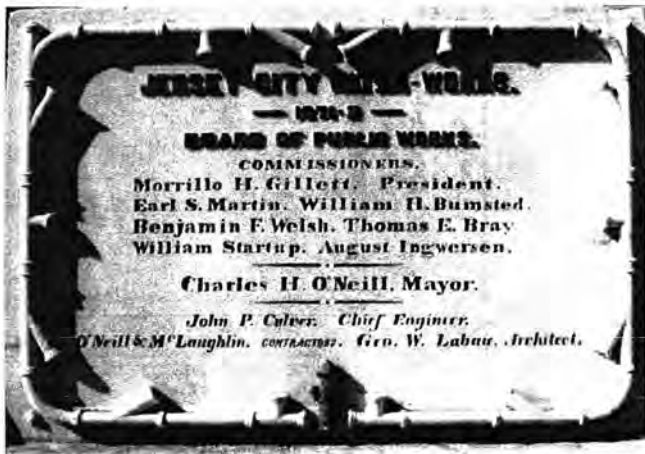
Figure 8. Photograph of builder's plaque originally placed on the High Service Engine House at Reservoir #2 in 1872. This plaque has since been re-located to the offices of United Water (RBA Group, Cultural Resource Unit, photograph, April 2006).

An additional historic marble plaque, bordered with water pipes and a hydrant, was originally placed on the High Service Engine House at Reservoir #2 in 1872. No longer extant, the High Service Engine House was adjacent to Reservoir #2. Gatehouse #1 was originally sited across from the High Service Engine House, located on the other side of Summit Avenue. This plaque has since been re-located to the offices of United Water (Figure 8).
