United States Department of the Interior  
National Park Service  
**NATIONAL REGISTER OF HISTORIC PLACES  
REGISTRATION FORM**

Historic name: Chagrin Falls East Side Historic District

street & number: East Washington Street & Philomethian Street not for publication n/a  
city or town: Chagrin Falls vicinity n/a  
state: Ohio code: OH county: Cuyahoga code: 035  
zip code: 44022

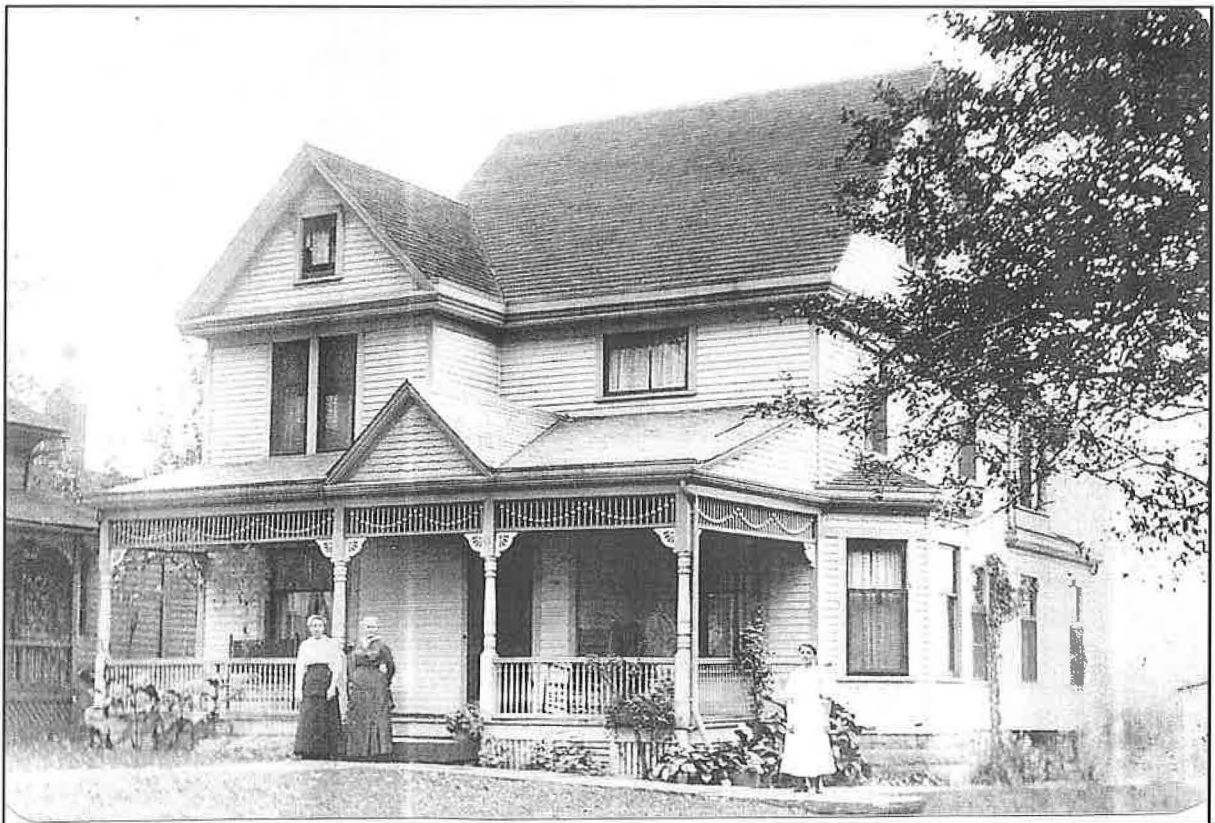
**Figure 1**

**Joel W. Burnett House, 1895**  
96 East Washington Street

**Date/history:** Joel W. Burnett House, 1895

This two and one-half story Queen Anne wood frame dwelling is constructed on an ashlar course sandstone foundation. Narrow clapboard siding is defined by vertical corner boards and a single horizontal trim band connecting the windows and doors. The front façade includes a decorative apron and wrap-around porch supported by turned columns, a spindled balustrade and spindled frieze with a ball wave pattern supported by brackets. The

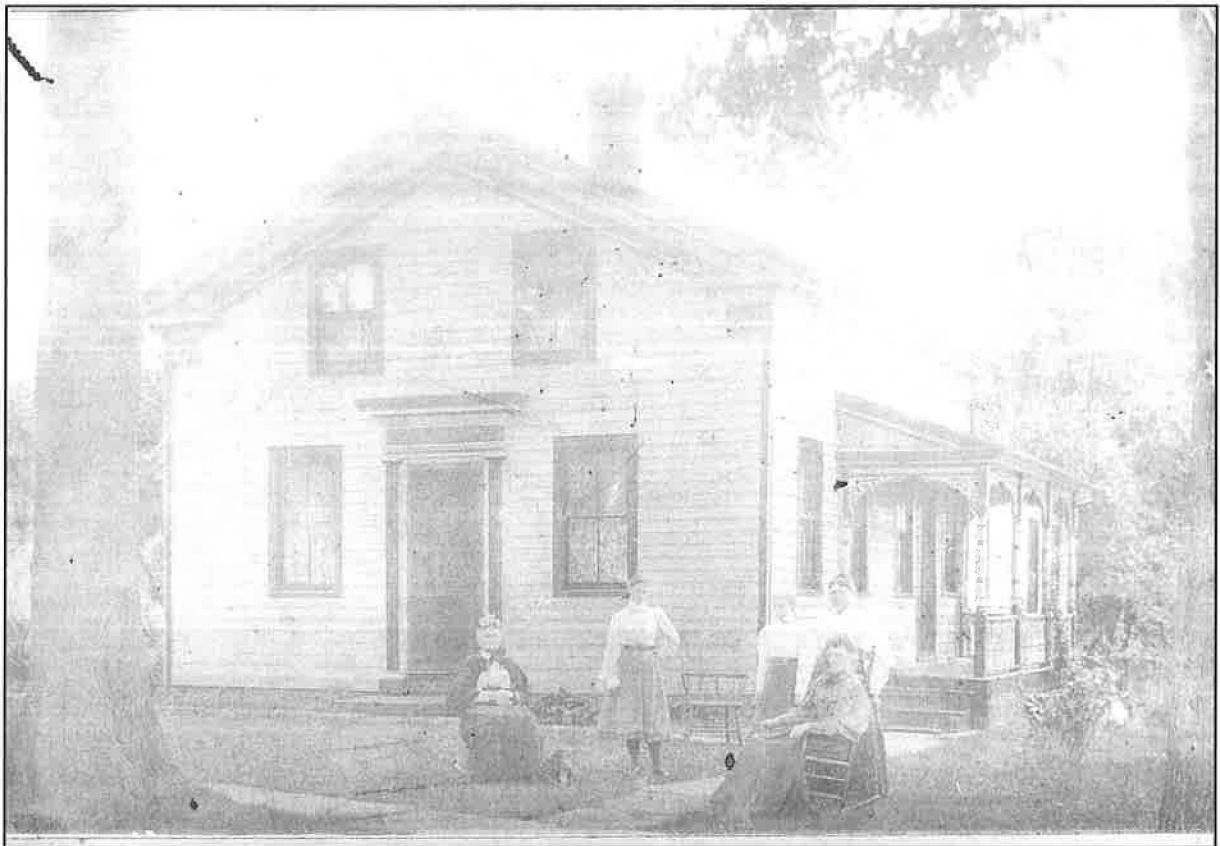
**Figure 2**

**Phineas Upham-George Honeywell House, 1844**

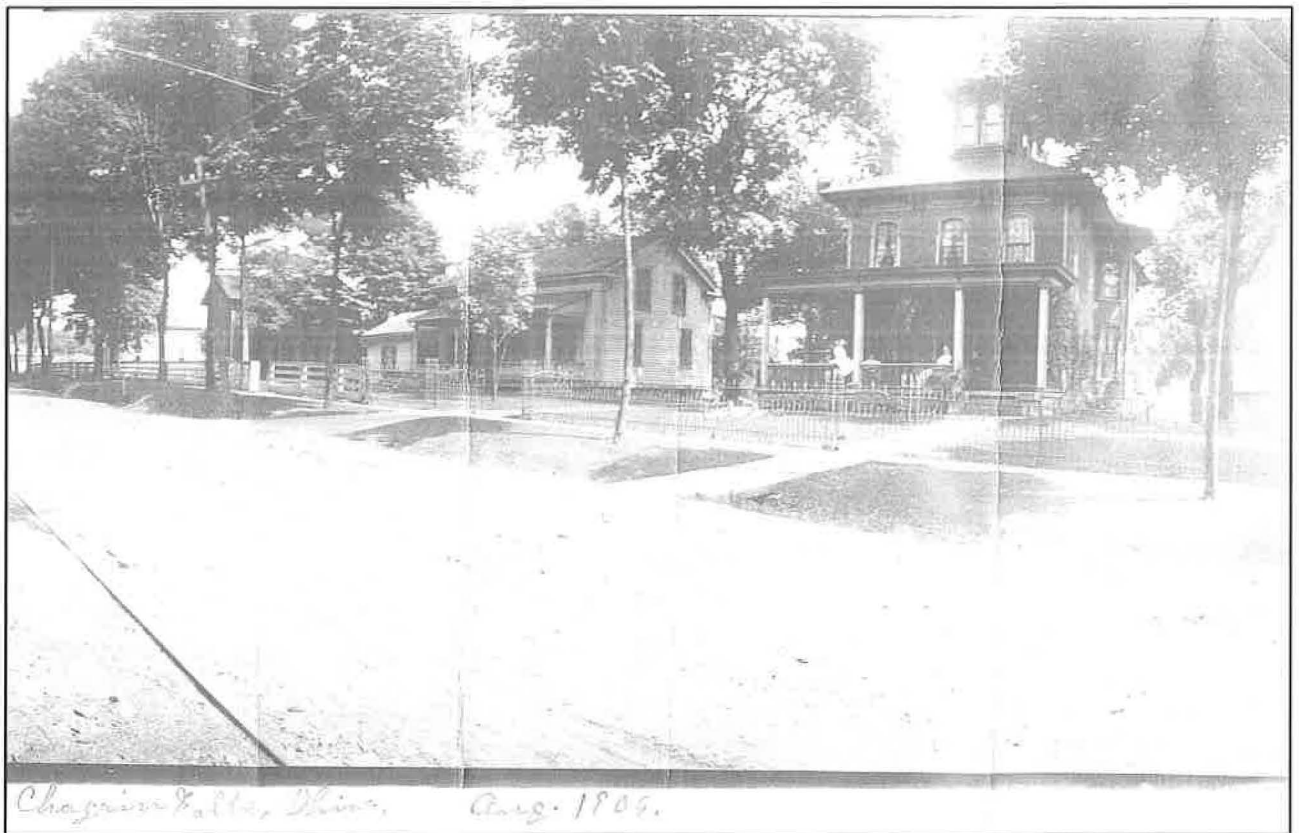
**Figure 3**

**George March Jr. House, 1875**

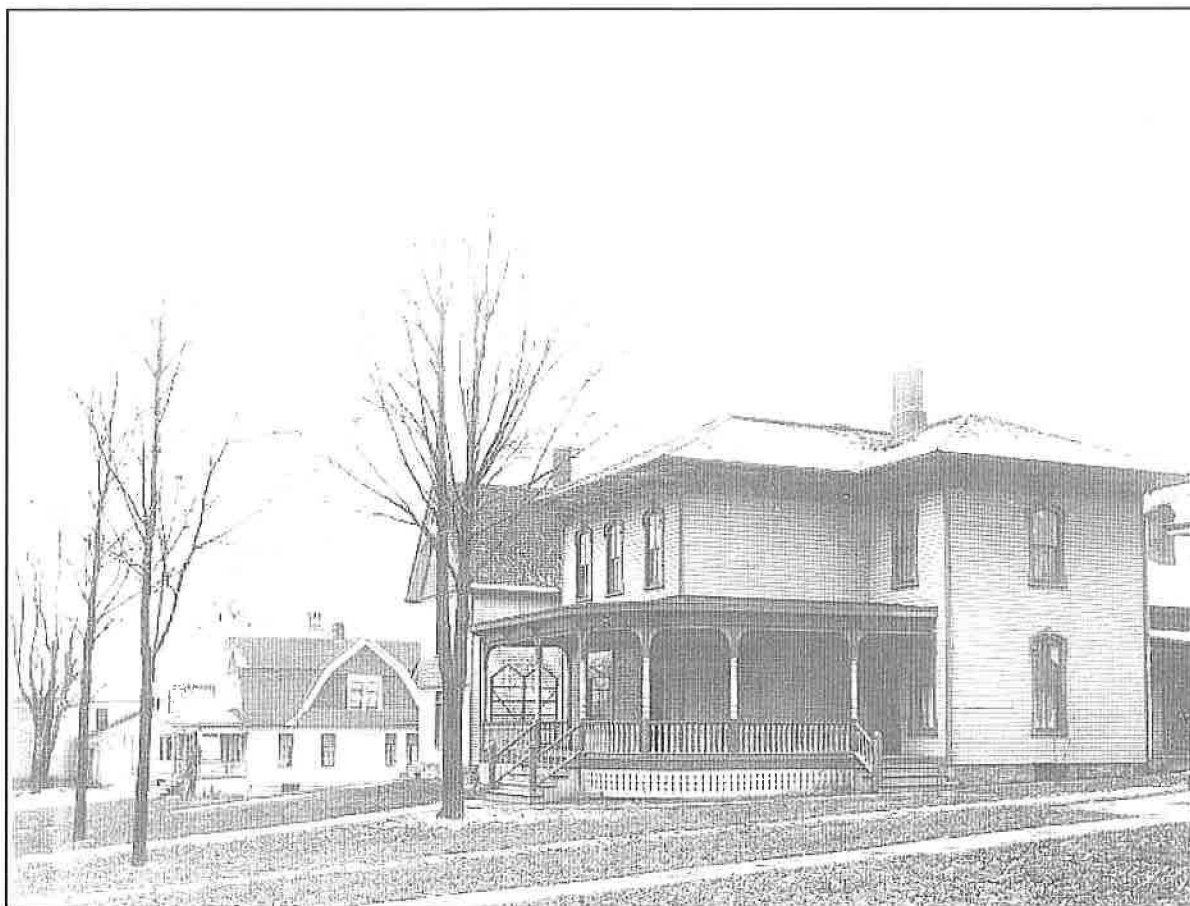
**Figure 4**

**George Ober House, 1874** (Italianate in foreground)

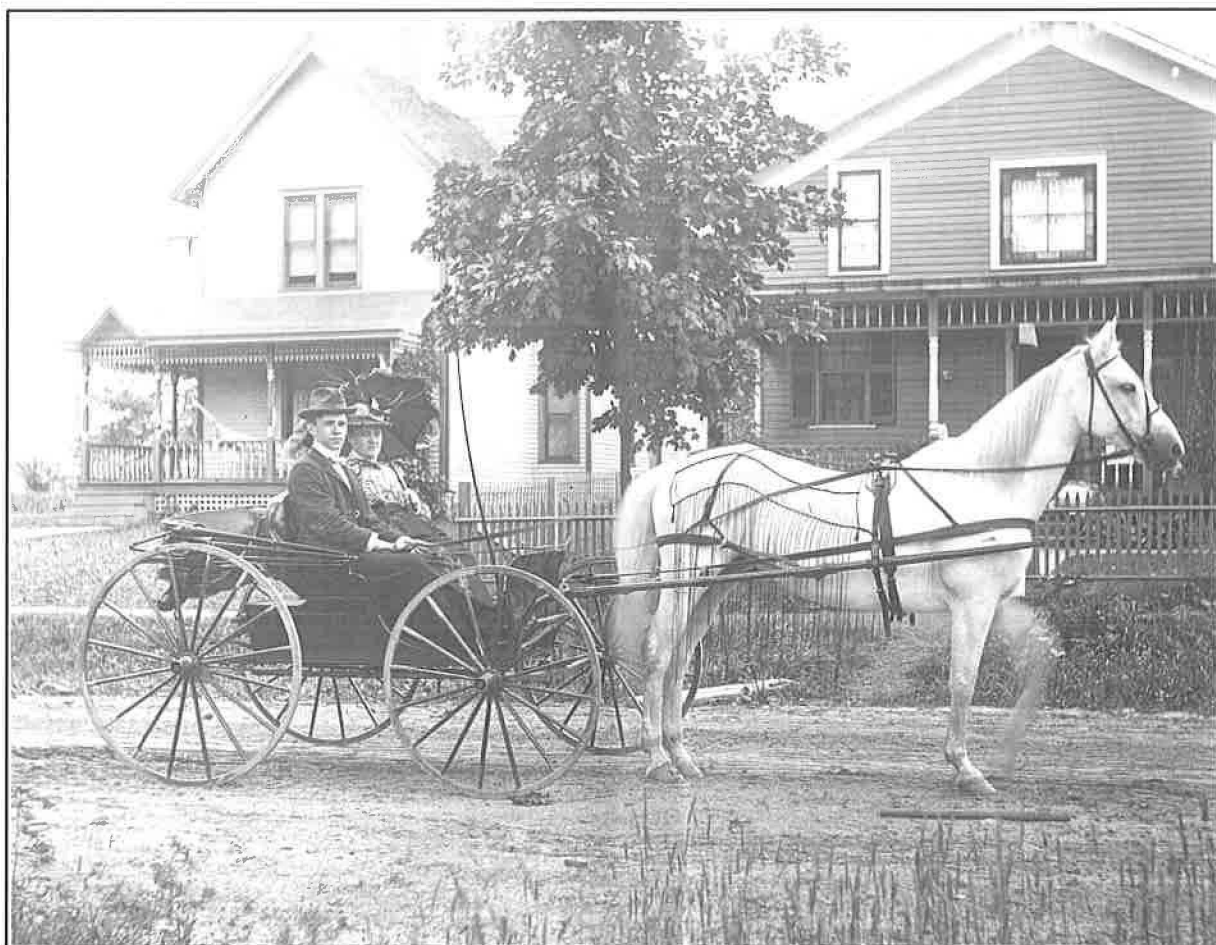
**Figure 5**

**R.W. Stoneman House, ca. 1891 (Vernacular)**
