CLASSIFIED STRUCTURE FIELD INVENTORY REPORT
(Attach 4" x 5" Black and White Photograph)

REGION RMR PARK/AREA NAME Dinosaur NM PARK NUMBER 1400

STRUCTURE NAME Chew/Pool Creek House STRUCTURE NUMBER HS-344
(STR1)

CHew RANCH COMPLEX DINOSAUR NATIONAL MONUMENT MOFFAT COUNTY, COLORADO

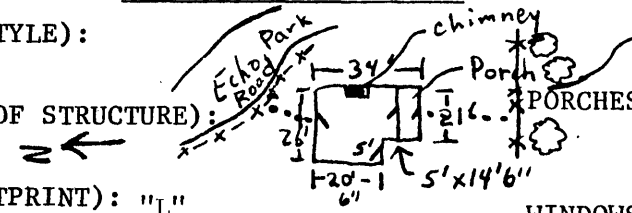
TYPE OF STRUCTURE (NPS 28 CODE): BU CHIMNEYS: brick w/ brick cap
 ARCHITECTURAL CHARACTER (STYLE): Ranch, Gabled
 SITE (INCLUDE ORIENTATION OF STRUCTURE):

PORCHES: sun porch - rear - 8' x 21'
 shed roof
 3-4' walls topped with windows &
 OVERALL BUILDING PLAN (FOOTPRINT): "L" WINDOWS: double hung sash- 1 over 1
 OVERALL DIMENSIONS: 34' x 26' Porch - 8' x 21' screens
 COMPOSITION (NPS 28 CODE): WD DOORS: front & rear
 rear - 3 light (vert) over 1 panel
 front - 4 light over 3 panel
 STORIES: 1 ADDITIONS: side door nailed shut
 sun porch
 FOUNDATION: 30' ± high/ stucco covered
 WALLS: hewn log, concrete
 INTERIOR PLAN:
 2 bedroom, unplumbed bath, kitchen,
 living room
 ROOF: wood shingle gable, shed roof porch
 INTERIOR FINISHES:
 lathe & plaster with paint (ugly)
 carpeted floors
 no electricity

Exterior whitewashed; only minor repairs needed to interior walls for cabin to be habitable.

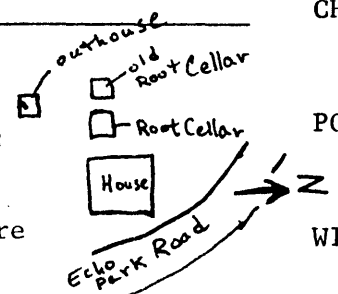
TYPE OF STRUCTURE (NPS 28 CODE): BU CHIMNEYS: None
 ARCHITECTURAL CHARACTER (STYLE): Vernacular
 SITE (INCLUDE ORIENTATION OF STRUCTURE):

PORCHES: None
 OVERALL BUILDING PLAN (FOOTPRINT): square WINDOWS: None
 OVERALL DIMENSIONS: 6' x 6'
 COMPOSITION (NPS 28 CODE): WD DOORS: New Plywood
 STORIES: 1 ADDITIONS: None
 FOUNDATION: on grade
 WALLS: Fiberboard & 2x4s/wood INTERIOR PLAN: 2 holer
 ROOF: gable plank & tar paper roof INTERIOR FINISHES: fiberboard

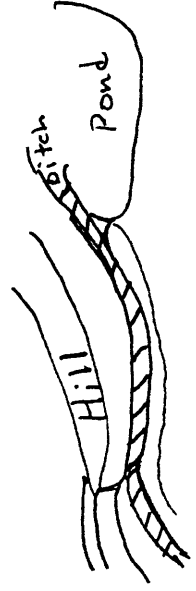
Type of Structure: ES/WS/CA

Material: EA

• Meadow → N
