NATIONAL REGISTER OF HISTORIC PLACES  
PROPERTY PHOTOGRAPH FORM

COMMON: Abram-Buford--James K. Duke House

AND/OR HISTORIC: Richland

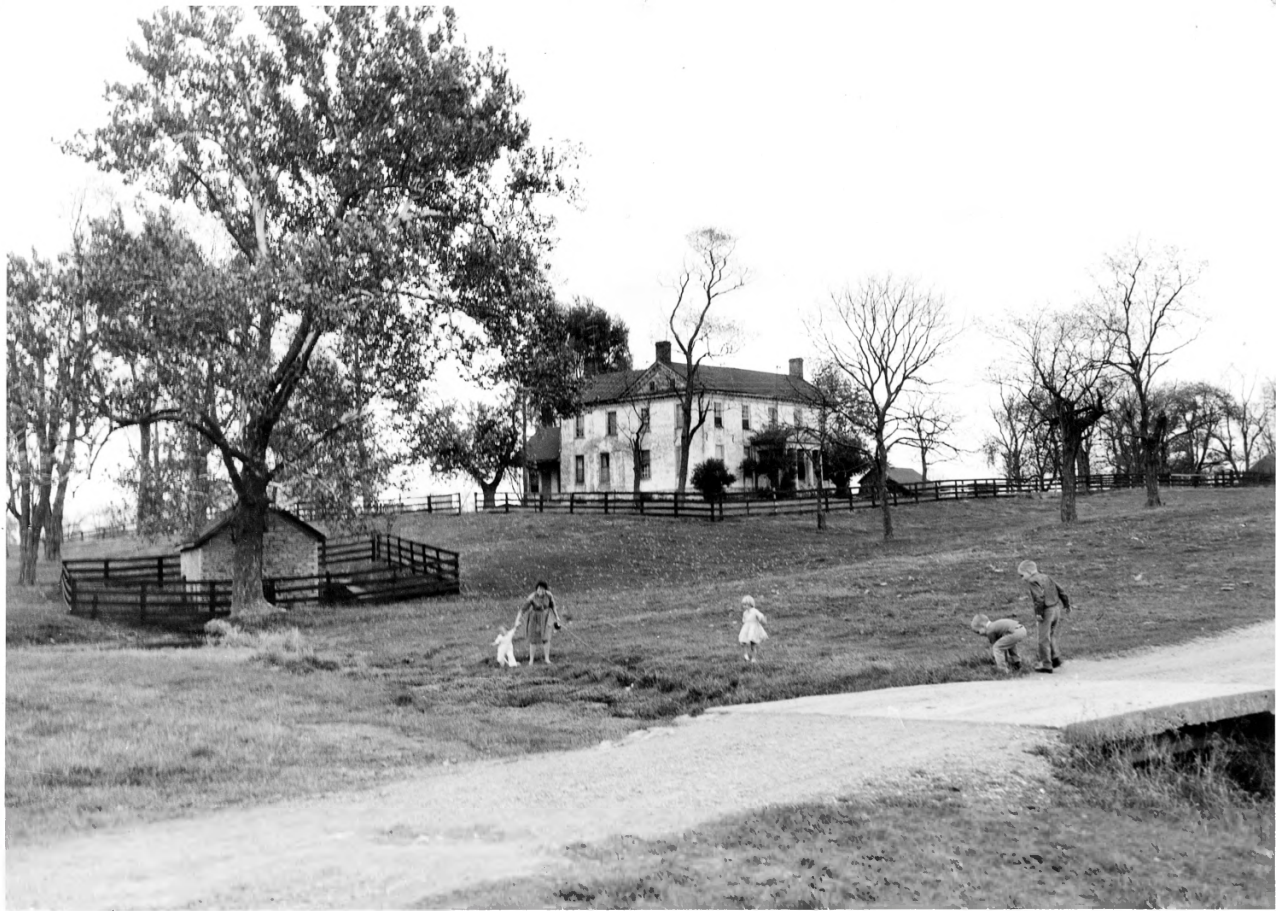
This photograph shows Richland as it faces southwest, with the stone spring house in the foreground. The ell, which faces west, was probably the original house, with the front five bays being rebuilt around 1830.

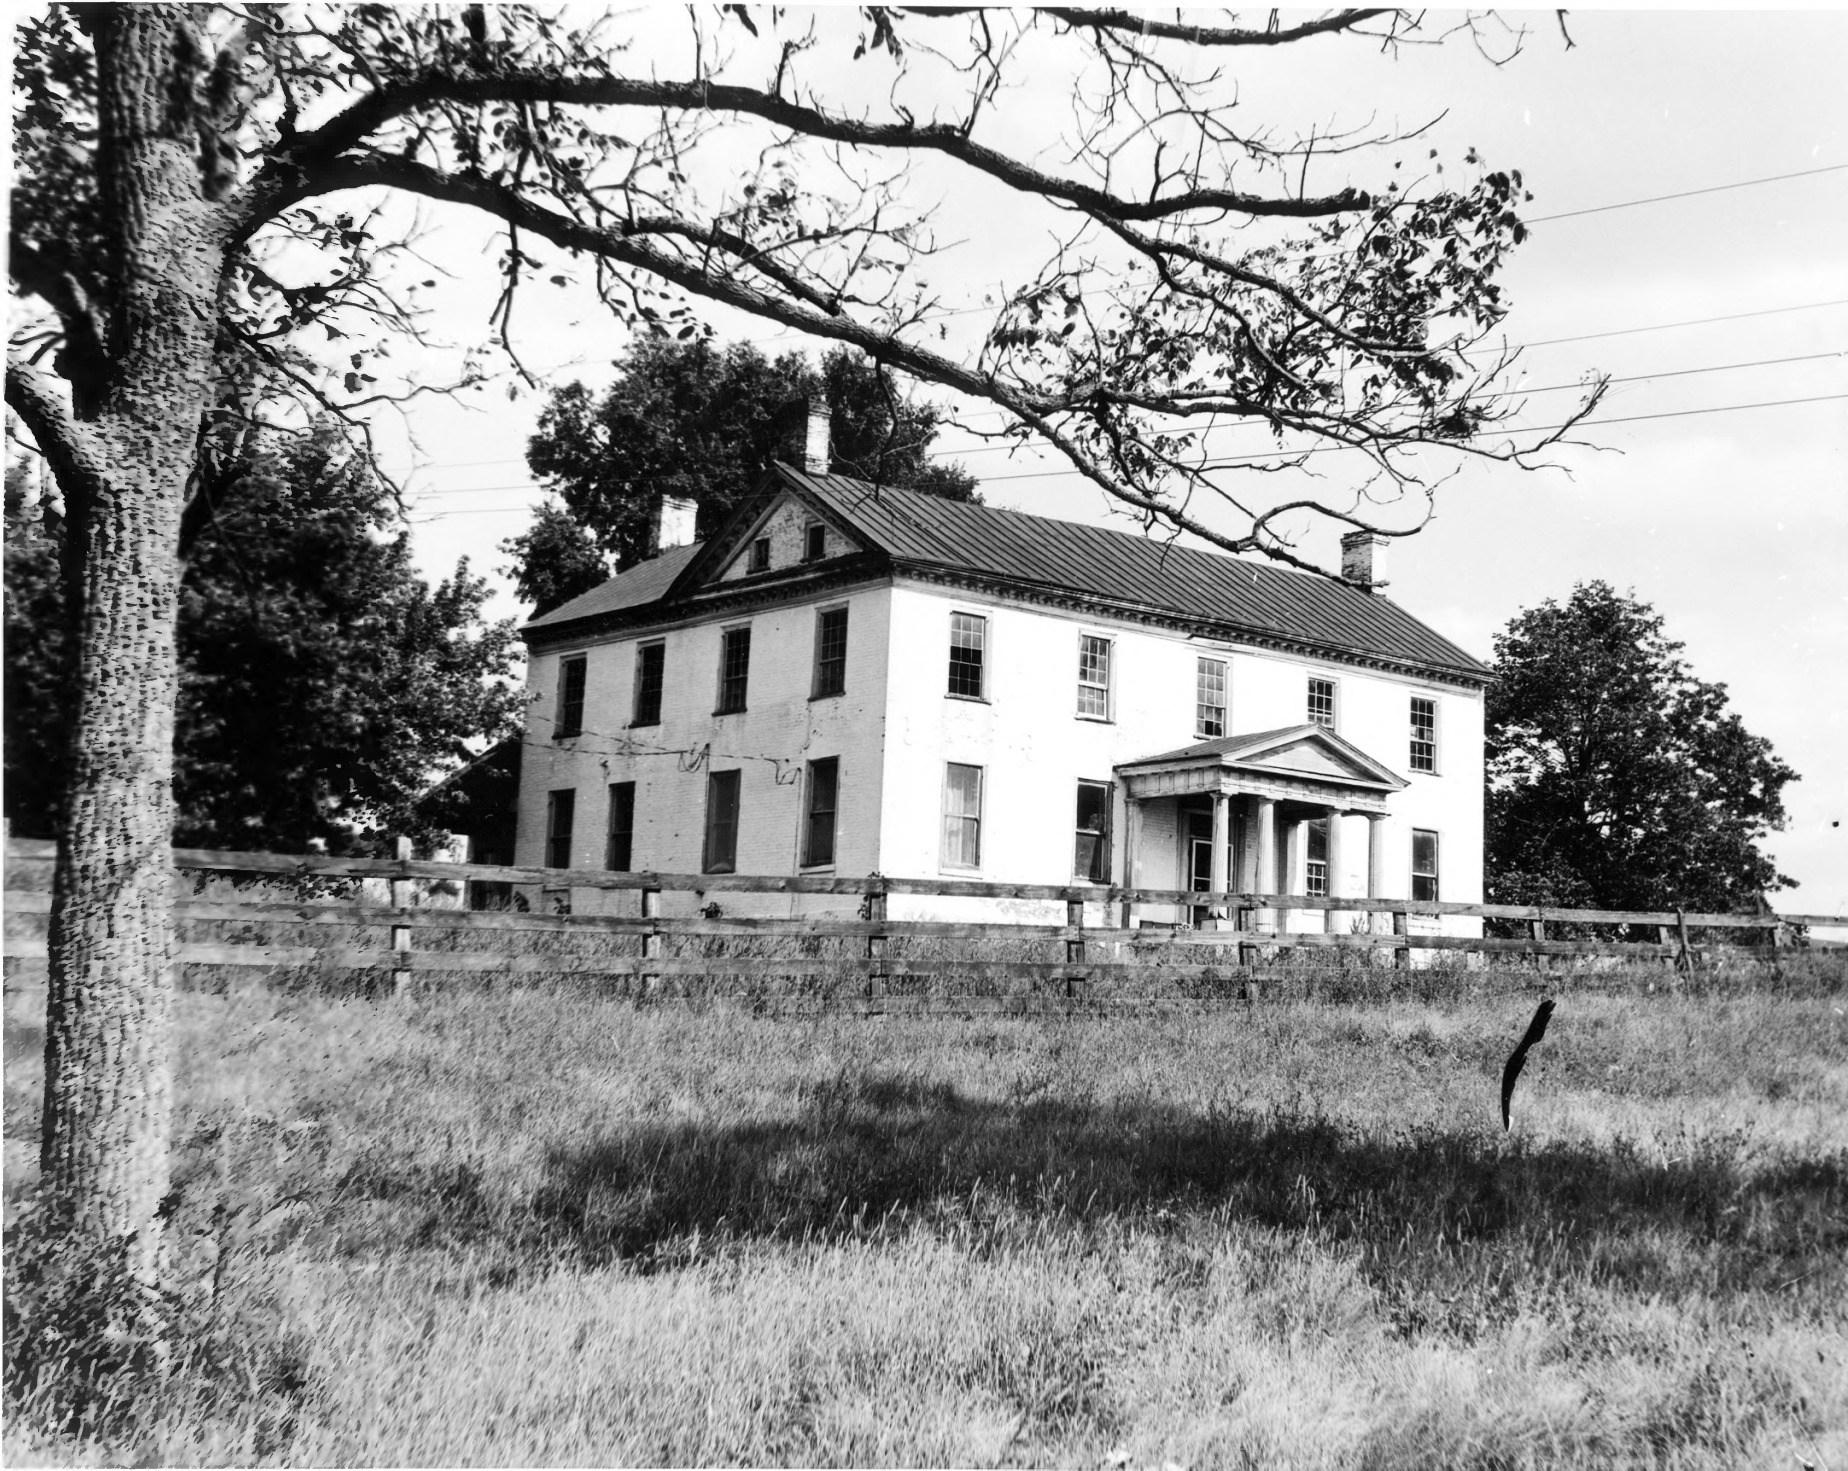
Taken from the southwest. Showing the front and the ell which was reworked when the new front was developed in the early 1830's.

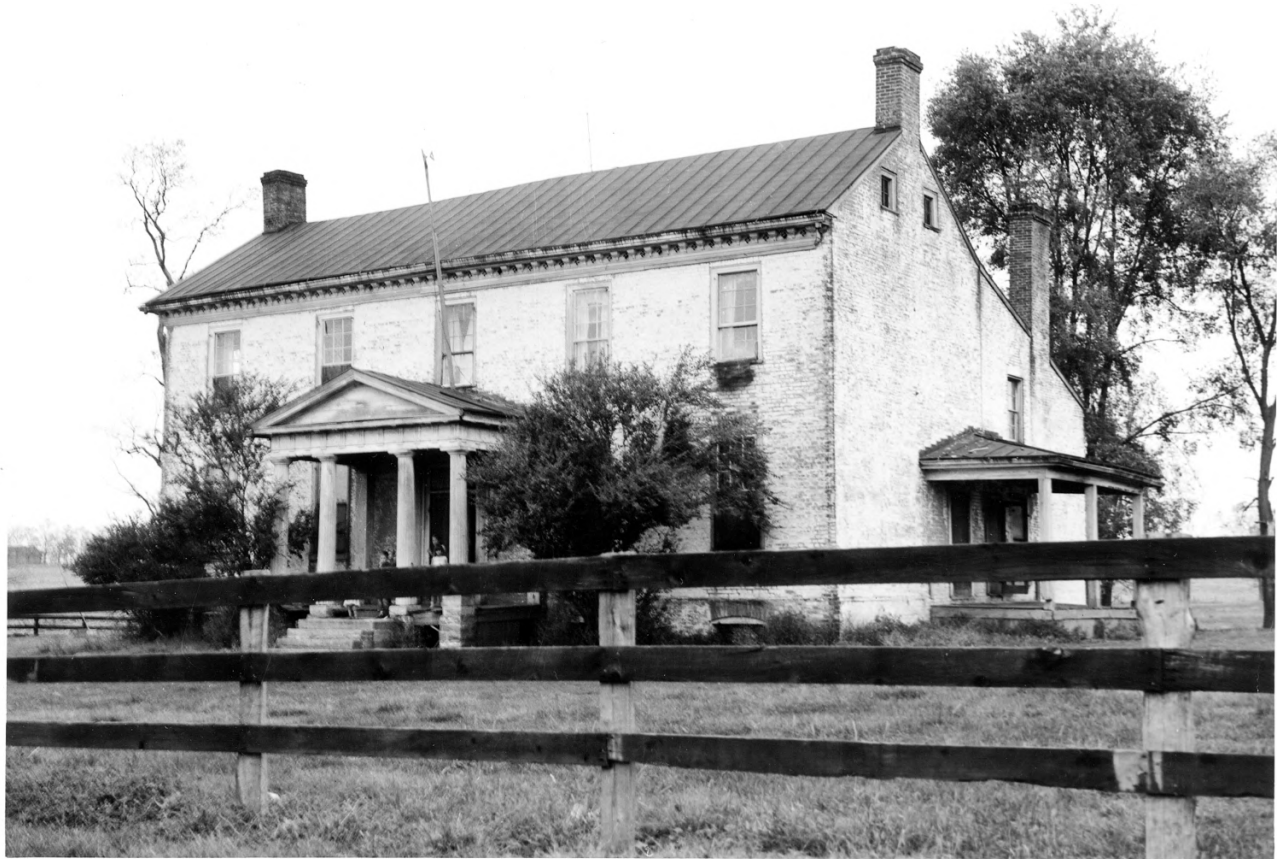
From the southeast showing the front of the house.

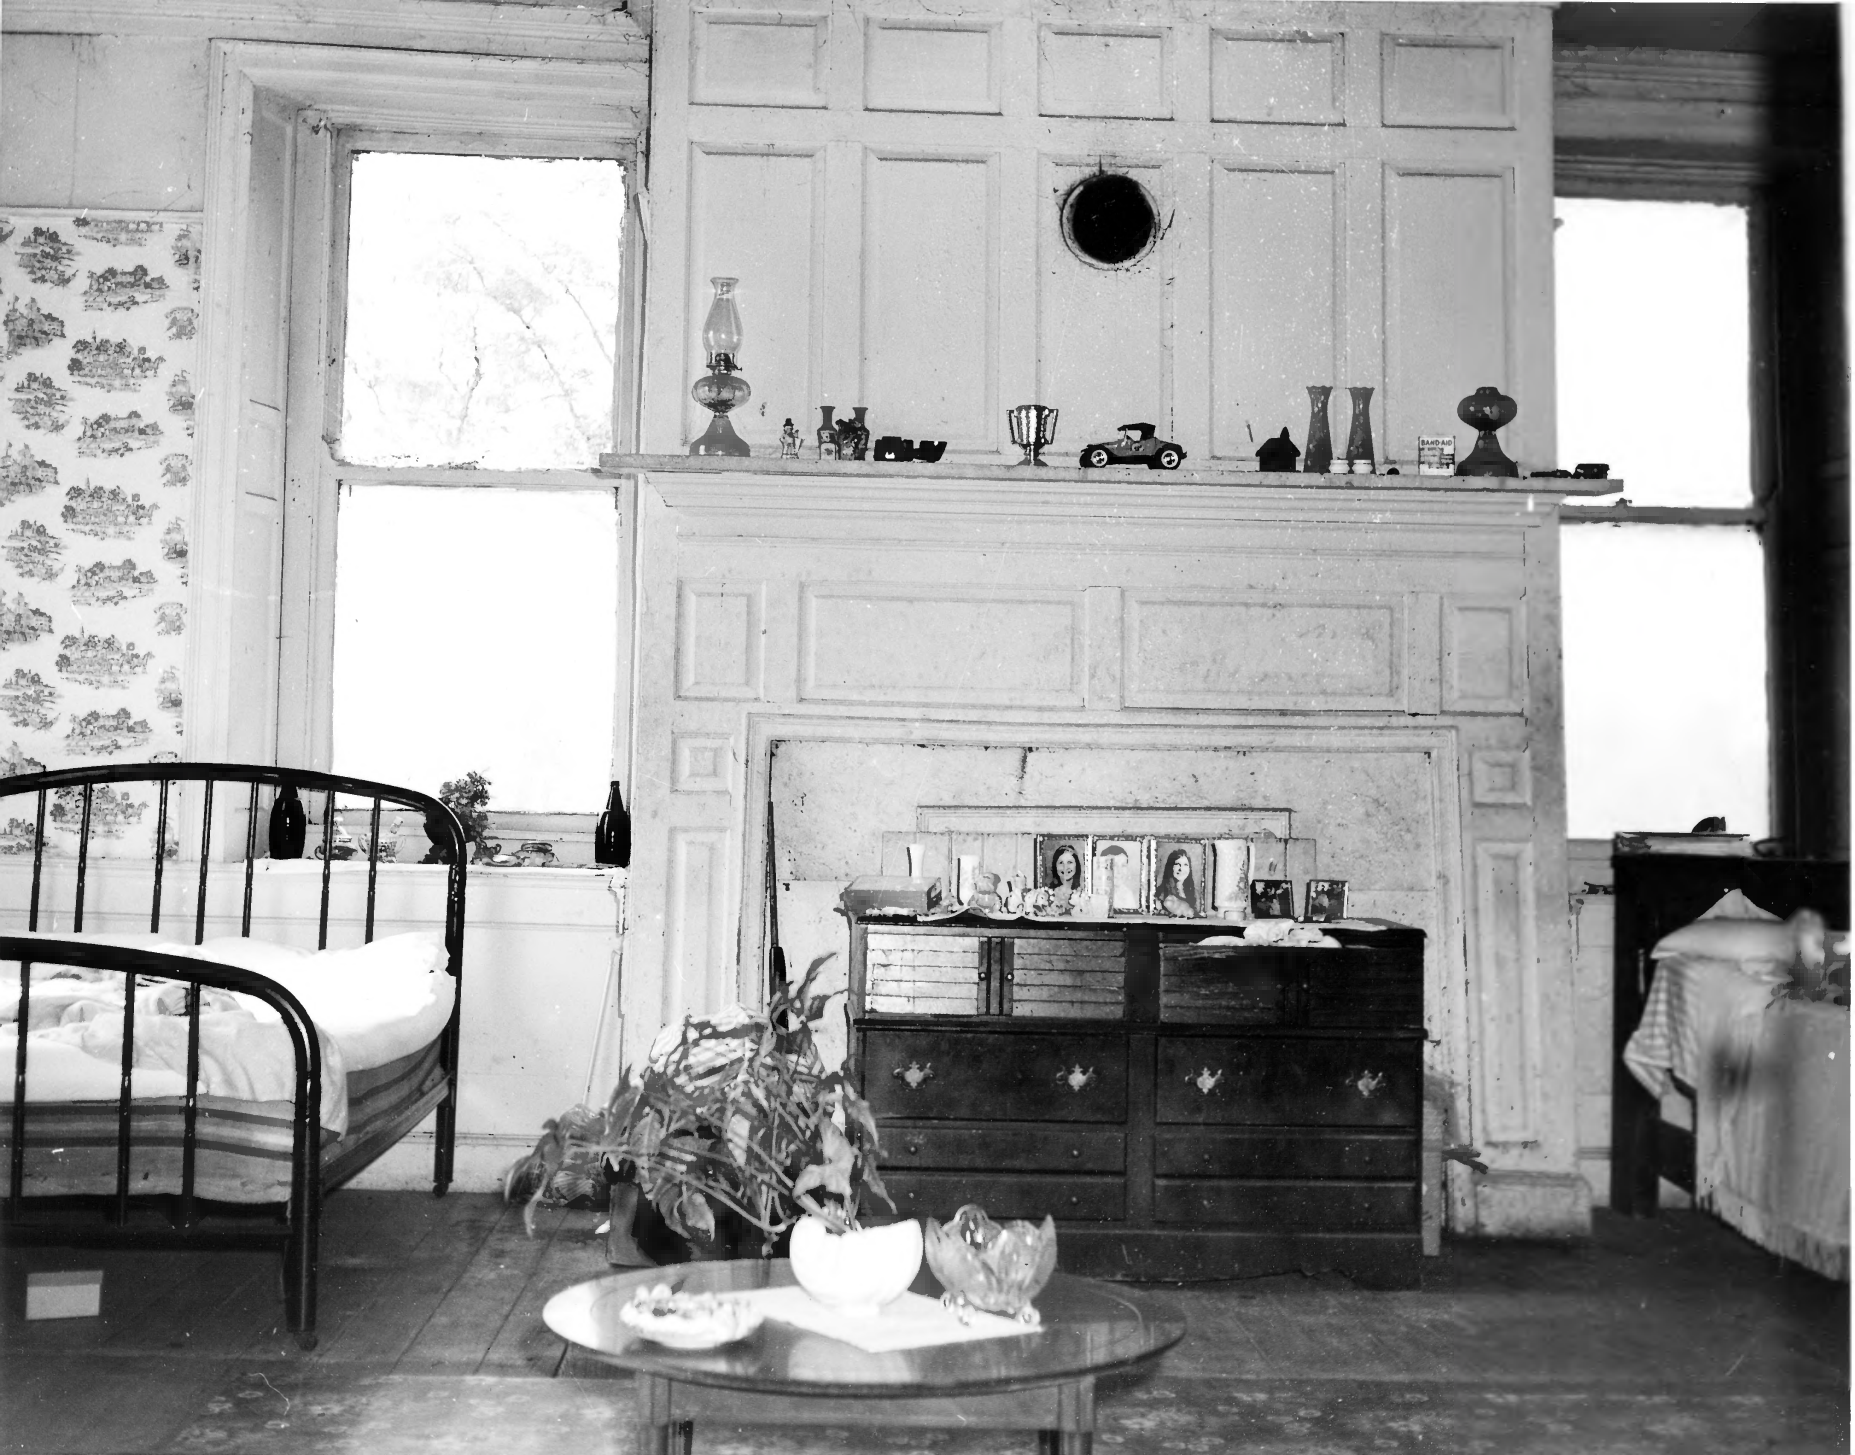
The mantel which was probably originally set in the end of the wall which was reworked forming the new front of the house. It is now in the south end of the house.

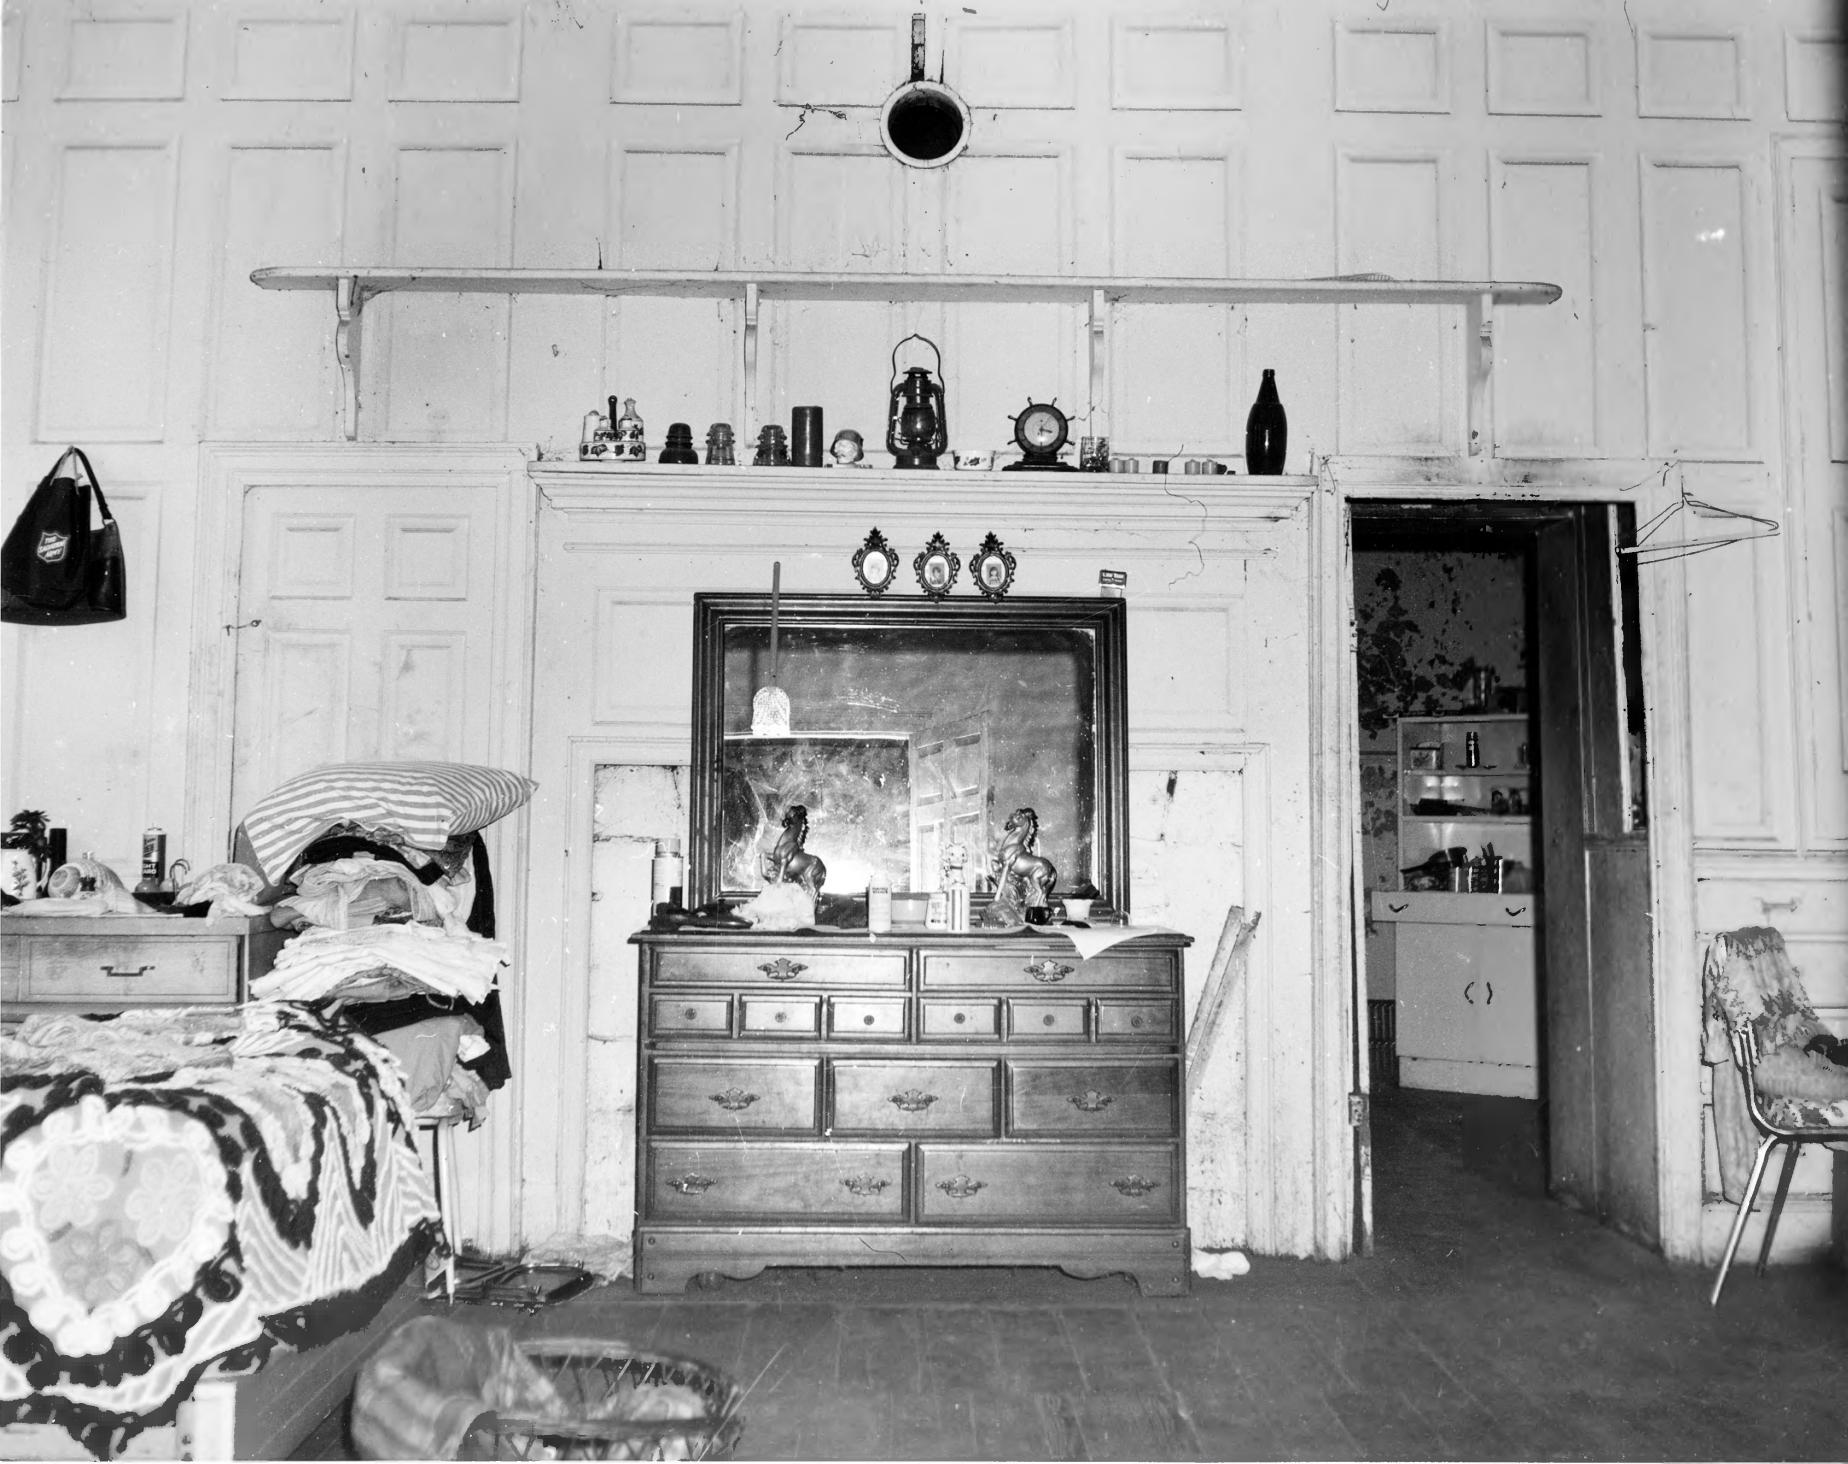
The mantelpiece in the north end of the ell which apparently was the original end wall of the first part of the house.
