Elkhorn Guard Station

National Register of Historic Places Registration Form

historic name Elkhorn Guard Station

other name/site number Elkhorn Ranger Station Historic District

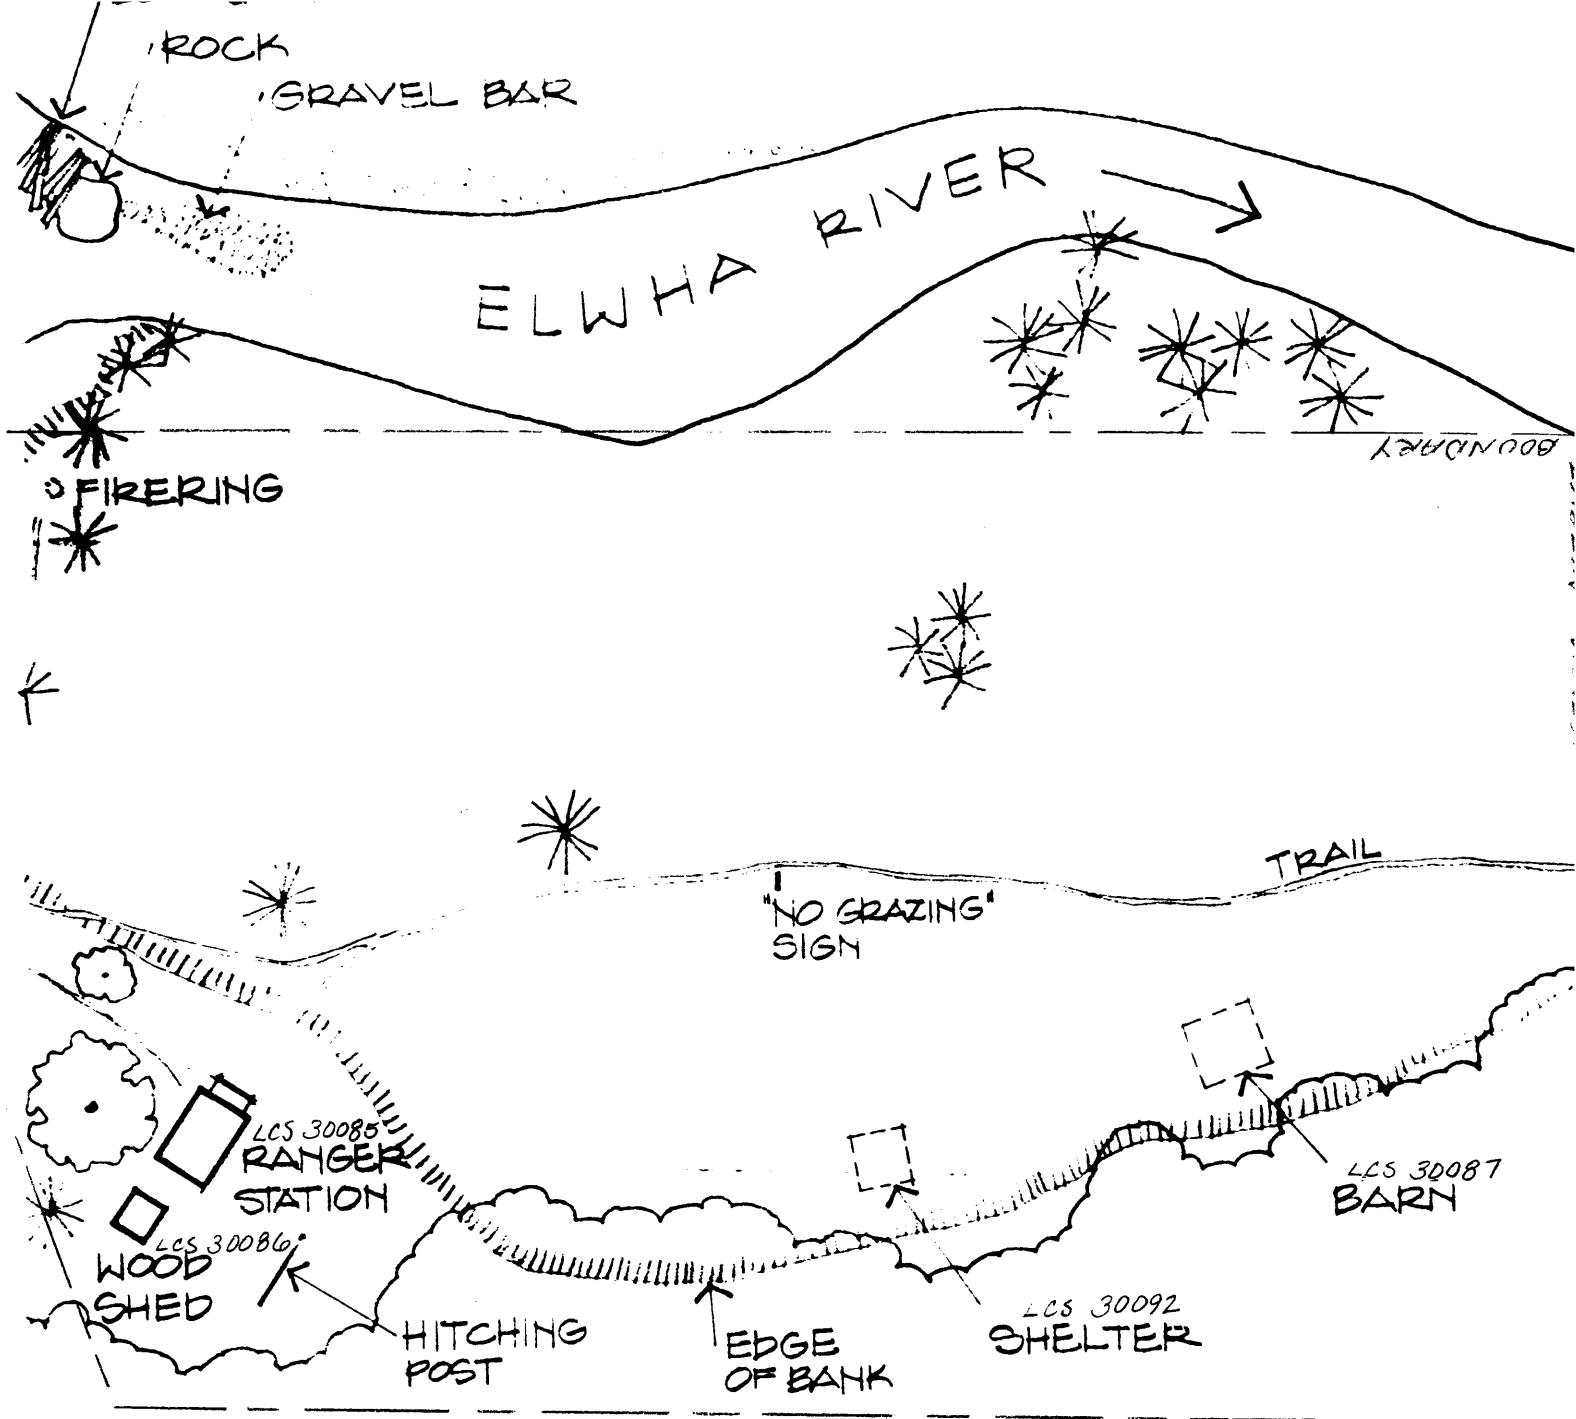
ELKHORN GUARD STATION HISTORIC DISTRICT

The boundary is formed by an irregular polygon which encompasses the one building, three structures and the open meadow that reaches the river's edge and is visible from the residence.

The boundary includes the guard station residence, woodshed, shelter and barn, and the immediate surrounding clearing and forest backdrop to convey a sense of the historic setting.
